ROYAL AIRCRAFT ESTABLISHMENT

Technical Report 77014

**A CHEMICAL TREATMENT
FOR MERCURY ACCIDENTALLY
SPILLED IN AIRCRAFT**

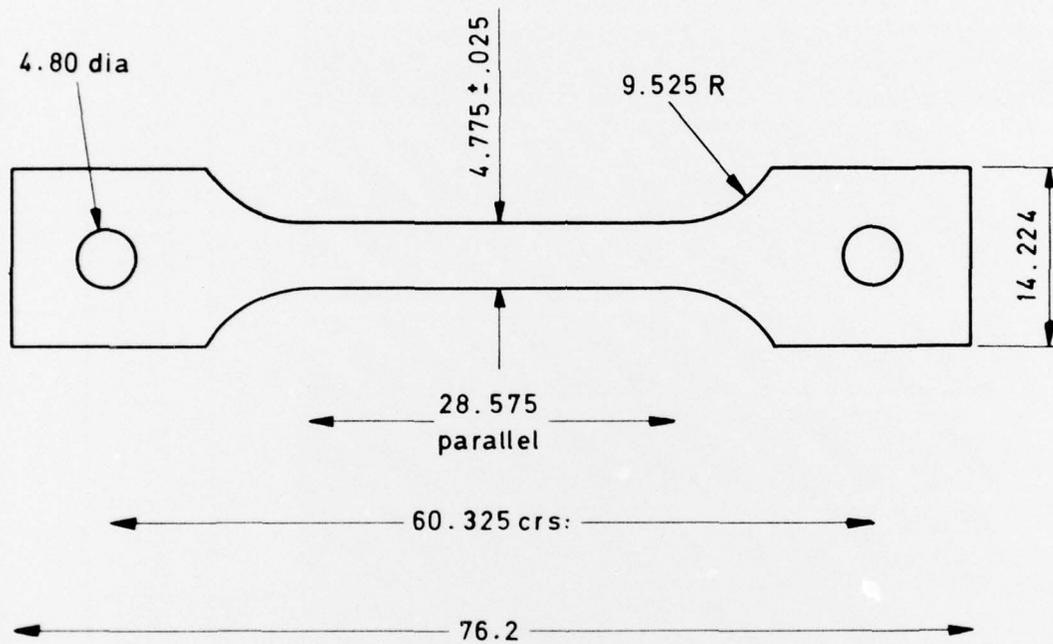
Dimensions in mm
Scale 2:1

Fig 1 'C'-type sheet tensile test piece

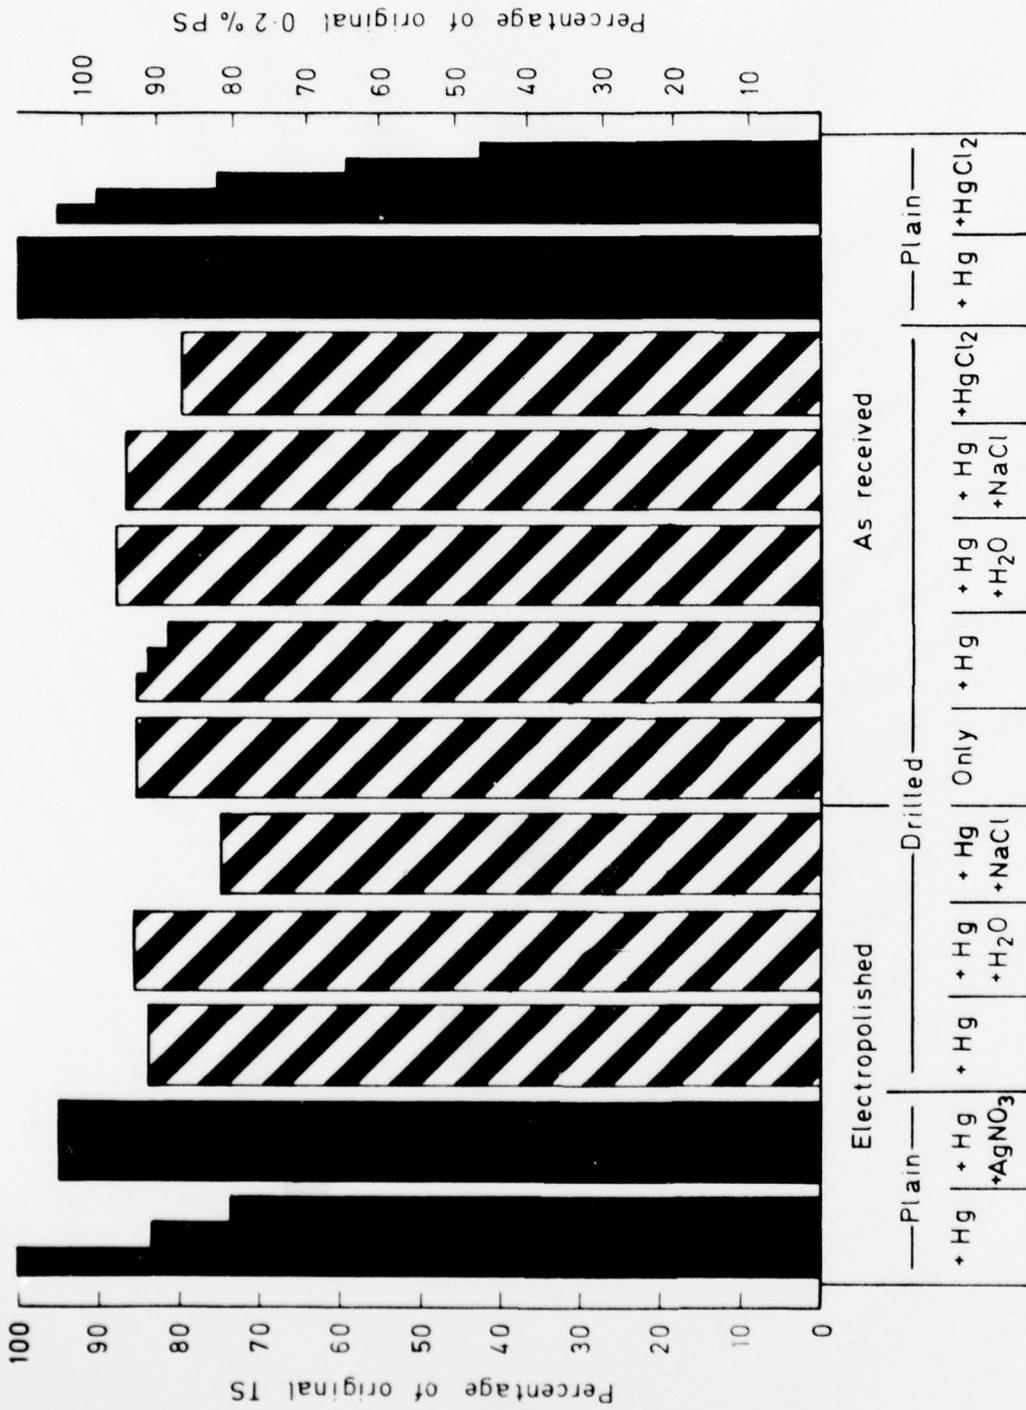
Fig 2 L71 C'-type long transverse test pieces. Residual strength after exposure to mercury environments while stressed at up to 80% of 0.2% proof stress

The initial experiments were done in triplicate in a Hounsfield Tensometer using transverse L71 sheet tensile test pieces, pre-stressed at 80% of the 0.2% PS. The technique described in section 2.2.2 was used, drilling through mercury into the alloy while stressed. This did not produce failures within 18 h when the test pieces were stressed at 80% of the 0.2% PS, nor did the presence of water or of 5% sodium chloride around the mercury pool affect the results. After the period of sustained load the test pieces were strained to failure, which occurred between 89 and 96% of the 0.2% PS (see Fig 2). Attempts were then made to encourage the wetting of the test pieces, stressed to 80% of the 0.2% PS as before, using the technique described in section 2.2.1, electropolishing of the alloy before the application of elemental or combined mercury. No failures occurred in times up to 16 h. Similar results were obtained by drilling through the mercury pool in the presence of water or 5% sodium chloride. Subsequent testing to failure revealed a slight variation in the residual strength. For those test pieces drilled through mercury in the presence of 5% sodium chloride failure occurred at 82% of the 0.2% PS, whereas those drilled through mercury alone, or with mercury plus water, failed at 94 and 96% of the 0.2% PS respectively. When drilling was done through a solution of 2% mercuric chloride into three test pieces pre-stressed at 80% of the 0.2% PS, failure did not occur in up to 18 h. Subsequent testing to failure produced residual strengths of 87% of the 0.2% PS (see Fig 2).

The difference between the residual strengths of the as-received test pieces treated with mercury alone (109% of the 0.2% PS), and those electropolished prior to exposure to mercury (80-109% of the 0.2% PS) may be related to the pre-stressing value of 80% of the 0.2% PS for the former and 60% for the latter. This suggests that attack was accelerated by the exposure of fresh surfaces of metal during testing to failure. This effect is also evident with as-received test pieces treated with 2% mercuric chloride when stressed between 40% and 80% of the 0.2% PS for several hours, after which they failed ultimately at stress levels between 45% and 97% of the 0.2% PS (Fig 2).

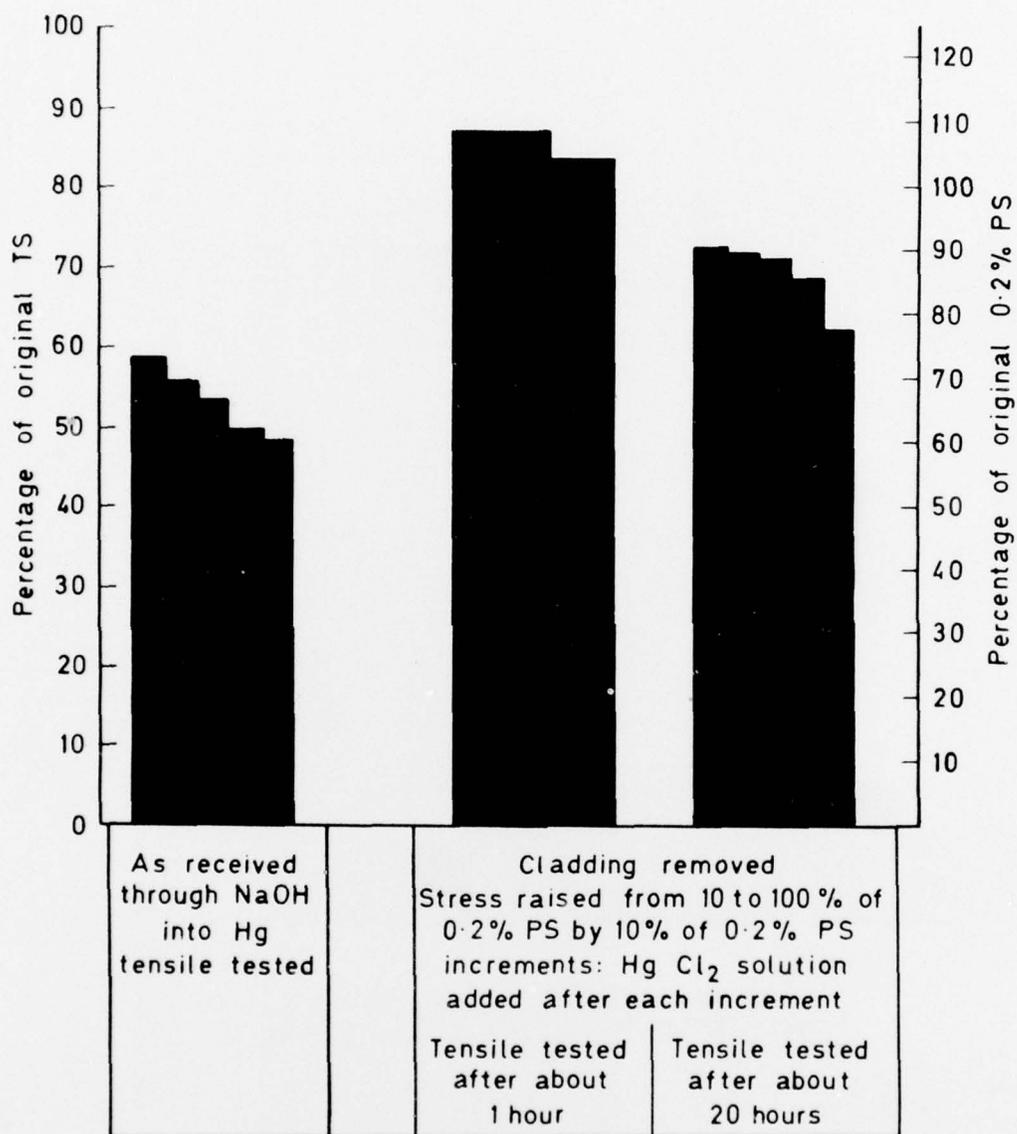
Fig 3 L88 'C'-type long transverse test pieces. Residual strength after exposure to mercury environments

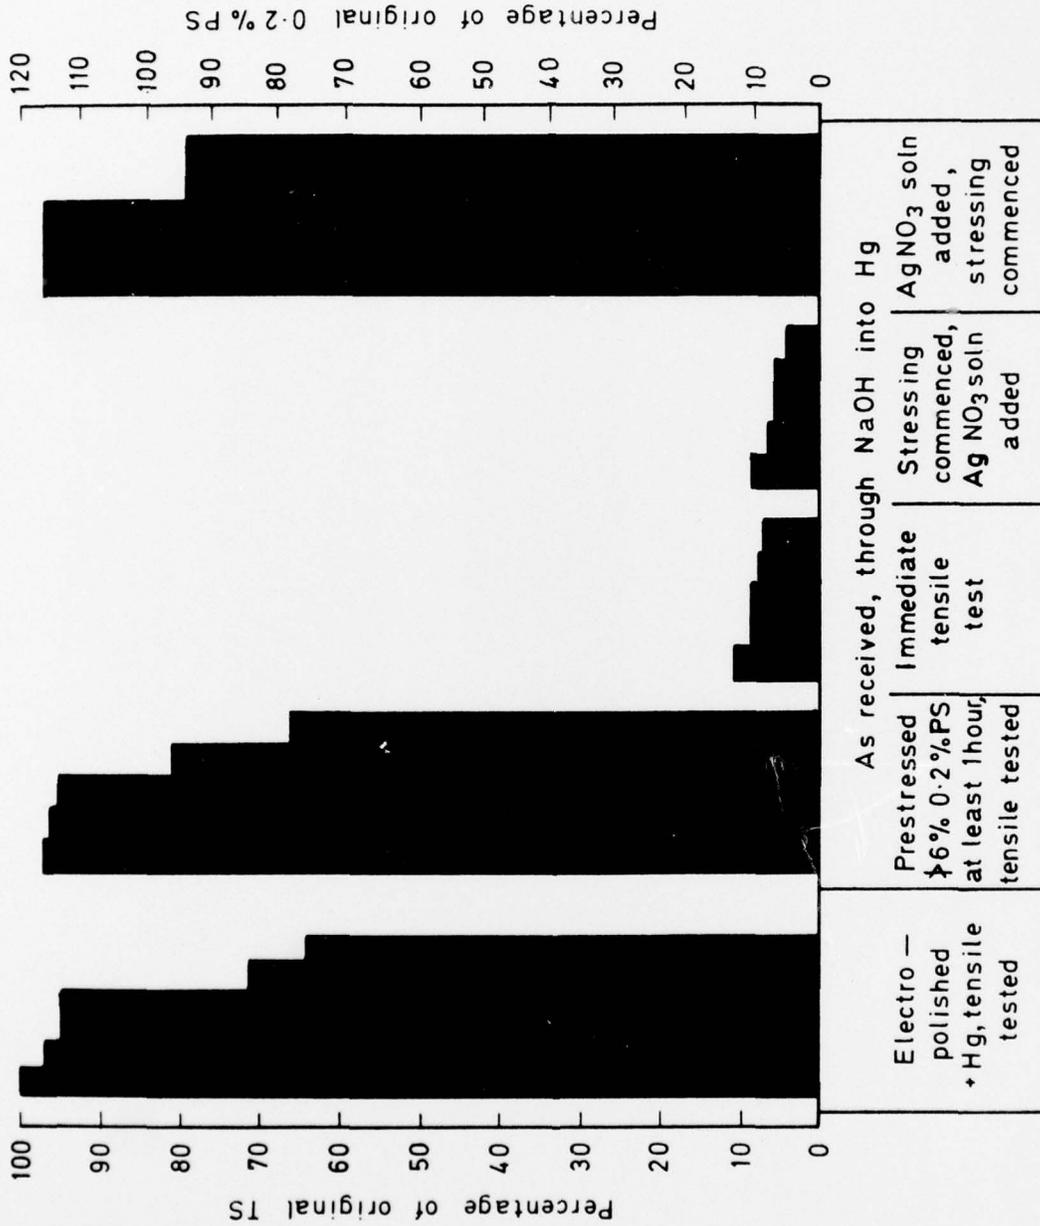
Fig 4 DTD 5050 'C' type short transverse test pieces. Residual strength after exposure to mercury

followed by an alcohol rinse *before* stress was applied, failed at between 94% and 115% of the 0.2% PS. Fig 4 summarizes all of the results obtained on short transverse sheet tensile test pieces of 5050, five of which were used in each experiment.

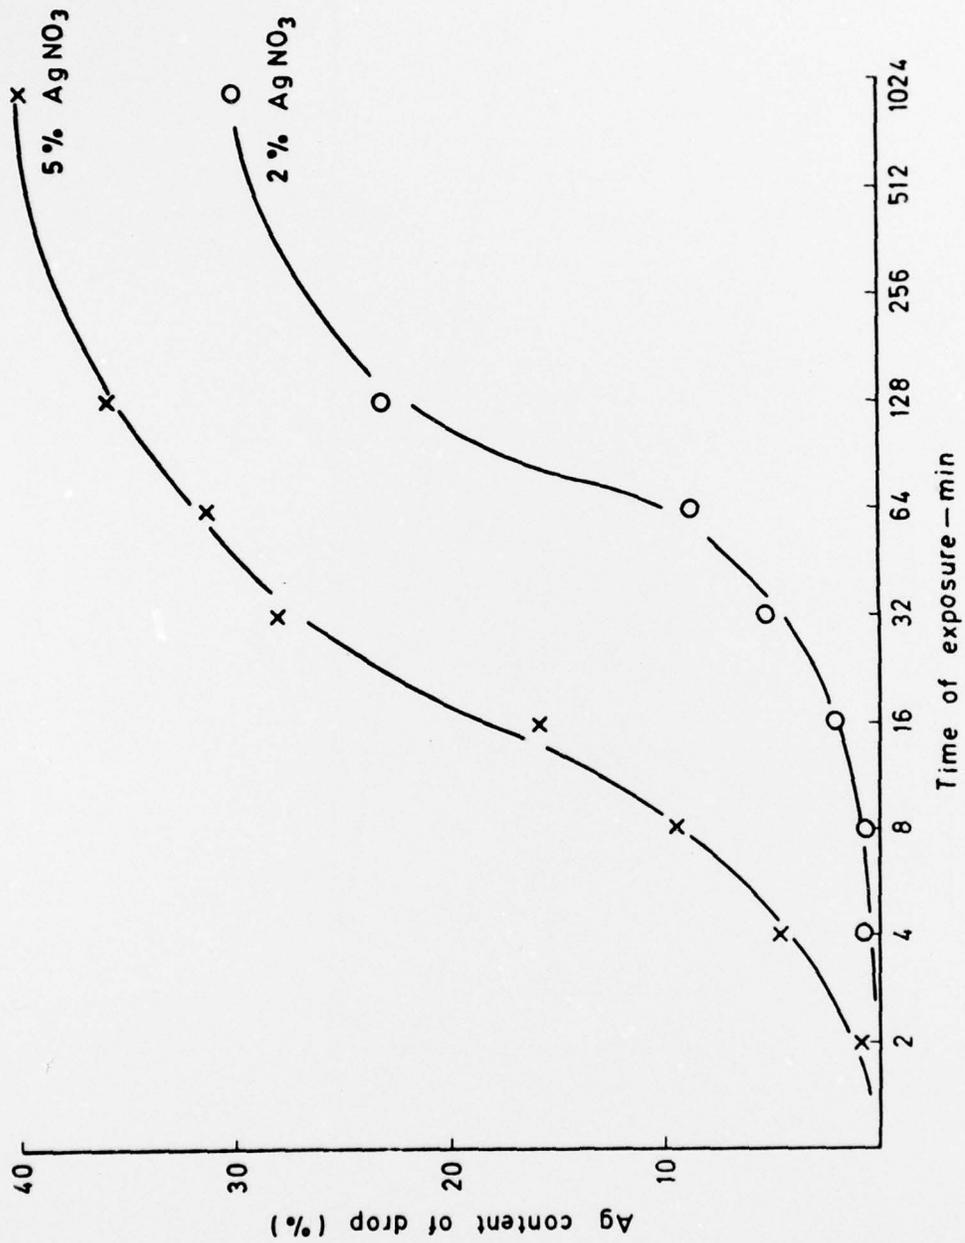
Fig 5 Uptake of silver by about 175mg mercury from 100 cm³ quantities of silver nitrate solution

the silver-mercury alloy, are plotted against the time of exposure in minutes. It can be seen that the uptake of silver in the case of the 5% solution was much faster and that the quantity of silver in the alloy had reached 30 wt.% after 30 min and 40 wt.% after 17 h, despite the absence of stirring, whereas in the 2% solution of silver nitrate the silver content of the mercury drops had only reached 30 wt.% after 17 h. A 5% silver nitrate solution was, therefore, chosen for this investigation to ensure rapid transformation of mercury to an alloy free from elemental mercury.

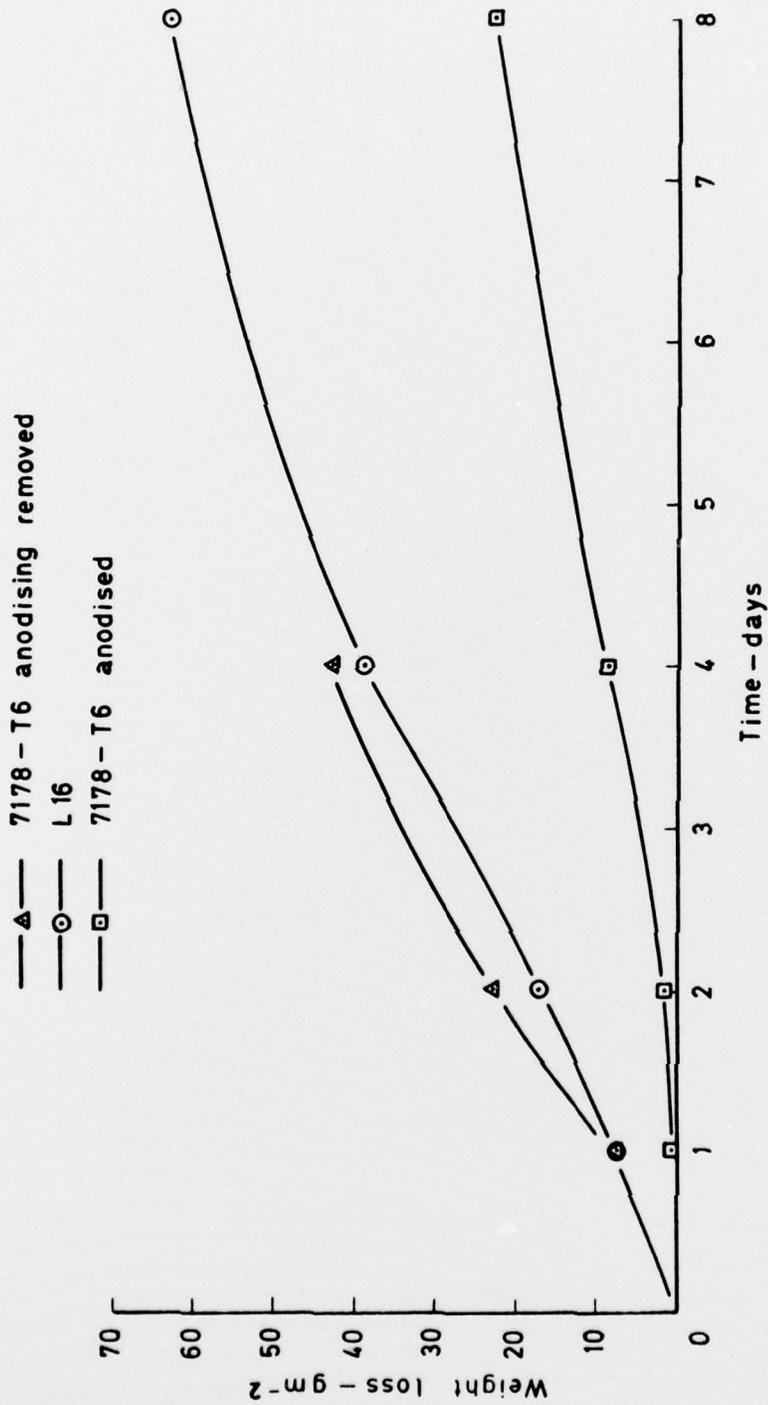
Fig 6 Weight loss from aluminium or aluminium alloy sheet when immersed in 5% silver nitrate solution

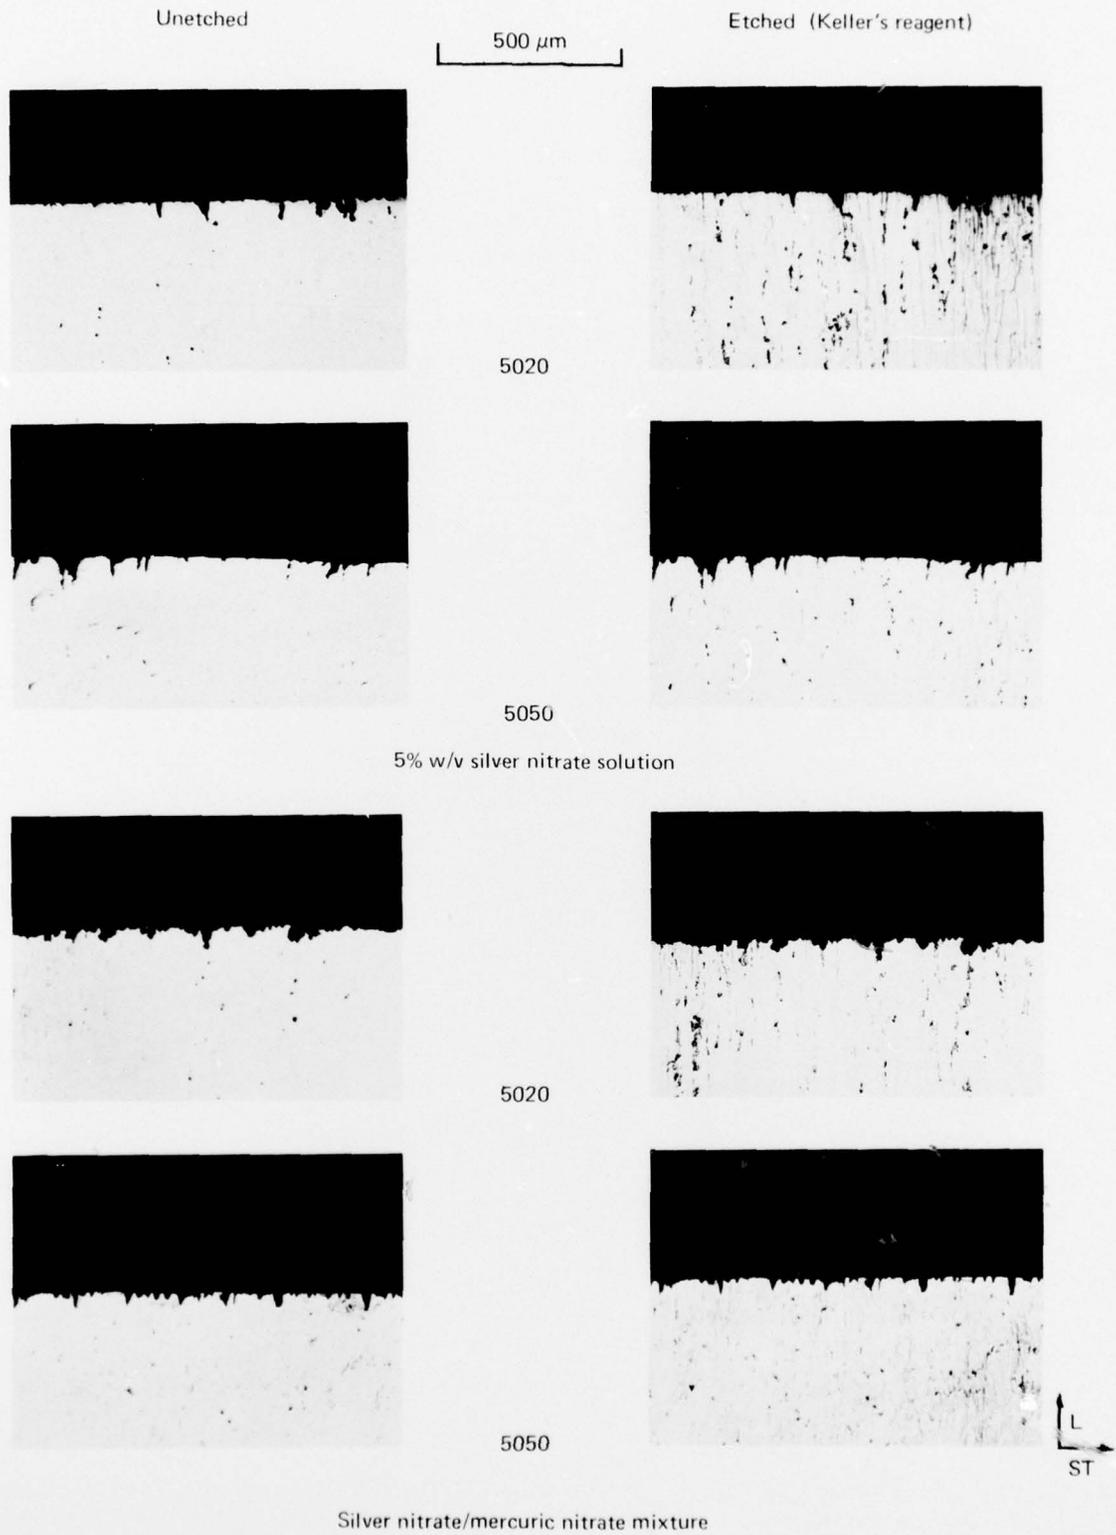
Fig 7 Test pieces stressed at 90% of 0.2% PS exposed for 28 days to alternate immersion in silver nitrate, and in mixed silver and mercuric nitrate solutions. L/ST sections

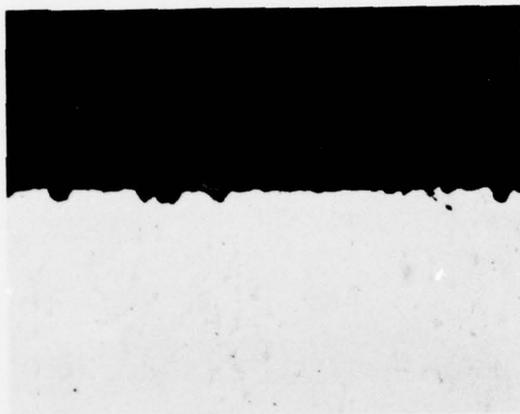
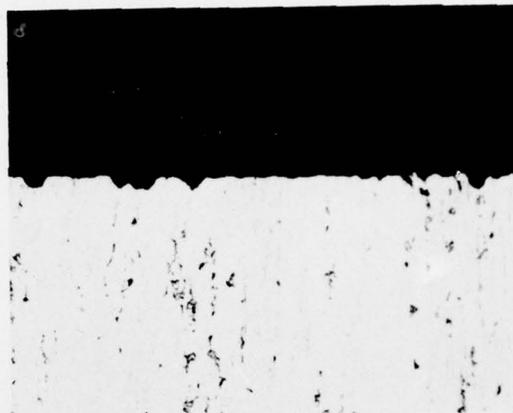
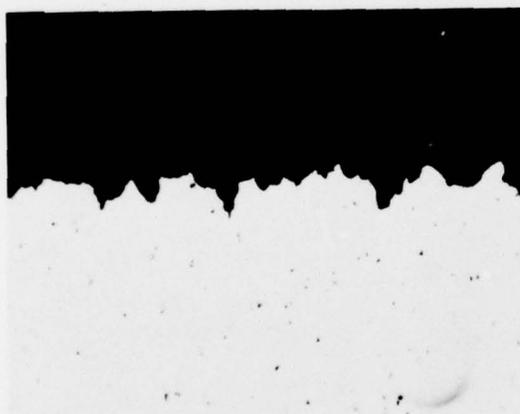
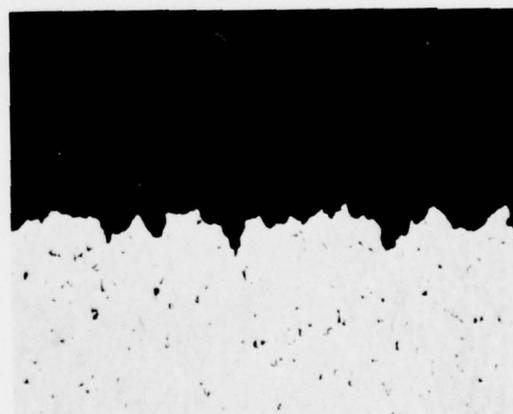
5020 stressed at 90% of 0.2% PS

5050 stressed at 30% of 0.2% PS

Fig 9 28 day exposure to moist silver-mercury alloy. L/ST sections

The other extreme situation envisaged was one in which a quantity of the silver amalgam was in contact with an aluminium alloy. Consequently the gauge lengths of stressed short transverse Alcoa-type test pieces of 5050 and 5020 alloy were surrounded with 10 g quantities of the silver/mercury alloy made by the reaction of mercury with an excess of silver nitrate. The amalgam *in situ* was moistened with 1 cm³ of 5% silver nitrate solution and the mixture hermetically sealed to prevent drying out. Three 5020 test pieces survived unbroken for 28 d when stressed to 90% of the 0.2% PS. Three 5050 test pieces survived for 28 d when stressed to 30% of the 0.2% PS; one of two survived when stressed to 60% and those stressed to 90% of the 0.2% PS both failed. Typical sections ($\times 76$) of etched and unetched unbroken test pieces are shown in Fig 9.
