Technical Report

CONTAINER OFF-LOADING AND TRANSFER SYSTEM (COTS)
Advanced Development Tests of Elevated Causeway System

VOLUME IV — FENDER SYSTEM AND LIGHTERAGE MOTIONS

by D. A. Davis

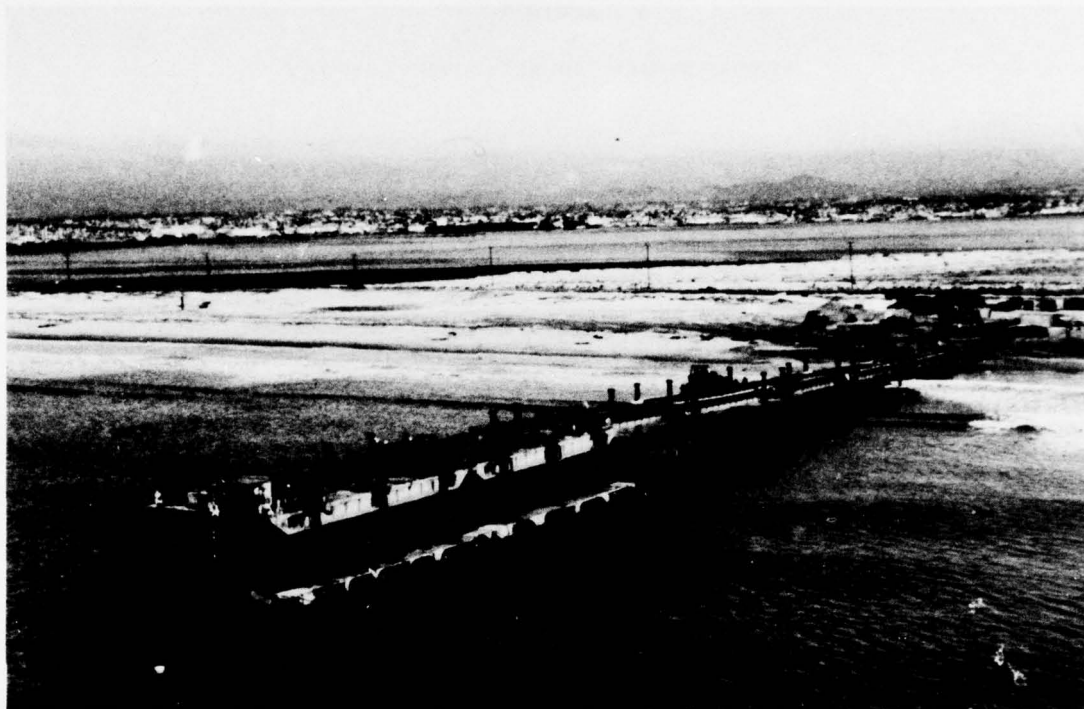
Figure 1-1. COTS elevated causeway.

The elevated causeway is comprised of a number of 3x15 NL pontoon sections [21.0 feet (6.4 m) wide and 90.0 feet (27.4 m) long] which are end-linked and side-connected together and supported clear of the water surface by steel piles (see Figure 1-1). Individual 3x15 pontoon sections arrive at the shore site aboard Navy LSTs and LSDs or aboard commercial bargeships. They are unloaded, linked together at sea to form the desired causeway configuration, and then beached. Steel piles that are inserted through spudwells in each pontoon section are driven into the sea-floor. After the end and side connections are disconnected, individual causeway sections are elevated into position by portable hydraulic jacks atop the piles. The end and side connections are re-established, the fender system is installed, and the elevated causeway is ready to function as a cargo unloading pier.

An essential subsystem of the COTS elevated causeway is the fender (see Figure 1-1). The purpose of the fender is to absorb the kinetic energy of the cargo lighters during berthing and to prevent contact between the lighters and the pier support piling. After a preliminary conceptual design study it was decided that the fender should be configured to capitalize on standardized Navy NL pontoon equipment and commercially available off-the-shelf hardware. General performance standards to be met included:

The Coronado elevated causeway (Figure 1-1) was comprised of nine 3x15 NL pontoon causeway sections. Four sections were aligned two abreast to form a pierhead at the seaward end of the causeway. The fender system, consisting of two 1x15 strings instead of the single unit used during the Phase I tests, was installed alongside the south-facing edge of the pierhead (Figure 1-7).

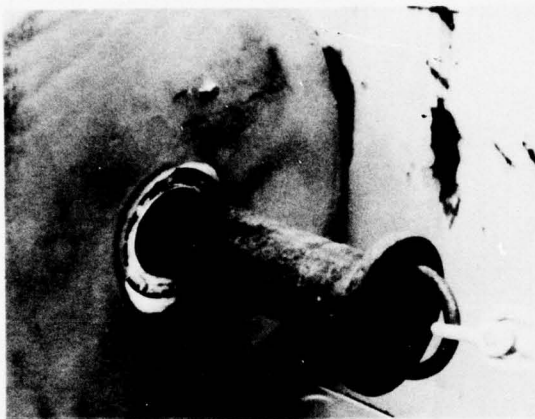
Figure 1-6. Pipe core pull-out on foam cushion.

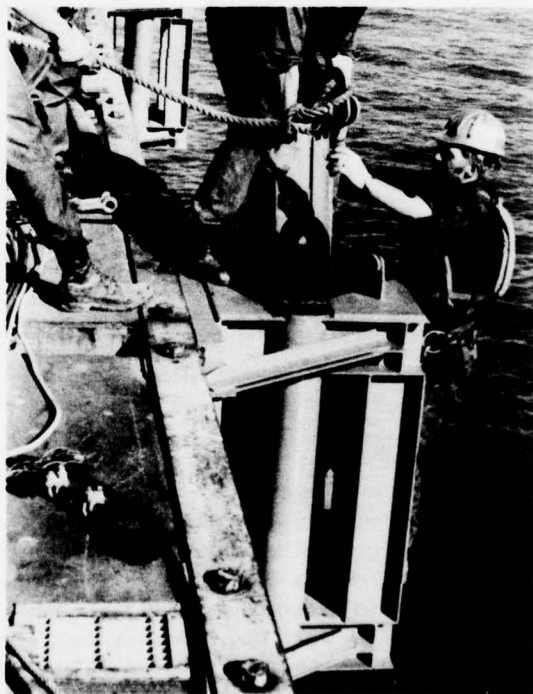
Figure 1-10. Installing pile guide in external spudwell.

Prior to the tug making its final approach at the elevated causeway site, a pier deck crew had inserted one of the tipped fender piles into the middle, external spudwell on the south-facing, shoreward-most pierhead causeway section (Figure 1-9). Their instructions were to drop the first pile when the fender system was properly aligned alongside the elevated causeway. Pile guides, i.e., steel sleeves, that fit inside the spudwell and are bolted to the spudwell's padeyes were used on five of the six fender piles (Figure 1-10).
