CERL-TR-M-221

TECHNICAL REPORT M-221  
July 1977

EVALUATION OF THE CORROSION RESISTANCE  
OF ALTERNATE REVETMENT WIRE FABRIC  
MATERIALS IN THE LOWER MISSISSIPPI RIVER

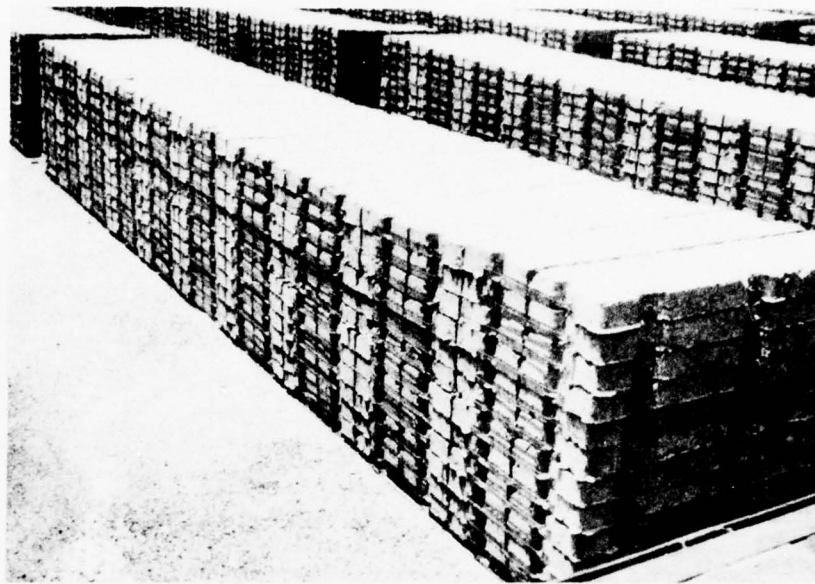
**Figure 2.** "Squares" after casting. The squares consist of concrete slabs cast onto the wire fabric.

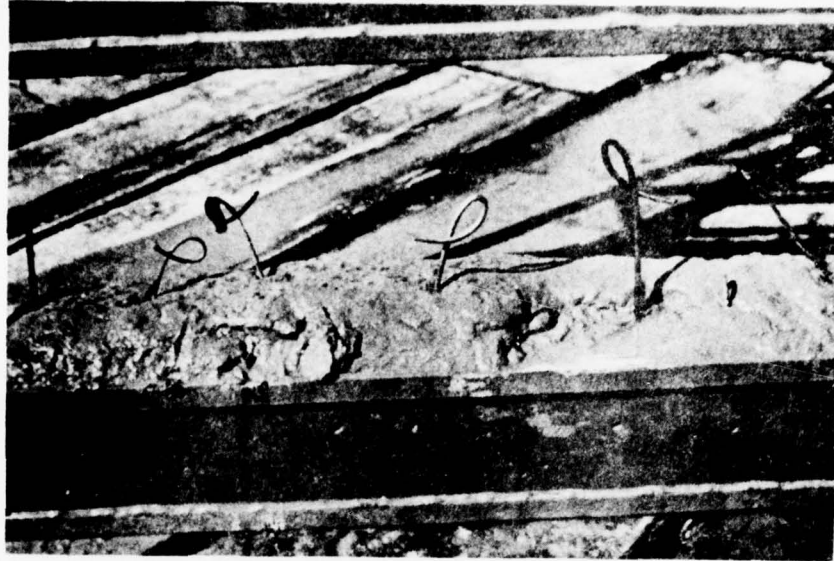
**Figure 4.** Test block with looped-end test wires after exposure.

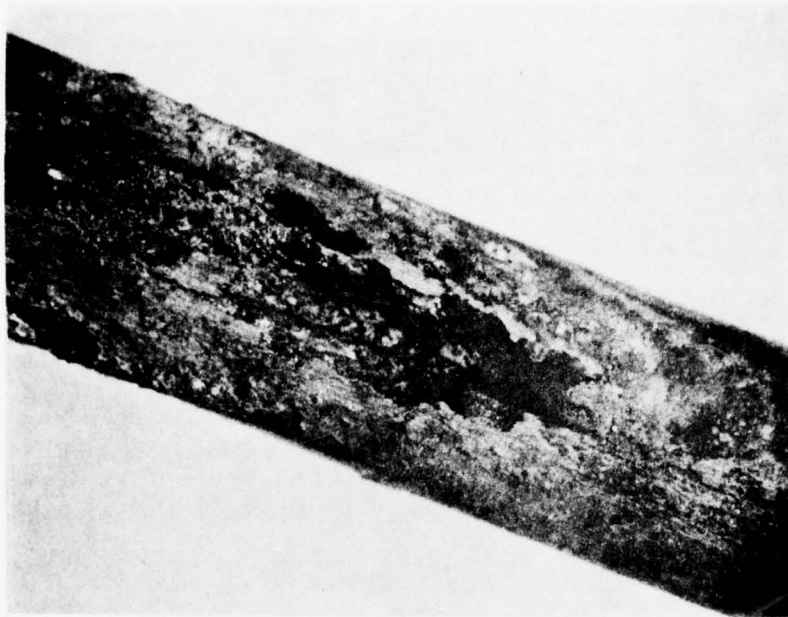
**Figure 8.** Corrosion attack into the interior of an AISI 430 stainless steel specimen. Only a thin uncorroded outer layer remains. (Block 45)(7.5x)

Exposure of AISI 430 specimens in brackish water resulted in obvious corrosion after 15 months. Figure 7 shows surface pitting and deep corrosion into the interior of AISI 430 wire samples. Figure 8 shows a closeup of the interior corrosion. Because the severe corrosion attack was away from the 4-in. (101.6-mm) test section, no change in electrical resistance was noted. The tensile test results (Table 11) show a 38 percent loss in strength and a complete loss in ductility.

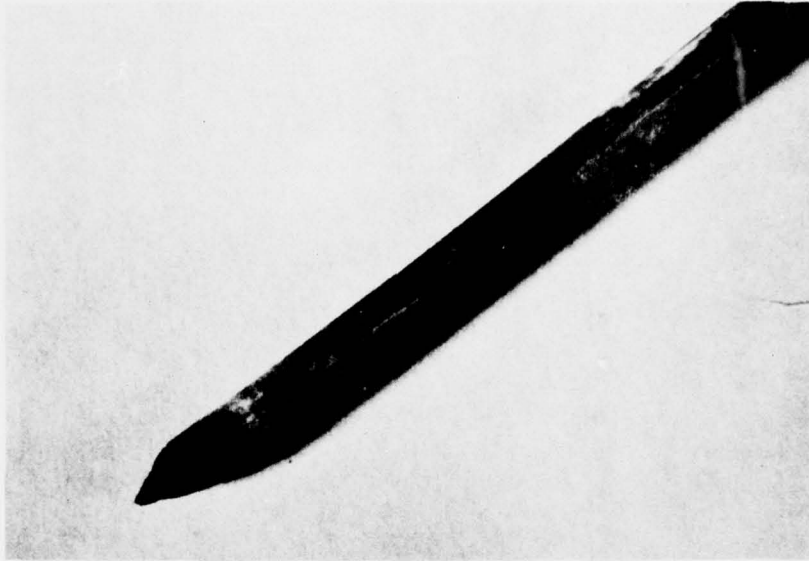
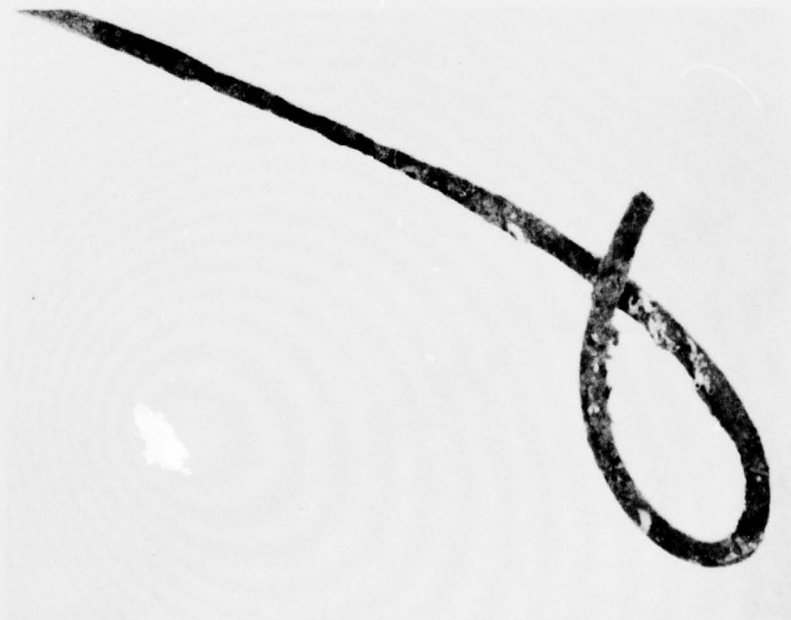
a. Freshwater specimen.

b. Brackish water specimen.

**Figure 10.** Accelerated corrosion in plain carbon steel wire at the region where the wire exits from the concrete.

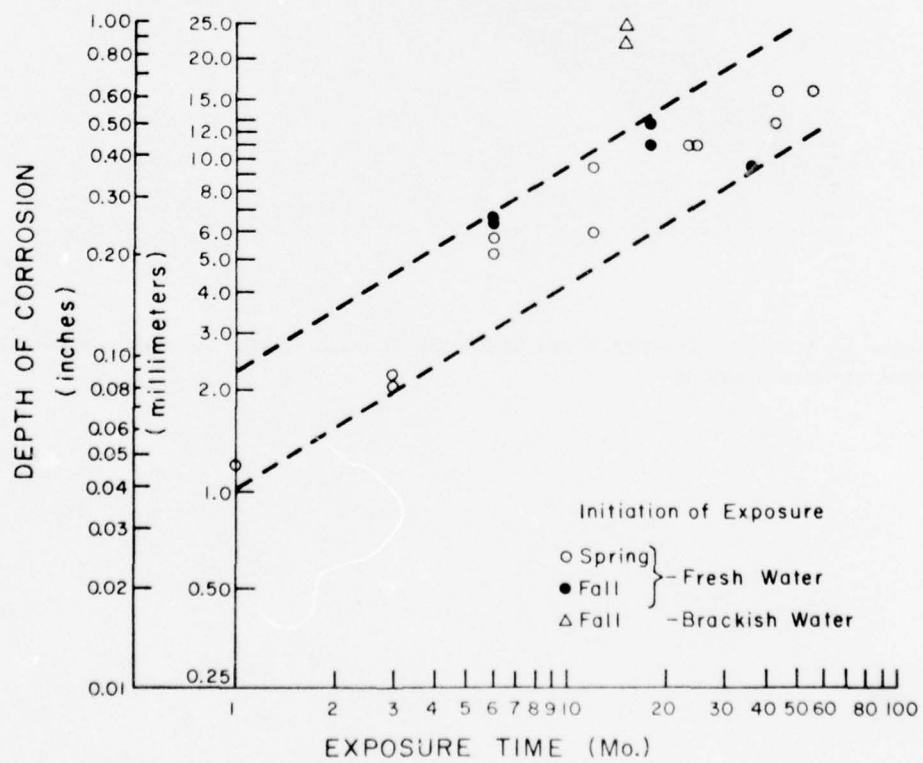
Figure 16. Depth of corrosion into the exposed end of copper-clad steel wires.

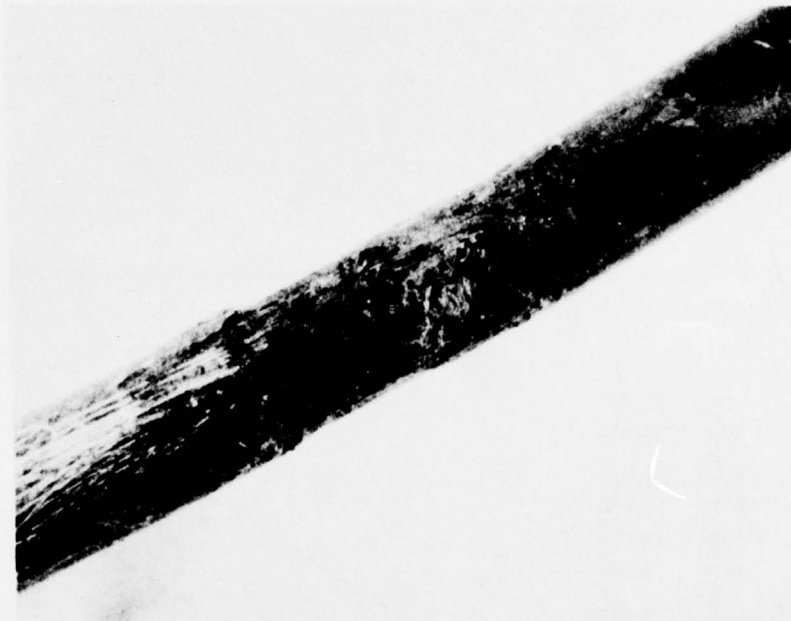
**Figure 17.** Localized corrosion attack in the copper cladding after 15 months exposure in brackish water. (Block 48)

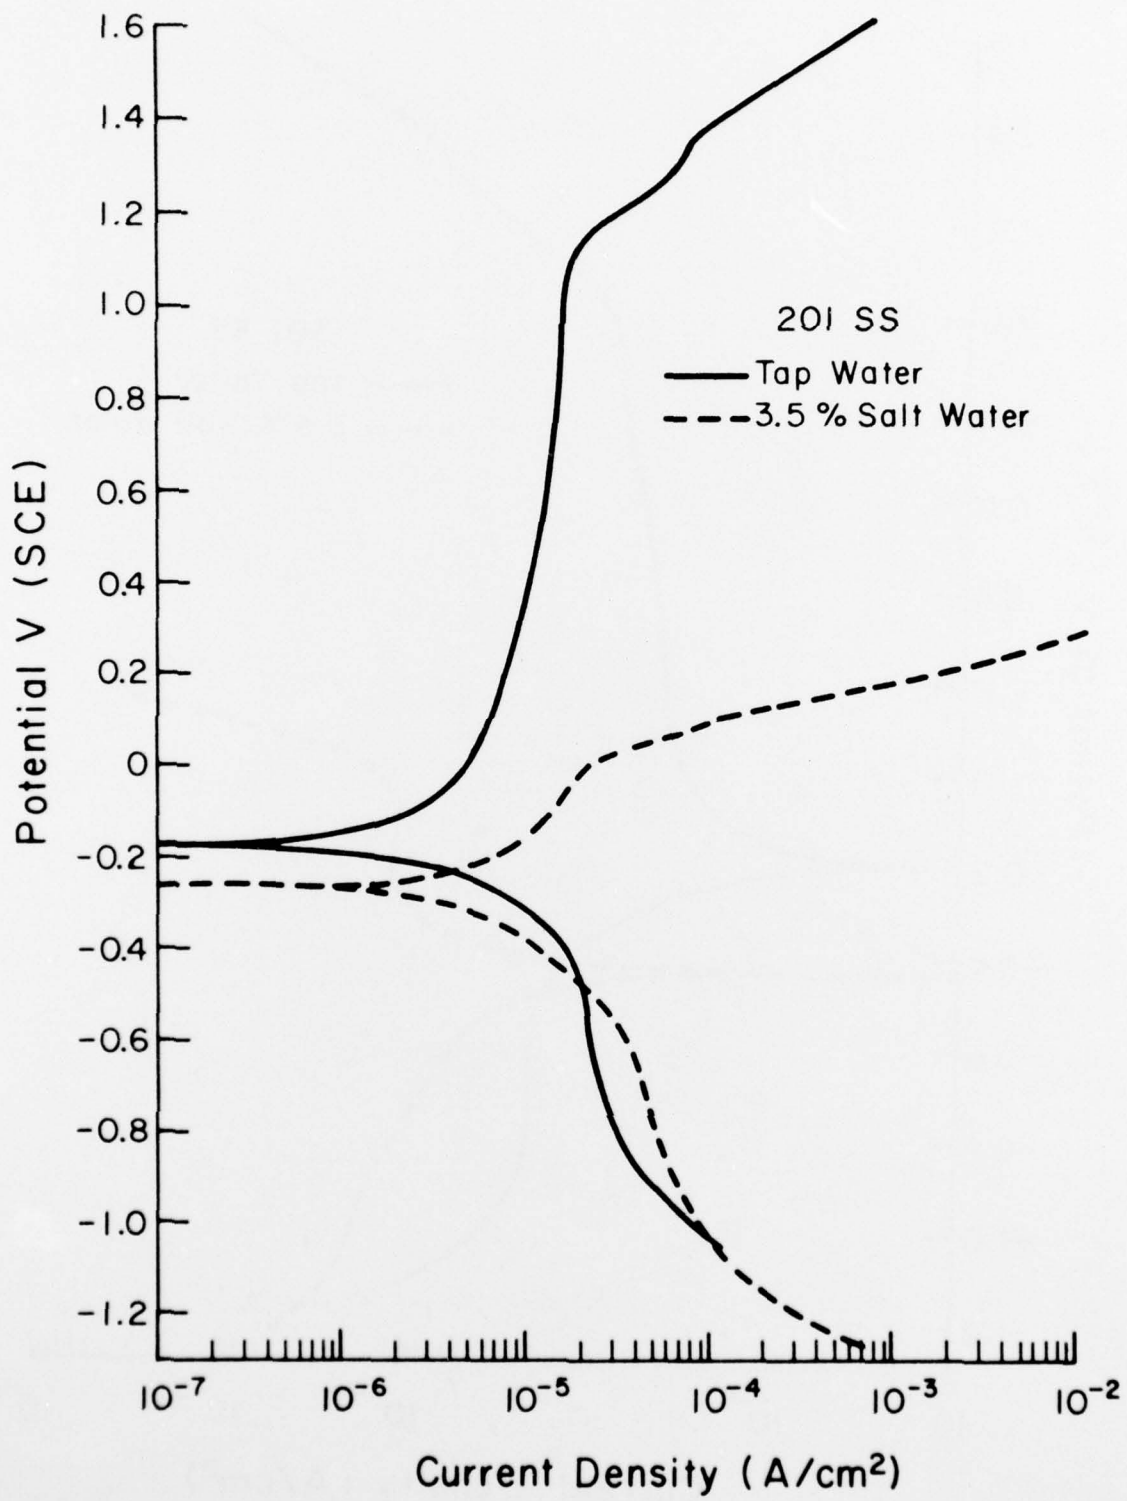
**Figure 24.** Potentiodynamic polarization curves for AISI 201 stainless steel in tap water and salt water.

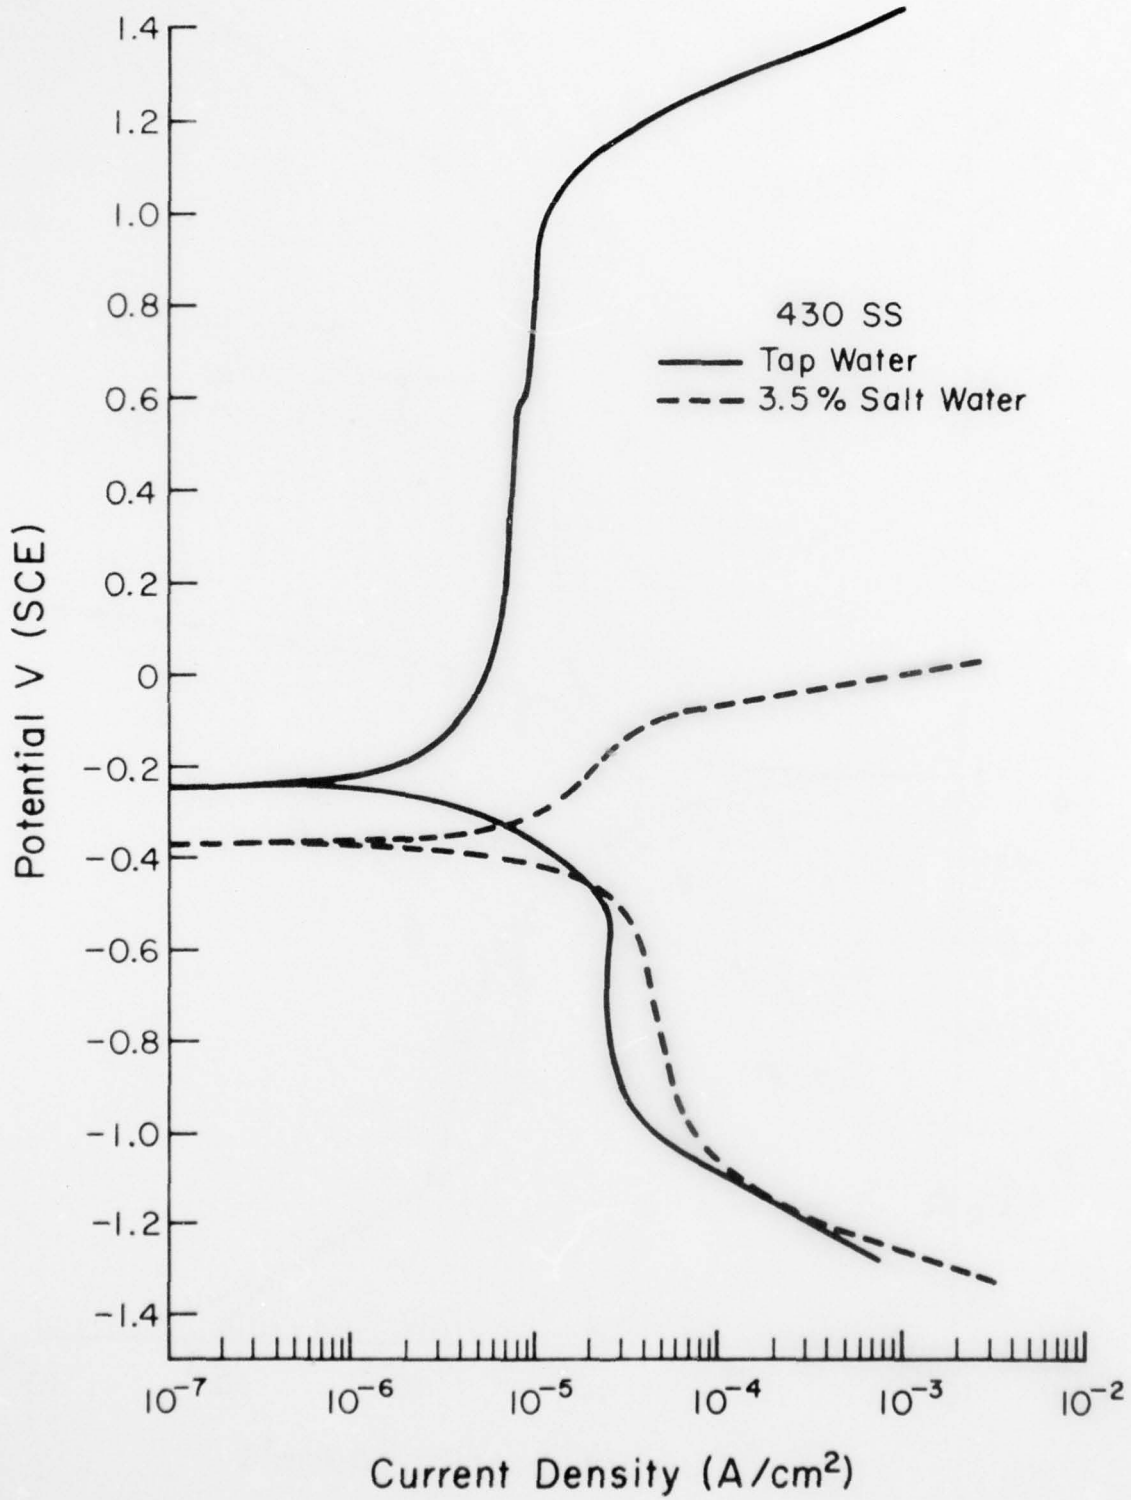
**Figure 27.** Potentiodynamic polarization curves for AISI 430 stainless steel in tap water and salt water.
