AN EVALUATION OF HEATING AND EROSION IN THE  
105mm XM204 HOWITZER AND 155mm M185 CANNON

Calspan Technical Report No. VL-6050-D-1

Prepared For:  
PICATINNY ARSENAL  
DOVER, NEW JERSEY

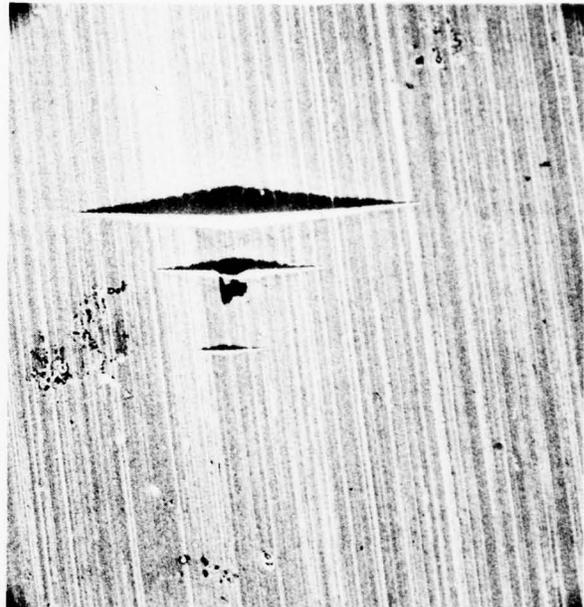
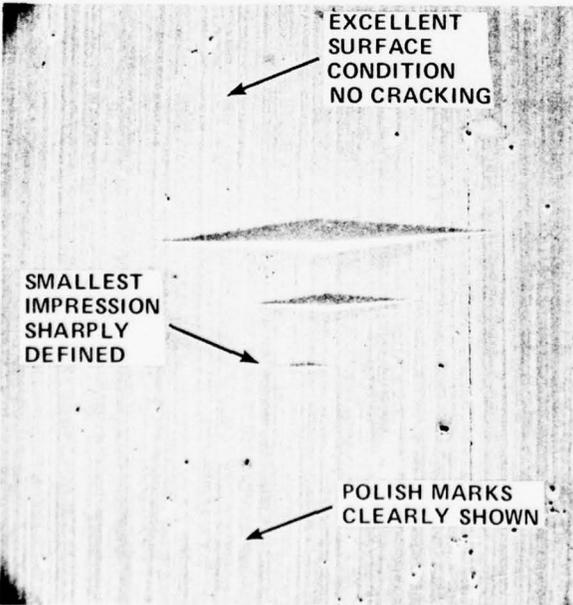
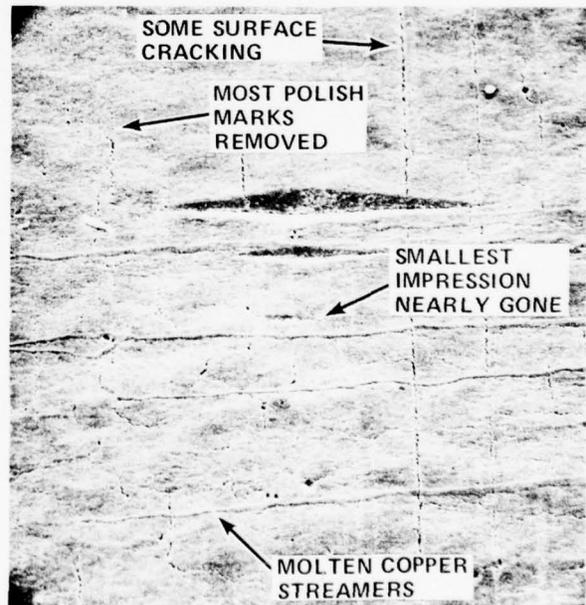
Figure 1 COMPARISON OF STEEL EROSION SENSORS FOR M119 AND UNMODIFIED XM 201 E2 CHARGES (200X)

SENSOR FOR GROUP 2 (M119) BEFORE FIRING

SENSOR FOR GROUP 8 (STD. XM 201 E2) BEFORE FIRING

SENSOR AFTER FIVE M119 SHOTS

SENSOR AFTER FIVE (STD. XM 201 E2) SHOTS

Erosion data generated after examination of the erosion sensors is summarized in Table III. A descriptive account of selected sensor surface condition before and after test is further given by the photographs of Figures 1 through 4. Generally, it was found that the XM201E2 mods showed greater erosion than that of the M119 charge. The unmodified XM201E2 showed greatest surface erosion. Figures 1 and 2 illustrate the erosion differences between the M119 charge and the unmodified XM201E2. In Figure 1, compared to the excellent surface condition on steel for the M119 after firing, the steel sensor used in the XM201E2 firings shows obvious surface loss and cracking. Differences are further amplified by the Inconel sensors of Figure 2. Of course, this result was anticipated from the earlier firings of Reference 2. Fortunately, it was also found in that work that erosion severity of the base ignited XM201E2 charge could be reduced considerably through the use of the 0.5 oz. black powder spot basepad and additional wear additive. Of those XM201E2 mods tested in the current work, it was found that increased internal additive resulted in reduced erosion. Hence, the 19 oz. internal additive design resulted in less erosion than the other internal additive designs of lesser additive weight. Furthermore, the erosion exhibited by the sensors for the 19 oz. internal liner design showed indistinguishable differences from that of the 12 oz. jacket (external) additive design shown effective in the 3000 round fired test at Yuma Proving Ground. Figures 3 and 4 illustrate the surface condition of both the steel and Inconel sensors for each of these two best performing designs.

The steel sensors for these designs compare favorably with that of the M119 (Figure 1). A comparison of Figures 4 and 2, showing the surface condition of the Inconel sensors, clearly demonstrates the improved performance of these mods over that of the unmodified XM201E2 as well as their degree of approach to erosivity of the M119 charge.

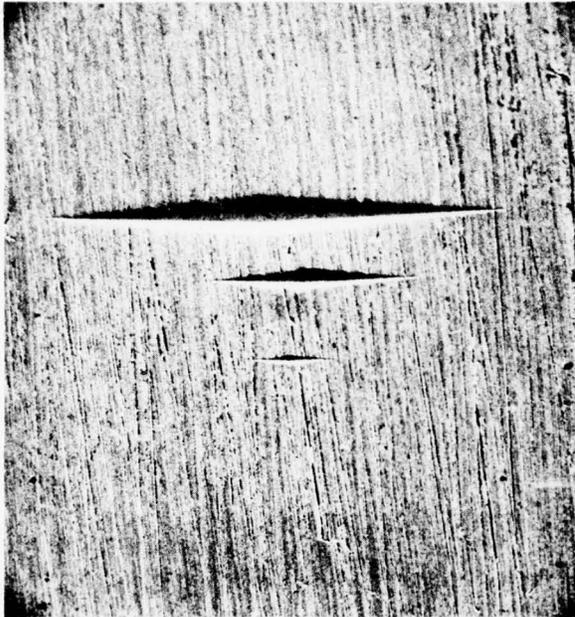
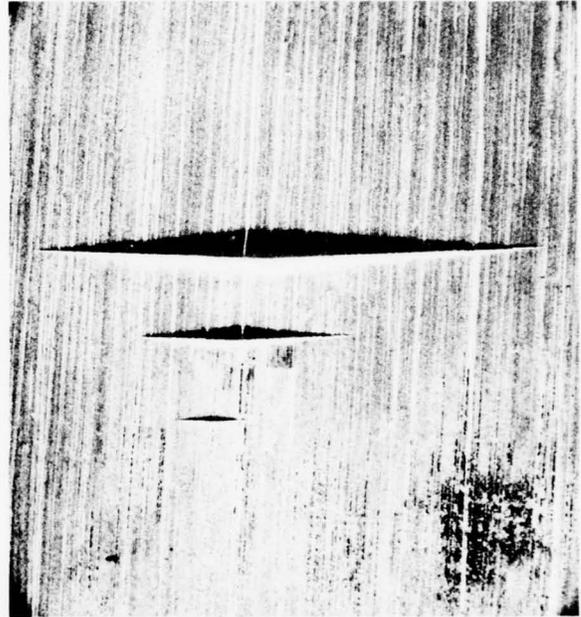
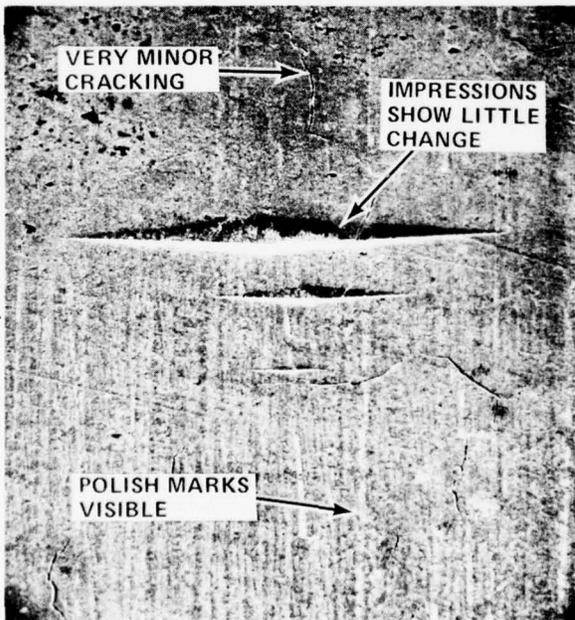
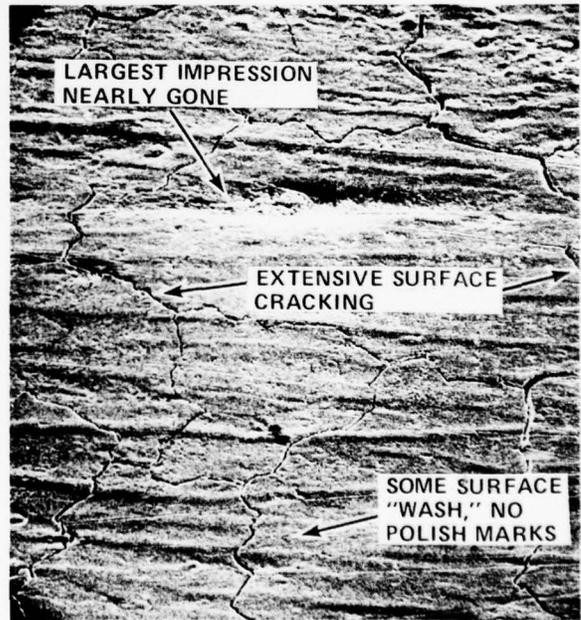
Figure 2 COMPARISON OF EROSION OF INCONEL SENSORS FOR M119 AND UNMODIFIED XM 201 E2 CHARGES (200X)

SENSOR FOR GROUP 2 (M119) BEFORE FIRING

SENSOR FOR GROUP 8 (XM 201 E2) BEFORE FIRING

SENSOR FOR GROUP 2 AFTER THREE M119 SHOTS

SENSOR FOR GROUP 8 AFTER THREE STD. XM 201 E2 SHOTS

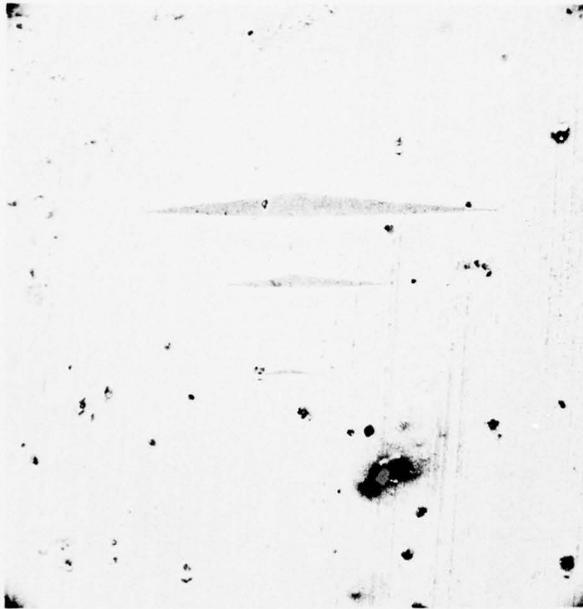
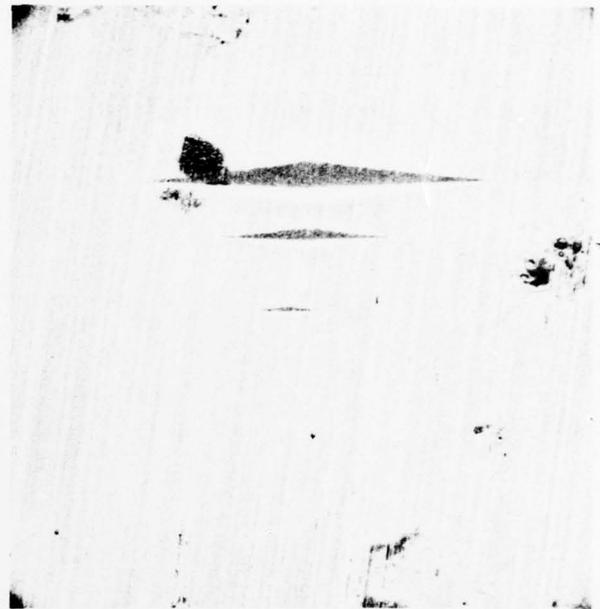
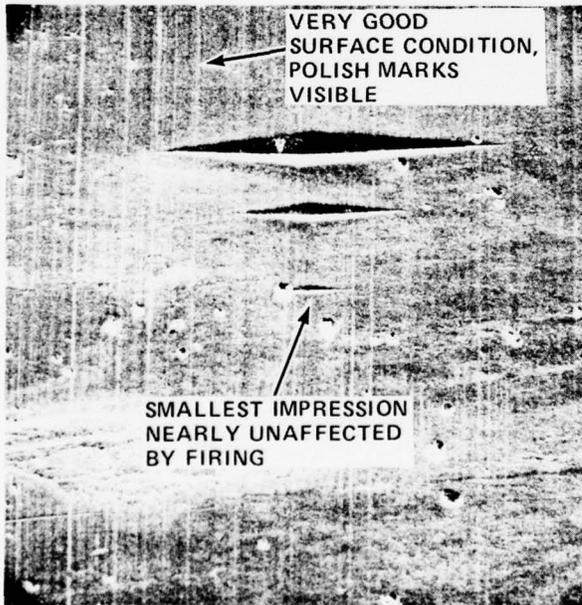
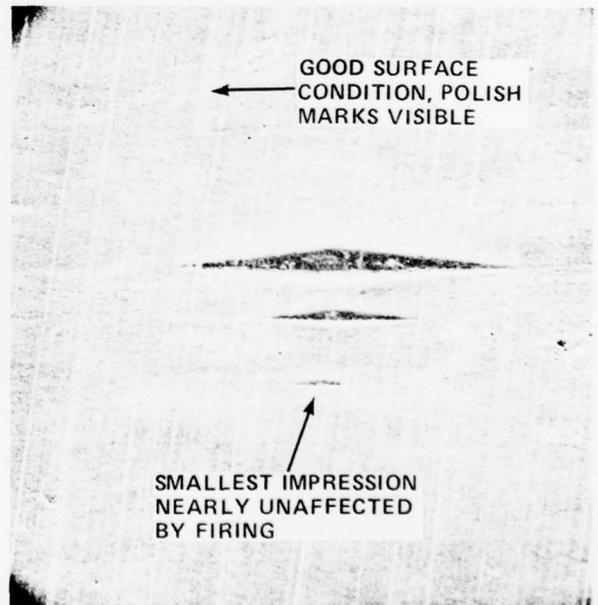
Figure 3 STEEL SENSOR SURFACE CONDITION BEFORE AND AFTER FIRING FOR TWO XM 201 E2 MODS INVOLVING INCREASED WEAR ADDITIVE (200X)

SENSOR FOR GROUP 6 (120Z JACKET) BEFORE FIRING

SENSOR FOR GROUP 5 (190Z LINER) BEFORE FIRING

SENSOR FOR GROUP 6 AFTER FIVE SHOTS

SENSOR FOR GROUP 5 AFTER FIVE SHOTS

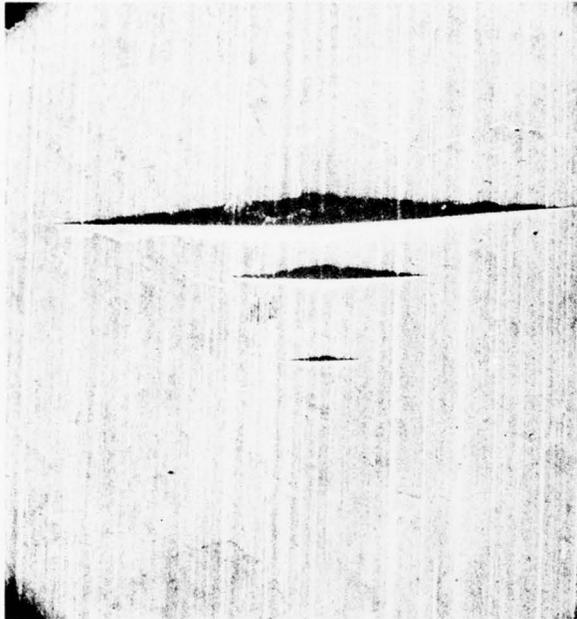
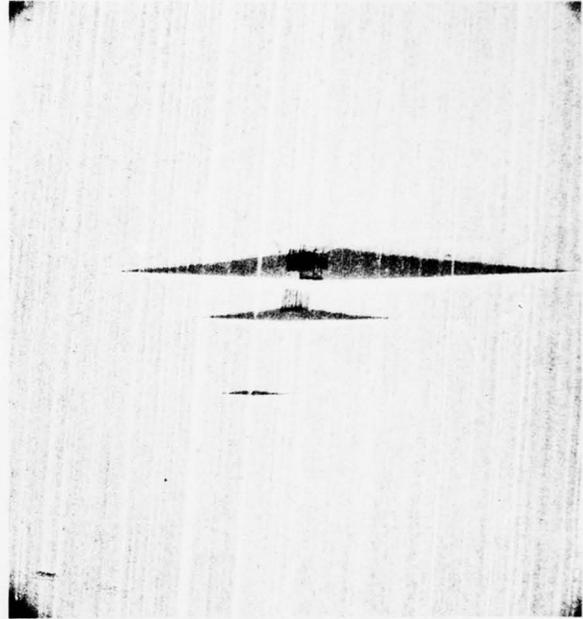
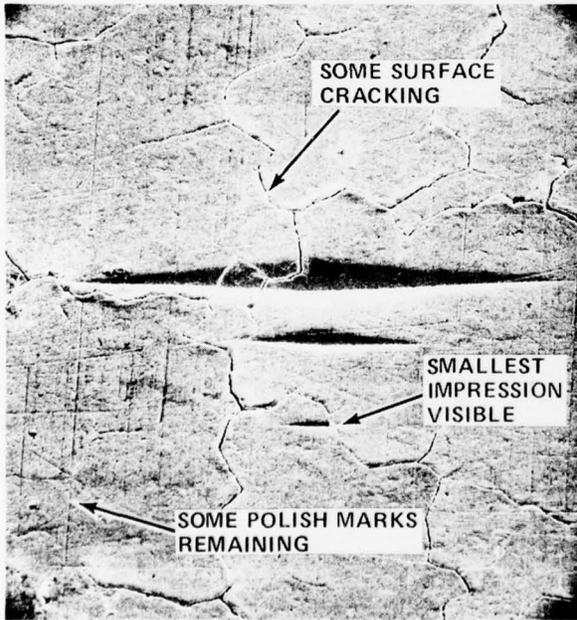
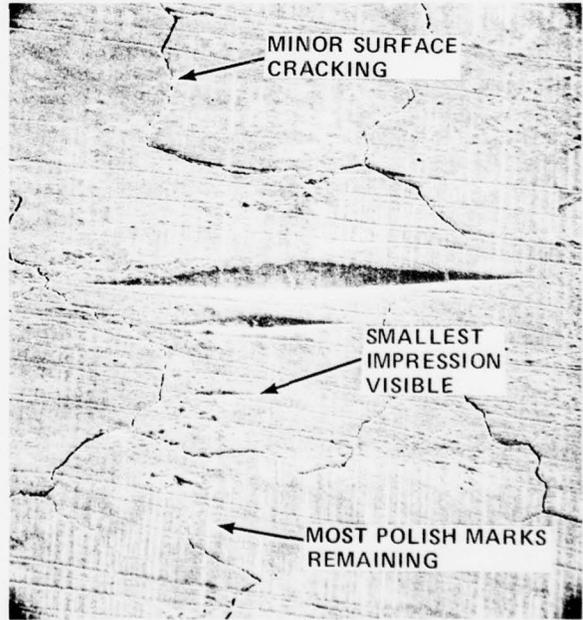
Figure 4 INCONEL SENSOR CONDITION BEFORE AND AFTER FIRING FOR TWO XM 201 E2 MODS INVOLVING INCREASED WEAR ADDITIVE (200X)

SENSOR FOR GROUP 6 (120Z JACKET) BEFORE FIRING

SENSOR FOR GROUP 5 (190Z LINER) BEFORE FIRING

SENSOR FOR GROUP 6 AFTER THREE SHOTS

SENSOR FOR GROUP 5 AFTER THREE SHOTS

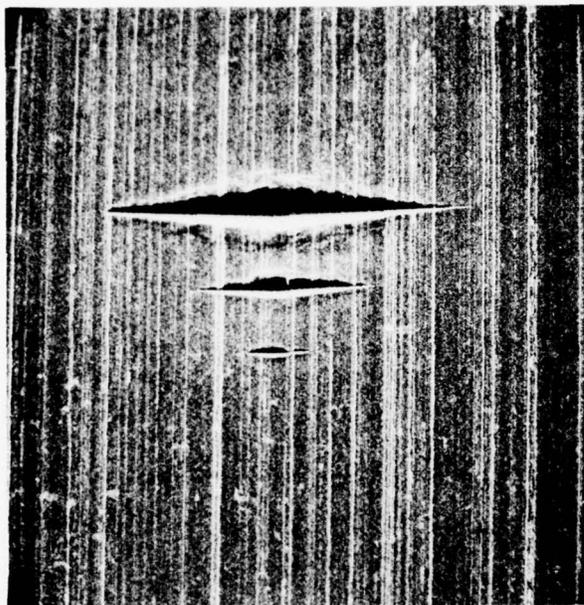
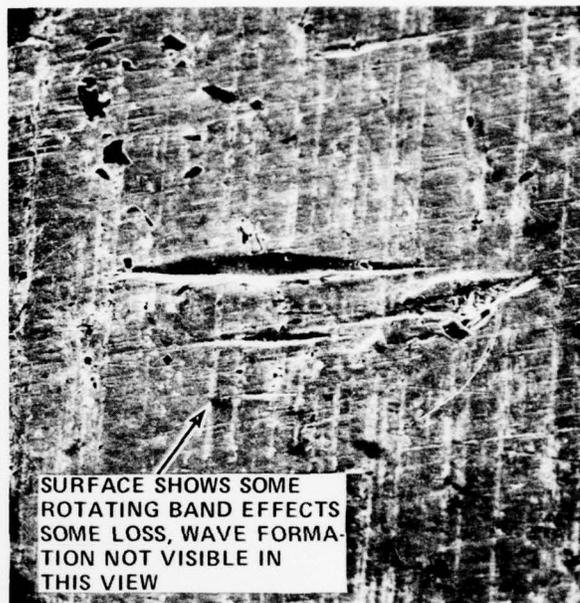
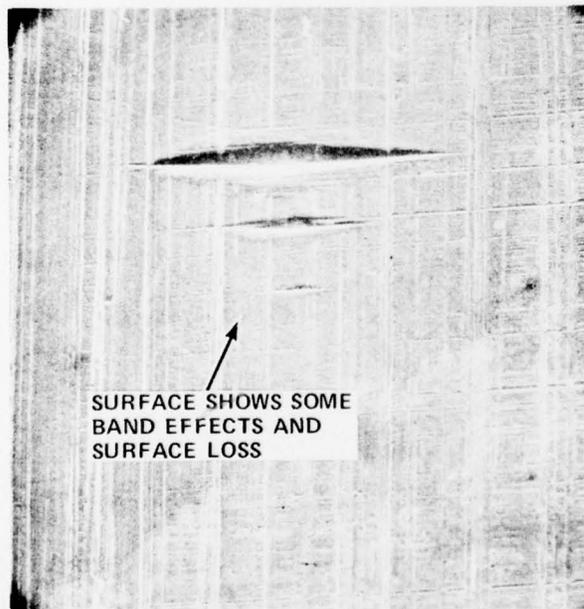
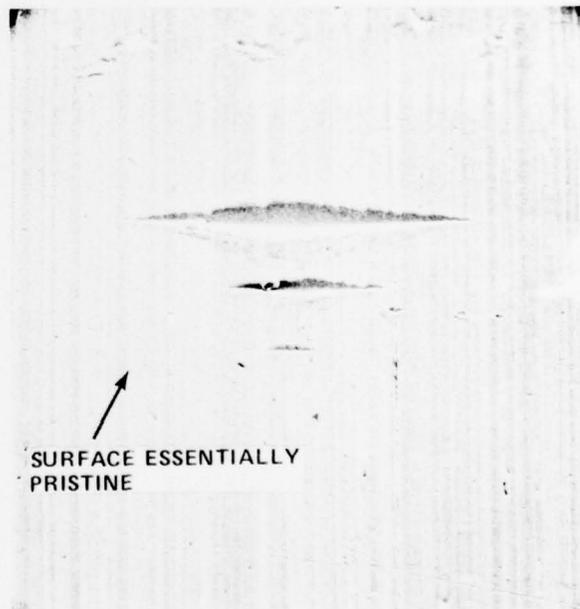
Figure 5 SURFACE CONDITION OF VASCOMAX SENSORS BEFORE AND AFTER FIRING FIVE M67 SHOTS (200X)

TYPICAL "KNOOP" PATTERN BEFORE FIRING

SENSOR AT 39.6 CM AFTER FIVE SHOTS

SENSOR AT 55 CM AFTER FIVE SHOTS

SENSOR AT 70 CM AFTER FIVE SHOTS

As noted above and anticipated at the outset of the program, conditions within the bore of the 105mm howitzer tested were found to be very mild compared to more energetic cannons such as the eight-inch cannon (ref. 1) or the 155mm cannon. Generally, it was found that erosion of even the sensitive Vascomax sensors placed in the lands was very minimal in 5 shots. Figures 5 through 9 illustrate the sensor surface condition for each type of round tested.

In an attempt to formulate a basis upon which each charge could be ranked with regard to erosivity, erosion sensor condition after test was characterized through analysis of several factors. First, the surface loss was estimated by careful observation of surface quality and impression length change. Resulting estimates are given in Table I. Photographs from which these surface loss estimates were based are shown in Figures 5 through 7.

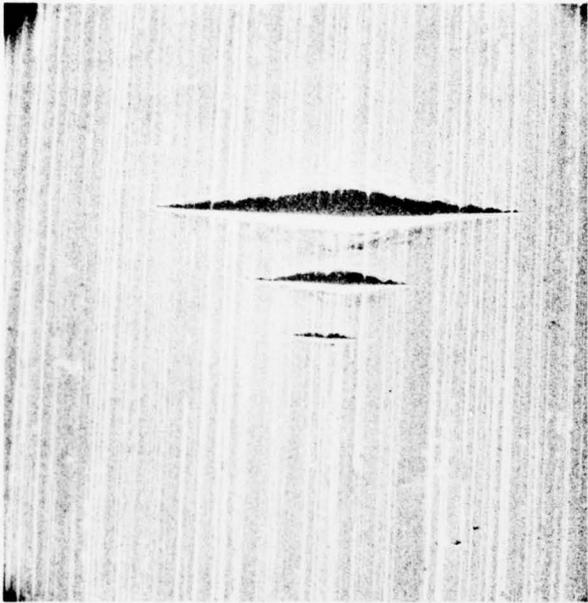
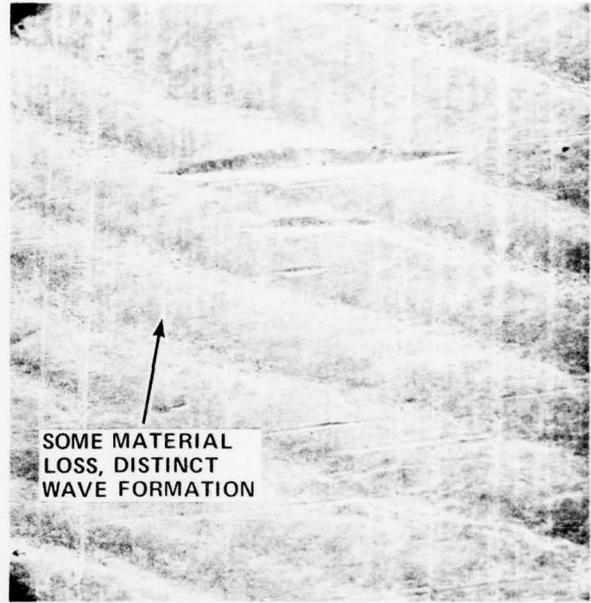
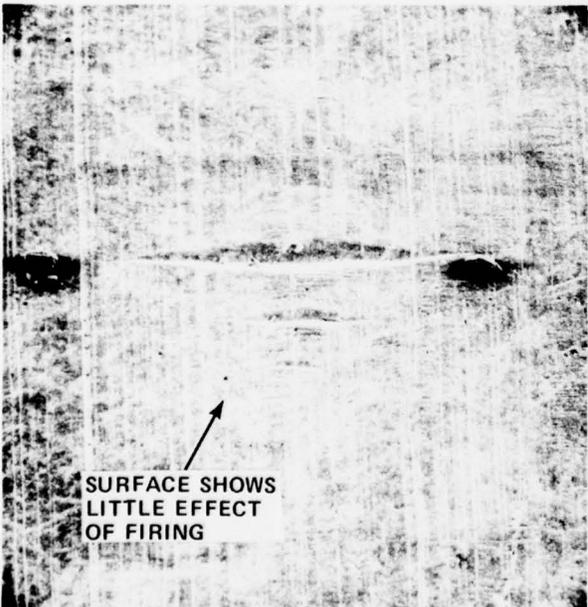
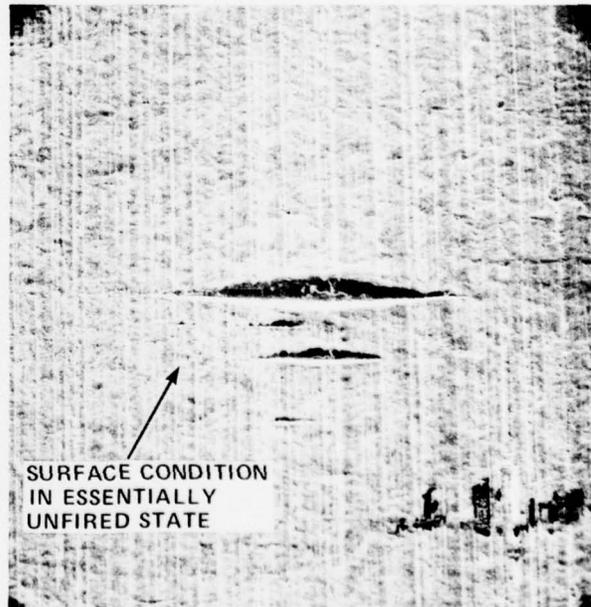
Figure 6 SURFACE CONDITION OF VASCOMAX SENSORS BEFORE AND AFTER FIVE XM 200 SHOTS (200X)

TYPICAL "KNOOP" PATTERN BEFORE FIRING

SOME MATERIAL  
LOSS, DISTINCT  
WAVE FORMATION

SENSOR AT 39.6 CM AFTER FIVE SHOTS

SURFACE SHOWS  
LITTLE EFFECT  
OF FIRING

SENSOR AT 55 CM AFTER FIVE SHOTS

SURFACE CONDITION  
IN ESSENTIALLY  
UNFIRED STATE

SENSOR AT 70 CM AFTER FIVE SHOTS

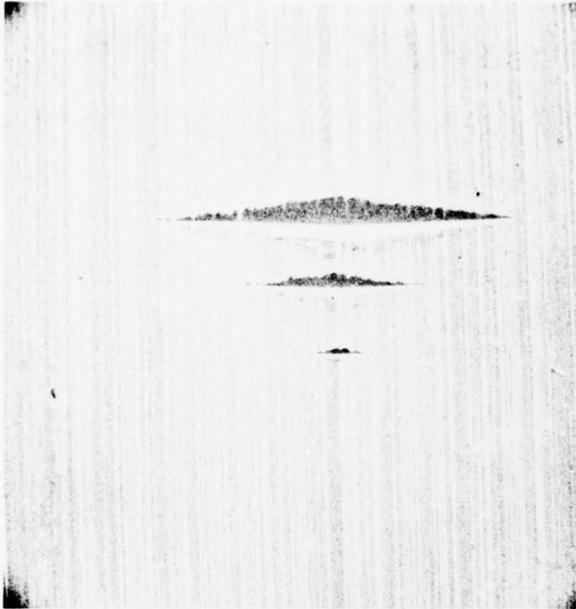
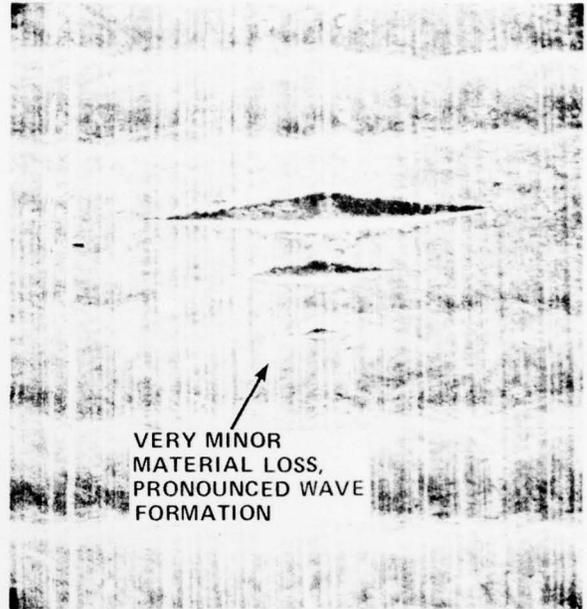
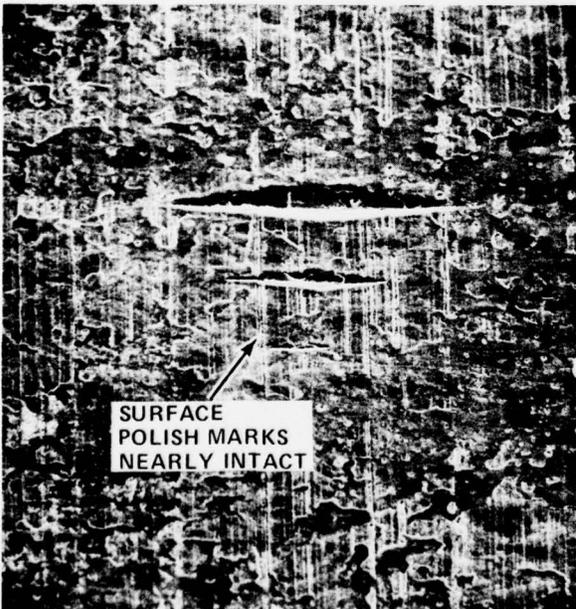
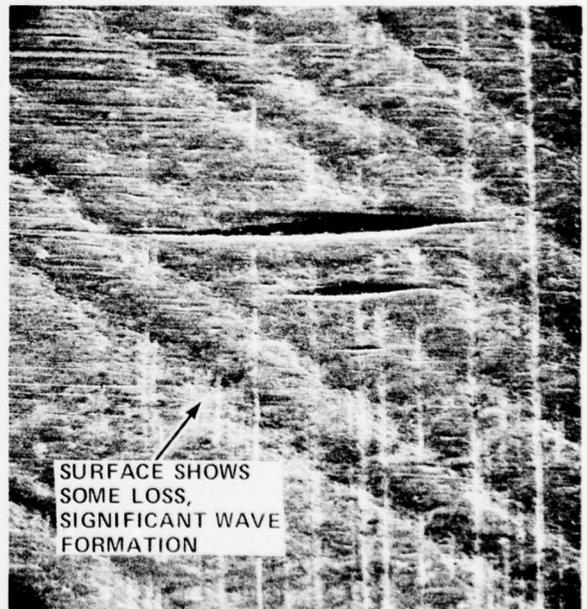
Figure 7 SURFACE CONDITION OF VASCOMAX SENSORS BEFORE AND AFTER FIVE XM 622 SHOTS (200X)

TYPICAL "KNOOP" PATTERN BEFORE FIRING

VERY MINOR  
MATERIAL LOSS,  
PRONOUNCED WAVE  
FORMATION

SENSOR AT 39.6 CM AFTER FIVE SHOTS

SURFACE  
POLISH MARKS  
NEARLY INTACT

SENSOR AT 55 CM AFTER FIVE SHOTS

SURFACE SHOWS  
SOME LOSS,  
SIGNIFICANT WAVE  
FORMATION

SENSOR AT 70 CM AFTER FIVE SHOTS

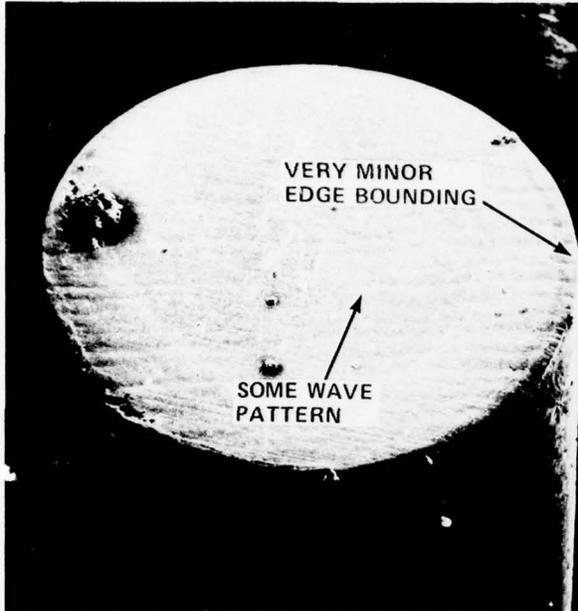
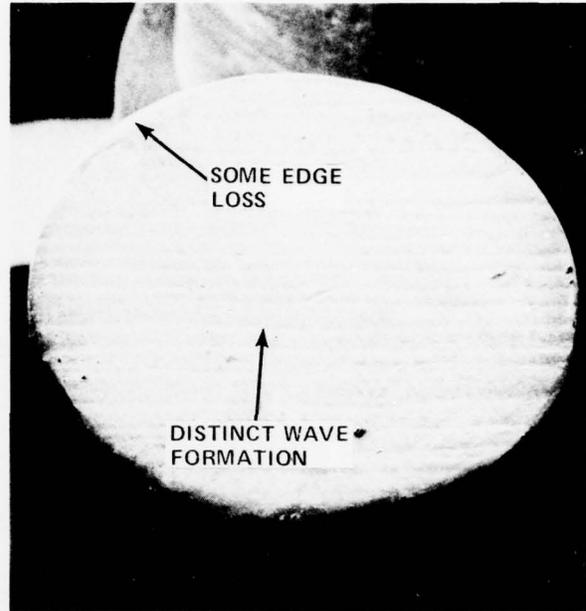
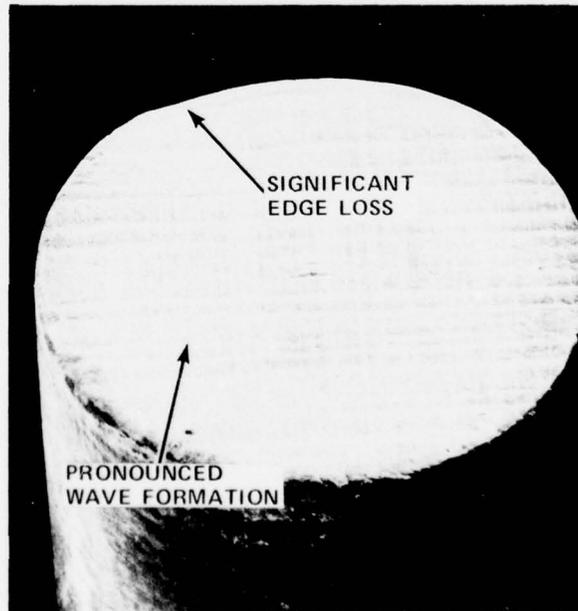
**Figure 8** POST TEST SURFACE WAVE FORMATION ON VASCOMAX EROSION SENSORS LOCATED NEAR THE ORIGIN OF RIFLING (20X)

VASCOMAX SENSOR AT 39.6 CM AFTER FIVE M67 SHOTS

VASCOMAX SENSOR AT 39.6 CM AFTER FIVE XM 200 SHOTS

VASCOMAX SENSOR AT 39.6 CM AFTER FIVE XM 622 SHOTS

Second, the presence of surface wave formation in varying degrees was observed on each sensor. Inasmuch as this wave pattern, presumably caused by softening of the surface, should be a measure of charge erosivity, each sensor was ranked with respect to the magnitude of wave formation observed. This was accomplished through subjective observation at low magnification as of the type shown in Figure 8. Ranking was based upon 0 indicating no wave formation and

10 indicating pronounced wave formation. The resulting ranking for each sensor is as given in Table V.

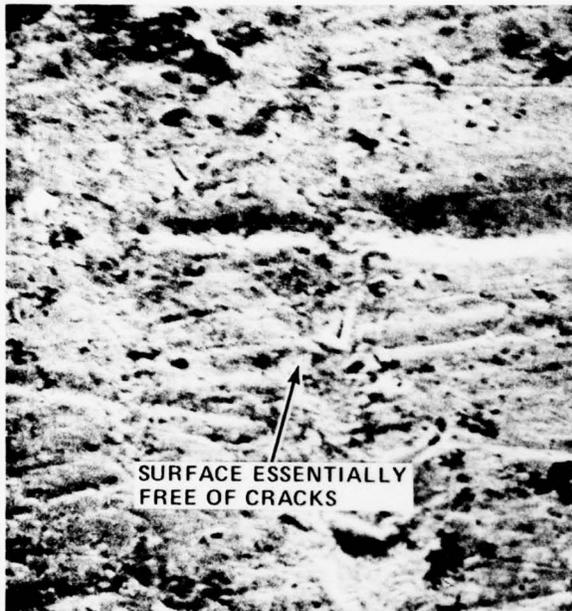
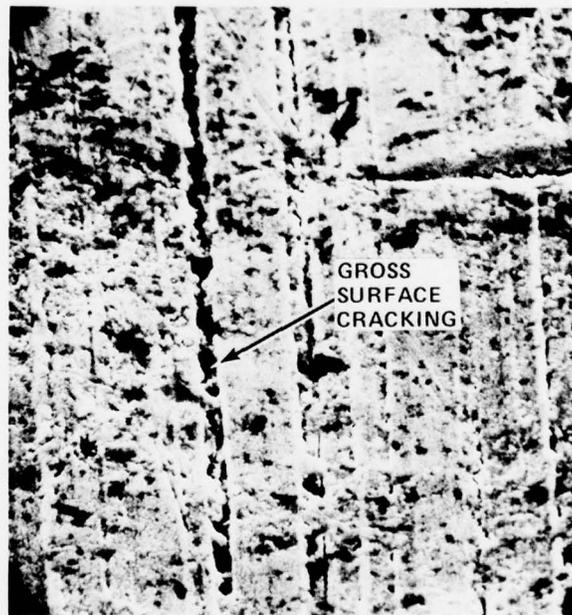
Figure 9 POST TEST SURFACE CRACK PATTERNS FOR VASCOMAX SENSORS LOCATED NEAR THE ORIGIN OF RIFLING (2000X)

VASCOMAX SENSOR AT 39.6 CM AFTER FIVE M67 SHOTS

VASCOMAX SENSOR AT 39.6 CM AFTER FIVE XM 200 SHOTS

VASCOMAX SENSOR AT 39.6 CM AFTER FIVE XM 622 SHOTS

Finally, at very high magnification as is shown in Figure 9, each sensor could be inspected for surface cracking. This was accomplished with similar ranking system to the above. Results are given in Table V.
