# GRADED PYROLYTIC GRAPHITE/SILICON CARBIDE COATING DEPOSITION STUDIES

ATLANTIC RESEARCH CORPORATION  
5390 CHEROKEE AVENUE  
ALEXANDRIA, VIRGINIA 22314

TECHNICAL REPORT AFML-TR-76-122  
Final Report for Period July 1974 - October 1975

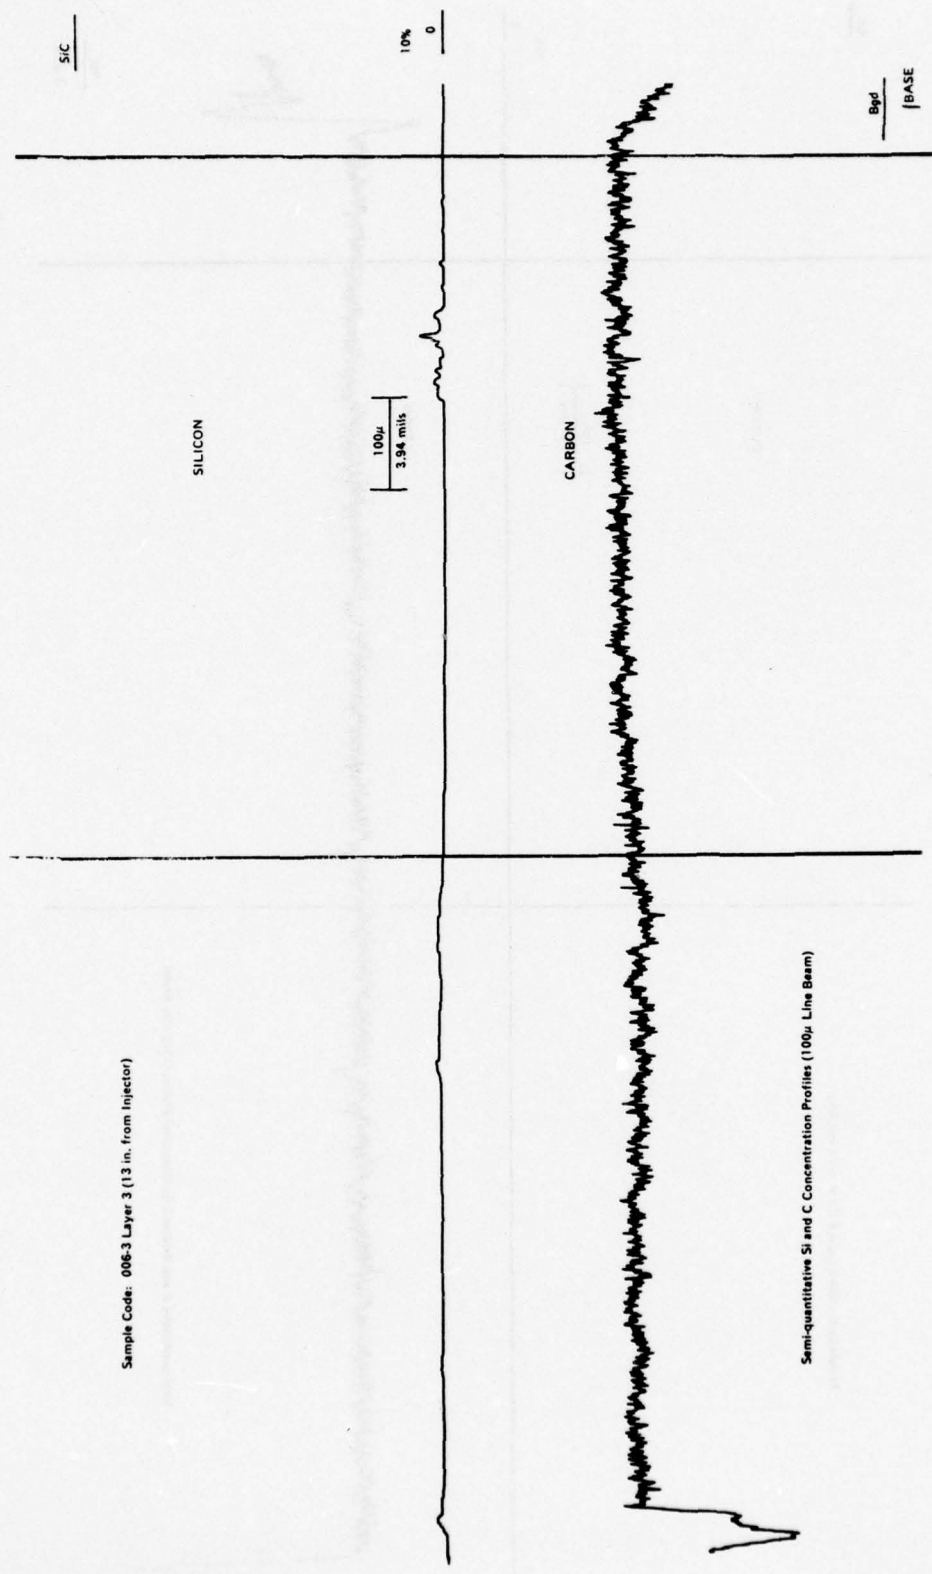
Figure 8. Electron Microprobe Scan of Coating Deposited at 3200° F.

Sample Code: 006-3 Layer 3 (13 in. from Injector)

Semi-quantitative Si and C Concentration Profiles (100 $\mu$  Line Beam)

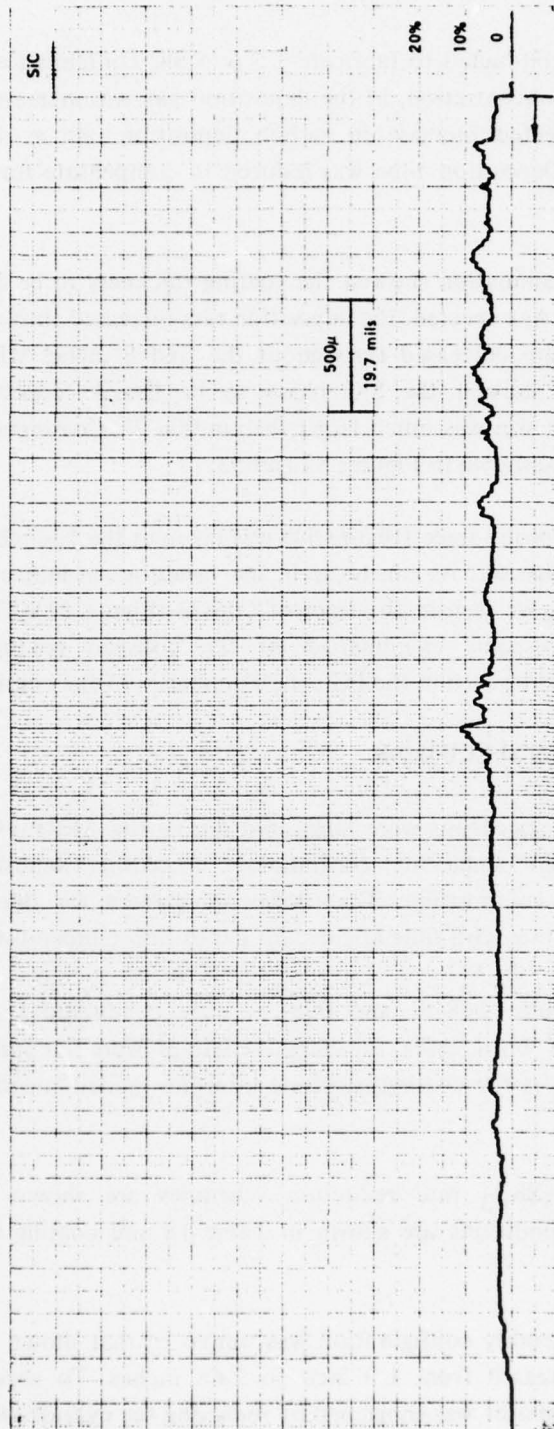
Figure 51. Electron Microprobe Scan of Coating From Run 006-23, 12 Inches From Injector.

An electron microprobe trace (Figure 51) was taken at the 12-inch position and showed the SiC concentration to average 5 w/o for the first deposited 61% of the coating thickness and 3 w/o for the remainder.

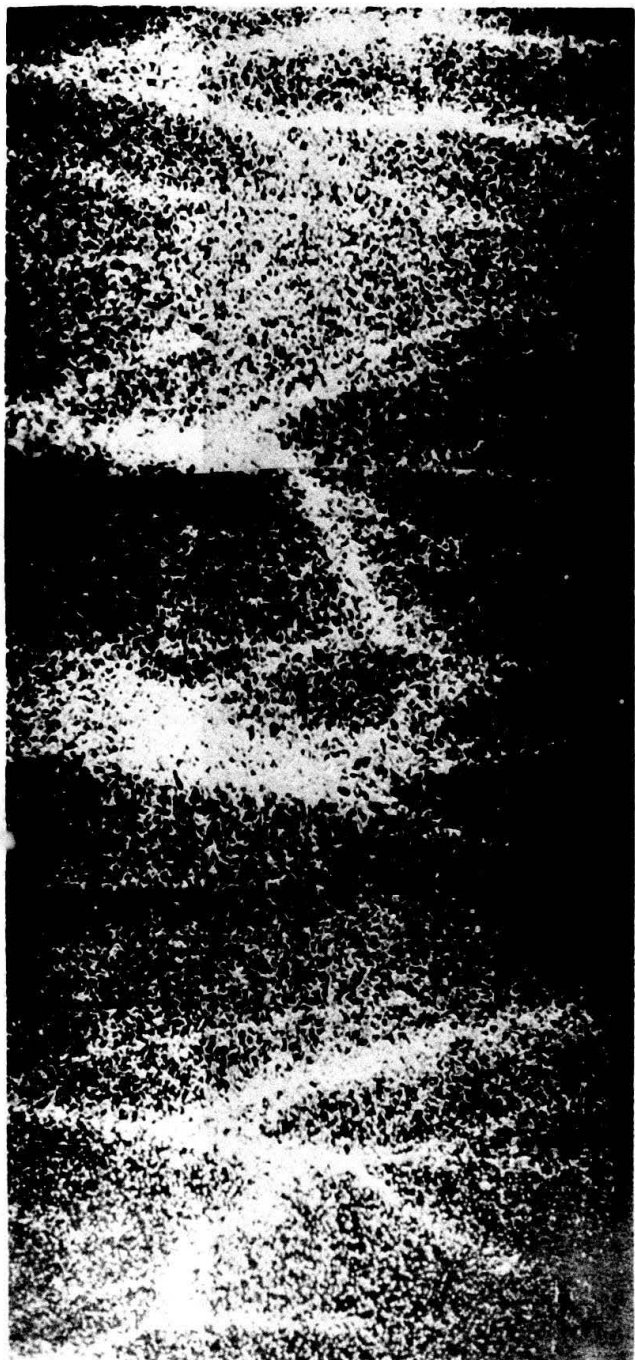
006 -- 22

FIG. 5A X-RAY SCANNING PHOTOGRAPH. SILICON IS REPRESENTED AS WHITE AREA.  
HIGH SILICON CONCENTRATION OCCURS AT BOUNDARIES.

The first traverse was made at constant speed automatically controlled by the machine and the second traverse was made at faster speed by hand-cranking the x-ray beam. Only, results from the first traverse are reported (Fig. 4). A beam of about  $300\mu$  wide was used. The silicon concentration (wt.%) was obtained by calibrating x-ray intensity with a pure silicon standard specimen. The silicon concentration is about 5% except for the middle portion of the coating thickness for 006-22 material, 3% for 006-23 material and 3 to 2% for 006-24 material. X-ray scanning photographs show the heterogeneity with higher silicon concentration at boundaries (Fig. 5).

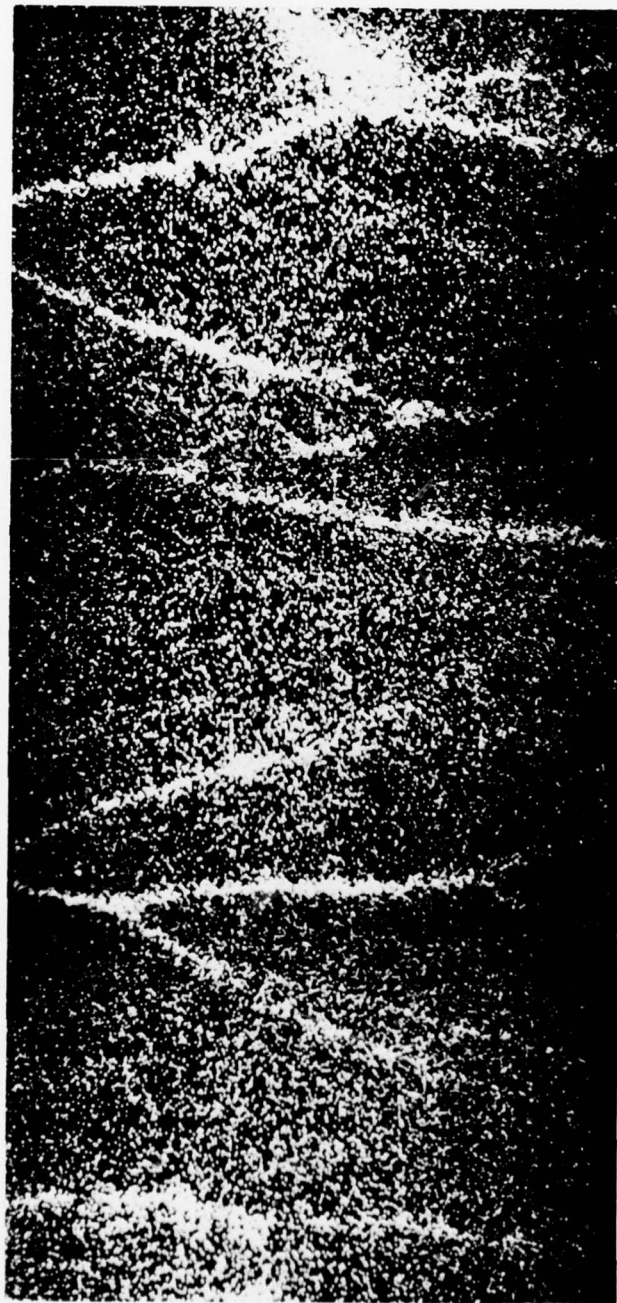
006-23

FIG. 5B X-RAY SCANNING PHOTOGRAPH. SILICON IS REPRESENTED AS WHITE AREA. HIGH SILICON CONCENTRATION OCCURS AT BOUNDARIES.
