NADC-77209-40

EJECTION UNDER DECELERATION

Russell L. Sanford and Kenneth L. Miller
Crew Systems Department
NAVAL AIR DEVELOPMENT CENTER
Warminster, Pennsylvania 18974

16 AUGUST 1977

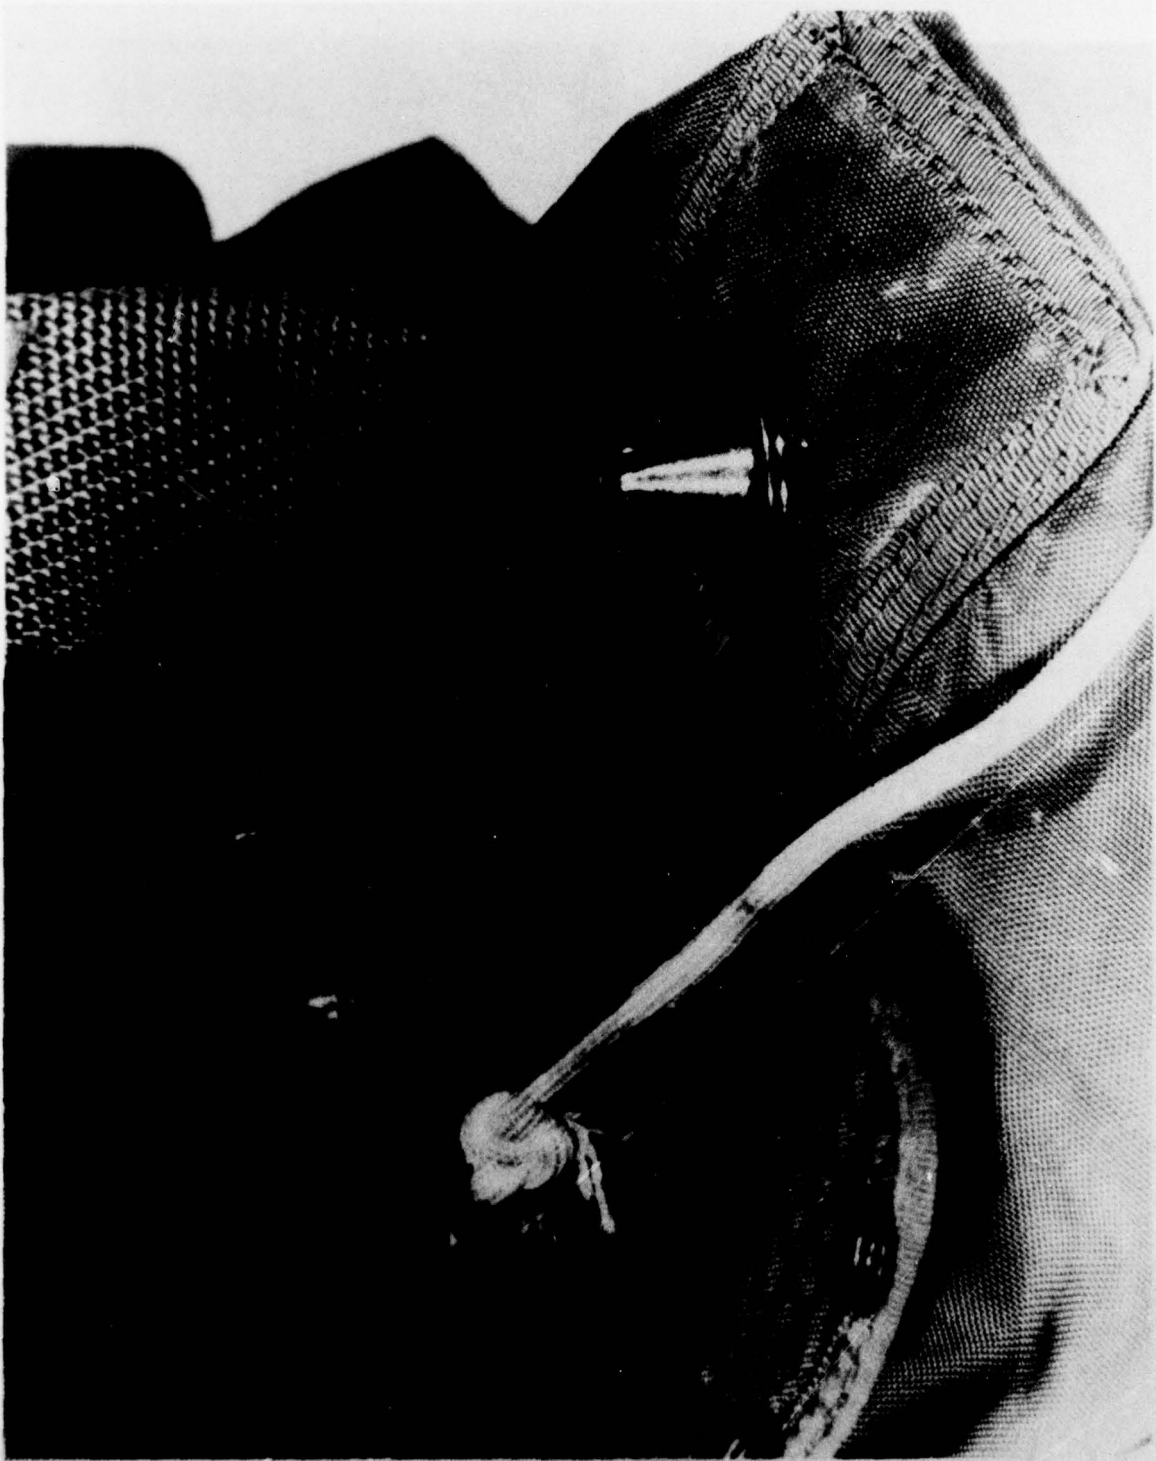
The end result of this snubbing action, coupled with the failure of the weak links to shear the snubber lines, was to inflict serious, and in the case of Test No. 3, catastrophic damage to the parachute container of the NB-11 parachute, specifically the "Alameda" clamp and bracket assembly located at the top of the parachute container. Post test photos of the damage inflicted on this assembly are shown in figures 12, 13 and 14.

FIGURE 12 - Alameda Clamp and Bracket - After Test No. 1.

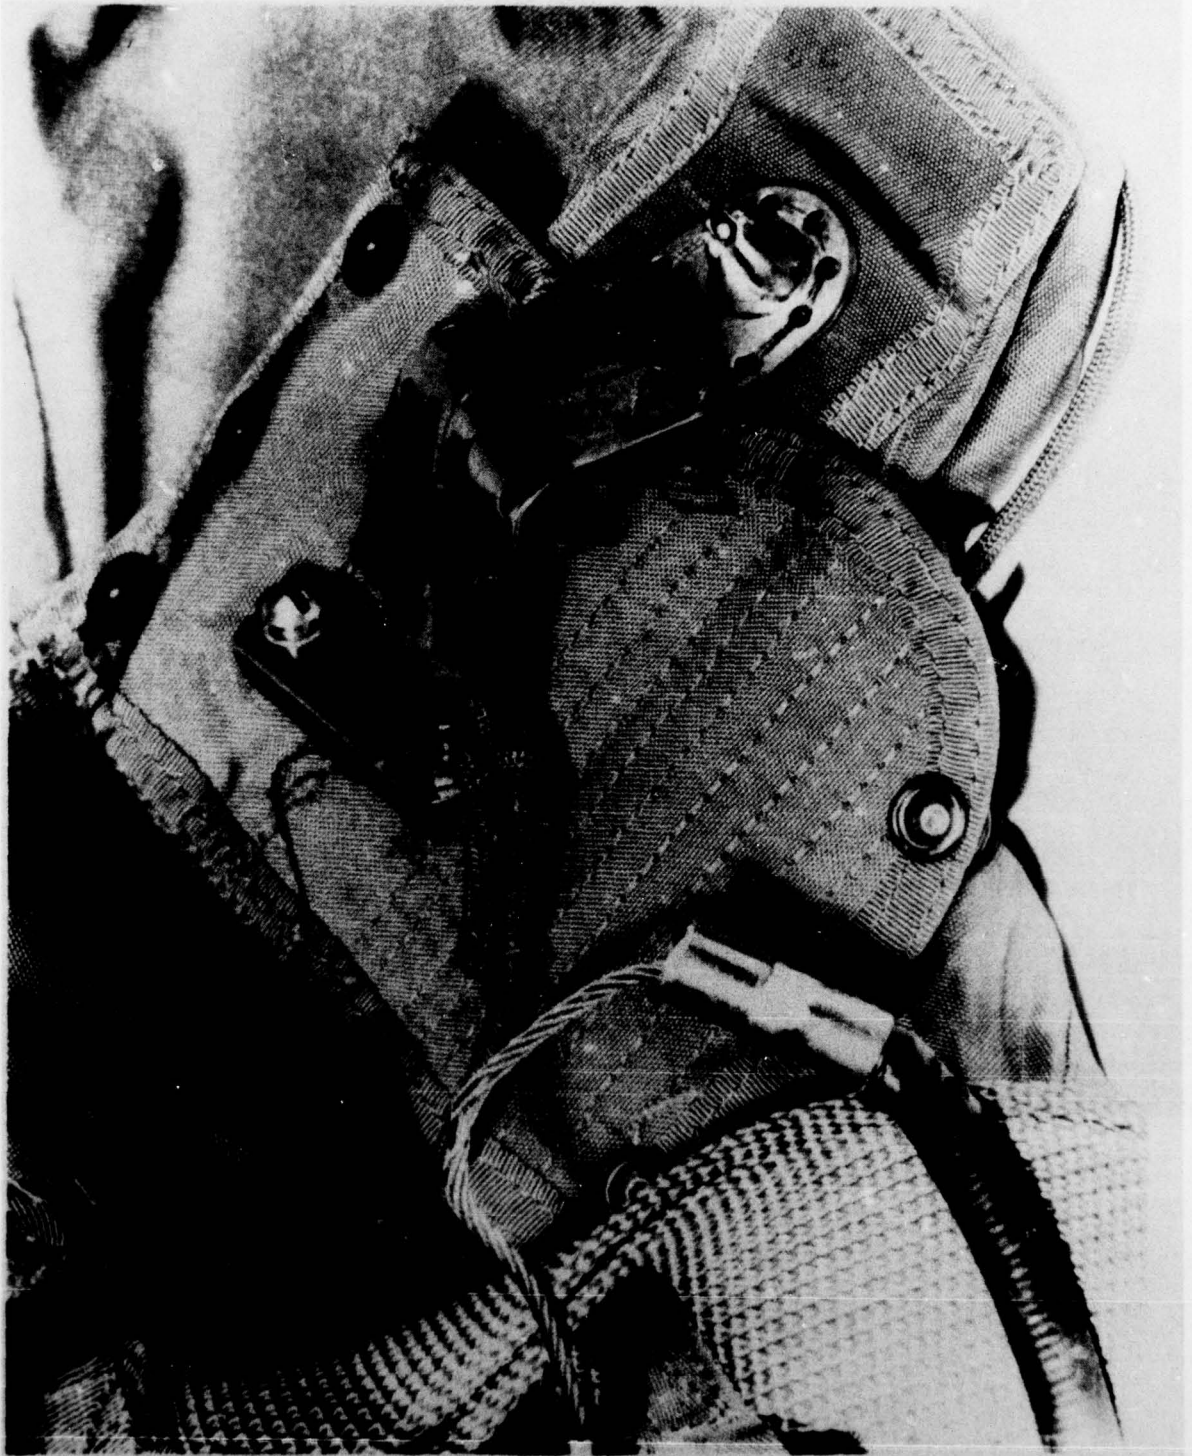
automatic actuator did fire and the dummy was observed in free flight for a period in excess of 2 seconds. Post-test examination of the NB-11 parachute disclosed severe damage to the parachute manual/automatic cable bracket and clamp assembly which precluded automatic actuator extraction of the rip pins from the closure cones of the parachute.

FIGURE 14 - Alameda Clamp and Bracket - After Test No. 3.

1. Expand the area of investigation involved in this test program to include ejection under deceleration combined with adverse attitude.
2. Initiate a priority investigation program to determine reasons for

random operation of the weak links in the DART/SNUBBER seat/man separation subsystem of the ESCAPAC 1A-1 ejection seat.

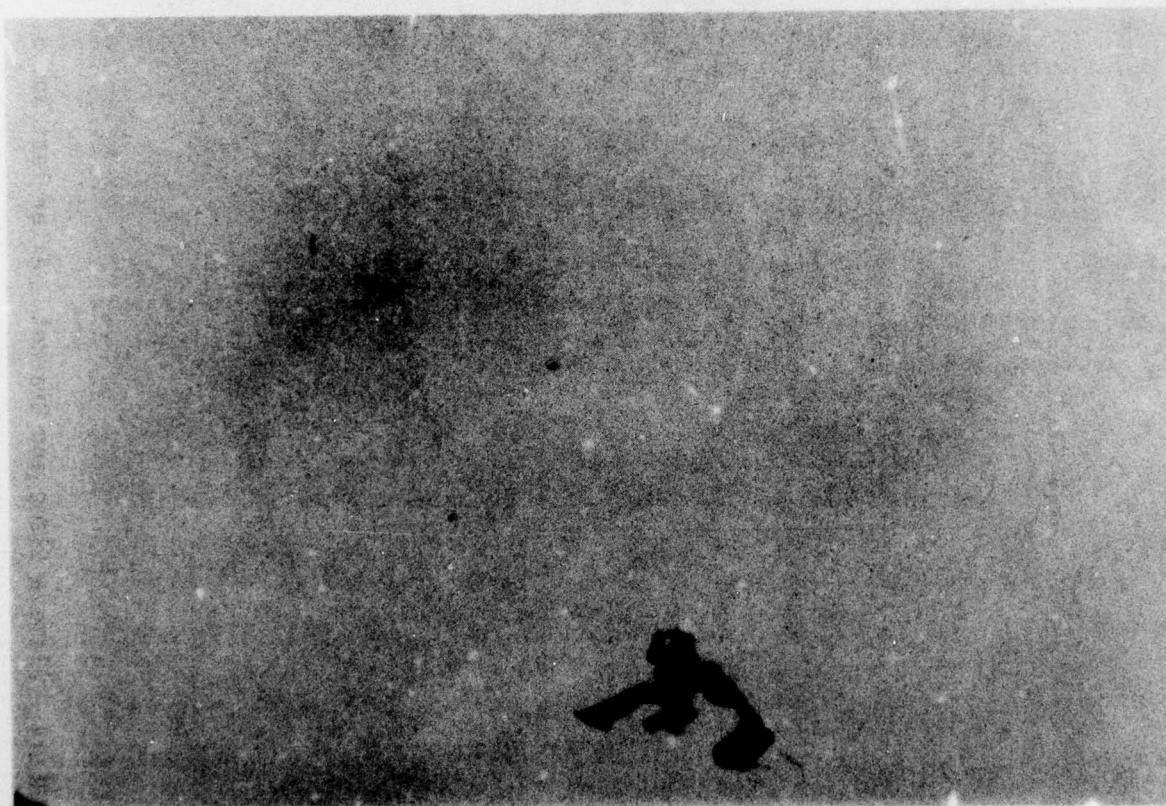
FIGURE 15 - Seat/Man Separation - Test No. 3.
