FINAL REPORT

LABORATORY EVALUATION OF 4-3/4-INCH
FLASH-WELDED ALLOY STEEL STUD
LINK ANCHOR CHAIN
(Report No. NSSC 1-1)

August 1977

BATTELLE
Columbus Laboratories
Tactical Technology Center
505 King Avenue
Columbus, Ohio 43201

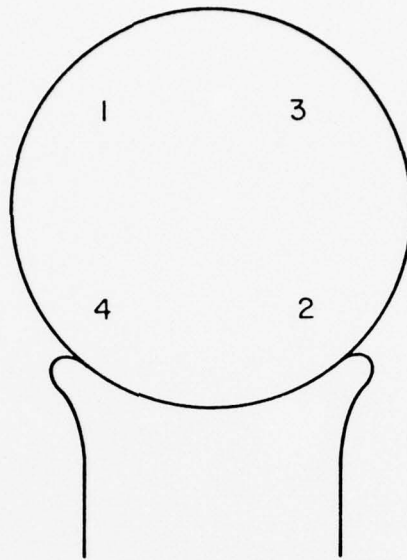
FIGURE 24. ULTRASONIC INSPECTION AREAS, SAMPLE B LINK

The strongest indication (about 29 percent of maximum) was at Location 1 (estimated area $\frac{3}{8}$ by $\frac{1}{2}$ in.), Location 2 (estimated area $\frac{1}{8}$ by $\frac{1}{8}$ in.) and Locations 3 and 4 (estimated area $\frac{1}{16}$ by $\frac{1}{16}$ in.) gave indications of about 5 percent of maximum.

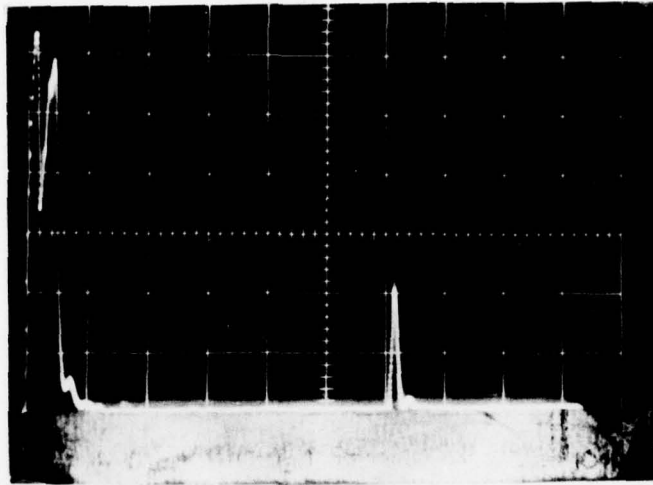
FIGURE 28. SHEAR-WAVE ULTRASONIC INDICATION OF THE 1/8-IN.-DEEP SAWCUT, SAMPLE C LINK

The sawcut was made across the surface of the link as a reference flaw.

To perform the shear-wave test, a reference flaw was made on the surface. A sawcut 1/8 in. deep was made across the link sample. The ultrasonic indication from the sawcut is shown in Figure 28. The ultrasonic indication of the suspected flaw found at Location 1 is shown in Figure 29.

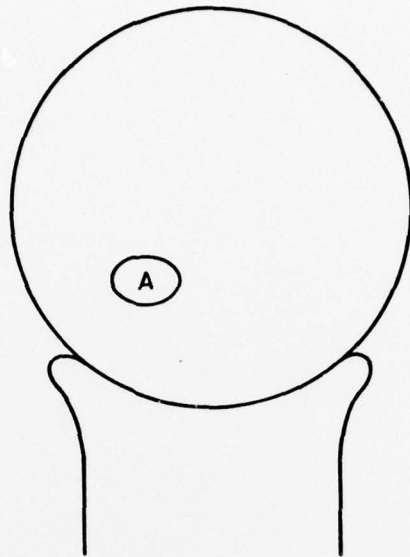
FIGURE 30. ULTRASONIC INSPECTION AREA, SAMPLE D LINK

Position A (estimated size $3/4$ by $1/2$ in.) gave the strongest indication. No other indications over 5 percent were recorded.

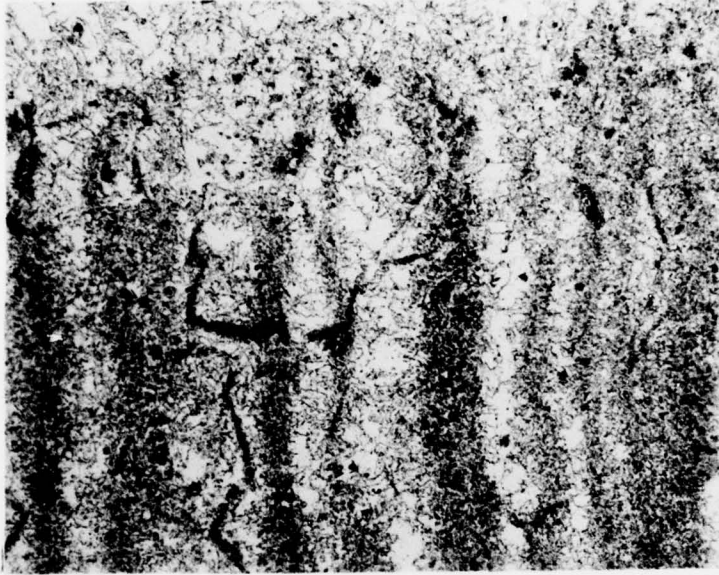
FIGURE 37. CRACKS, LACK OF FUSION, AND POOR CONTOUR
OF STUD FILLET WELD IN LINK FROM SAMPLE C

Weld fusion
zone

100X

Examination of the Sample C section revealed that the fillet weld between the stud and the link was of poor quality. As is shown in Figure 37, the weld beads contained cracks, and regions of lack of fusion. Also, the contour of the weld bead did not conform to the requirements shown in Figure 1 of the *Interim Specification*.
