**BIAXIAL TESTING OF GRAPHITE/EPOXY COMPOSITES
CONTAINING STRESS CONCENTRATIONS — Part II**

*IIT RESEARCH INSTITUTE
10 WEST 35th STREET
CHICAGO, ILLINOIS 60616*

TECHNICAL REPORT AFML-TR-76-244, PART II
Final Report for Period April 1976 — March 1977

AIR FORCE MATERIALS LABORATORY
AIR FORCE WRIGHT AERONAUTICAL LABORATORIES
AIR FORCE SYSTEMS COMMAND
WRIGHT-PATTERSON AIR FORCE BASE, OHIO 45433

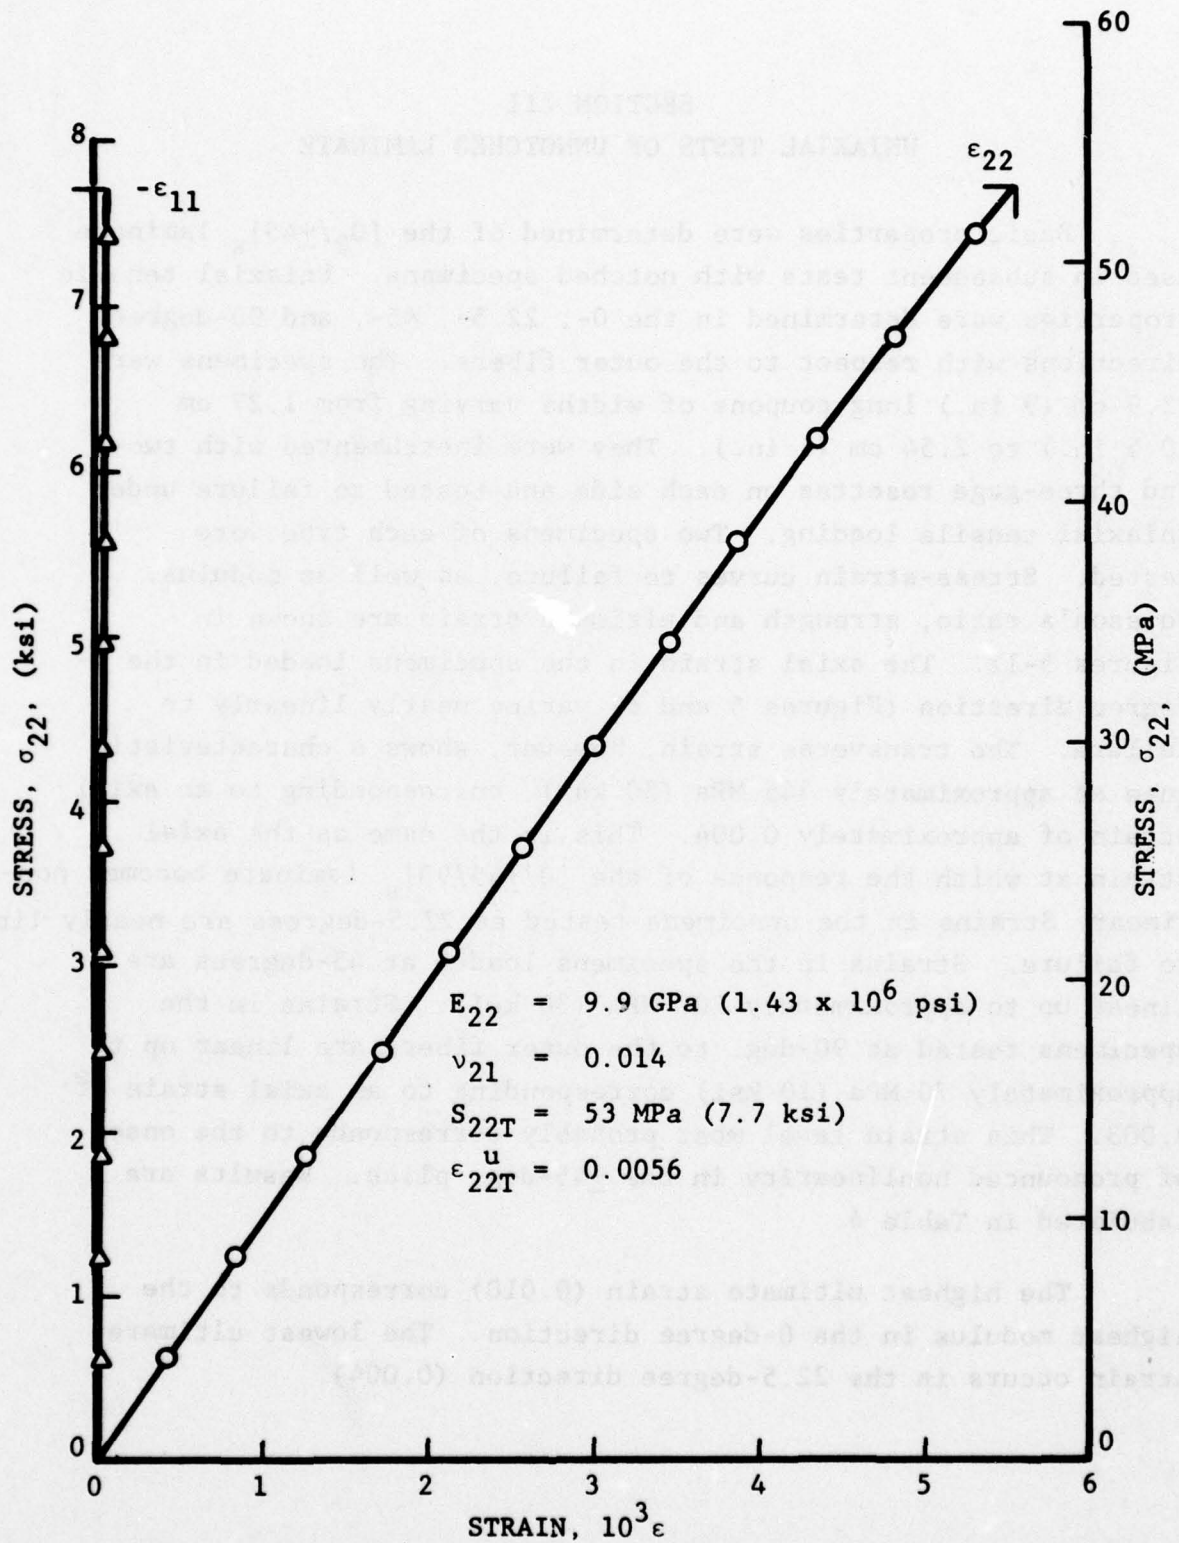
Figure 4. Strains in 90-Degree Unidirectional Specimen Under Uniaxial Tensile Loading

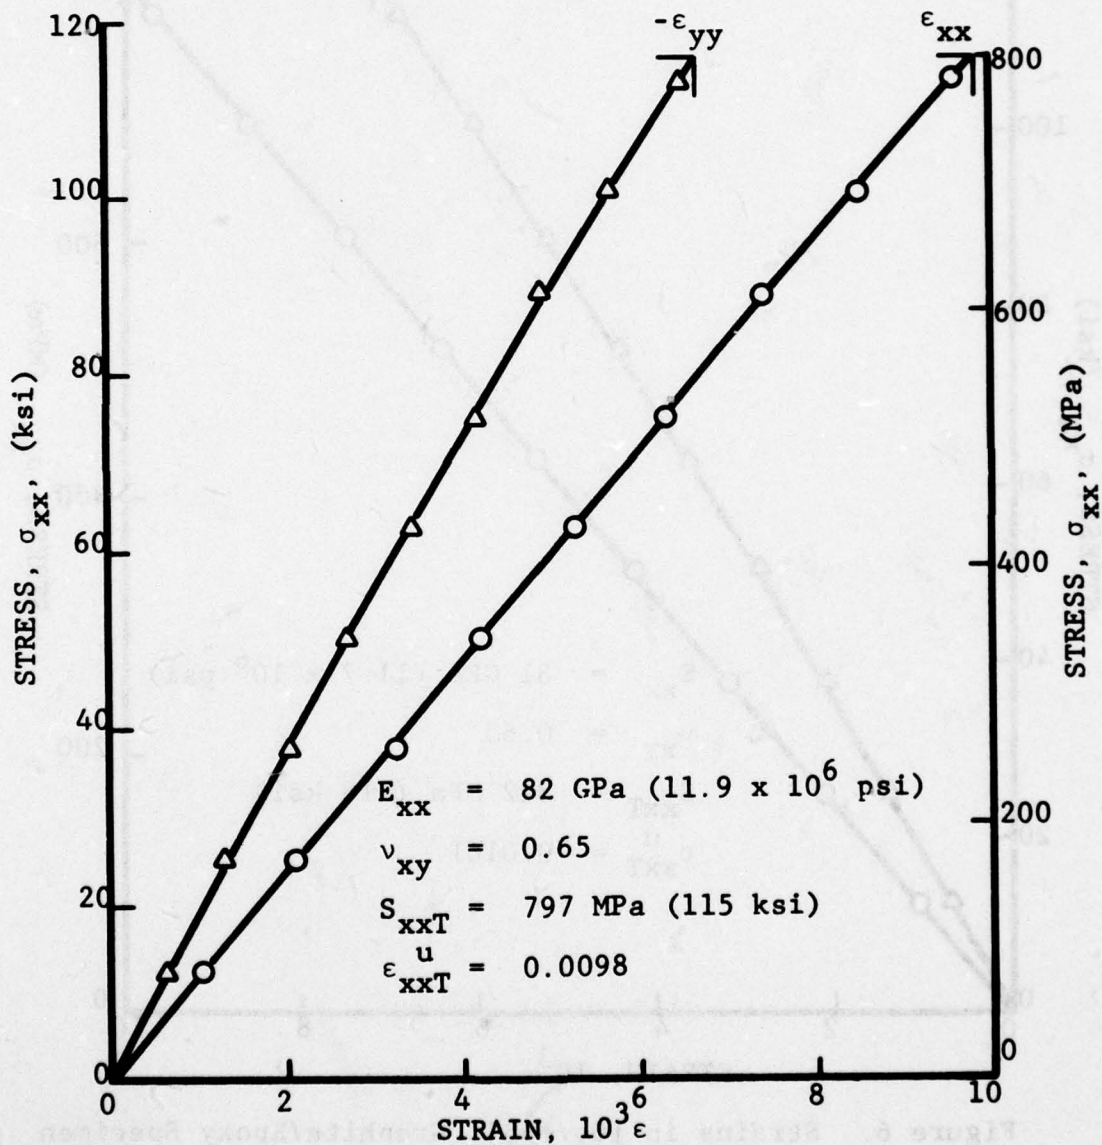
Figure 5. Strains in $[0_2/+45]_s$ Graphite/Epoxy Specimen Under Uniaxial Tensile Loading

Basic properties were determined of the $[0_2/\pm 45]_s$ laminate used in subsequent tests with notched specimens. Uniaxial tensile properties were determined in the 0-, 22.5-, 45-, and 90-degree directions with respect to the outer fibers. The specimens were 22.9 cm (9 in.) long coupons of widths varying from 1.27 cm (0.5 in.) to 2.54 cm (1 in.). They were instrumented with two- and three-gage rosettes on each side and tested to failure under uniaxial tensile loading. Two specimens of each type were tested. Stress-strain curves to failure, as well as modulus, Poisson's ratio, strength and ultimate strain are shown in Figures 5-12. The axial strain in the specimens loaded in the 0-degree direction (Figures 5 and 6) varies nearly linearly to failure. The transverse strain, however, shows a characteristic knee at approximately 345 MPa (50 ksi), corresponding to an axial strain of approximately 0.004. This is the same as the axial strain at which the response of the $[0/\pm 45/90]_s$ laminate becomes non-linear. Strains in the specimens tested at 22.5-degrees are nearly linear to failure. Strains in the specimens loaded at 45-degrees are linear up to approximately 207 MPa (30 ksi). Strains in the specimens tested at 90-deg. to the outer fibers are linear up to approximately 70 MPa (10 ksi) corresponding to an axial strain of 0.003. This strain level most probably corresponds to the onset of pronounced nonlinearity in the ± 45 -deg. plies. Results are tabulated in Table 4.

The highest ultimate strain (0.010) corresponds to the highest modulus in the 0-degree direction. The lowest ultimate strain occurs in the 22.5-degree direction (0.004).

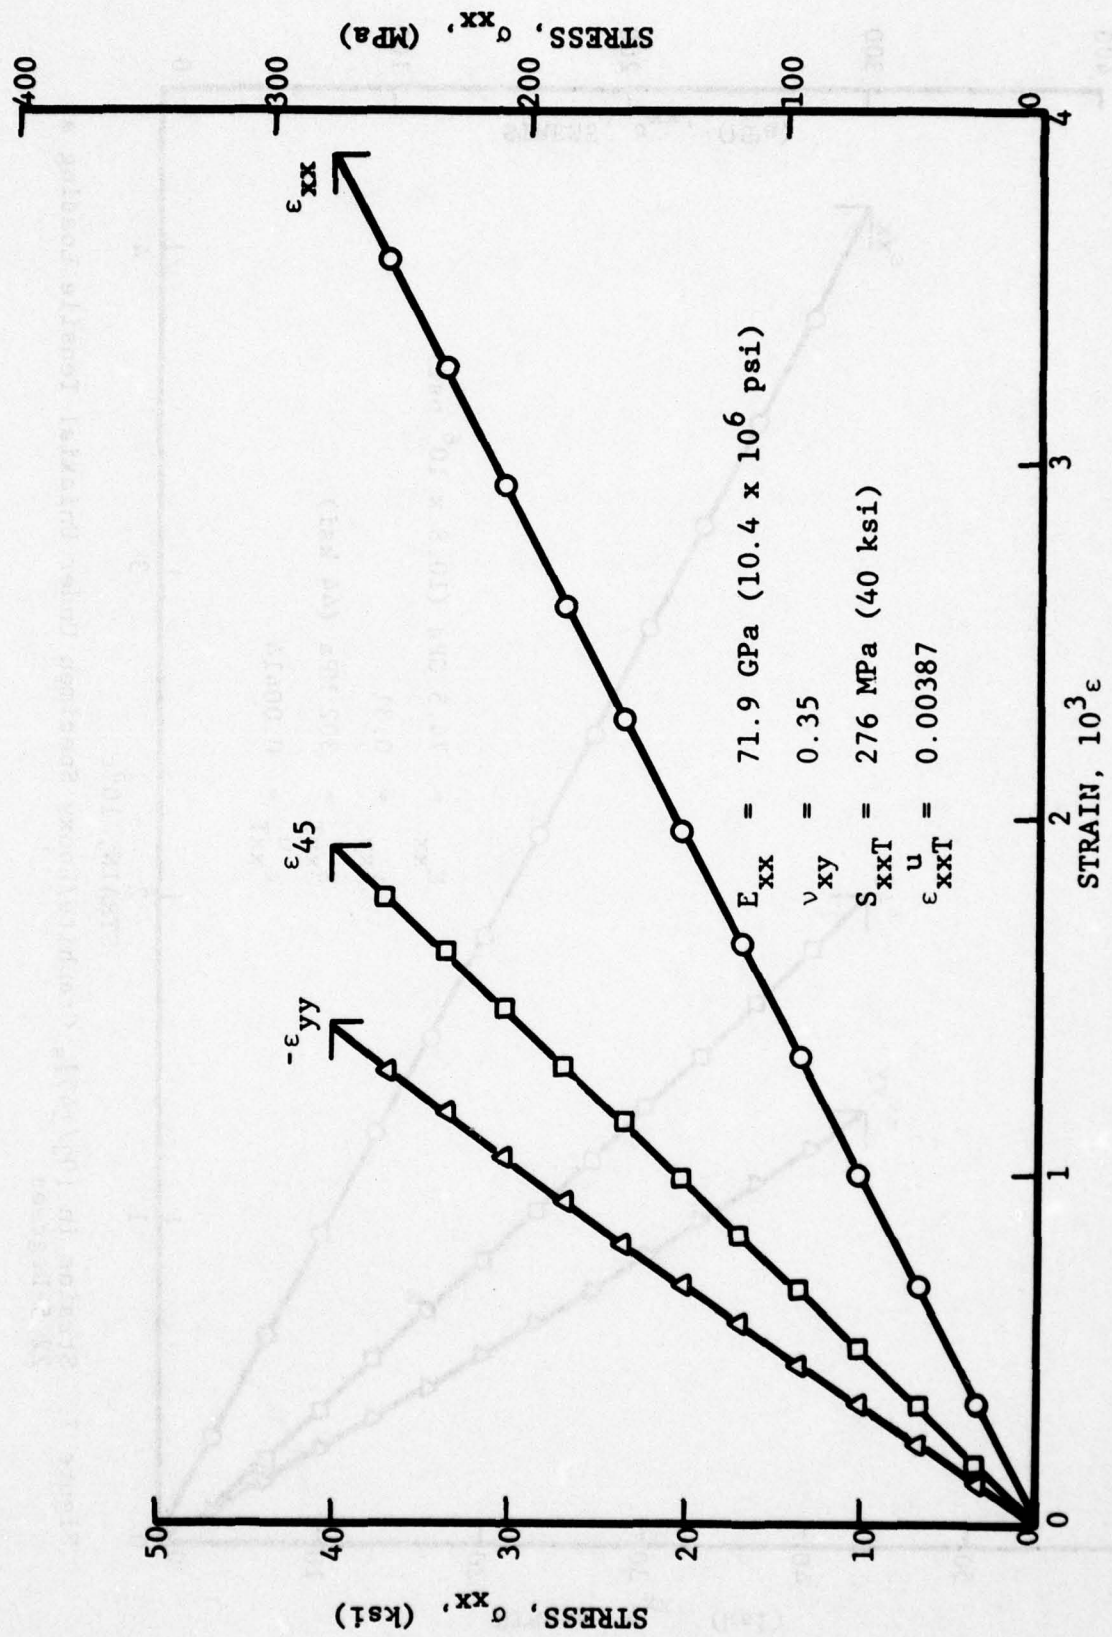
Figure 8. Strains in $[0_2/+45]_s$ Graphite/Epoxy Specimen Under Uniaxial Tensile Loading at 22.5-Degrees

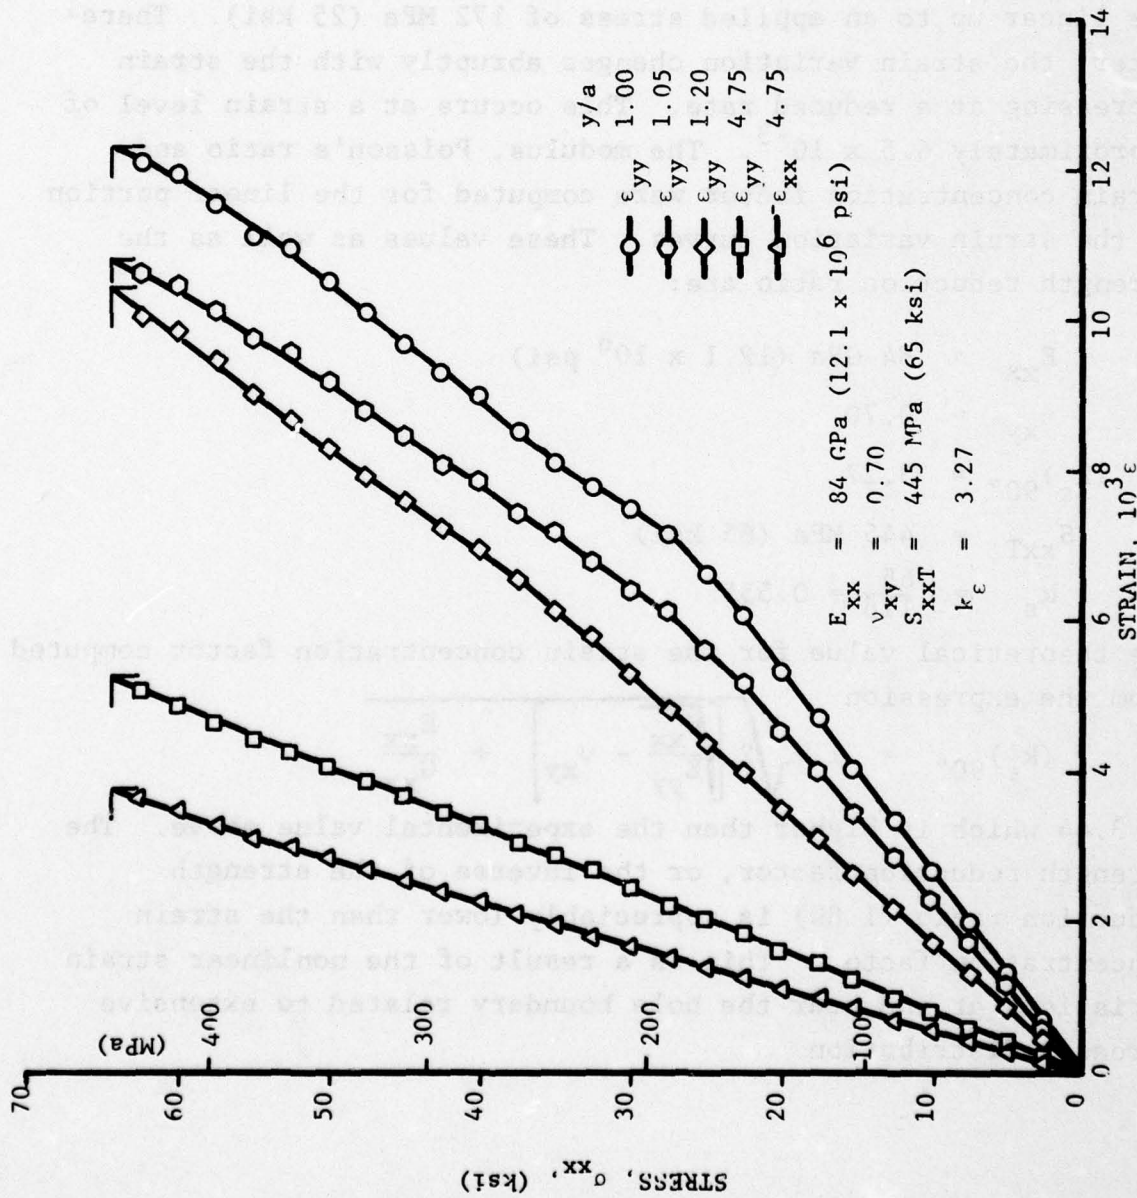
Figure 14. Strains Along Horizontal Axis of [02/+45] Graphite/Epoxy Specimen With 2.54 cm (1 in.) Circular Hole Under Uniaxial Tensile Loading (Spec. No. 4A-1)

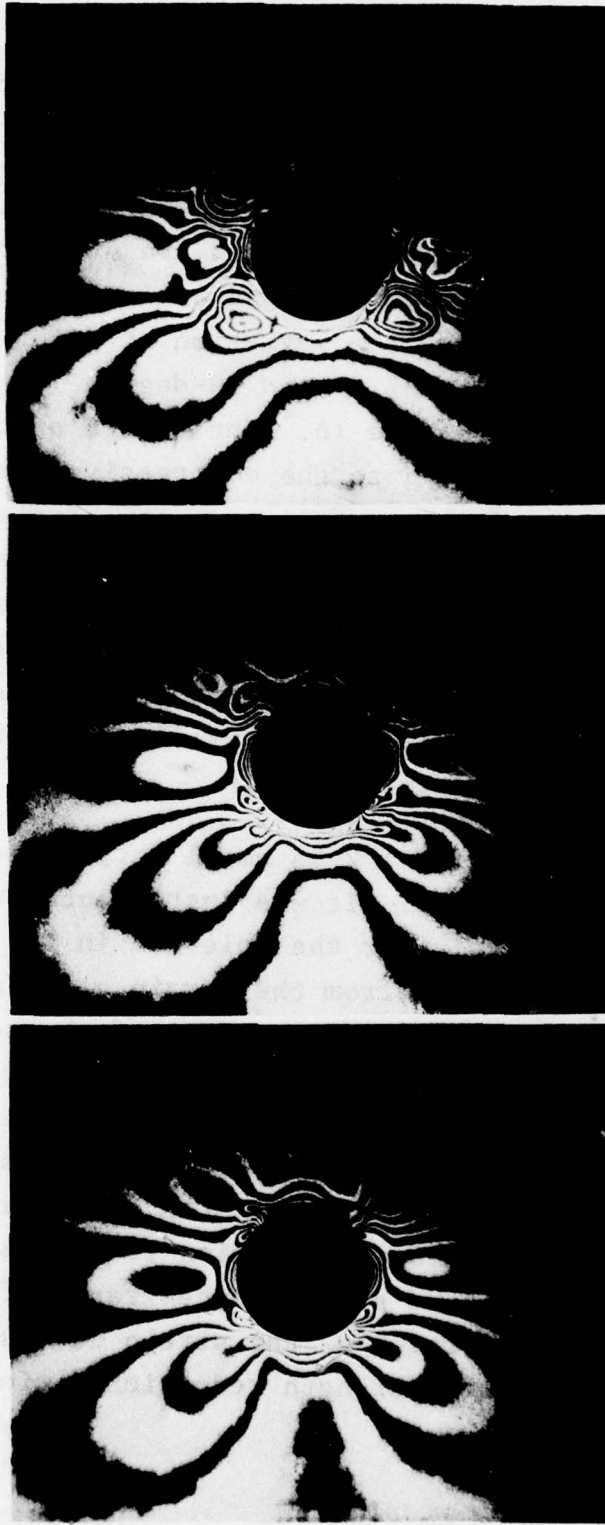
Photoelastic fringe patterns in the coating around the hole are shown in Figure 15 for three levels of load. The characteristic points of high tangential strain concentration on the hole boundary off the horizontal axis are evident. In this case these points are located at an angle of approximately 67.5° from the loading axis. The variation of fringe order and tangential strain at the 0-, 67.5- and 90-degree locations on the hole boundary is shown in Figure 16. The fringe order at the 0-degree location, corresponding to the compressive strain at that point, varies nearly linearly to failure. The birefringence at the 90-degree location varies linearly up to an applied stress of approximately 241 MPa (35 ksi), thereafter it increases at a much reduced rate as the corresponding strains obtained from strain gages. The birefringence at the 67.5-degree location becomes nonlinear at a lower stress of 138 MPa (20 ksi). Failure initiated at these off-axis points.

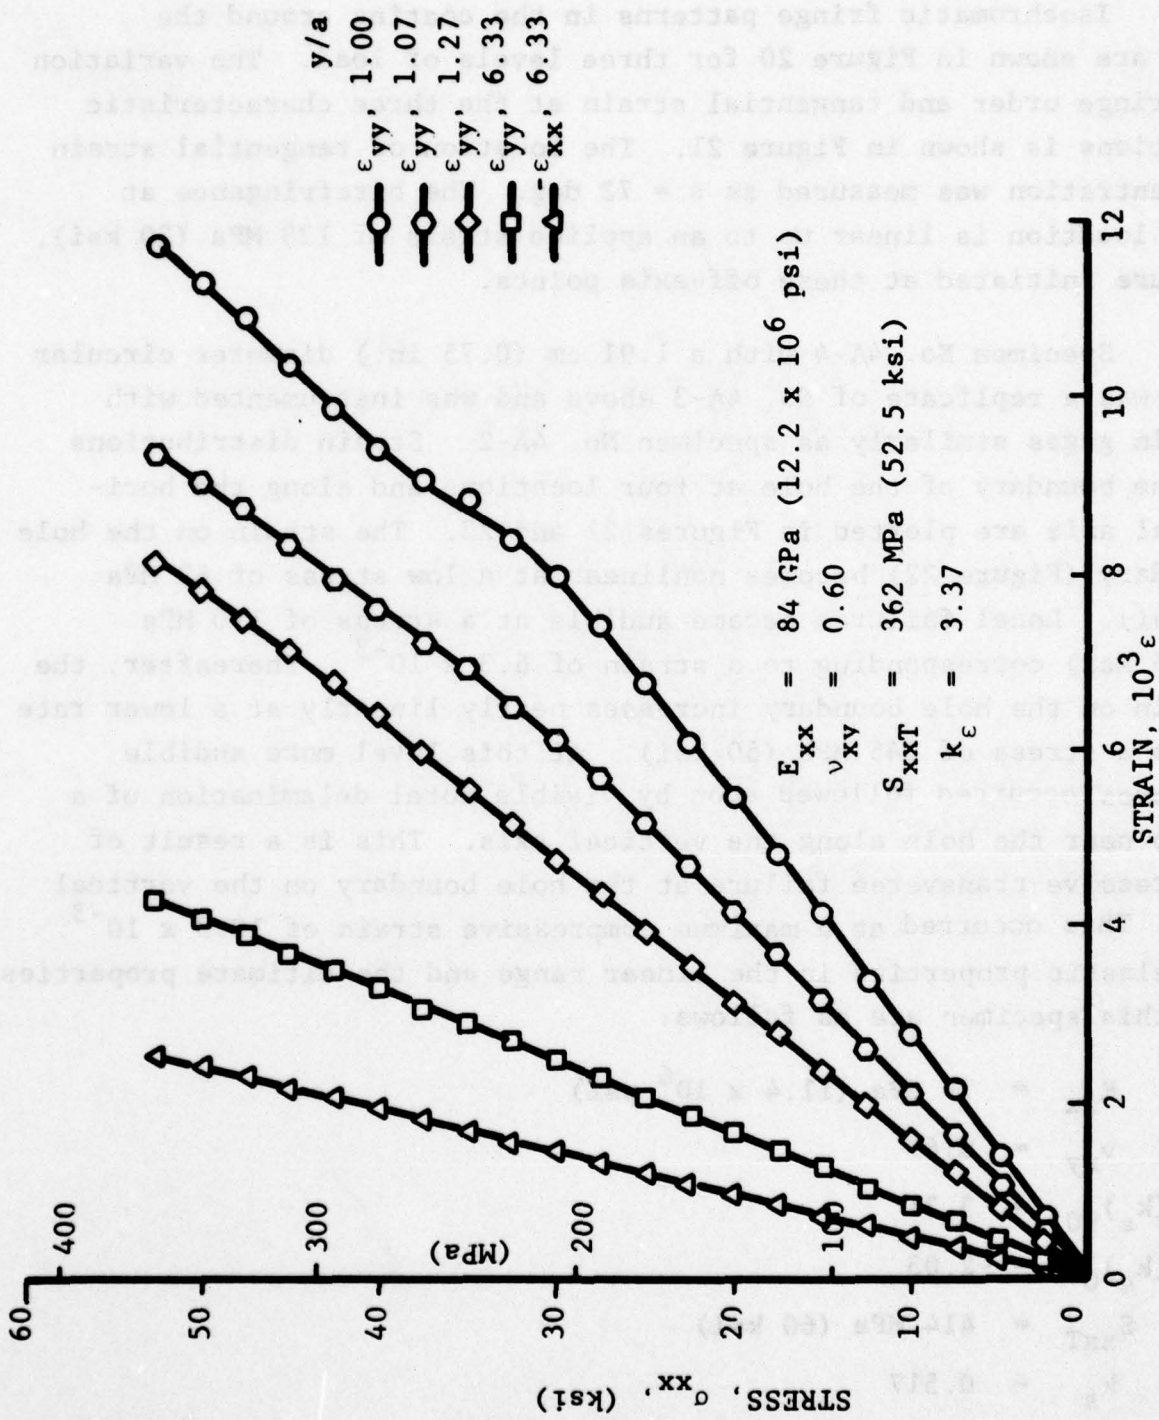
Figure 19. Strains Along Horizontal Axis of [02/+45]s Graphite/Epoxy Specimen with 1.91 cm (0.75 in.) Circular Hole Under Uniaxial Tensile Loading (Spec. No. 4A-3)

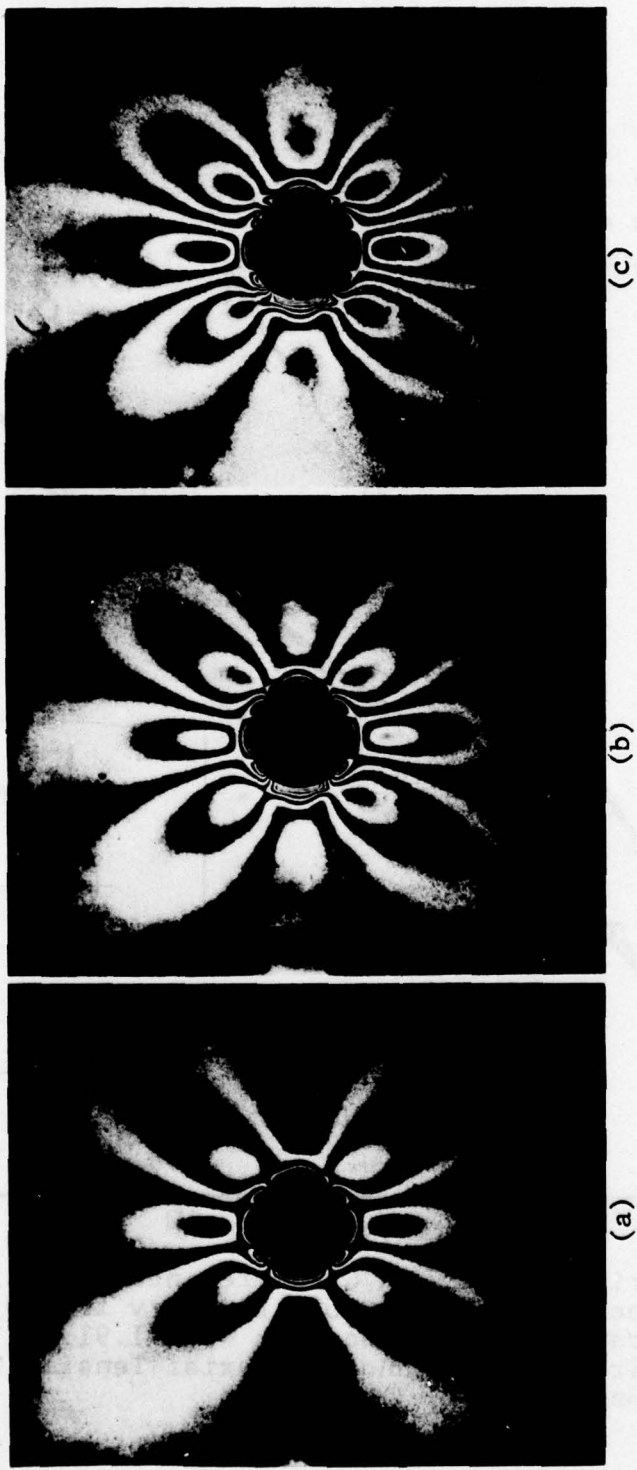
Figure 20. Isochromatic Fringe Patterns in Photoelastic Coating of $[0_2/+45]_s$ Graphite/Epoxy Specimen with 1.91 cm (0.75 in.) Diameter Circular Hole Under Uniaxial Tensile Loading (Spec. No. 4A-3)

Isochromatic fringe patterns in the coating around the hole are shown in Figure 20 for three levels of load. The variation of fringe order and tangential strain at the three characteristic locations is shown in Figure 21. The location of tangential strain concentration was measured as $\theta = 72$ deg. The birefringence at this location is linear up to an applied stress of 138 MPa (20 ksi). Failure initiated at these off-axis points.

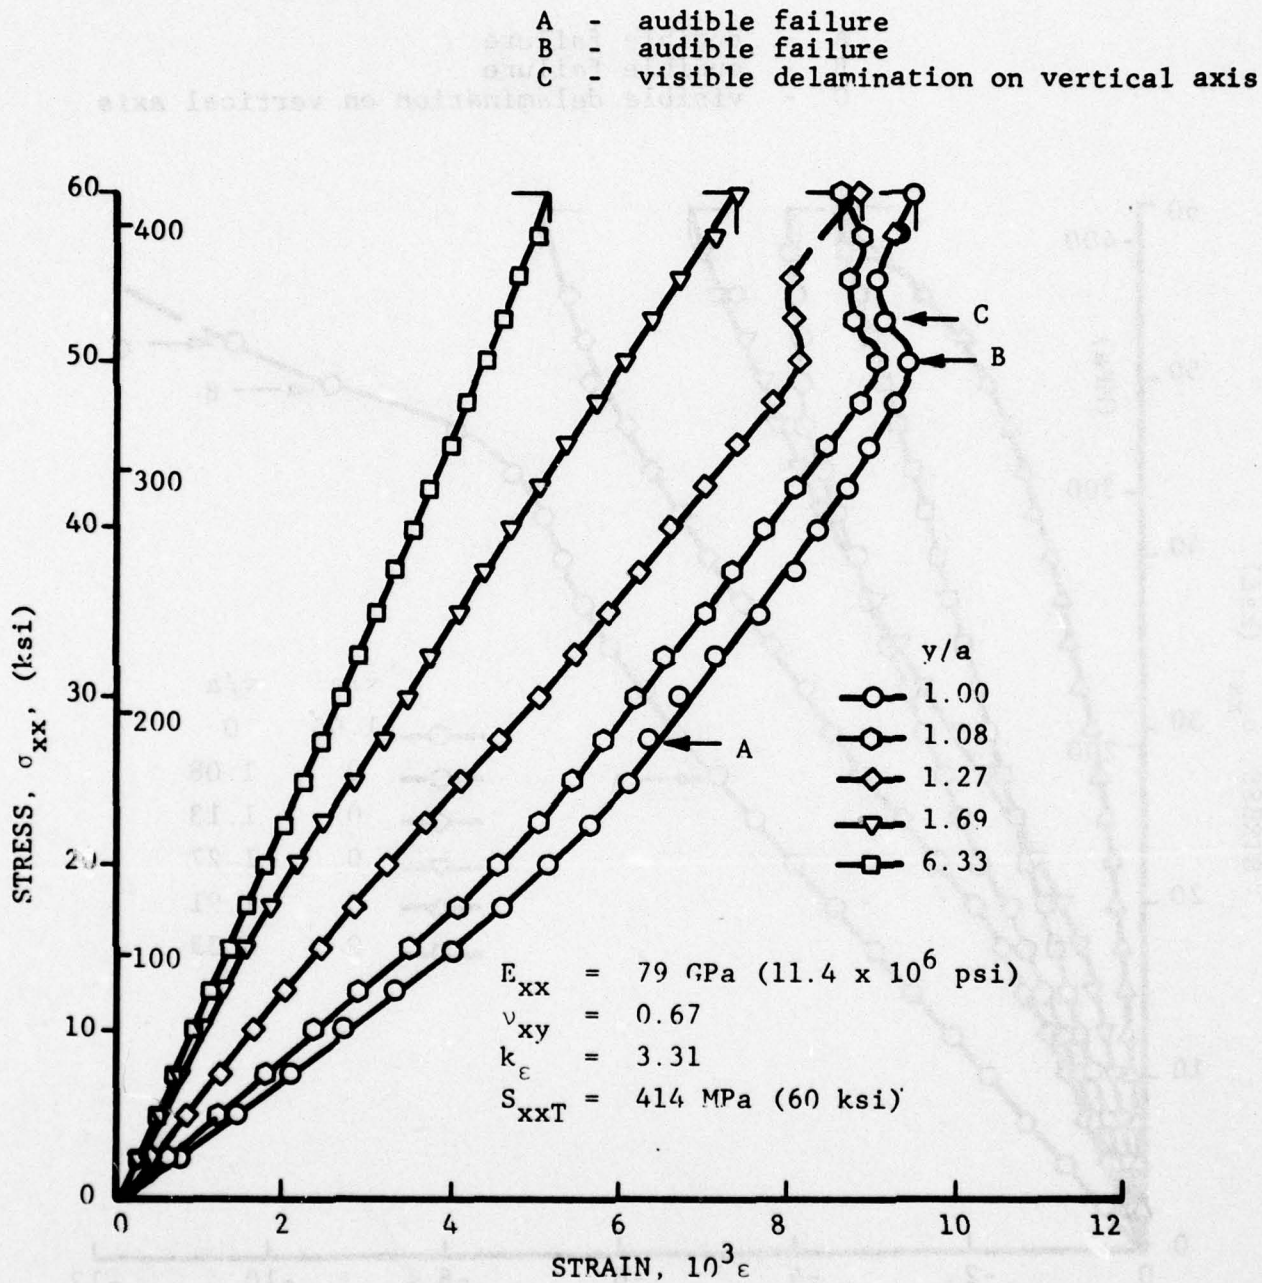
Figure 22. Vertical Strains Along Horizontal Axis of $[0_2/+45]_s$ Graphite/Epoxy Specimen with 1.91 cm (0.75 in.) Diameter Hole Under Uniaxial Tensile Loading (Spec. No. 4A-4)

- A - audible failure
- B - audible failure
- C - visible delamination on vertical axis

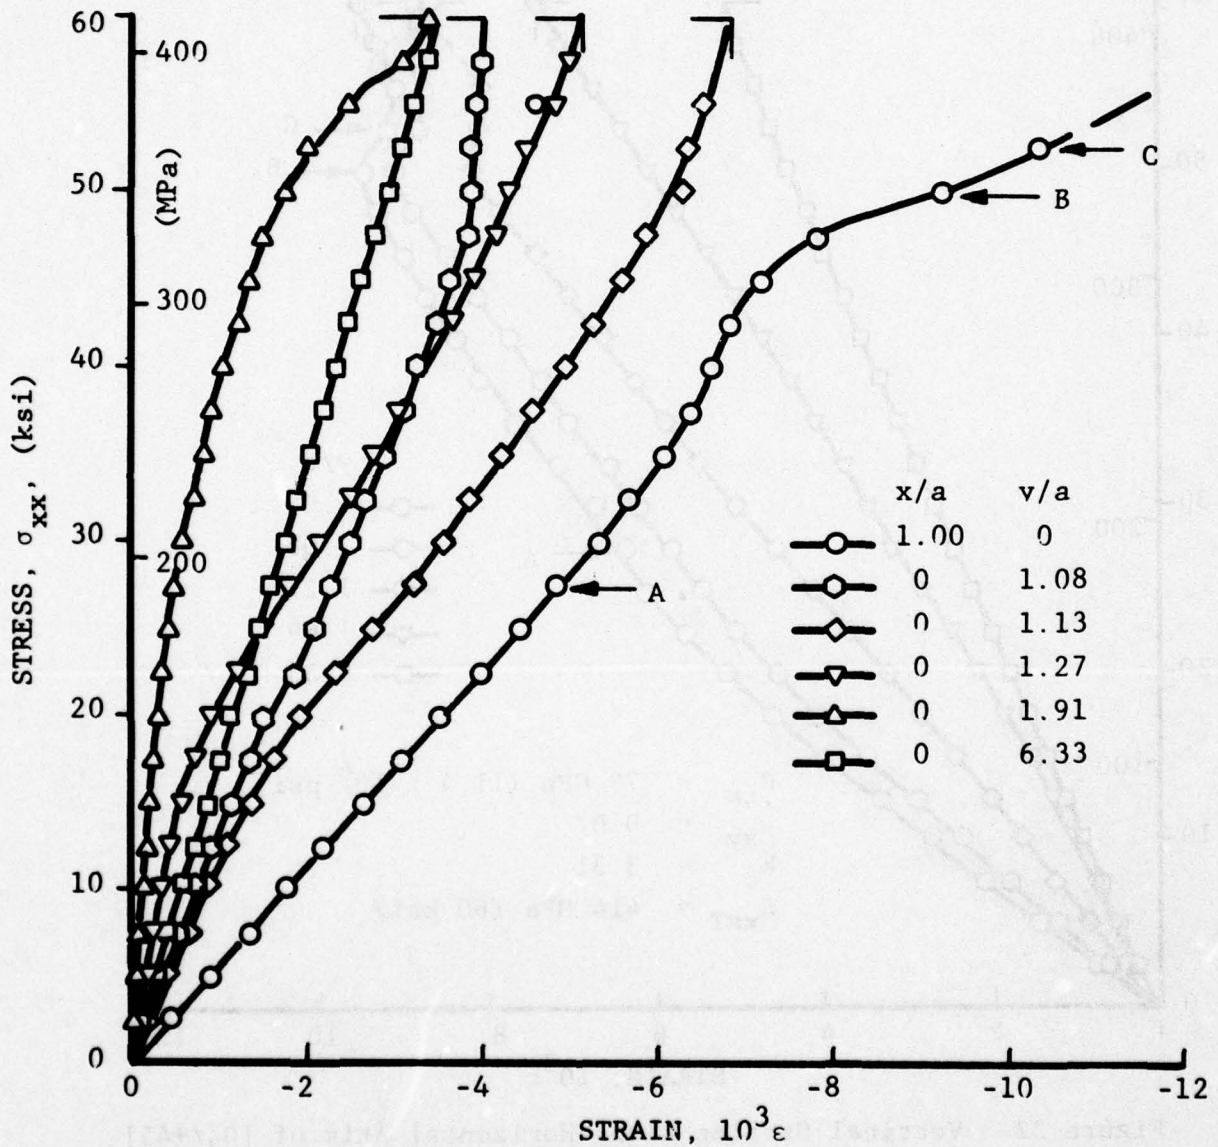
Figure 23. Horizontal Strains on the Hole Boundary and Along Horizontal Axis of $[0_2/+45]_S$ Graphite/Epoxy Specimen with 1.91 cm (0.75 in.) Diameter Hole Under Uniaxial Tensile Loading (Spec. No. 4A-4)

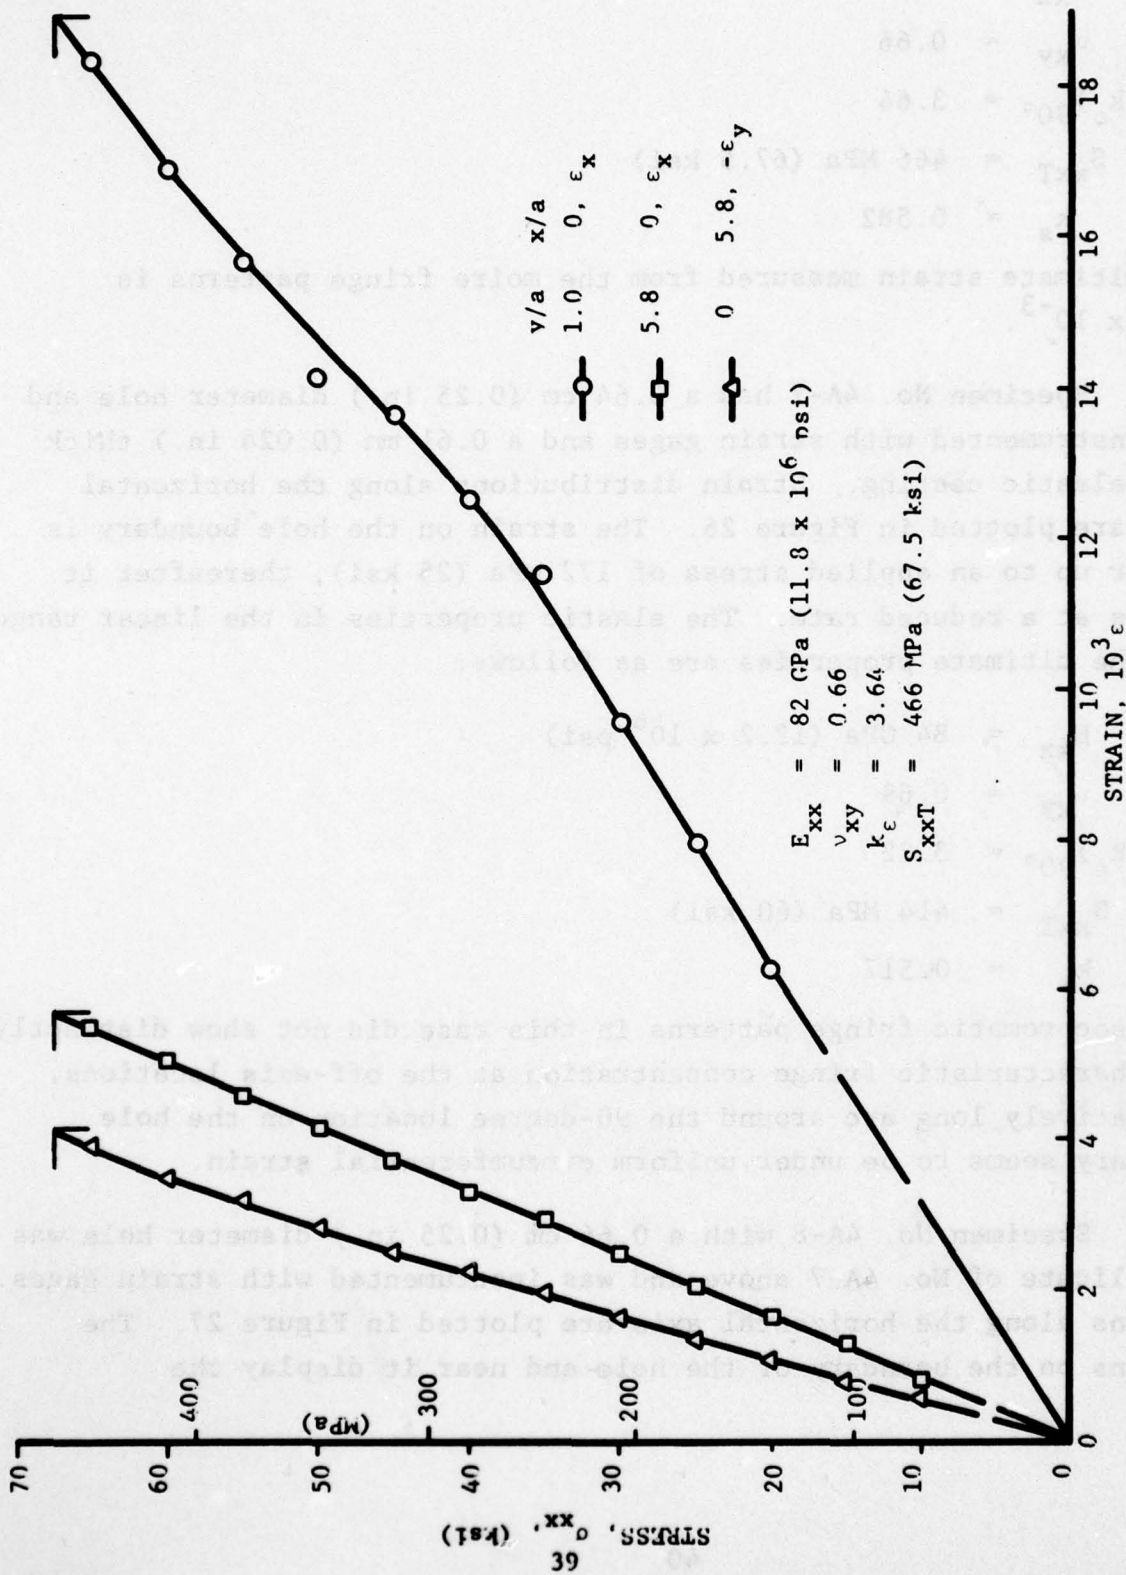
Figure 25. Strains on the Boundary of the Hole and in the Far Field of $[0_2/+45]$ s Graphite/Epoxy Specimen With 1.27 cm (0.50 in.) Diameter Hole Under Uniaxial Tensile Loading (Spec. No. 4A-6)

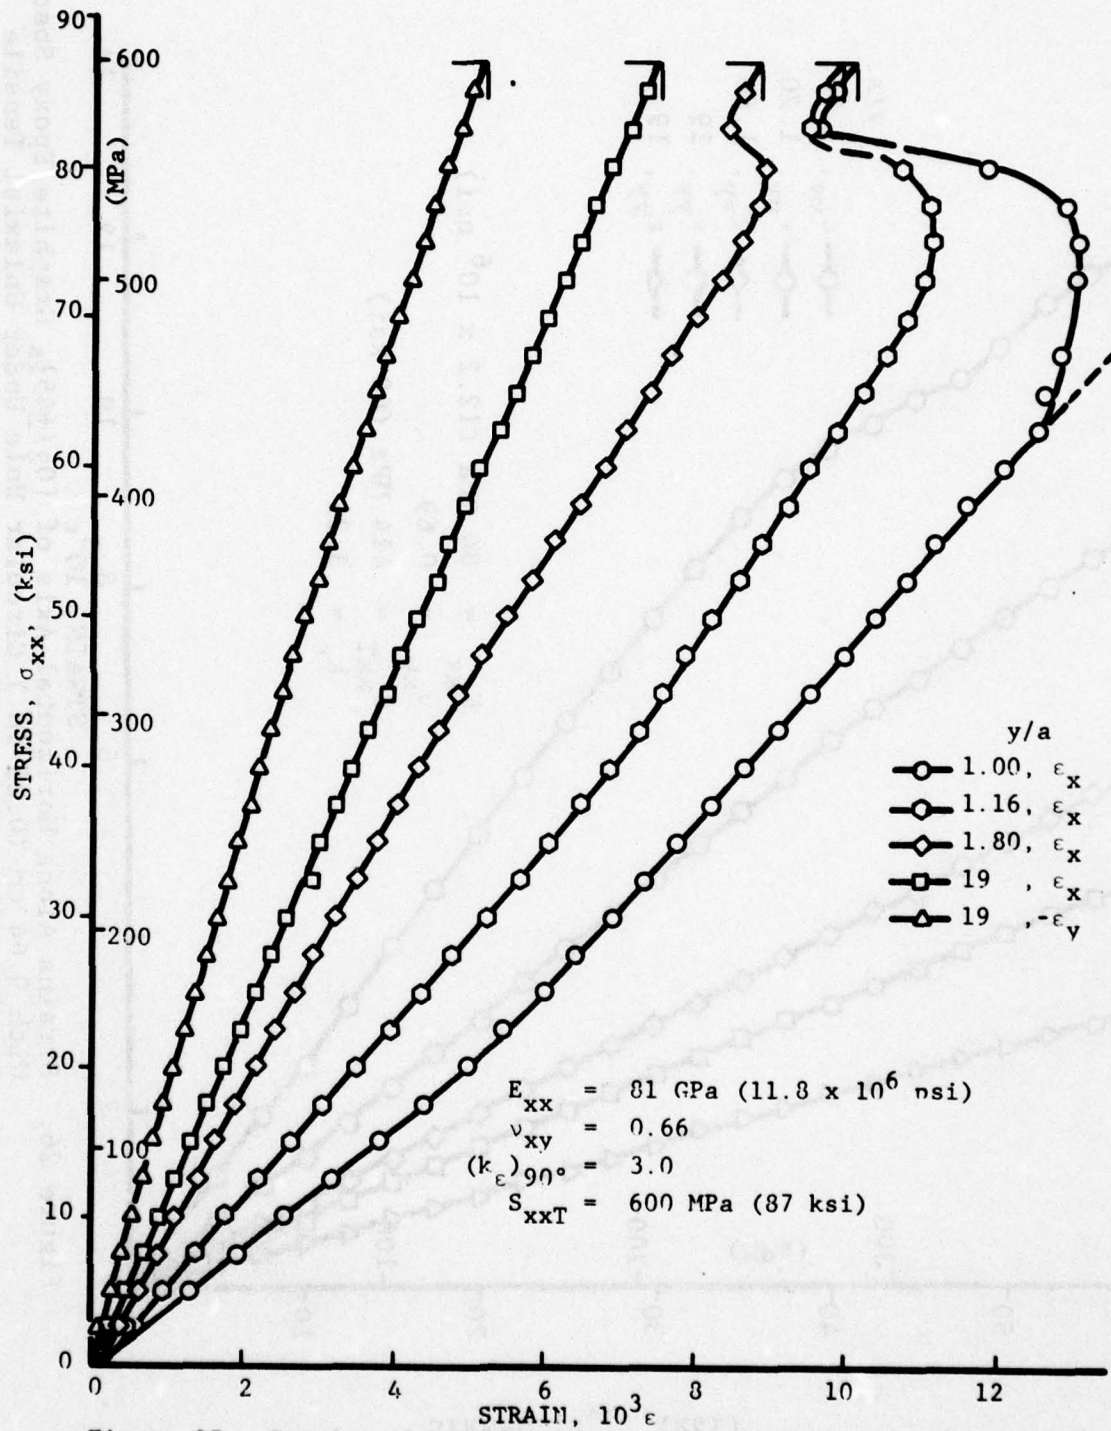
Figure 27. Strains Along Horizontal Axis of $[0_2/+45]_s$ Graphite/Epoxy Specimen With 0.64 cm (0.25 in.) Diameter Hole Under Uniaxial Tensile Loading (Spec. No. 4A-8)

characteristic bilinear behavior. The maximum strain becomes nonlinear first at a stress of 138 MPa (20 ksi), thereafter it increases nearly linearly at a lower rate up to a stress of 431 MPa (62.5 ksi). At this level the outer 0-degree strips along the vertical axis of the specimen through the hole started separating, thereby blunting the strain concentration. Final failure occurred away from the hole after the specimen had separated essentially into two strips. The elastic properties in the linear range and the ultimate properties are as follows:

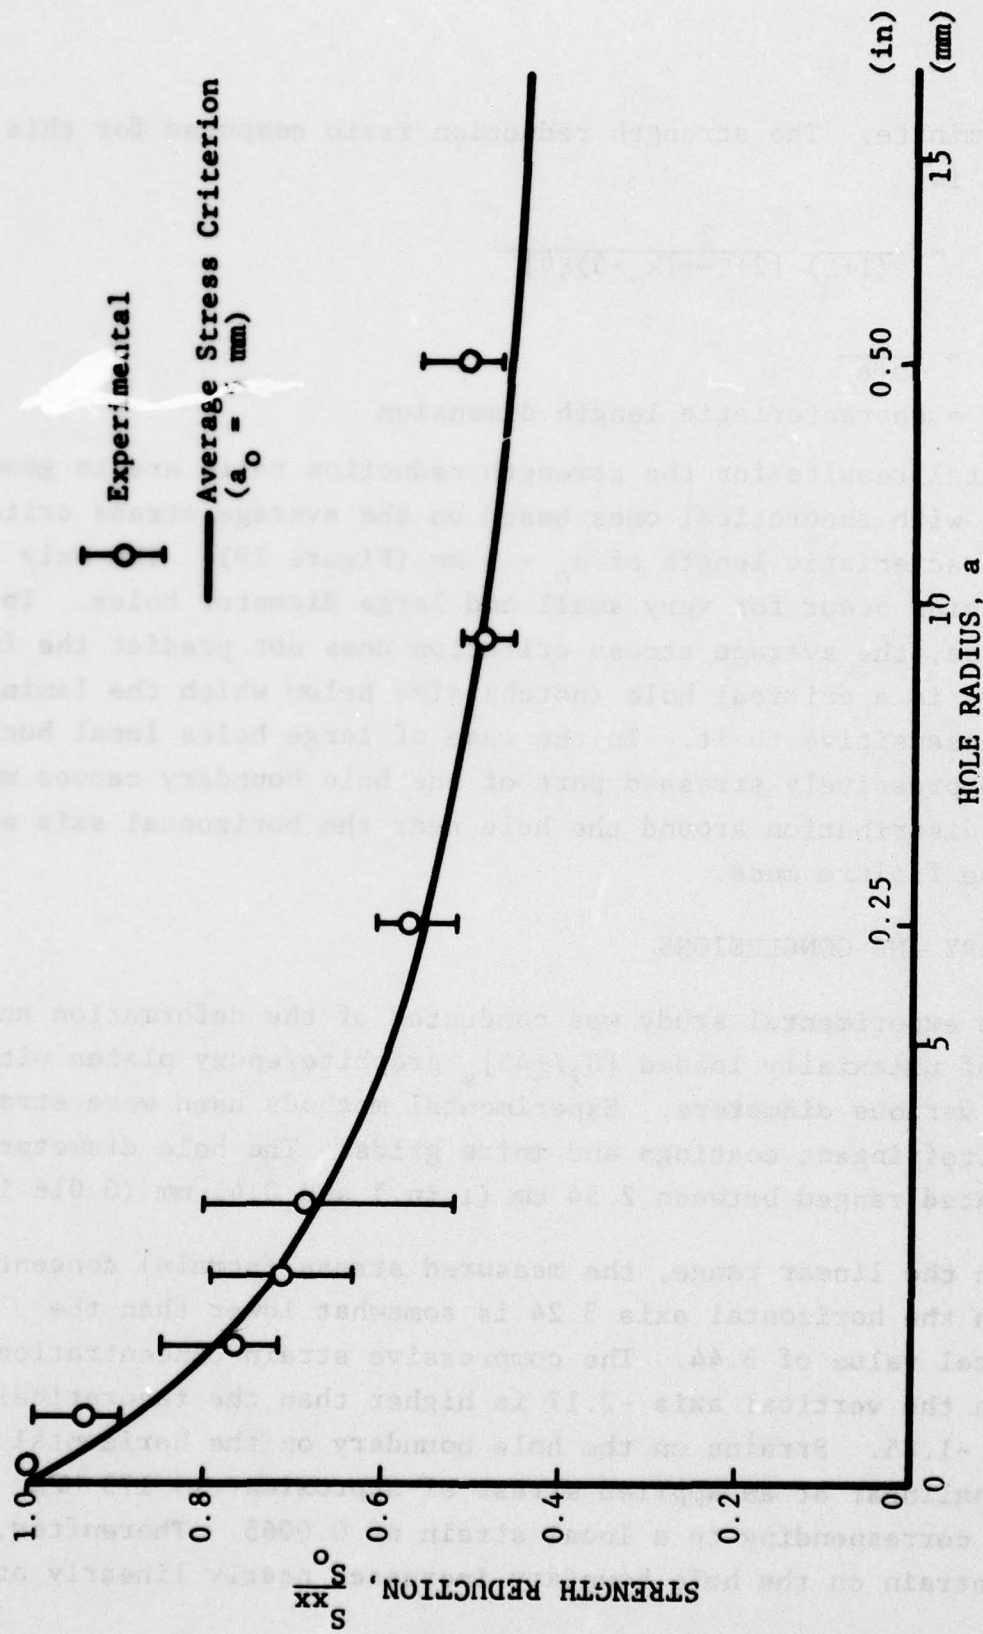
Figure 29. Strength Reduction as a Function of Hole Radius for [02/+45]s Graphite/Epoxy Plates With Circular Holes Under Uniaxial Tensile Loading

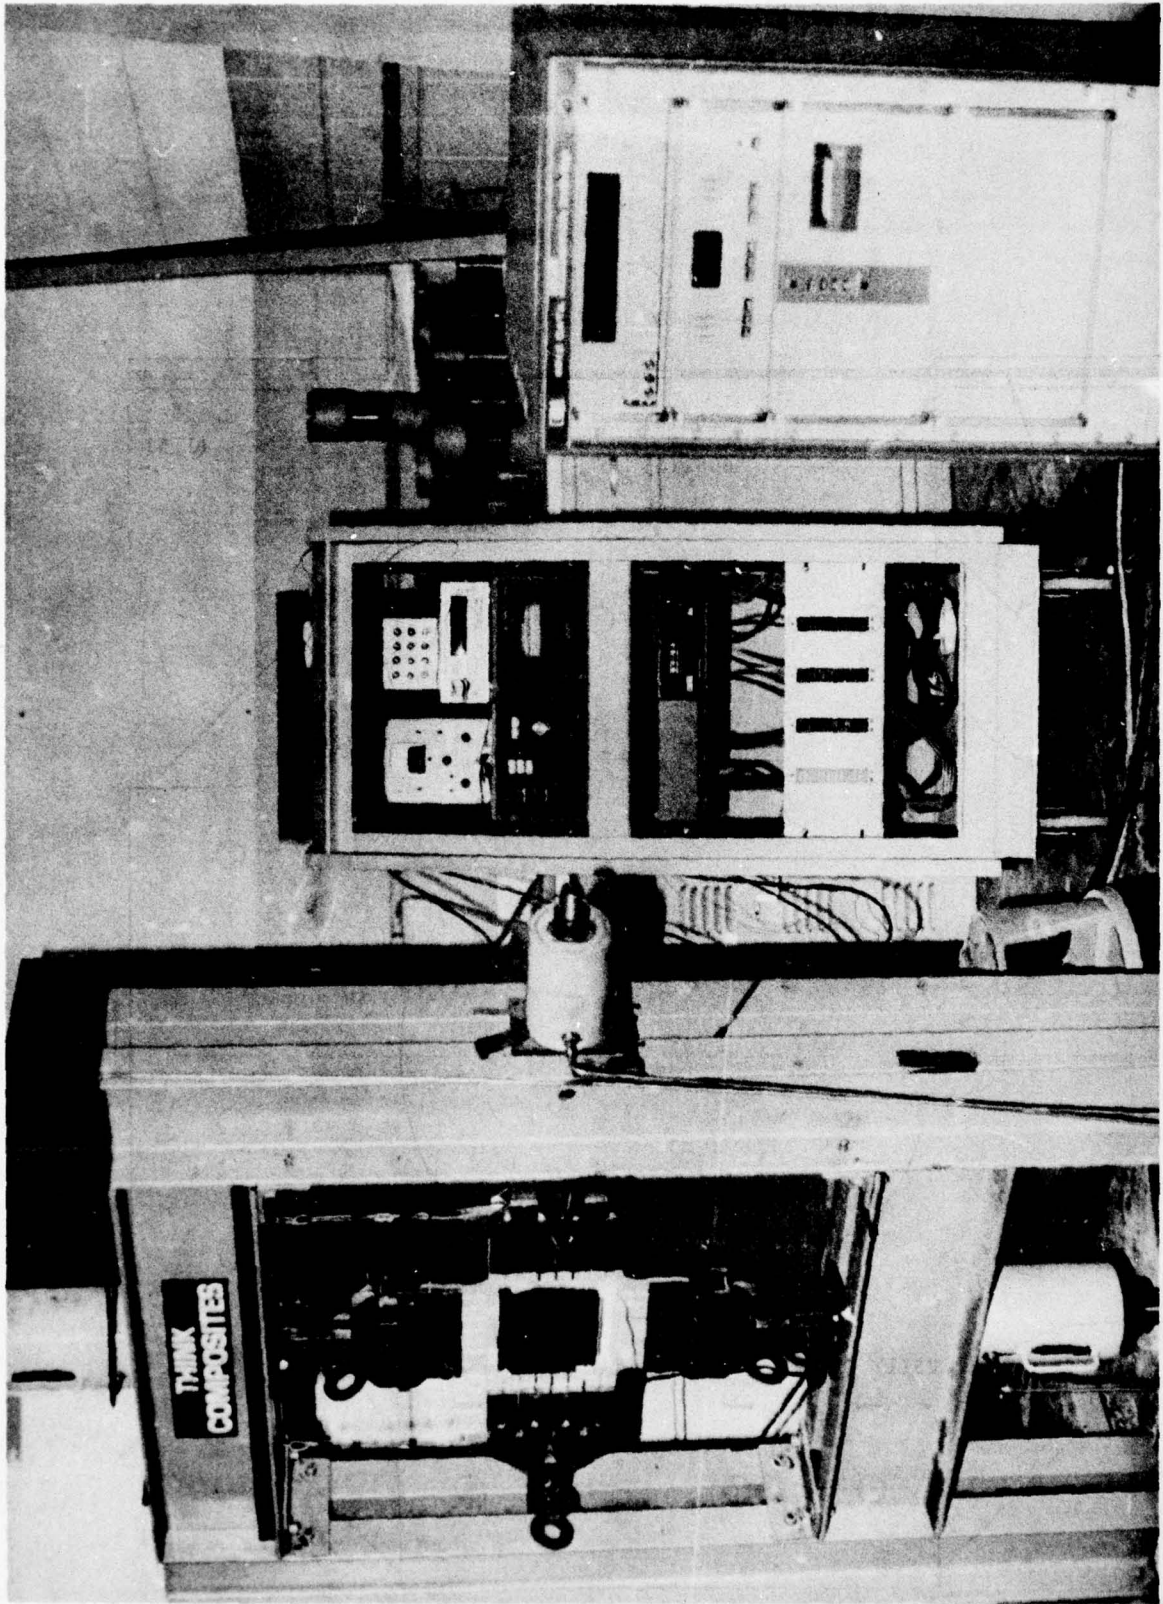
Figure 31. Loading Frame for Biaxial Testing of Flat Laminates and Associated Strain Recording Instrumentation

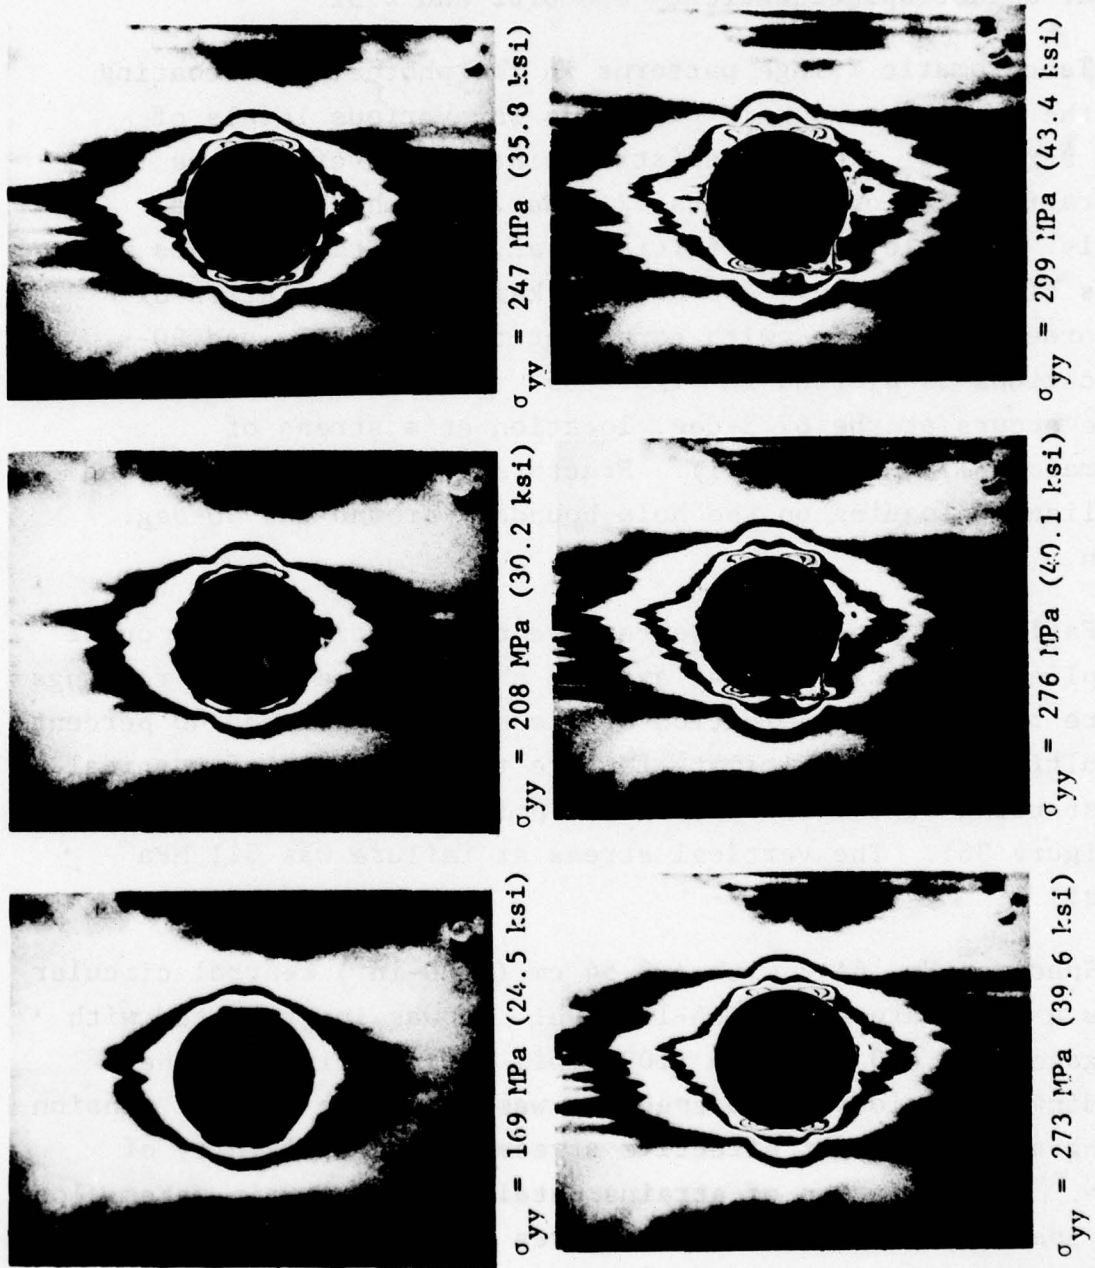
Figure 34. Isochromatic Fringe Patterns in Photoelastic Coating Around 2.54 cm (1.00 in.) Diameter Hole in $[0_2/+45]_s$ Graphite/Epoxy Specimen Under Biaxial Loading $\sigma_{yy} = 2\sigma_{xx}$ (Spec. No. 6A-1)
