**BIAXIAL TESTING OF GRAPHITE/EPOXY COMPOSITES
CONTAINING STRESS CONCENTRATIONS — Part II**

*IIT RESEARCH INSTITUTE
10 WEST 35th STREET
CHICAGO, ILLINOIS 60616*

TECHNICAL REPORT AFML-TR-76-244, PART II
Final Report for Period April 1976 — March 1977

AIR FORCE MATERIALS LABORATORY
AIR FORCE WRIGHT AERONAUTICAL LABORATORIES
AIR FORCE SYSTEMS COMMAND
WRIGHT-PATTERSON AIR FORCE BASE, OHIO 45433

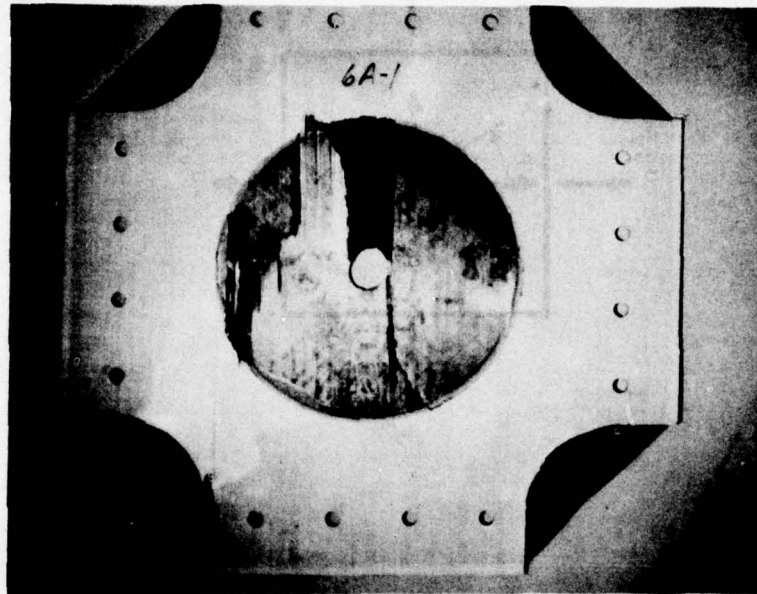
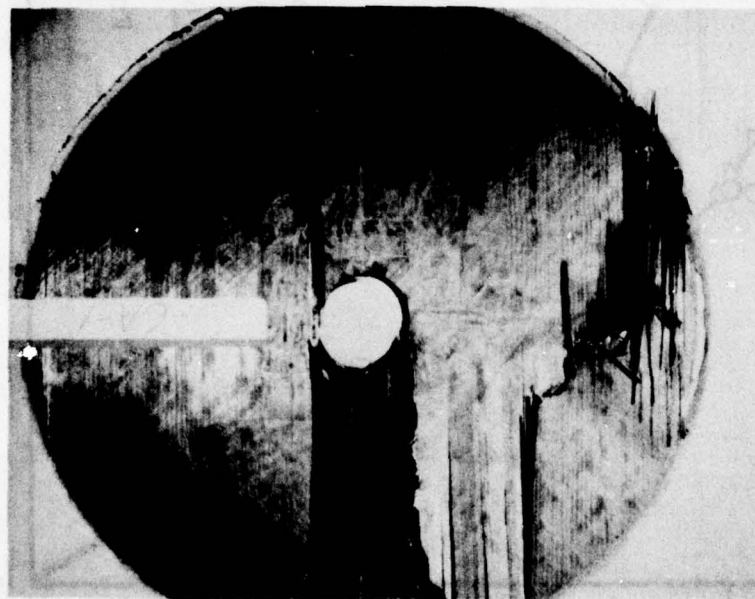
Figure 36. Failure Pattern in $[0_2/+45]_s$ Graphite/
Epoxy Specimen With 2.54 cm (1 in.)
Diameter Hole Under 2:1 Biaxial Loading
(Spec. No. 6A-1)

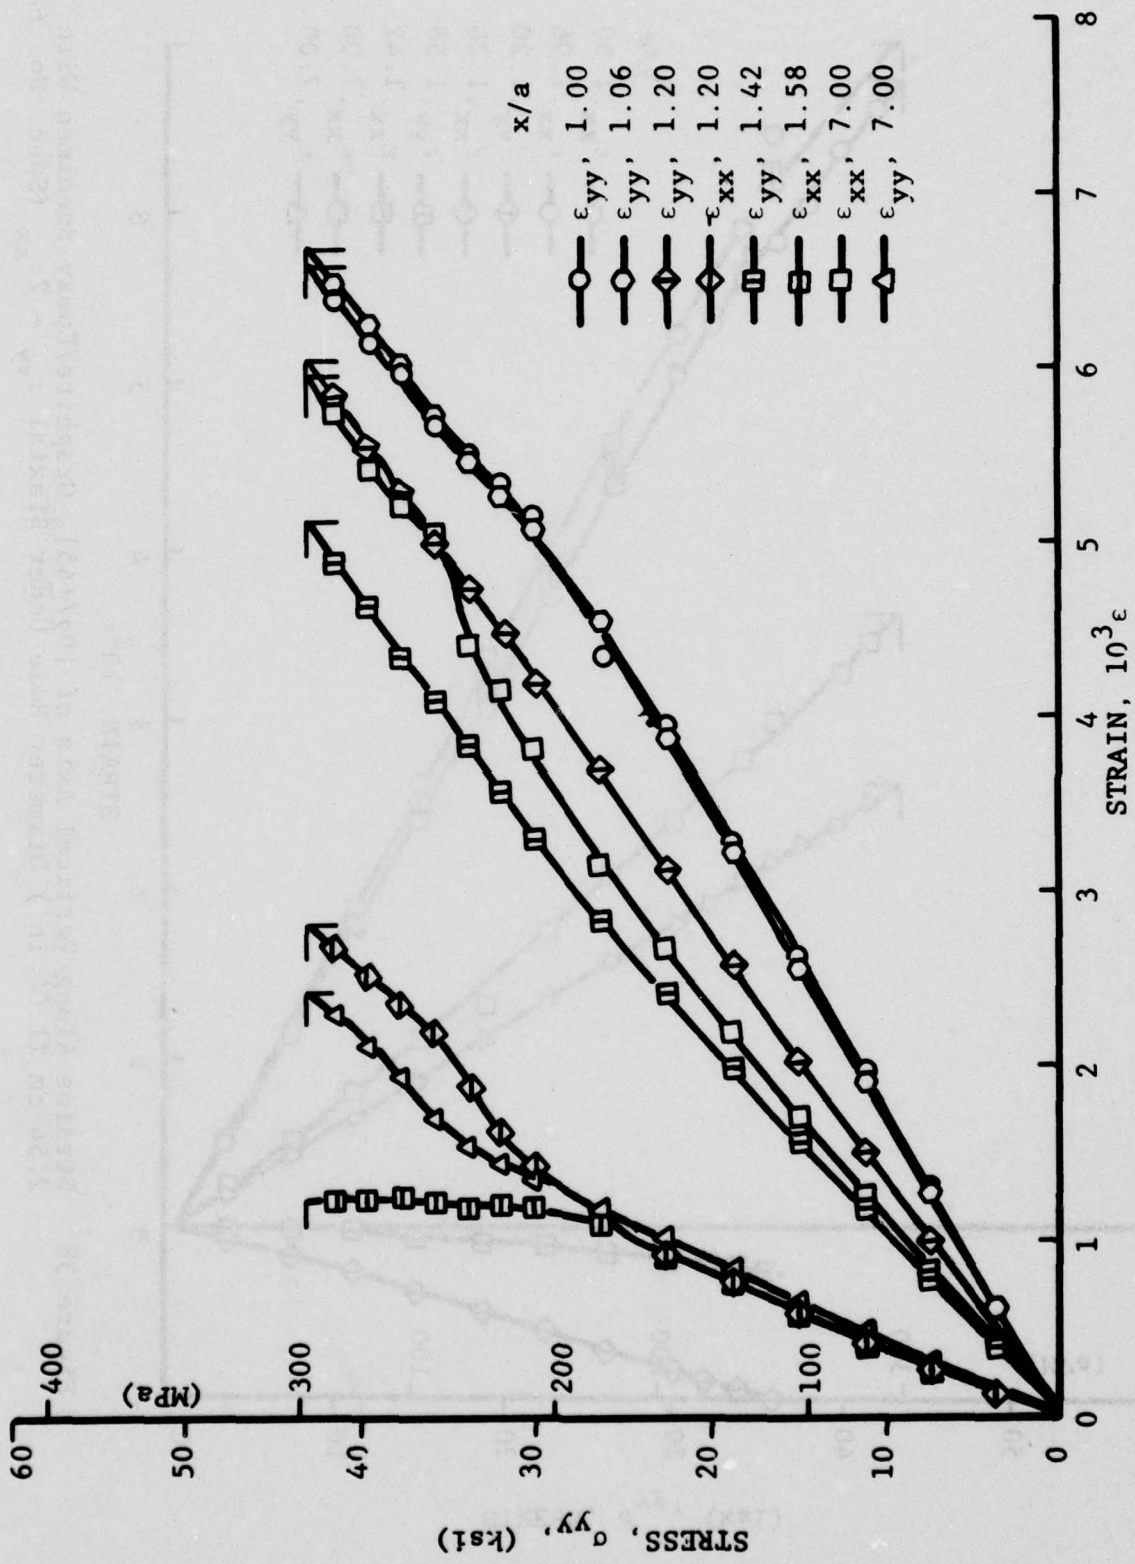
Figure 37. Strains Along Horizontal Axis of $[0_2/+45]_s$ Graphite/Epoxy Specimen With 2.54 cm (1.00 in.) Diameter Hole Under Biaxial Loading $\sigma_{yy} = 2\sigma_{xx}$ (Spec. No. 6A-2)

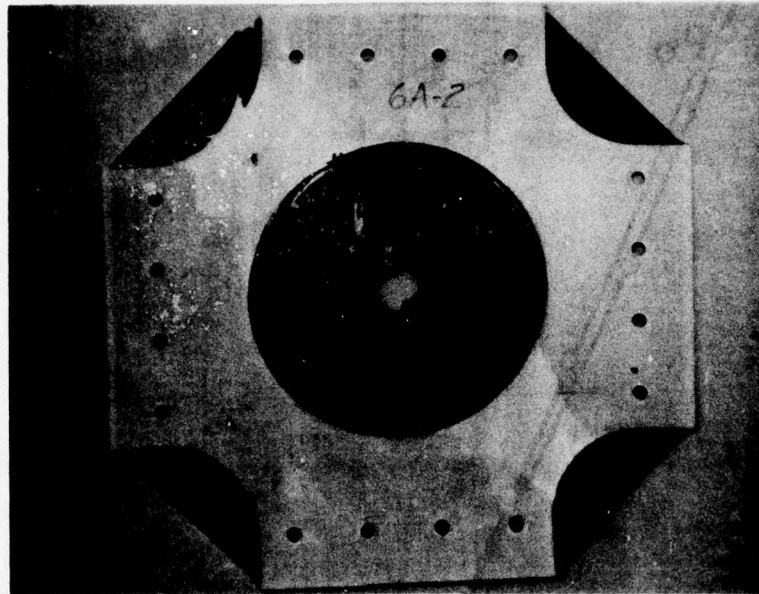
Figure 41. Failure Pattern of $[0_2/+45]_s$ Graphite/Epoxy Specimen
With 2.54 cm (1.00 in.) Hole Under Biaxial Loading
 $\sigma_{yy} = 2\sigma_{xx}$ (Spec. No. 6A-2)

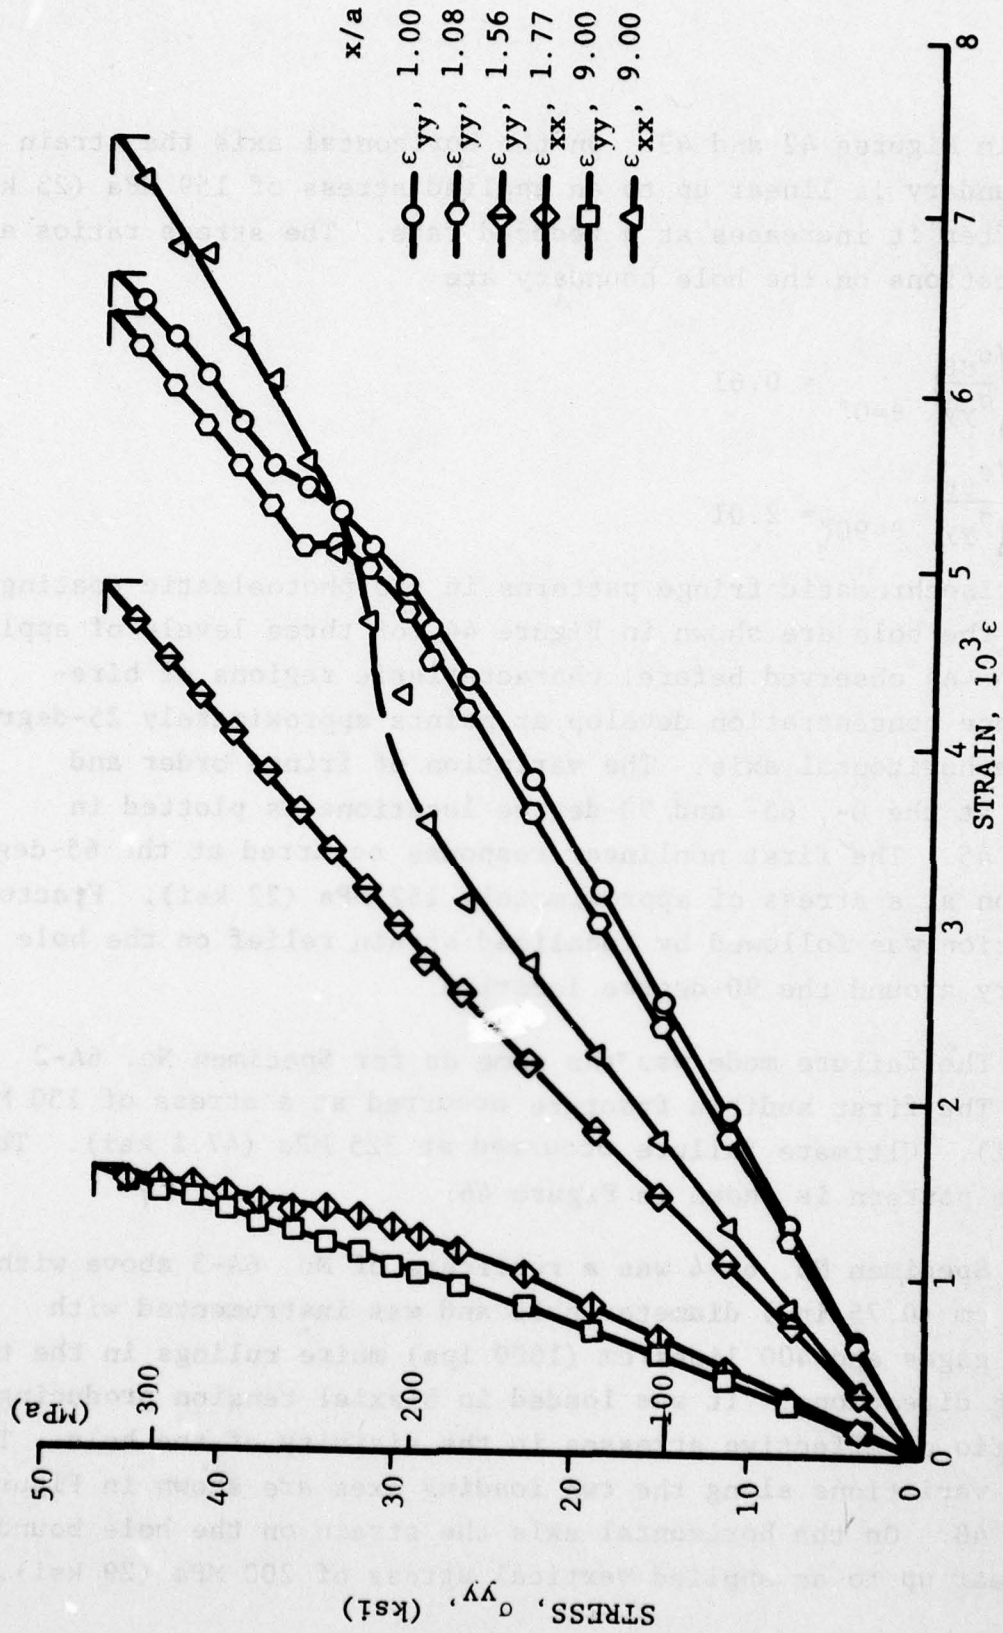
Figure 42. Strains Along Horizontal Axis of $[0_2/+45]_s$ Graphite/Epoxy Specimen With 1.91 cm (0.75 in.) Diameter Hole Under Biaxial Loading $\sigma_{yy} = 2\sigma_{xx}$ (Spec. No. 6A-3)

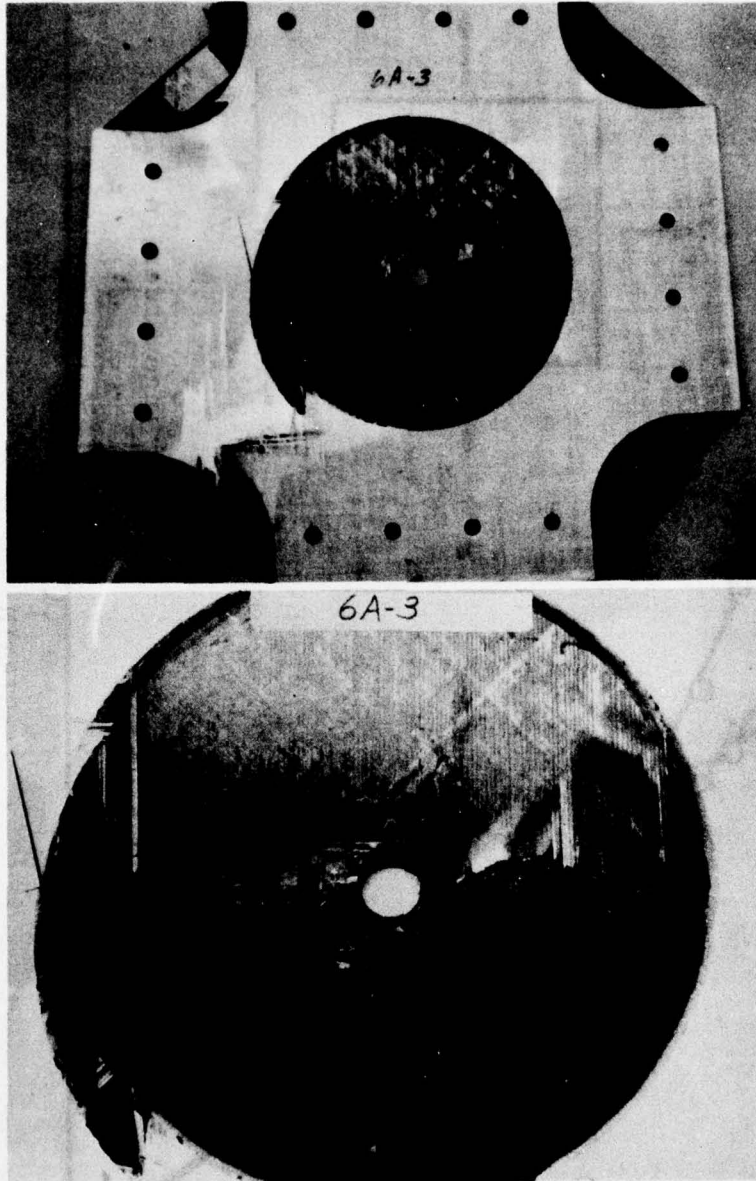
Figure 46. Failure Pattern of $[0_2/+45]_s$ Graphite/Epoxy Specimen With a 1.91 cm (0.75 in.) Hole Under Biaxial Loading $\sigma_{yy} = 2\sigma_{xx}$ (Spec. No. 6A-3)

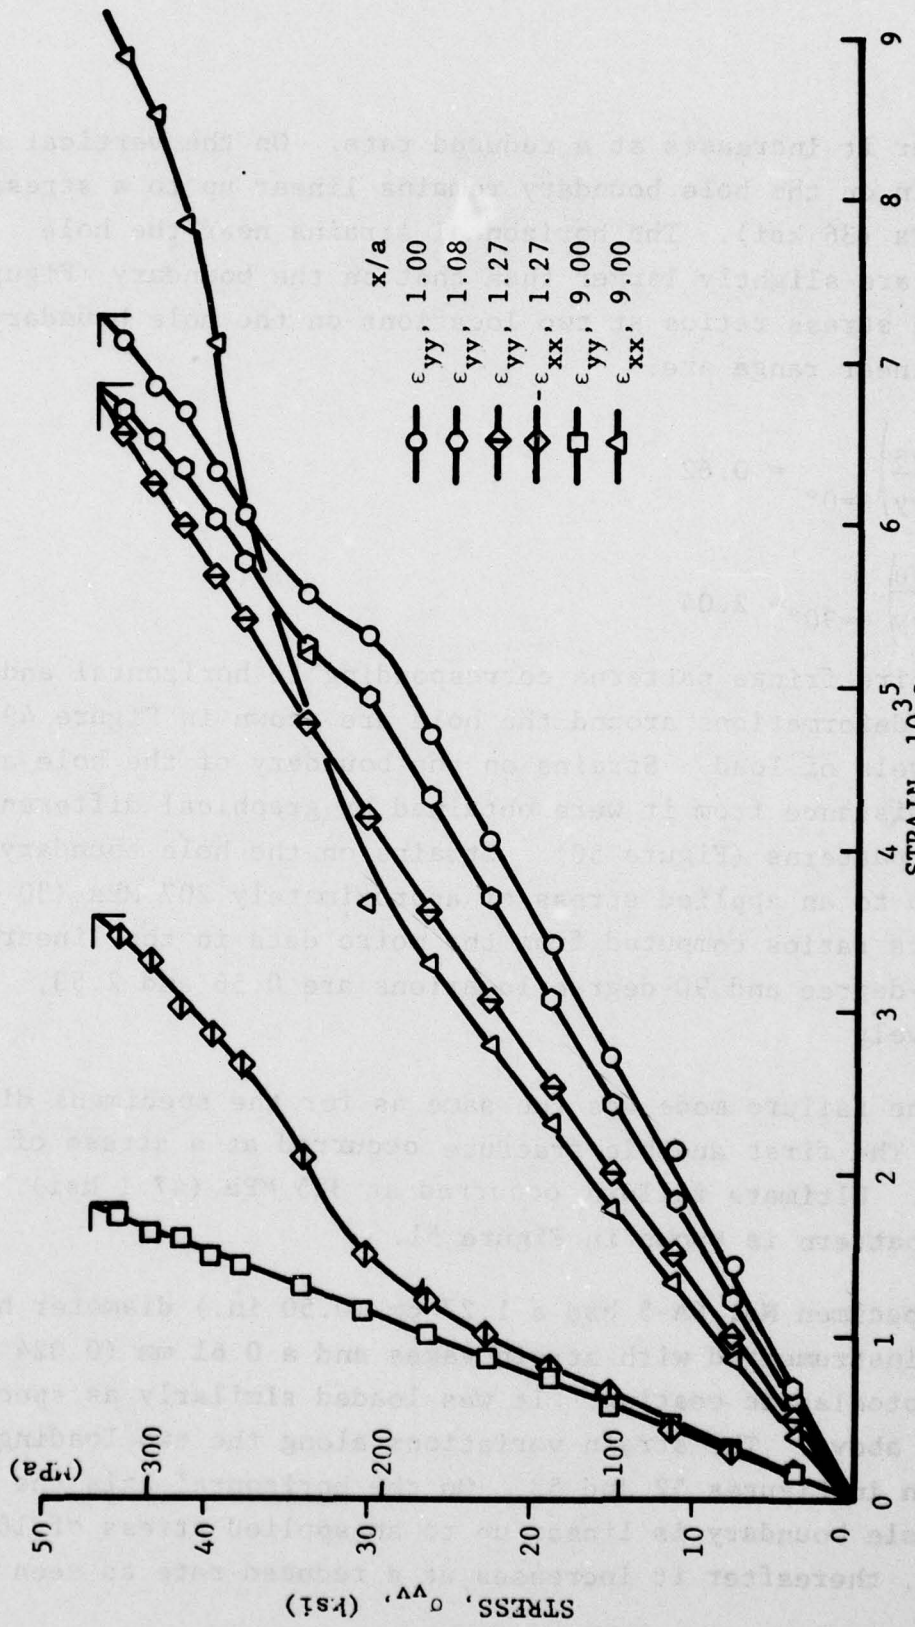
Figure 47. Strains Along Horizontal Axis of [0/±45]_s Graphite/Epoxy Specimen With 1.91 cm (0.75 in.) Diameter Hole Under Biaxial Loading $\sigma_{yy} = 2\sigma_{xx}$ (Spec. No. 6A-4)

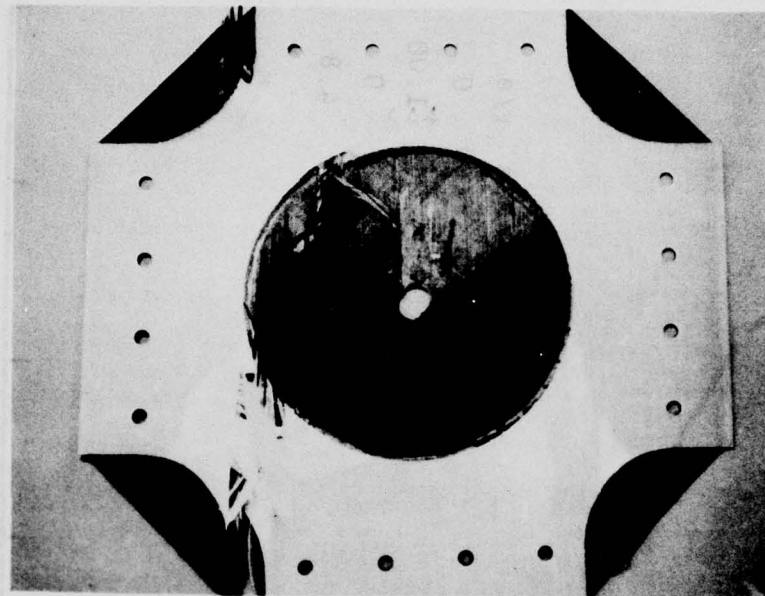
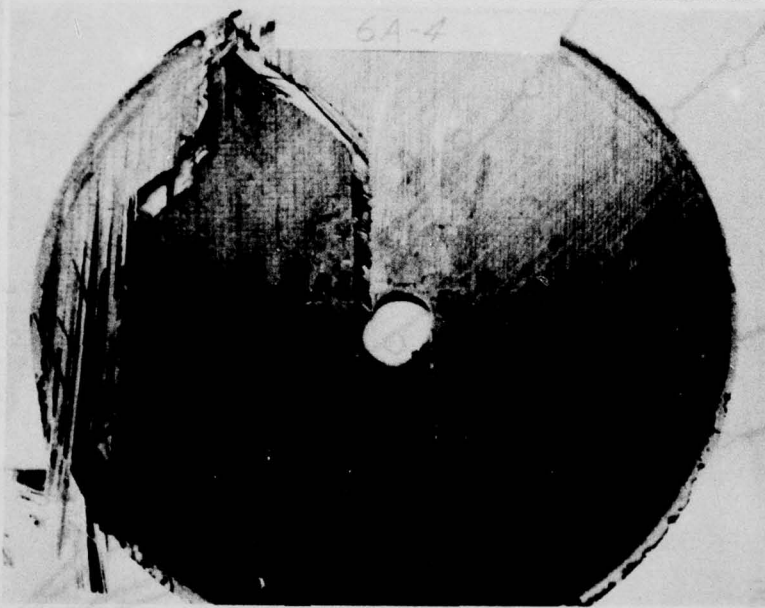
Figure 51. Failure Pattern of $[0_2/+45]_s$ Graphite/Epoxy Specimen With a 1.91 cm (0.75 in.) Diameter Hole Under Biaxial Loading $\sigma_{yy} = 2\sigma_{xx}$ (Spec. No. 6A-4)

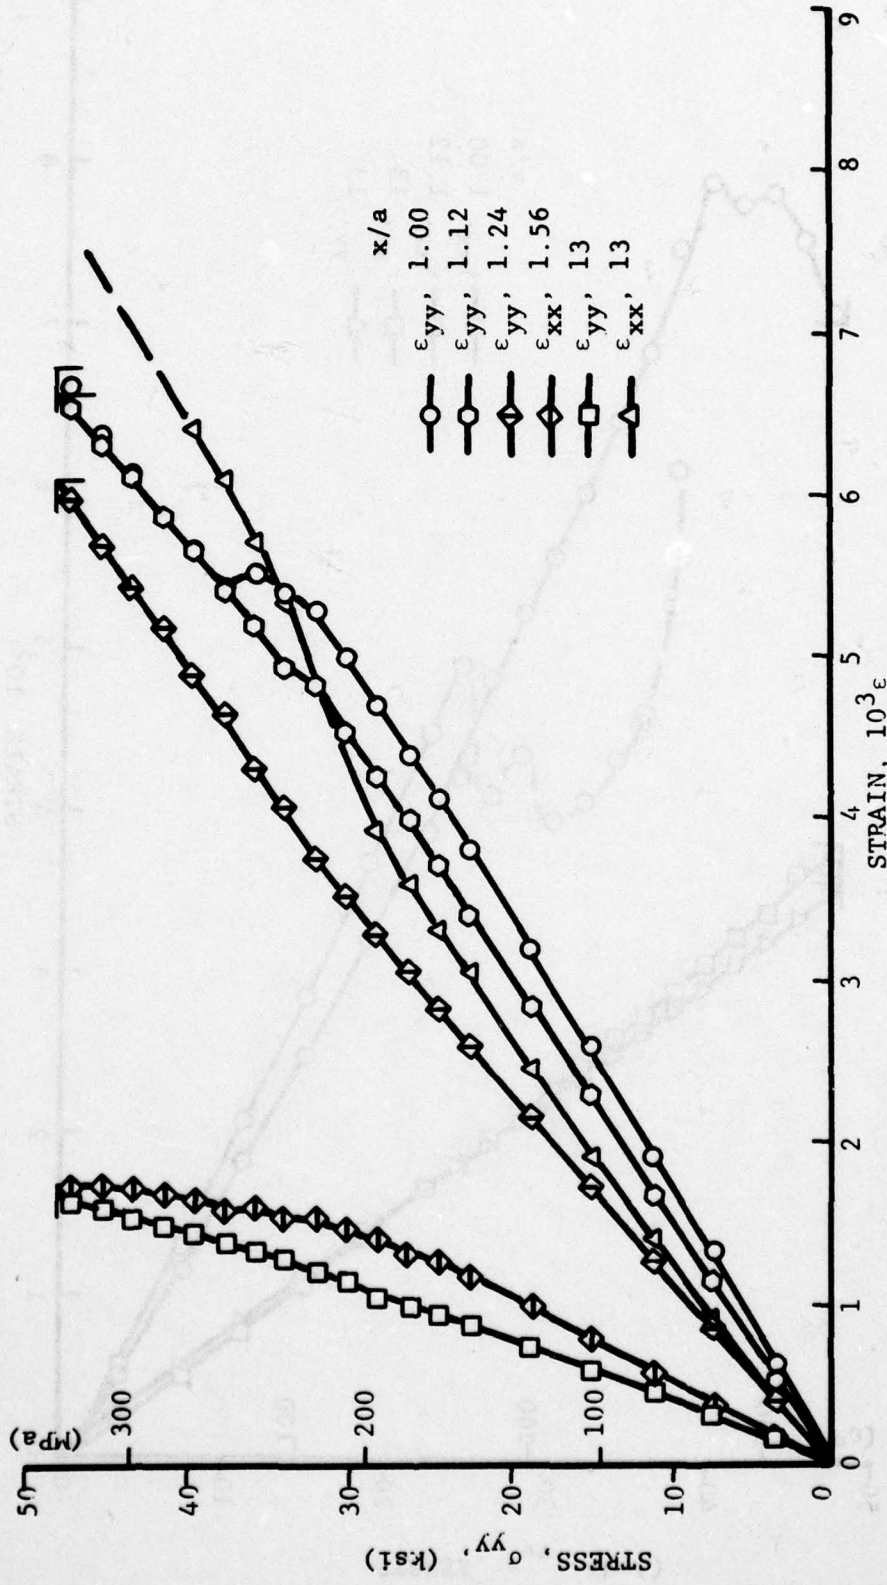
Figure 52. Strains Along Horizontal Axis of [02/+45]_s Graphite/Epoxy Specimen With 1.27 cm (0.50 in.) Diameter Hole Under Biaxial Loading $\sigma_{yy} = 2\sigma_{xx}$ (Spec. No. 6A-5)

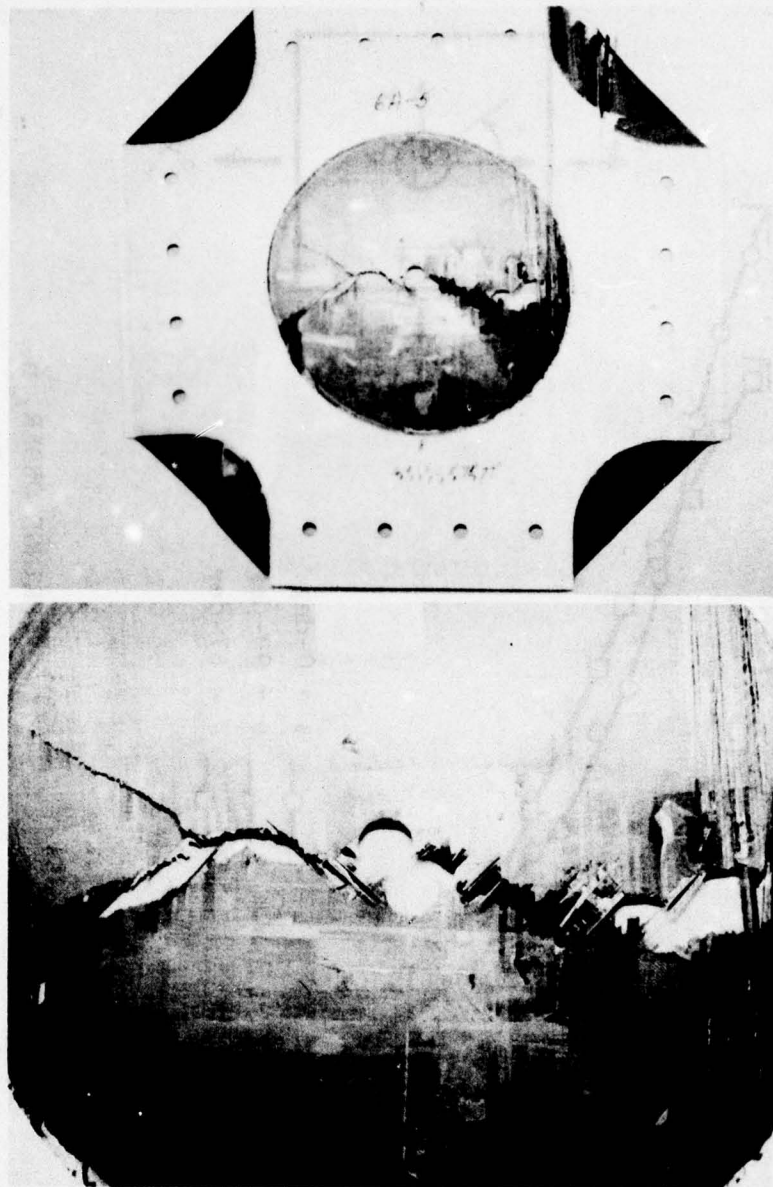
Figure 56. Failure Pattern of $[0_2/+45]_s$ Graphite/Epoxy Specimen With 1.27 cm (0.50 in.) Diameter Hole Under Biaxial Loading $\sigma_{yy} = 2\sigma_{xx}$ (Spec. No. 6A-5)

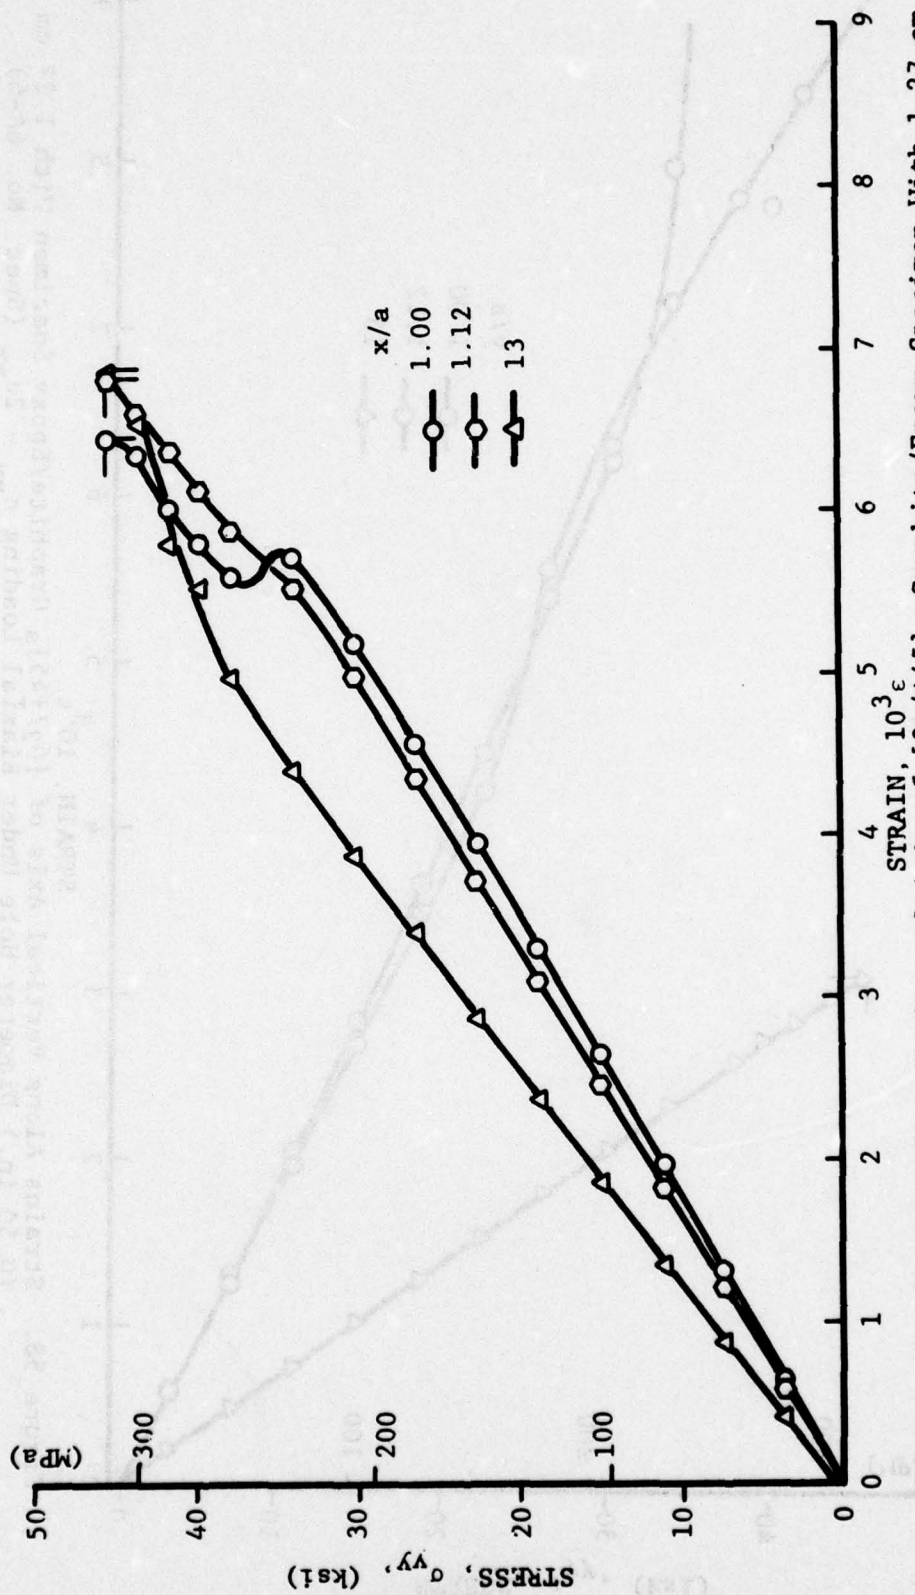
Figure 57. Strains Along Horizontal Axis of [0/±45]s Graphite/Epoxy Specimen With 1.27 cm (0.50 in.) Diameter Hole Under Biaxial Loading $\sigma_{yy} = 2\sigma_{xx}$ (Spec. No. 6A-6)

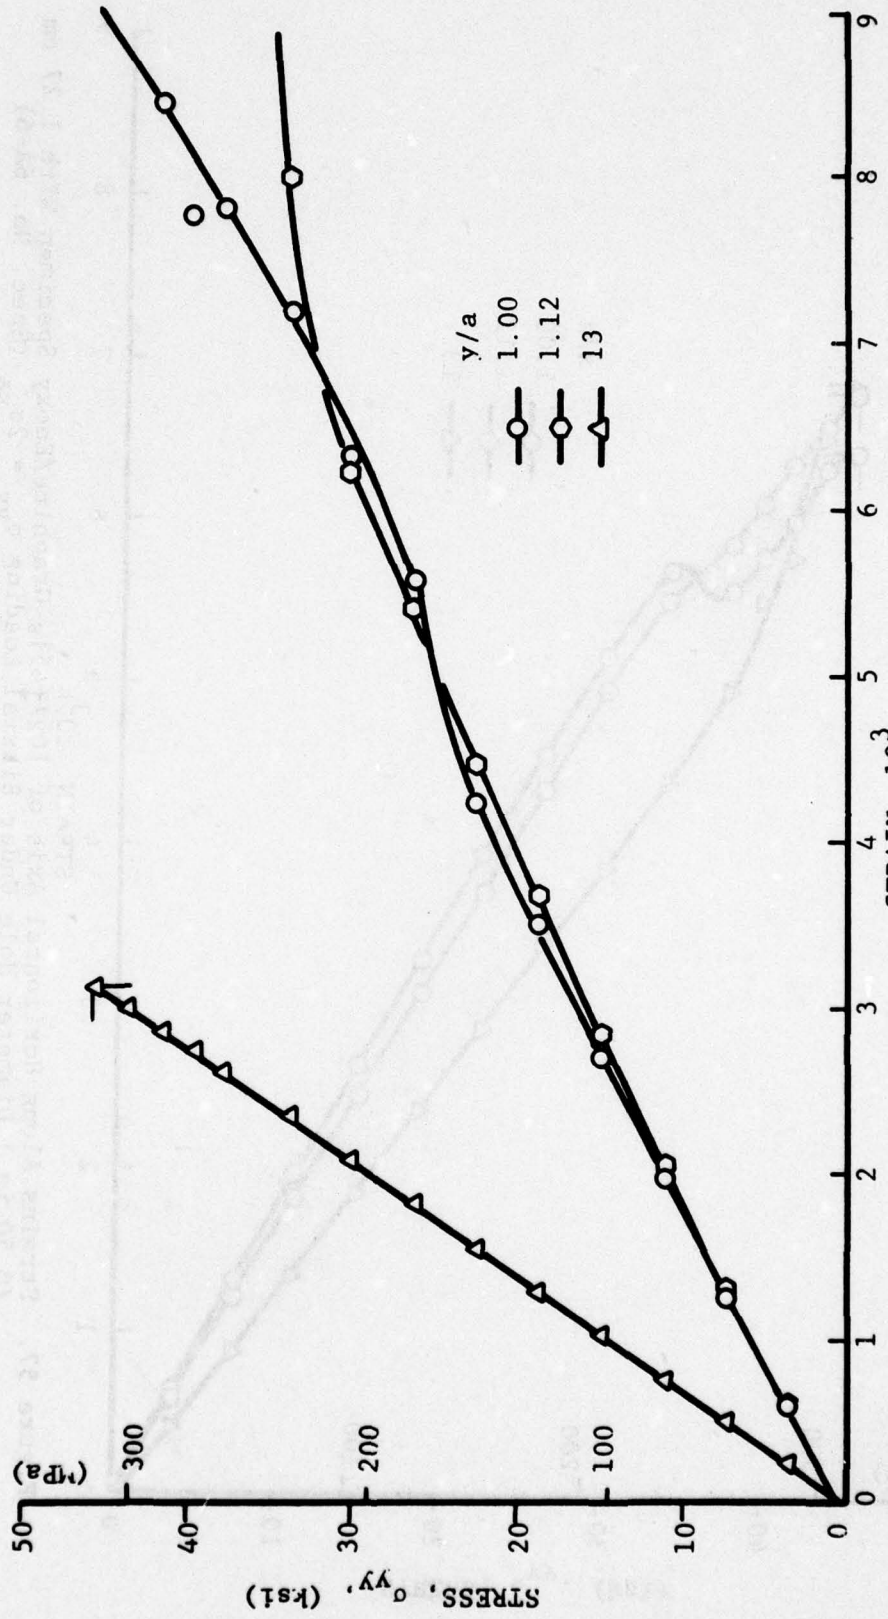
Figure 58. Strains Along Vertical Axis of $[0_2/+45]_s$ Graphite/Epoxy Specimen With 1.27 cm (0.50 in.) Diameter Hole Under Biaxial Loading $\sigma_{yy} = 2\sigma_{xx}$ (Spec. No. 6A-6)

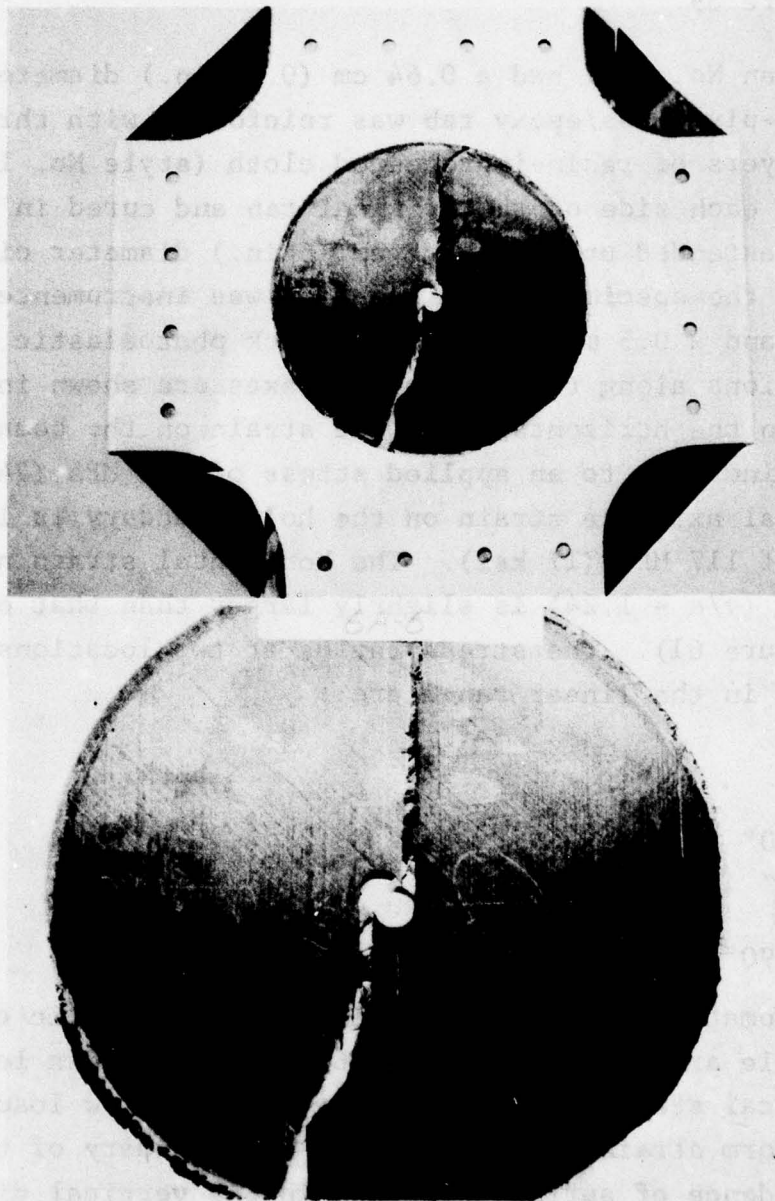
Figure 59. Failure Pattern of $[0_2/+45]_s$ Graphite/Epoxy Specimen With 1.27 cm (0.50 in.) Diameter Hole Under Biaxial Loading $\sigma_{yy} = 2\sigma_{xx}$ (Spec. No. 6A..)

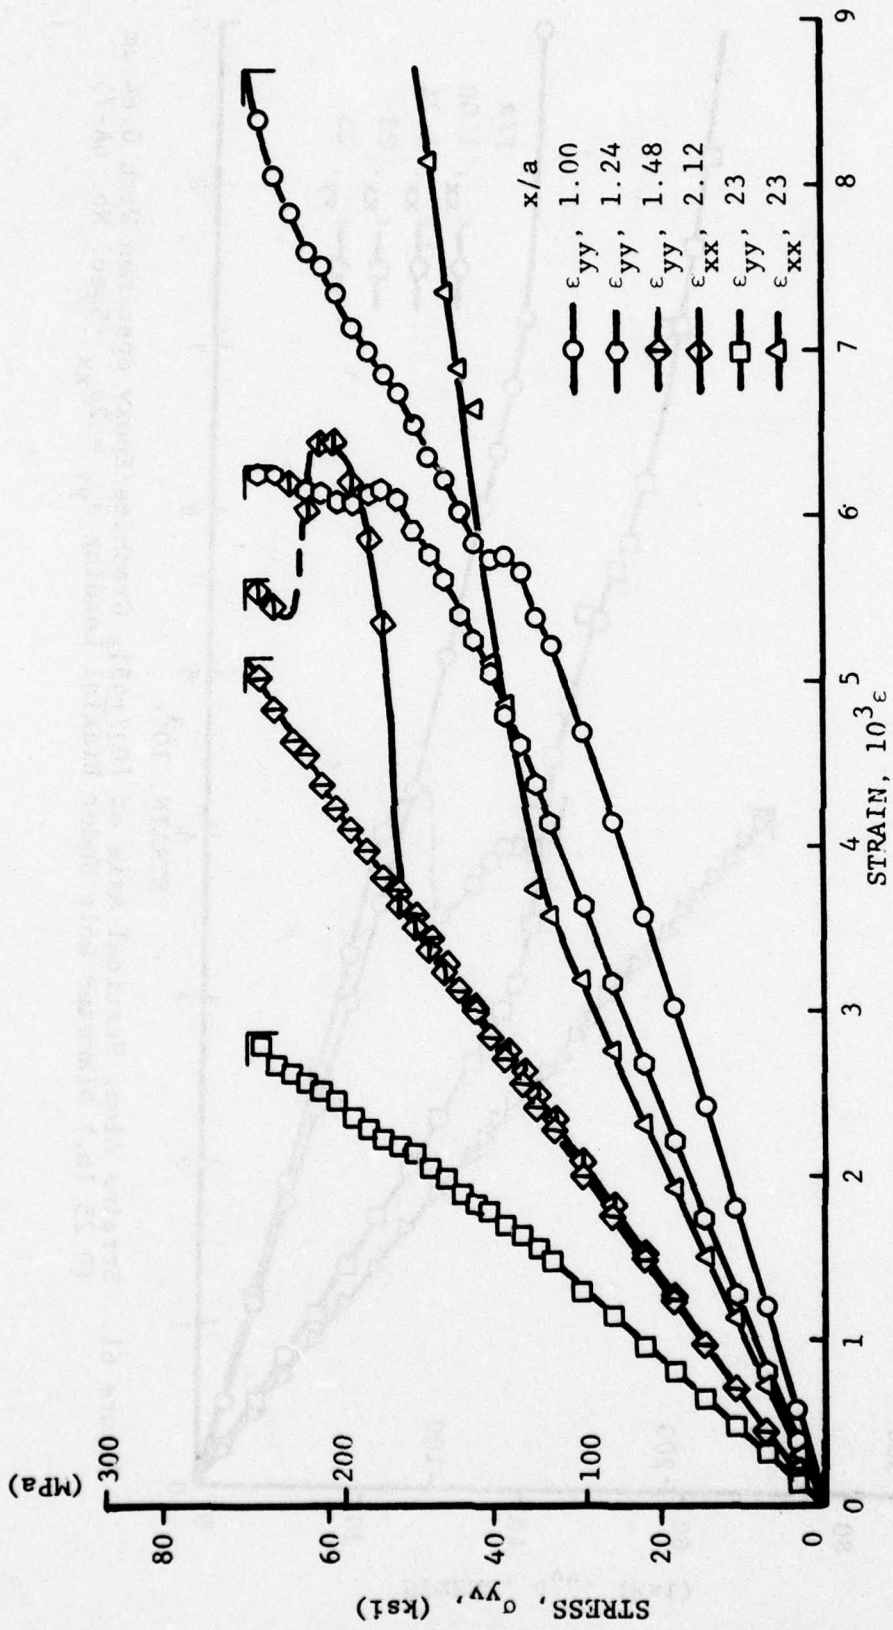
Figure 60. Strains Along Horizontal Axis of $[0_2/+45]_s$ Graphite/Epoxy Specimen With 0.64 cm (0.25 in.) Diameter Hole Under Biaxial Loading $\sigma_{yy} = 2\sigma_{xx}$

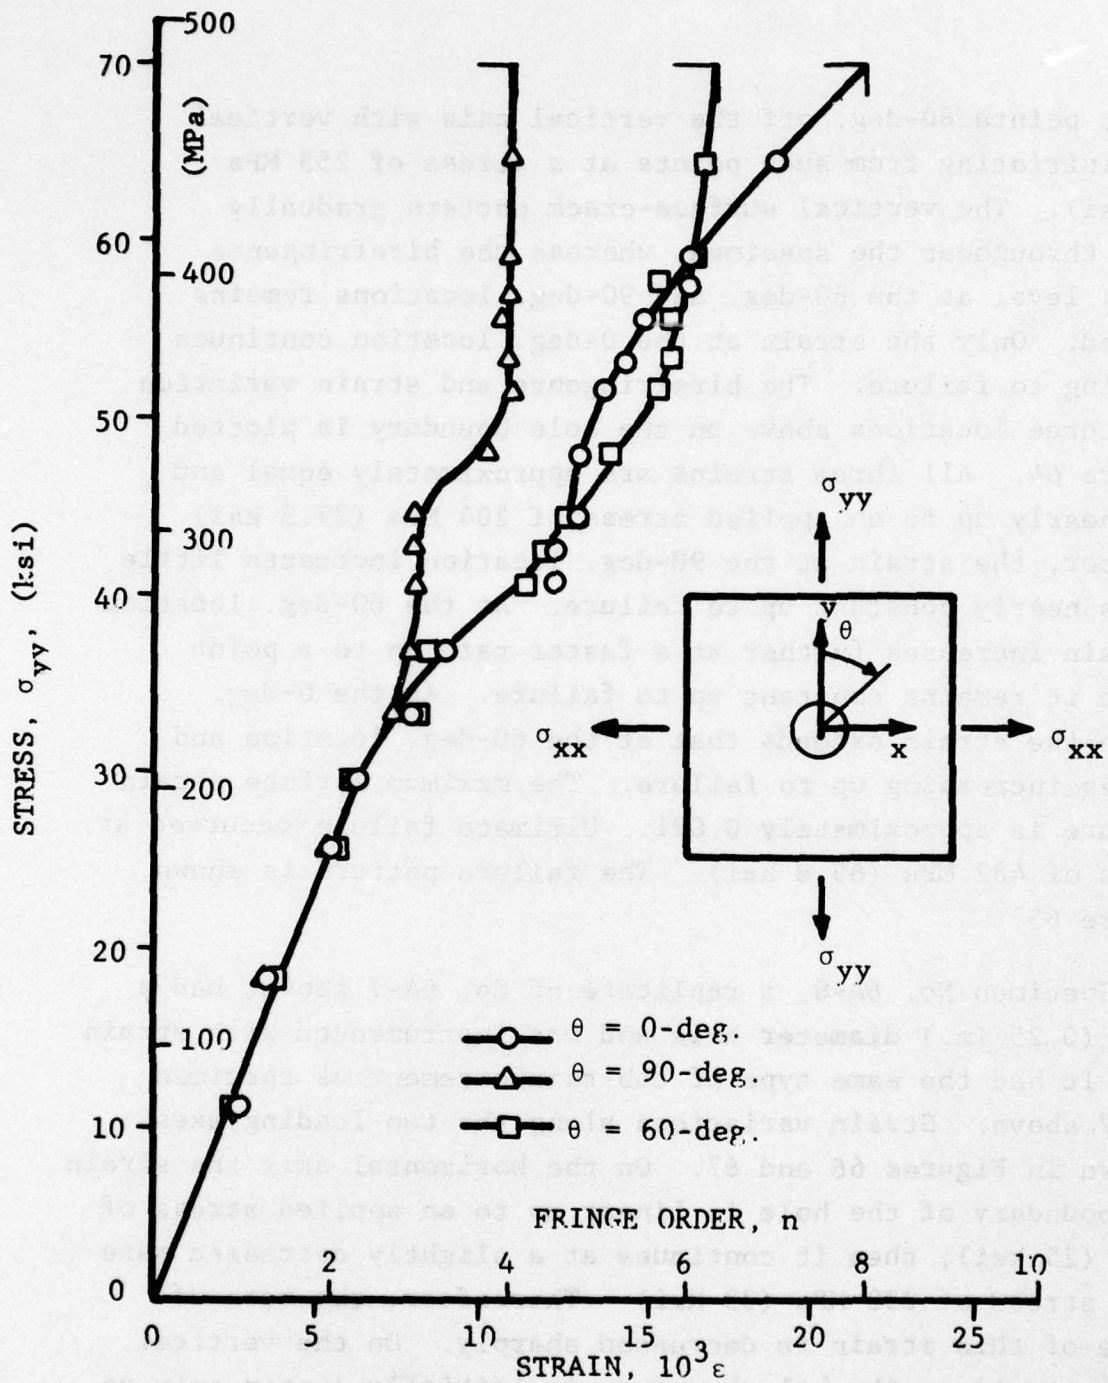
Figure 64. Fringe Order and Circumferential Strain at Three Locations on the Hole Boundary of $[0_2/+45]_S$ Graphite/Epoxy Specimen With 0.64 cm (0.25 in.) Diameter Hole Under Biaxial Loading $\sigma_{yy} = 2\sigma_{xx}$ (Spec. No. 6A-7)

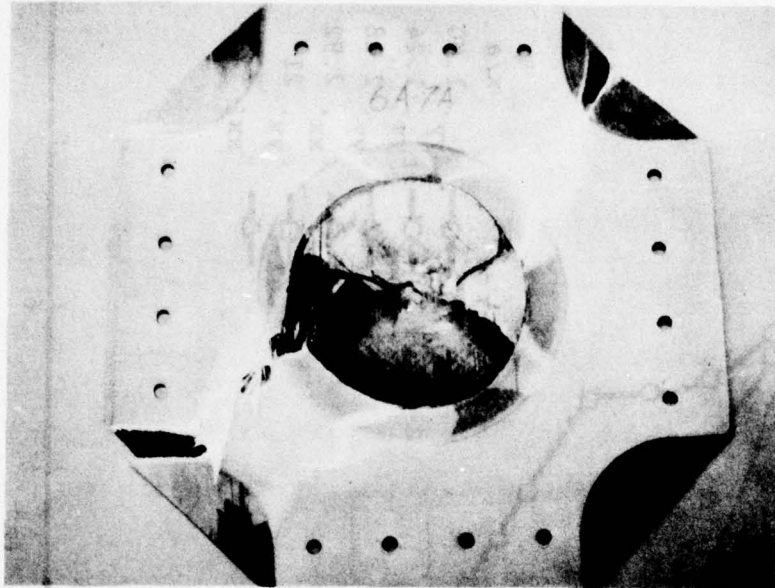
Figure 65. Failure Pattern of $[0_2/+45]_s$ Graphite/Epoxy Specimen With 0.64 cm (0.25 in.) Diameter Hole Under Biaxial Loading $\sigma_{yy} = 2\sigma_{xx}$ (Spec. No. 6A-7)

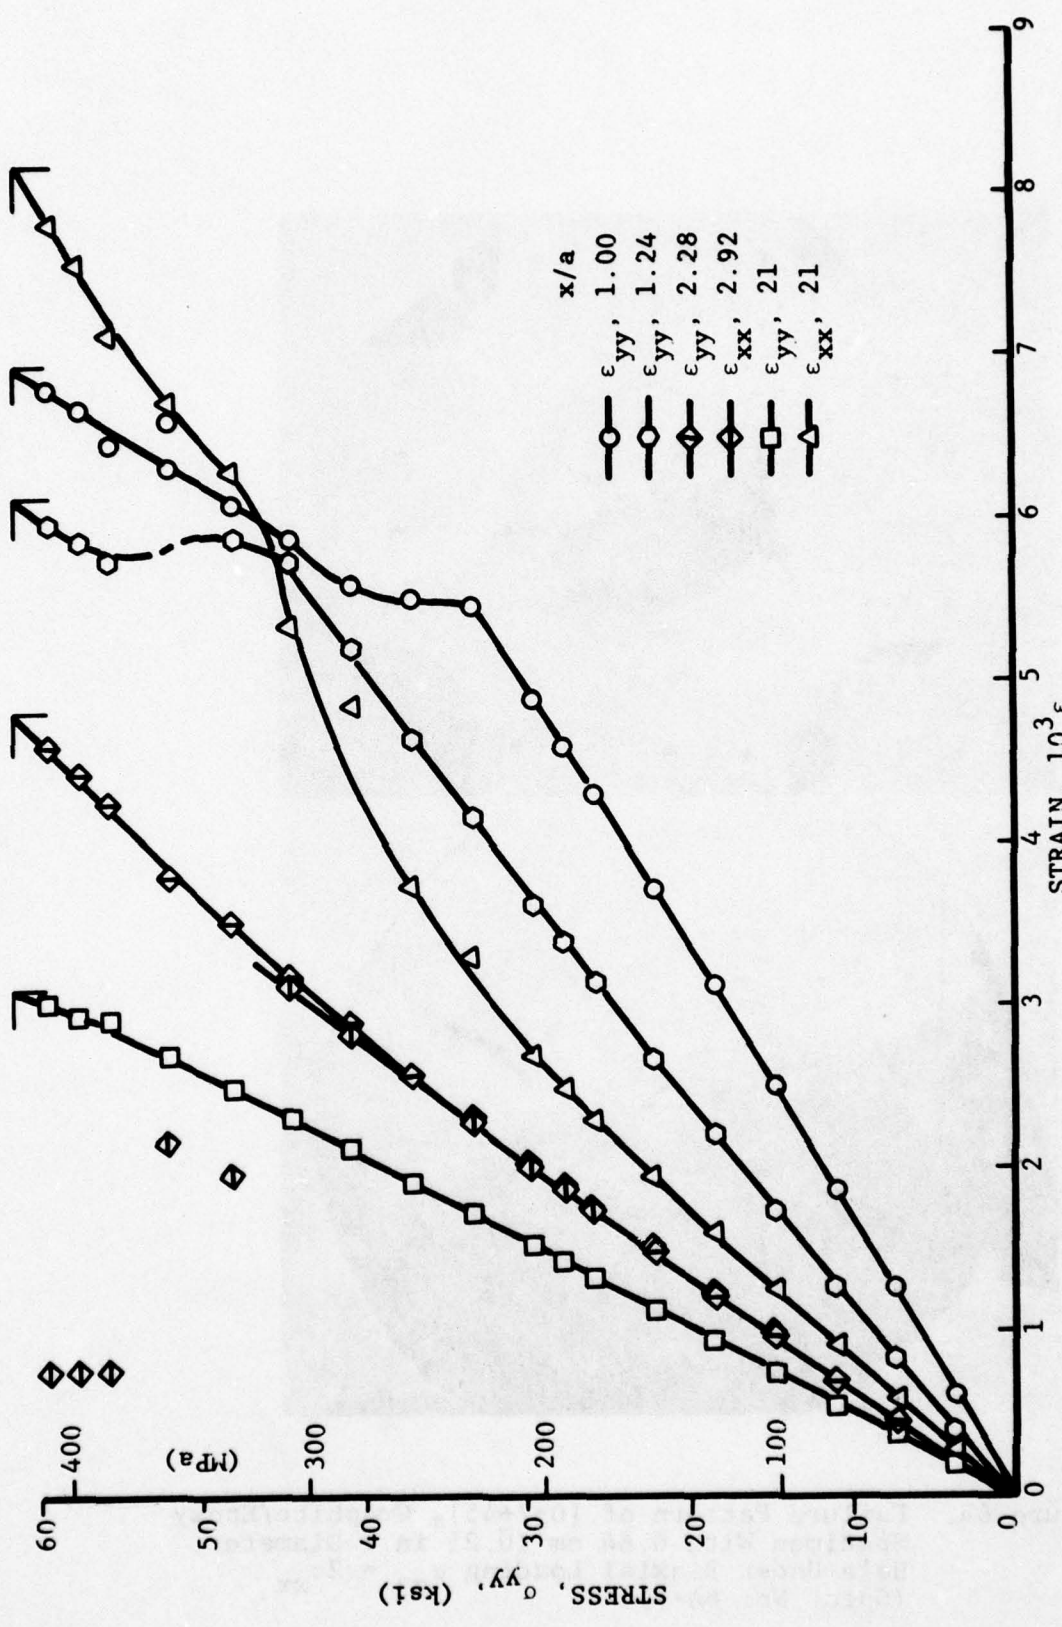
Figure 66. Strains Along Horizontal Axis of [02/+45]_s Graphite/Epoxy Specimen With 0.64 cm (0.25 in.) Diameter Hole Under Biaxial Loading $\sigma_{yy} = 2\sigma_{xx}$ (Spec. No. 6A-8)

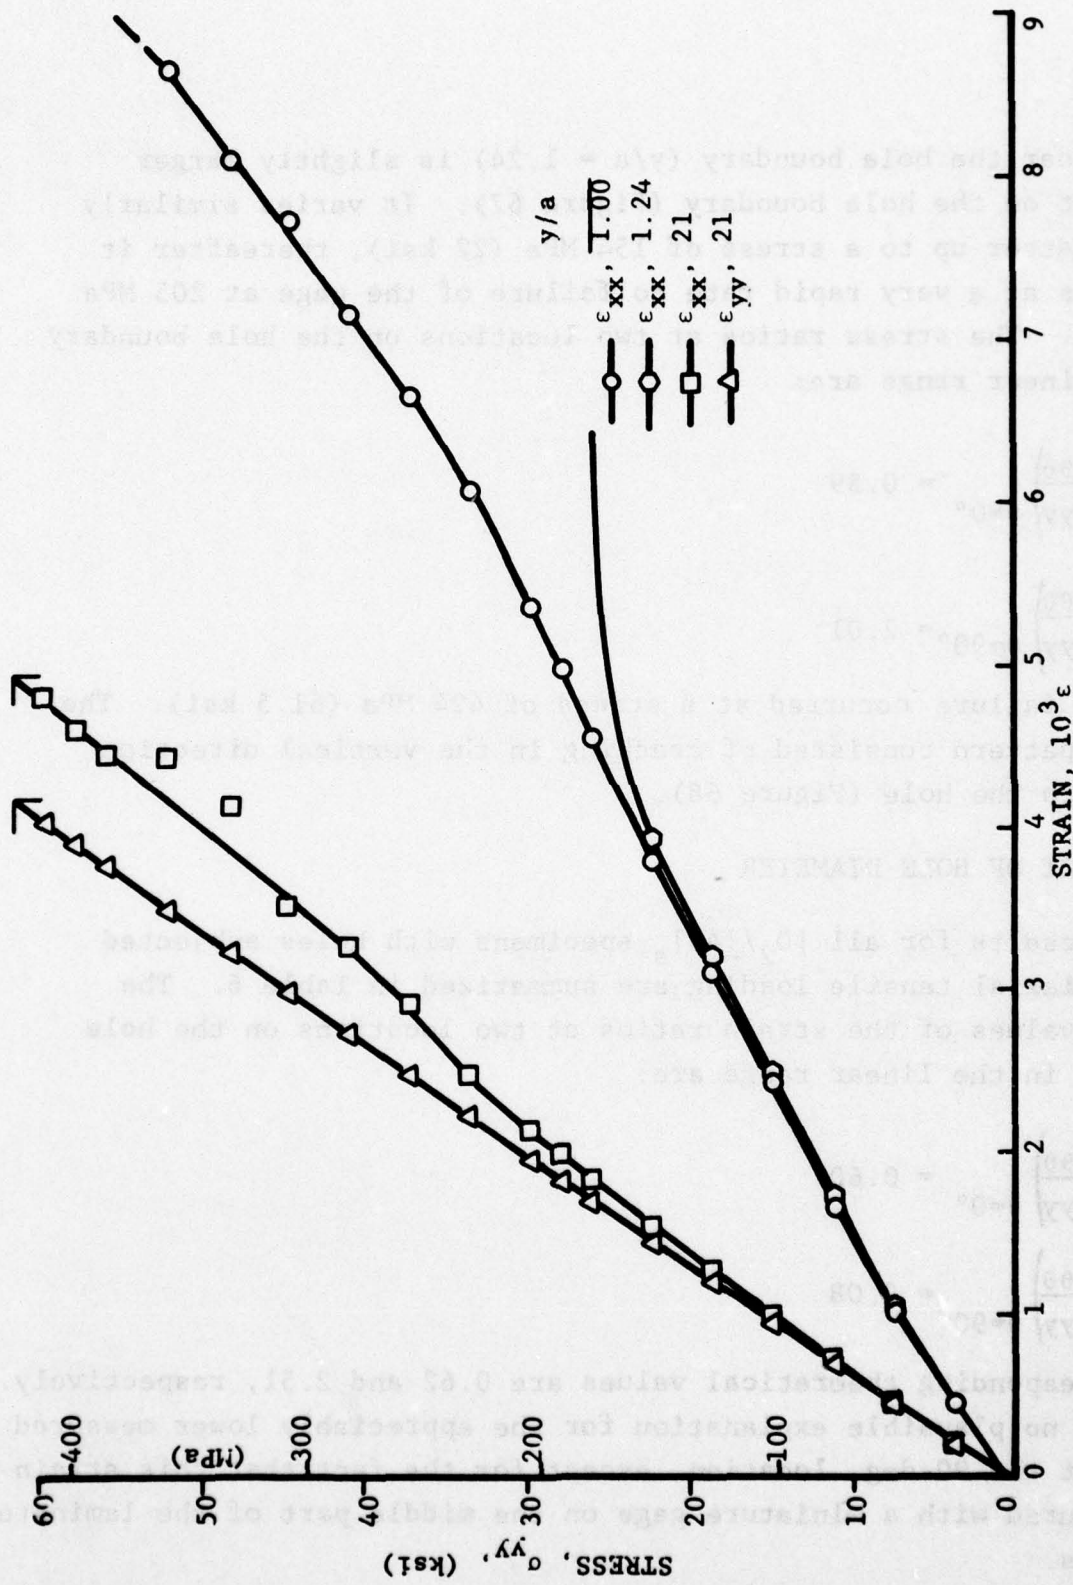
Figure 67. Strains Along Vertical Axis of $[0_2/+45]_s$ Graphite/Epoxy Specimen With 0.64 cm (0.25 in.) Diameter Hole Under Biaxial Loading $\sigma_{yy} = 2\sigma_{xx}$ (Spec. No. 6A-8)

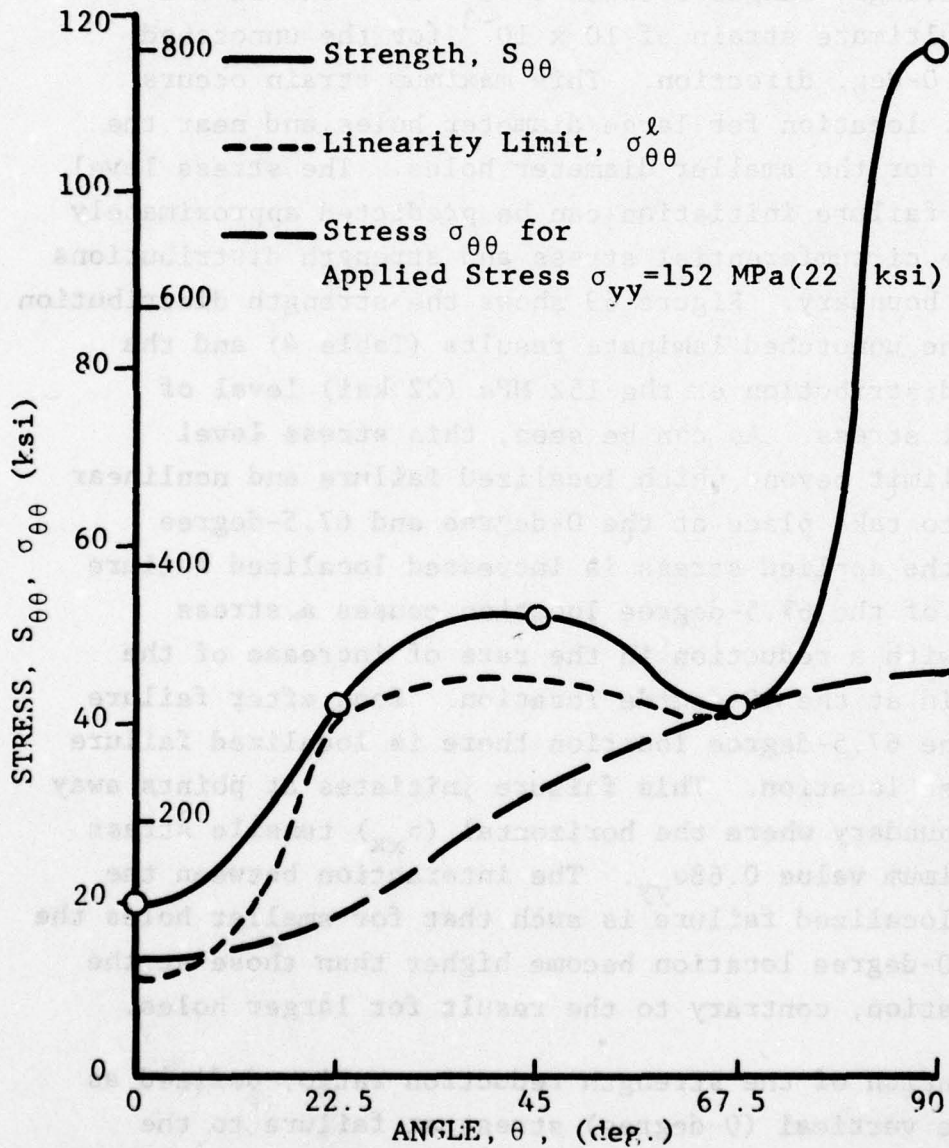
Figure 69. Distribution Around Boundary of Hole of Circumferential Strength and Stress for $[0_2/+45]_s$ Graphite/Epoxy Specimen Under Biaxial Loading $\sigma_{yy} = 2\sigma_{xx}$
