**BIAXIAL TESTING OF GRAPHITE/EPOXY COMPOSITES
CONTAINING STRESS CONCENTRATIONS — Part II**

*IIT RESEARCH INSTITUTE
10 WEST 35th STREET
CHICAGO, ILLINOIS 60616*

TECHNICAL REPORT AFML-TR-76-244, PART II
Final Report for Period April 1976 — March 1977

AIR FORCE MATERIALS LABORATORY
AIR FORCE WRIGHT AERONAUTICAL LABORATORIES
AIR FORCE SYSTEMS COMMAND
WRIGHT-PATTERSON AIR FORCE BASE, OHIO 45433

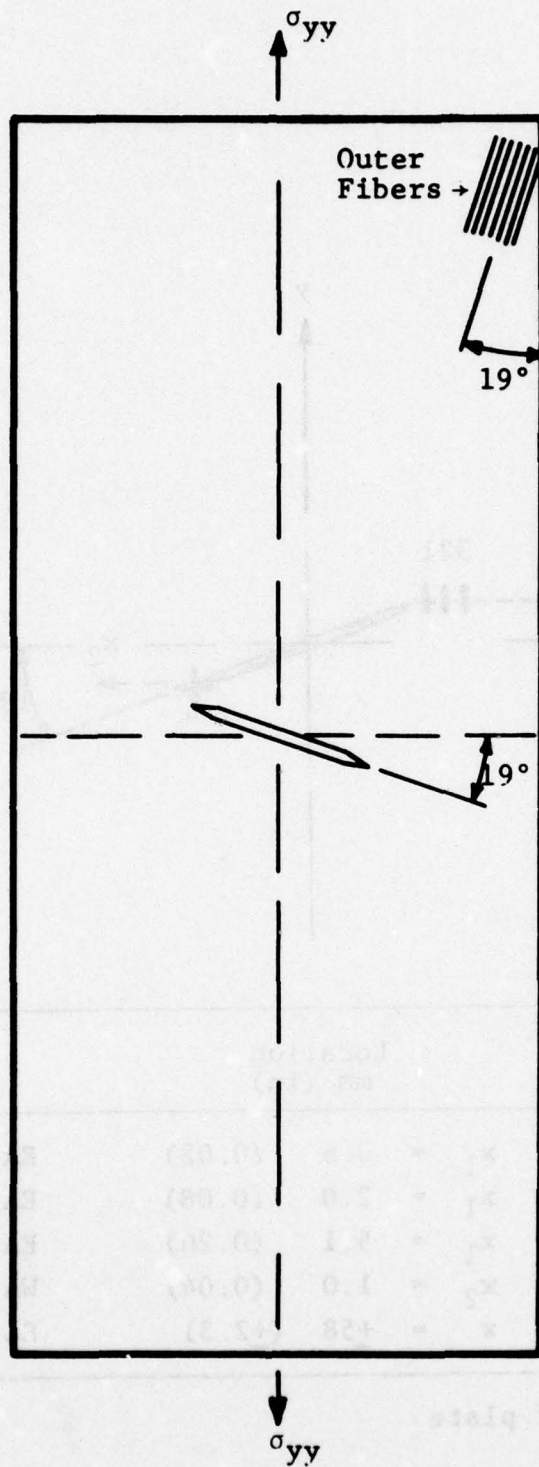
Figure 74. Uniaxial Loading of $[0/+45/90]_s$ Graphite/Epoxy Specimens With Inclined Cracks

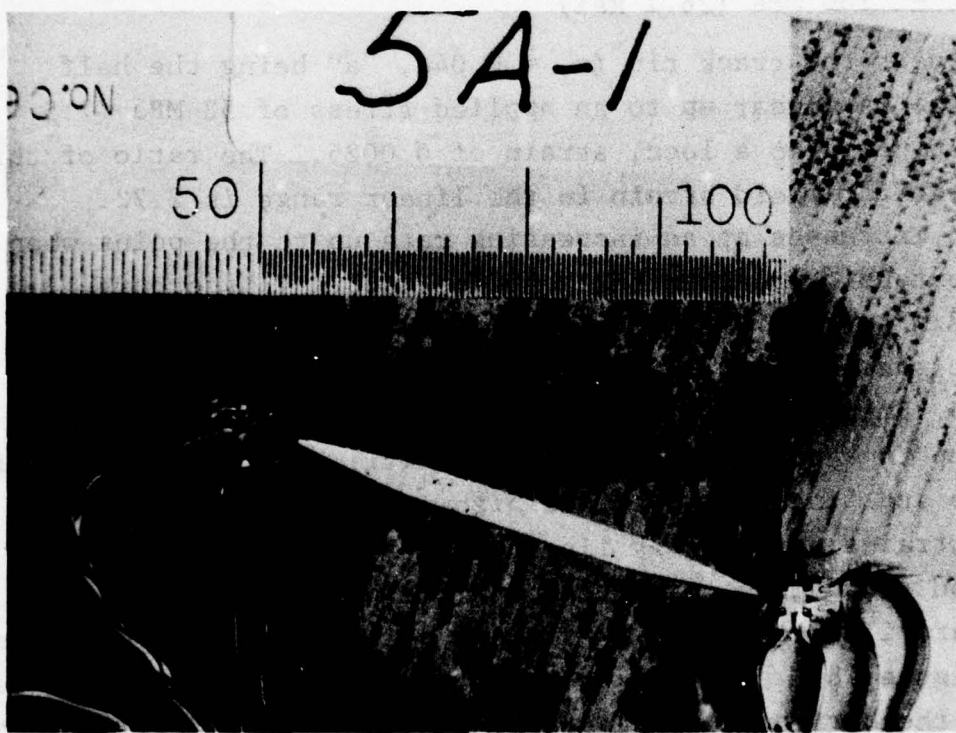
Figure 76. Closeup of Gage Layout Near 2.54 cm
(1.00 in.) Crack of Spec. No. 5A-1
(Smallest Division Shown in 0.01 in.)

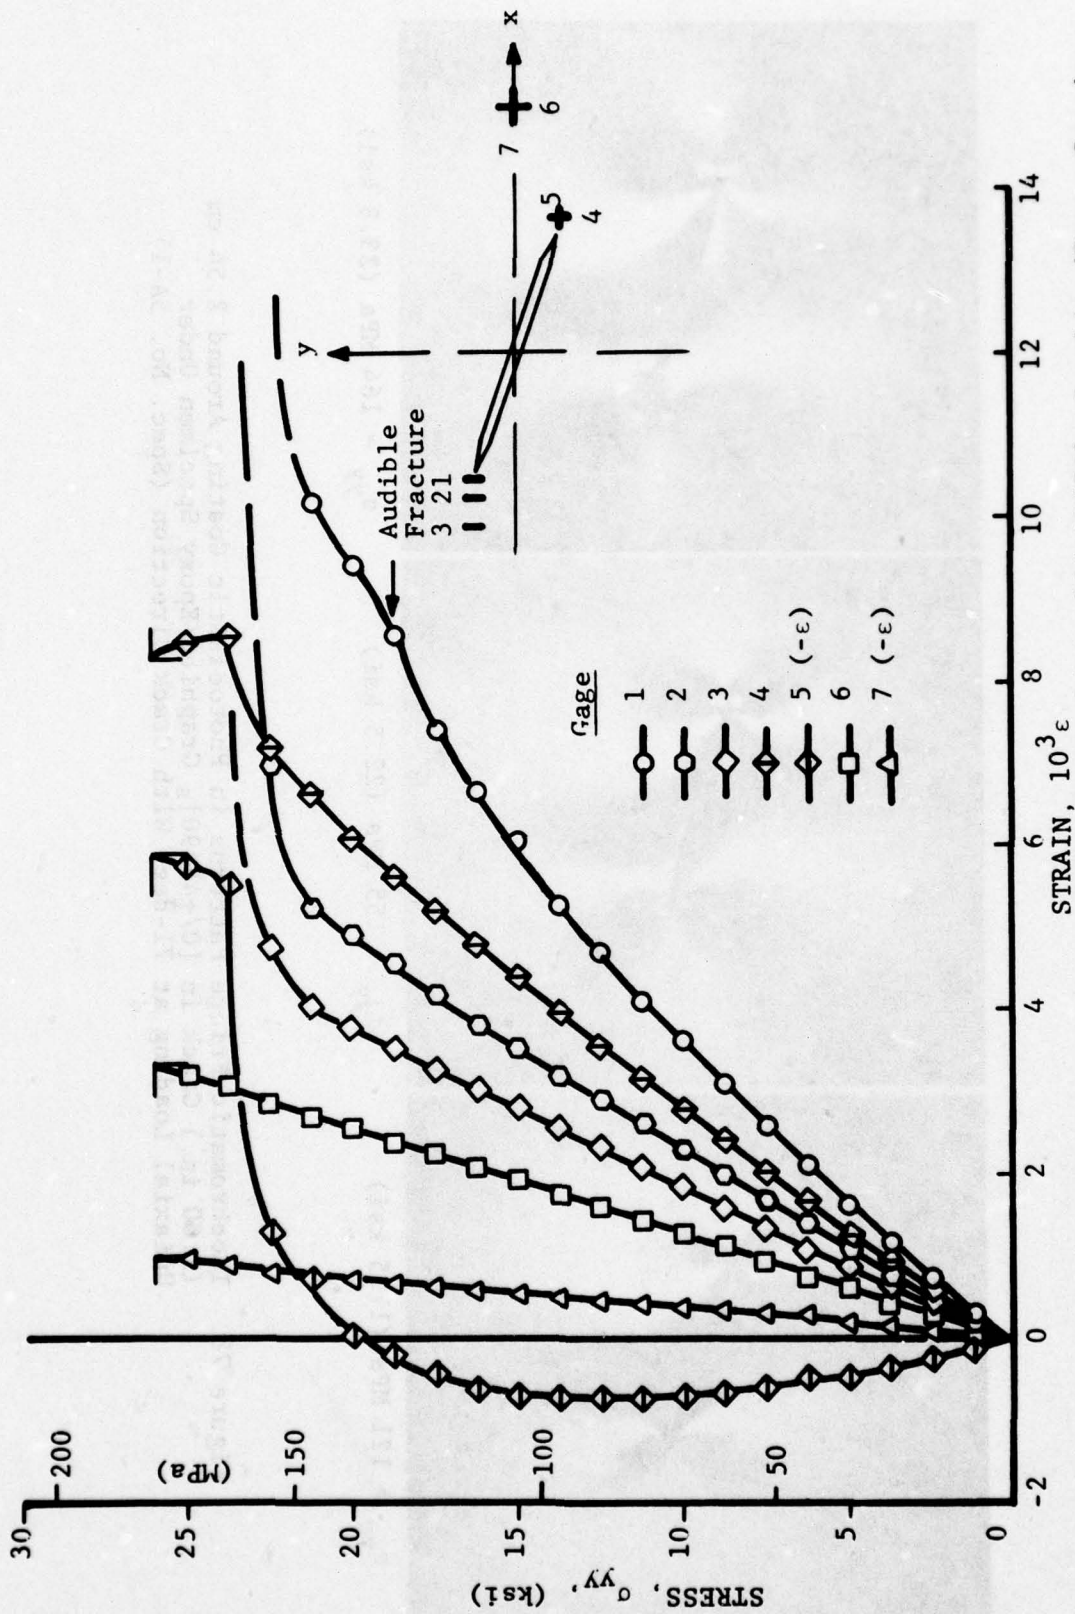
Figure 77. Strains Near Crack Tip and in Far Field in [0/+45/90]s Graphite/Epoxy Specimen With 2.54 cm (1.00 in.) Crack Under Uniaxial Loading at 71-deg. With Crack Direction (Spec. No. 5A-1)

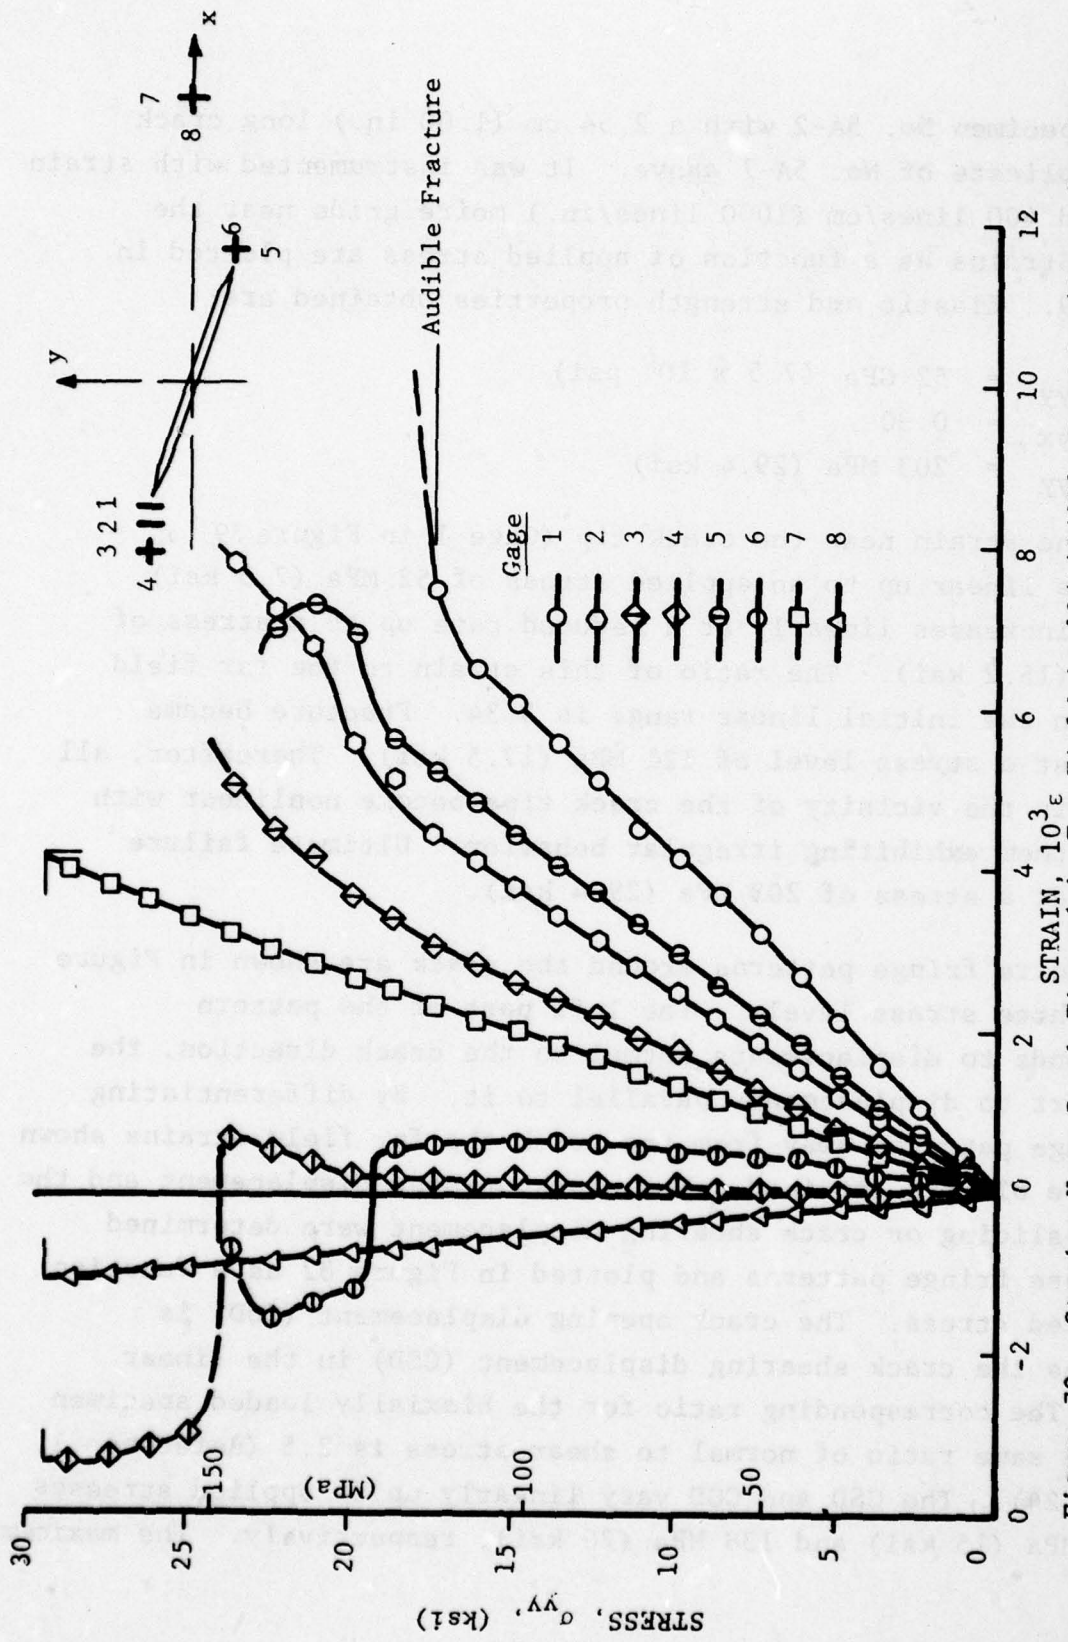
Figure 79. Strains Near Crack Tip and in Far Field in $[0/+45/90]_s$ Graphite/Epoxy Specimen With 2.54 cm (1.00 in.) Crack Under Uniaxial Loading at 71-deg. With Crack Direction (Spec. No. 5A-2)

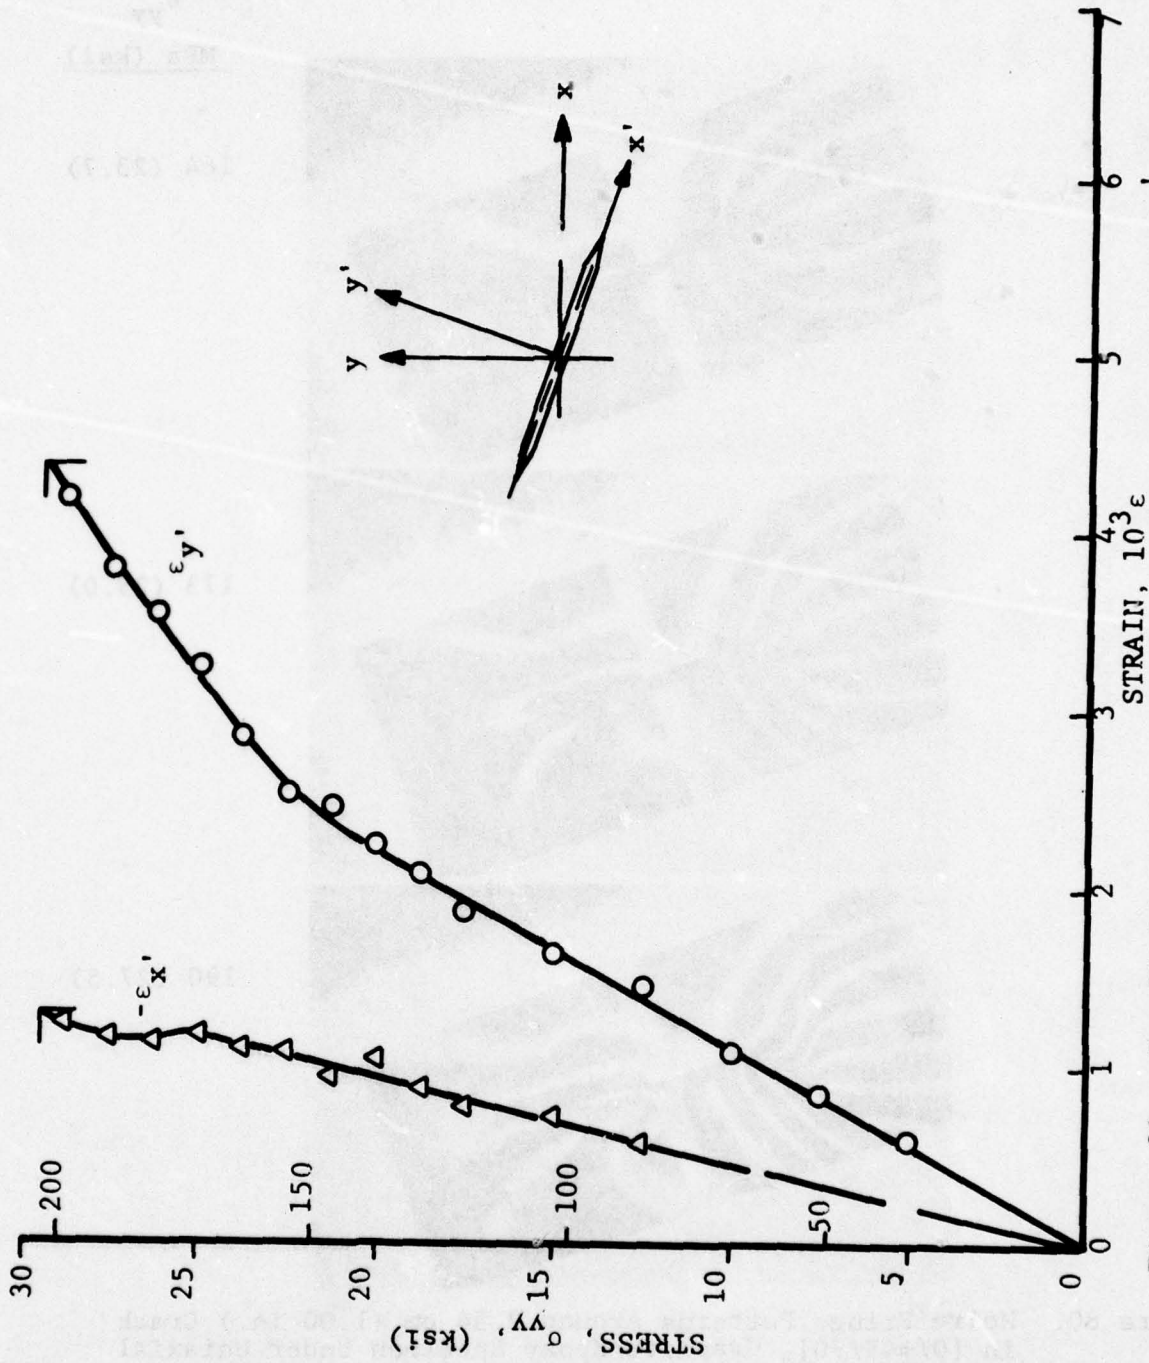
Figure 81. Far Field Strains Around Crack Obtained from Moiré Fringe Patterns (Spec. No. 5A-2)

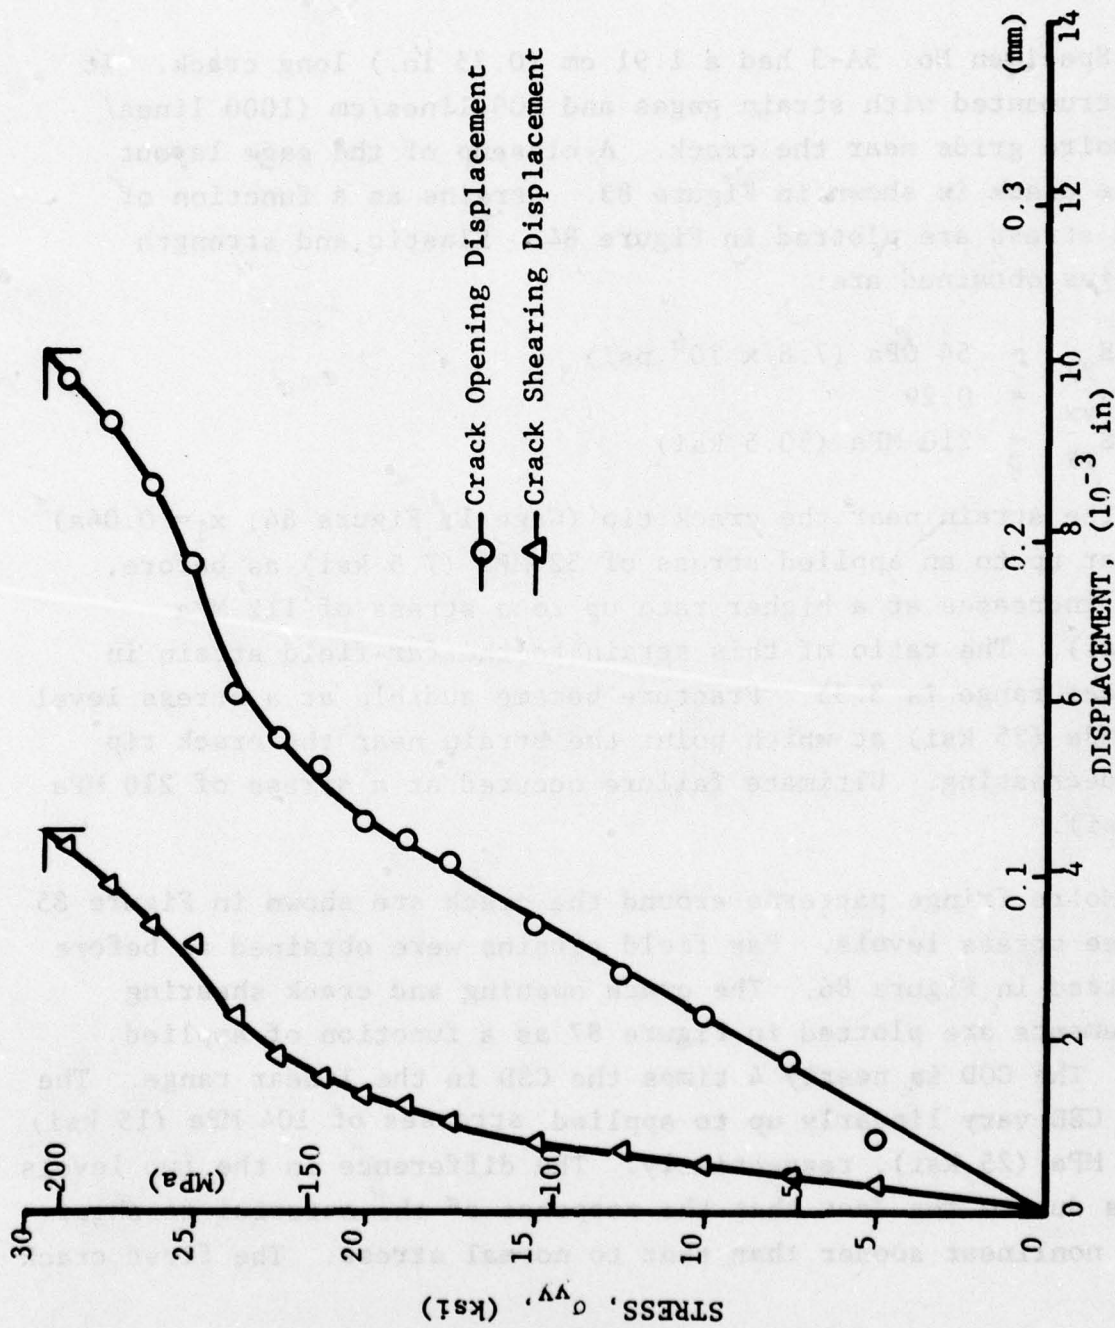
Figure 82. Crack Opening and Crack Shearing Displacement in $[0/+45/90]_s$ Graphite/Epoxy Specimen With 2.54 cm (1.90 in.) Crack Under Uniaxial Loading at 71-deg. With Crack Direction (Spec. No. 5A-2)

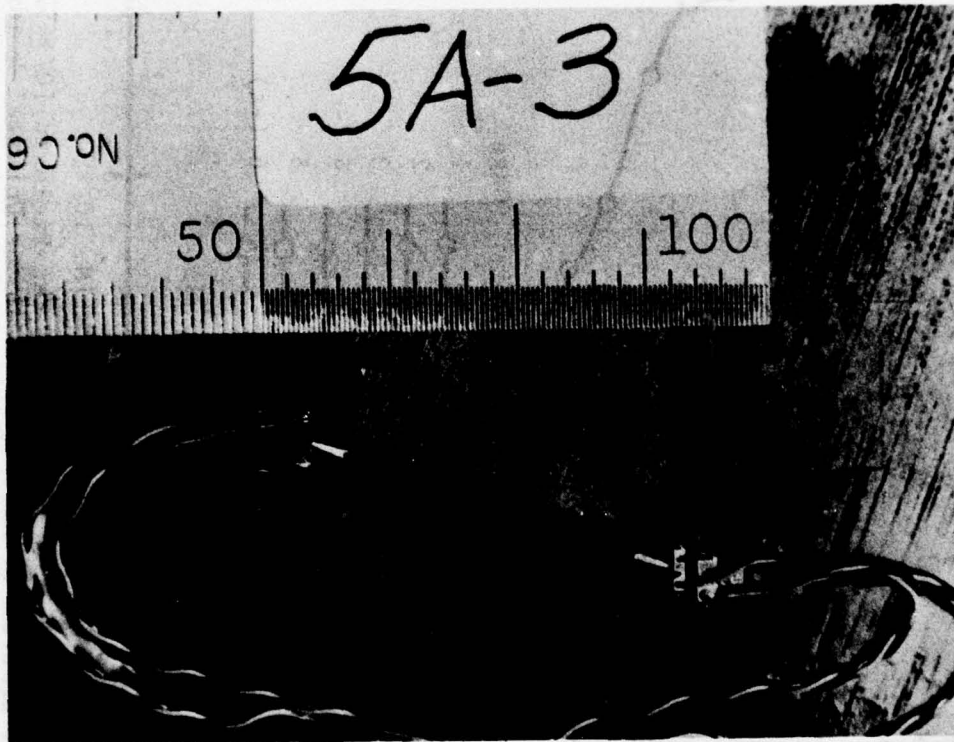
Figure 83. Closeup of Gage Layout Near 1.91 cm
(0.75 in.) Crack of Spec. No. 5A-3
(Smallest Division Shown is 0.01 in.)

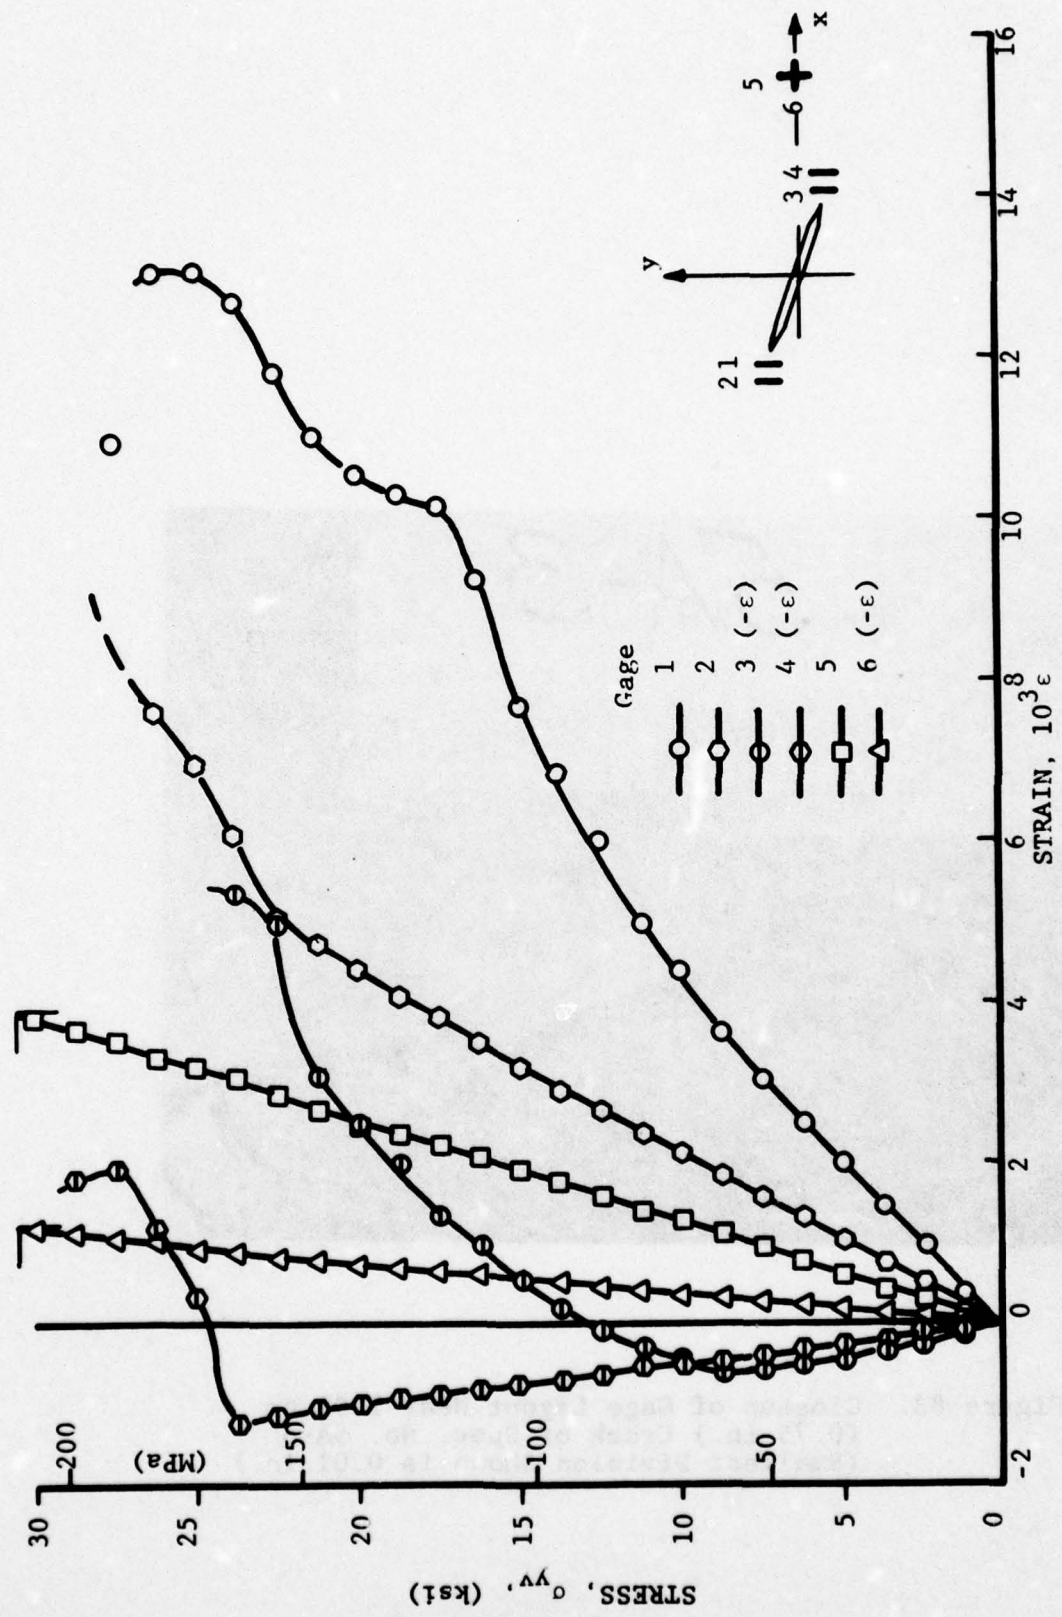
Figure 84. Strains Near Crack Tip and in Far Field in [0/+45/90]s Graphite/Epoxy Specimen With 1.91 cm (0.75 in.) Crack Under Uniaxial Loading at 71-deg. With Crack Direction (Spec. No. 5A-3).

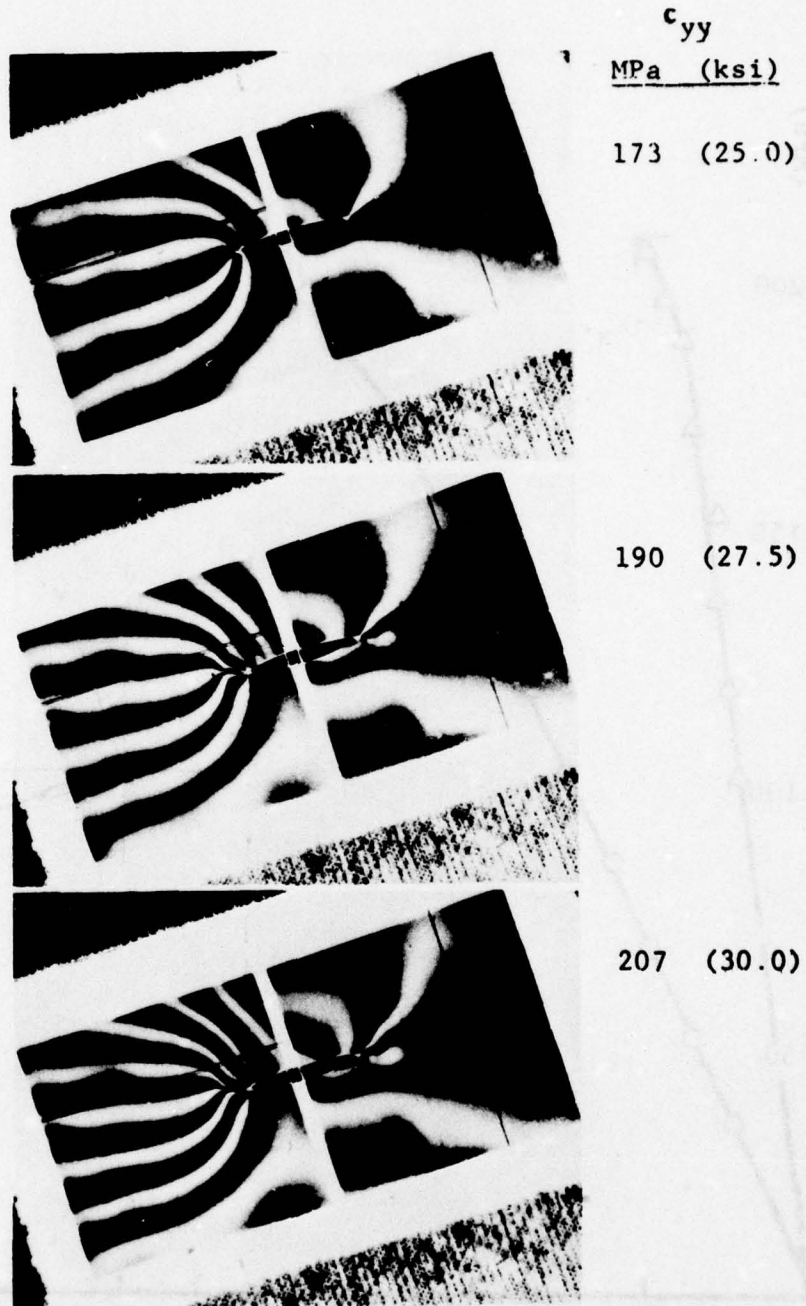
Figure 85. Moiré Fringe Patterns Around 1.91 cm (0.75 in.) Crack Under Uniaxial Loading at 71-deg. with Crack Direction (Spec. No. 5A-3)

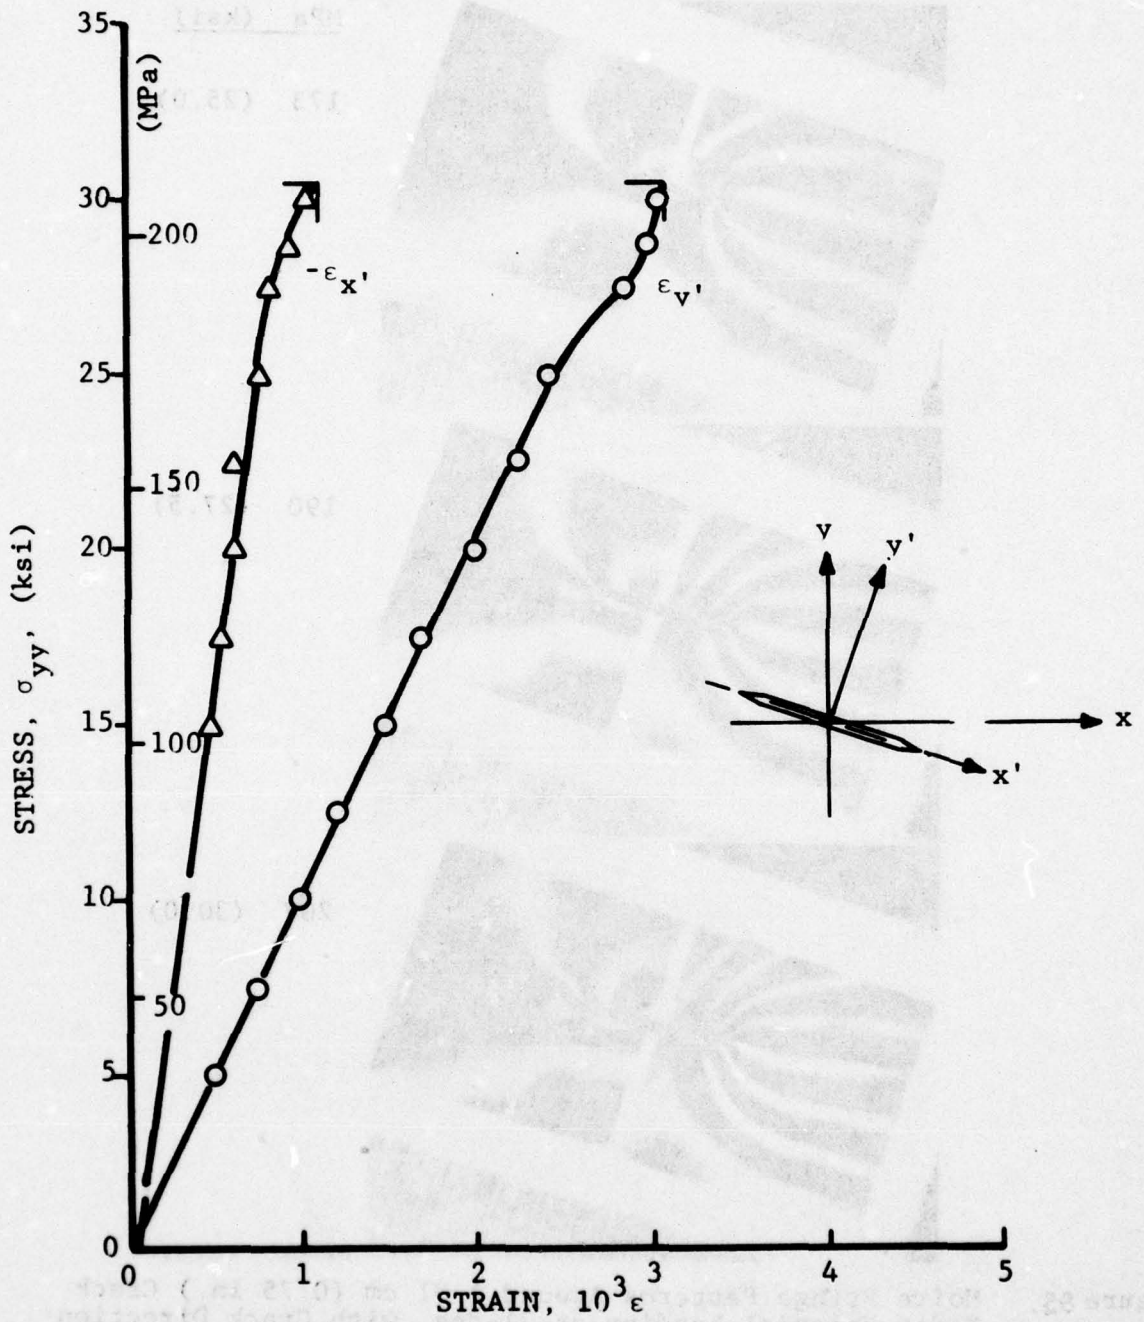
Figure 86. Far Field Strains Around 1.91 cm (0.75 in.) Crack Obtained from Moiré Fringe Patterns (Spec. No. 5A-3)

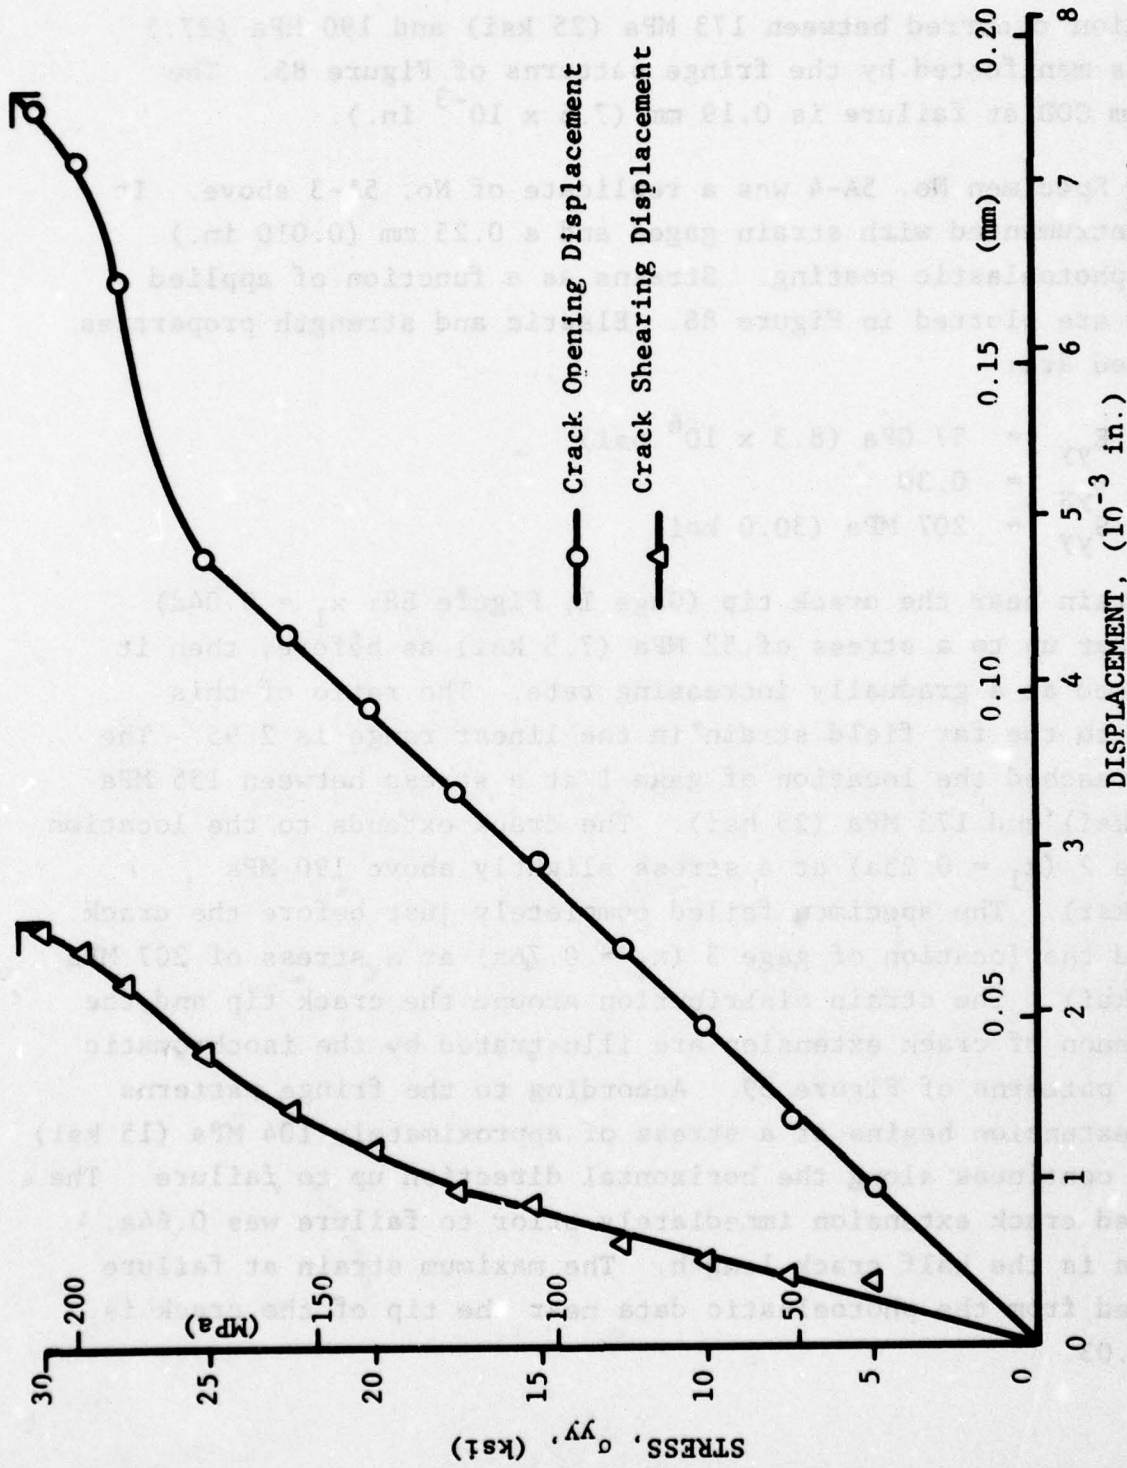
Figure 87. Crack Opening and Crack Shearing Displacements in [0/+45/90]s Graphite/Epoxy Specimen With 1.91 cm (0.75 in.) Crack Under Uniaxial Loading at 71-deg. With Crack Direction (Spec. No. 5A-3)

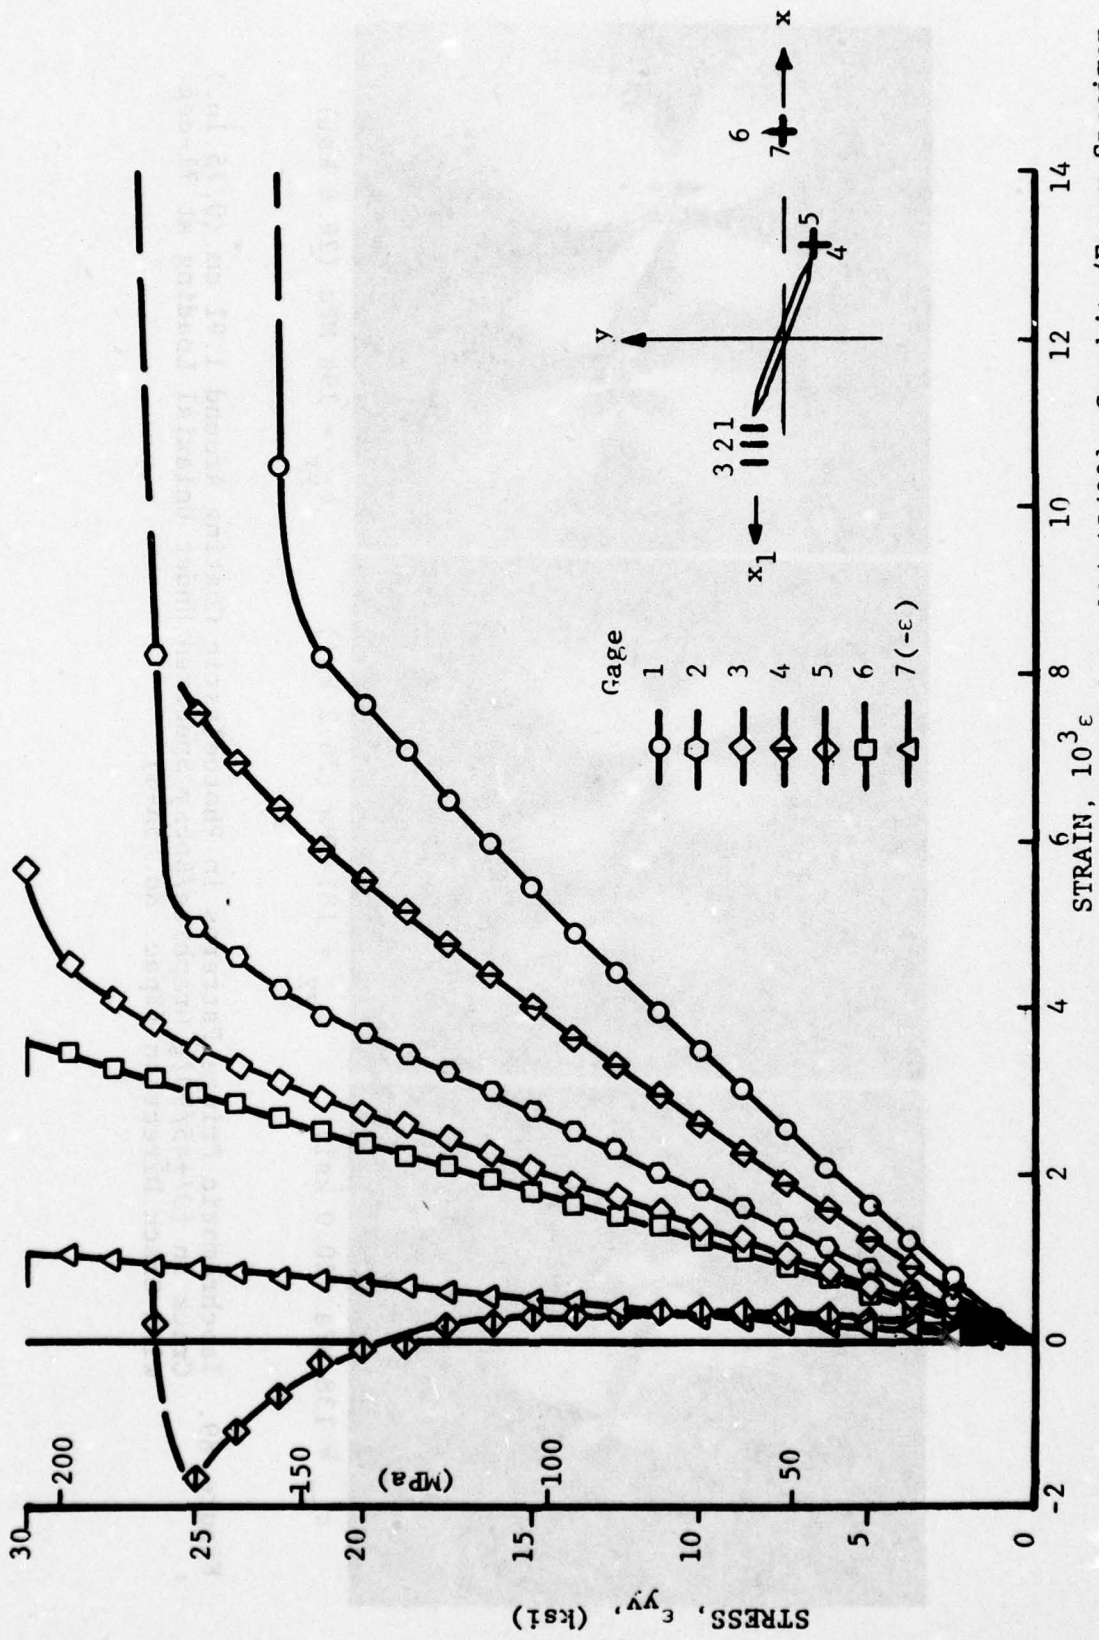
Figure 88. Strains Near Crack Tip and in Far Field in [0/+45/90]_s Graphite/Epoxy Specimen With 1.91 cm (0.75 in.) Crack Under Uniaxial Loading at 71-deg. With Crack Direction (Spec. No. 5A-4)

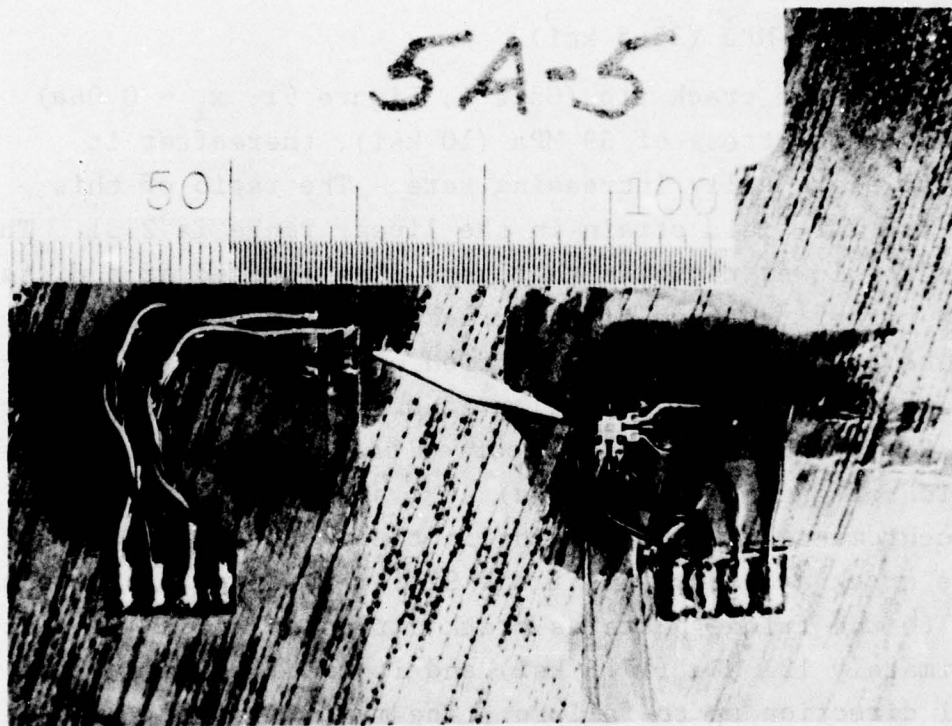
Figure 90. Closeup of Gage Layout Near 1.27 cm
(0.50 in.) Crack of Spec. No. 5A-5
(Smallest Division Shown is 0.01 in.)

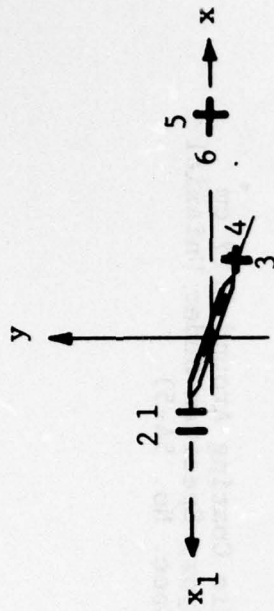
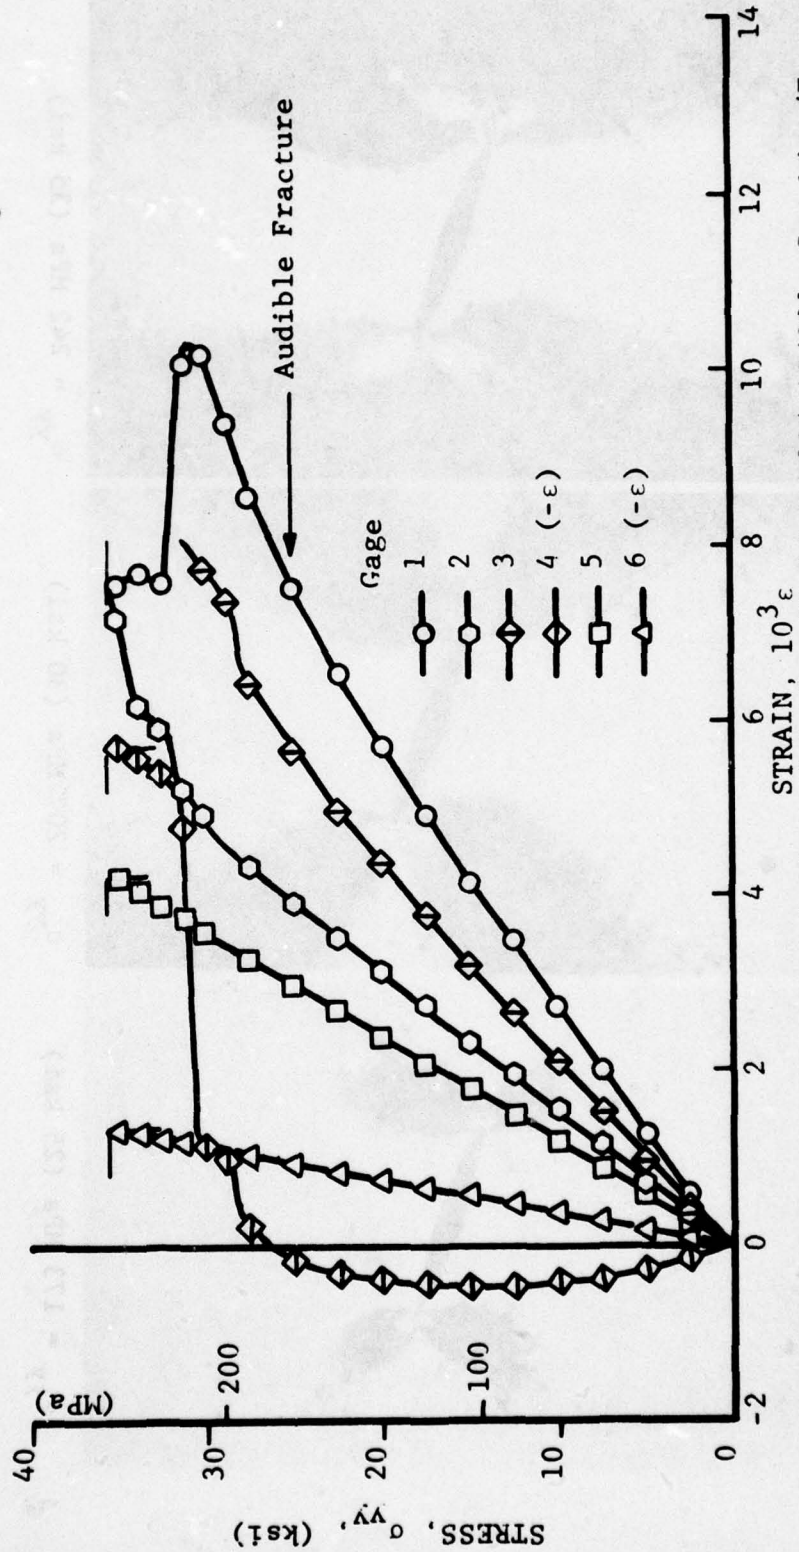
Figure 91. Strains Near Crack Tip and in Far Field in $[0/+45/90]_s$ Graphite/Epoxy Specimen With 1.27 cm (0.50 in.) Crack Under Uniaxial Loading at 71-deg. With Crack Direction (Spec. No. 5A-5)

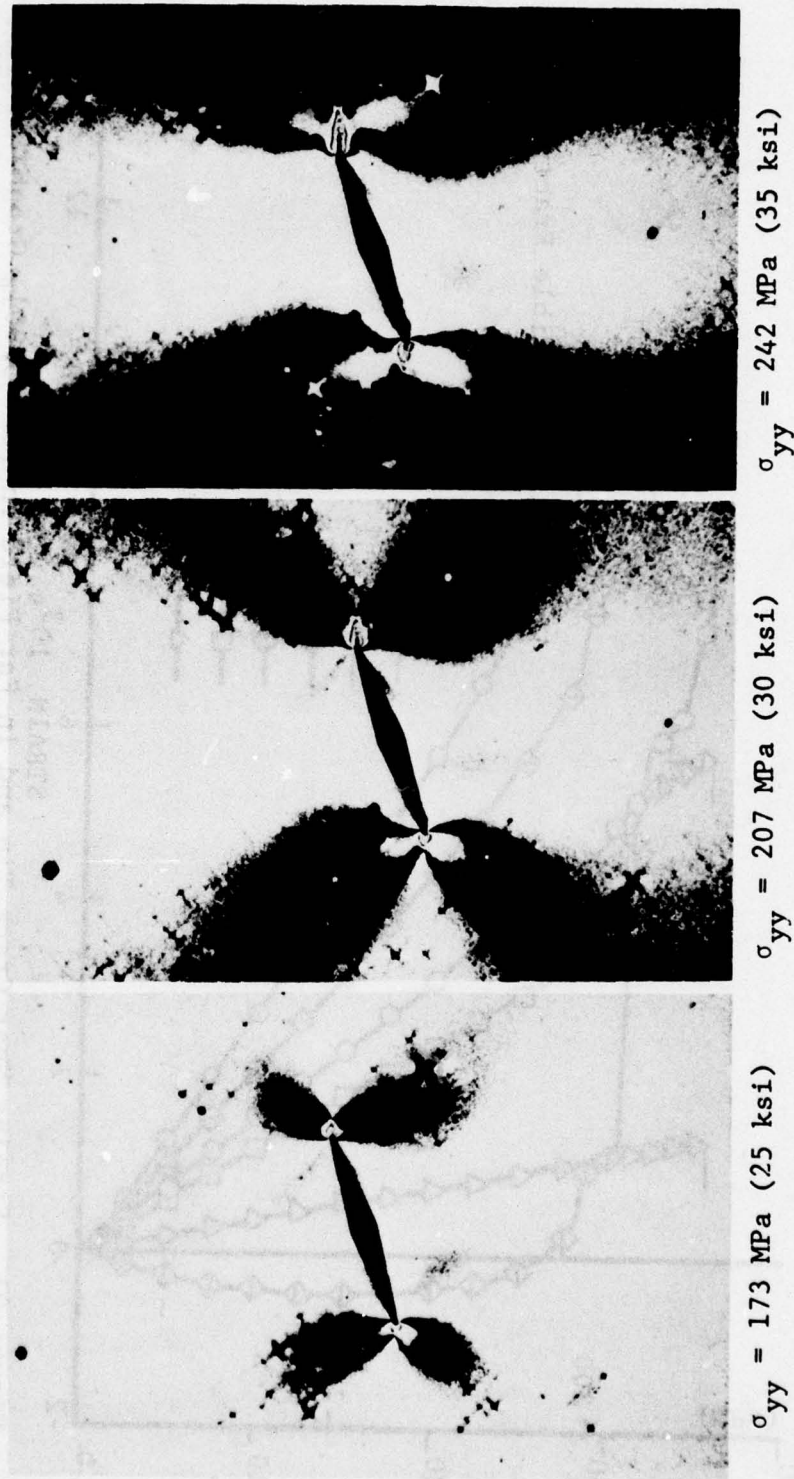
Figure 92. Isochromatic Fringe Patterns in Photoelastic Coating Around 1.27 cm (0.50 in.) Crack in [0/+45/90]_s Graphite/Epoxy Specimen Under Uniaxial Loading at 71-deg. with Crack Direction (Spec. No. 5A-5)

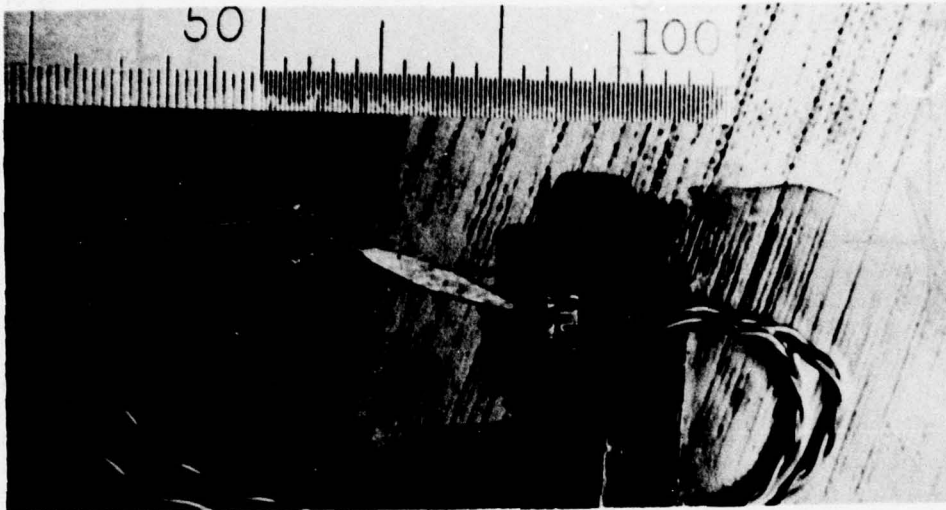
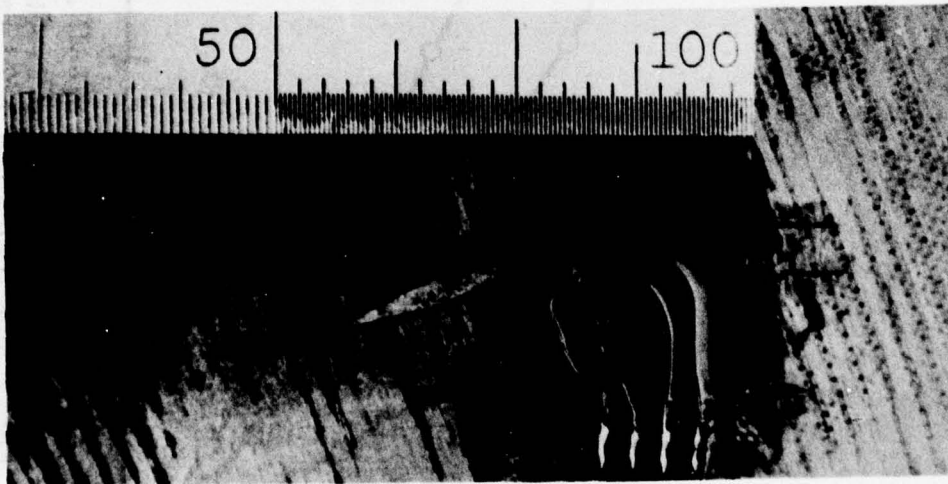
Figure 93. Closeup of Gage Layout Near 1.27 cm (0.50 in.)
Crack of Spec. No. 5A-6
(Smallest Division Shown in 0.01 in.)

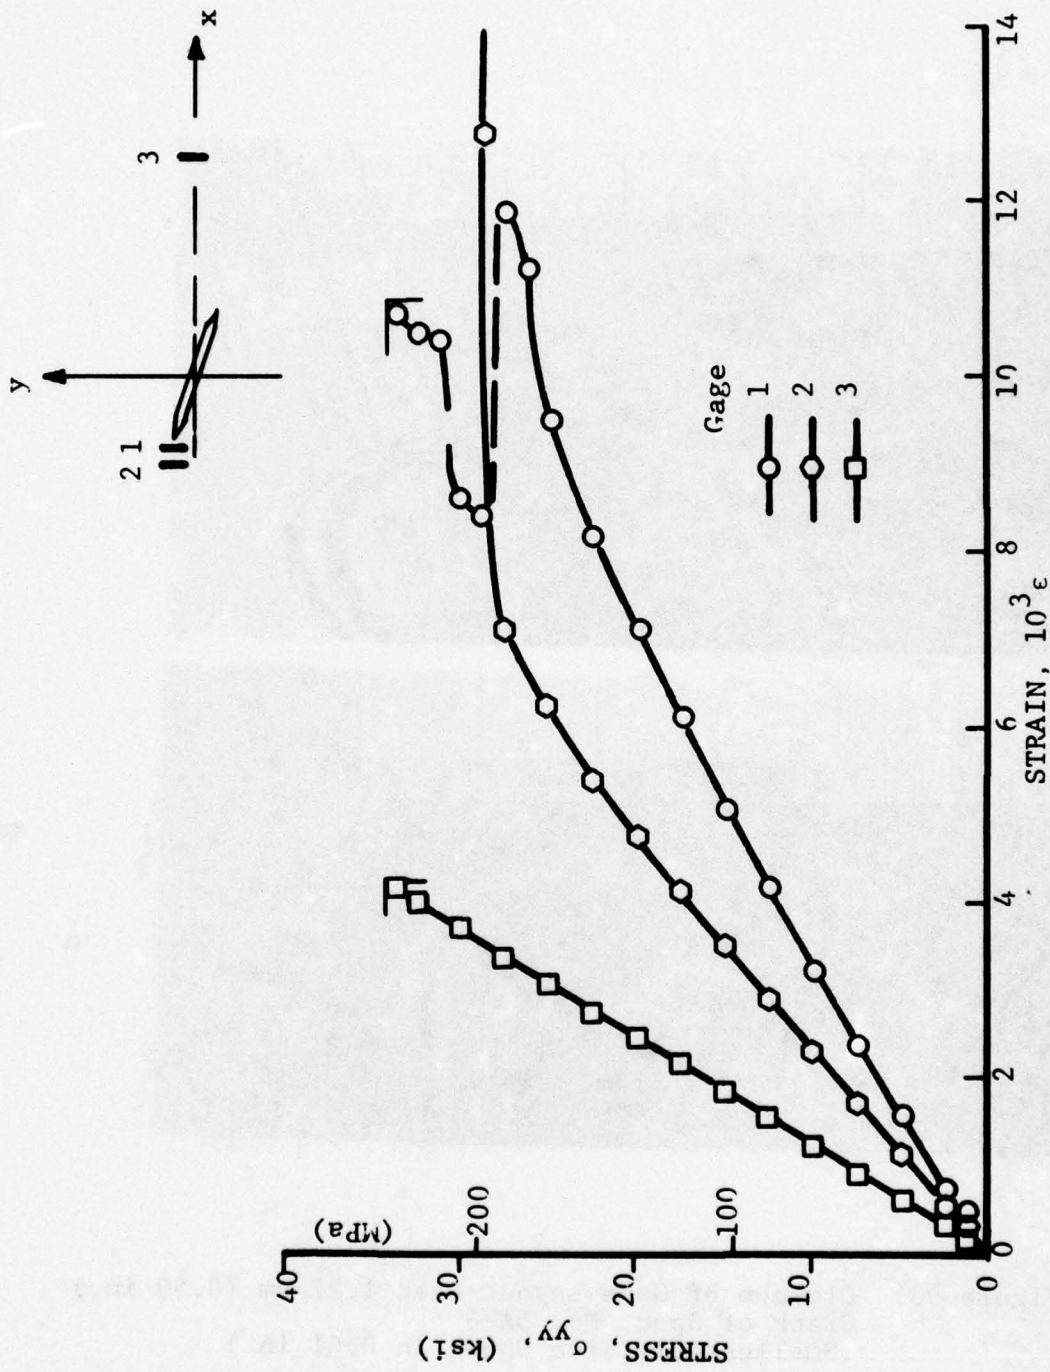
Figure 94. Vertical Strains Near Crack Tip and in Far Field in $[\gamma/+45/90]_s$ Graphite/Epoxy Specimen With 1.27 cm (0.50 in.) Crack Under Uniaxial Loading at 71-deg. With Crack Direction (Spec. No. 5A-6)
