**BIAXIAL TESTING OF GRAPHITE/EPOXY COMPOSITES
CONTAINING STRESS CONCENTRATIONS — Part II**

*IIT RESEARCH INSTITUTE
10 WEST 35th STREET
CHICAGO, ILLINOIS 60616*

TECHNICAL REPORT AFML-TR-76-244, PART II
Final Report for Period April 1976 — March 1977

AIR FORCE MATERIALS LABORATORY
AIR FORCE WRIGHT AERONAUTICAL LABORATORIES
AIR FORCE SYSTEMS COMMAND
WRIGHT-PATTERSON AIR FORCE BASE, OHIO 45433

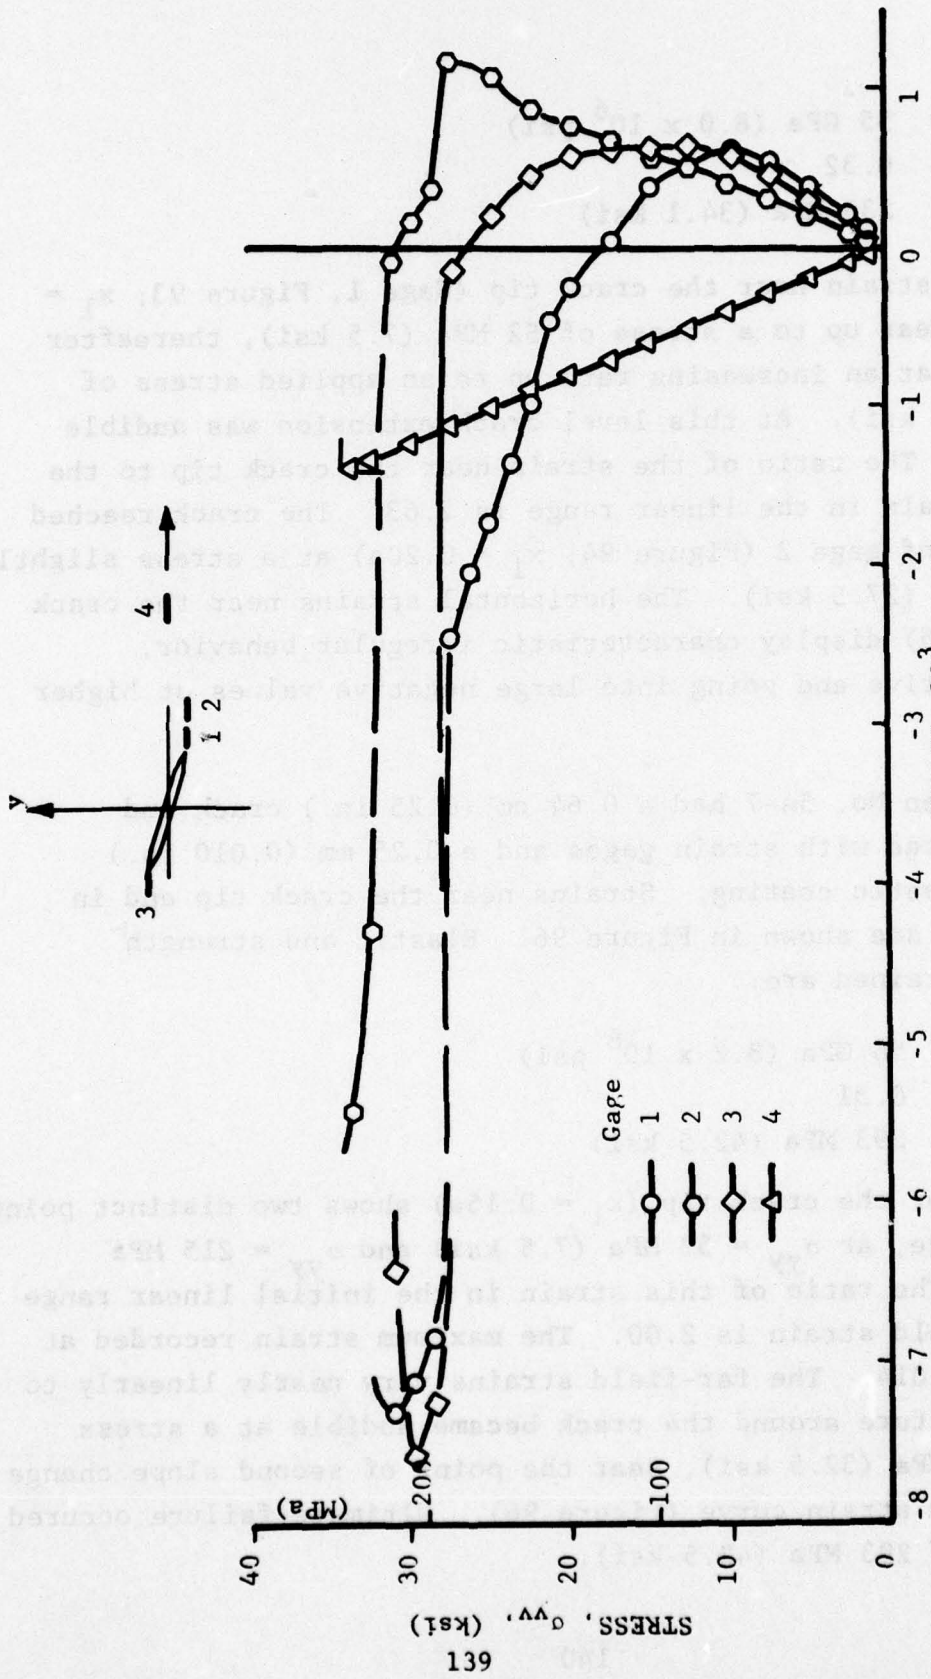
Figure 95. Horizontal Strains Near Crack Tip and in Far Field in [0/+45/90]s Graphite/Epoxy Specimen With 1.27 cm (0.50 in.) Crack Under Uniaxial Loading at 71-deg. With Crack Direction (Spec. No. 5A-6)

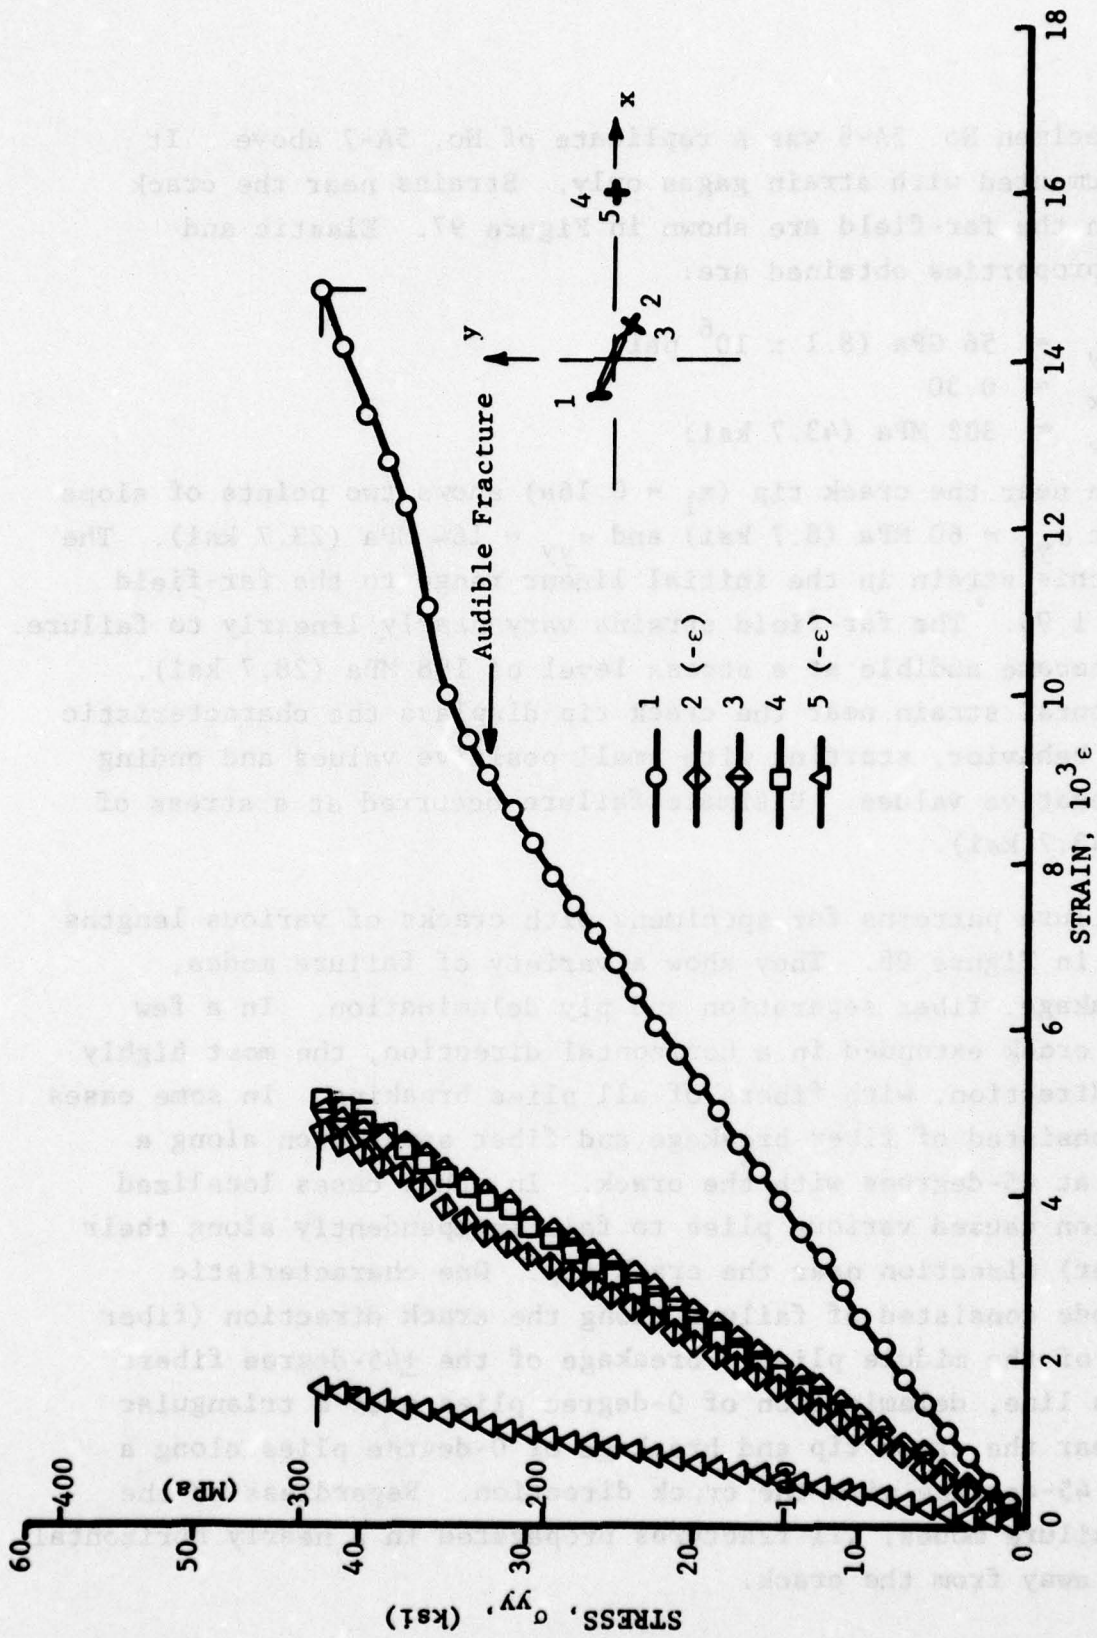
Figure 96. Strains Near Crack Tip and in Far-Field in [0/+45/90]_s Graphite/Epoxy Specimen With 0.64 cm (0.25 in.) Crack Under Uniaxial Loading at 71-deg. With Crack Direction (Spec. No. 5A-7)

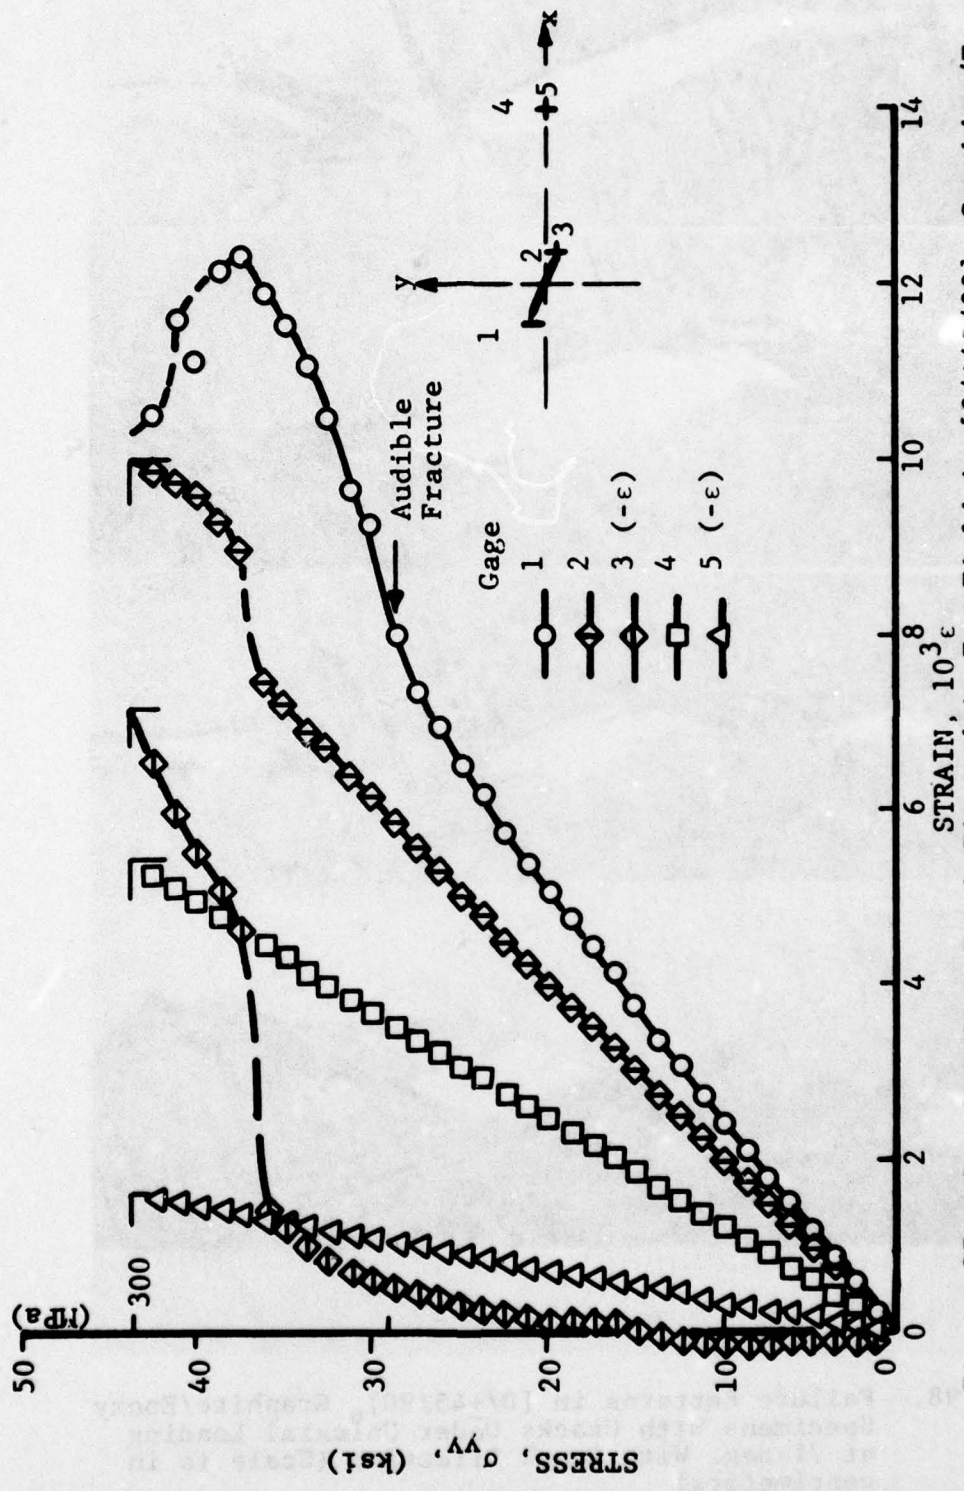
Figure 97. Strains Near Crack Tip and in Far-Field in [0/+45/90]s Graphite/Epoxy Specimen With 0.64 cm (0.25 in.) Crack Under Uniaxial Loading at 71-deg. With Crack Direction (Spec. No. 5A-8)

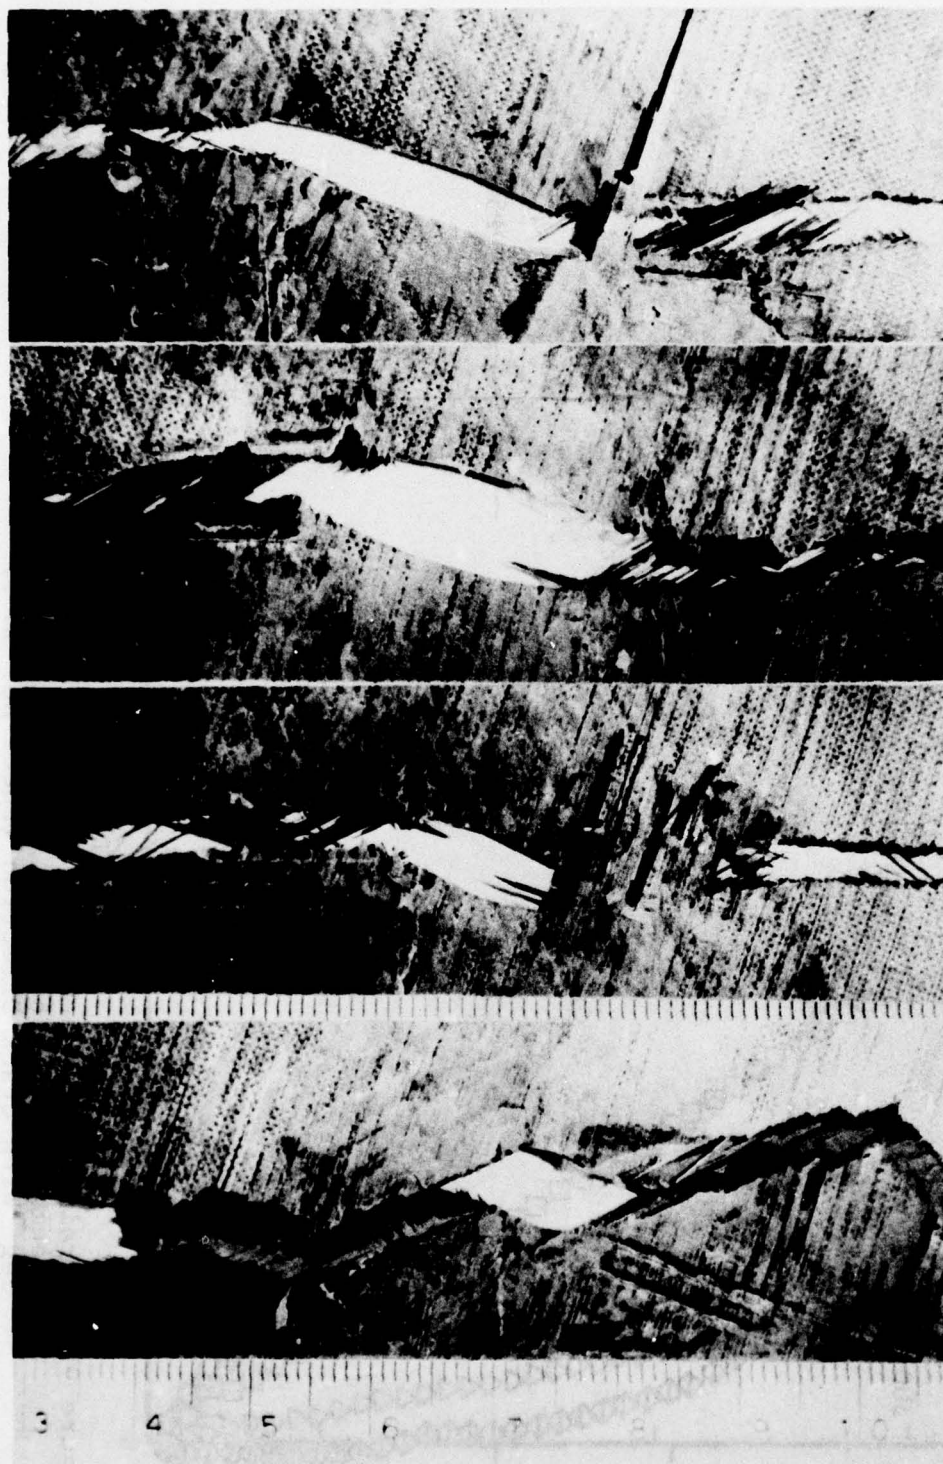
Figure 98. Failure Patterns in $[0/+45/90]_s$ Graphite/Epoxy Specimens With Cracks Under Uniaxial Loading at 71-deg. With Crack Direction (Scale is in centimeters)
