Report No. CG-M- 1-78

PRELIMINARY TESTS OF INFLATABLE LIFERAFTS
FOR STABILITY IN HIGH WINDS

December 1, 1977

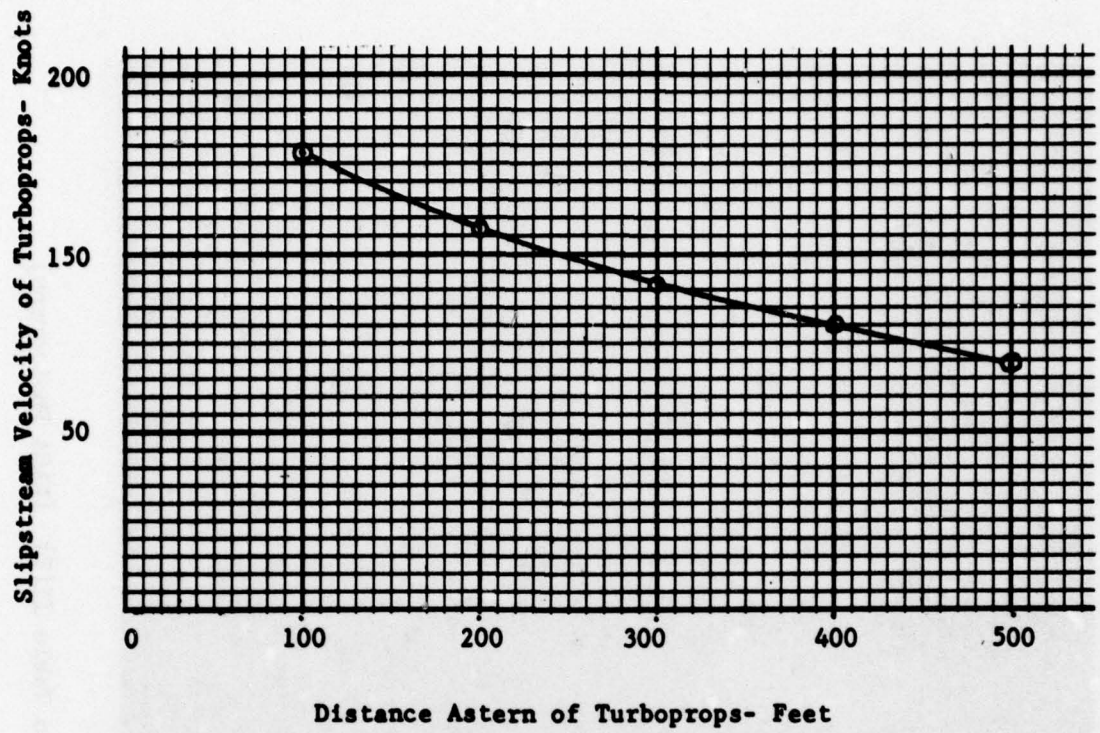
Fig.4 C-130 Aircraft Full-Power Slipstream Velocities (1)

In the second series of tests, the floating rafts were released to drift into the slipstream astern of a fixed-wing aircraft (the Coast Guard Lockheed C-130, four-engined turboprop) chocked in place on the ground as shown in Figure 3, while generating the wind velocities shown in Figure 4. Full-power rotation of the turboprops generated waves approximately 1-foot in height with white caps at a distance approximately 200 feet astern of the aircraft engines. For the slipstream tests, the rafts were tested both empty and loaded with sand bags to simulate 2-person loads. In several of the slipstream trials, the rafts were exposed with and without their drogues in the water. The recorded results of this series consisted of individual sightings of each raft with photographs and films similar to those described above for the tests with the helicopter.

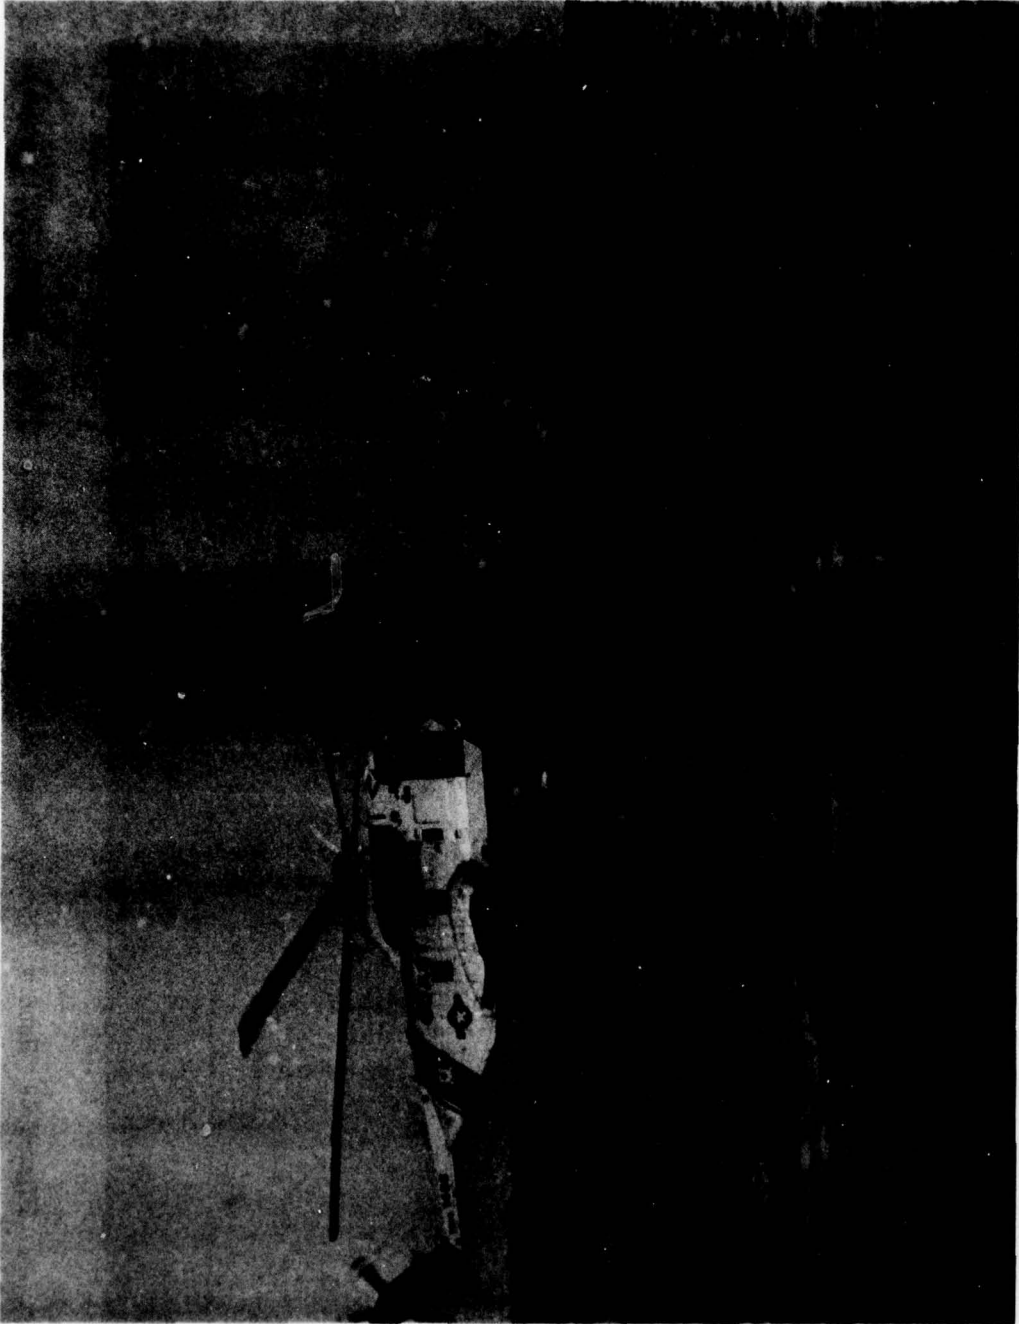
Figure 7- RFD '25' Capsizing: Refer to Table II(9) (NASA Photograph)

Figure 8- RFD '25' Capsized: Refer to Table II(9) (NASA Photograph)

- (8) Raft lifted up on beam end and dropped back upright. Refer to Fig. 6.
- (9) Helicopter approached raft on its untethered (the unweighted) end. Raft turned over and stayed upsidedown with loss of sand bags. Refer to Figs. 7 and 8.
