USAAMRDL-TR-77-13

CRASHWORTHY TROOP SEAT TESTING PROGRAM

Boeing Vertol Company
P. O. Box 16858
Philadelphia, Penn. 19142

Final Report for Period May 1974 - December 1976

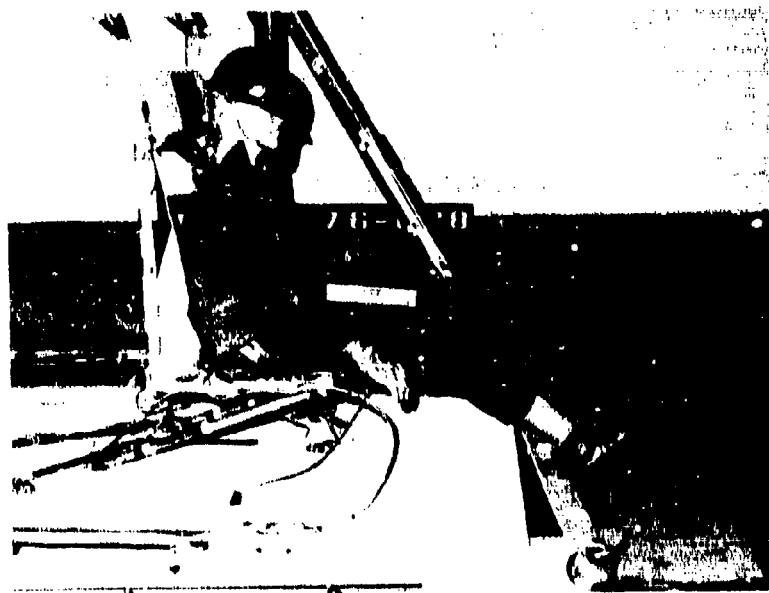
Figure 73. Post-test 3A - Forward yaw loading.

A visual inspection of the seat was made after the test and no structural or fabric damage was detected (Figure 73). A review of the motion picture film showed that the dummy was retained in a proper position throughout the seat stroking sequence. The seat deflected 30 degrees to the left from its original yawed position to align itself in the direction of impact. Swivel fittings at the point of attachment to the floor allowed the seat to realign itself.

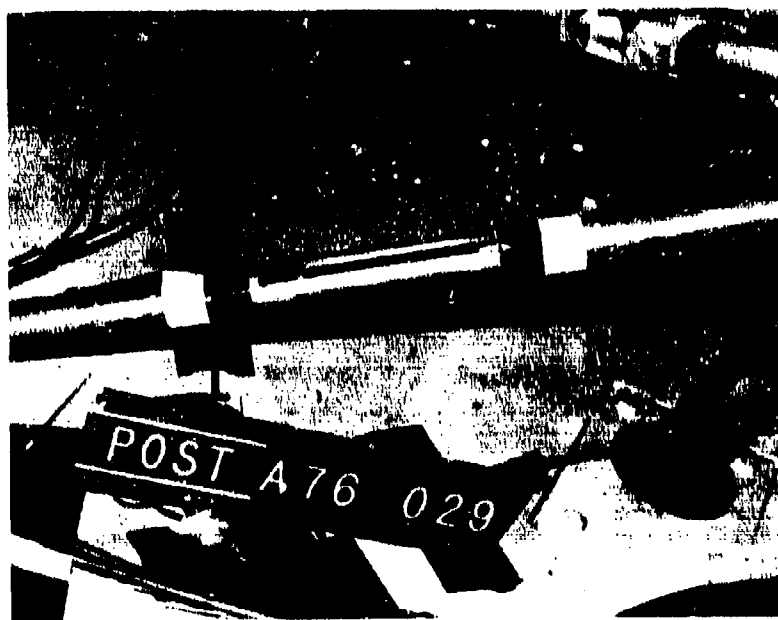
Figure 81. Upper and lower stroked attenuators.

All of the attenuators intended to stroke did stroke. The left and right upper attenuators stroked 4.3 and 5.5 in., respectively. The left and right diagonal-strut attenuators stroked 6 in. and 8 in., respectively (Figure 81).

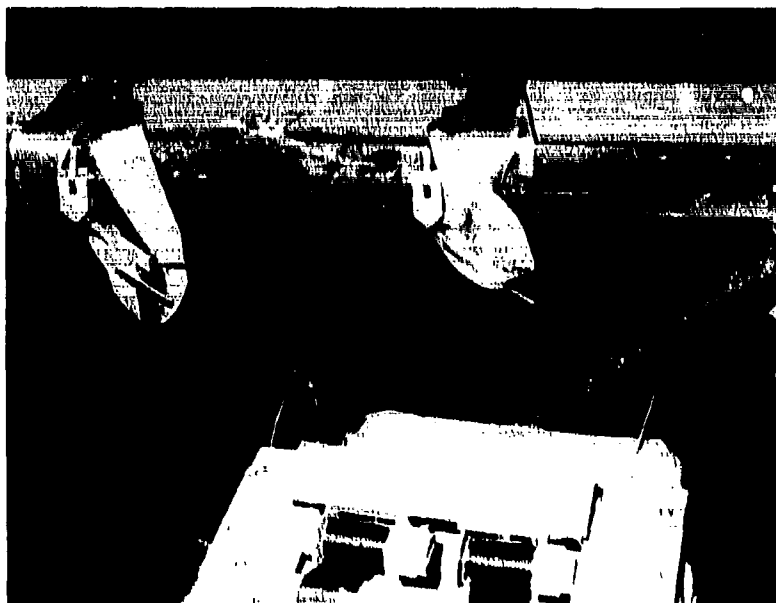
Figure 86. Stroked vertical attenuators.

A visual inspection of the seat after the test revealed no structure or fabric damage (Figure 85). Both vertical attenuators had stroked 11 in. (Figure 86). The diagonal-strut attenuators did not stroke; they are not intended to stroke in predominantly vertical impacts. There was no physical evidence of the seat having bottomed, and review of the motion picture film showed that the seat had approximately 2.5 in. of additional stroke remaining before making contact with the floor.

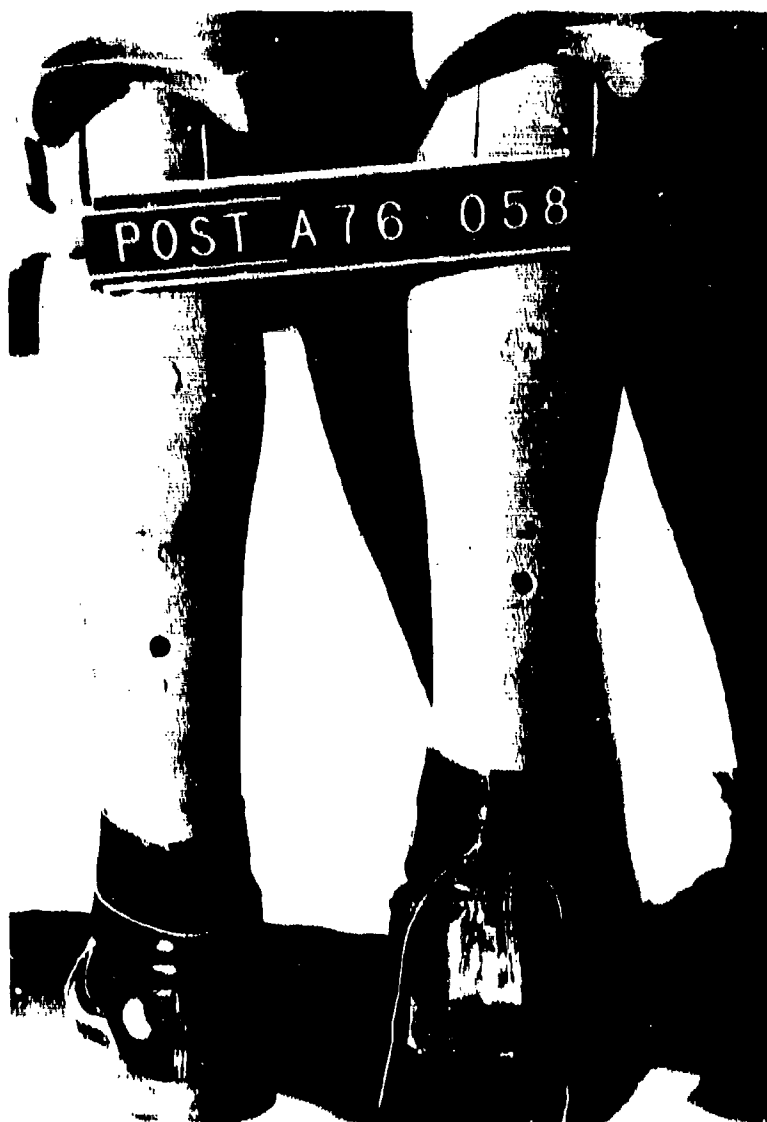
Figure 103. Seat impact with dummy's legs.

← Impact with
dummy's legs
