TECHNICAL REPORT ARLCB-TR-77043

TEMPER. EMBRITTLEMENT IN 4140 SEAMLESS TUBING

November 1977

US ARMY ARMAMENT RESEARCH AND DEVELOPMENT COMMAND
 LARGE CALIBER WEAPON SYSTEMS LABORATORY
 BENÉT WEAPONS LABORATORY
 WATERVLIET, N. Y. 12189

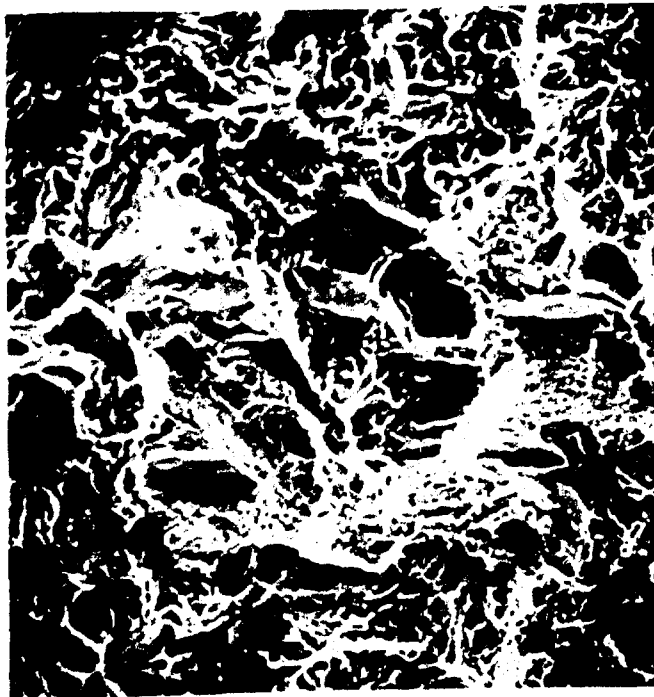
Figure 7. SEM fractograph showing cleavage and intergranular failure modes - 750°F temper - 900X.

Fractographic examination of broken CVN bars indicates the increasing tendency towards "low energy" intergranular failure as opposed to "low energy" cleavage failure as the tempering temperature is lowered. The 1000°F (538°C) temper displays quasi-cleavage as the principal mode of failure (Figure 6). This mode, however, changes to a mixed mode of intergranular and quasi-cleavage in the 750°F (390°C) temper (Figure 7). The high energy mode of failure for both tempers was ductile fracture by microvoid coalescence (Figures 8-9).

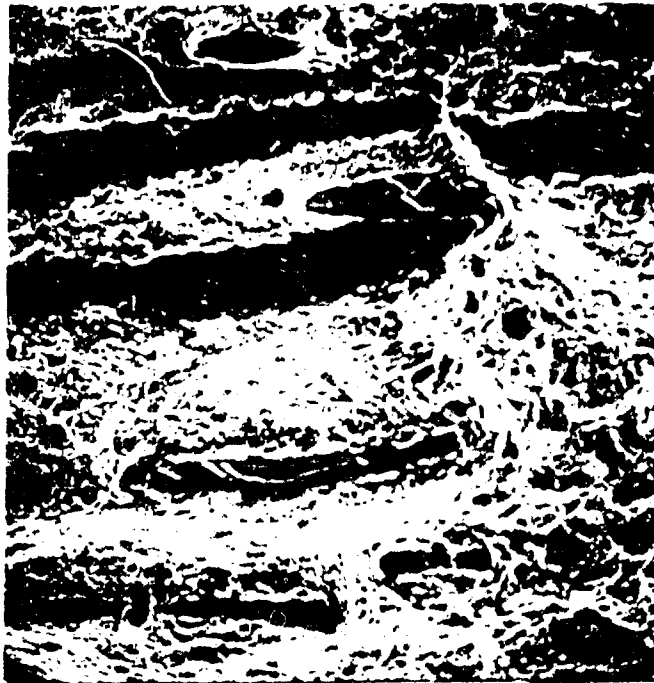
Figure 8. SEM fractograph showing ductile failure mode - 1000°F temper - 500X.
