THE CUTTING OF ICE WITH WATER JETS

D.B. COVENEY, W.H. BRIERLEY

DIVISION OF MECHANICAL ENGINEERING

REPORT
MD-54

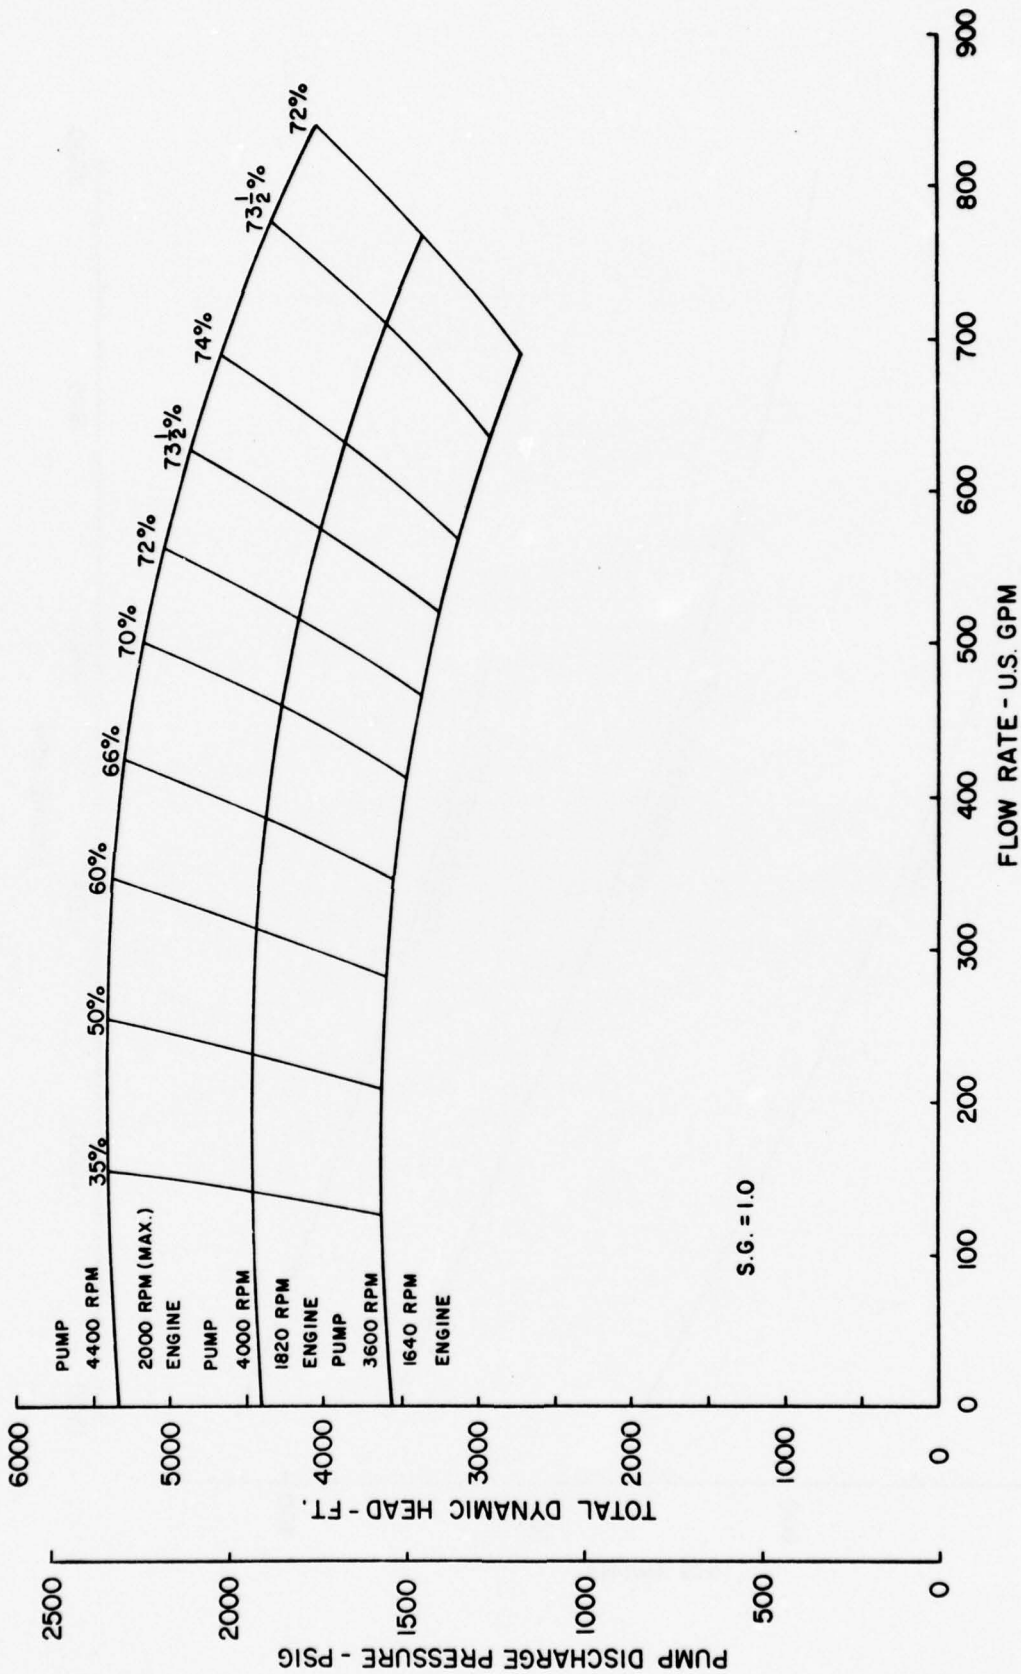
FIG. 1: PUMP PERFORMANCE CURVES

The main pump is an eight-stage, 4" x 4" x 10" centrifugal pump with horizontally split casing. It is capable of producing about 2,300 psig at up to about 400 US gpm. The performance curves are given in Figure 1.

In Figure 3 the limitations on pump performance imposed by the rated capabilities of the diesel engine have been superimposed on the pump performance curves, assuming no slip of the centrifugal clutch.

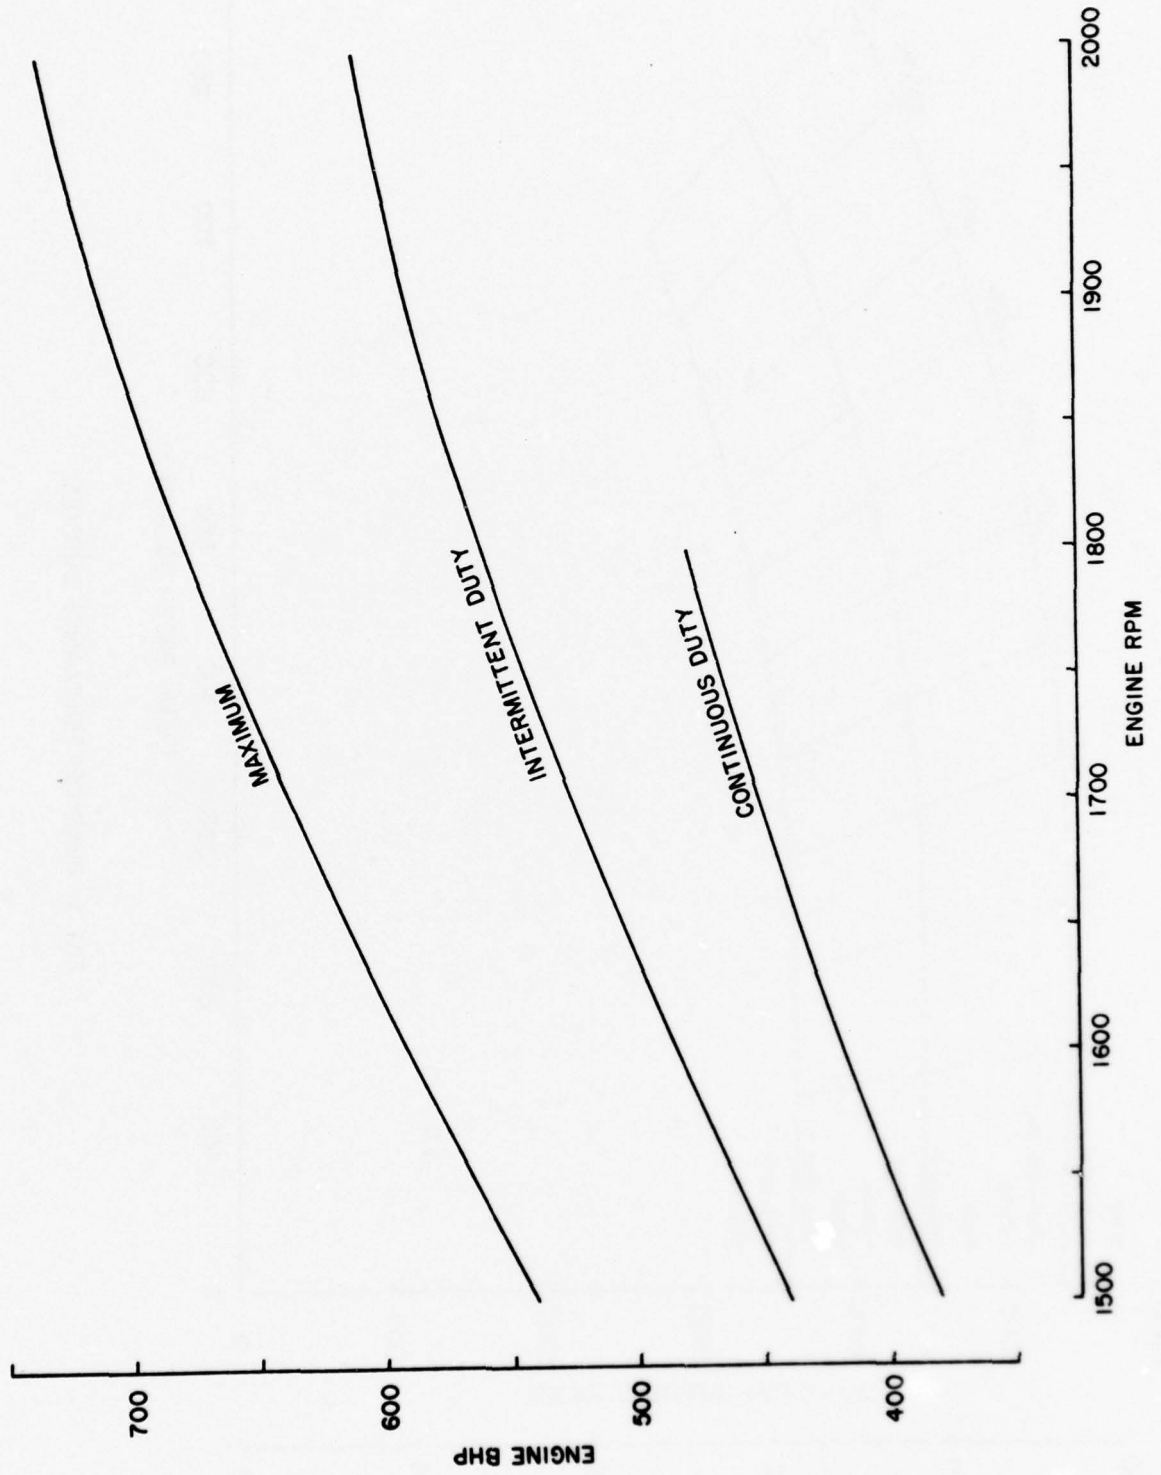
FIG. 2: DIESEL ENGINE PERFORMANCE CURVES

A water cooled 1191 C.I.D. V-8 diesel engine with aftercooled turbo-chargers drives the main pump. The "Hydra-Mechanical" governor is set to limit the full load speed to 2,000 rpm and the low idle speed to 500 rpm. The engine is rated at 480 bhp @ 1,800 rpm for continuous duty, 610 bhp @ 2,000 rpm for intermittent duty and 735 bhp @ 2,000 rpm maximum. For the engine performance curves see Figure 2.

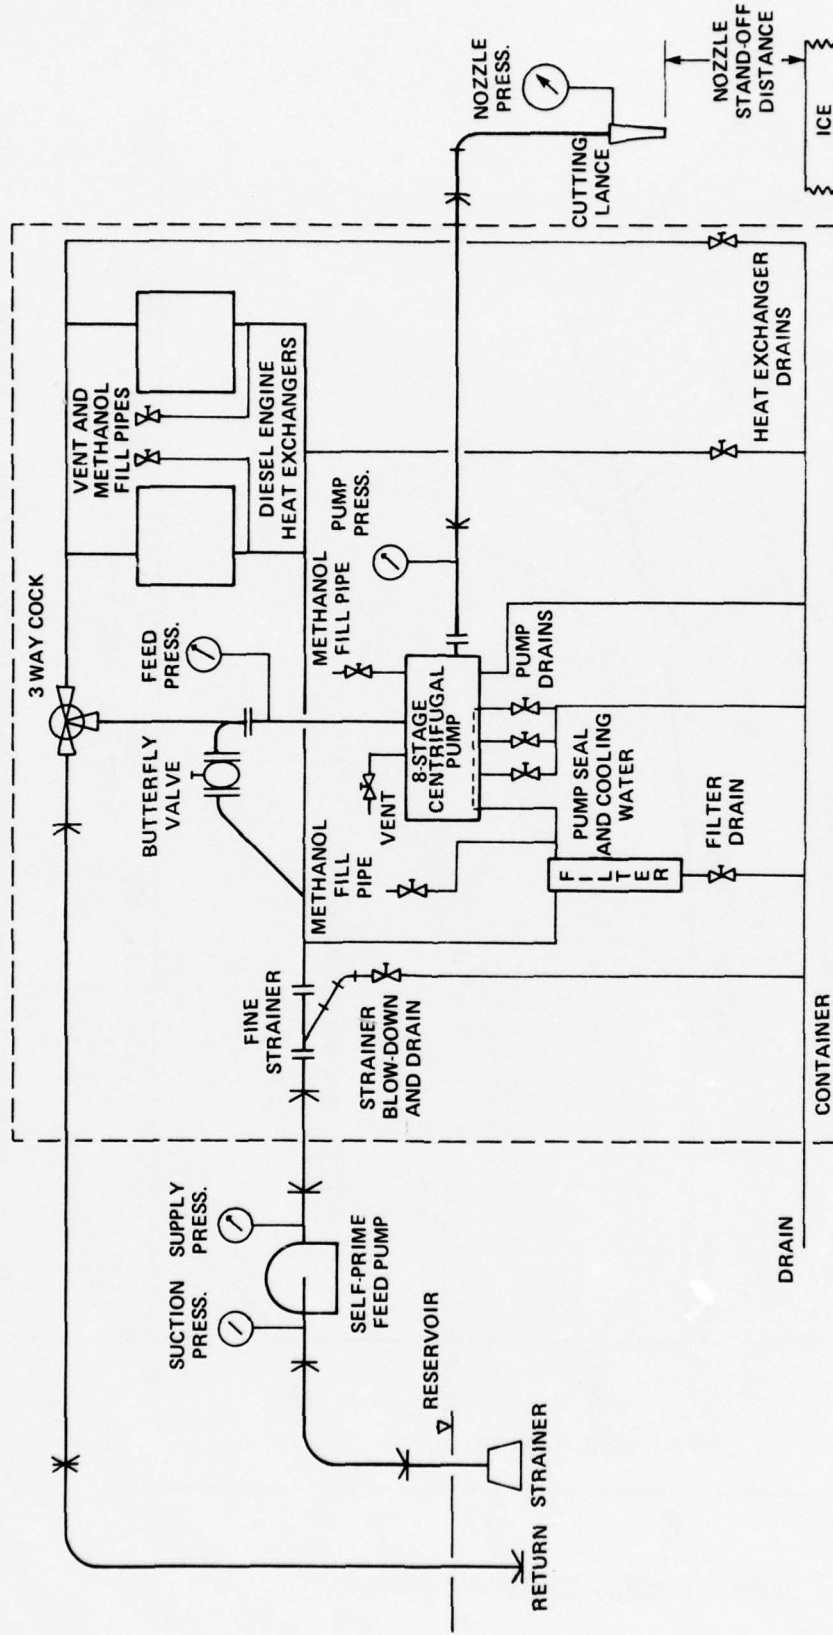
FIG. 4: WATER SYSTEM SCHEMATIC

The water piping system within the container is shown in Figure 4. To prevent freezing of water in the system after shutdown, drain connections are provided to permit rapid draining of the entire system with the exception of small quantities in the bottom of five of the eight pump volutes. After draining, any water left in the system is diluted with methanol fed into the system at critical points from a drum seated in a cradle on the container roof. A propane space heater provides back-up protection as well as allowing for a "warm" start-up of the system.

The entire water system is shown diagrammatically in Figure 4. Water is drawn through the suction strainer and one or two 20-ft. lengths of 4" diameter heavy duty suction hose by the feed pump. This pump supplies the water to the container system through one or two 50-ft. lengths of 4" diameter heavy duty discharge hose. When more water is needed for engine cooling than for ice cutting, the excess is returned to the reservoir through the return line, consisting of the remaining length(s) of discharge hose (a total of three lengths of discharge hose are available). All low pressure hose connections are made with mating quick-connect fittings, thereby allowing a variety of hose arrangements.

As the water enters the container it passes through a fine strainer (3/16" diameter holes). A small quantity is passed through a filter (10 micron) for cooling and sealing the pump. The remainder can be directed through a variety of paths, depending on the setting of the butterfly valve and the three-way cock.

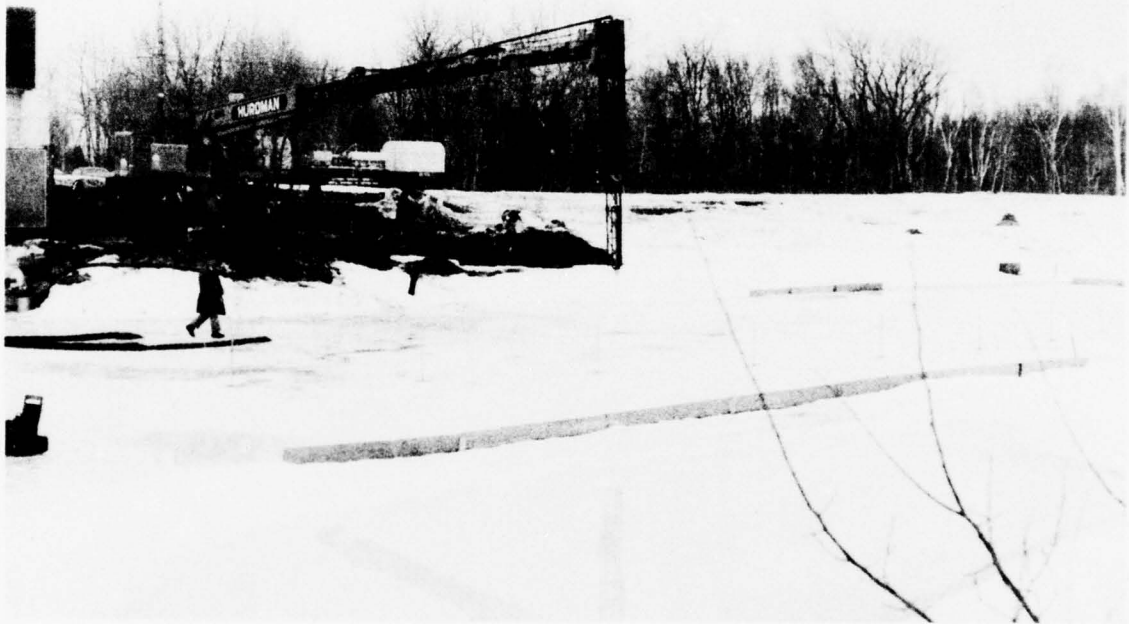
FIG. 5: ICE CUTTING TEST SITE

A spring-fed pond adjacent to Building U-89 at Uplands was selected as a convenient test site (Fig. 5). This site had adequate accessibility, adequate size (about 300 ft. X 100 ft.) and adequate depth (up to about 8 ft.). By late January, it had an 18-inch natural ice cover with only a light covering of snow.

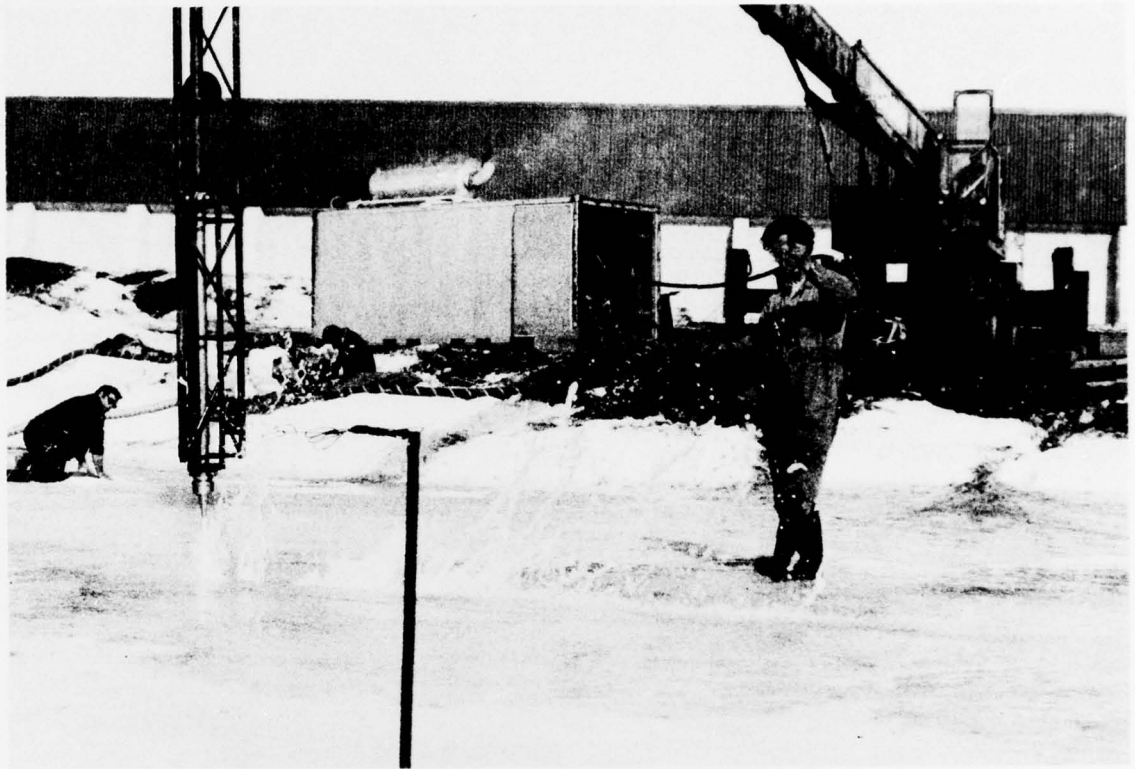
FIG. 6: ICE CUTTING TEST SET-UP

On 8 March 1977, the container complete with the main pumping system was placed and levelled on the bank of the pond immediately adjacent to the site selected for the crane. The trailer with the feed pump system was placed on the ice surface nearby. On the following day the crane was positioned and "levelled" on the selected site (the levellest and most accessible available). The cutting lance support column was mounted on the head of the crane boom and the cutting lance and pipe were mounted in the column.

To provide a reference for the traverse speed measurement, ten posts (see foreground Fig. 6) were set at 10 ft. increments on a 90-ft. radius arc centred on the swing axis of the crane.

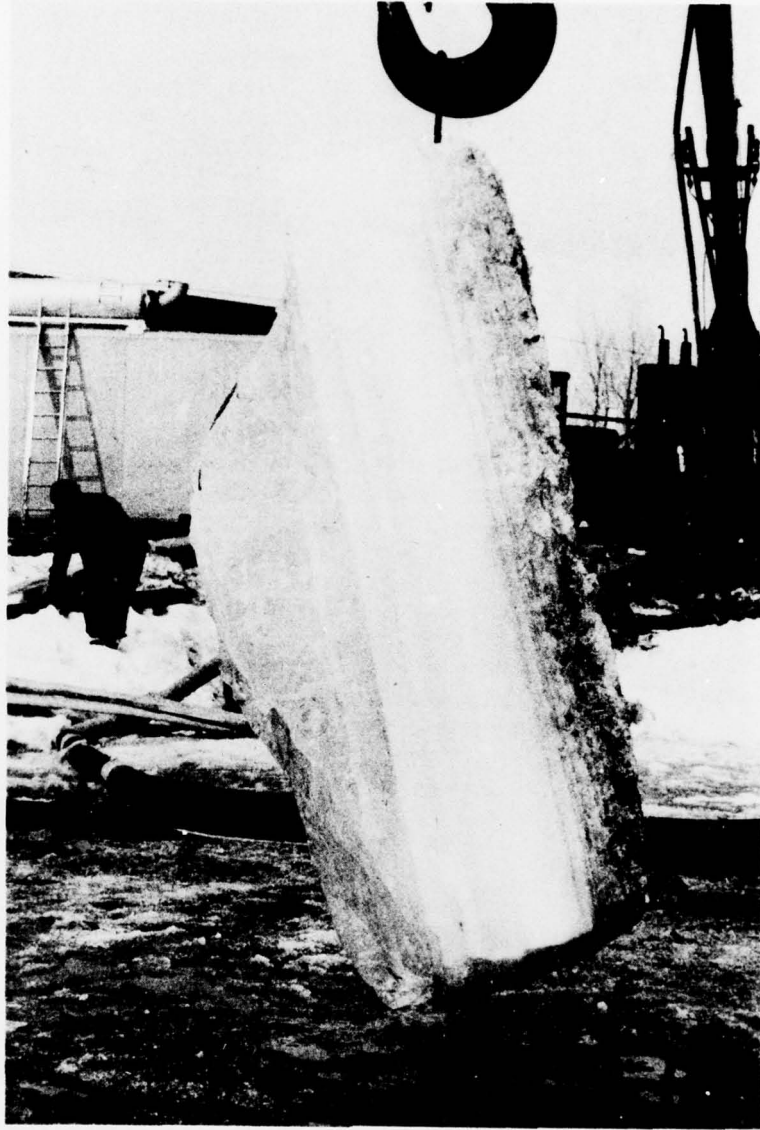
FIG. 7: CROSS-SECTION OF POND ICE

The latter condition is particularly apparent upon examination of Figures 7 and 8. In Figure 7 it can be readily seen that the water jet has cut cleanly through all but the bottom clear ice layer. Figure 8 shows that significant delamination has occurred between the bottom clear ice and the first opaque ice layer. In addition, Figure 11 illustrates a phenomenon often found during these tests; the jet was causing the delamination, which then allowed part of the water jet to escape through the resulting gap and up the neighbouring slot cut during a previous pass. This may explain why portions of many of the cuts apparently terminated at or near the top surface of the bottom clear ice layer. However, Table I indicates that this layer was penetrated by the water jet during Tests No. 2, 3, 10 and 11.

Figures 7 and 8 also illustrate one manner in which full penetration was achieved. While the upper layers were cut cleanly, entire sections of the bottom clear layer were apparently broken out. Since the fractures were at approximately 45° to the plane of the ice sheet, and since they were often remote from the water jet cut, it is postulated that the delaminated clear bottom layer failed by exceeding the principal shear strength of the ice where the bending stresses were highest, i.e. generally at the ends of a beam with fixed ends.

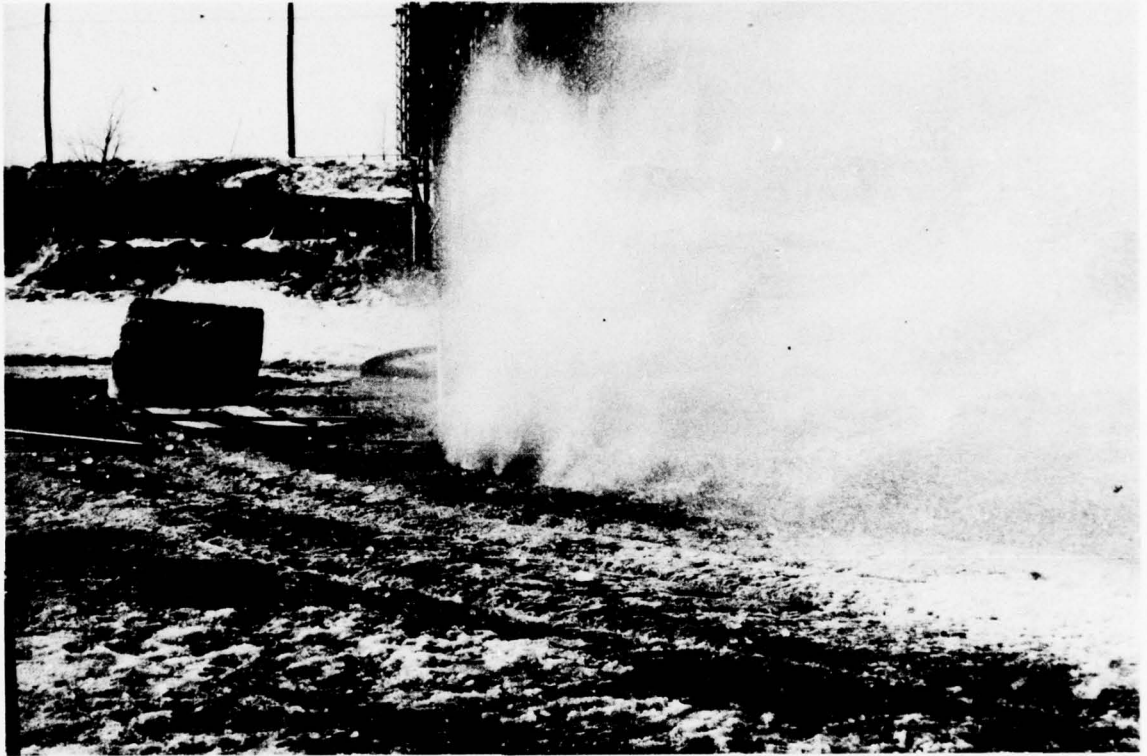
FIG. 14: HIGH SPEED TRAVERSE OF ICE CUTTING TEST NO. 14

Penetration was complete for the slow speed traverse and 8" to 12" for the high speed traverse. The centrifugal clutch was slipping badly for both of these tests.
