EVALUATION OF SEATBELT AND RESTRAINT SYSTEMS
AND ANTHROPOMORPHIC DUMMIES
CONDUCTED DURING FISCAL YEAR 1976

10 Richard F. Chandler
Edwin M. Trout

FAA Civil Aeromedical Institute
Oklahoma City, Oklahoma

11 February 1978

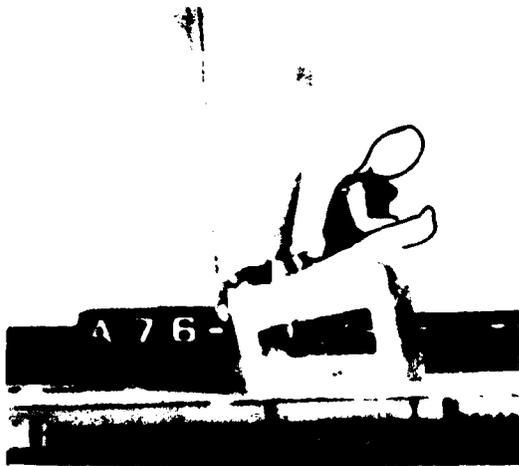
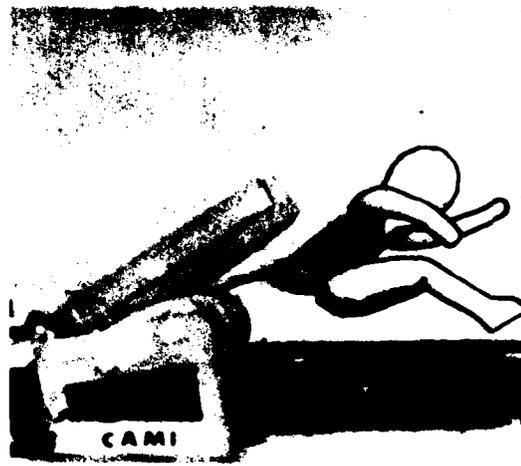
Figure 3. Dynamic Crash Test.
Sequence taken from high-speed film.

Figure 4. Dynamic Crash Test.
Sequence taken from high-speed film.

Crash conditions were simulated on the test track under the criteria outlined in Table 1. The restraint system allowed the dummy to move to the far edge of the seat, even under the least severe test conditions (Figure 3). Under slightly more severe conditions (Figure 4), the restraint system failed through tears in stitching and material and allowed the dummy to move off the seat onto the floor. More severe tests, even with the lighter weight dummy, caused the restraint system to fail. An additional problem inherent in this type of restraint system is that no protection was provided to prevent the seat back from compressing the child against the seat bottom.

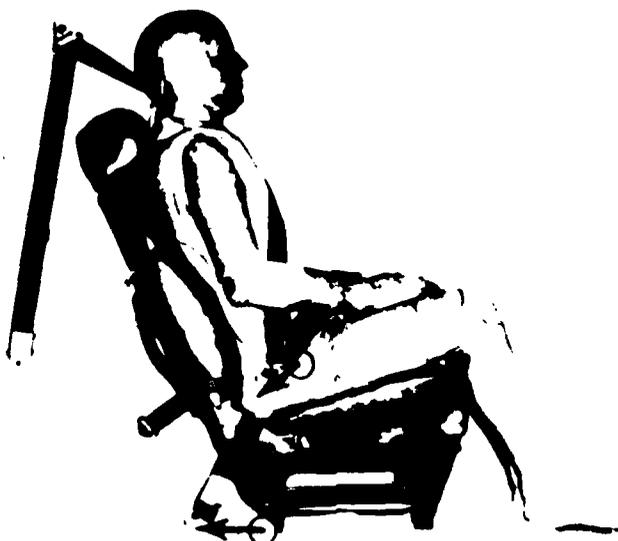
Figure 8. Modifications to restraint included relocation of buckle to the side of the hip and movement of inboard anchorage point to the rear. Initial locations are shown by circles.

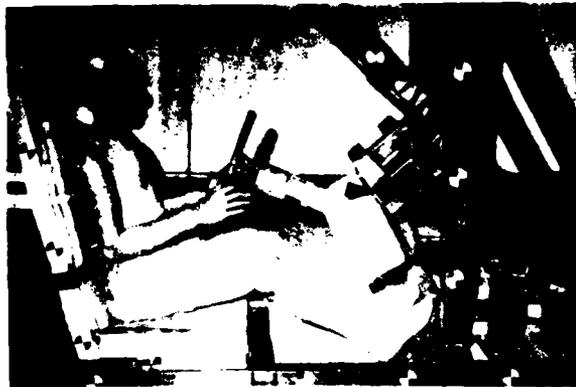
Figure 18.

This program was conducted to evaluate the performance of automotive-type energy-absorbing steering column assemblies so that the feasibility of their use as aircraft control columns could be determined. Initial static testing on the columns indicated that the columns stroked at between 350 and 500 lb of force when loaded axially. Initial dynamic tests positioned the column in a conventional automobile configuration and used an unrestrained anthropomorphic dummy (Figure 18). Crushable knee bolsters provided a contact surface to prevent knee damage. It was found that the column would "lock" because of the eccentric load application and transmit up to 2,400 lb of force with minimal column stroke. Efforts to increase the bearing area and alleviate locking conditions on the column were of little improvement, increasing the stroke displacement only from 1 in to 4 in. The fourth, fifth, and sixth tests used a dummy with lapbelt so that the chest contacted the column in a manner more conducive to producing axial loads. Although the column stroke increased to more than 7 in, peak chest decelerations were not significantly reduced. Data are shown in Table 7. It was concluded that the energy-absorbing steering column is sensitive to eccentric loading and would require further development to eliminate this sensitivity before consideration of aircraft application is warranted.

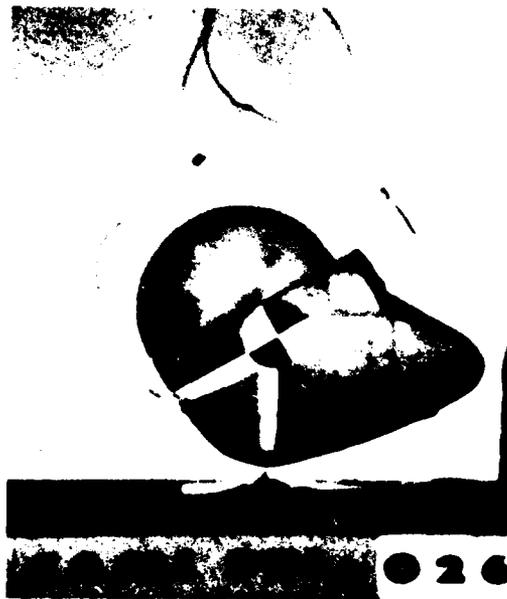
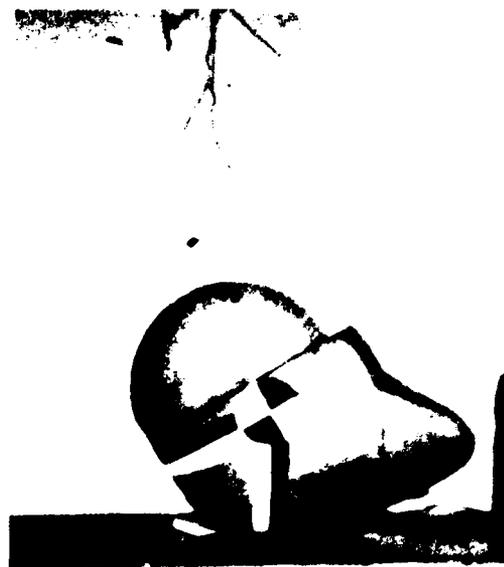
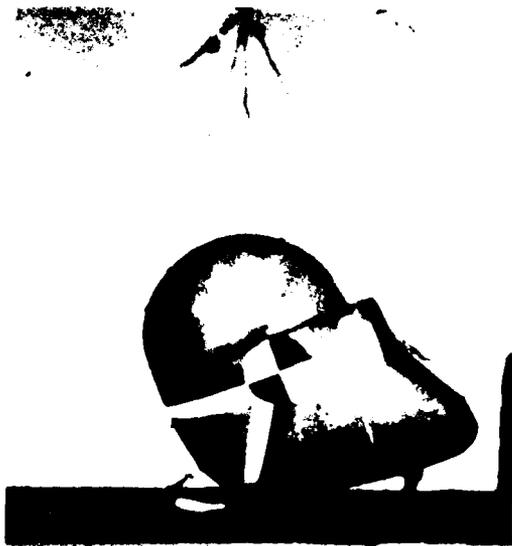
Figure 29. Head impact test.

In the head impact test procedure, the head is dropped onto a 2-in steel plate from heights of 10 and 35 in, and acceleration is measured at the center of mass. This test is shown in Figure 29. Note that although the head impacts at a point directly below the center of mass, an eccentric force is generated during the impact that causes the head to rotate. The effects of this rotation will not be distinguished by the accelerometer installation in the head. The results of these tests are shown in Figure 30.
