HARRIS CORP MELBOURNE FLA ELECTRONIC SYSTEMS DIV  
QA PROCEDURES FOR COMPLEX MICROCIRCUITS. (U)  
DEC 77 L R PARADISO, J L WOLCOTT

4. TITLE (and Subtitle) QA PROCEDURES FOR COMPLEX MICROCIRCUITS.	5. TYPE OF REPORT & PERIOD COVERED Final Technical Report, Jul, 1976 - Jul, 1977	6. PERFORMING ORG. REPORT NUMBER N/A

9. PERFORMING ORGANIZATION NAME AND ADDRESS Harris Corporation/Electronic Systems Division P.O. Box 37 Melbourne FL 32901	10. PROGRAM ELEMENT, PROJECT, TASK AREA & WORK UNIT NUMBERS P.E. 62702E S.O. 23380104	11. REPORT DATE Dec 1977

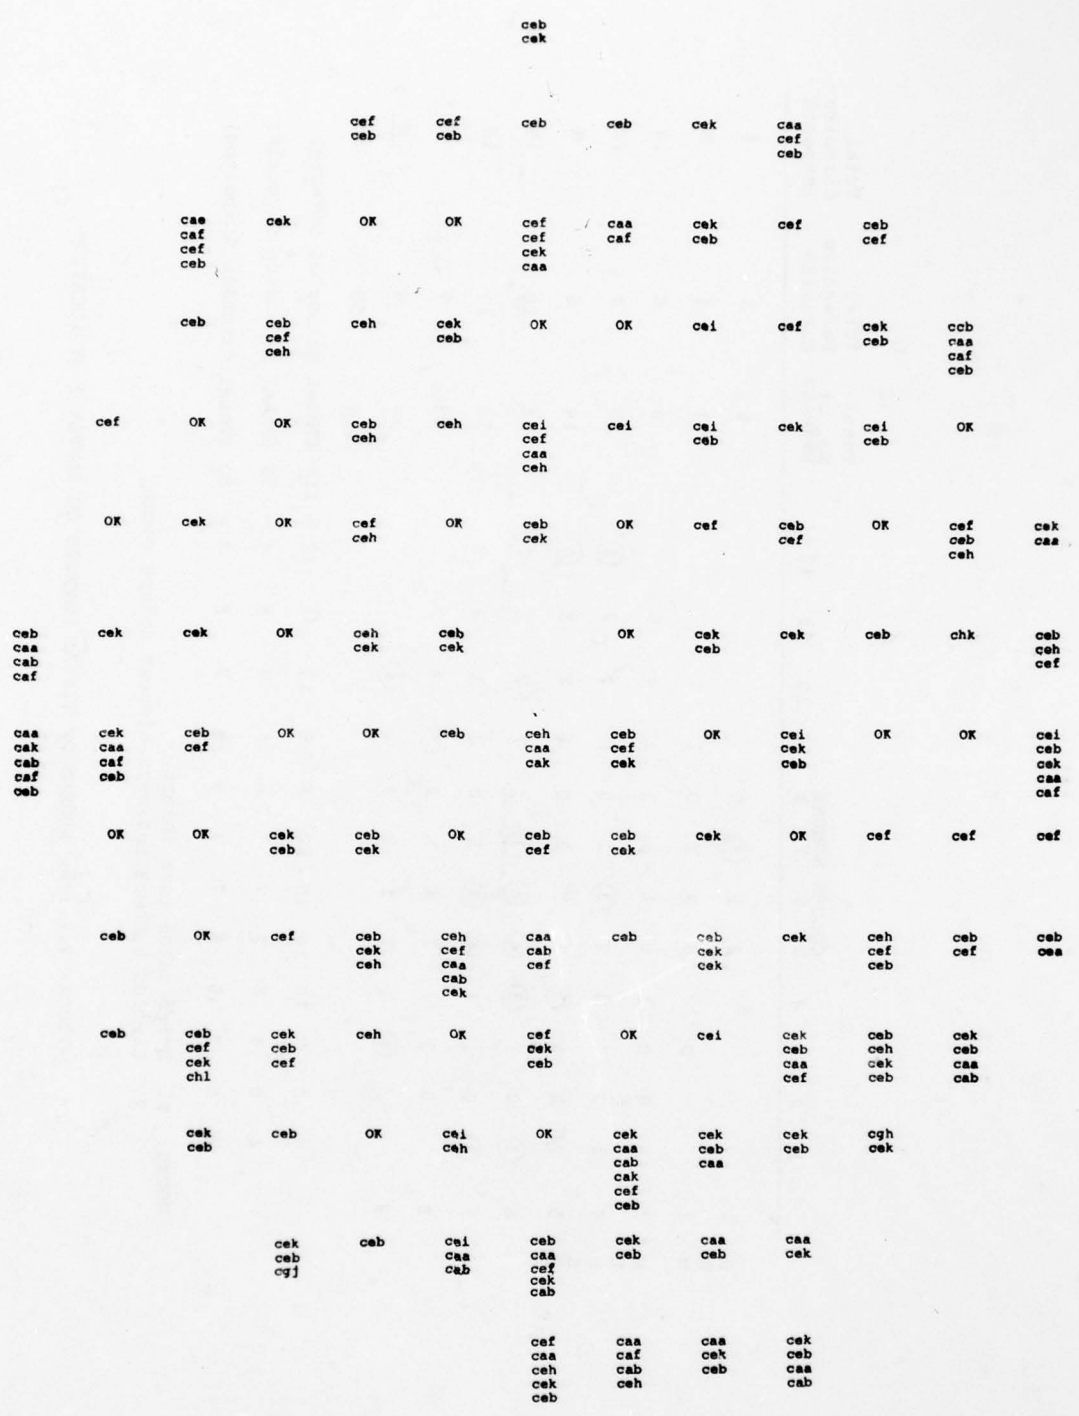
FIGURE 2.1.1-5

SAMPLE 5. VENDOR B METAL GATE CMOS CUSTOM LSI ARRAY - 3" WAFER 216 X 204 MIL DIE

Table 2.1.1-1 summarizes the wafers selected for the inspection. Figures 2.1.1-1 through 2.1.1-5 are the wafer maps generated from each wafer. From the wafer maps of Figures 2.1.1-1 through 2.1.1-5, an additional set of wafer maps were generated. These maps, Figures 2.1.1-6 through 2.1.1-10, show the number of defects found in each individual circuit. Analysis of the data from Sample 1, Figure 2.1.1-6, revealed a high concentration of visual defects around the edge of the wafer and one row below and one row to the left of the center. Sample 2, Figure 2.1.1-7, shows a high concentration of visual defects near the bottom of the wafer and a band of defects scattered across the center of the wafer. Sample 3, Figure 2.1.1-8, shows a high concentration of visual defects around the edges and near the center of the wafer. Sample 4, Figure 2.1.1-9, shows a high concentration of visual defects around the edge of the wafer. Sample 5, Figure 2.1.1-10, shows a high concentration of visual defects around edges of the wafers and in a band across the bottom third of the wafer. The visual defect patterns as observed on these wafers can be explained as follows:

The edges of the wafers are where the manufacturer picks up the wafer during processing. This edge loss is expected. The high concentration of defects near the bottom of some wafers was caused by the scribing of the lot numbers on the wafer. The high defect counts near the centers of Samples 1, 2, and 3, are due to anomalies in the manufacturer's tooling.

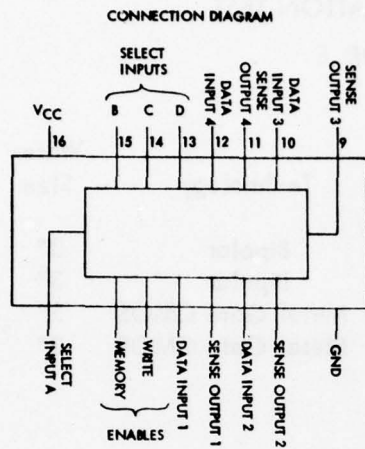
**TRUTH TABLE**

MEMORY ENABLE	WRITE ENABLE	OPERATION	OUTPUTS
0	0	WRITE	LOGICAL "1" STATE
0	1	READ	COMPLEMENT OF DATA STORED IN MEMORY
1	X	HOLD	LOGICAL "1" STATE

FIGURE 4.1.1-1 BIPOLAR DEVICE LOGIC DIAGRAM, 64 BIT READ/WRITE MEMORY
