CEEDO-TR-77-45

HARDWALL EXPANDABLE SHELTER

SEPTEMBER 1977

FINAL REPORT FOR PERIOD
APRIL 1973-AUGUST 1977

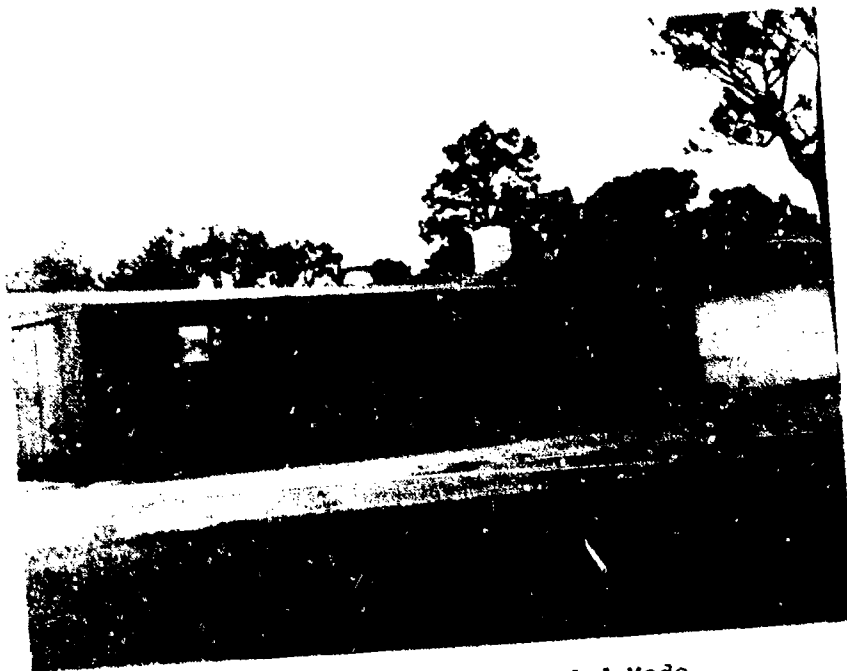
Figure 2. HES in Expanded Mode

The HES is an 8x8x20 foot container which expands to an 8x20x50 foot shelter (Figures 1 and 2). All components and erection hardware are packed within the container for storage and shipment. Primary components are aluminum skin/honeycomb core composite panels and aluminum extrusions.

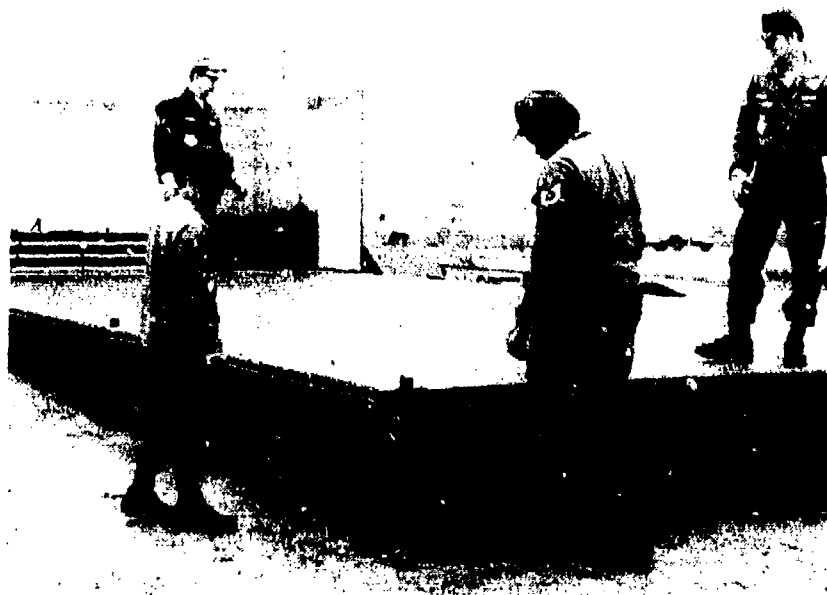
Figure A-6. Shelter Floor Levelled on 3 Percent Slope

Procedure. Erect the shelter on terrain which varies 18 inches over 50 feet. After erection ascertain that both container and floor beam jacks can be adjusted to compensate for settling (Figure A-6).

a. The shelter was erected on a sand and shell test site which had been surveyed and graded to obtain the 3 percent grade. New, higher quality container jacks had been received from Brunswick and the entire shelter was leveled on the test site.
