Special Report 78-3

PHYSICAL MEASUREMENT OF ICE JAMS

1976-77 Field Season

Prepared for
DIRECTORATE OF CIVIL WORKS
OFFICE, CHIEF OF ENGINEERS
By
CORPS OF ENGINEERS, U.S. ARMY
COLD REGIONS RESEARCH AND ENGINEERING LABORATORY
HANOVER, NEW HAMPSHIRE

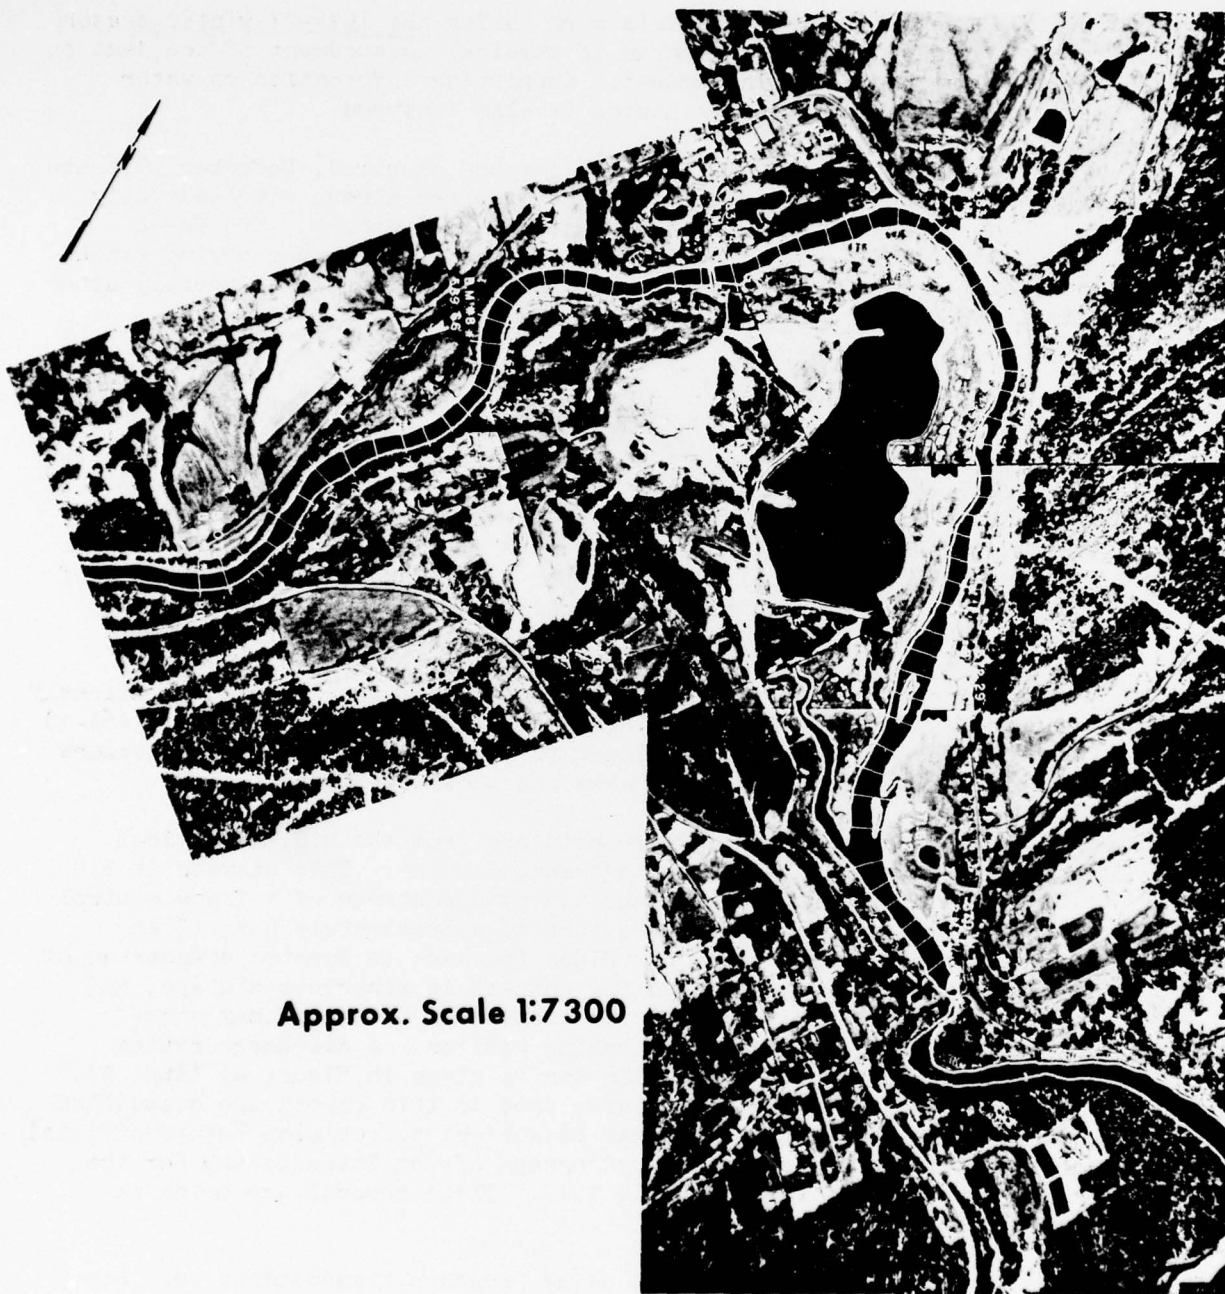
Figure 1. Ottawaquechee River, Quechee, Vermont.
17 April 1976

An extensive survey of selected portions of the river was previously conducted (Calkins¹) with river cross-sections profiled at 200-ft (61-m) intervals and benchmarks established for survey control. The locations of the cross sections and benchmarks are shown in Figure 1.

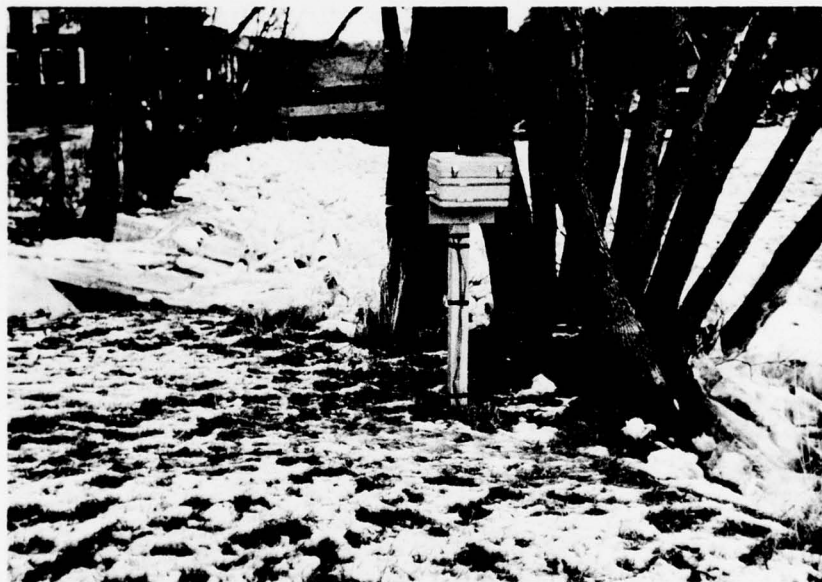
The water level recorders used on the Ottawa-Quebec River employed Endevco Model 8503-40 pressure transducers installed on the riverbed along surveyed river cross sections. The signal cables from the transducers were run underground to an instrument box mounted on a short post. The signal from a pressure transducer was recorded on a battery-operated Gulton Rustrak Model 288 strip chart recorder, set up to measure relative changes in river stage over a range of about 5 m. Figure 2 shows the installation at Quebec cross section 13.

Figure 2. Stage recorder installation.

Several problems with the water level recorders were encountered during the season, including the following:

1. Although the signal cables were buried in the riverbank, the transducers were not adequately anchored and could move around, altering the calibration. In addition, the calibration of the system could drift internally making periodic calibration imperative.
2. The strip chart recorder paper frequently jammed on the takeup reel. It should be possible to prevent this by bypassing the takeup reel and allowing the paper to collect in the base of the instrument box. The boxes must be waterproofed, however, since water was frequently found in the bottom of the boxes this season.

3. Better locations for the instrumentation must be found. During the past season the installations at cross sections 13, 32 and 47 were hit by ice and the latter two would have been destroyed during the March 1977 jam if they had not been removed in time. The recorder at cross section 42 was vandalized early in the season, and was not replaced because of its close proximity to and visibility from the highway.

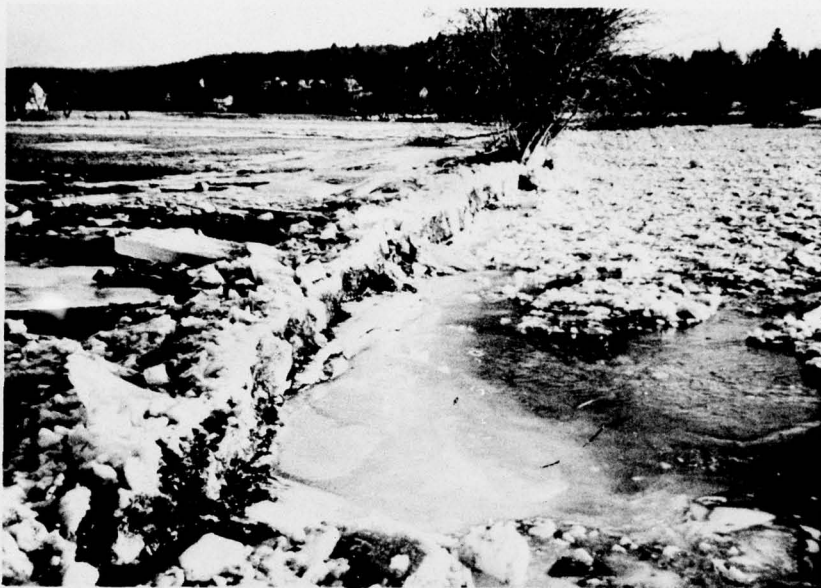
Figure B3. Ice run shear wall in contact with soil, near cross section 25 - December 1976.

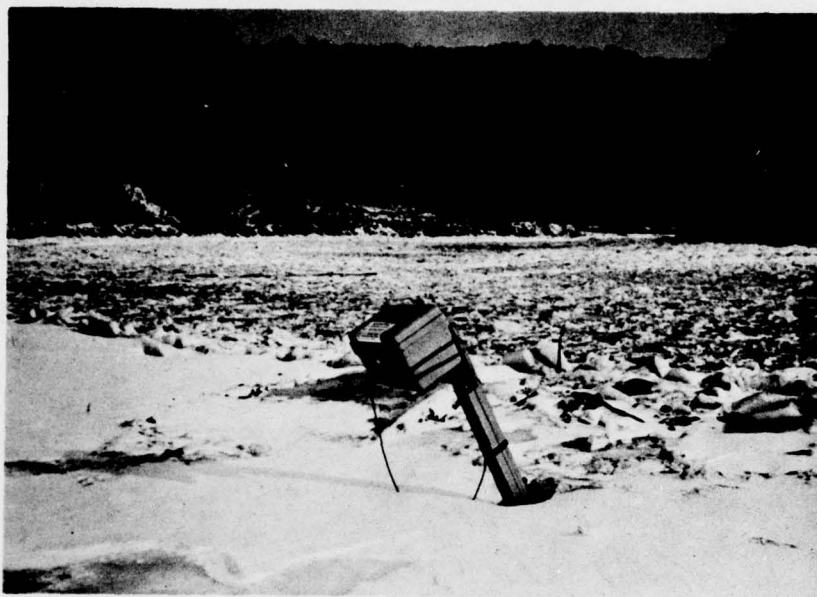
Figure B5. Damaged recorder installation, cross section 47 - December 1976.
