# EVALUATION OF THE PILOT ROCKET SCRUBBER

FINAL REPORT

AUTHOR: LUCIANO SEDILLO  
AIR FORCE ROCKET PROPULSION LABORATORY  
EDWARDS AFB, CALIFORNIA 93523

JANUARY 1978

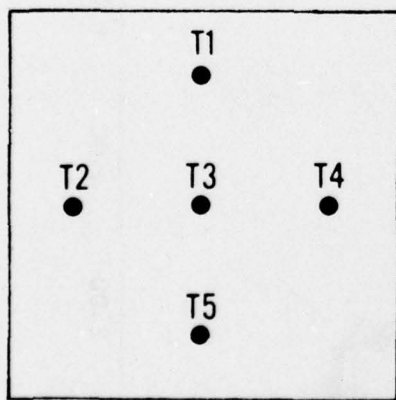
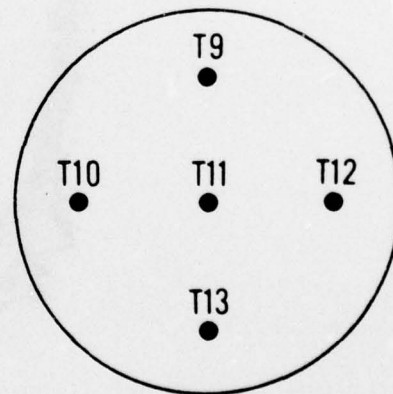
Figure 10. Demister Thermocouple Location

Three important locations were selected for thermocouple installation; they were: (a) upstream of the demister, (b) downstream of the demister, and (c) at the demister exit. The location of these thermocouples are shown in Figure 10. The temperatures of the various locations were quite reproducible from test to test. Typical temperature plots located upstream, downstream, and demister exit are shown in Figures 11, 12, and 13 respectively.

and six feet from the ceiling (Figure 10). A thermocouple at the ceiling would be expected to exceed the highest temperature reading of 600°F recorded one foot from the ceiling. Charring of the ceiling was evident after every test. It was these results that raised doubts whether the demister could survive a 30 second test.
