AMMRC TR 78-14 BRITTLE MATERIALS DESIGN, HIGH TEMPERATURE GAS TURBINE

Volume 1 Ceramic Component Fabrication and Demonstration

March, 1978

Interim Report Number 12, January 1, 1977 to September 30, 1977

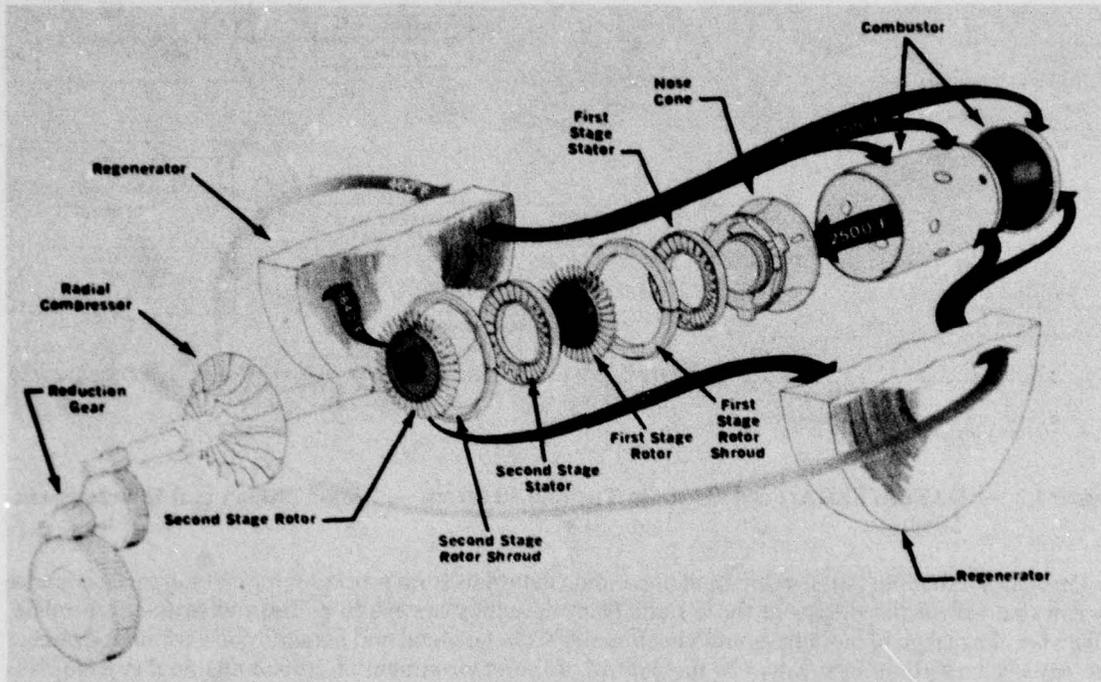
Figure 1.1 — Schematic View of the Vehicular Turbine Engine Flowpath

The vehicular project is organized to design and develop an entire ceramic hot flow path for a high temperature, vehicular gas turbine engine. Figure 1.1 shows a schematic of this experimental regenerative engine, designated model 820. Air is induced through an intake silencer and filter into a radial compressor, and then is compressed and ducted through one side of each of two rotary regenerators. The hot compressed air is then supplied to a combustion chamber where fuel is added and combustion takes place.

The hot gas discharging from the combustor is then directed into the turbine stages by a turbine inlet nose cone. The gas then passes through the turbine stages which comprise two turbine stators, each having stationary airfoil blades which direct the gas onto each corresponding turbine rotor. In passing through the turbine, the gas expands and generates work to drive the compressor and supply useful power. The expanded turbine exhaust gas is then ducted through the hot side of each of the two regenerators which, to conserve fuel, transfer much of the exhaust heat back into the compressed air.

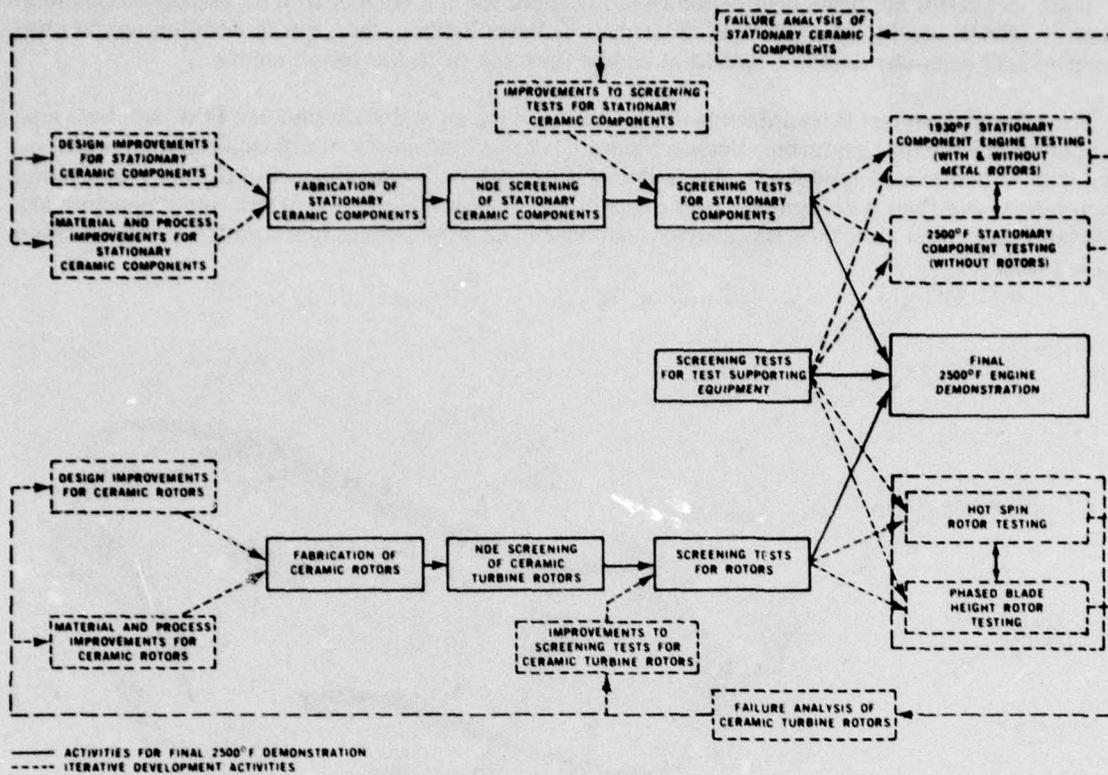
Figure 1.2 — DARPA/ERDA/Ford Ceramic Turbine Program — Major Project and Development Loops

Successful development of the entire ceramic flow path, as demonstrated in a high temperature vehicular gas turbine engine, will involve a complex iterative development. Figure 1.2 shows a block diagram flow chart, including the feedback loops, of the major factors involved, and serves to illustrate the magnitude of this complex and comprehensive iterative development program. Of particular importance is the interrelationship of design, materials development, ceramic processes, component rig testing, engine testing, non-destructive evaluation and failure analysis.

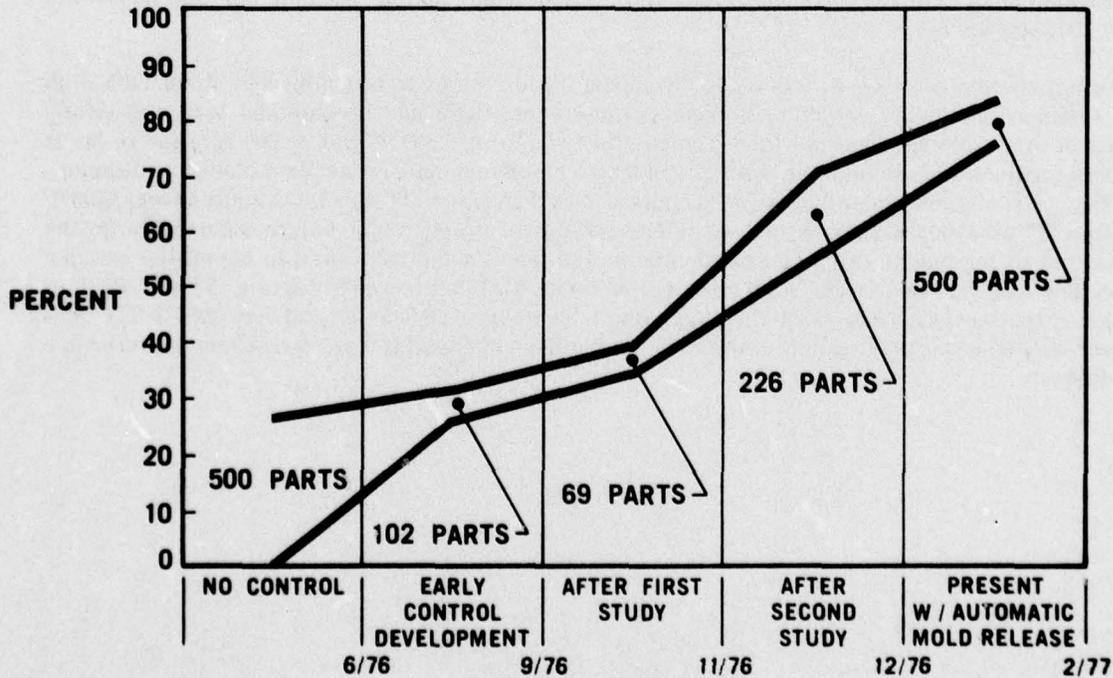
Figure 3.1 — Yield of Good As-Molded Blade Rings

The improvements in both the processing of injection molded material and injection molding are covered in Volume 2 of this report which was supported by ERDA — Division of Transportation. The increase in yield of good as molded parts as a function of control development is shown in Figure 3.1. The bottom curve represents blade rings having no visible defects, in the as molded state, under 70X

microscopic inspection. The top curve represents usable test blade rings and includes those molded with no cracks or other functional defects and less than two minor surface imperfections. The number of parts refers to the total number of blade rings molded during a particular stage of control development. It should be noted that flaws were detected in some of these components after subsequent processing steps (see Volume 2 of this report). Improved NDE techniques being investigated may reveal more flaws in as molded components decreasing the yield of good parts.

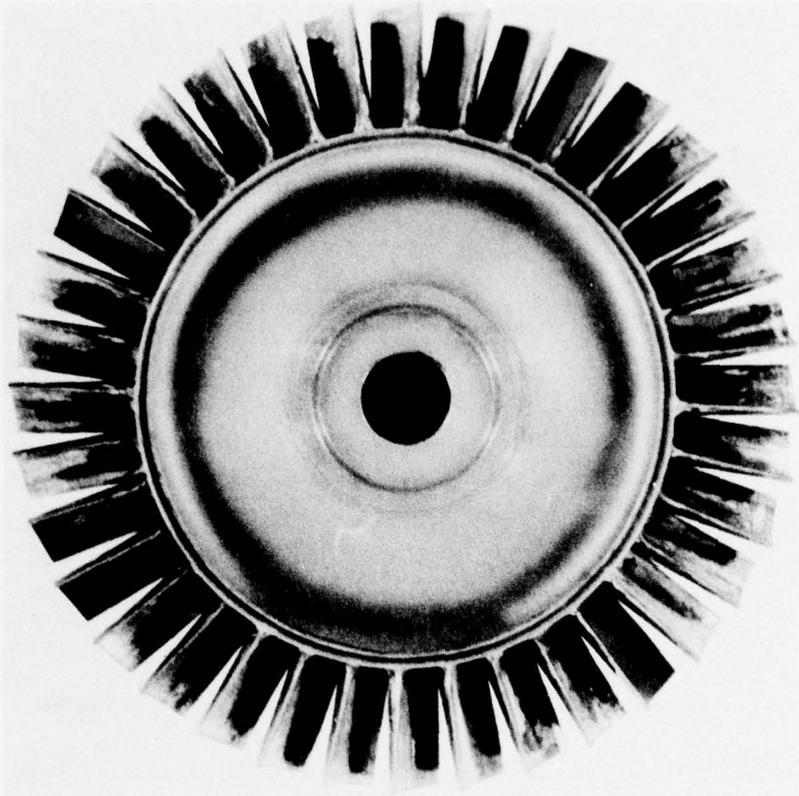
Figure 3.5 — Finish Machined Duo-Density Turbine Rotor

Rotors which were scheduled for engine testing were further machined by grinding curvic coupling face splines on the forward and aft mounting surfaces.

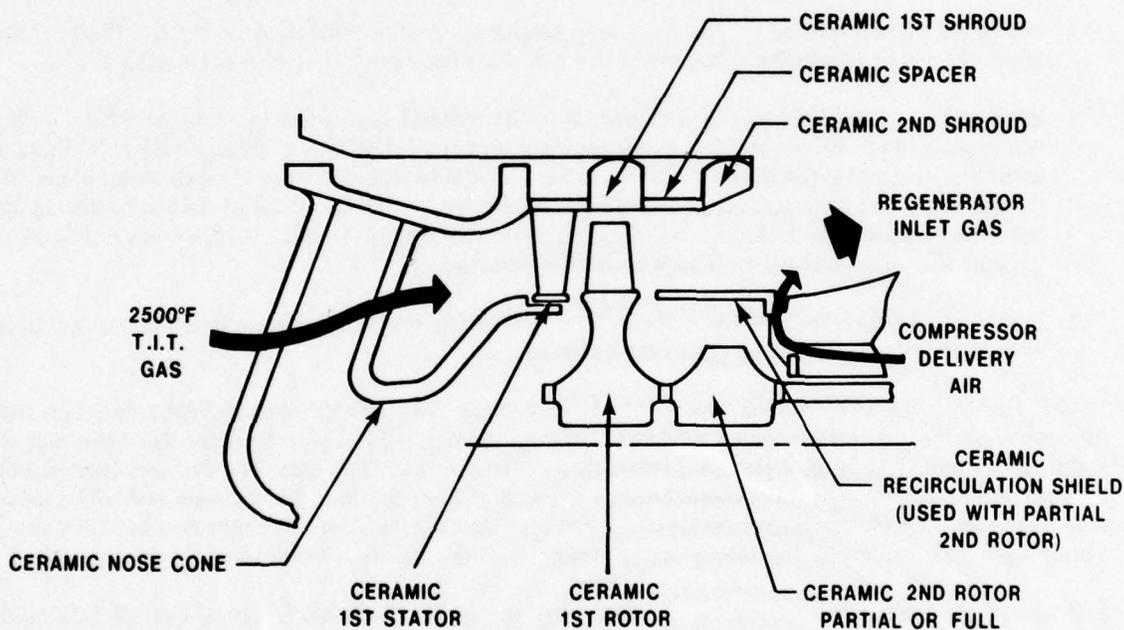
Figure 3.11 — Cross Section of Modified Engine Flowpath

Since the duo-density ceramic turbine rotor to be tested during this reporting period contained more blades of longer length and therefore would extract more work from the hot gases and further reduce the turbine exit temperature from that experienced in 709's run, only the compressor discharge bypass route was employed (see Figure 3.11). This configuration was a step closer to the original design engine as more air was routed through the turbine flow path.

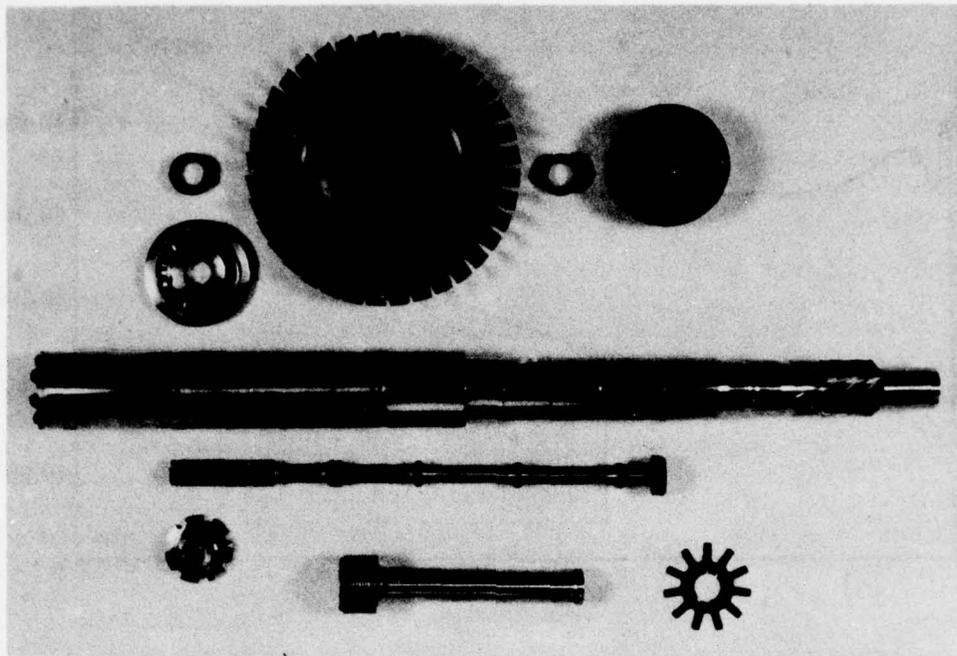
Figure 3.12 — Ceramic Turbine Rotor 1195, Attachment Hardware and Main Shaft

Rotor 1195 was the second, fully machined, design D prime duo-density ceramic turbine rotor produced using the simplified two-piece fabrication concept described in detail in reference 11. The 2.7g/cc reaction sintered silicon nitride blade ring (produced by injection molding) was hot press bonded to the hub while simultaneously hot pressing the hub from silicon nitride powder containing 3.5 w/o magnesium oxide densification additive. The assembly was then diamond ground to final dimensions using the procedure outlined earlier in this report. Figure 3.12 shows the finished rotor and attachment hardware prior to testing.

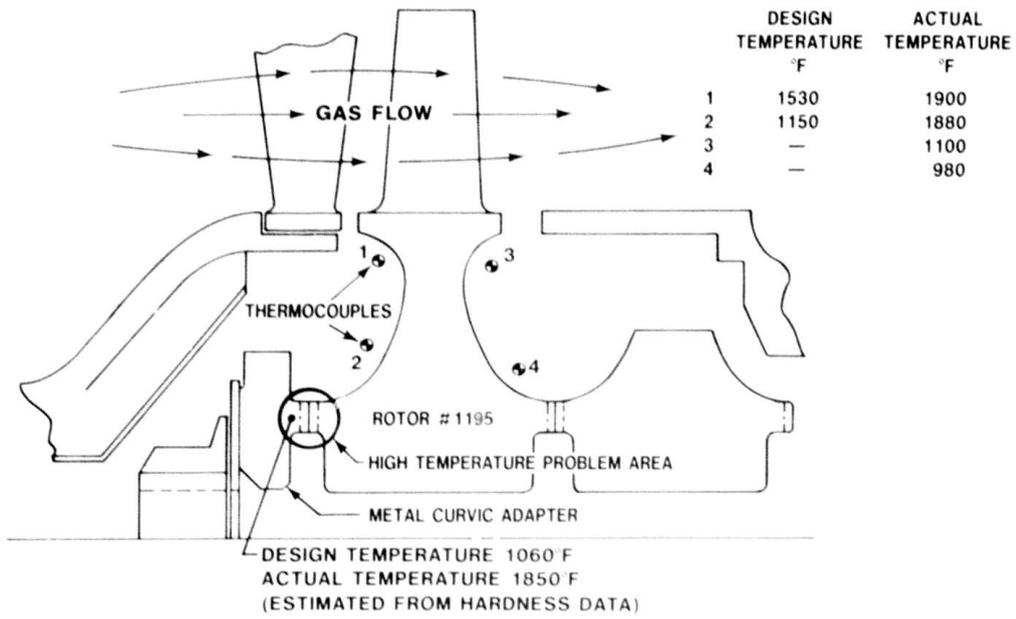
Figure 3.17 — Cross-Sectional View Showing Rotor Front Face Cavity

During the course of the last phase of this 26-1/2 hour run it was observed that the measured gas temperature in the rotor front face cavity, shown in Figure 3.17, had approached 1900°F. This was cause for concern since it was considerably in excess of design expectations (i.e. 1150°F). Prior furnace testing of the metal curvic adaptor to ceramic curvic rotor interface indicated potential damage due to interface friction at high temperature. A gradual shutdown was started by decreasing turbine inlet temperature while maintaining 50,000 rpm, but catastrophic failure occurred six minutes into the shutdown with the turbine inlet temperature at 1900°F.

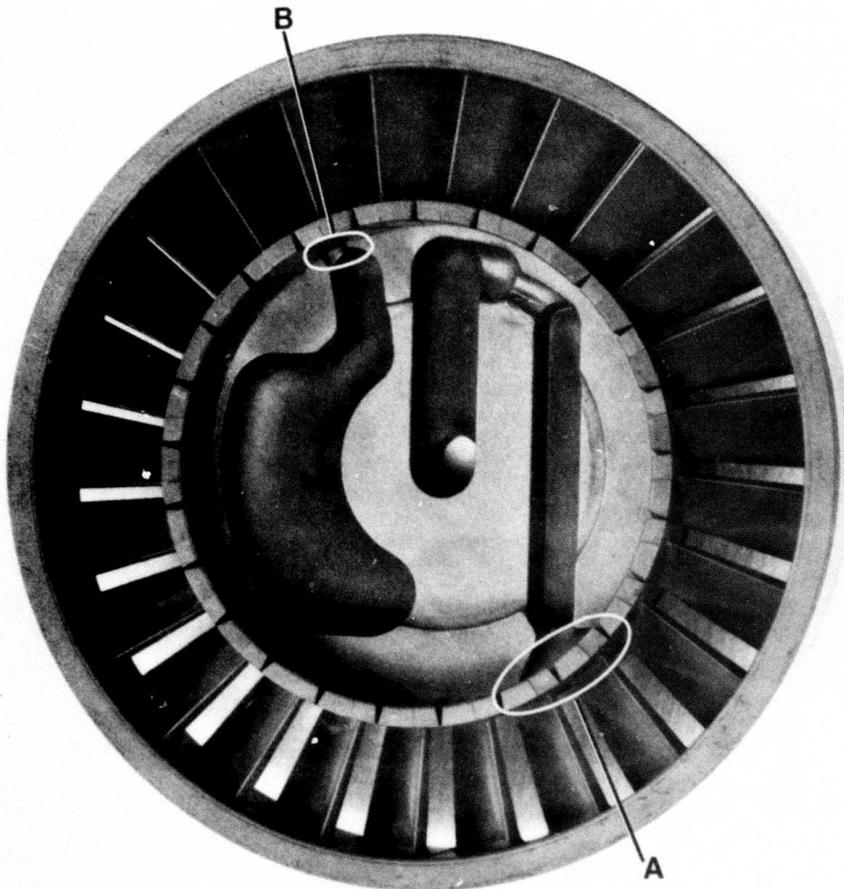
Figure 3.20 — Sprue Detail of Design D' Stator Tool

Fabrication of injection molded reaction bonded silicon nitride stators at the 2.7 g/cc density level was continued during this reporting period. As previously reported⁽¹¹⁾, a cracking problem had been experienced at the I.D. shroud due to sticking of the part in the sprue entrance detail of the tool. To eliminate the sticking, the sprue detail was teflon coated and several stators were molded. The sticking at the entrance (see location A in Figure 3.20) was eliminated. However, one area at the material overflow (see location B in Figure 3.20) continued to stick. It was determined that this sticking was due to overheating of a local spot in the die. The overheating resulted from restricting the material flow in the gate and by closing the overflow reservoir, the overheating was eliminated.

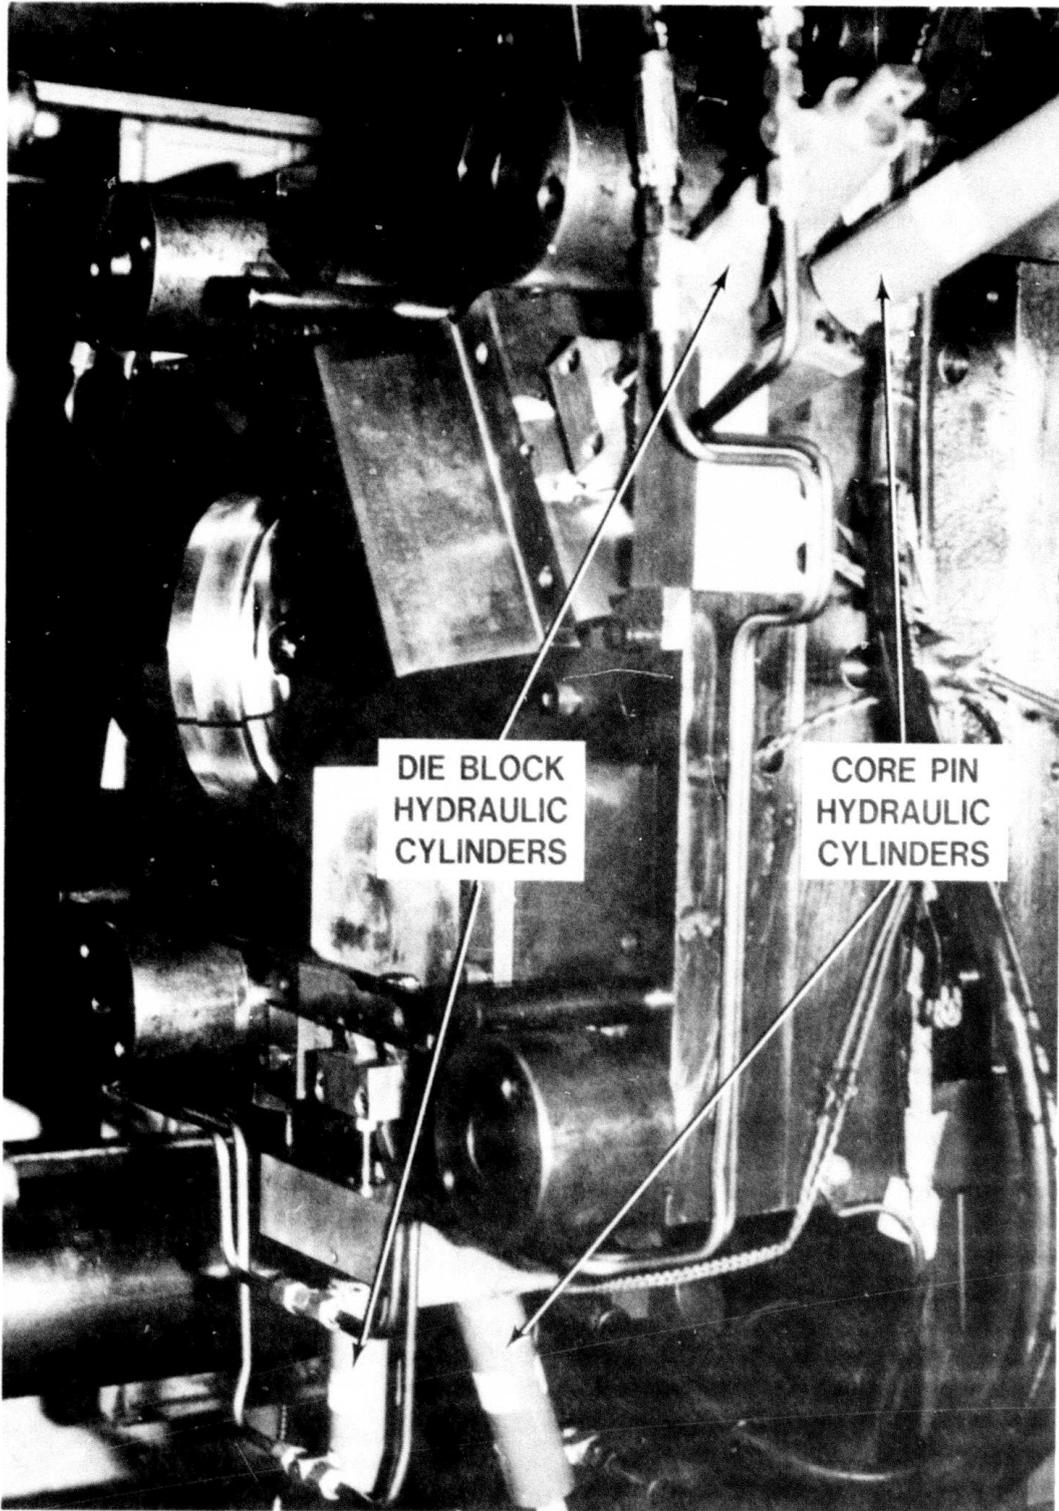
Figure 3.21 — Modified Nose Cone Tooling

As previously reported⁽¹¹⁾ nose cones fabricated prior to this reporting period exhibited small cracks in the center body to strut fillet and outer body to strut fillet. The cause of the cracks was traced to the movement of the outer die blocks prior to complete withdrawal of the center core pins. A rework of the die was made to eliminate this problem. The die was reworked to allow center core pin withdrawal with the die fully clamped. The outer die blocks now open only after core pin withdrawal. Hydraulic cylinders were used to clamp and move the core pins and die blocks. Cylinder configuration is shown in Figure 3.21. An initial molding run was conducted to check out tool operation. During this run it was determined that center core pins were being pushed out of the die due to material pressure. Larger hydraulic cylinders were installed to eliminate the problem. After the die was operating properly 10 nose cones were molded and visually inspected. None of the 10 showed any cracks in the strut attachment areas. These nose cones were further processed through burnout and argon sintering. To date no strut cracks are visible after processing. X-ray evaluation of the nose cones molded revealed no voids detectable in 80% of the parts. This is directly attributable to the improved clamping of the die. The tighter cavity allows higher injection pressure which tends to reduce trapped gas pockets which appear as voids. Further molding of nose cones was conducted and a large group was produced for further processing.

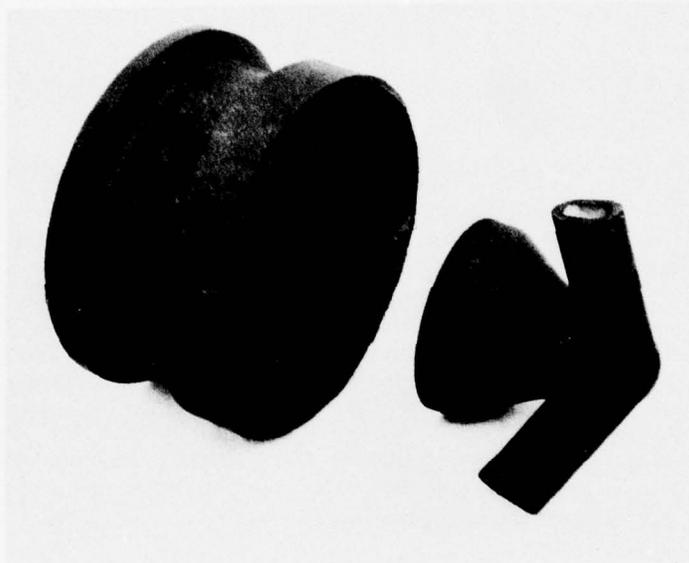
Figure 3.22 — Slip Cast Nose Cone

A slip cast nose cone feasibility investigation was conducted during this reporting period with the objective of manufacturing one nose cone for test rig evaluation. To expedite the study, an entire plaster mold system was chosen, which in turn required that the nose cone be cast in two pieces with a subsequent bonding assembly. One casting consisted of the struts and bell and the other casting consisted of the outer skirt as shown in figure 3.22. A standard blade fill silicon/silicon nitride slip was used to cast the individual units (See Blade Fill Processing section 3.1.1 this report). After casting, each piece was thoroughly dried and then argon sintered to a suitable machinability hardness. The machining required was minimal due to the dimensional accuracy of the castings; however, to facilitate the assembly process, oversized strut access holes had to be milled in the outer skirt. Once assembled the struts were bonded to the skirt using low green shrink bonding slips and using previously reported bonding procedures¹³. Another argon sinter was conducted on the bonded nose cone, after which each bond joint was optically inspected for green shrink cracks. None were observed and therefore the assembly was nitrided and final diamond ground. NDE procedures on the final product showed the part to be free of "obvious" flaws. The nose cone was then released for test rig evaluation. Details are covered in Section 3.2.2.

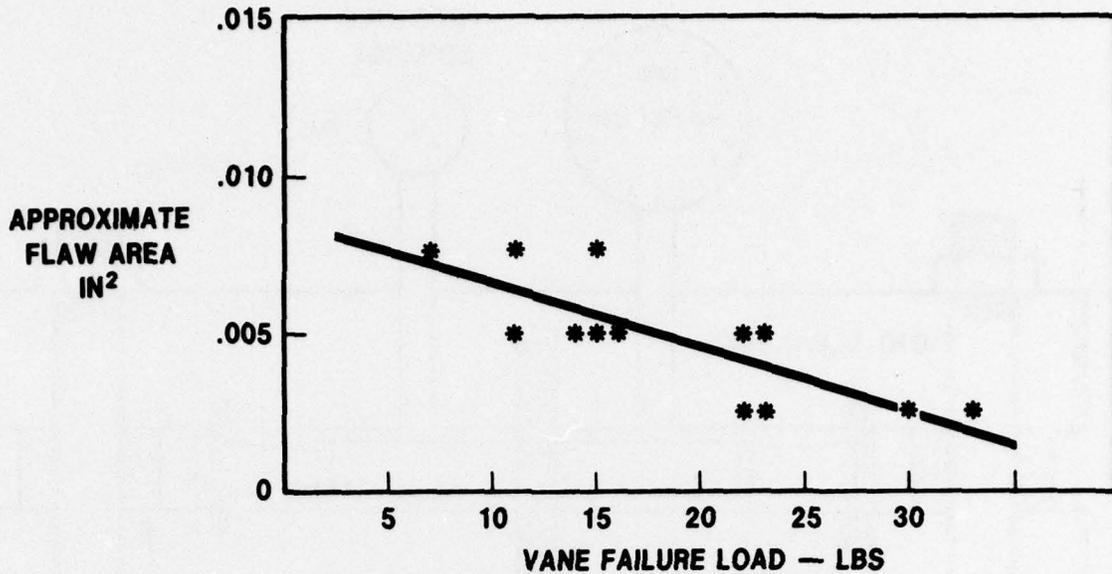
Figure 3.24 — Flaw Size Versus Failure Load

In reviewing the vane load capability (Figures 3.24 and 3.25) it was noted that a majority of the vanes (66 out of 77) successfully withstood an applied load of greater than 19 pounds. Of the 11 which did not, 7 contained the previously noted central interior flaw.

These observations indicated that an increase in the qualification load to 19 pounds could enhance the screening out of poor quality vanes without jeopardizing quality components. To verify this, 5 stator assemblies were subjected to a 19 pound/vane qualification load and subsequently 10-light tested. Vanes in two of these stator assemblies failed during the 10-light test. This result was therefore still not satisfactory and an effort continues in this area.

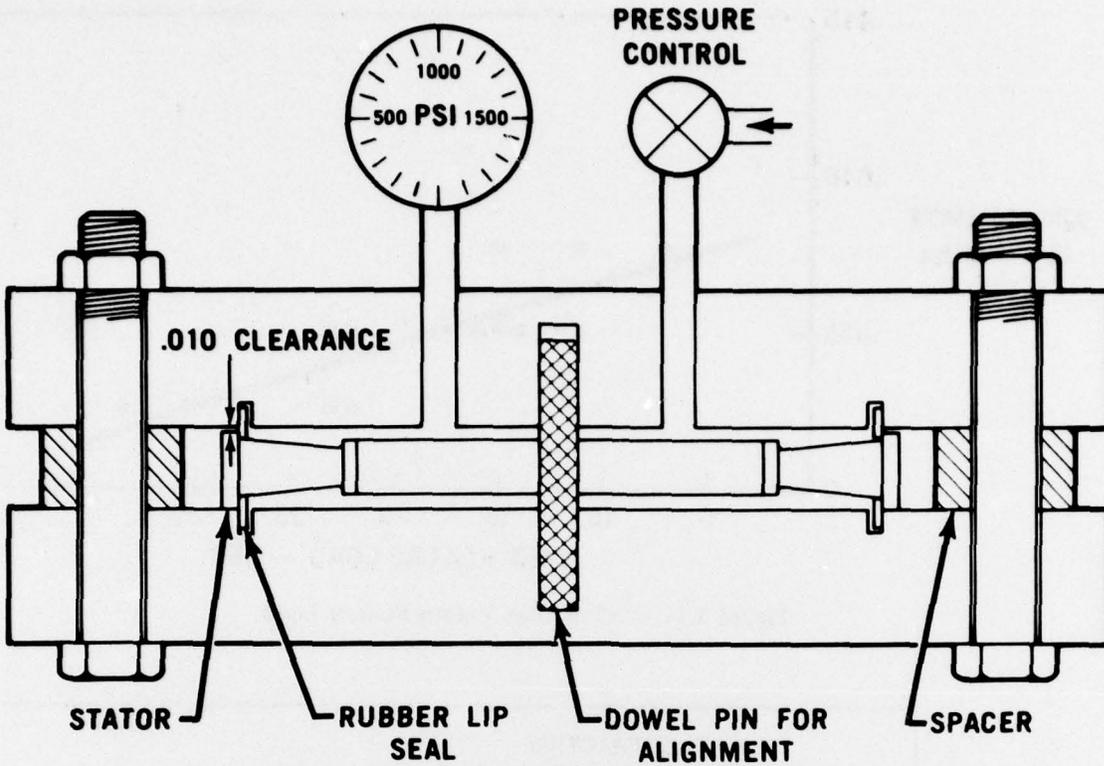
Figure 3.26 — Stator Outer Shroud Pressure Test Fixture

The second of these tests subjects the stator outer shroud to an internal pressure using the fixture shown in Figure 3.26. A tensile stress is produced in the shroud to screen the outer shroud for unacceptable defects. During this reporting period, an effort was made to establish the internal pressure which accomplishes the screening purpose.

Table 3.11 summarizes the data from 2.7g/cc stator assemblies subjected to the shroud pressure test. Details of the test rig and establishment of the initial pressure were covered in the last report⁽¹¹⁾. The results show that the original pressure of 100 psi did not adequately screen out defective parts since three qualified components (1086, 1104, and 1134) subsequently failed through gross fabrication flaws in the shroud during the 10-light test. Therefore, the pressure load specification was reviewed.

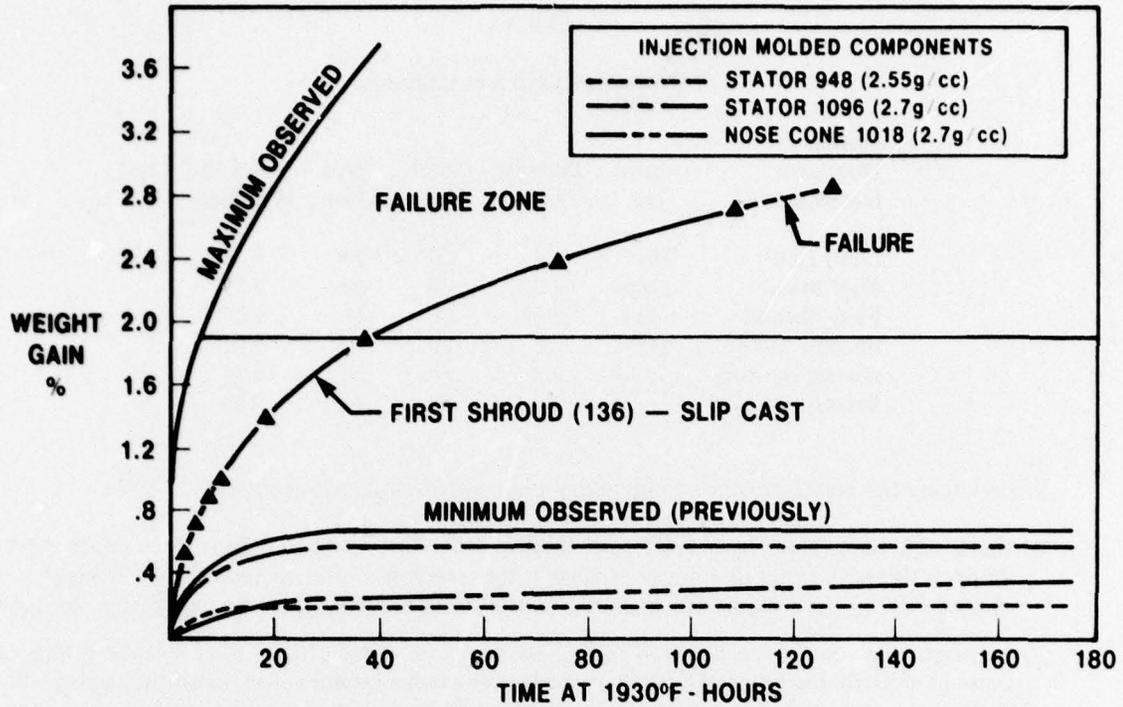
Figure 3.28 — Percent Weight Gain versus Time Data for 175 Hour, 1930°F Components

The last report(11) presented an accumulation of weight gain versus time data for 2.55g/cc density injection molded silicon nitride stators. The 175 hour test provided additional 2.55g/cc weight gain data and initial 2.7g/cc weight gain data. In the case of the 2.7g/cc material, data was acquired for the nose cone as well as the stator. In addition, weight gain data for the slip cast silicon nitride first stage shroud was obtained. These data are presented in Figure 3.28. As a reference, the "maximum observed", "minimum observed", and "failure zone" notations established by the prior 2.55g/cc data have been retained. Note that all three injection molded components from the 175 hour test exhibited weight gains below the previous minimum observed line.

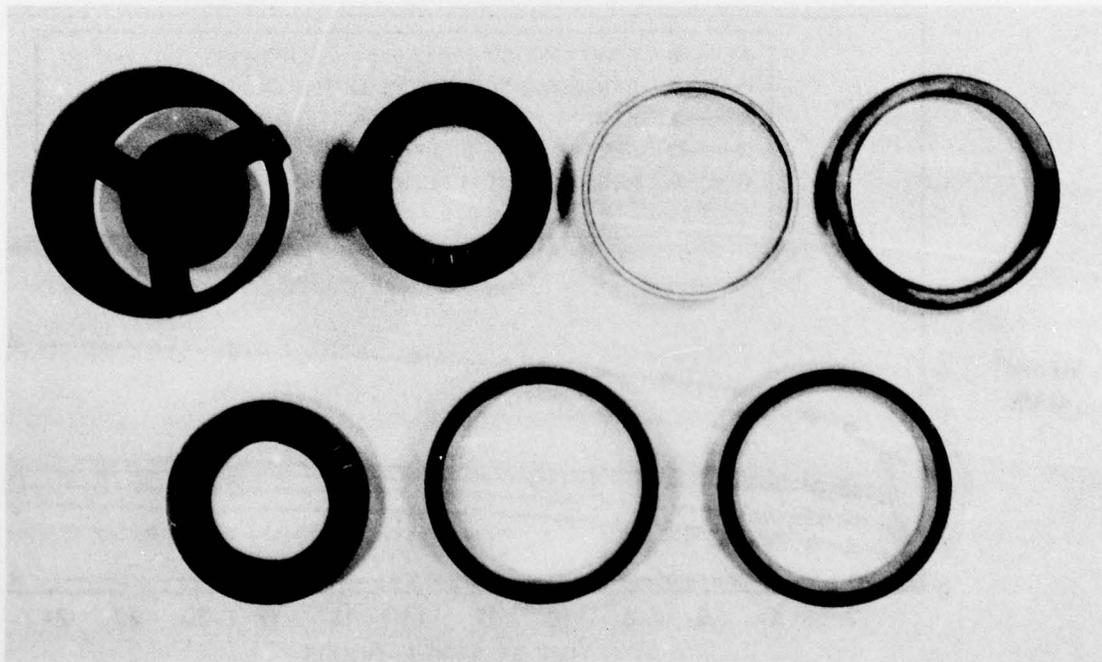
Figure 3.29 — Flowpath Components after 25 Hours at 2500°F

Another set of ceramic stationary flow path components completed 25 hours at 2500°F average turbine inlet temperature (See Figure 3.29). Data on the specific components are contained in Table 3.14.

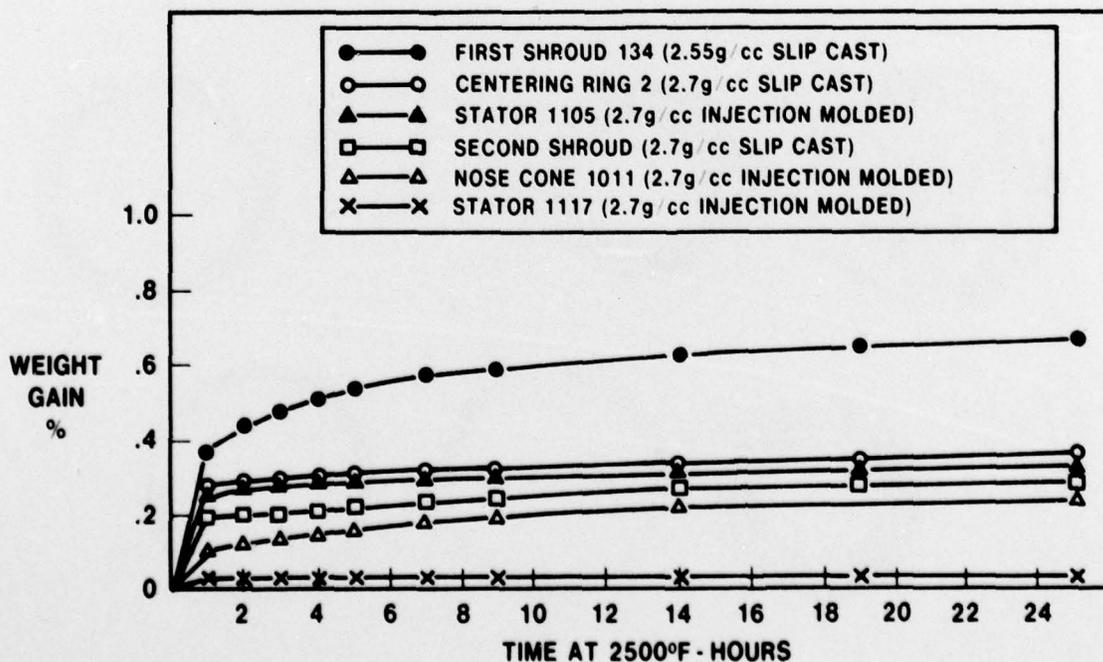
Figure 3.30 — Percent Weight Gain versus Time Data for 25 Hour, 2500°F Components

As was the case with the 175 hour, 1930°F durability components, weight gain versus time at temperature data was accumulated. Figure 3.30 documents this data for the flow path components tested for 25 hours at 2500°F. This is the initial data obtained on engine components at this temperature for extended times. The only observation to be made at this point is that weight gain rates and total percent weight gains after 25 hours are comparable to the data obtained on successful 1930°F durability tested components.
