USARTL-TR-78-22

CH-47 CRASH TEST (T-40) STRUCTURAL, CARGO RESTRAINT,
AND AIRCREW INFLATABLE RESTRAINT EXPERIMENTS

April 1978

Prepared for
APPLIED TECHNOLOGY LABORATORY
U. S. ARMY RESEARCH AND TECHNOLOGY LABORATORIES (AVRADCOM)
Fort Eustis, Va. 23604

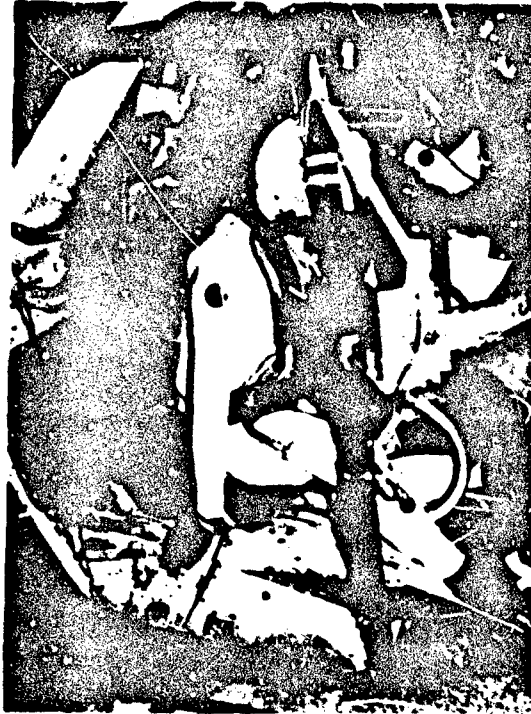
Figure 43. Post-test cockpit showing crash damage and dummy position.

A review of the motion pictures revealed that the inflatable restraint system functioned properly during the crash. Although the seats were considerably deformed by the crash forces, the inflatable restraint was able to constrain the dummy in the pilot seat (Figures 42 and 43). Unfortunately, the inertia reel on the copilot's seat failed, releasing the shoulder straps and allowing the dummy to pitch forward in the seat. This unforeseen failure eliminated all chance for a meaningful comparison of the data collected from transducers on both dummies.
