Fifth Quarterly Report

IC FABRICATION USING ELECTRON-BEAM TECHNOLOGY

Contract No. DAAB07-76-C-8105

Texas Instruments Incorporated
P.O. Box 5012
Dallas, Texas 75222

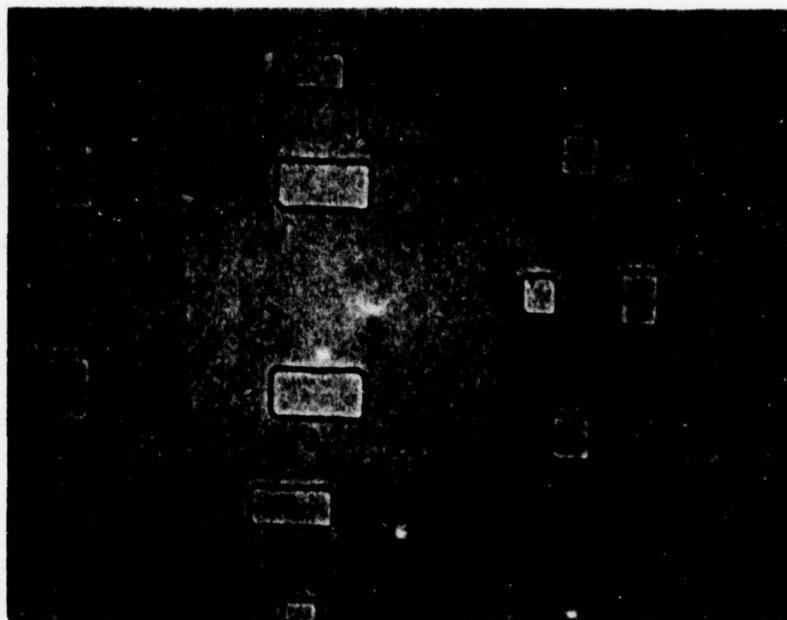
Figure 1. PBS Adhesion: No Pretreatment

Included are some photographs taken from blank oxidized slices that were patterned with PBS. Figure 1 was taken from a slice that had no treatment prior to applying PBS. Figure 2 shows a slice which had the steam treatment prior to applying PBS. Figure 3 was taken from a slice which had the PTCS treatment prior to applying PBS. These pictures are representative of the results achieved using these processes.

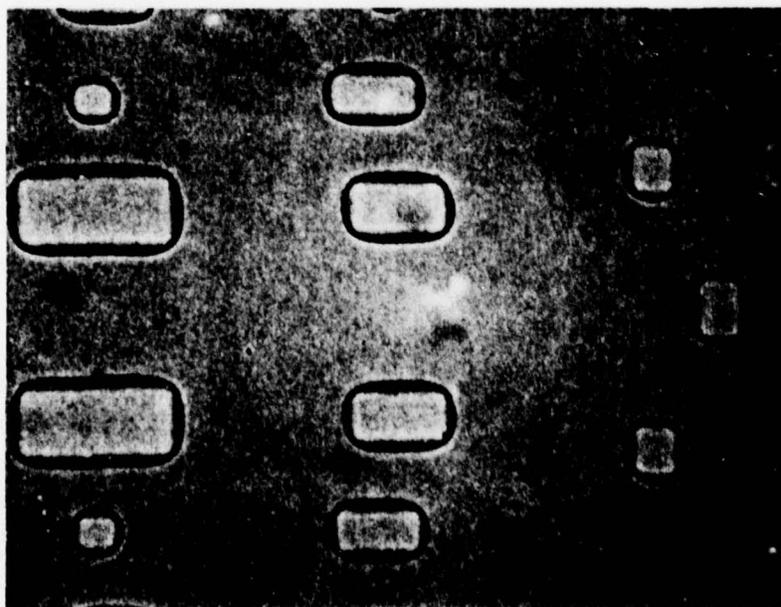
Figure 2. PBS Adhesion: Steam Pretreatment

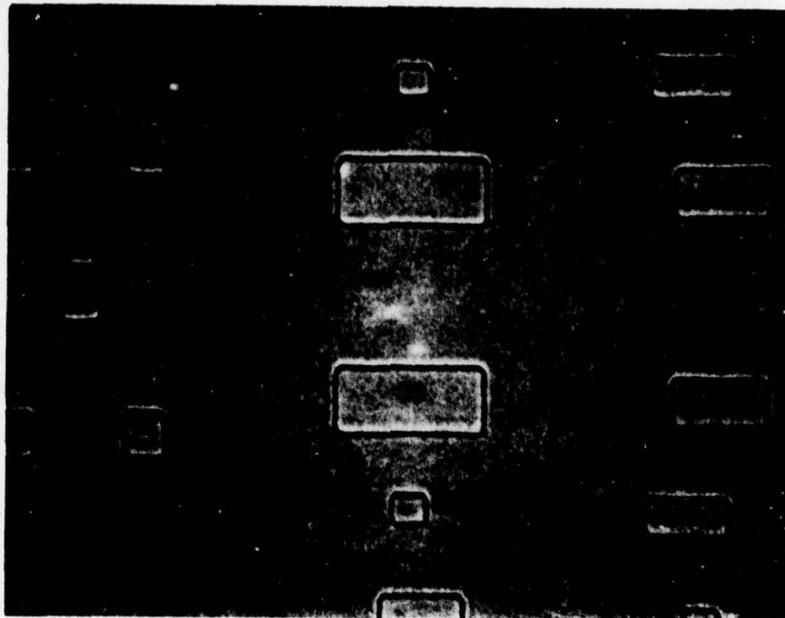
Figure 3. PBS Adhesion: Phenyl Trichlorosilane Pretreatment

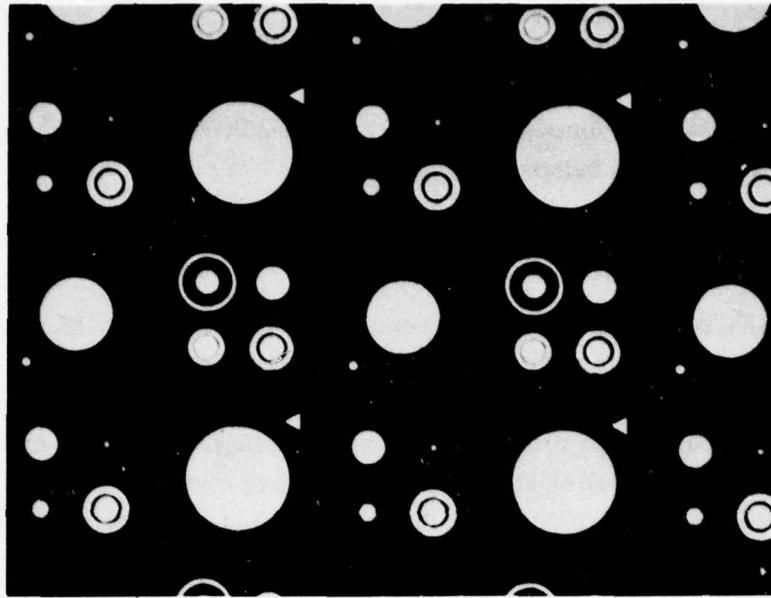
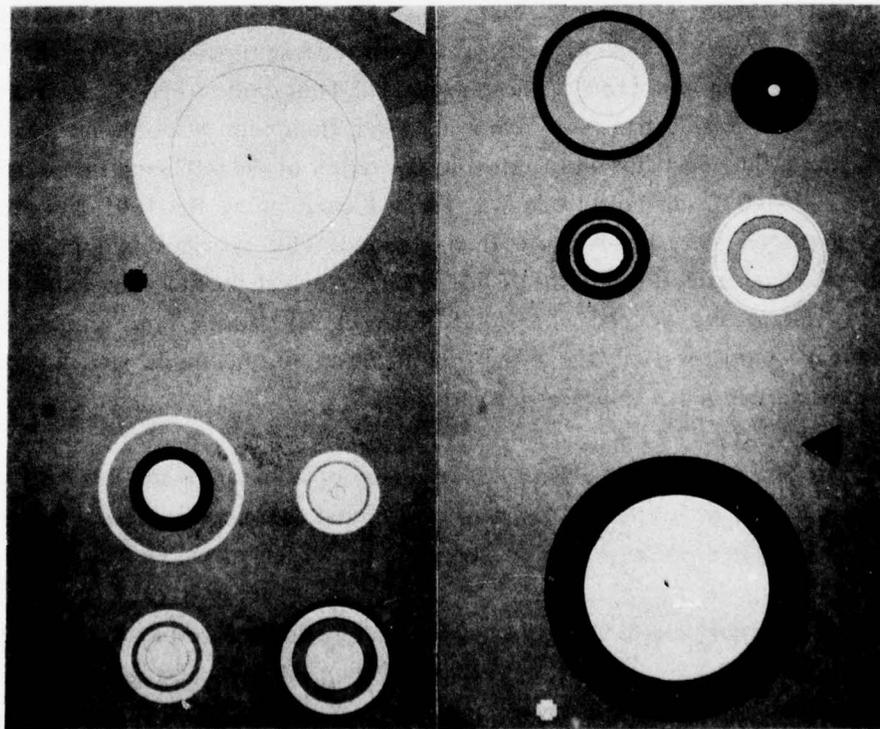
Figure 4. Array of Nested and Overlap MOS Capacitor Test Structures

A better procedure which evolved during the test program permitted exact simulation of the oxide steps occurring on the circuit arrays and direct comparison of flat surface and oxide step defects on the same slice. Such structures are shown in Figure 4, a photomicrograph of a test structure array containing a variety of circular and annular MOS capacitors. The small triangles are markers for alignment of the photomask levels. Considering only the two largest circular units in the array, circular areas of 0.01 and 0.02 cm² were protected by silicon nitride dots. Normal field oxides of one-micrometer thickness were grown surrounding these dots, after which the nitride was selectively etched away with 180°C phosphoric acid. Thin oxides (850 Å) were then grown in the regions where the nitride had been removed. After aluminum evaporation, a contact mask was aligned so that a 0.01 cm² dot was formed in the center of the 0.02 cm² thin oxide region (nested capacitor), and a 0.02 cm² electrode was formed overlapping the 0.01 cm² thin oxide region (overlap capacitor). The wafers were then sintered. This provides two interlocking arrays of capacitors of equal effective area (0.01 cm²), one of which includes an oxide step at its outer perimeter (overlap) and one of which does not (nested). Having both arrays on a single wafer permits direct comparison of the effect of inclusion of the oxide step without concern for wafer-to-wafer variation due to processing variability.

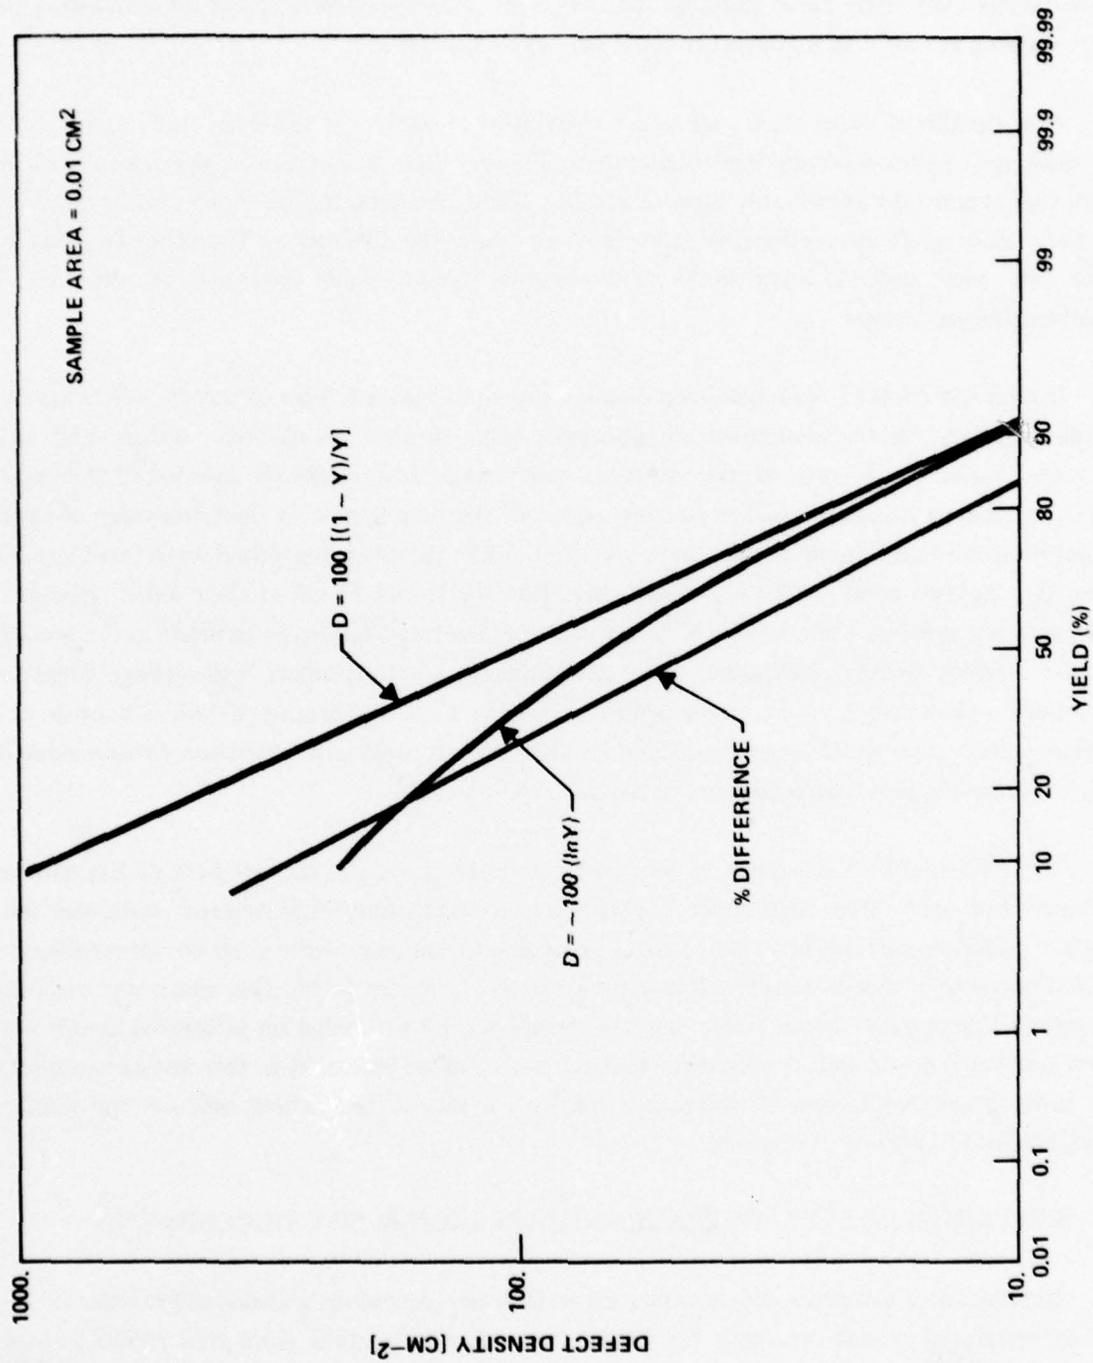
Figure 5. Comparison of the Yield-Defect Density Relationship for Two Statistical Models

is a more valid representation of the relationship between yield, sample area, and defect density. For values of $A \times D$ much less than unity, equations (1) and (2) are very nearly equal, and the percent difference is only 44% when $A \times D = 1$. Figure 5 is a plot of the two relationships for the case of $A = 0.01 \text{ cm}^2$, the most commonly used value in these experiments.

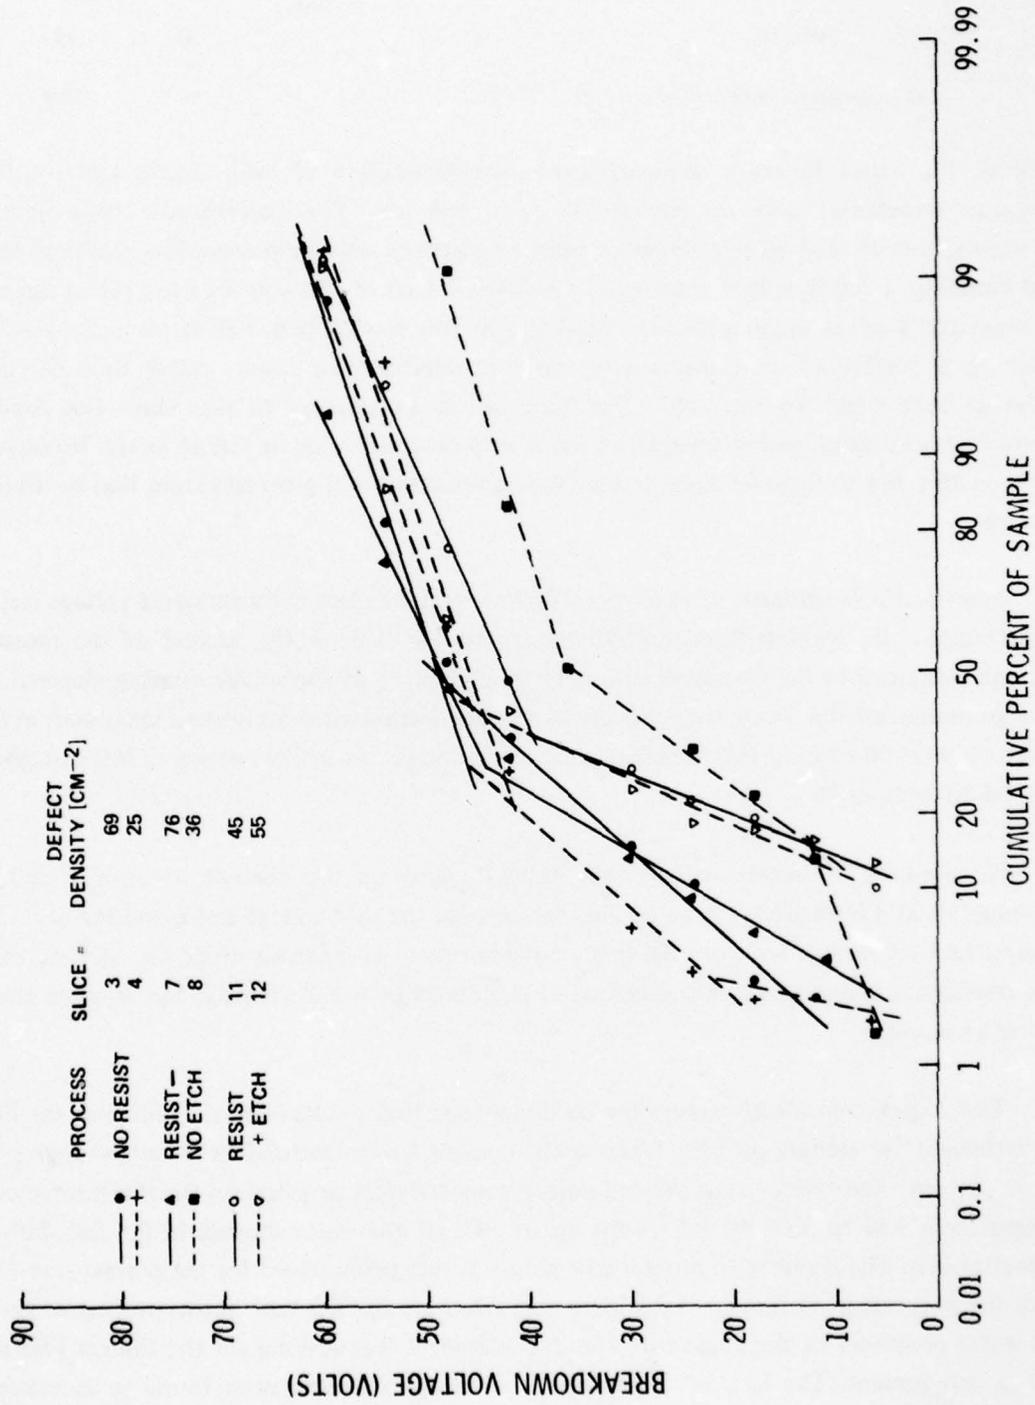
Figure 6. Experiment G: Thin Oxide Integrity Associated with E-Beam Resist Pinholing

The relatively high incidence of shorted units observed on the etched slices of Experiment G supports the contention that under normal process conditions, PBS electron resist can fail to protect underlying oxides in oxide removal processes. Conversion of the short circuit results on the etched slices to a defect density gives approximately 12 defects/cm². This value, and even those shown on Figure 6, are much lower than the defect density estimated on integrated circuit wafers from test bar data. In order to confirm that the resist failure observed in this test can account for the gross integrated circuit functionality problem, a second test which includes the effects of nonplanar oxide surfaces is required.

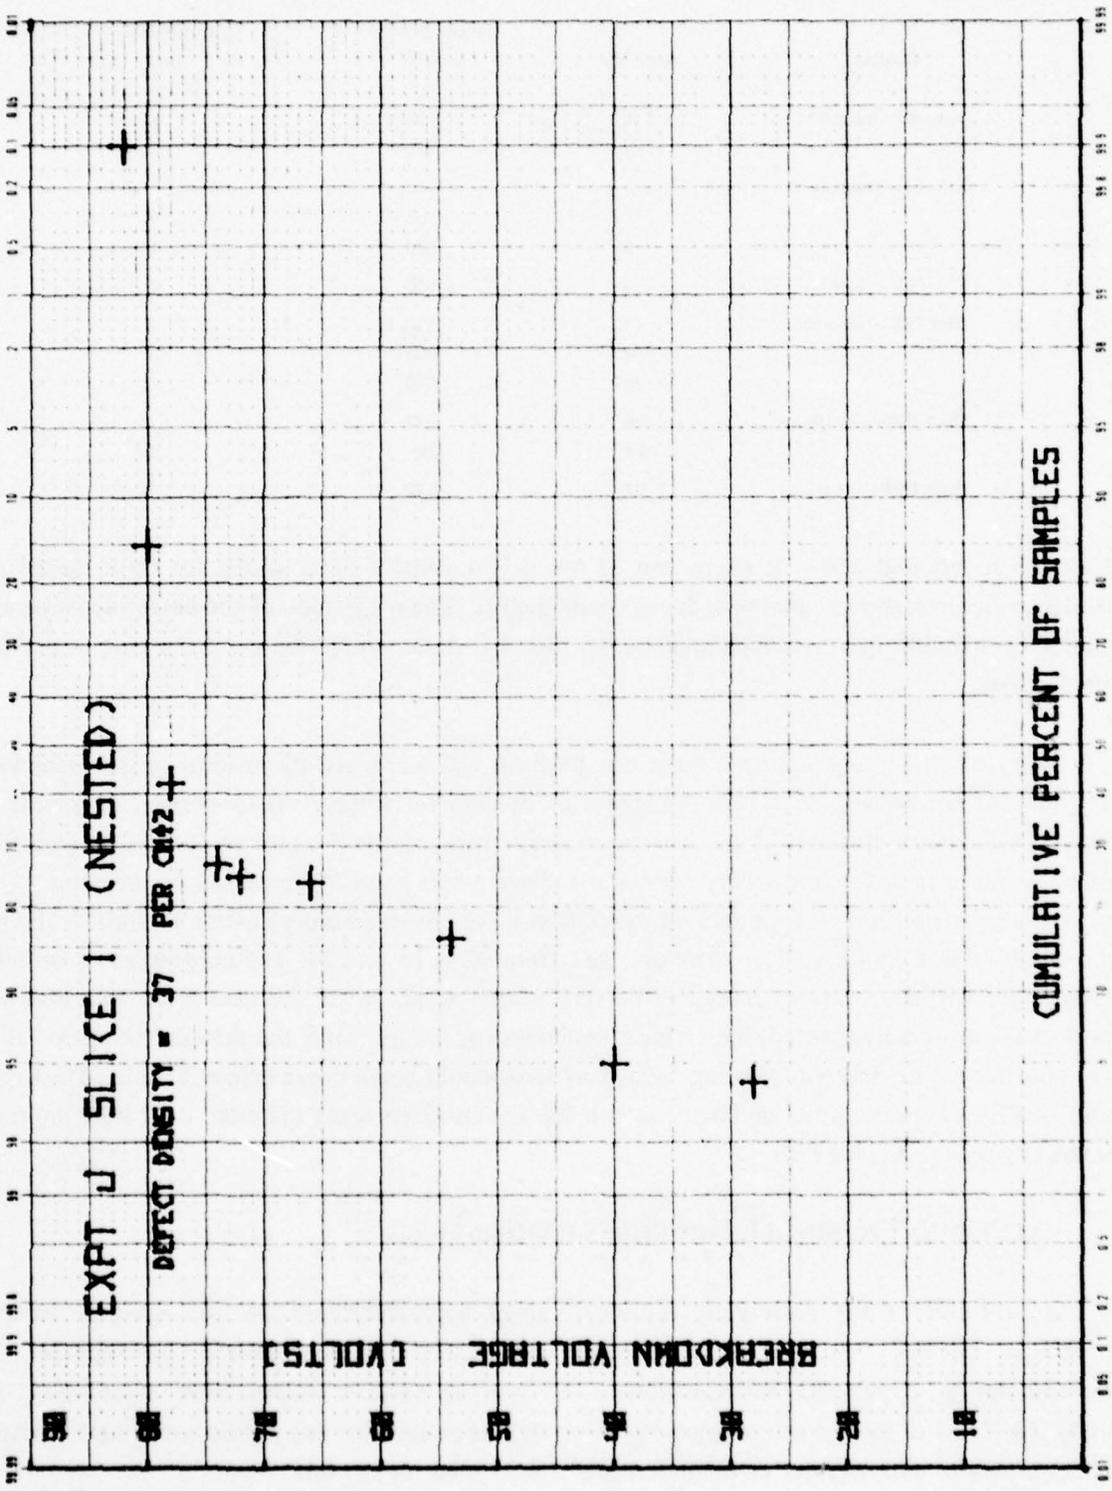
Figure 7. Experiment J: BV Distribution for Nested Control Samples

Many of these degradation effects can be most clearly judged by examining the breakdown distributions themselves, so probability plots of breakdown voltage versus percent of sample are shown in Figures 7 through 12 for one wafer from each of the six groups. As can be seen from Table II, wafer-to-wafer uniformity within a subgroup was good. An example of the value of the breakdown distribution plots in data interpretation is seen by overlaying Figures 11 and 12, the thin and thick PBS-overlap capacitor structure data from slices 13 and 24. The percentage of defective units in the two distributions is seen to be very nearly equal, but in the case of the thin PBS film, most of the units were shorted, indicating complete resist failure, while the thicker PBS resist failure was only partial or delayed, yielding capacitors that would break down below 20 volts. The overall poor quality of these results dictates a search for an improved resist material, or at least improved processing techniques for PBS.

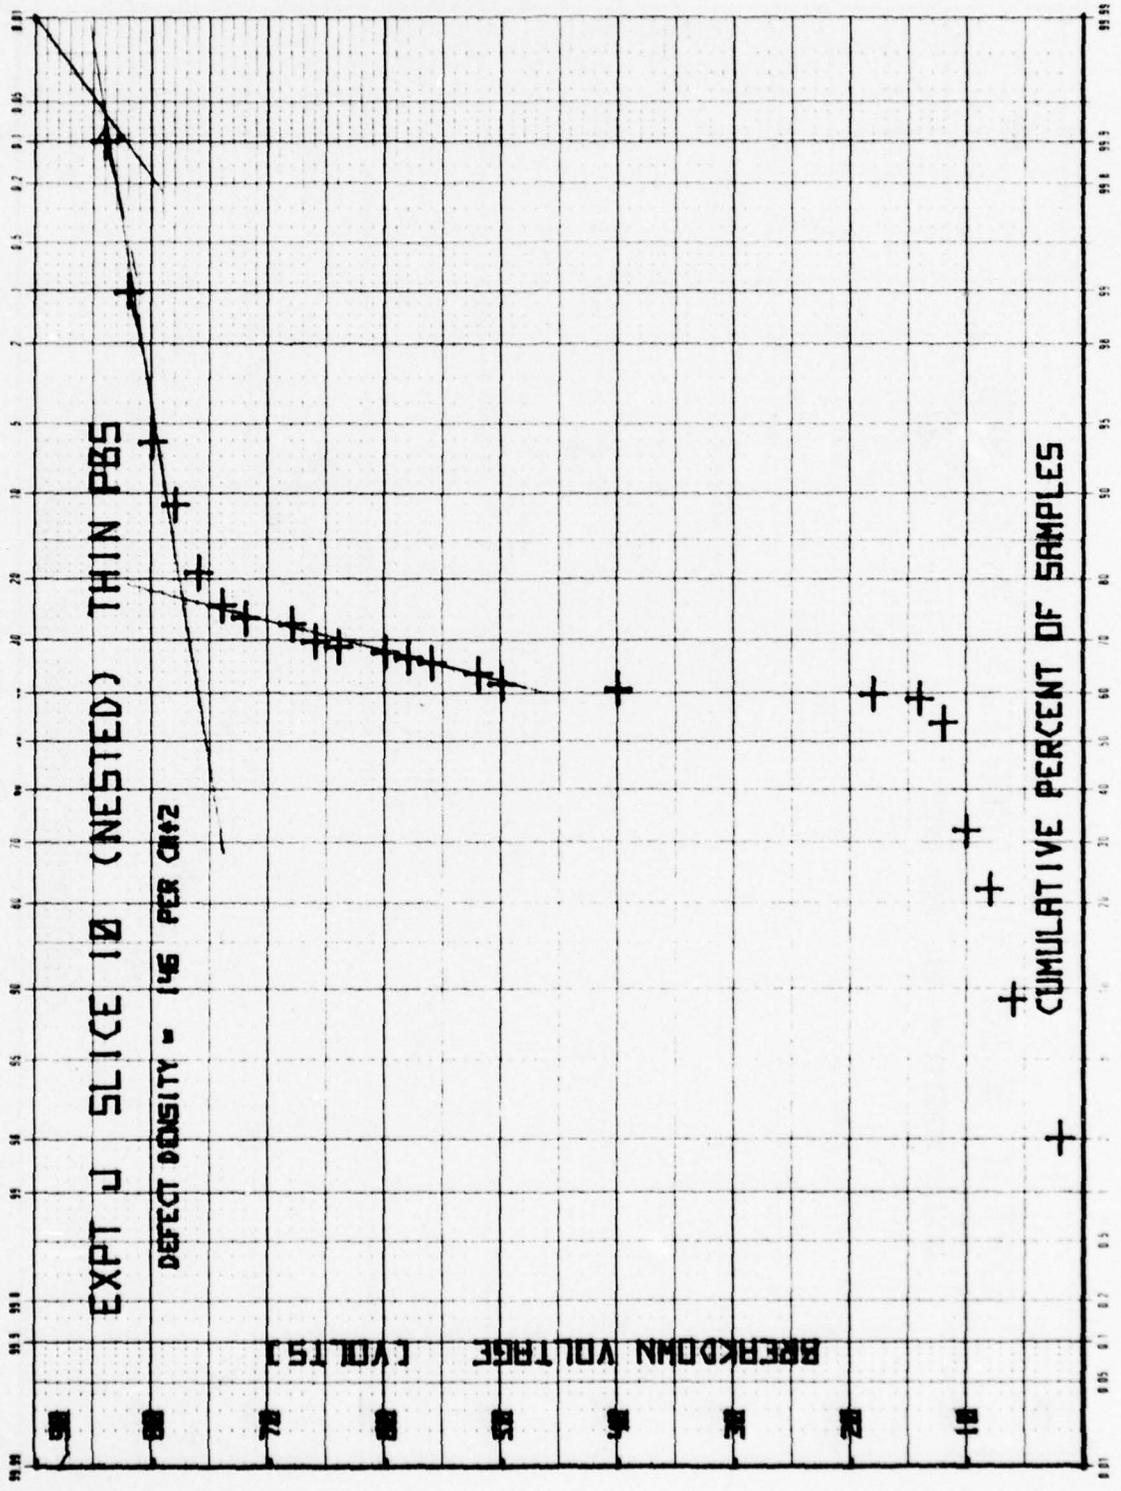
Figure 8. Experiment J: BV Distribution for Nested Samples Protected with Thin PBS

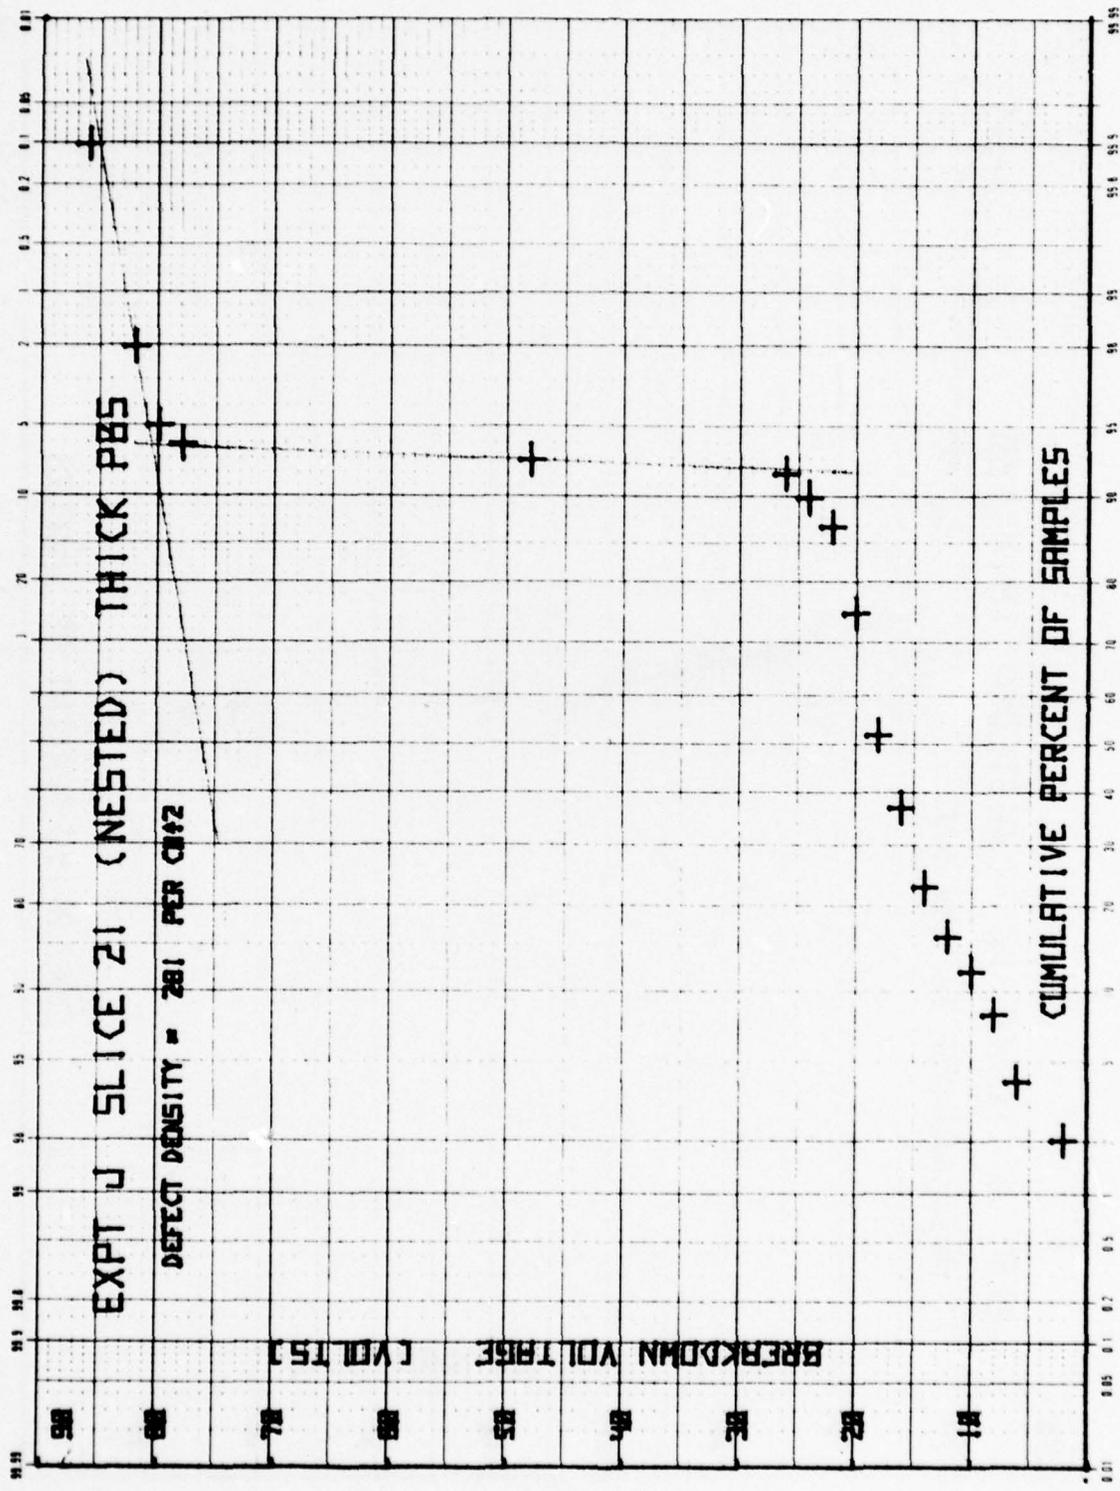
Figure 9. Experiment J: BV Distribution for Nested Samples Protected with Thick PBS

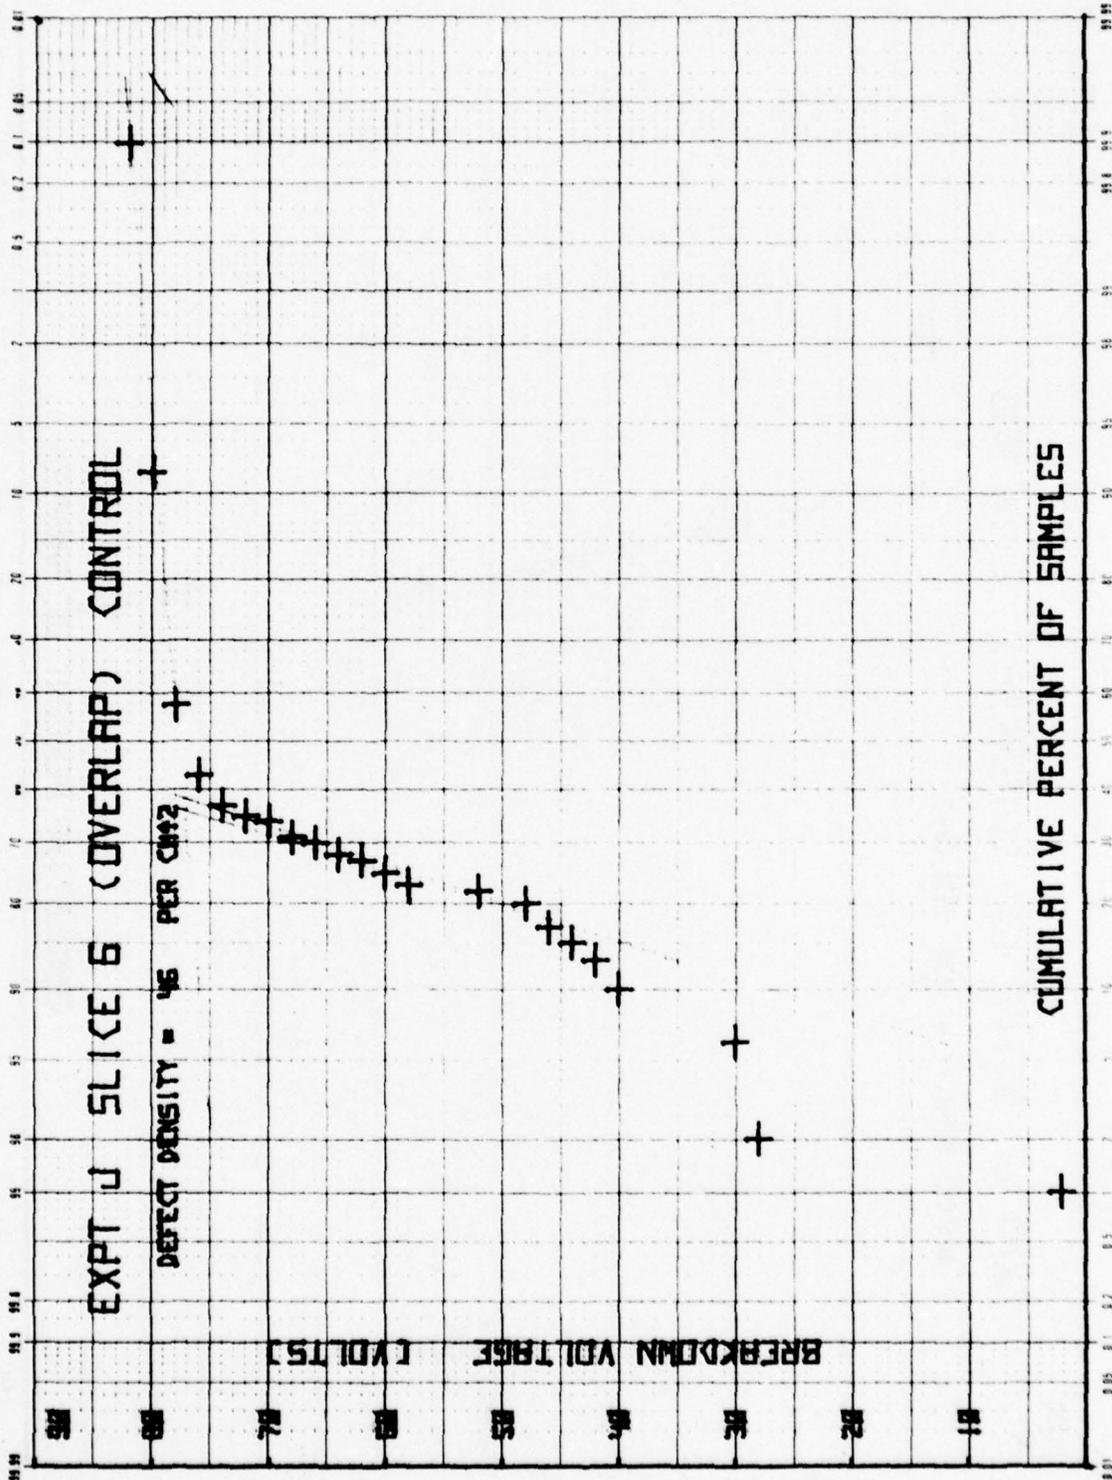
Figure 10. Experiment J: BV Distribution for Overlap Structures (Control)

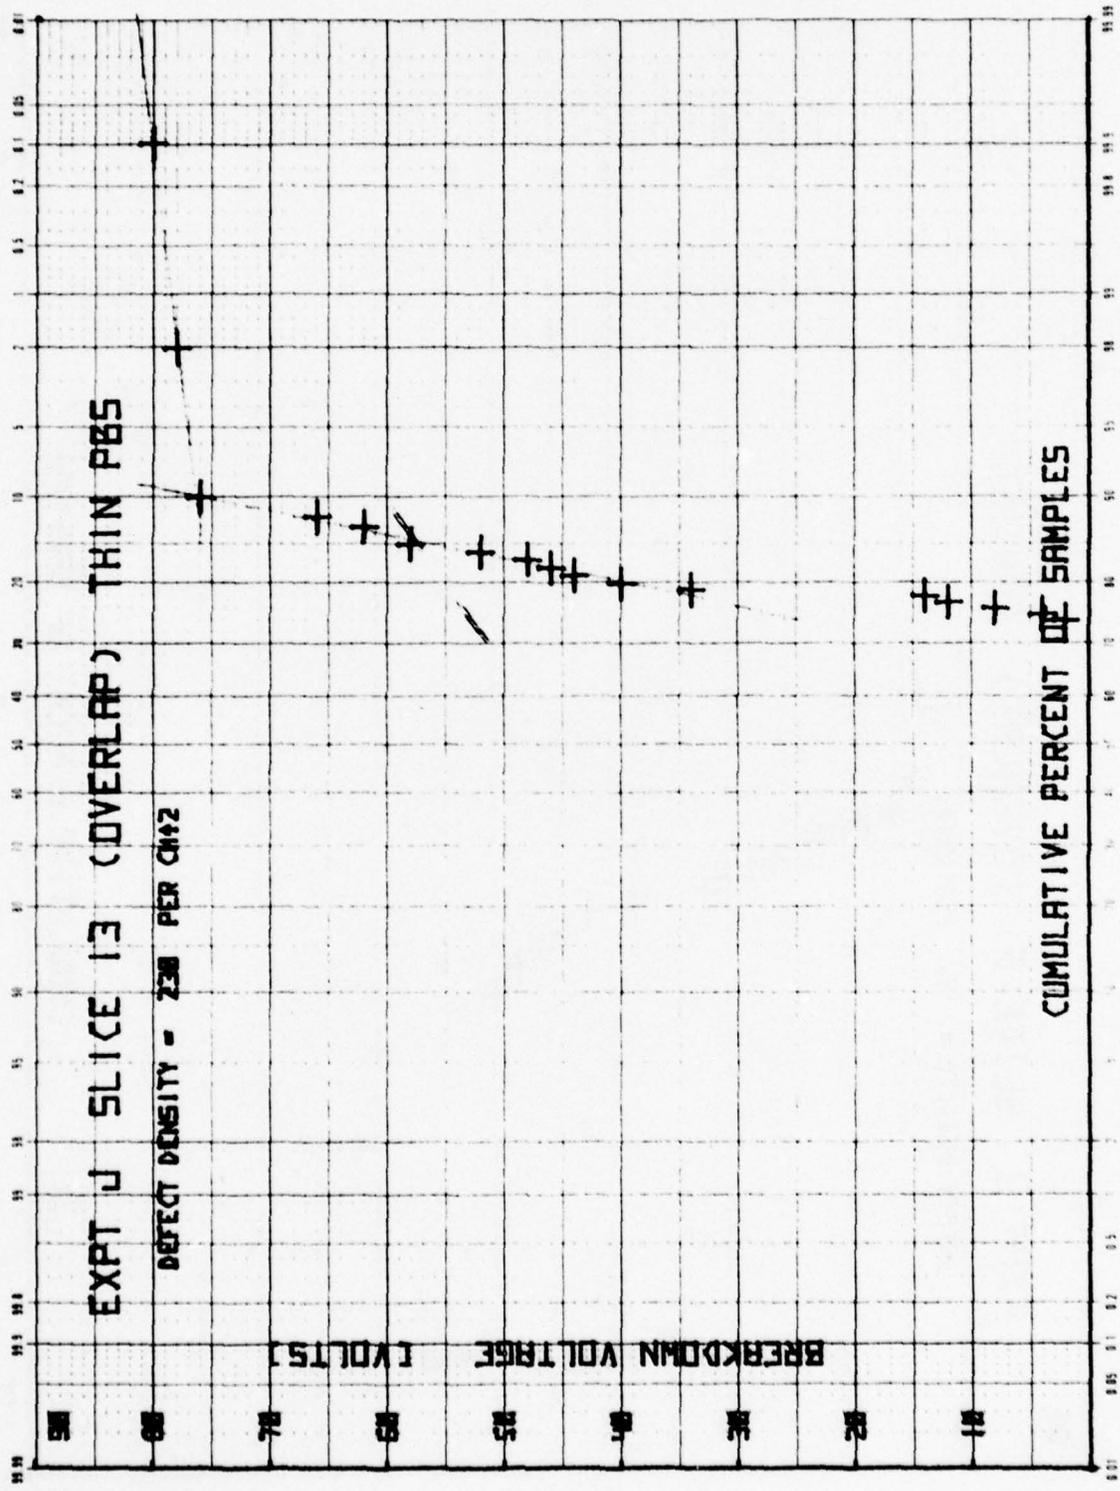
Figure 11. Experiment J: BV Distribution for Overlap Structures Protected with Thin PBS

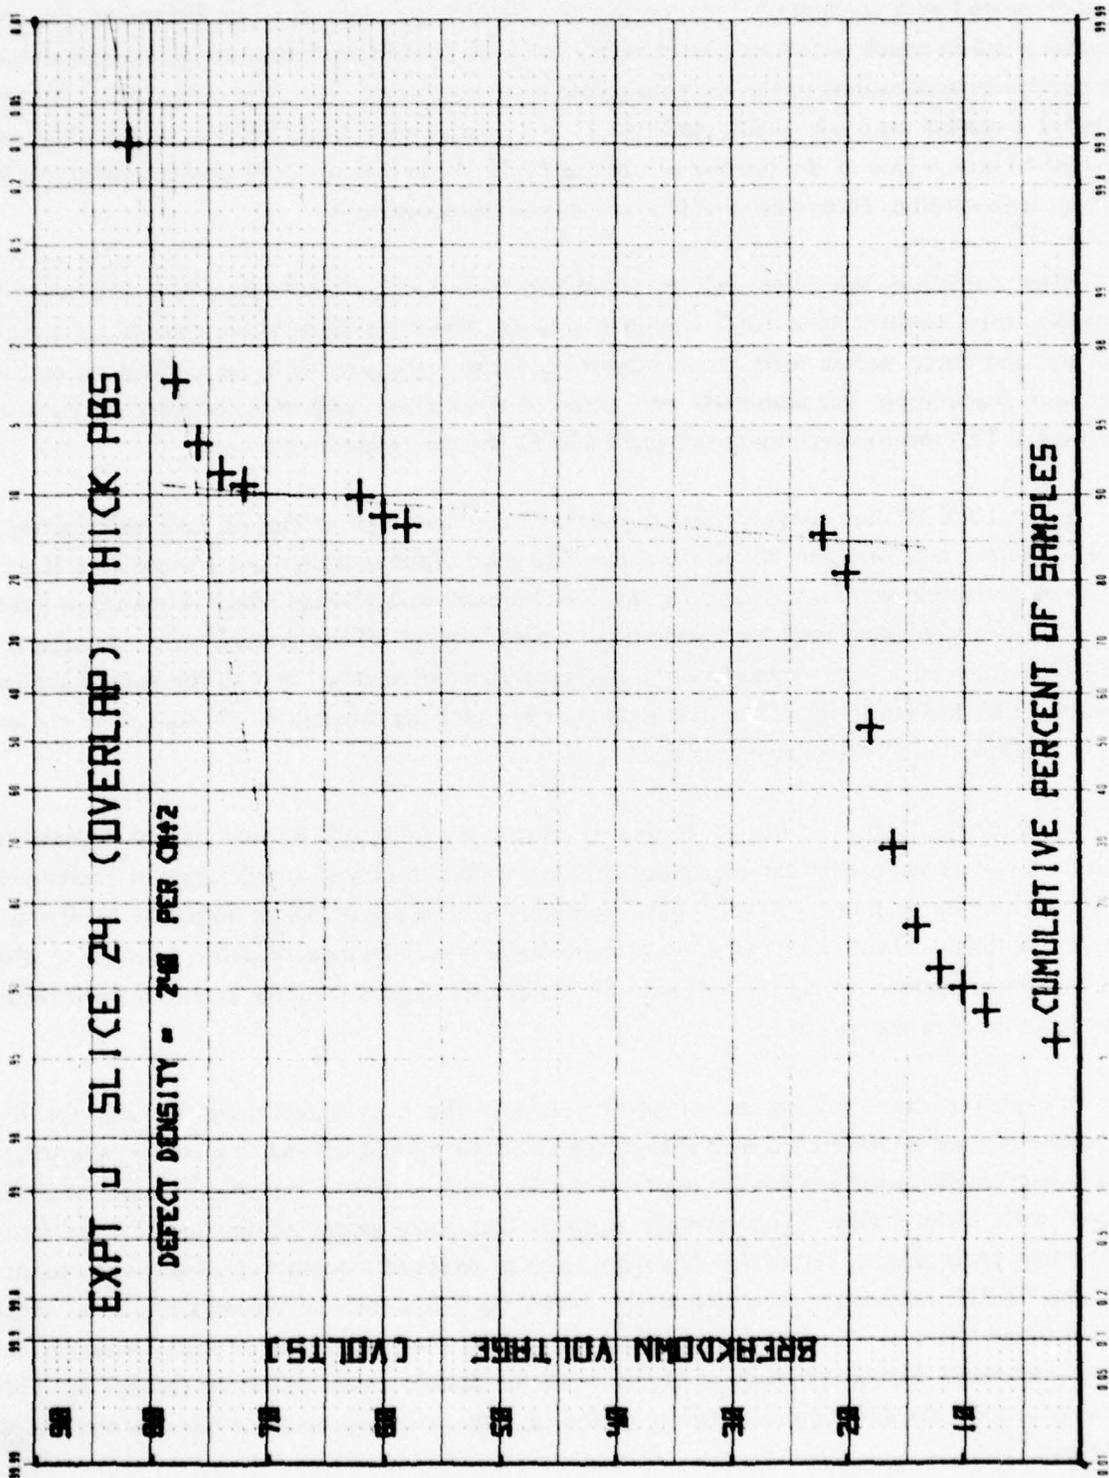
Figure 12. Experiment J: BV Distribution for Overlap Structures Protected with Thick PBS

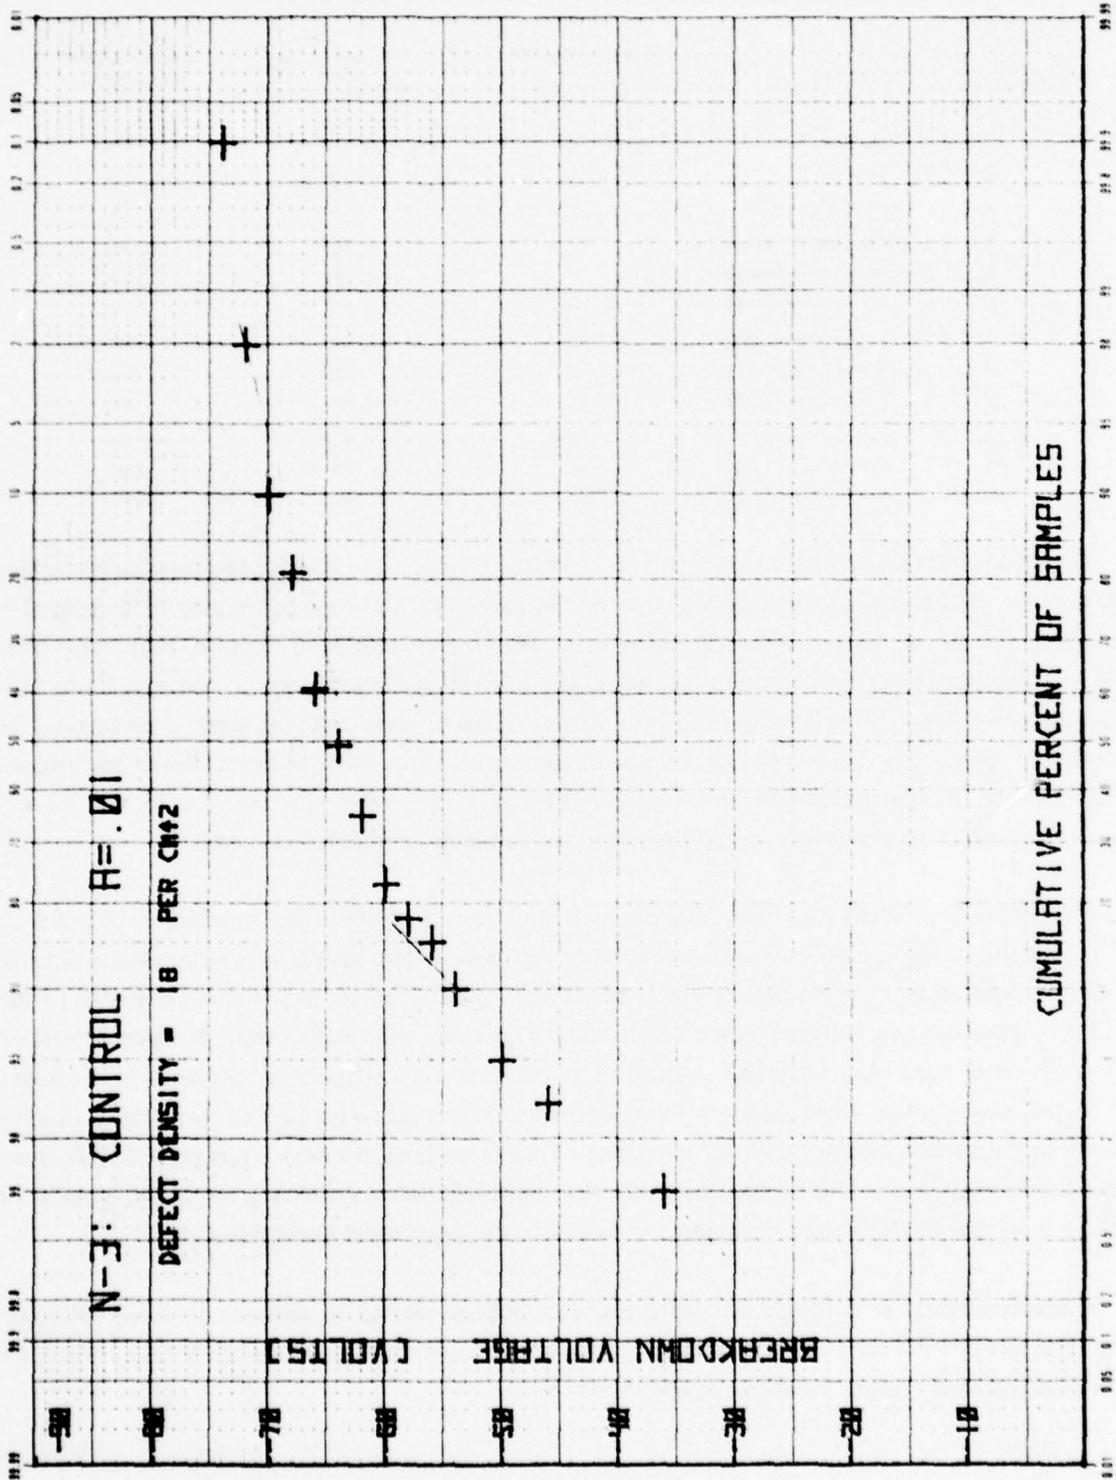
Figure 13. Experiment N: Median BV Distribution for Control Group

To obtain the fairest possible comparison of these processes, the probability plot for the wafer with median defect characteristics from each of the four cells is shown in Figures 13 through 16. Overlaying the three latter figures showing data on etched wafers, it is seen that very little difference exists in the shape of the plots. All have a low-voltage distribution including 25% to 40% of the sample below -20 volts, followed by a gradually rising curve to the primary distribution. At the 40-volt level, only 12 percentage points separate the three distributions. While the overall quality is low, it appears the behavior of the TI-313 is not markedly inferior to that of the photoresist, and as mentioned before, is likely related to handling-induced damage.

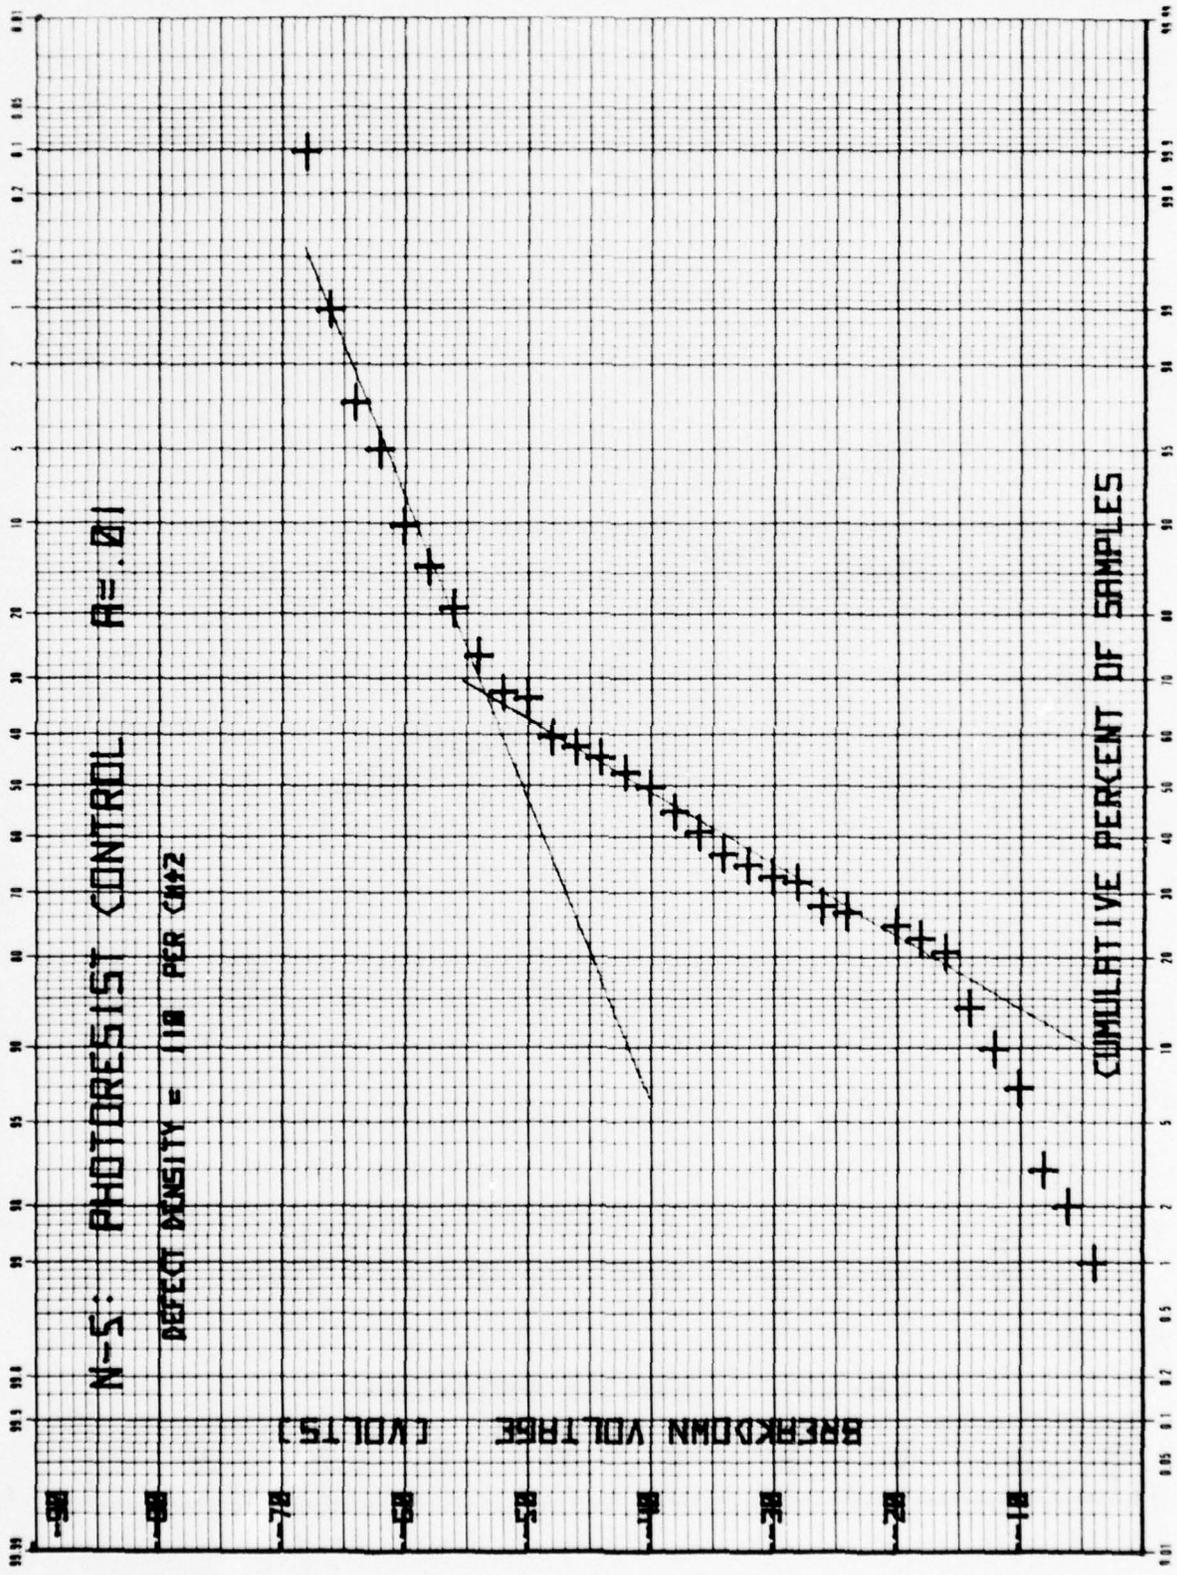
Figure 14. Experiment N: Median BV Distribution for Photoresist Control Group

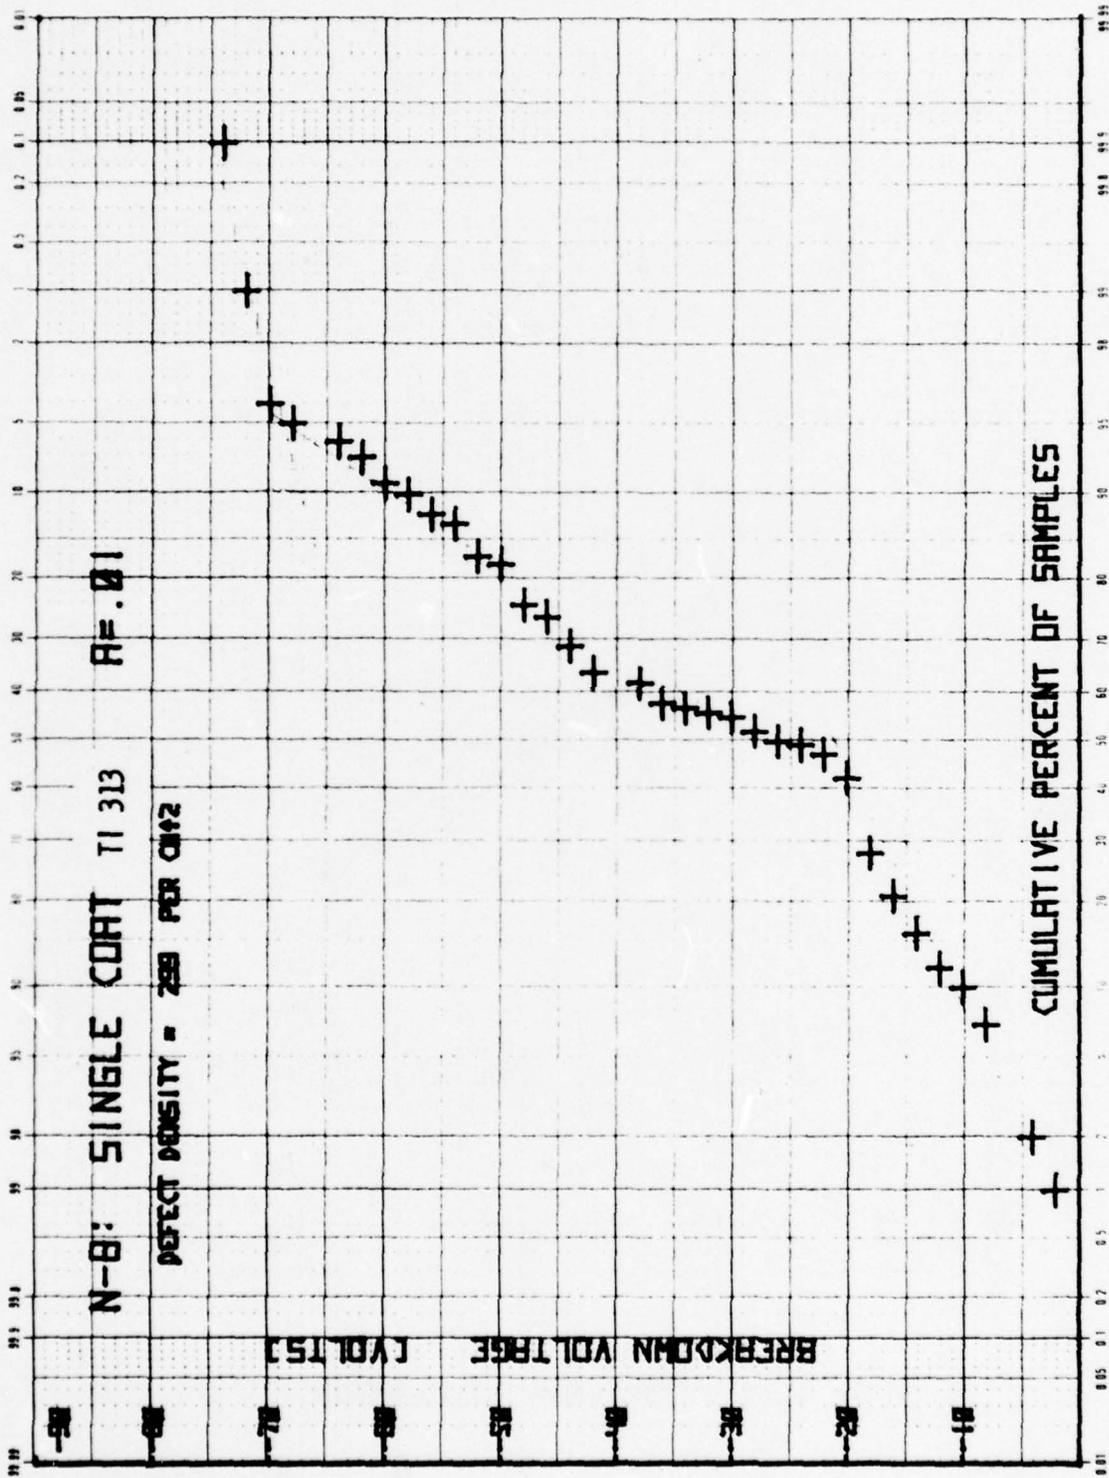
Figure 15. Experiment N: Median BV Distribution for Single Coat TI 313 Group
