Fifth Quarterly Report

IC FABRICATION USING ELECTRON-BEAM TECHNOLOGY

Contract No. DAAB07-76-C-8105

Texas Instruments Incorporated
P.O. Box 5012
Dallas, Texas 75222

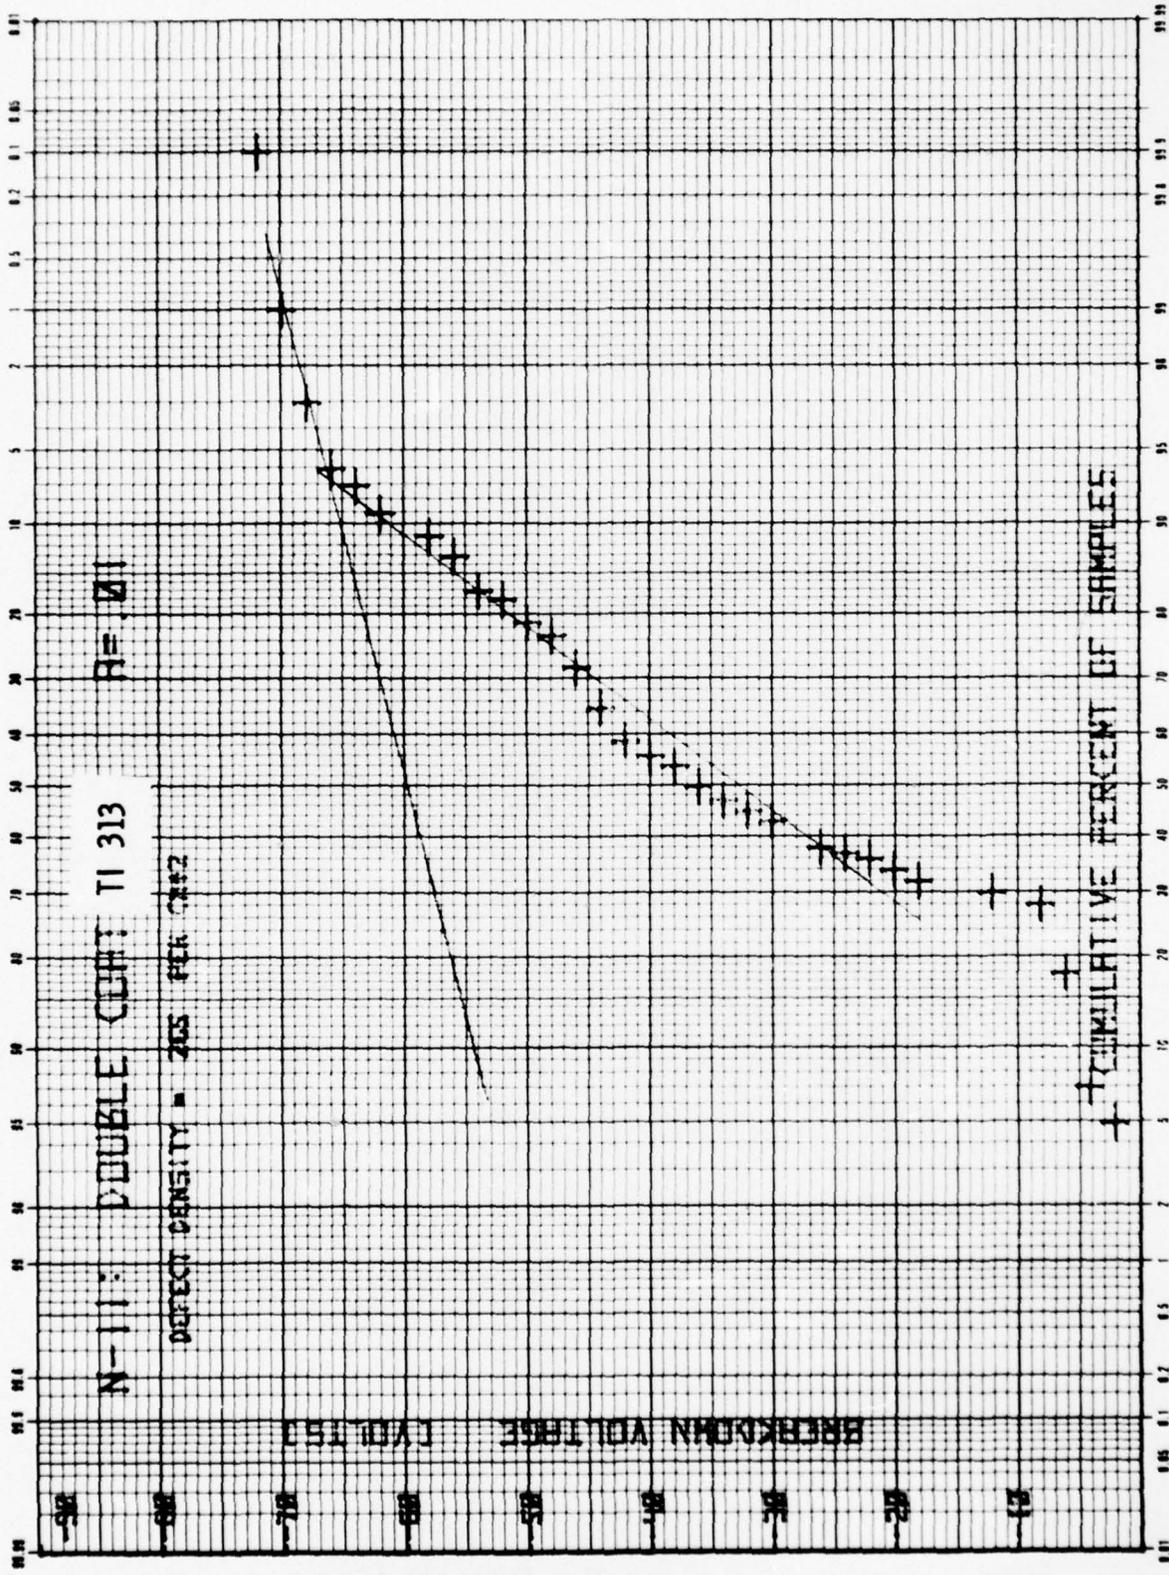
Figure 16. Experiment N: Median BV Distribution for Double Coat TI 313 Group

To obtain the fairest possible comparison of these processes, the probability plot for the wafer with median defect characteristics from each of the four cells is shown in Figures 13 through 16. Overlaying the three latter figures showing data on etched wafers, it is seen that very little difference exists in the shape of the plots. All have a low-voltage distribution including 25% to 40% of the sample below -20 volts, followed by a gradually rising curve to the primary distribution. At the 40-volt level, only 12 percentage points separate the three distributions. While the overall quality is low, it appears the behavior of the TI-313 is not markedly inferior to that of the photoresist, and as mentioned before, is likely related to handling-induced damage.

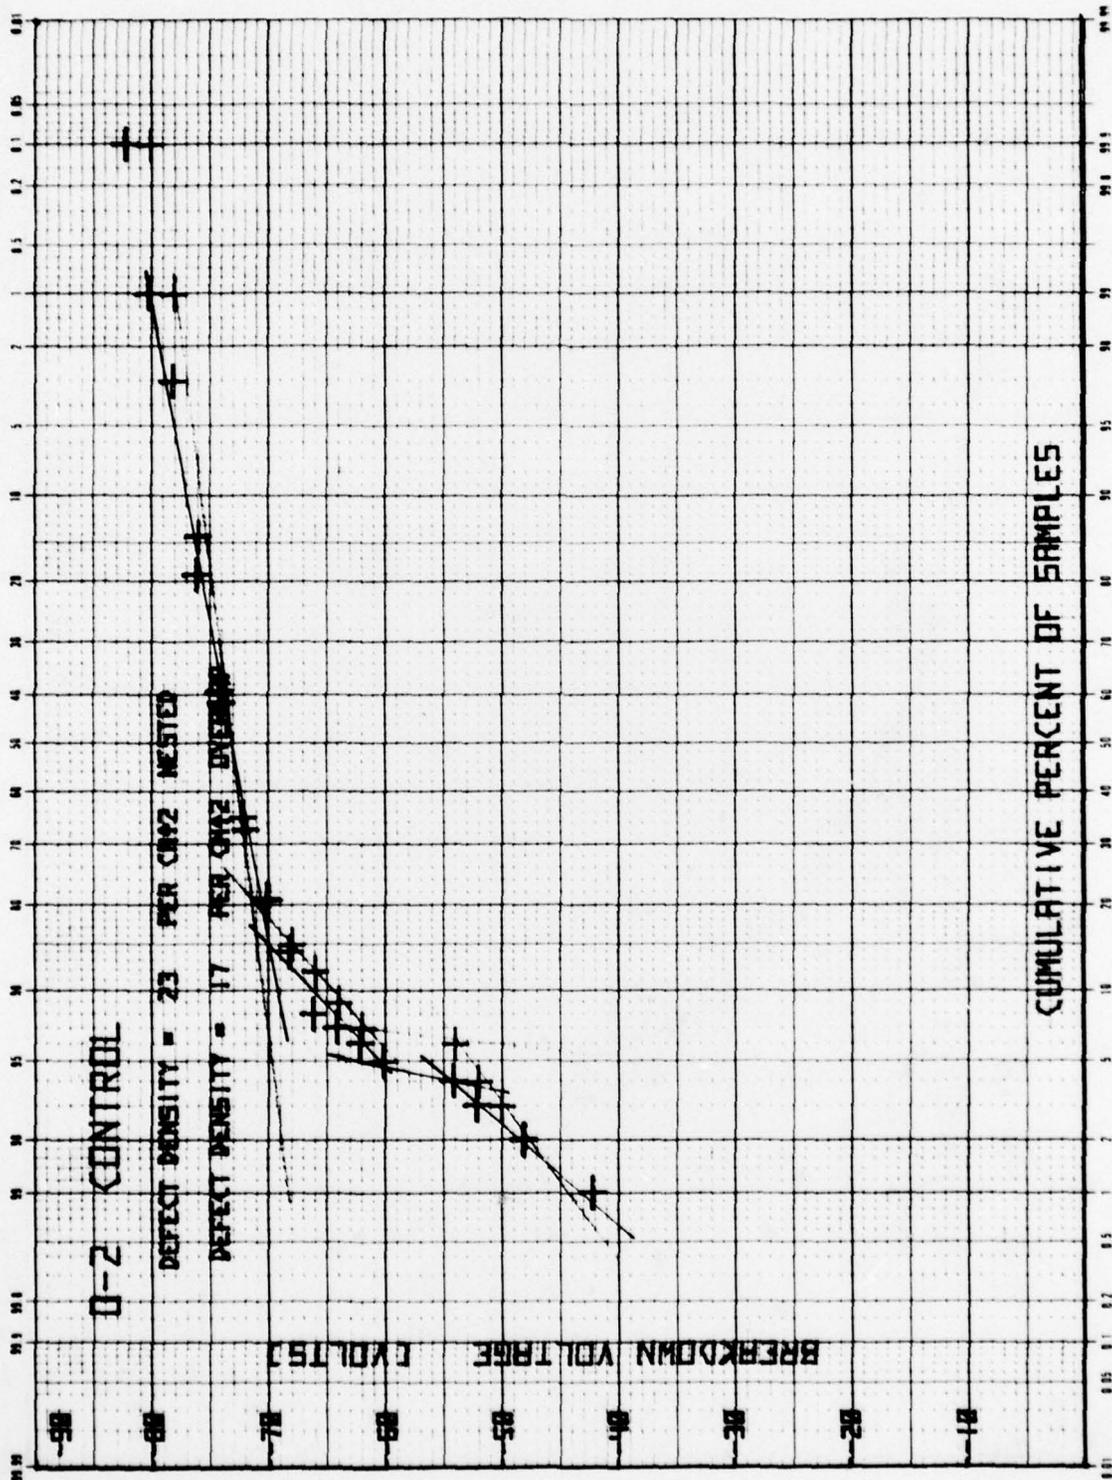
Figure 19. Experiment O: Typical Control Group BV Distribution (Nested and Overlap)

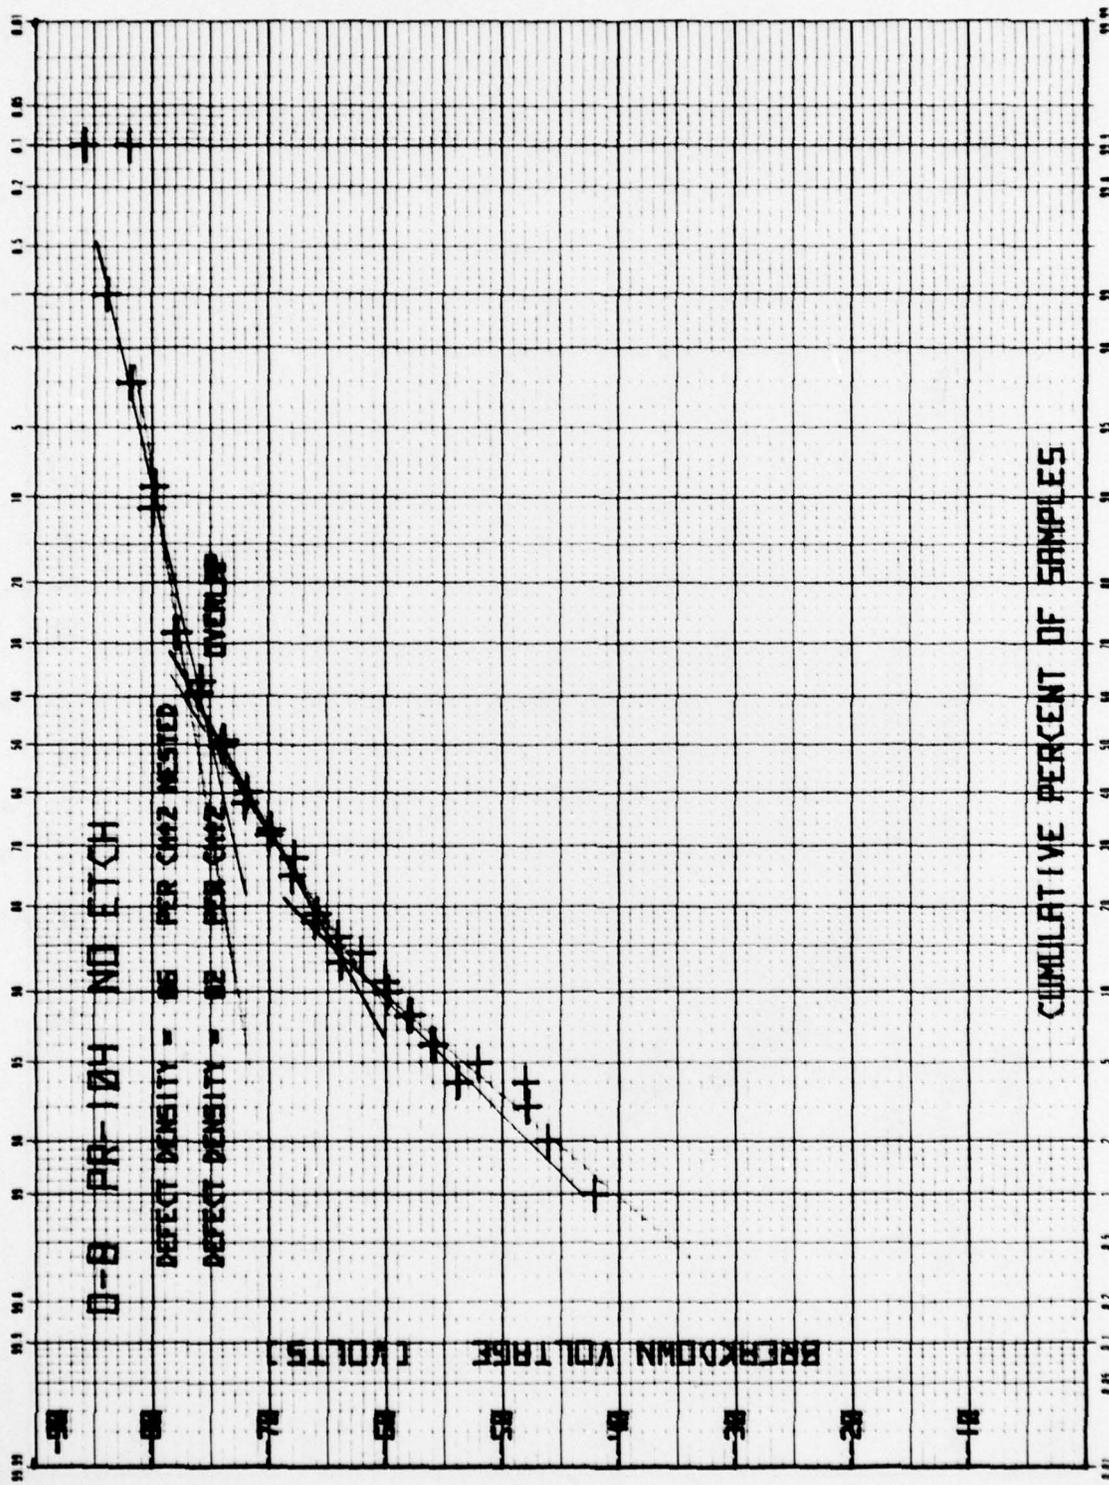
Figure 20. Experiment O: Typical BV Distribution from the PR-104/No Etch Group
 (Nested and Overlap)

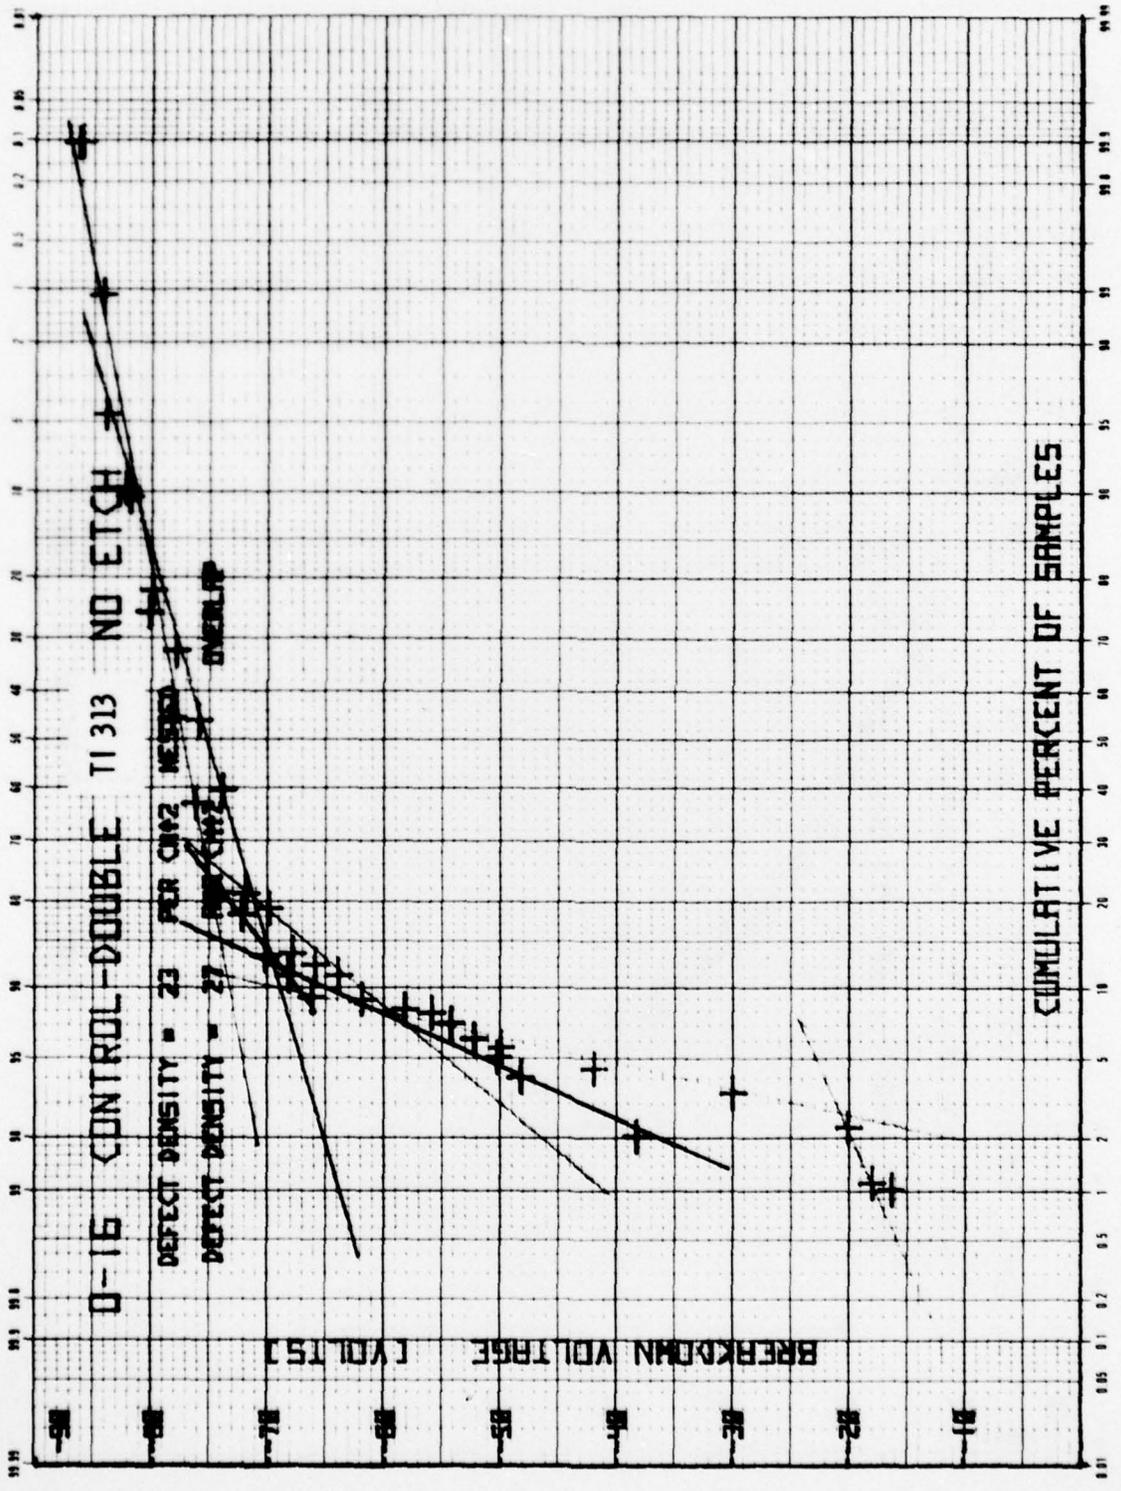
Figure 21. Experiment O: Typical BV Distribution from the Double-Coated TI 313/No Etch Control Group

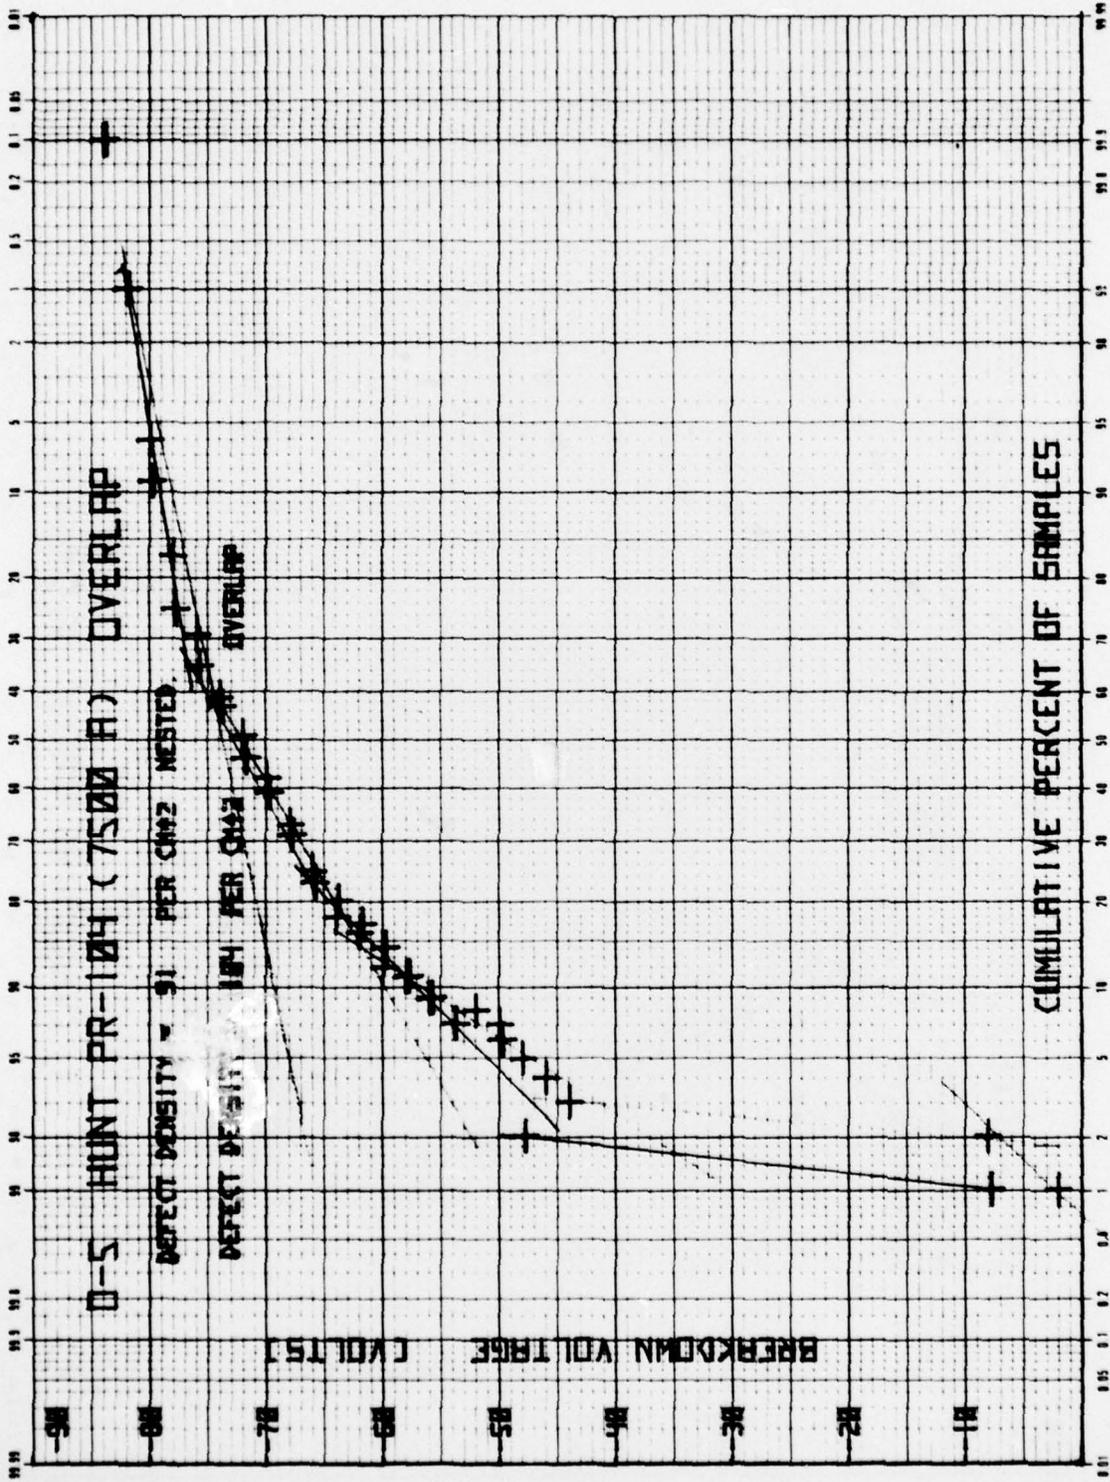
Figure 22. Experiment O: Typical BV Distribution from PR-104/Etched Group (Nested and Overlap)

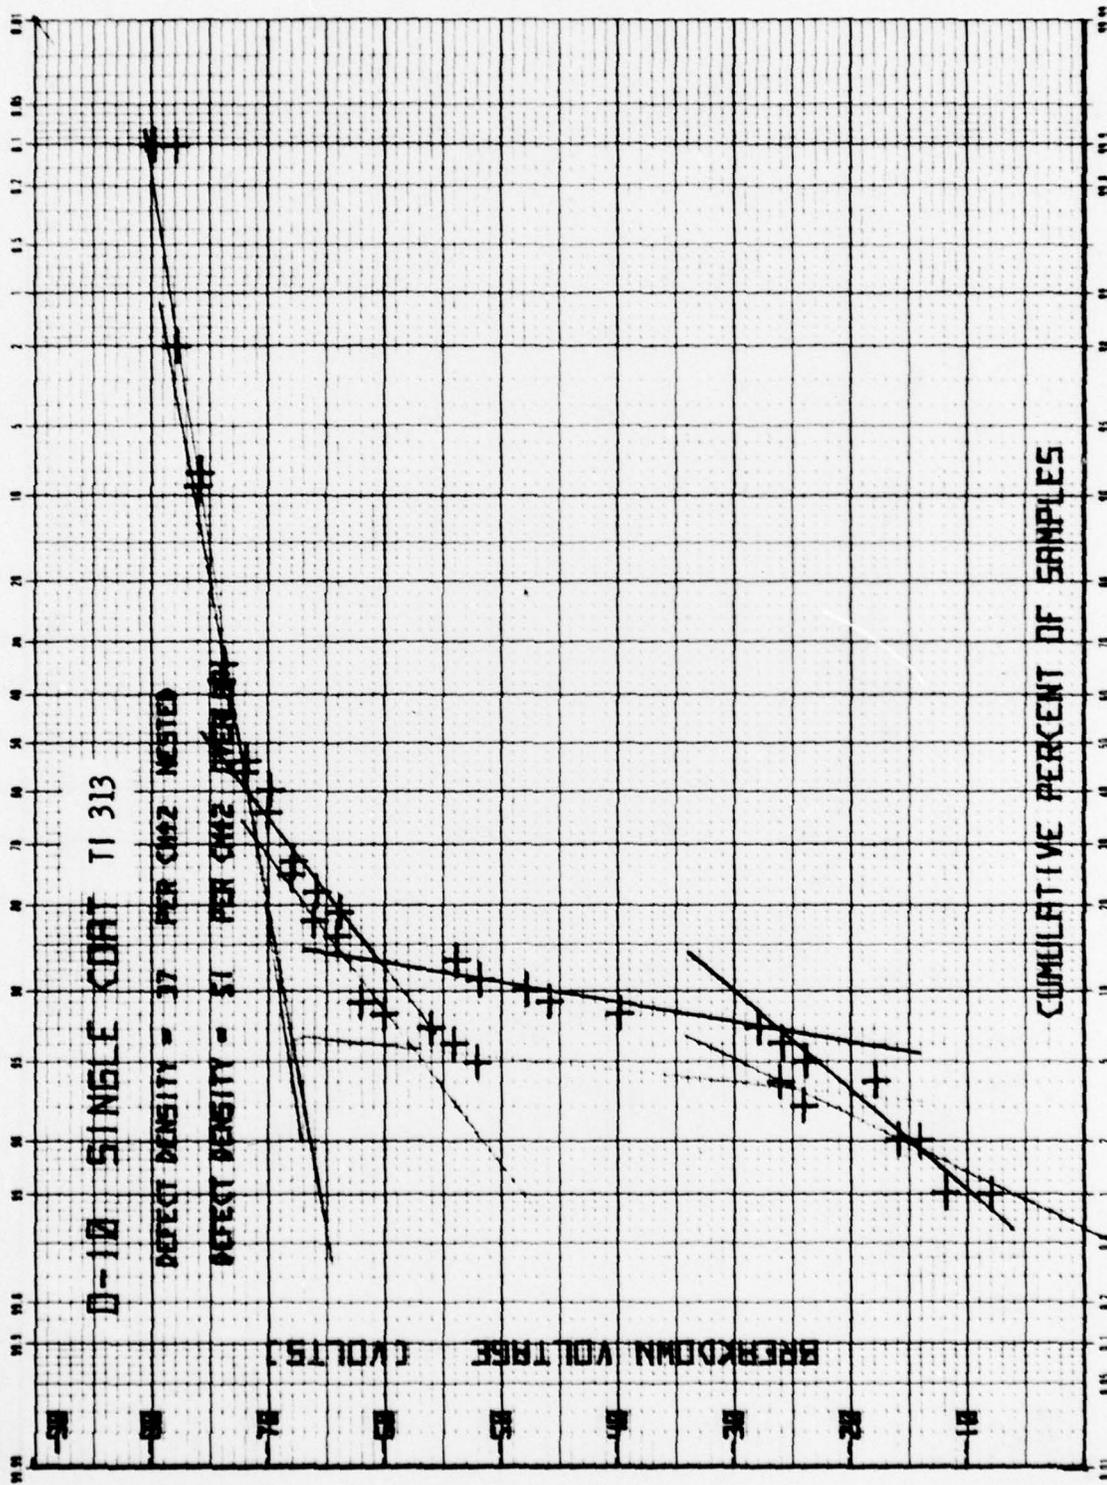
Figure 23. Experiment O: Typical BV Distribution from the Single Coat TI 313/Etched Group
(Nested and Overlap)

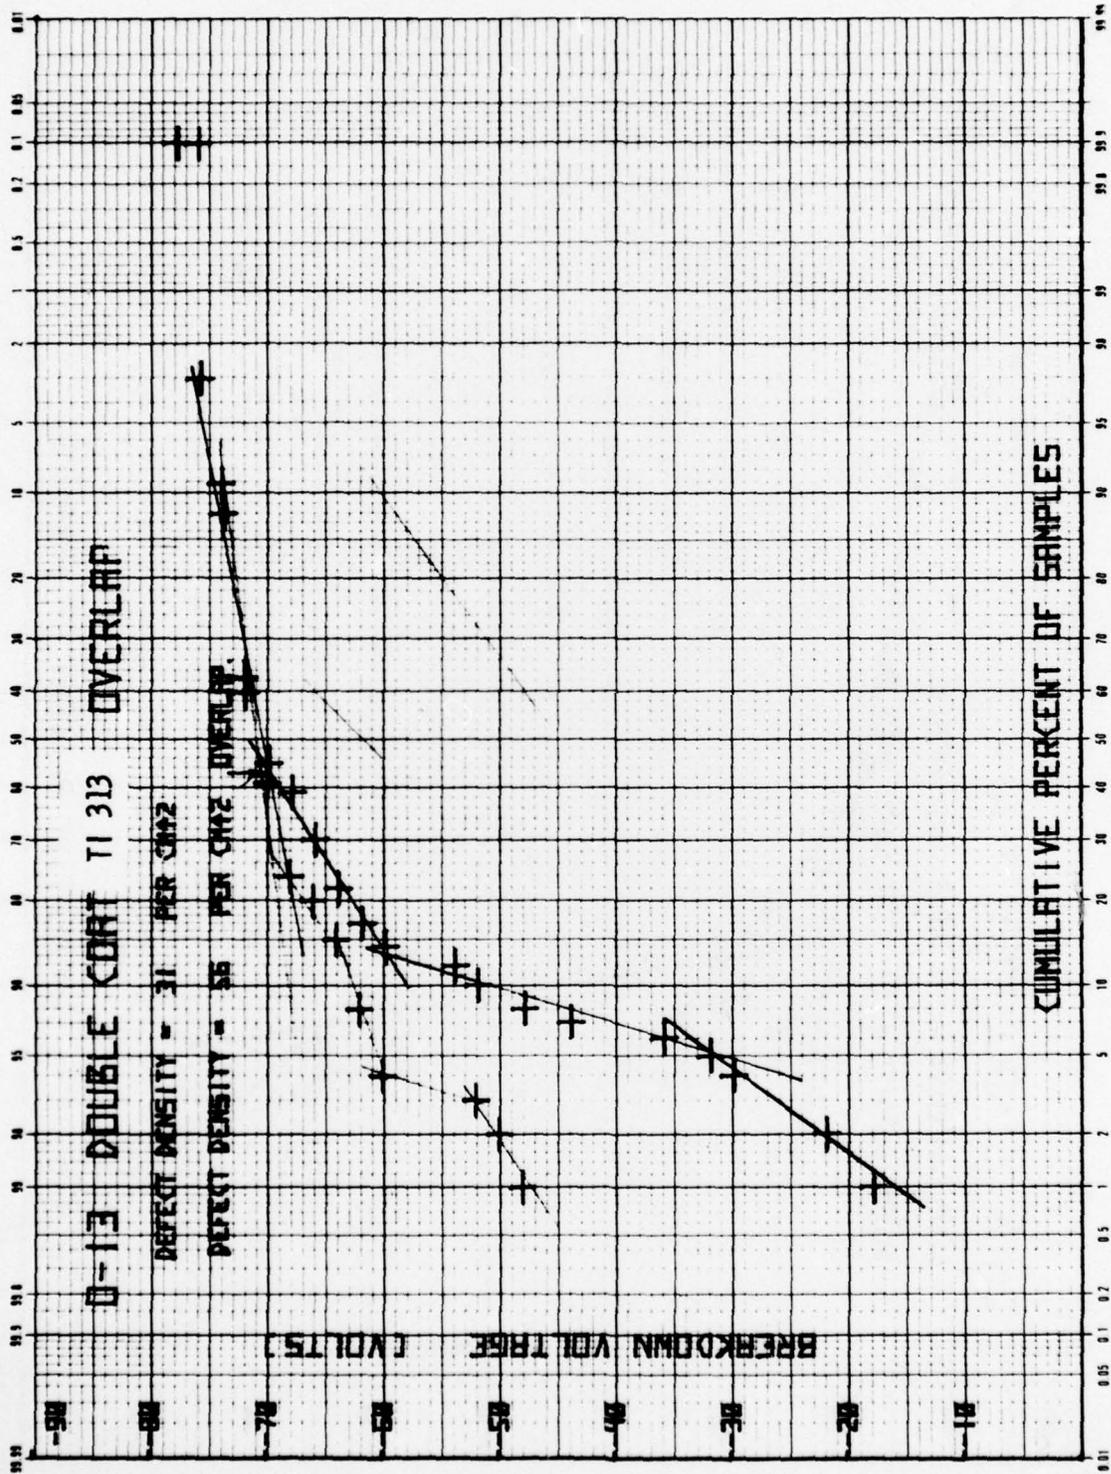
Figure 24. Experiment O: Typical BV Distribution from the Double Coat TI 313/Etched Group
(Nested and Overlap)

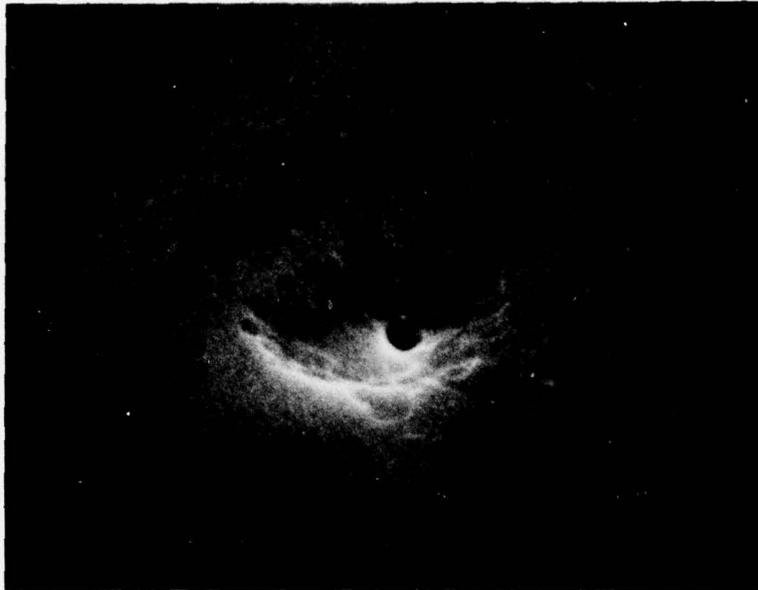
10,000X, 60°

Figure 25. Scanning Electron Micrograph of a Pinhole Defect Site

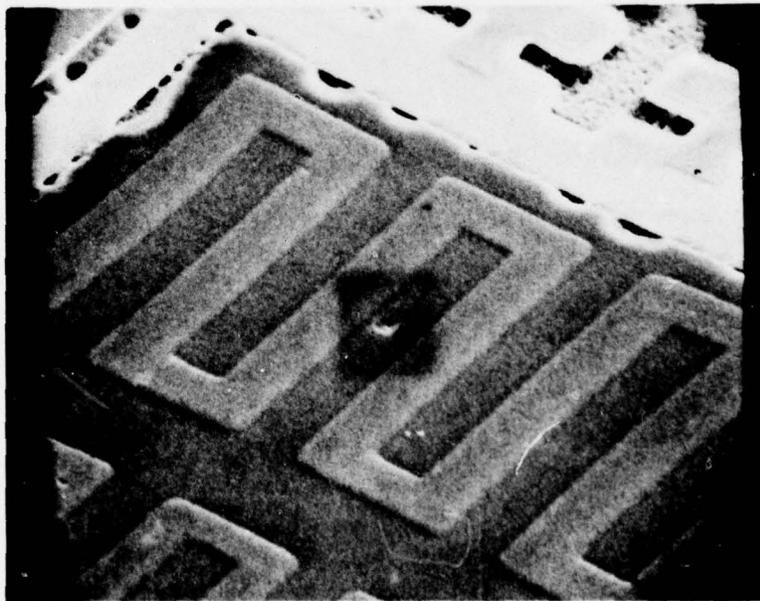
1,000X, 60°

Figure 26. Scanning Electron Micrograph Array Containing Defect Shown in Figure 25

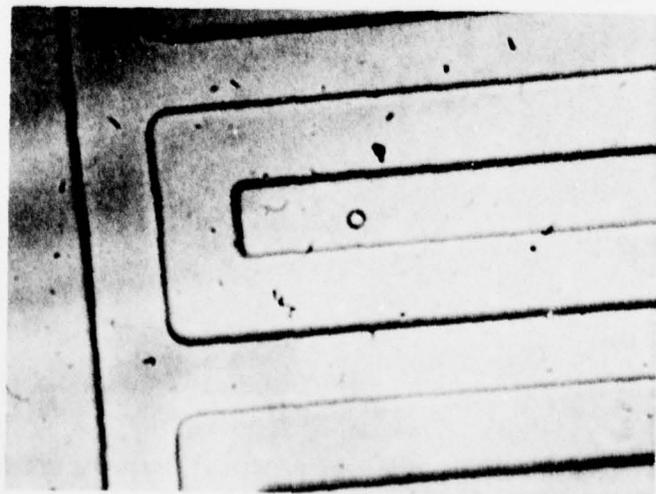
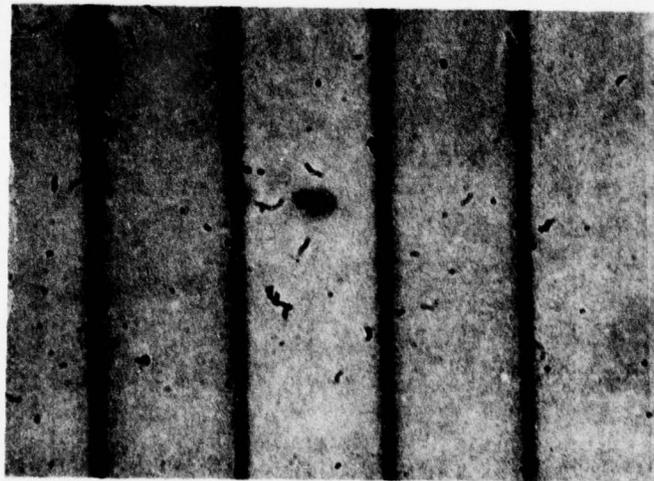
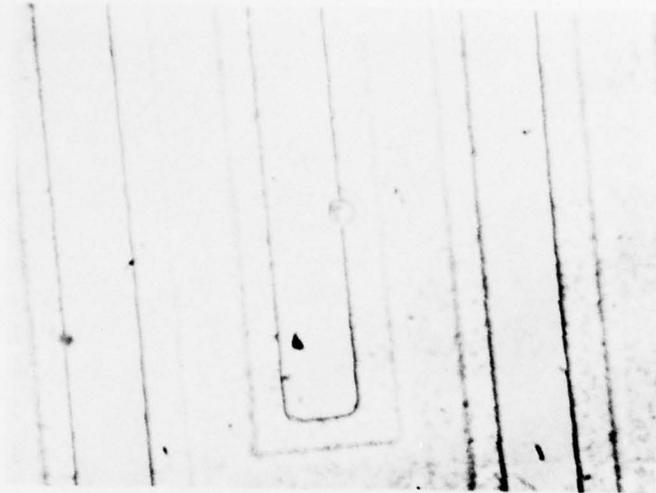
Figure 27. Optical Photomicrographs of Pinholes in
PBS-Fabricated Microcircuits (Sheet 1 of 2)

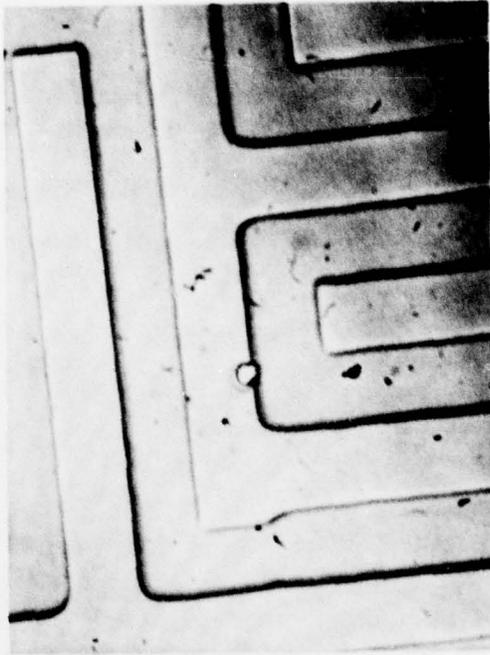
Figure 27. Optical Photomicrographs of Pinholes in
PBS-Fabricated Microcircuits (Sheet 2 of 2)
