AD A 0 5 6 8 0 3 DRIED (GED) MANDERIAL RESEARCH PROGRAM O WEST OF THE YOLF ST COLONIAL FIRD USE AND FLANT CCESSION ON DREDGED MATERIAL ISLANDS IN ELORIDA. Volum VOL. III PATTERNS OF PLANT SUGGESSION, ODC FILE COPY.

SUBJECT: Transmittal of Technical Report D-78-14 (Volume II)

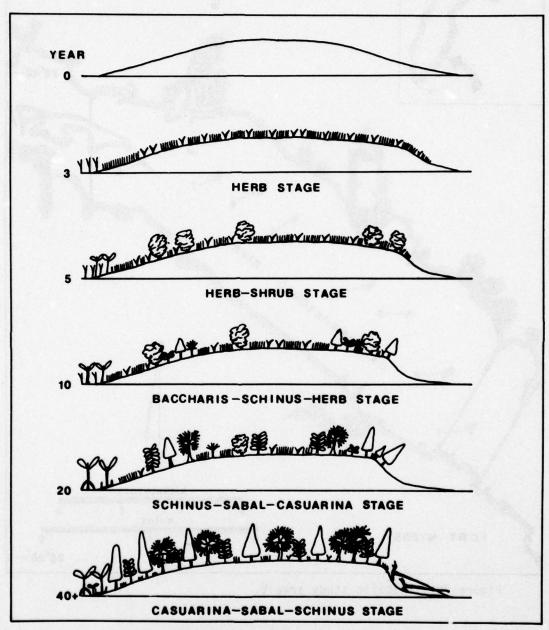
Figure 21. Generalized habitat succession on dredged material islands in Florida. See Figure 22 for vegetation key.

- 26. Table 43 lists the major plant species associated with each succession stage. Both Figure 21 and Table 43 are derived from the overall general pattern observed and indicated from data analysis.

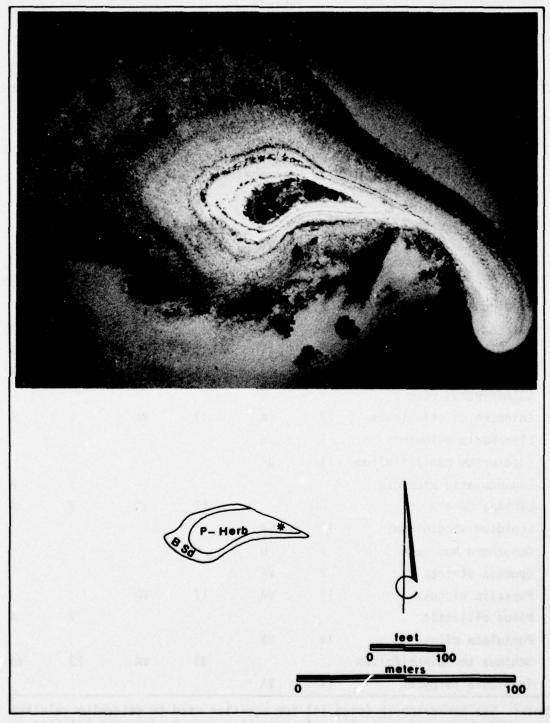
Figure 23. Vertical aerial photograph and vegetation map of dredged material island I-4.

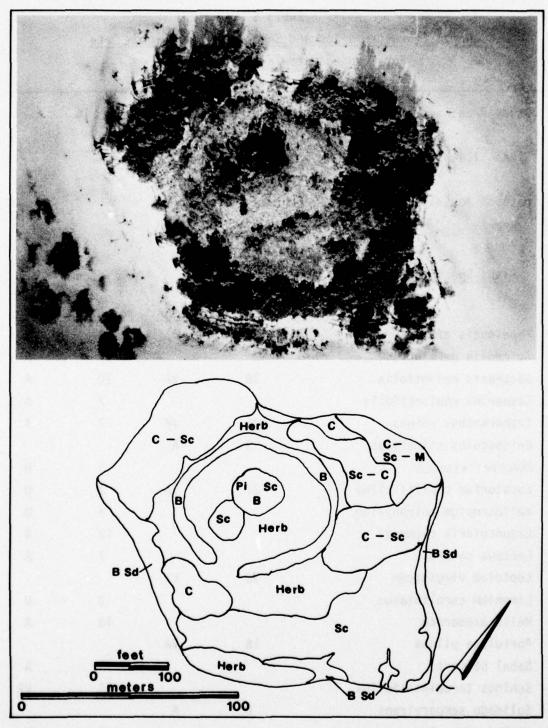
Figure 24. Vertical aerial photograph and vegetation map of dredged material island I-14.

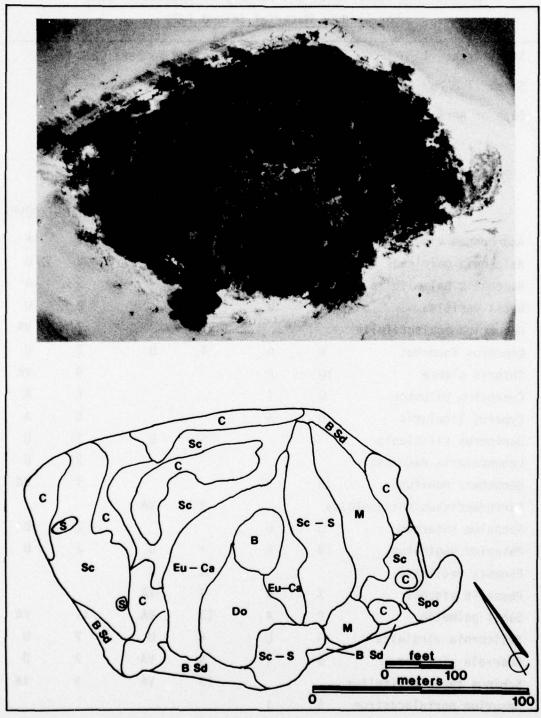
Figure 25. Vertical aerial photograph and vegetation map of dredged material island I-15.

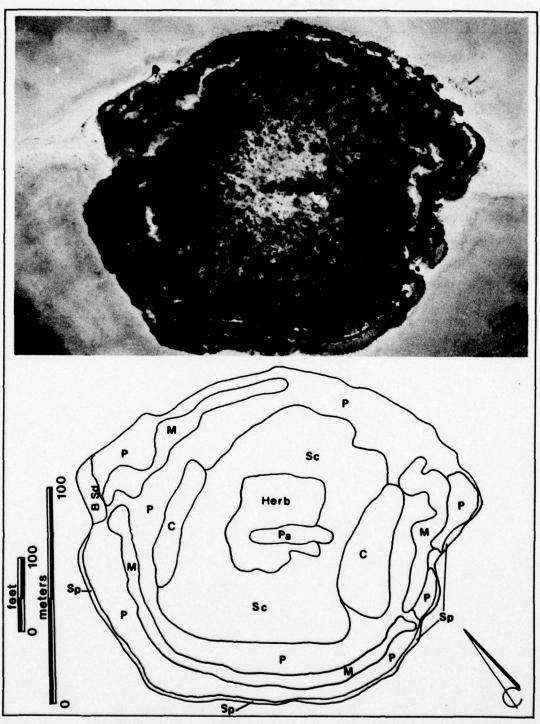
Figure 26. Vertical aerial photograph and vegetation map of dredged material island I-21

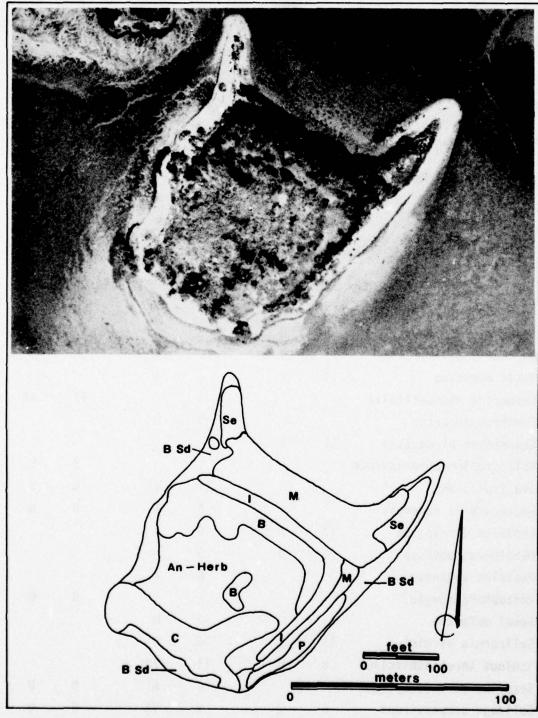
Figure 27. Vertical aerial photograph and vegetation map of dredged material island I-39.

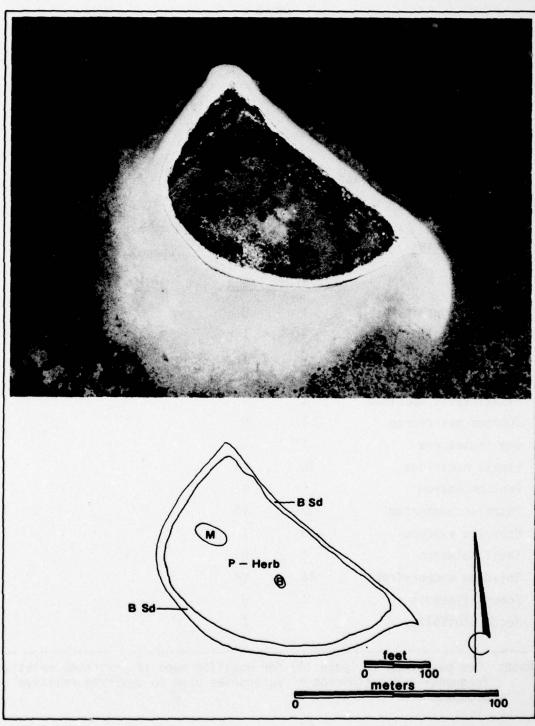
Figure 28. Vertical aerial photograph and vegetation map of dredged material island I-48.

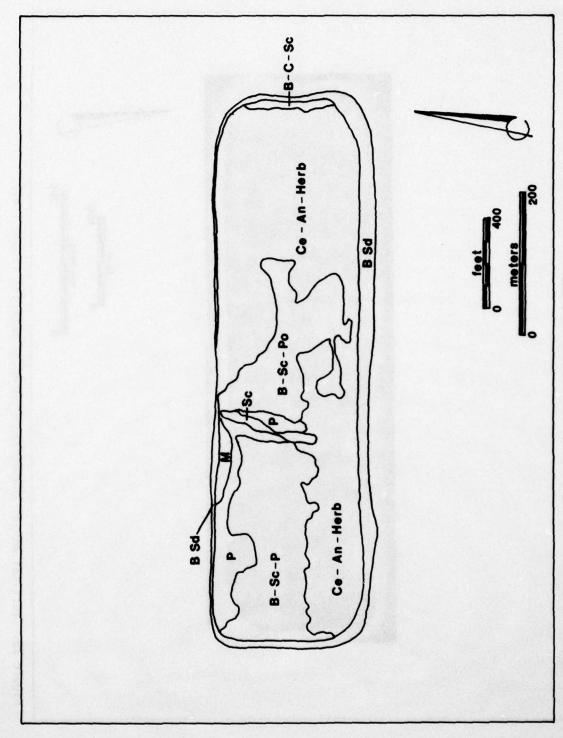
Figure 30. Vegetation map of dredged material island I-49B.

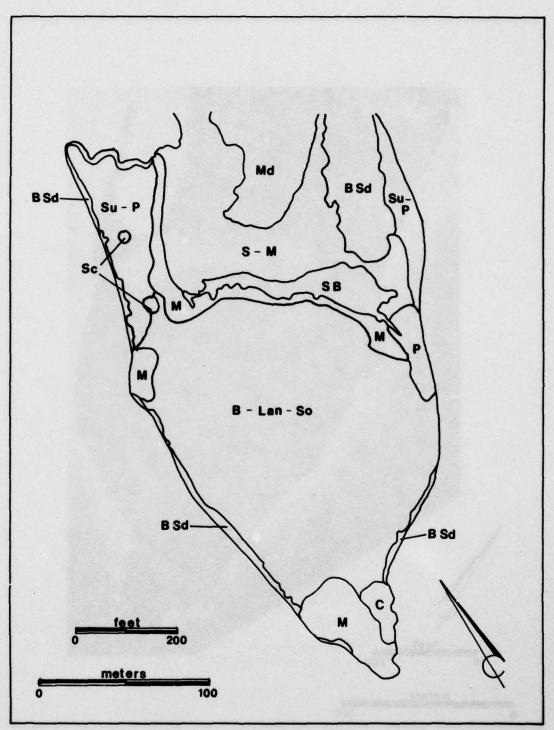
Figure 32. Vegetation map of dredged material island I-54.

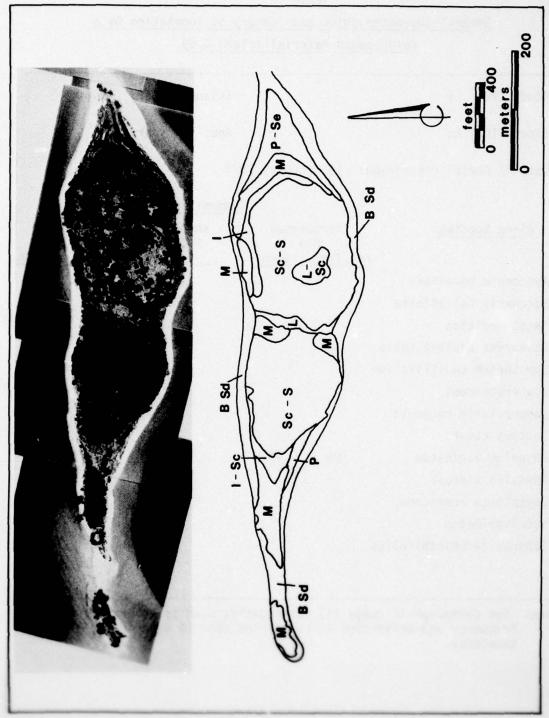
Figure 35. Vertical aerial photograph and vegetation map of dredged material island I-59.

II-125, Fig. 61; II-128, Fig. 62; and V-1, Fig. 71). If the initial deposit of dredged material is elongate with one end facing the prevailing winds or boat wakes, erosion produces single spits (I-59, Fig. 35; I-61, Fig. 38). If the long side of the island is facing the winds, both ends of the island erode and the island usually quickly disappears. If the initial deposit is round and in a protected area, then it may have a more or less uniform distribution of intertidal vegetation around its perimeter. This is an unusual condition, but does appear to have occurred on II-26 (Fig. 45). A more common condition is a round deposit that is eroding on one side and producing two spits on the lee side due to accretion of the same material (I-39, Fig. 27; I-58, Fig. 33; II-88, Fig. 54). In extreme cases of erosion and accretion (see Lewis and Dunstan, 1975a), the island may appear to "migrate" due to continual erosion and accretion, and eventually the spits may curl and fuse to form a land-locked cove (II-125, Fig. 61).

- 42. Qualitative observations show that the rapid and luxuriant growth of Brazilian pepper on very rocky soil on I-59 and natal grass on similar soil on I-66 appears to be due to avian fecal contributions of nutrients. Both islands have large colonial seabird and wading bird populations. Gillham (1956) notes that not only can fecal deposits encourage growth in what are termed "ornithocoprophilous vegetation" but can cause destruction or complete loss of other communities. An example of this destructive role can be seen in the mangrove communities on I-58

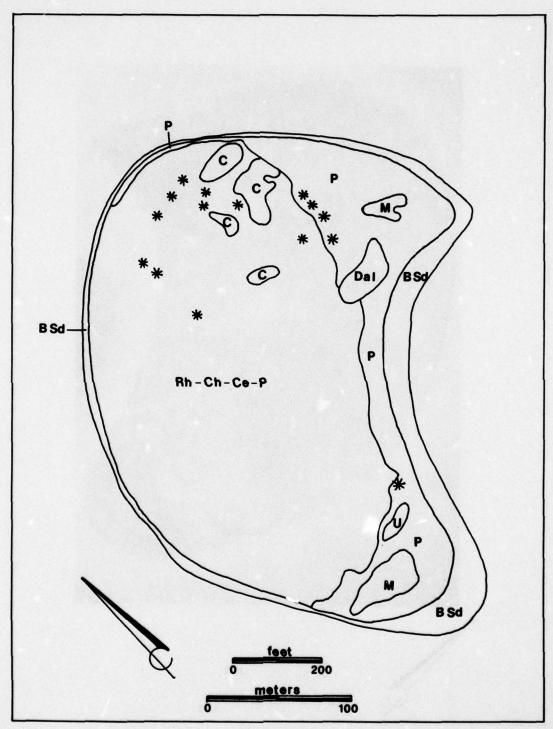
Figure 37. Vegetation map of dredged material island I-60.

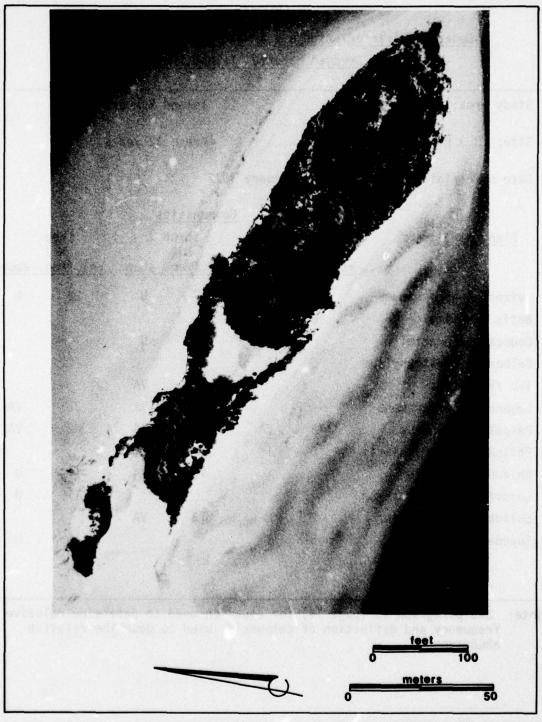
Figure 38. Vertical aerial photograph of dredged material island I-61.

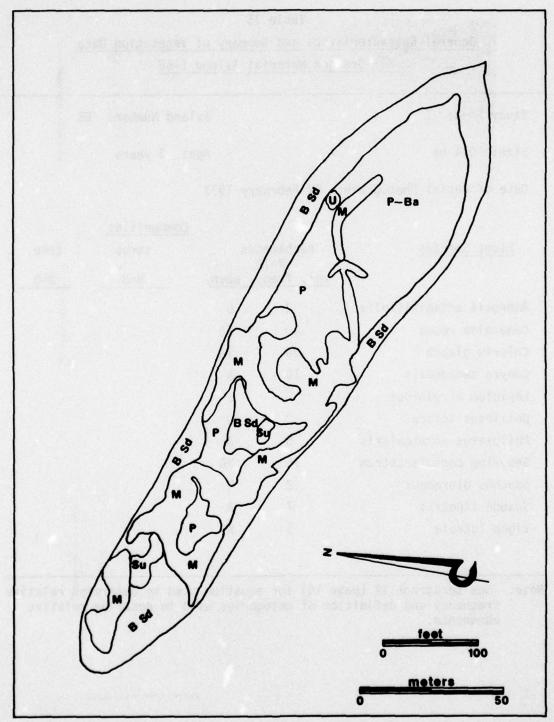
Figure 39. Vegetation map of dredged material island I-61.

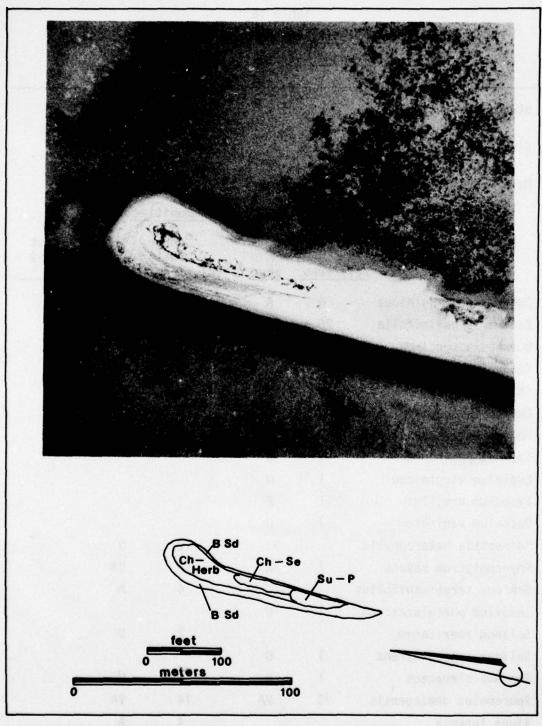
Figure 40. Vertical aerial photograph and vegetation map of dredged material island I-65.

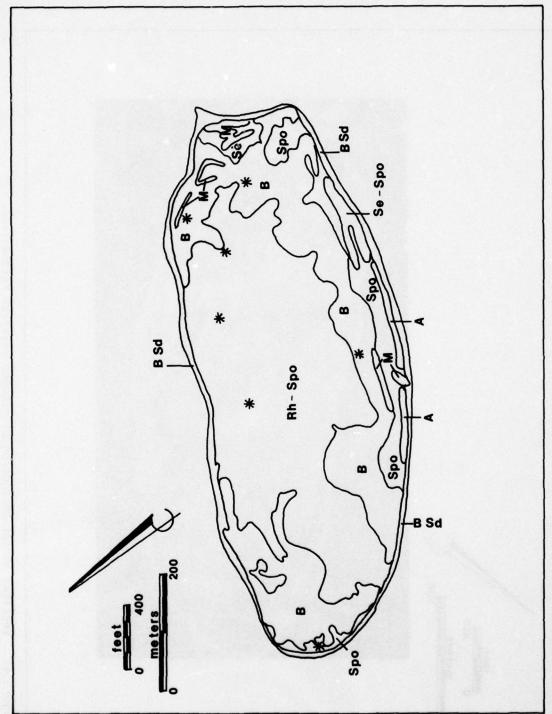
Figure 42. Vegetation map of dredged material island I-66.

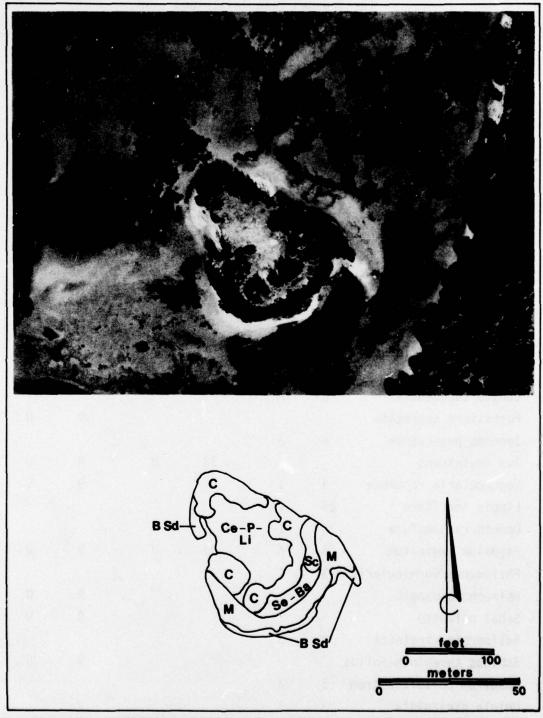
Figure 43. Vertical aerial photograph and vegetation map of dredged material island I-68.

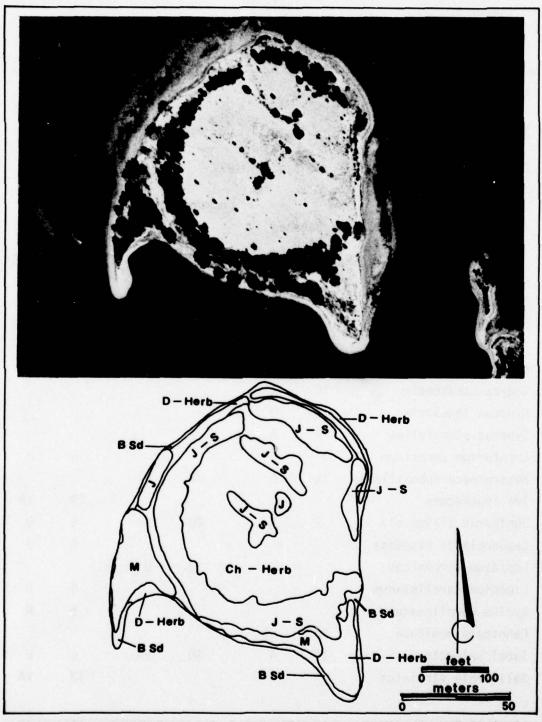
Figure 44. Vertical aerial photograph and vegetation map of dredged material island II-12.

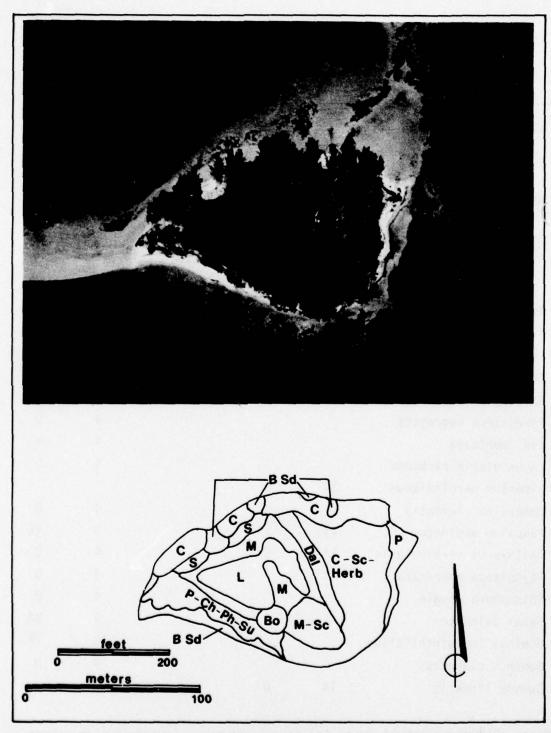
Figure 61. Vertical aerial photograph and vegetation map of dredged material island II-125.

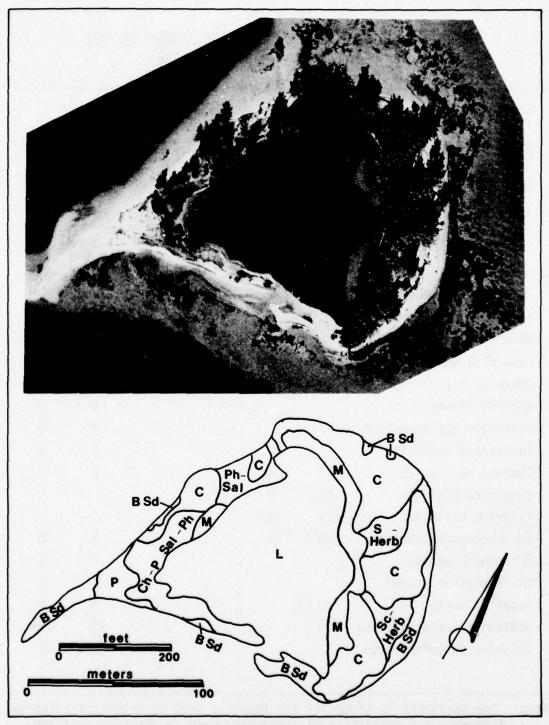
Figure 62. Vertical aerial photograph and vegetation map of dredged material island II-128.

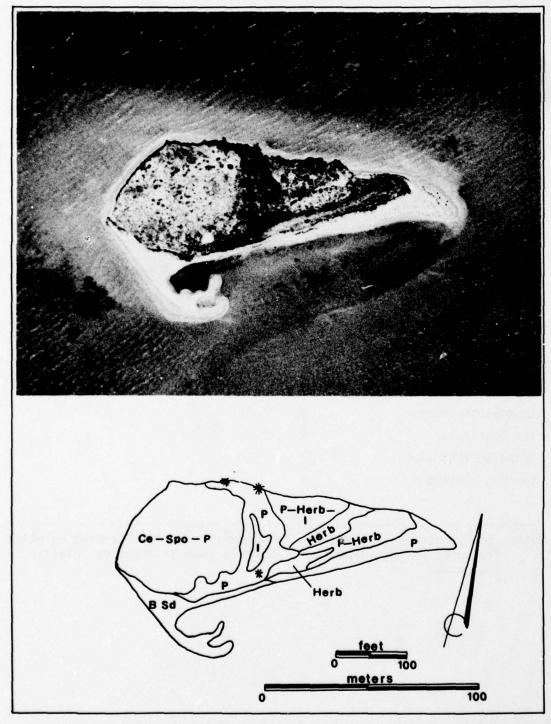
Figure 63. Vertical aerial photograph and vegetation map of dredged material island II-129.

- 23. If the appropriate physical conditions are not available, intertidal plant communities will not establish. This is a very common condition where a combination of high wave energy and low elevation of the initial deposit may prevent the formation of a "lee" side. Islands of this type are completely surrounded by a bare sandy beach and are usually experiencing heavy erosion (I-4, Fig. 23; I-48, Fig. 28; I-60, Fig. 36; I-65, Fig. 40; II-80, Fig. 52; II-129, Fig 63; III-7, Fig 66; III-12, Fig 68; III-13, Fig. 69; and V-4, Fig. 73).

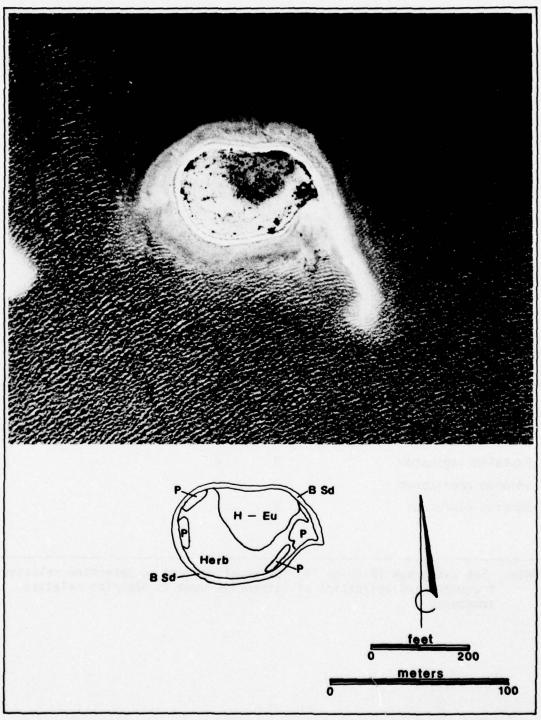
Figure 66. Vertical aerial photograph and vegetation map of dredged material island III-7.

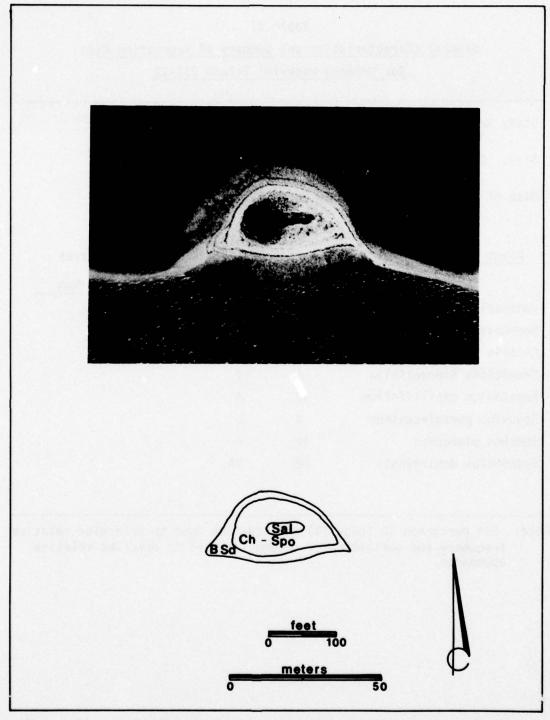
Figure 68. Vertical aerial photograph and vegetation map of dredged material island III-12.

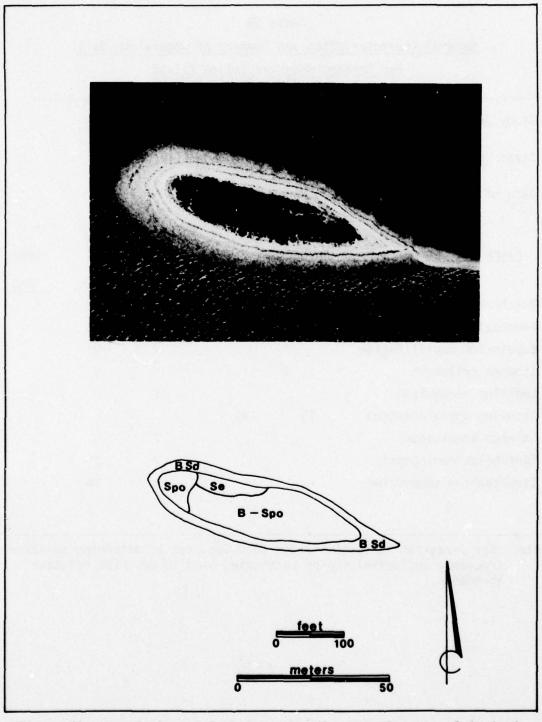
Figure 69. Vertical aerial photograph and vegetation map of dredged material island III-13.

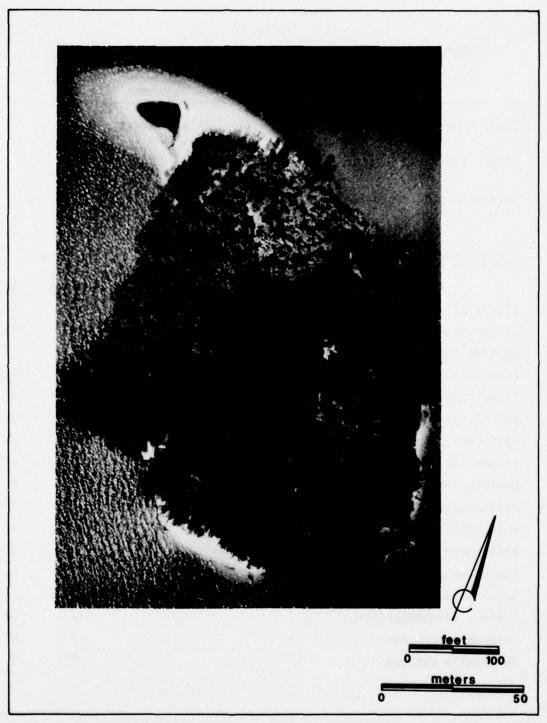
Figure 71. Vertical aerial photograph of dredged material island V-1.

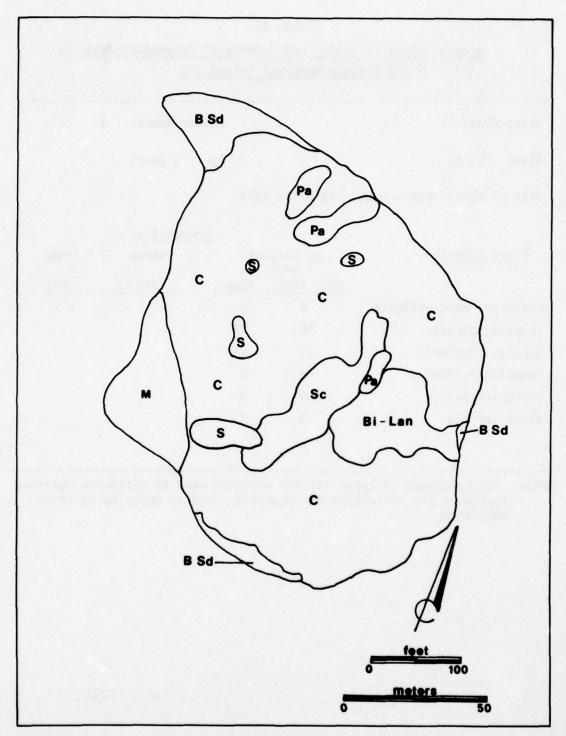
Figure 72. Vegetation map of dredged material island V-1.

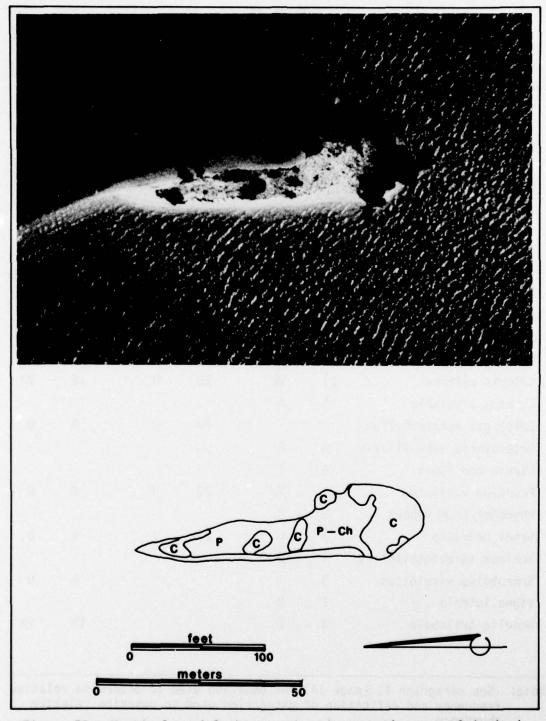
Figure 73. Vertical aerial photograph and vegetation map of dredged material island V-4.

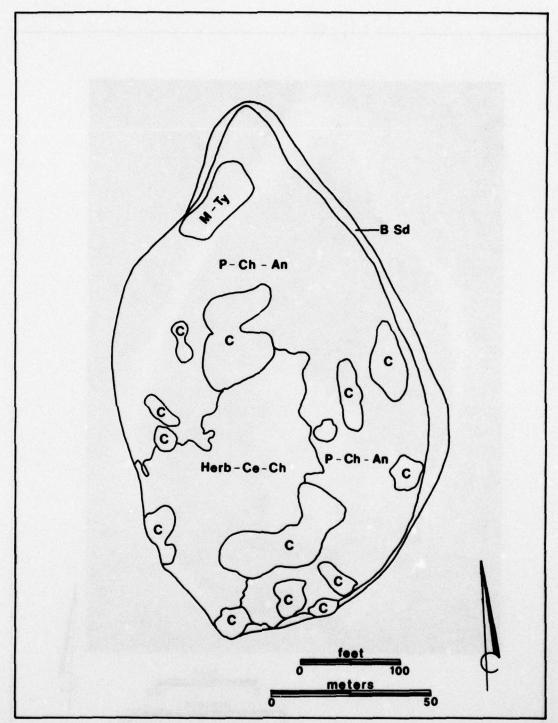
Figure 75. Vegetation map of dredged material island V-7.
