GE Document No. 77SDR2315

ENVIRONMENT VARIABILITY IN THE DEEP SOUND CHANNEL

Eric J. Softley
M. J. Engel

May 1977

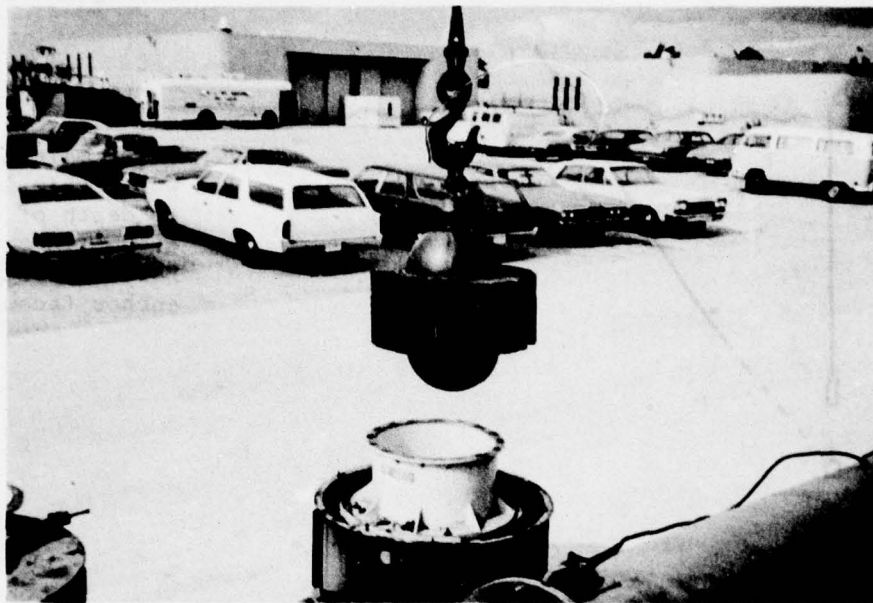
Figure 13 Staging The Radioisotopic Power Generator(RPG)

The RPG was shipped from Tracor (Ft. Lauderdale) by a leased truck and staged with the Sea Robin IV hull and electronics on the dock, see Figure 13. It was found that an internal connection was missing from the RPG multi-pin connector. Fortunately, a remedy was made without removing the potting compound. The buoy electronics worked satisfactorily and Dave Rogers (GE-OSL) proceeded to Eleuthera to man the shore station. The buoy was loaded aboard the ship and connected to the computer to maintain an operational check on the system. Almost immediately the buoy ceased its timed operation. When the buoy RF module was removed it was found that the high frequency switching transients from the DC-DC converters in the RPG were resetting the interval timer in the buoy electronics. This was corrected by suitable filtering. The electronics were reinserted in the buoy and a continual operational check maintained using the onboard computer.
