USARTL-TN-29

TESTS TO DETERMINE THE ULLAGE EXPLOSION TOLERANCE OF HELICOPTER FUEL TANKS

Charles M. Pedraini

June 1978

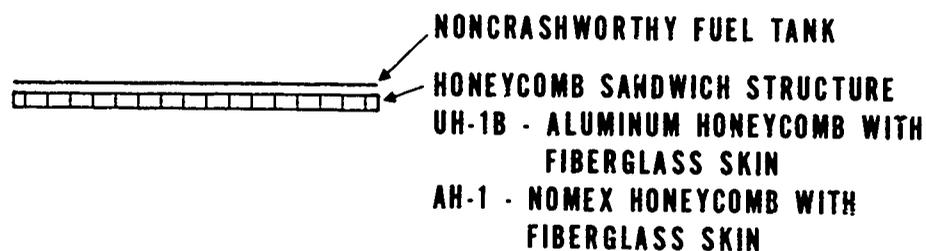
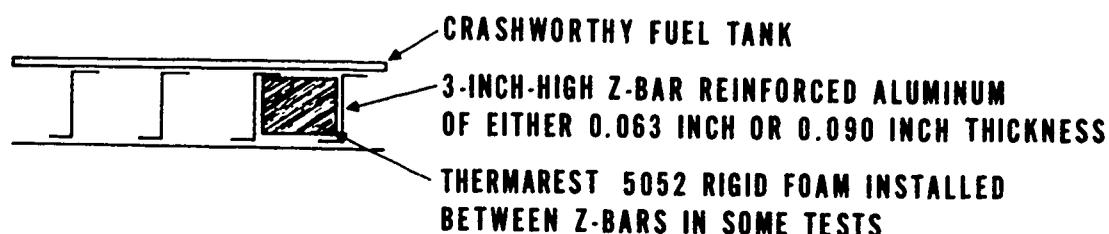
Figure 1. Schematic diagram of fuel tank configurations tested for combustion overpressure tolerance.

Several fuel tanks were available for use on this program which appeared to offer the desired variety of construction: two UH-1B aircraft fuel tanks, one UH-1H aircraft fuel tank, one AH-1 fuel tank, and several fuel tank cubes manufactured in accordance with MIL-T-27422B. A schematic diagram of each test tank configuration is shown in Figure 1. The UH-1B and AH-1 tanks used in this test have honeycomb structure around noncrashworthy bladders, the UH-1H contains a complete crashworthy fuel system, and the fuel tank cubes are made of crashworthy material and fit a fixture that accommodates Z-bar reinforced aluminum structure.

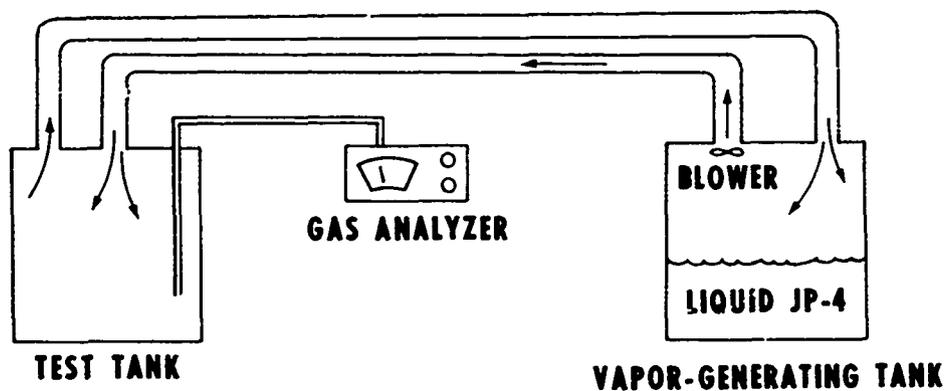
Figure 2. Schematic diagram of vapor-generating and sampling system.

The apparatus used to inject the fuel vapors, measure the ullage concentration, and record the data was the same for each shot. A vapor-generating tank was used as shown in Figure 2 to provide a JP-4/air mixture to the test tank. The fuel/air ratio was monitored with an MSA Lira Infrared Analyzer.* Sufficient control of the fuel/air ratio was achieved by controlling the temperature of the JP-4 liquid in the generating tank. Provisions were made in each test tank for disconnecting the generating tank prior to the shot.

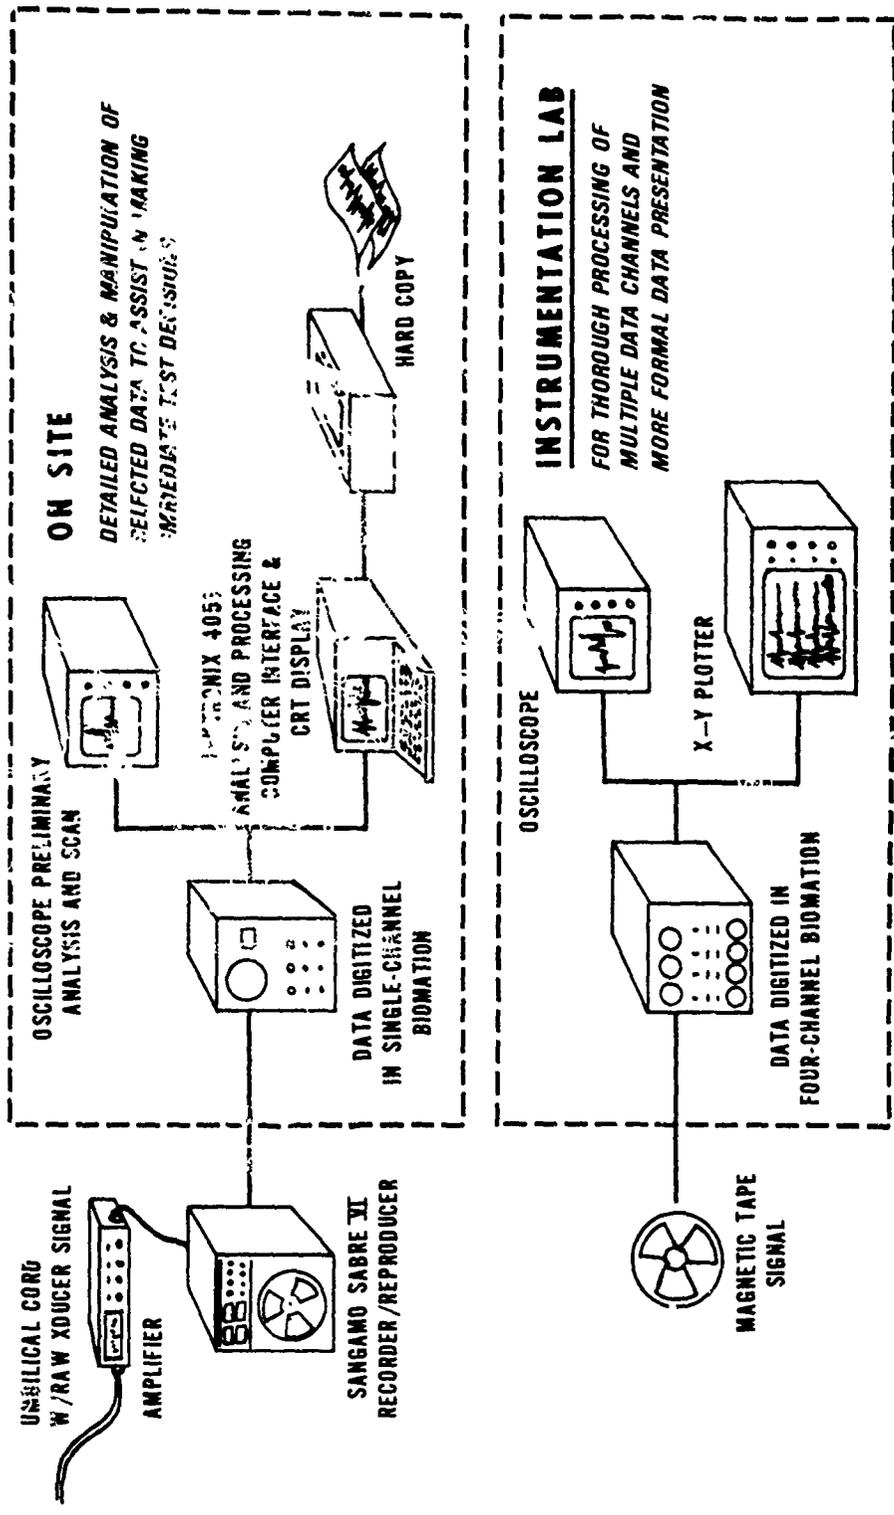
Figure 3. Schematic diagram of data acquisition/processing equipment.

Kulite model HKS pressure transducers were used and the data was recorded and processed using the equipment shown in Figure 3. Thermocouples were used to monitor the ambient, test tank, and vapor-generating tank temperatures. Velocity screens and a Hewlett-Packard Model 5304 frequency counter were used to measure the projectile velocity. Grid paper placed over the impact point provided time of impact data to the instrumentation.

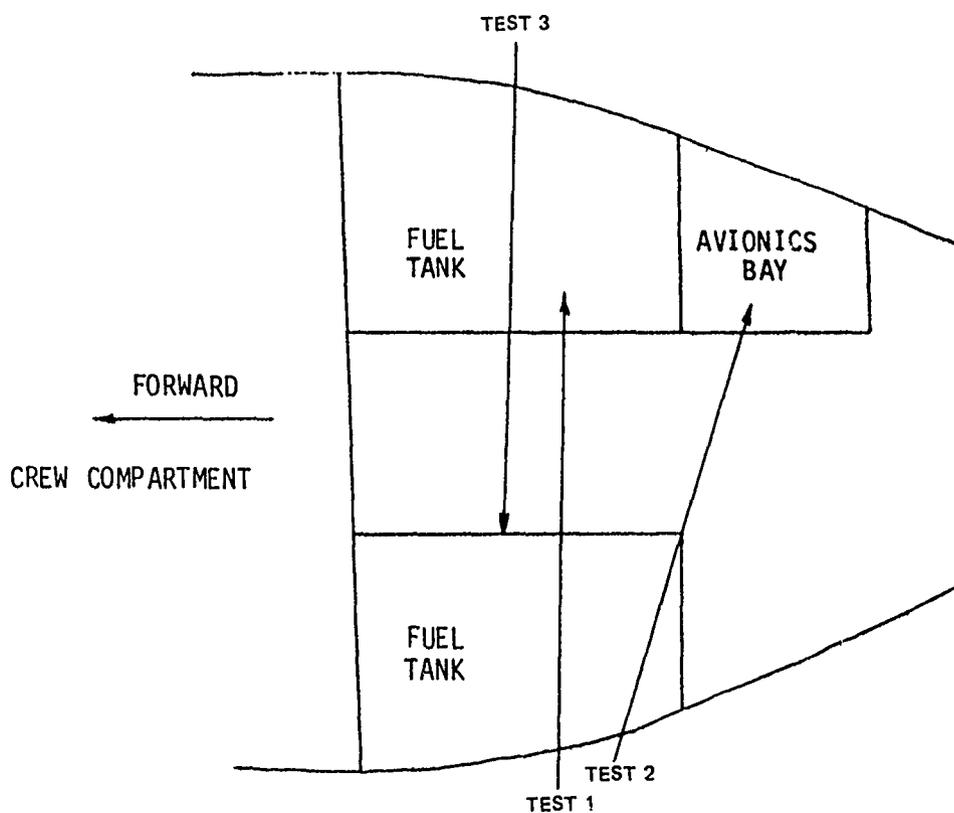
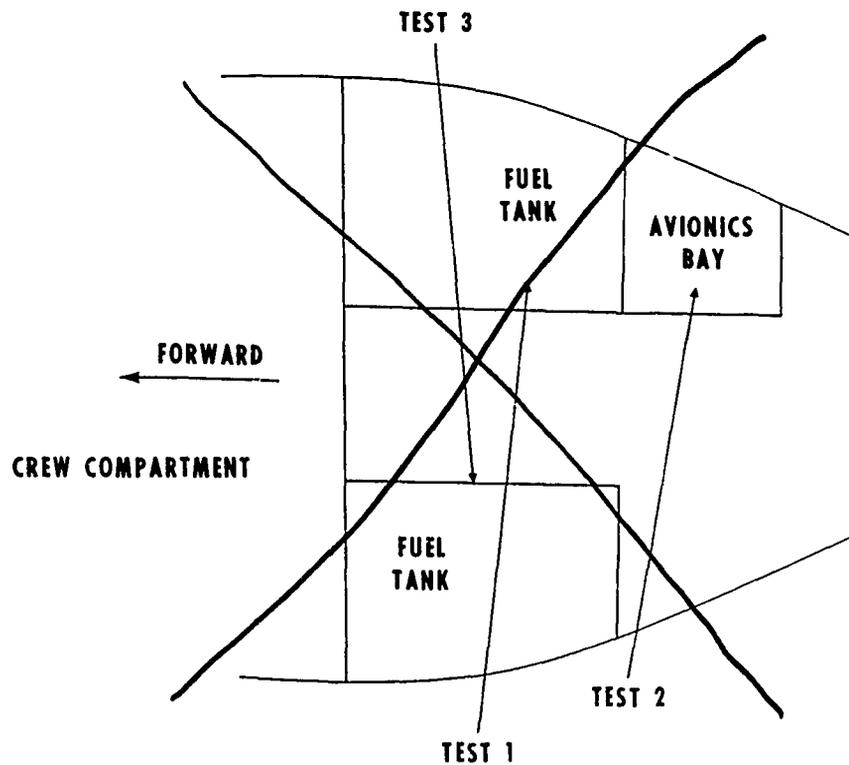
Figure 5. Diagram of projectile flight paths - UH-1B tests.

Three tests were conducted using substantially the same general procedure discussed earlier. Vapor samples were taken at three depths: 6 inches, 18 inches, and 30 inches from the top of the tank. The ambient and ullage temperatures were measured. Each tank was impacted about one-third from the bottom and a 0.125-inch-thick 2024-T3 aluminum plate was taped on the aircraft at that point to insure projectile activation.

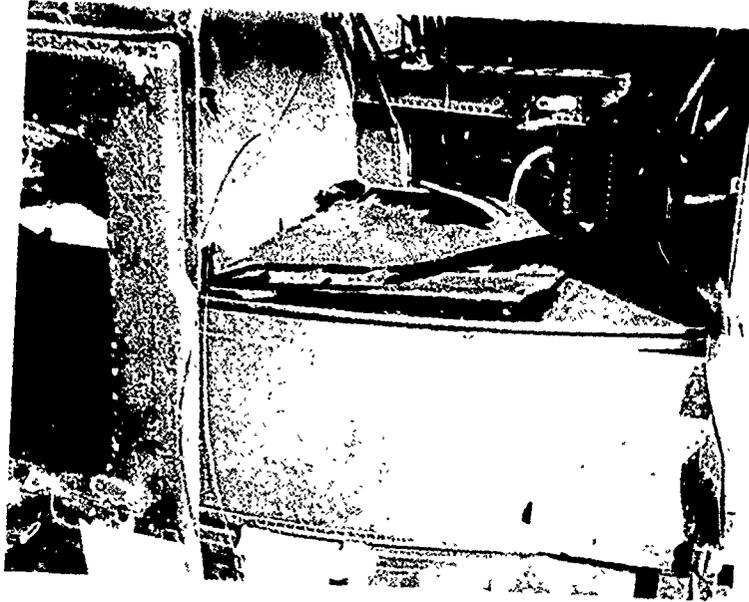
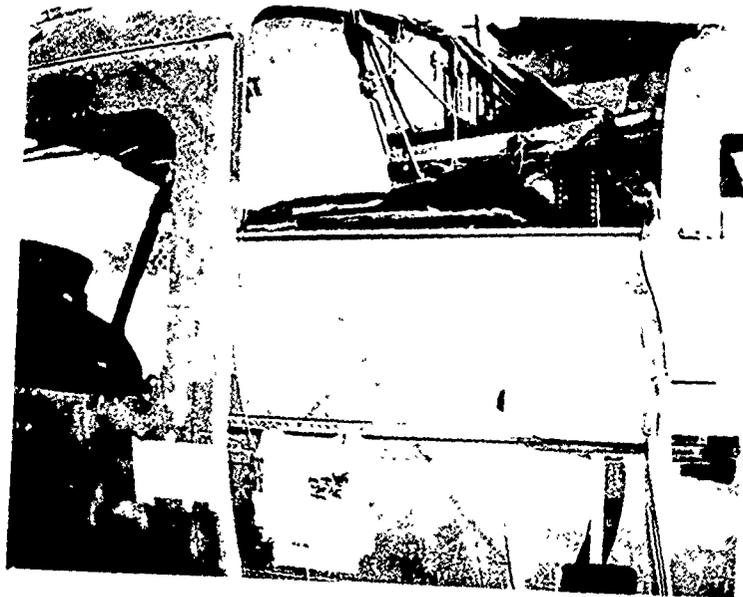
During the first UH-1B test the caliber .30 incendiary M1 projectile impacted the left fuel tank at about the one-third level, passed through the function plate and the entire tank structure, and was expended inside the right fuel tank (Figure 5). The resulting overpressure damaged the deck plate and fiberglass subpanel, but aside from the entrance and exit holes, the bladder was undamaged (Figure 6). The transducer in the top of the tank was damaged and provided no data. Pressure measurements from the bottom transducer indicated a peak of 15.9 psig and a rise time of 0.53 second.

Figure 6. Aircraft damage resulting from the first UH-1B test.

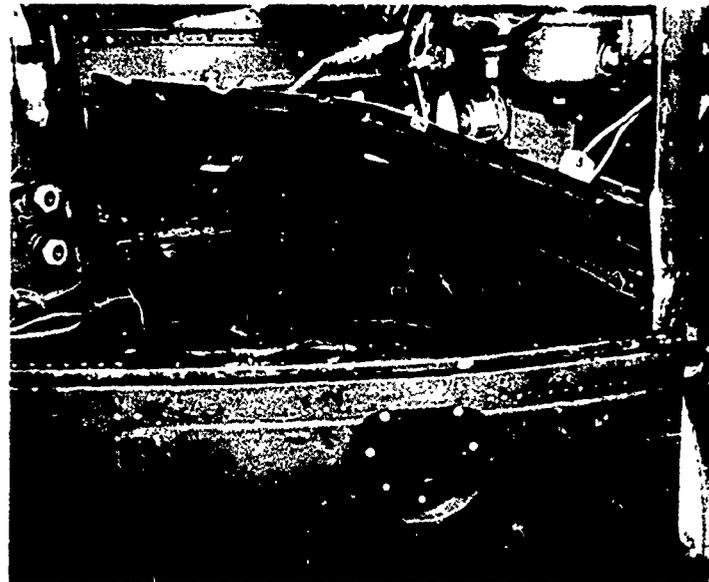
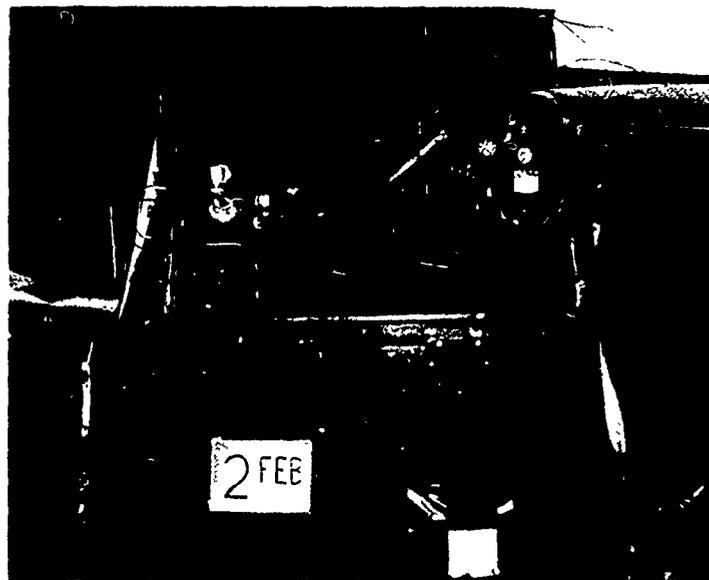
During the third UH-1B test the projectile impacted the right tank, continued through the tank, and expended between the bladder and tank structure of the left fuel tank (Figure 5). The resulting explosion cracked the deck plate and blew it off except for three fasteners, and the fiberglass subpanel failed around its circumference, permitting the bladder to collapse inward about 5 inches. The oval aluminum tank top was bowed and the upper transducer wire was broken. The bladder was torn on three sides around the top of the tank (Figure 8). The pressure transducer near the bottom of the tank indicated a peak of 23.5 psig in 0.22 second.

Figure 8. Aircraft damage resulting from the third UH-1B test.

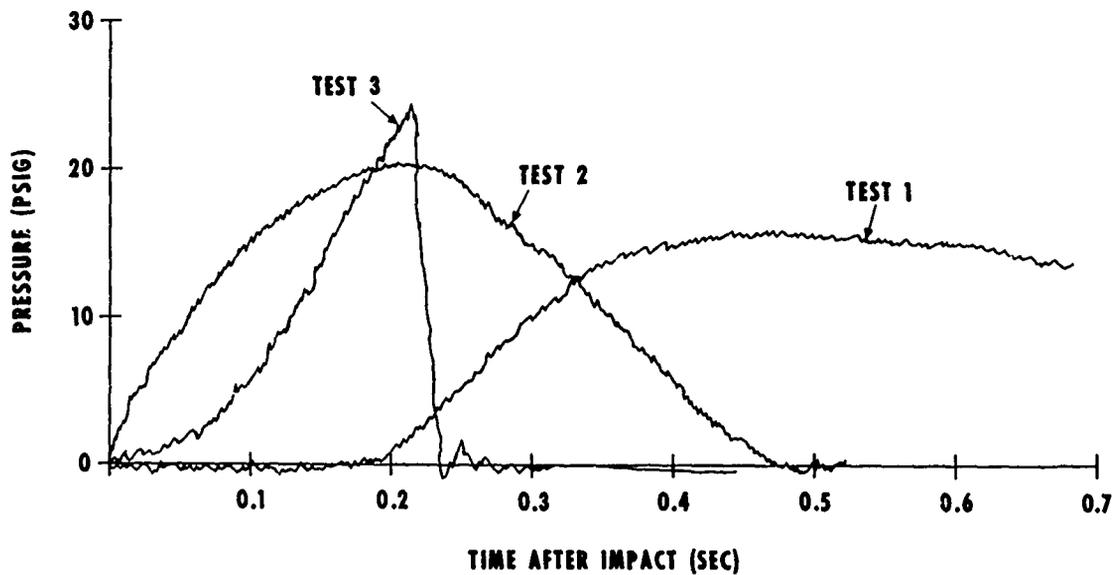
The data obtained during the UH-1B testing is summarized in Table 1. The pressure-time histories for those three tests are shown in Figure 9. In general, the readings are somewhat lower than would be expected because of two factors. The bladders were collapsed inward from the tank structure, which effectively lowered the amount of fuel vapors in the container and provided some expansion volume for the bladder. Also, the aft crossover line was deliberately left open on the first two shots in an attempt to minimize the pressure buildup by venting. This line was covered in the third test to permit destructive pressure buildup. Note that the shape of the pressure trace on the third test is different from the shapes of the first two tests. The pressure is still rising when bladder failure occurs, resulting in a sharp drop-off.

Figure 9. Pressure-time histories obtained during UH-1B fuel tank ullage overpressure tolerance tests.

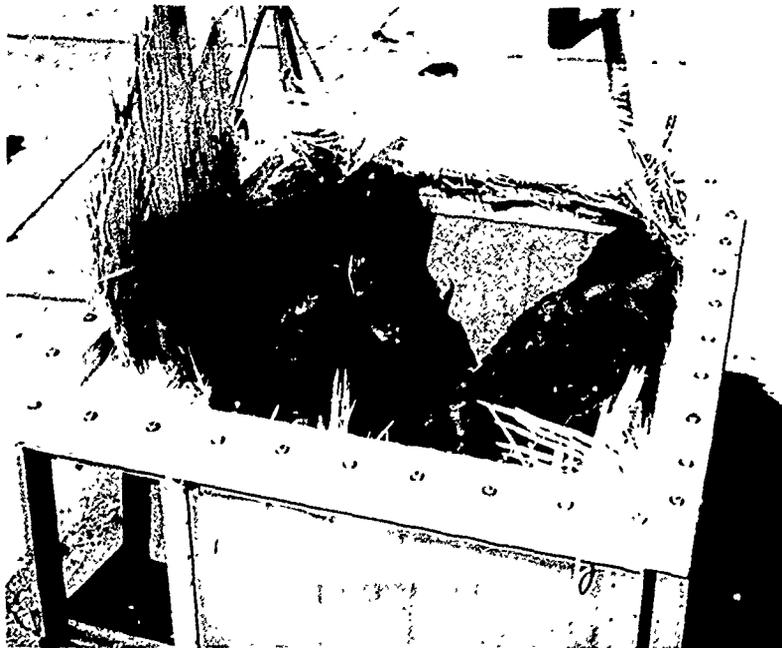
The tank was filled with a uniform 1 percent JP-4 by volume mixture. The caliber .30 incendiary at 2000 feet per second passed from left to right through the middle of the tank, initiating an explosion that blew off the tank top and tore the bladder across the top (Figures 10 and 11). The lower side panels were also cracked at projectile entrance and exit sites (Figures 12 and 13).

Figure 10. Damage to top of simulated AH-1 structure.

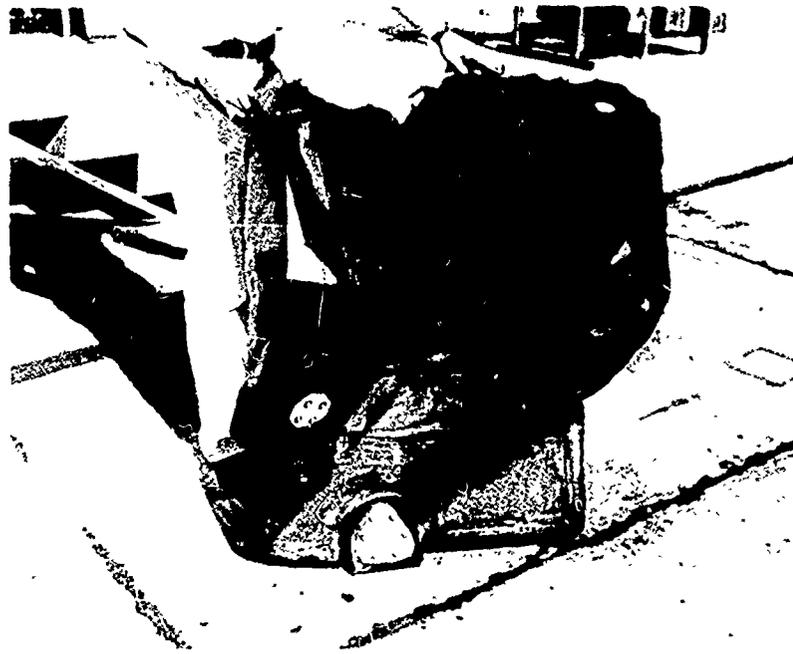
Figure 11. Damage to AH-1 bladder tank.

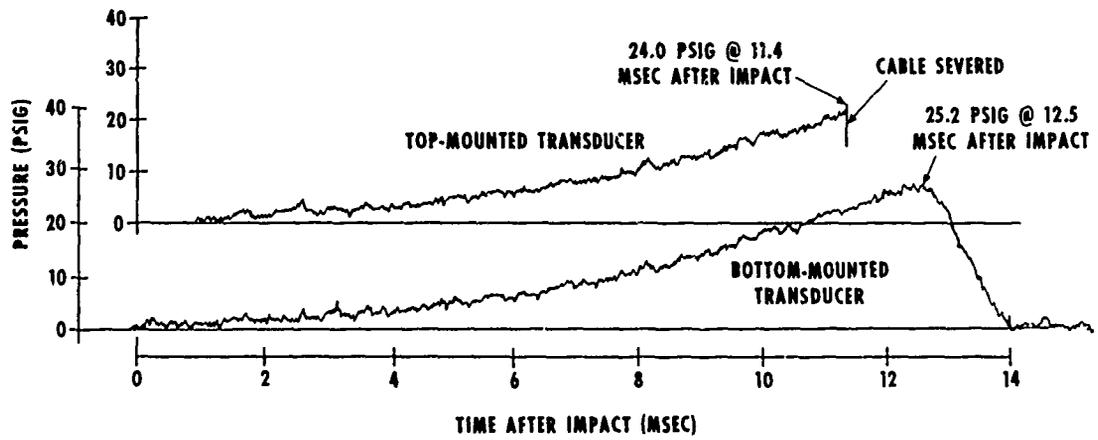
The pressure-time histories obtained during the test are shown in Figure 14. The top transducer cable was severed by failing structure during the explosion and did not provide a complete history. However, it seems to parallel the reading of the front transducer, which indicated bladder failure at 25.5 psig, 0.125 second after impact. Note that this pressure corresponds closely to the pressure at failure of the UH-1B bladder tank.

Figure 14. Pressure-time histories obtained during AH-1 fuel tank overpressure tolerance test.

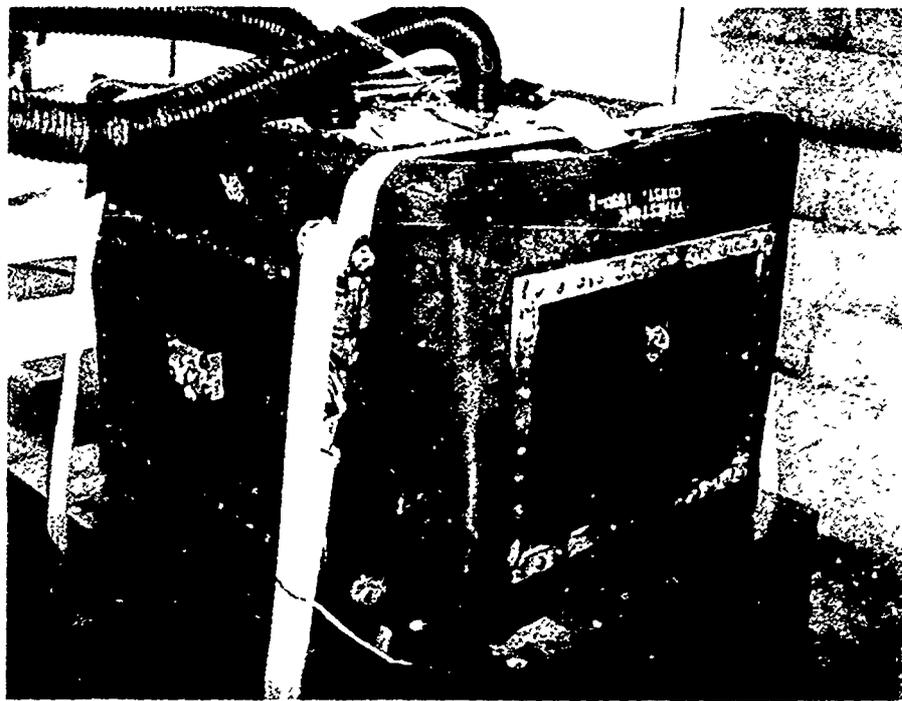
The unsupported cubes were simply strapped to a table as shown in Figure 15. A 0.125-inch-thick 2024-T3 aluminum function plate was taped to the front. Figure 16 is a photograph of the test equipment positioned in the ballistic backstop.

Figure 15. Unsupported MIL-CUBE test tank prior to test.

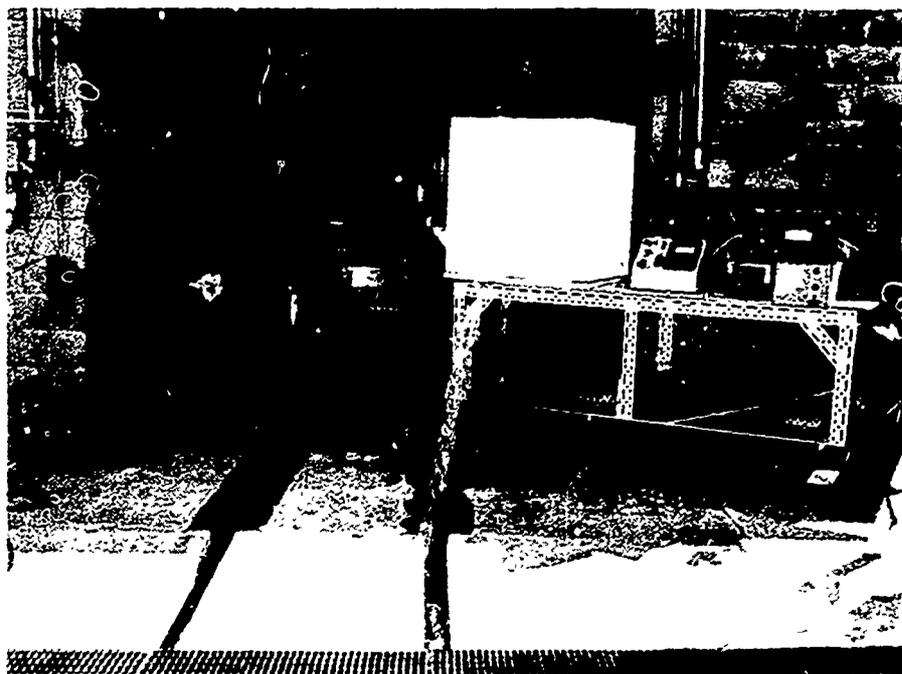
Figure 16 Unsupported MIL-CUBE test equipment at ballistic backstop.

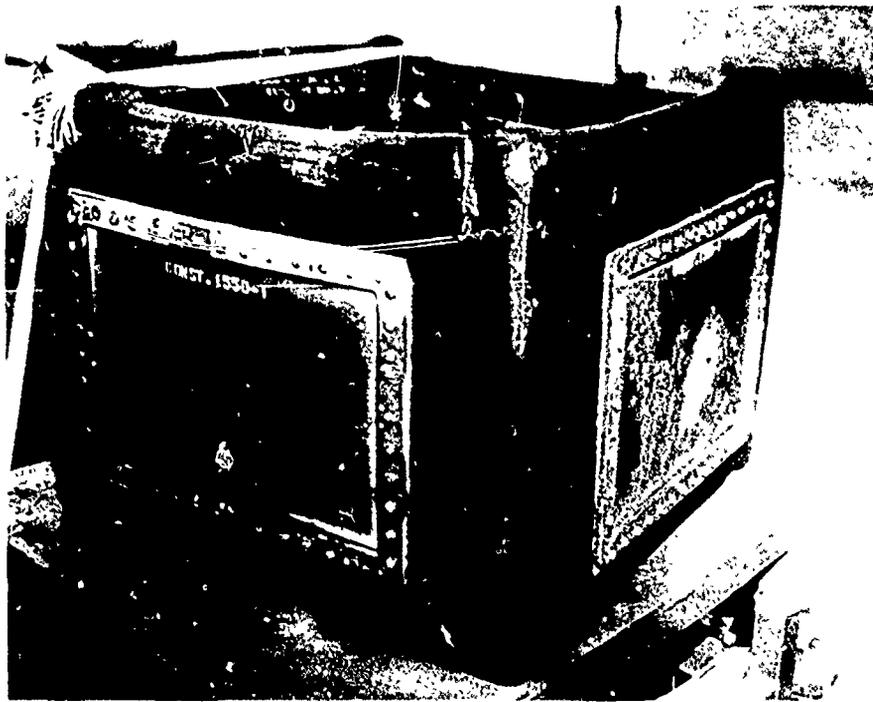
The first two tests were conducted with fuel/air mixtures higher than stoichiometric, resulting in moderate pressure rises that did not cause tank failure. Considerable venting was observed from the top access ports and several windows. The steel flanges were bent slightly during each test. The fuel/air ratio was lowered for the next two tests, resulting in pressure rises that caused catastrophic damage. In test 3 the entire top access port was blown off (see Figure 17), and in test 4 the front of the tank tore across the entire tank width and the escaping gases had enough reactive force to overturn the tank and table (see Figure 18). The tear in this tank, as well as the severe flange bending that also occurred in this test, is shown in Figure 19.

Figure 17. Damage resulting from MIL-CUBE test 3.

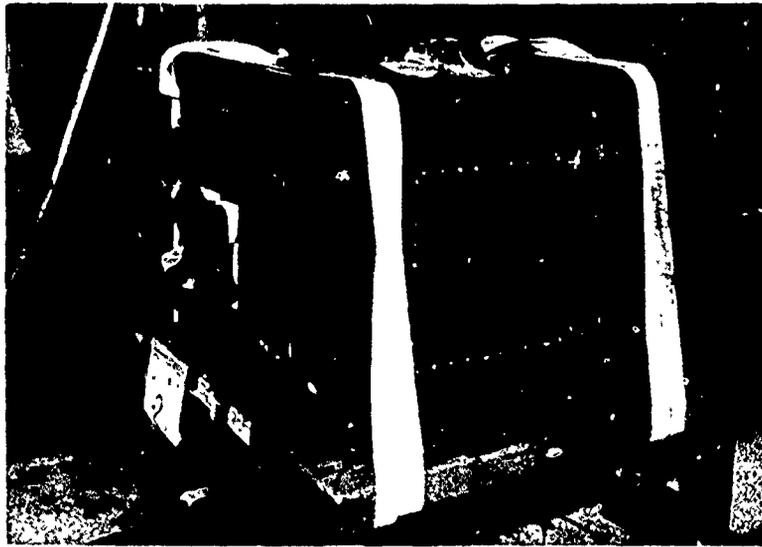
Figure 19. Tank damage resulting from MIL-CUBE test 4.

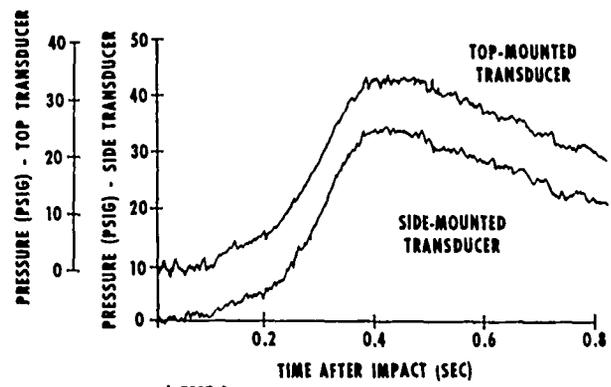
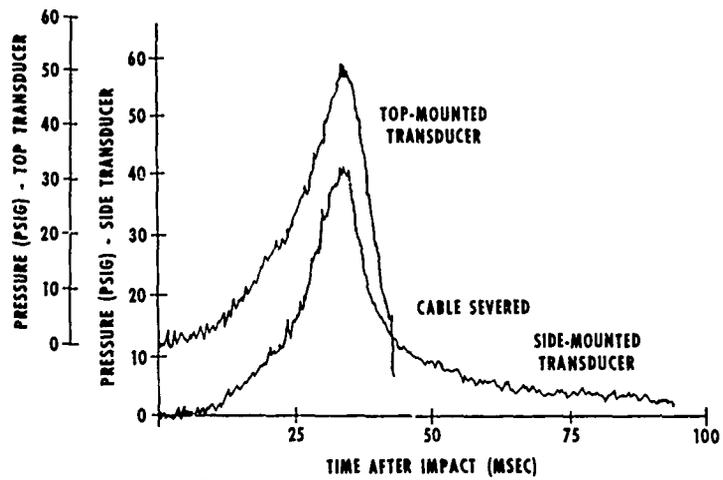
Tests results are summarized in Table 2. Representative pressure-time histories are shown in Figure 20 for tests 1 and 4. Note that the higher fuel/air ratio resulted in a longer time to peak and a lower peak pressure. This trend agrees with that observed in Reference 3. There appears to be good agreement between both transducers. Both tank failures occurred in the vicinity of the window fitting, which did not provide a true indication of the basic bladder material strength.

a) TEST 1

b) TEST 4

Figure 20. Pressure-time histories of MIL-CUBE tests 1 and 4.

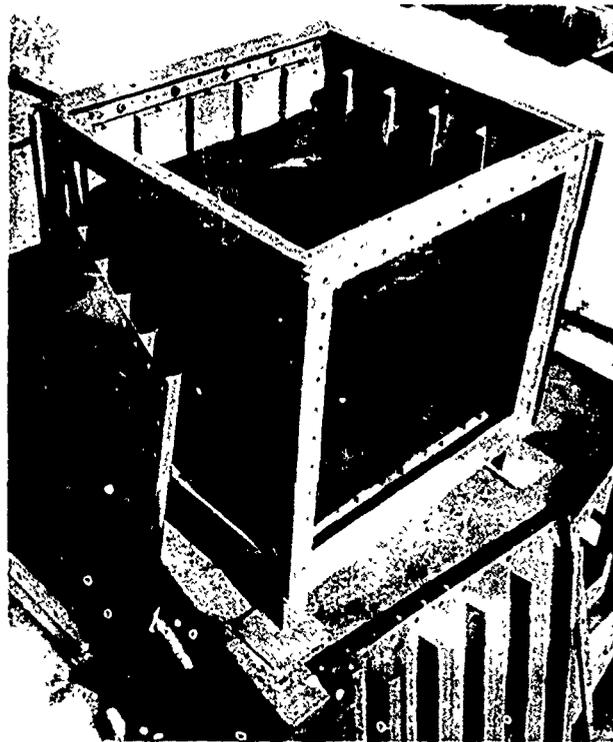
The fixture shown in Figure 21 allowed mounting of Z-bar reinforced aluminum panels on three sides of the tank. The bottom and one side were channel reinforced steel panels. The location of the vapor transfer and sample lines and instrumentation probes prior to testing is shown in Figure 22. The space above the tank was filled with Thermarest rigid foam during the actual testing. The aluminum panels were fabricated from 0.063-inch-thick 2024-T3 for tests 5 through 9 and from 0.090-inch-thick material for tests 10 through 15. In tests 11 through 15 the space between the Z-bars was filled with Thermarest rigid foam.

Figure 21. Fixture used in structurally supported MIL-CUBE tests.

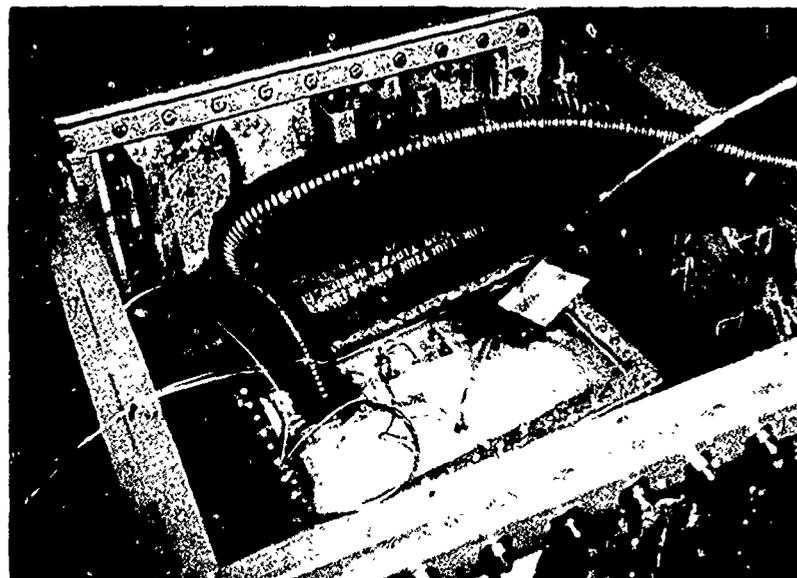
Figure 22. Location of vapor transfer and sample lines in supported MIL-CUBE tests.

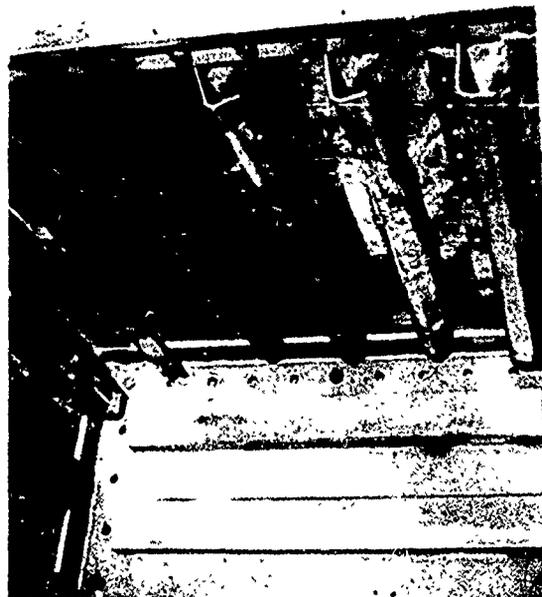
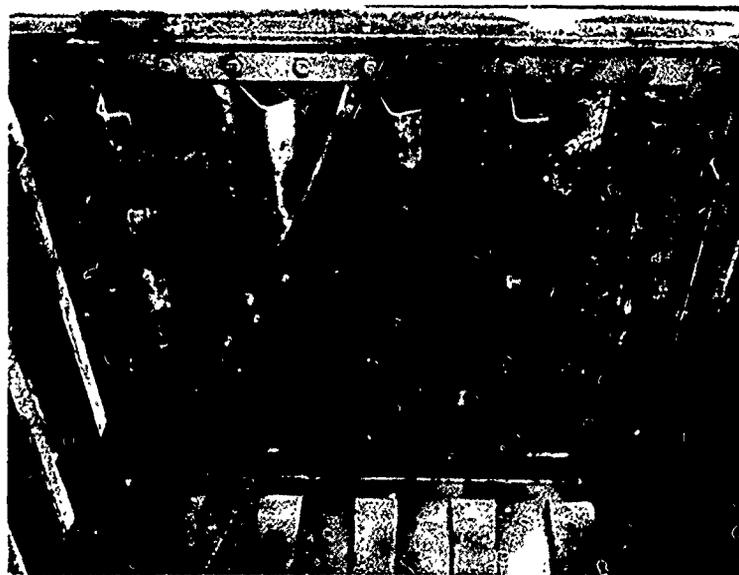
In test 5 the 32 psig pressure rise caused no tank damage and only moderate Z-bar damage. The Z-bars were slightly bent and a few rivets were popped (see Figure 23). The fuel/air ratio was increased for tests 6 through 8, resulting in pressure rises around 60 psig and increased structural damage as shown in Figure 24. The bladder itself was basically undamaged; however, the top cover and windows came loose and resulted in considerable venting during the pressure rise. In test 9 the pressure rise of about 70 psig caused the bladder to tear across the back as shown in Figure 25. In test 10, a 0.090-inch-thick aluminum structure was used and the 68 psig pressure rise resulted in less Z-bar damage (Figure 26). The cube, which had no side windows, failed at the top access cover (Figure 27). Tests 11 through 15 with Thermarest foam-filled 0.090-inch-thick Z-bar reinforced structure resulted in only minor structural damage and no bladder damage (Figure 28). Three consecutive tests, 12 through 14, were conducted on the same tank and the damage was limited to the entrance and exit holes.

Figure 23. Structural damage resulting from MIL-CUBE test 5.

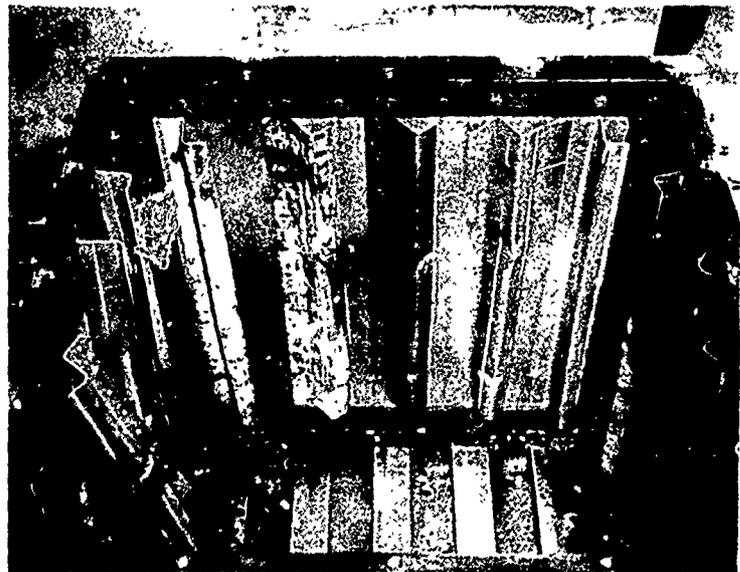
Figure 24. Structural damage resulting from MIL-CUBE test 6.

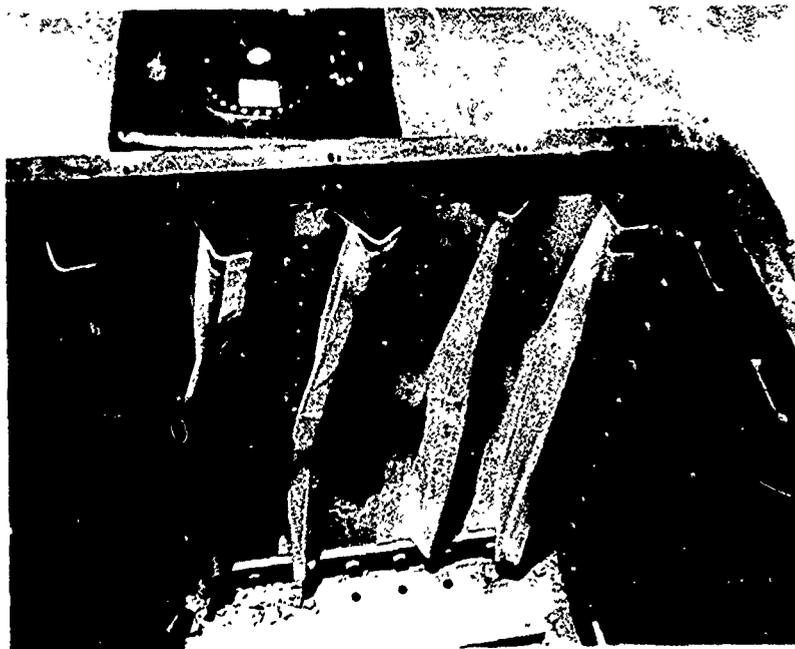
Figure 26. Structural damage resulting from MIL-CUBE test 10.

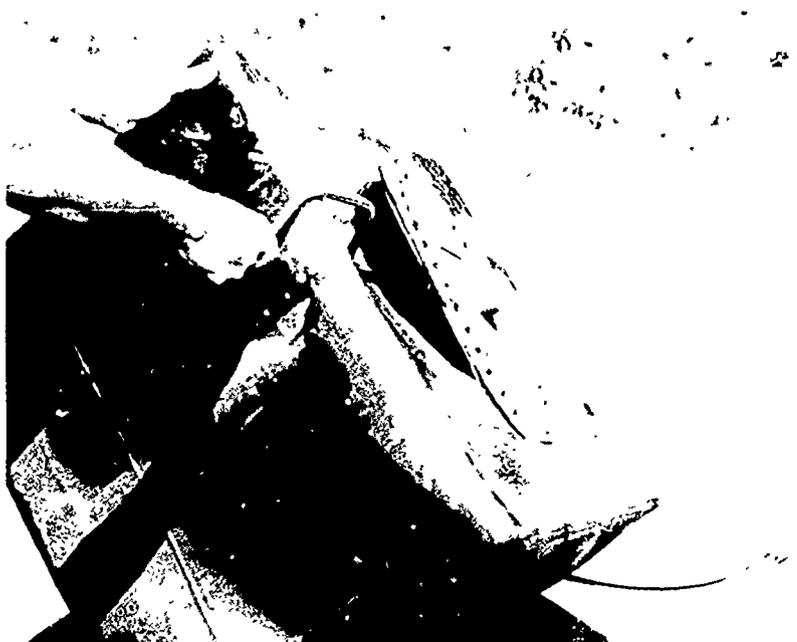
Figure 27. Access cover failure resulting from MIL-CUBE test 10.

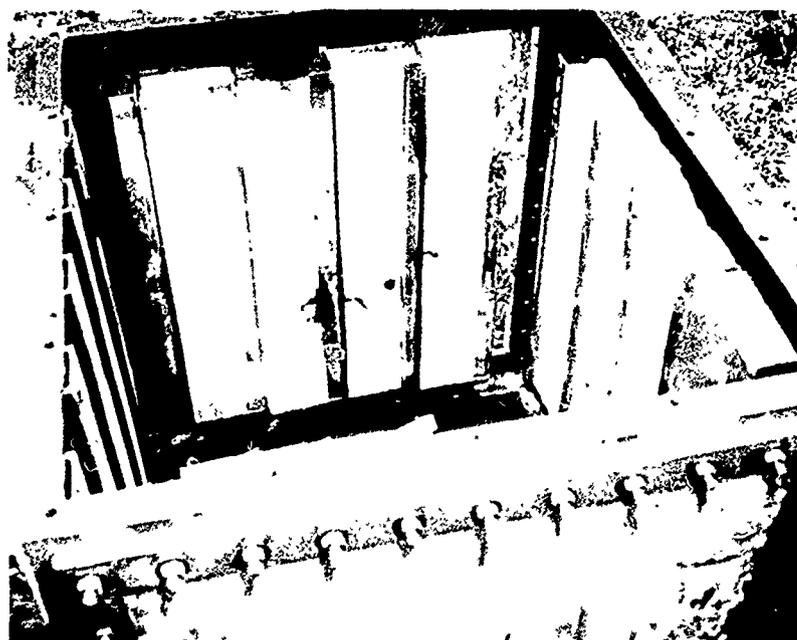
Figure 28. Typical structural damage resulting from MIL-CUBE tests 11 through 14.

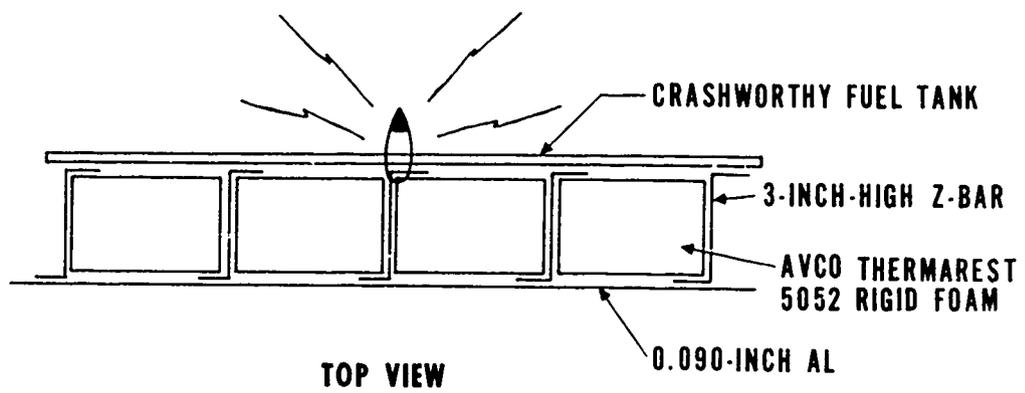
Test 15 was conducted with 23mm HEI-T at an impact velocity of 2420 feet per second. The projectile had an MG-25 (delay) fuse, so detonation occurred after penetration as shown in Figure 29. The projectile was expected to detonate further into the tank; however, it may have been slowed by the relatively heavy aluminum structure, its impact point on the Z-bar, and the presence of rigid foam. Photographs of the damage are shown in Figure 30. The exit sides sustained damage from the large fragments, but the wider cone of smaller fragments did only minor damage. Most of these fragments were imbedded in the crashworthy tank material; only a few penetrated the entire structure. In spite of the high internal pressure generated by both the blast and subsequent combustion, there was only minor structural damage and no tank damage attributable to this failure mode. The pressure-time history for this test is shown in Figure 31.

Figure 29. Sketch of 23mm HEI-T detonation location.

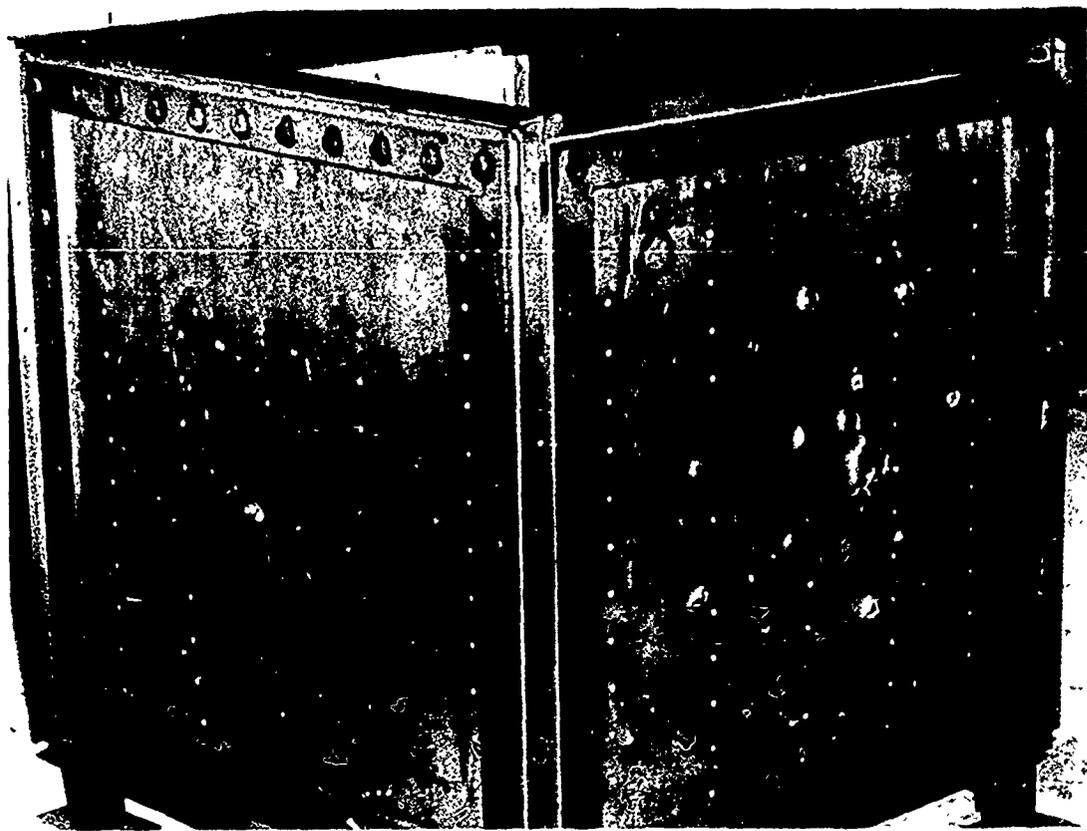
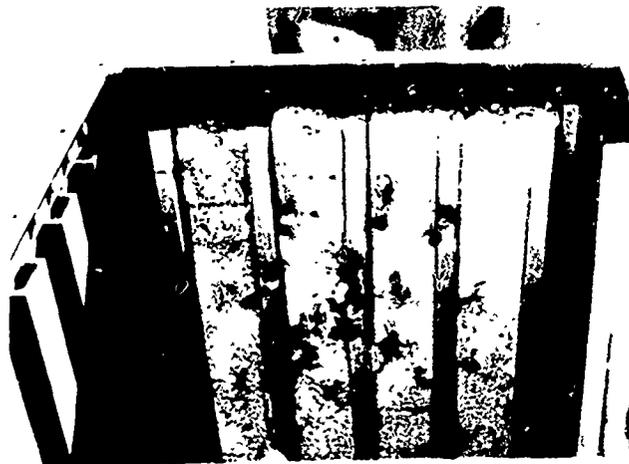
(a) Entrance hole in bladder

Figure 30. Damage resulting from MIL-CUBE test 15.

(b) Damage to structure, exit and right side

(c) Interior damage to exit panel

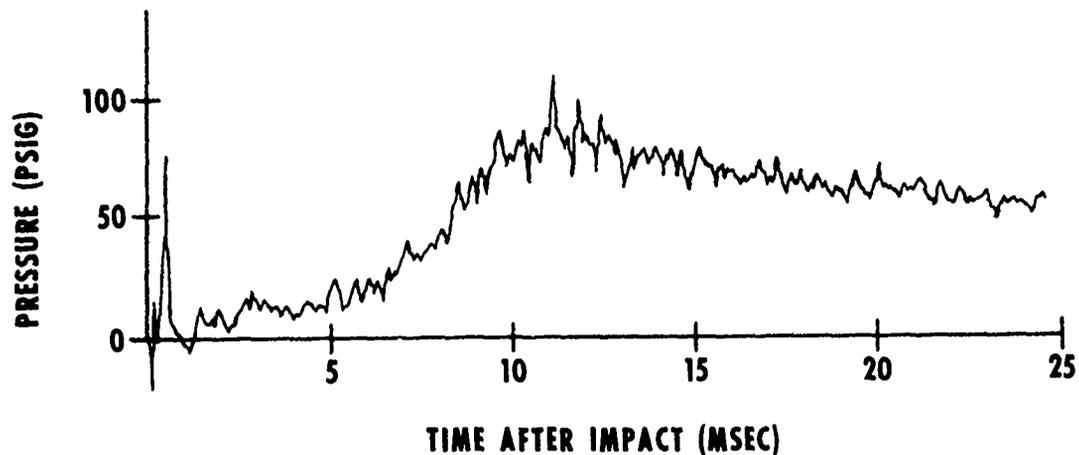
Figure 31. Pressure-time history of test 15.

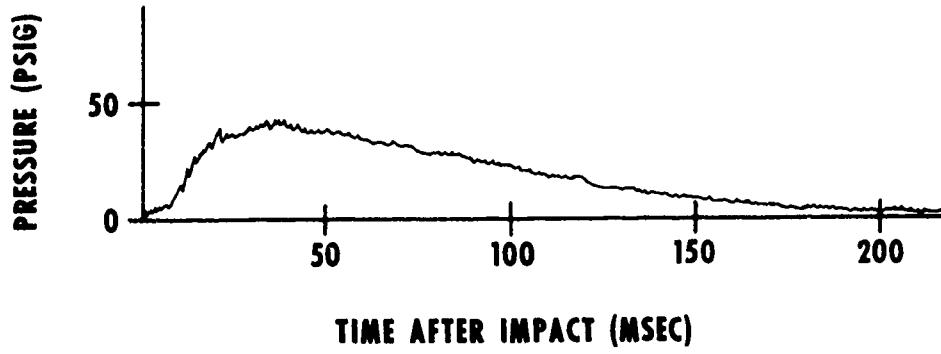
The filler cap in the upper-right tank was modified to permit injection of fuel/air vapors and mounting of a pressure transducer. Connections to the lower tanks were blocked. The tank was filled with a 1.5-percent JP-4 by volume mixture and impacted with a caliber .30 M1 incendiary through the outside wall at the middle of the tank. The resulting pressure-time history is shown in Figure 32.

Figure 32. Pressure-time history of UH-1H tank (upper right).

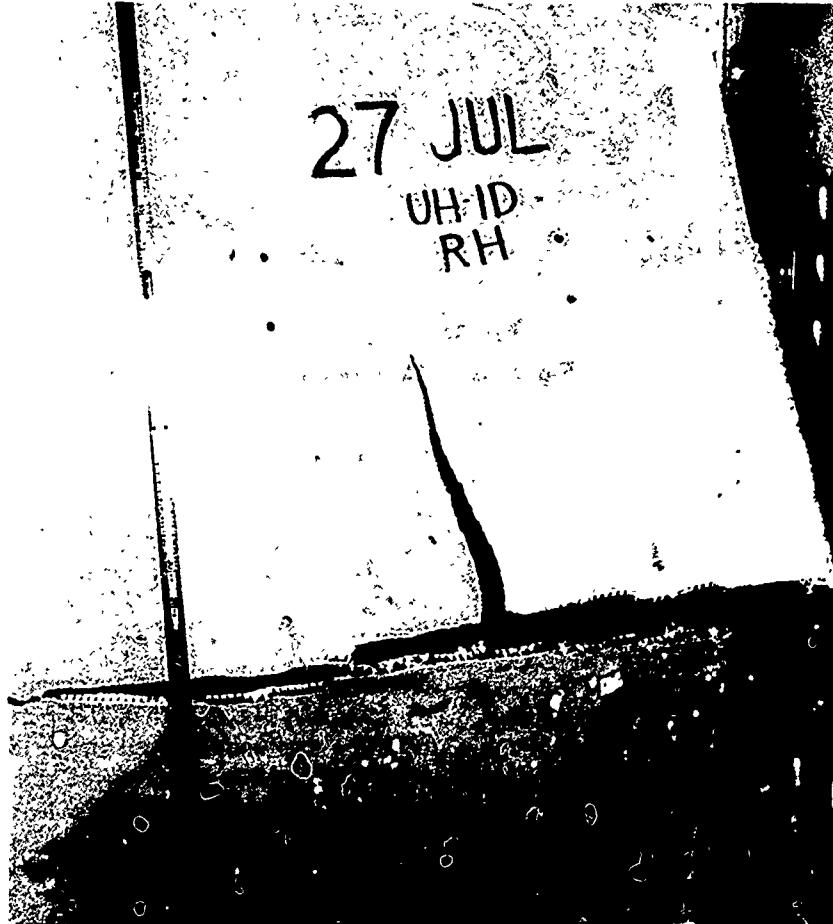
The honeycomb structure on the front and rear of the tank was damaged as shown in Figure 33, but the tank itself was not damaged. The pressure rise was not as high as expected. Since the fore and aft walls of the cavity failed, expansion of the bladder could have reduced the pressure. Also, some pressure relief occurred through the vent.

(a) Forward panel

Figure 33. Damage to upper-right UH-1H tank structure.

(b) Aft panel
Figure 33. Continued.
