RECORDS POND DAM

PHASE I INSPECTION REPORT

NATIONAL DAM SAFETY PROGRAM

DE 00057

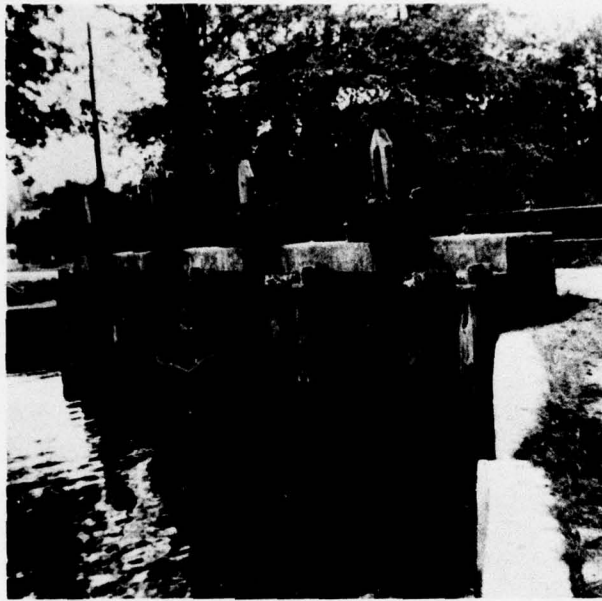
The Records Pond Dam consists of four sluiceways or culverts controlled by movable, hand operated timber gates flanked by an earth causeway or dam. This causeway is Willow Street and the sluiceway or culverts are referred to as the Willow Street Bridge. A complete inspection of the gates was not possible since approximately eight (8) inches of water was flowing over them at the time of the inspection.

UPSTREAM FACE WITH GATES

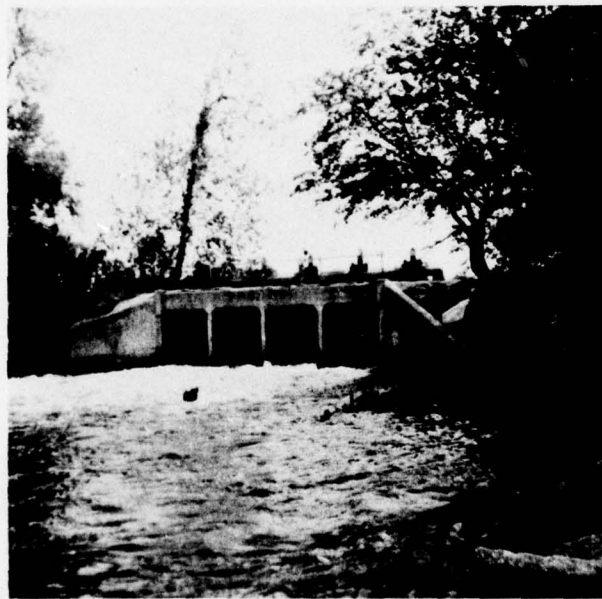
Although the structure was completed in 1900, it appears to be in fairly good condition. Aggregate is exposed in the concrete along both wing walls but no serious cracking is apparent.

FOUR CELL BOX CULVERT DOWNSTREAM VIEW

2. Bridge/Box Culverts - Aggregate is exposed in the concrete but no serious cracking was observed. A full inspection of the timber gates was not possible since overflow was occurring but the hand operated controls and the timber gate stems were in satisfactory condition. Large trees are directly adjacent to the structure.

Large trees adjacent to the present abutments and wingwalls should be removed.

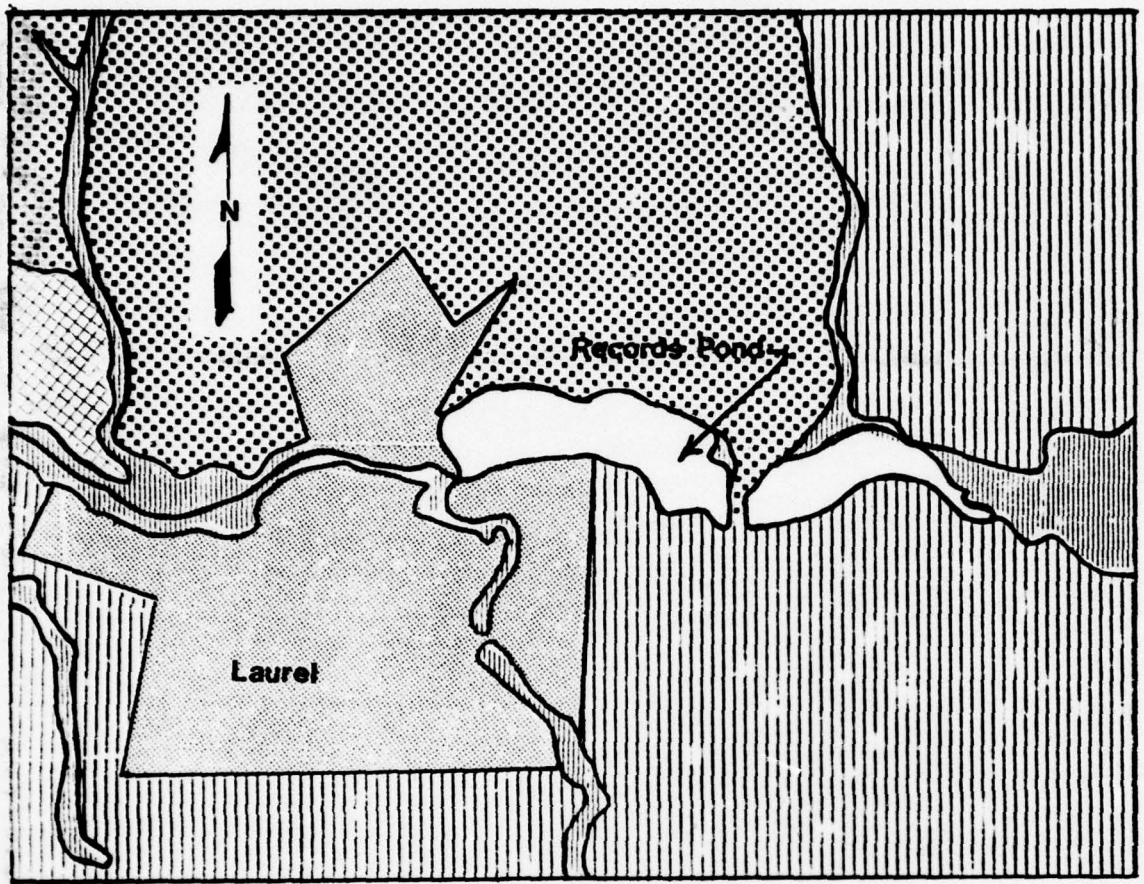
Figure 2
Geological Map

e. Seismic Stability - The structure is located in relatively featureless topography within the Atlantic Coastal Plain physiographic province of southern Delaware. Relief in the general area ranges from elevation 5 to 40 MSL datum. The dam is founded in Recent alluvium and abuts on silty to clayey sandy unconsolidated sediments of the Pleistocene Columbia formation. Bedrock is of no consideration in the foundation of this dam.

-  
AM2/24 - Sandy soil
-  
AM2/23 - Poorly graded sandy soil
-  
AR Z - Alluvial gravel, silt, sand and clay
-  
AM12/24 - Gravelly and sandy soil
-  
Laurel, DE

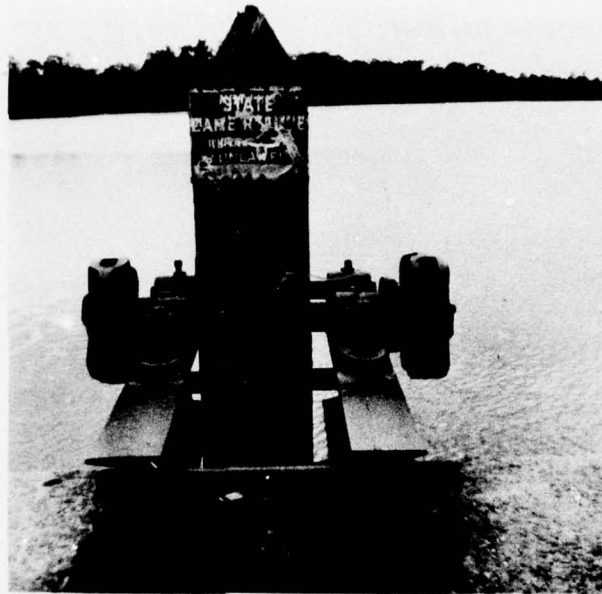
TYPICAL GATE CONTROL

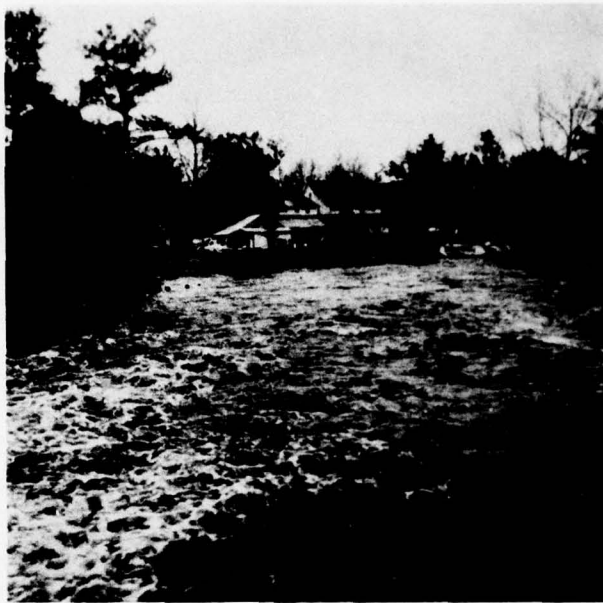
d. Hazard Classification - Significant development is present immediately downstream of this structure and serious flooding would result in damage to personal property and, possibly, loss of human life. Therefore, Records Pond Dam should be classified in the high hazard category as defined by the Recommended Guidelines for Safety Inspection of Dams.

DOWNSTREAM RESIDENCES, LEFT BANK

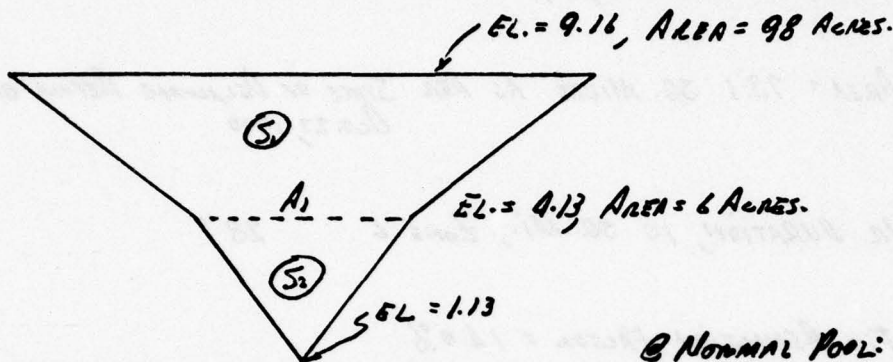
DRAWDOWN COMPUTATIONS

@ NORMAL POOL:
EL. = 8.9
STORAGE = 270 AC. FT.
AREA = 90 ACRES.

$$\begin{aligned} \text{EQ. 1)} & (98 + A_1) / 2 \times 5.03 = S_1 \\ \text{EQ. 2)} & (A_1 + 0) / 2 \times 3 = S_2 \\ \text{EQ. 3)} & S_1 + S_2 = 270 \text{ AC. FT.} \end{aligned}$$
