An Investigation Into the Use of Polymer-Concrete for Rapid Repair of Airfield Pavements

AIR FORCE INSTITUTE OF TECHNOLOGY
WRIGHT-PATTERSON AFB, OH 45433

JANUARY 1978

FINAL REPORT FOR PERIOD JUNE 1977-DECEMBER 1977

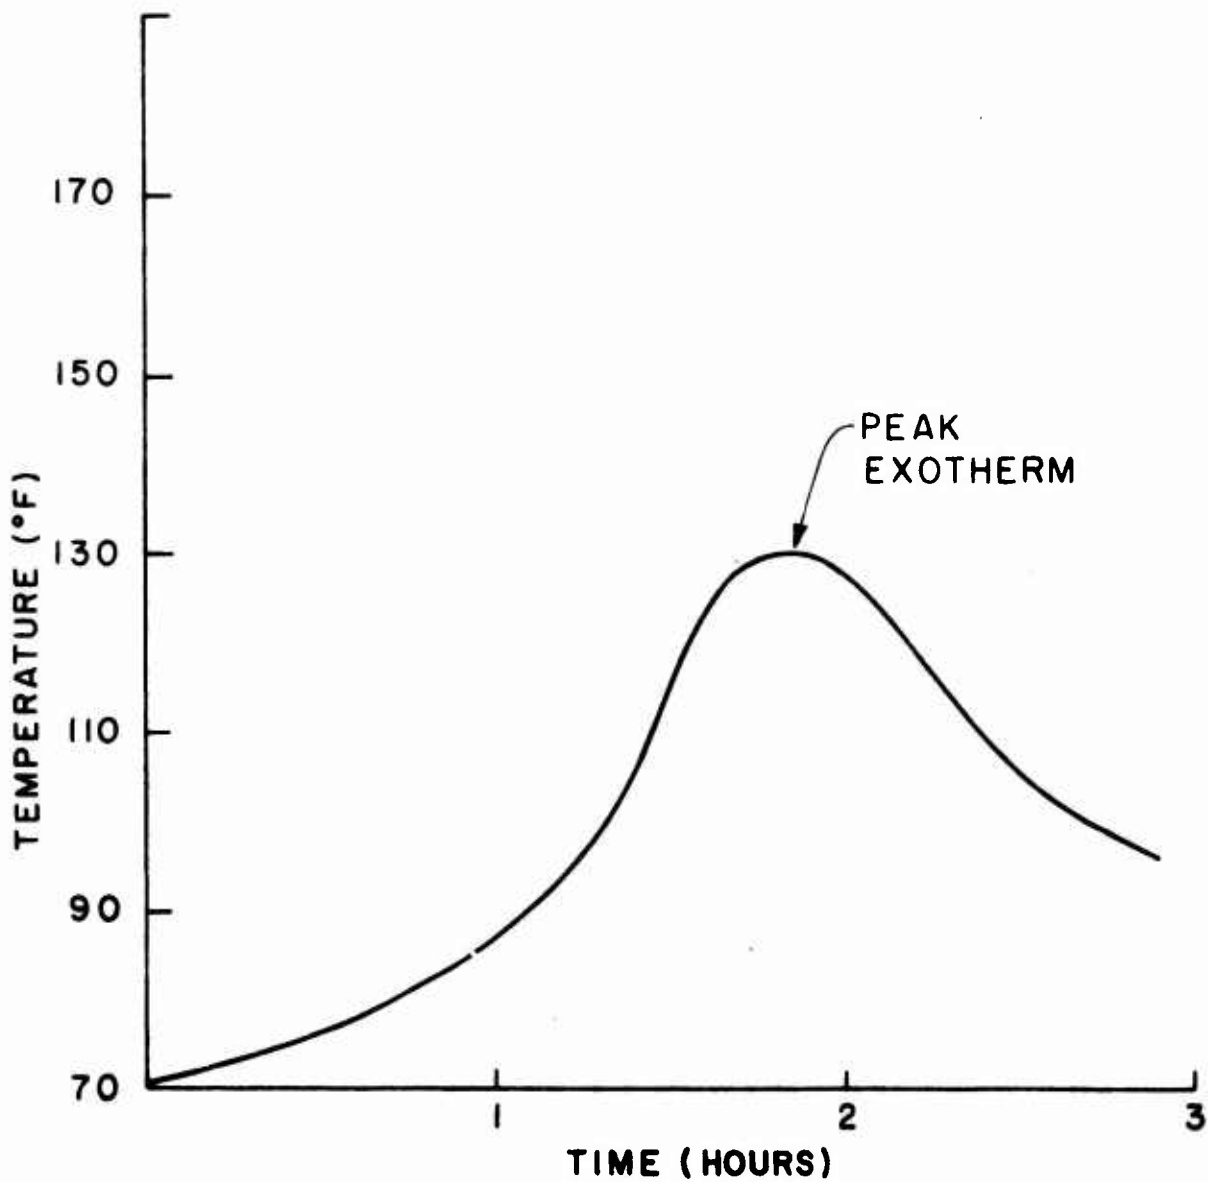
Figure 5. Typical Time Temperature Curve for PC

The results of the tests showed conclusively, for all formulations, that the higher the ambient temperature the less time was required to reach the peak temperature. Conversely, the lower the ambient temperature, the longer the set time.

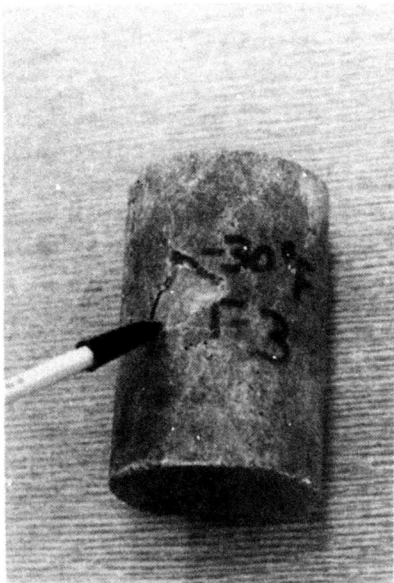
Figure 13. Failure Plane Through Large Aggregate

Just as portland cement concrete depends largely on the strength of the aggregate for the strength and modulus of elasticity so does polymer-concrete. Polymer-concrete can be made from dense, lightweight, and normal aggregates just like portland cement concrete. The stronger the aggregate the stronger the PC. In most cases, the failure plane in PC tends to pass through the large aggregate (Figure 13). In tensile tests, it is common to see the failure plane pass through more than half of the large aggregate (Figures 14 and 15).

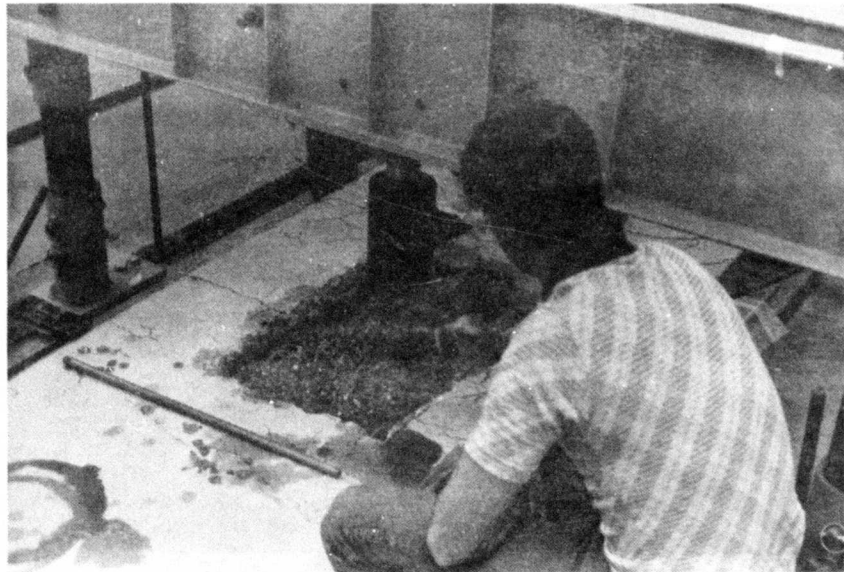
Figure 25. Slab 1 Being Rodded

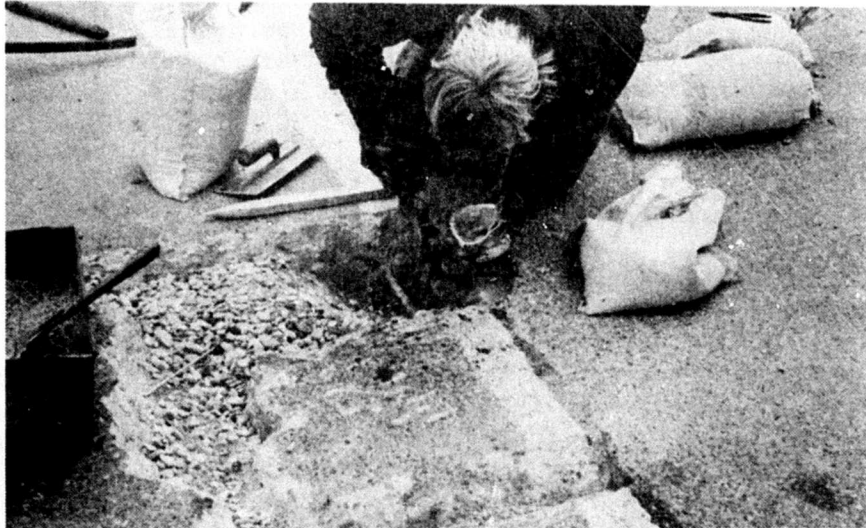
Figure 41. Repair Area 3 Interstate Highway 35

Area 1. The repair measured 66 x 30 inches by 8 inches deep and was bounded by an expansion joint to the north side. Unsound concrete and asphalt joint filler were removed with an air hammer, and loose debris was cleaned out with compressed air (Figure 40). The concrete was then dried with a portable butane heater to remove possible moisture due to the rain which had fallen the previous day. The bottom of the repair was coated with polyester putty to preserve the expansion joint. Polyester putty was also applied to the vertical face of the adjoining slab, and a 1 x 8-inch board was placed vertically to maintain the expansion joint. A sand and gravel mixture of dried aggregate (40:60 ratio by weight) was placed in the void and screeded to grade. The aggregate was then saturated with the monomer system and finished with concrete trowels at 11:00 AM (Figure 41). There was some leakage at

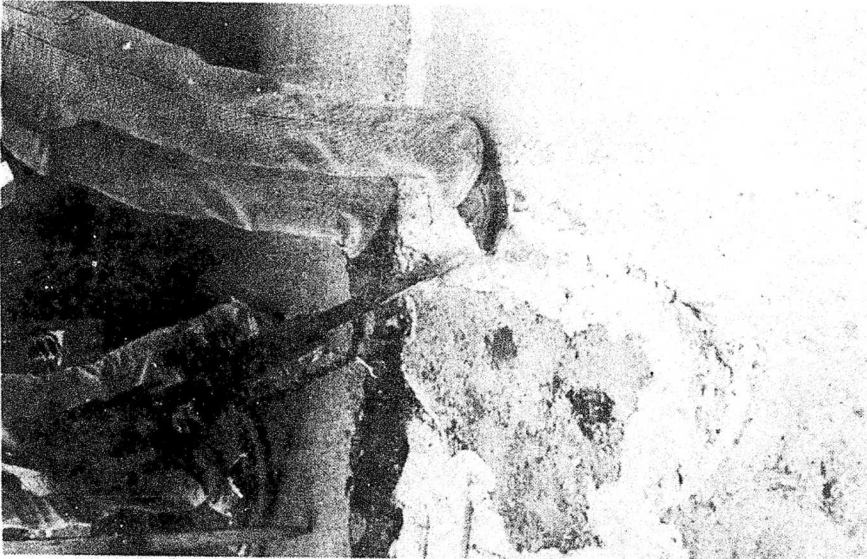
Figure 44. Concrete Preparation

1. Unsound concrete was removed with an air hammer at least to the depth of steel, then loose debris was removed with compressed air (Figure 44).
2. The repair was sealed with polyester putty to seal cracks or protect asphalt shoulder (Figure 45).
3. The repair was filled with a sand and gravel mixture of dried aggregate (40:60 ratio by weight) (Figure 46).
4. Monomer was added to saturate the aggregate (Table 16) (Figure 47).
5. The PC was vibrated to remove entrapped air (Figure 48).
6. The surface was finished by screeding and then troweling to achieve the desired texture.
7. The repair was covered with polyethylene to prevent evaporation of monomer.

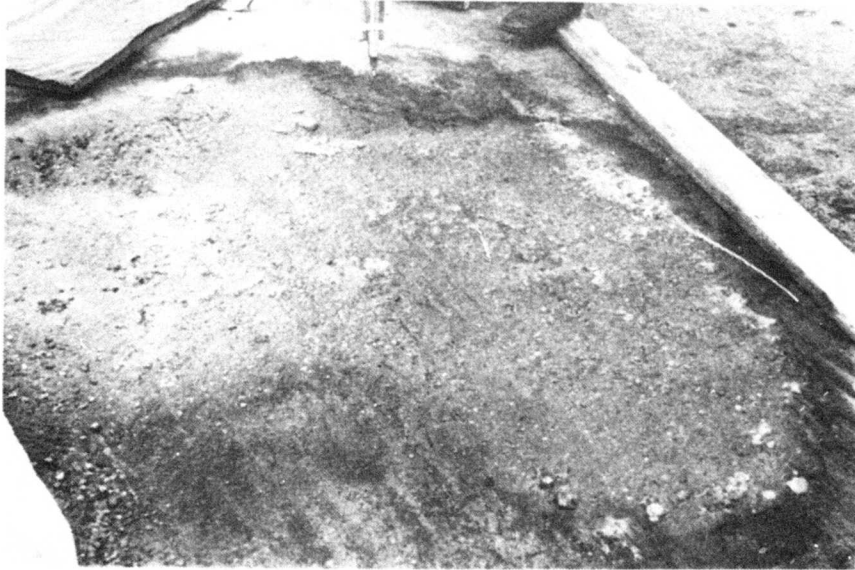
Figure 50. Blistering of Area 1

All repairs polymerized in less than 1 hour and were structurally sound. The surface of Repair Area 1 exhibited surface blisters which were theorized to be caused by expanding air from the exotherm reaction being trapped below the semi-hard surface of PC (Figure 50). The effect is only cosmetic and the "blistered" skin is quickly worn away by traffic. The reason for a preliminary surface hardening was the high ambient temperature and rapid cure time. The surface of Area 5 which was screeded rather than troweled contained less blistering of PC. The blistering was absent in Repair Areas 2, 3, and 4 which suggested that blistering was more of a problem in the deeper repairs (Figure 51). Both Areas 1 and 5 indicated a slight volumetric expansion resulting in the surface being 1/8 to 1/4 inch above concrete grade.

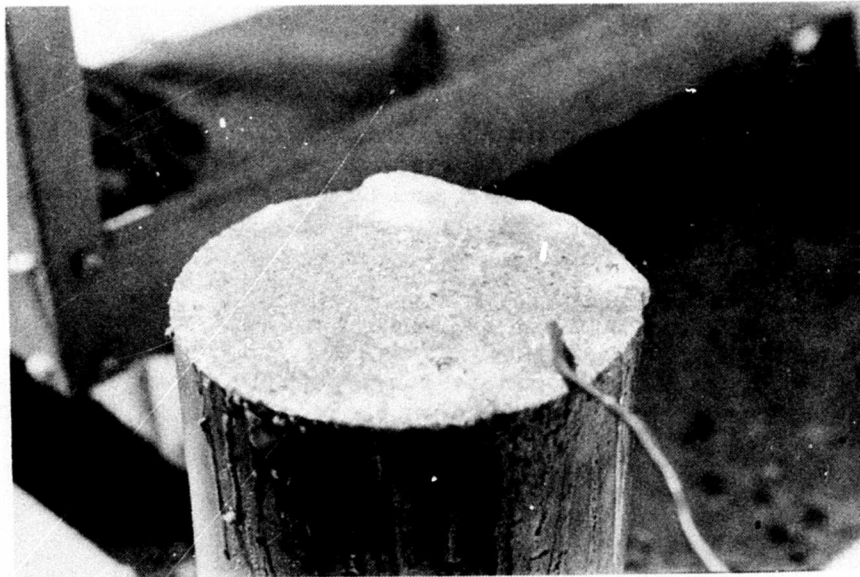
Figure 66. Close-up View of Blistered Speciment
