ELECTRICAL OVERSTRESS TEST PROGRAM AND INTEGRATED CIRCUIT FAILURE MODE EVALUATION

The BDM Corporation
P.O. Box 9274
Albuquerque International
Albuquerque, New Mexico 87119

26 April 1978

Final Report for Period May 1977—October 1977

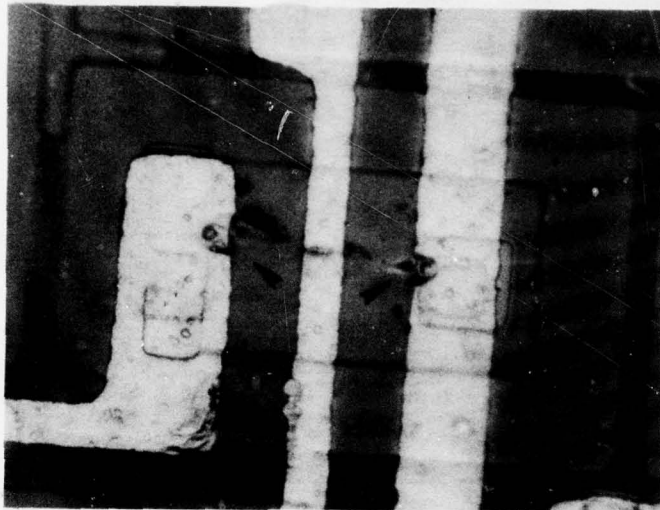
Another type of failure observed on DTL circuits with the inputs stressed was that of multiple junction shorts. This case is illustrated by unit 52, which was subjected to positive 10- μ s pulses and failed on pulse 6 at a power of 23.9 watts. In this case the Fairchild 5000 data showed an overrange of I_R plus a failure of V_{OH} , I_{CEX} , a decrease in V_{OL} and an increase in I_{SC} . These data would indicate that the input diode was damaged and the output transistor would not assume the high state. In order for the output transistor to go high for the V_{OH} test the input transistor must be turned off. This cannot be achieved if the emitter-base junction of Q_1 is shorted. The pre- and posttest curve tracer photos shown in Figures 23 and 24 indicate shorts not only at the input diode and the Q_1 (E-B) junction but at D_1 as well. The photomicrographs of Figures 25, 26, and 27 illustrate the junction shorts of junctions D_1 , Q_1 (E-B) and D_2 respectively on unit 52.

Figure 25. Photomicrograph of D_1 junction short on 946 HC unit 52.

Figure 26. Photomicrograph of Q, (EB) junction short on 946 HC unit 52.

Figure 27. Photomicrograph of D_2 junction short on 946 HC unit 52.
