AN INVESTIGATION OF THE USE OF POLYMER-CONCRETE FOR
RAPID REPAIR OF AIRFIELD PAVEMENTS

MICHAEL THOMAS MCNERNEY, B.S. C.E.

THESIS

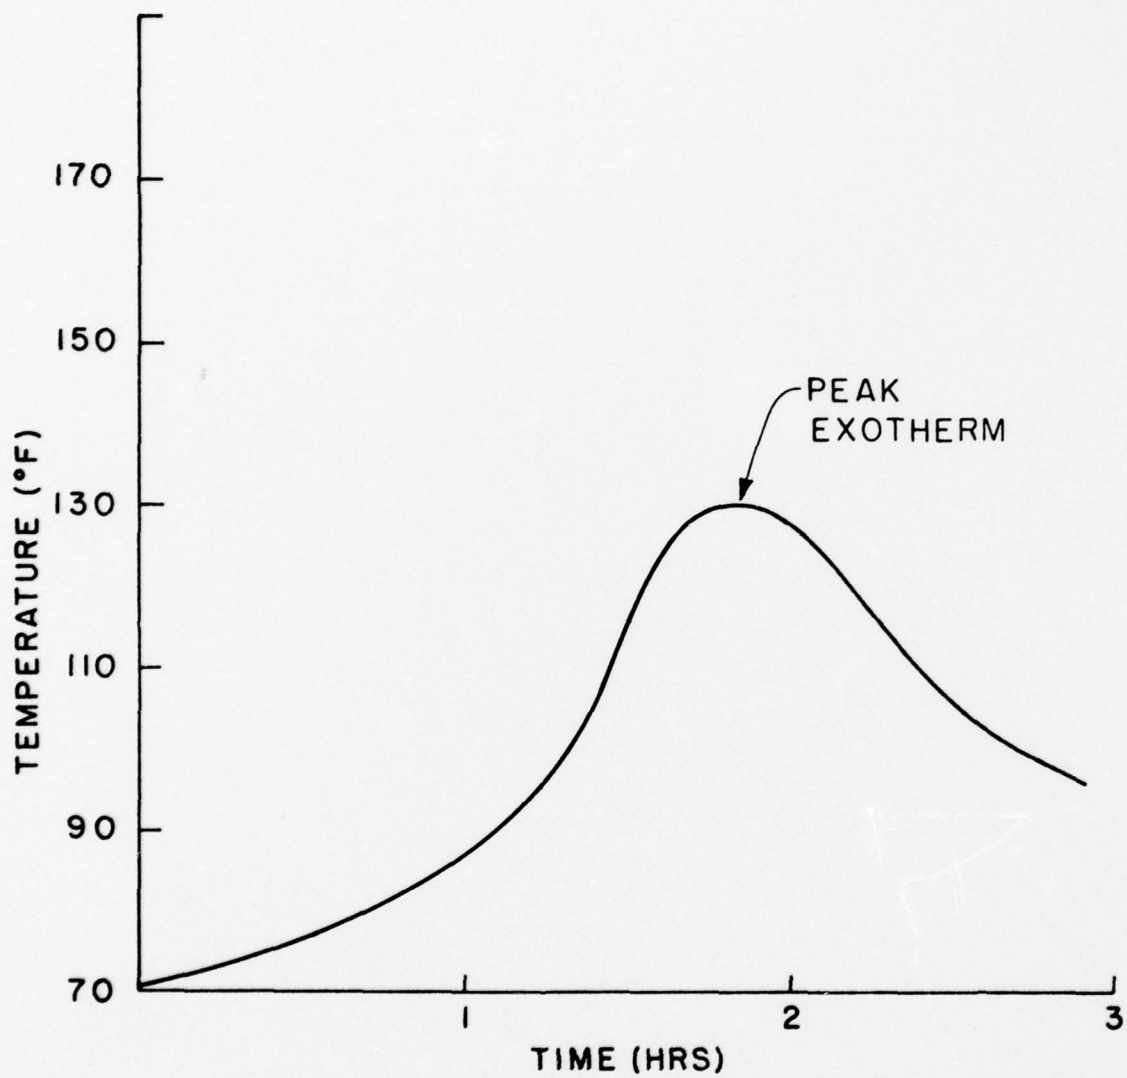
FIGURE 3.1 TYPICAL TIME-TEMPERATURE CURVE
FOR PC

Ambient temperature has one of the most significant effects on the time that it takes polymer-concrete to harden. A typical batch of polymer-concrete that is promoter-catalytic polymerized generates heat. In most cases, it is possible to monitor the temperature of the promoter-catalytic reaction and determine when polymerization has occurred. A typical plot of temperature versus time is shown in Figure 3.1. There are several factors which affect the shape and time required to reach peak temperature. As a general rule, when polymer-concrete has reached peak temperature the reaction is essentially complete. As the polymer-concrete cools, it hardens and reaches its maximum strength. Because polymer-concrete does not increase in strength with time, as in the hydration process of concrete, the time to reach maximum temperature is referred

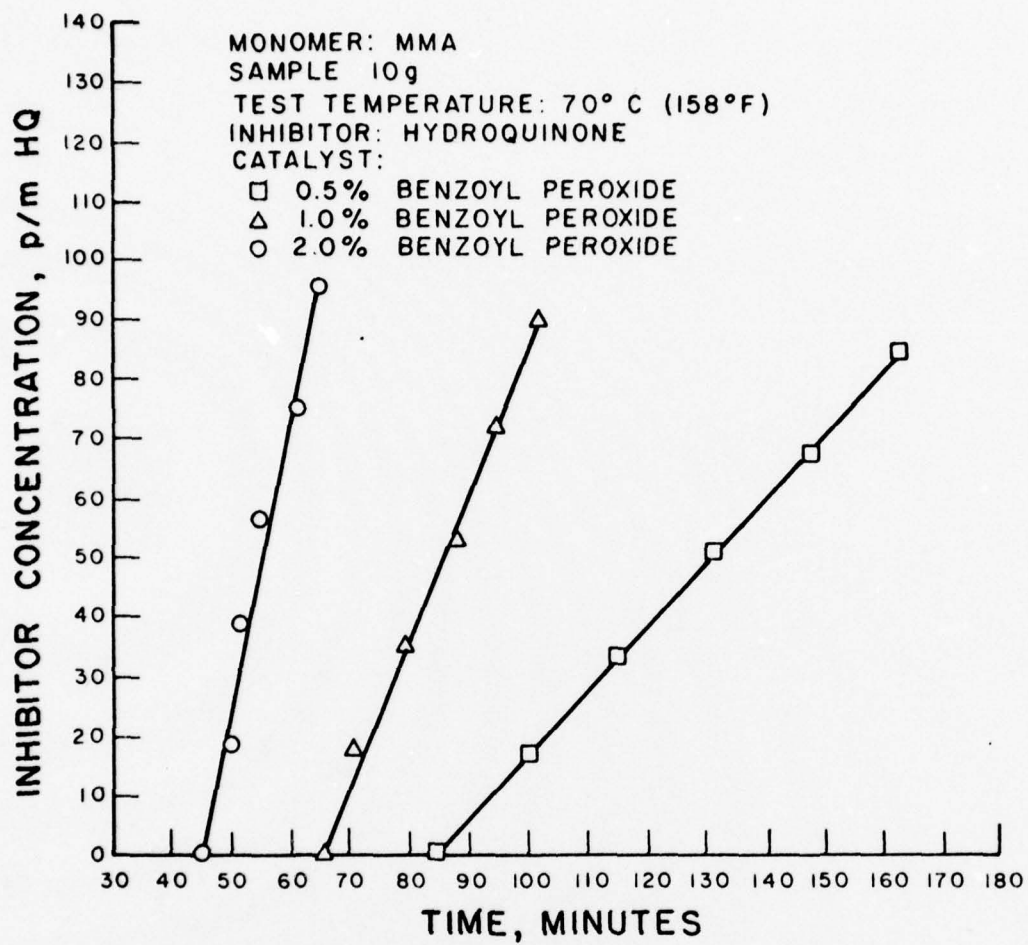
FIGURE 3.4 EFFECT OF INHIBITOR CONCENTRATION ON POLYMERIZATION TIME (2)

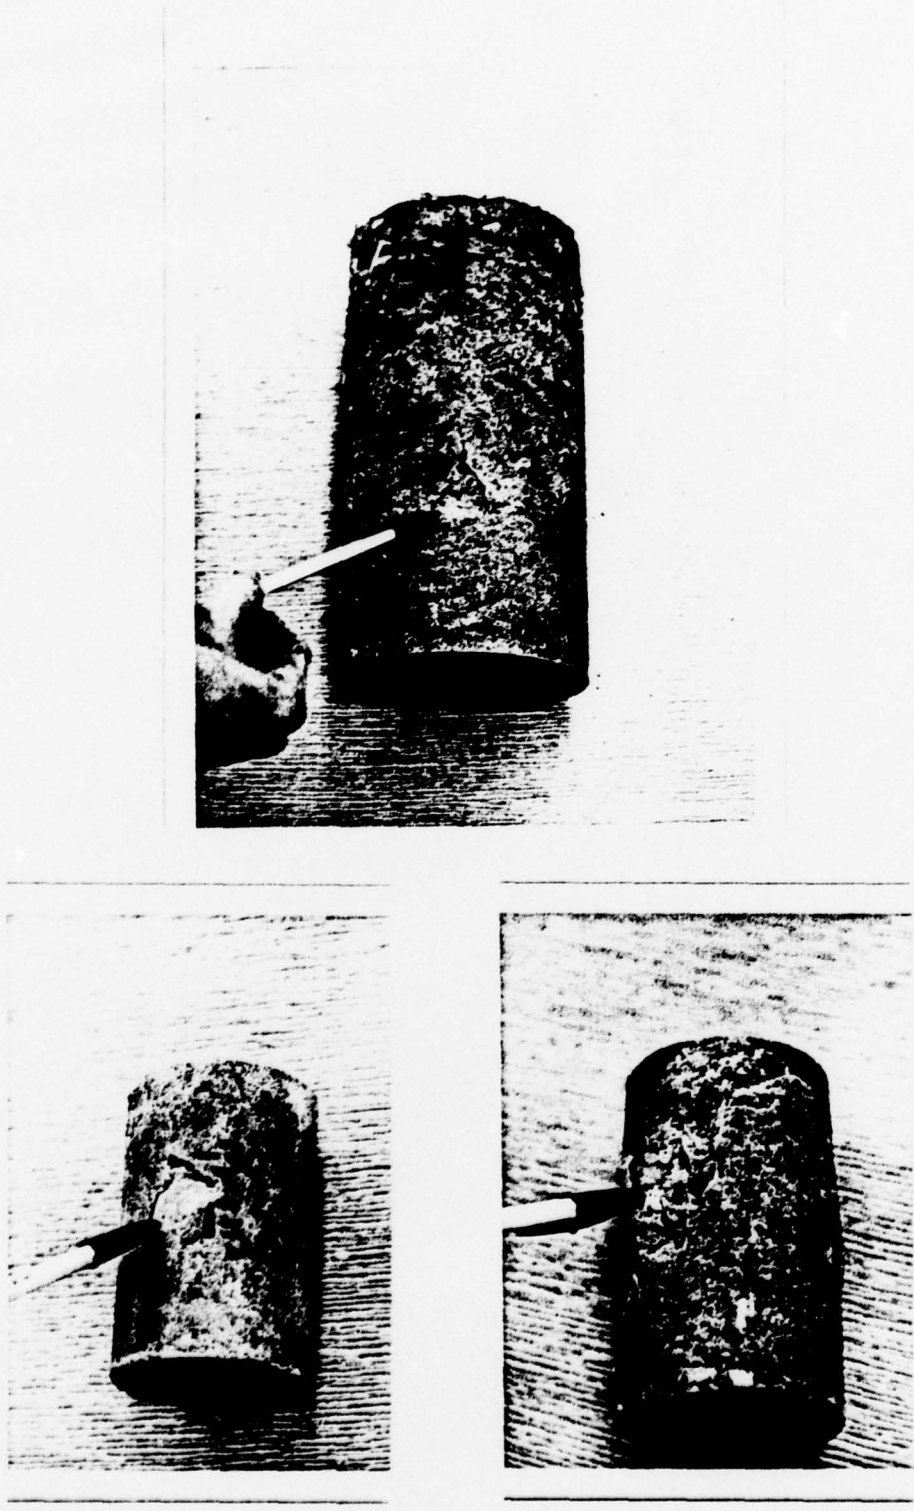
FIGURE 4.4 FAILURE PLANE THROUGH LARGE AGGREGATE

Just as portland cement concrete depends largely on the strength of the aggregate for the strength and modulus of elasticity so does polymer-concrete. Polymer-concrete can be made from dense, lightweight, and normal aggregates just like portland cement concrete. The stronger the aggregate the stronger the PC. In most cases, the failure plane in PC tends to pass through the large aggregate (Figure 4.4). In tensile tests, it is common to see the failure plane pass through more than half of the large aggregate (Figures 4.5 and 4.6).

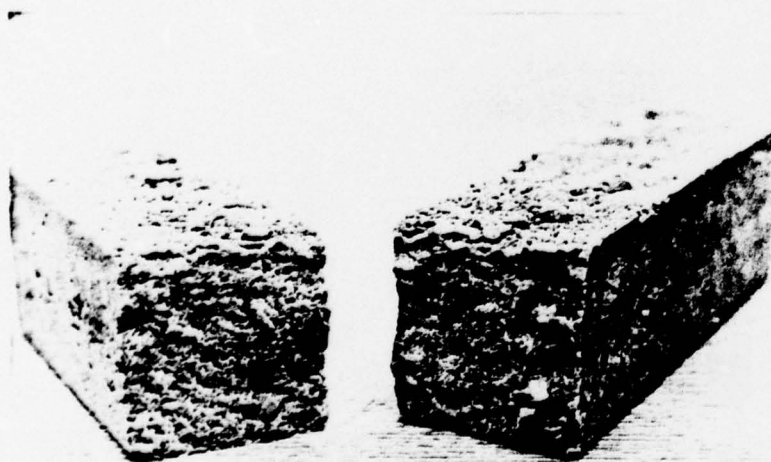
FIGURE 4.6 FAILURE PLANE OF PC BEAM

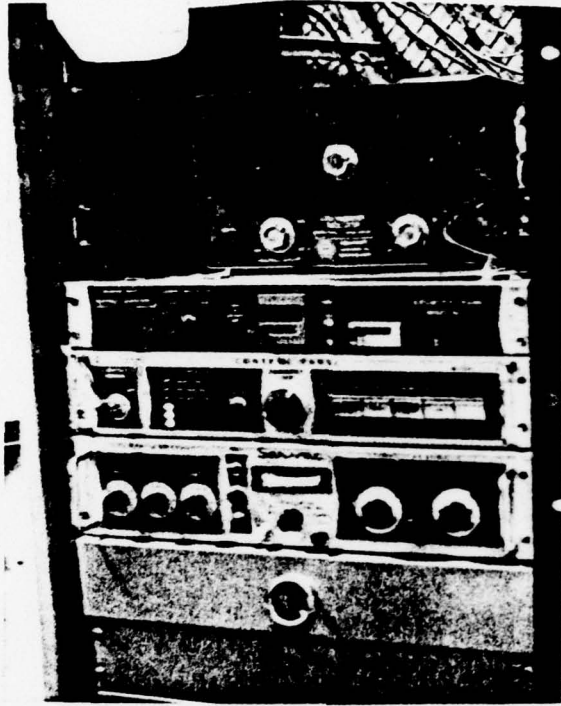
FIGURE 5.5 LVDT RECORDING EQUIPMENT AND
MTS LOAD MACHINE

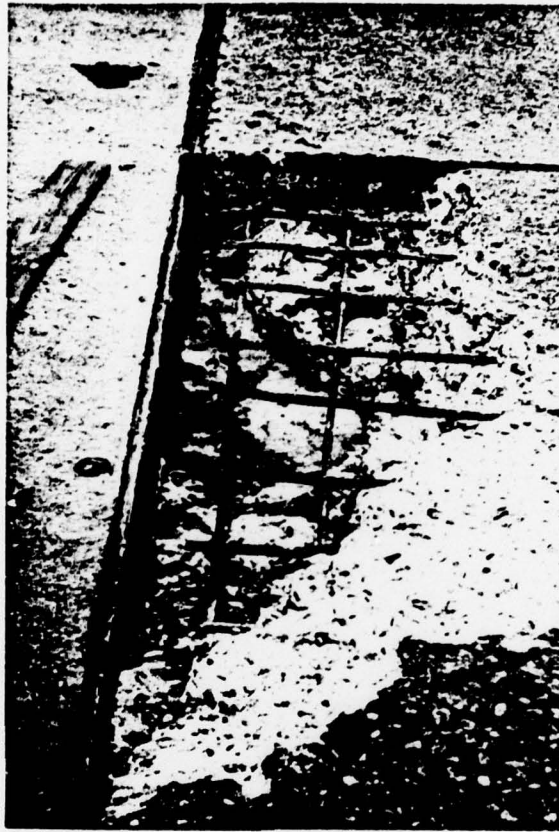
FIGURE 6.3 REPAIR AREA 1 AFTER REMOVAL OF CONCRETE

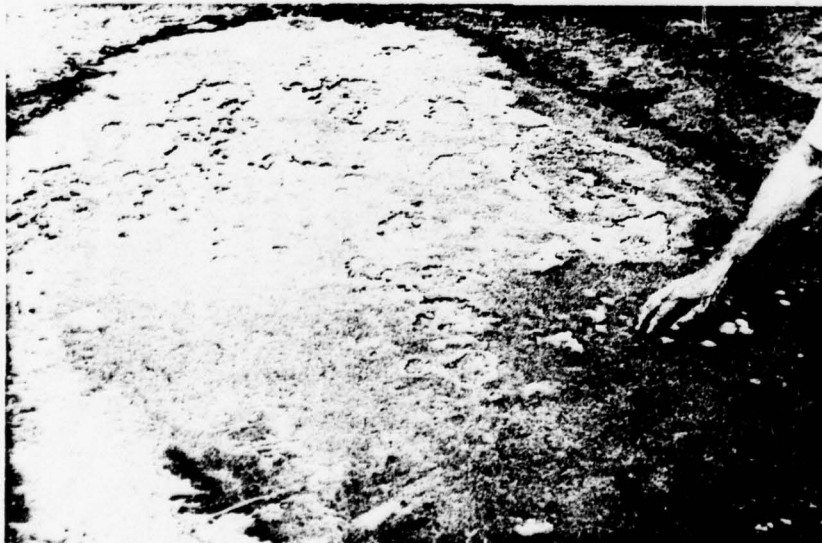
FIGURE 6.12 BLISTERING OF AREA 1

All repairs polymerized in less than one hour and were structurally sound. The surface of Repair Area 1 exhibited surface blisters which were theorized to be caused by expanding air from the exotherm reaction being trapped below the

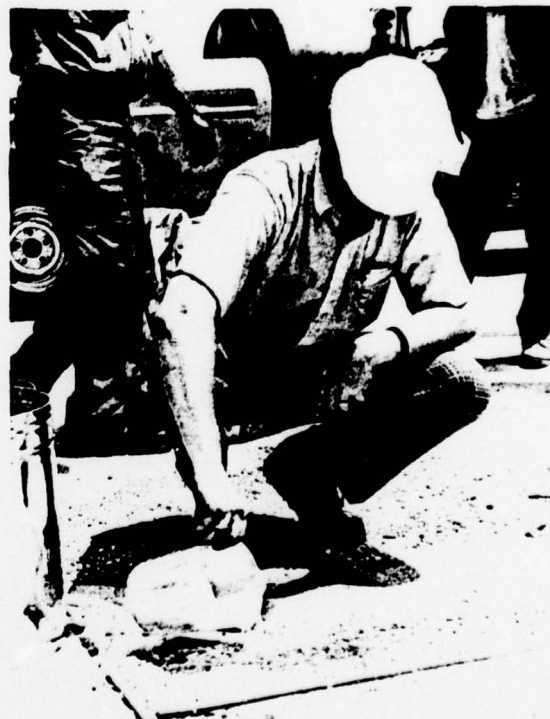
FIGURE 6.19 ADDING MONOMER
TO REPAIR
AREA 1

Area 1. The first repair was located at station 57 + 00 to 57 + 04, 12.5-ft. south of the centerline (Figure 6.15). The repair measured 45-in. by 9-in. with depths varying up to 6-in. and was bounded by two expansion joints (Figure 6.16). A temporary asphalt repair was removed with an air hammer (Figure 6.17) and sandblasting (Figure 6.18). The repair was then cleaned of loose debris with compressed air. The removal of all asphalt was deemed necessary because asphalt tends to retard the curing of the monomer system. Wood strips were fitted along the two edges to maintain the expansion joints. An approximate 50:50 mixture by weight of oven-dried 3/8-in. topping rock and sandblasting sand was placed in the repair and leveled to grade. The monomer system (Table 6.3) was added until the aggregate was saturated (Figure 6.19). The

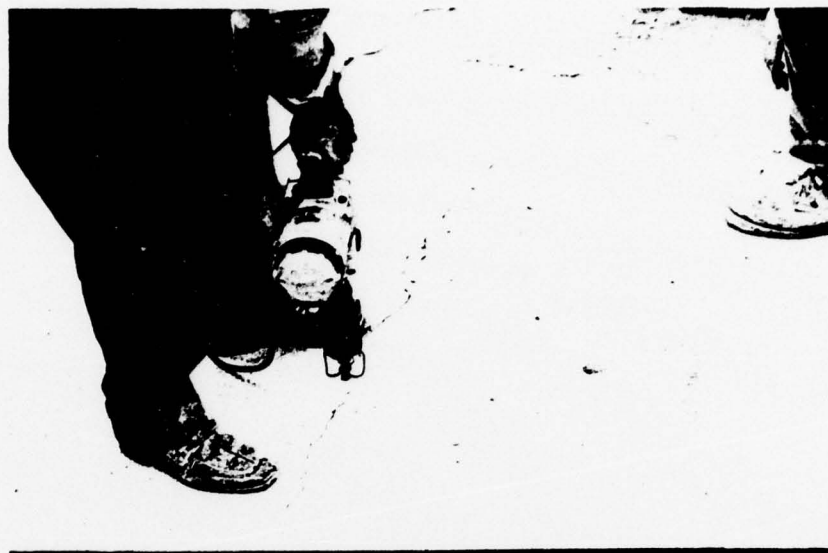
FIGURE 6.26 DRILLING HOLES ALONG CRACK IN AREA 4

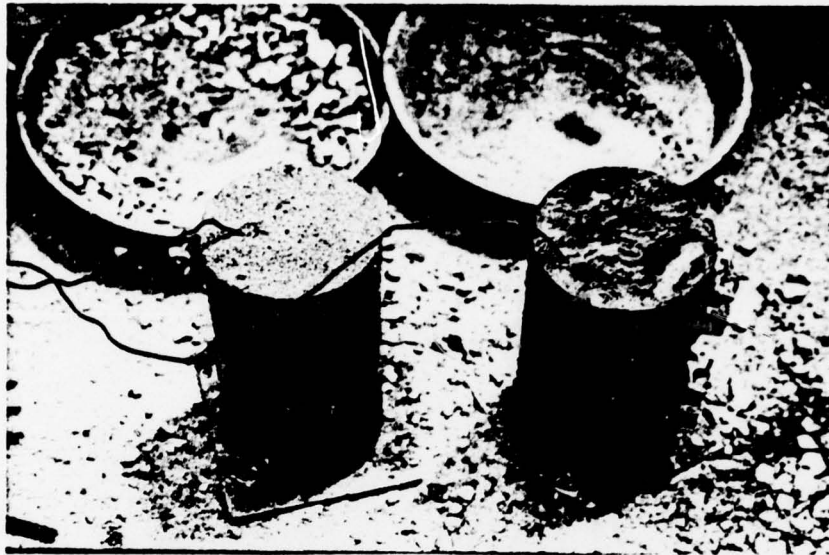
FIGURE 7.1 TEST CYLINDERS WITH TMPTMA (LEFT)
AND WITHOUT TMPTMA (RIGHT)

Blistering was a phenomenon observed in the field tests of PC at high ambient temperatures. This was a potentially significant problem for airfield pavements because of the possibility of pieces of PC flaking off and being ingested into jet engines. A test was conducted to duplicate the conditions of the field tests and then to attempt to eliminate the blistering. The test was conducted at an ambient temperature of 100°F and the monomer was set in the sun to warm. Specimens were cast using 6-in. by 12-in. cylinders, one with the field test formulation and one with an identical formulation except the addition of 5% TMPTMA, a cross-linking agent. The experiment showed that blistering can be controlled with the addition

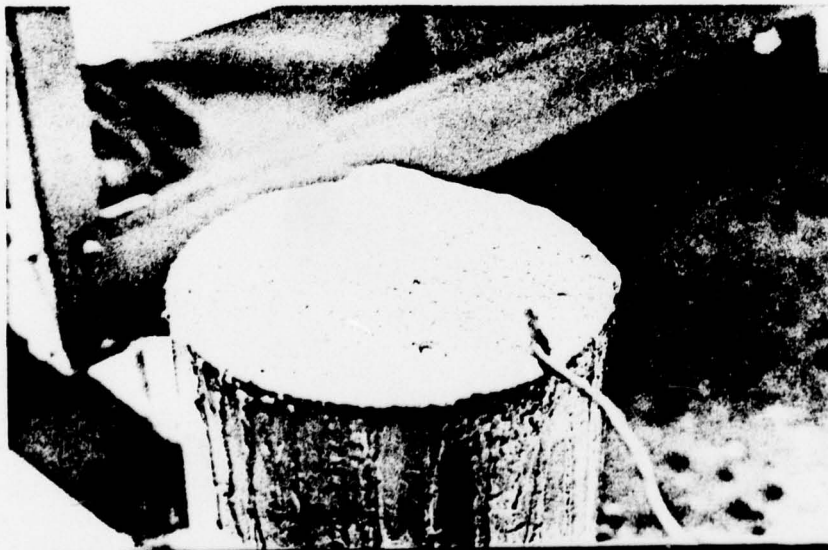
FIGURE 7.2 CLOSE-UP VIEW OF BLISTERED
SPECIMEN

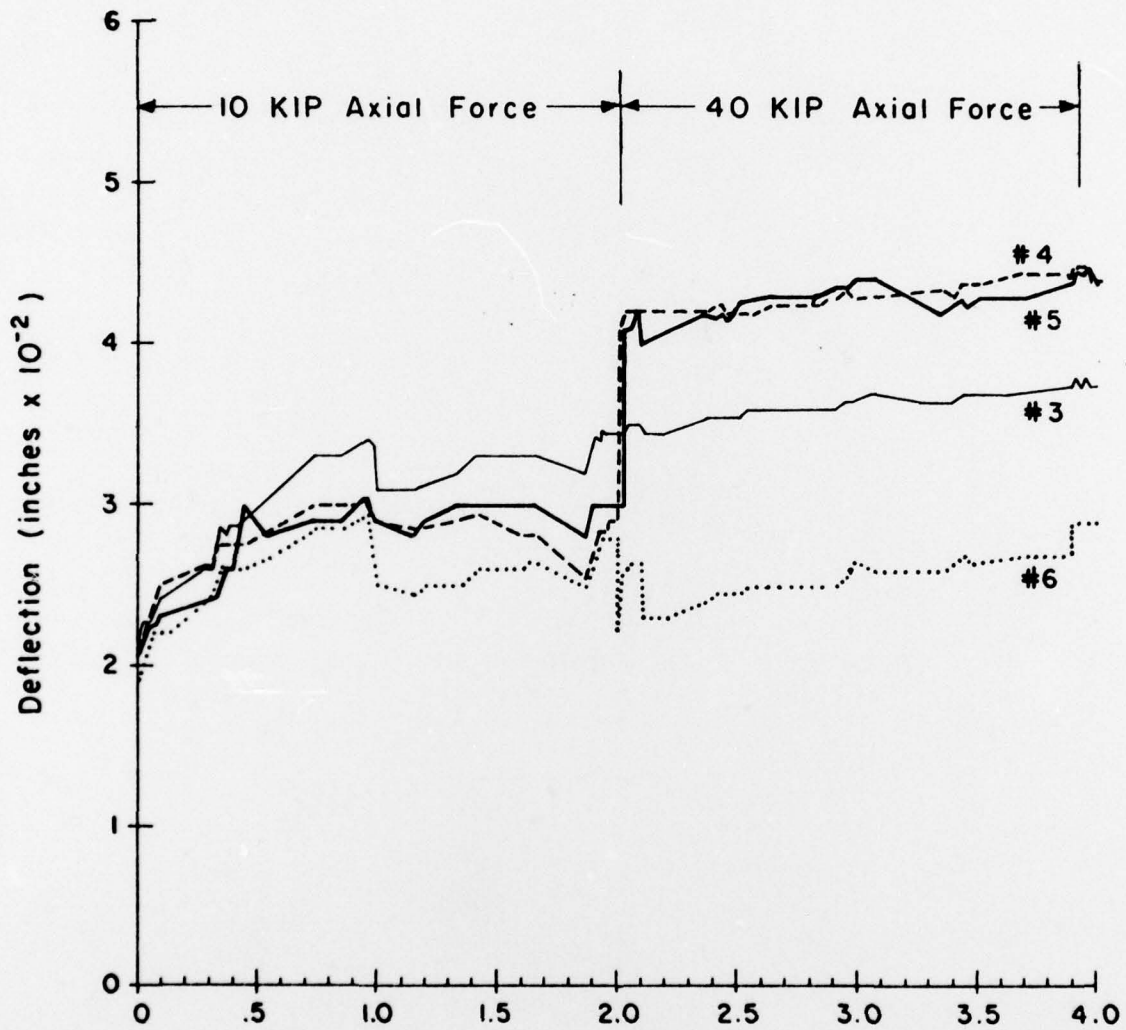
10^6 Applications of 5^k Load

FIGURE A.2 DEFLECTION PROFILE OF SLAB 1:
4-IN. CONCRETE WITH PC PATCH, VOIDED SUPPORT
