6 THE EFFECTS OF MULTIPLE WELD REPAIRS ON THE ALUMINUM-MAGNESIUM ALLOY 5083-0.

9 Master's thesis, by 10 George R. Speight, Jr.

Thesis Advisor: Terry R. McNelley

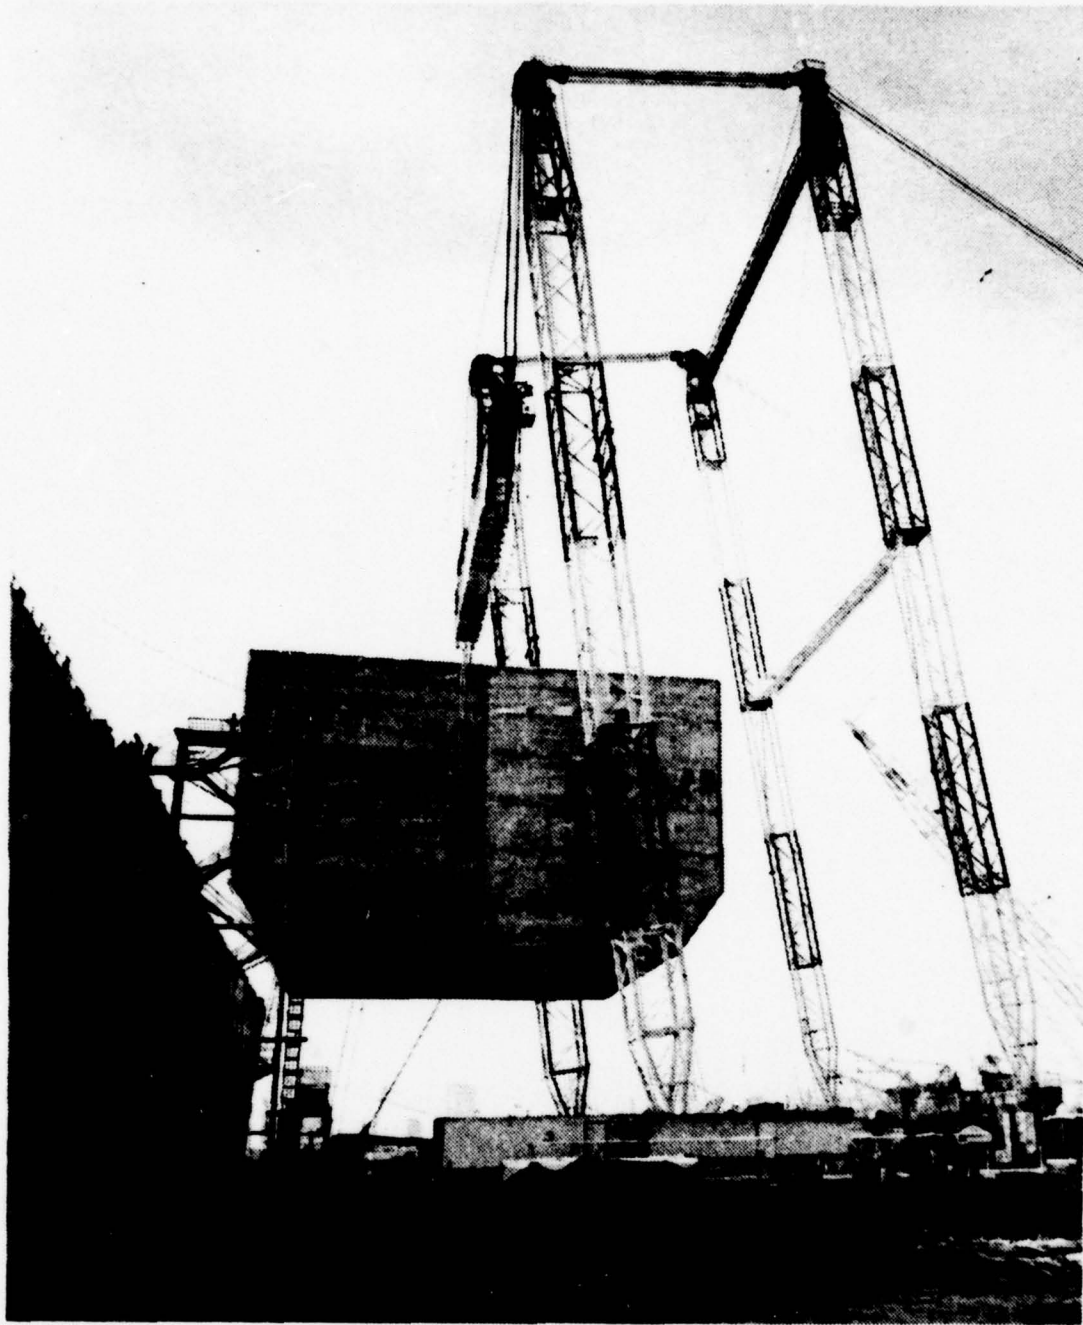
Figure 2. Photograph of a Conch design "self-supporting" Liquefied Natural Gas tank being loaded aboard ship at the Kaiser Fabricators Facility, Mobile, Alabama. The tank, one of five to be placed in the ship, is of all-welded, 5083 aluminum construction. (Photograph compliments of Kaiser Aluminum Chemical & Sales Inc.)

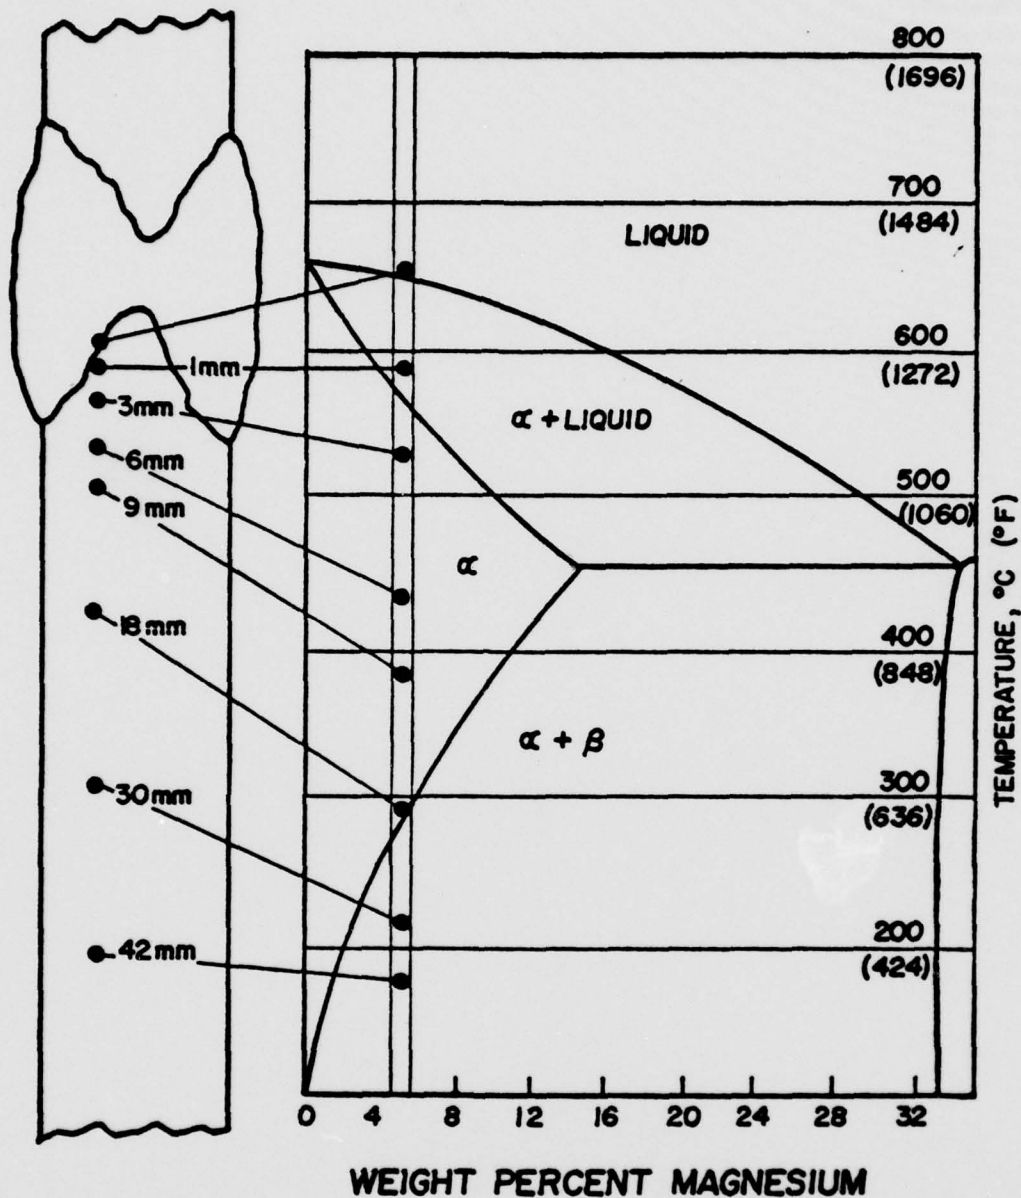
Figure 3. This figure represents the aluminum-magnesium binary equilibrium phase diagram. The defined vertical region is the percentage range of magnesium found in the 5083 alloy. The schematic of the welded joint is introduced to give the reader a general idea of the peak temperatures experienced at various distances from the weld interface relative to the phase diagram.

for strengthening. As illustrated on the phase diagram, the material is really in a metastable condition at ambient temperatures. Kinetic considerations, however, suggest that the transformation rate to the equilibrium two-phase alloy is slow and thus it is possible for the single phase alloy to remain essentially stable at ambient temperatures. However, aging may occur; this aging is manifested in the precipitation of the intermetallic compound Al_3Mg_2 (called β) from solid solution. Should precipitation occur preferentially at grain boundaries, problems may be encountered with stress-corrosion cracking or exfoliation. The phase diagram indicates that higher magnesium content leads to a greater degree of undercooling at ambient temperatures since the solvus temperature increases with increased magnesium content. This suggests a greater driving force for precipitation. Further, there is more magnesium which would want to precipitate, implying the possibility of a larger amount of grain boundary precipitation and hence more tendency for stress-corrosion cracking. The 5000 series alloys were formulated, based on many years of research, to avoid this problem. Service experience has shown that alloys containing less than 3.0% magnesium are unlikely to show evidence of stress-corrosion cracking at ambient temperatures [2]. Care must be taken, however, when using alloys whose magnesium content exceeds 3.0% and whose service environment exposes the material to moderately elevated temperatures for prolonged periods of time. The atom diffusion rate increases rapidly as temperature increases,

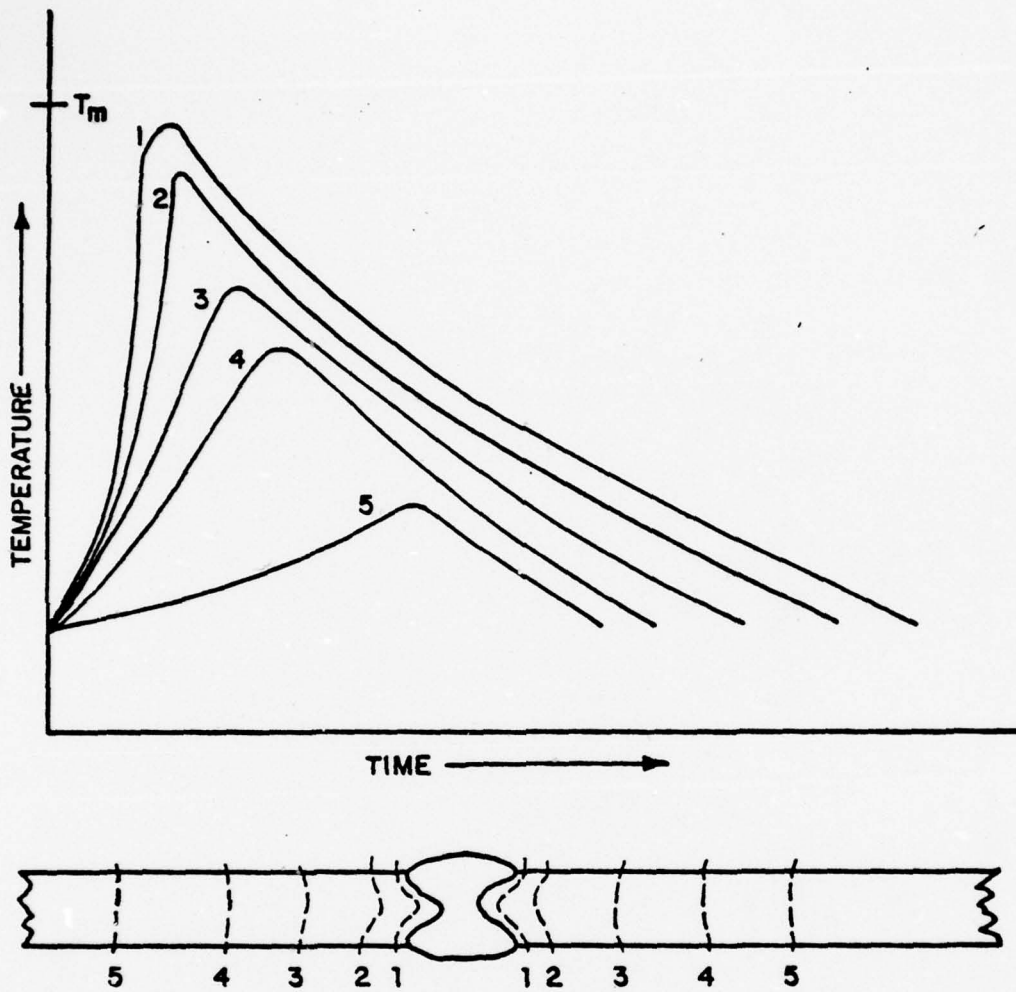
Figure 4. This figure shows curves which represent typical heating and cooling rates of a plate as a function of varying distances from the weld arc. The numbered curves correspond to the numbered locations shown on the schematic of the welded joint.

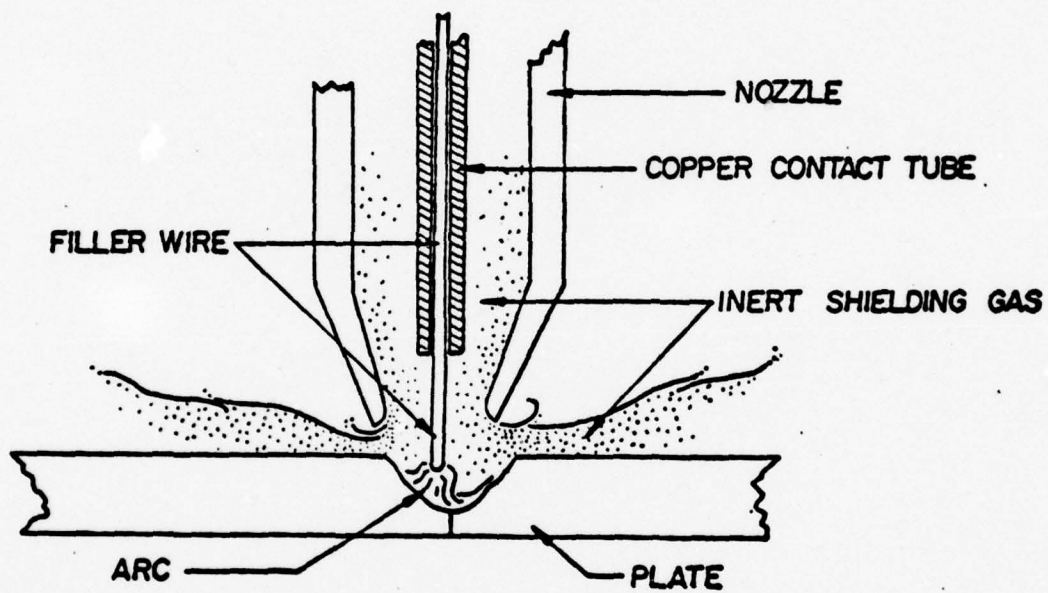
Figure 5. Schematic of a MIG "gun" nozzle arrangement. The nozzle directs inert shielding gas to the weld joint. The copper contact tube completes the electrical circuit to the filler wire thereby allowing initiation and maintenance of the welding arc between the filler wire and the plate to be welded.

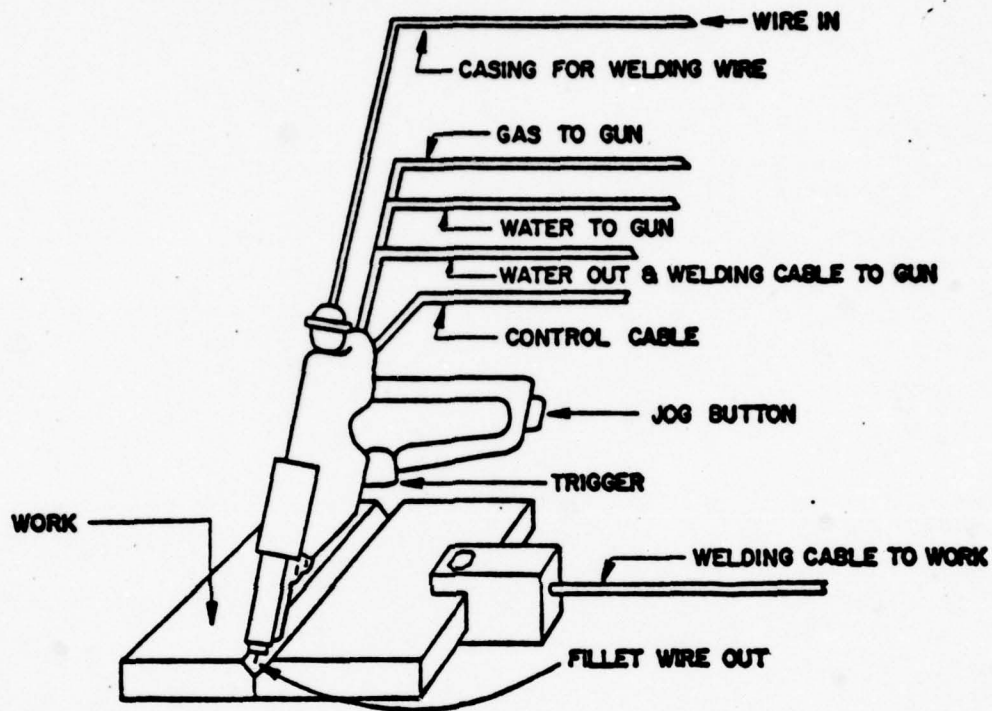
Figure 6. Metal Inert Gas Welding Gun with push type wire feed. This schematic represents the general orientation of the "hand held" MIG "gun" for making down hand butt welds. The stationary control unit feeds shielding gas and filler wire at a preset rate to the gun while maintaining a predetermined power input (heat input). Water is supplied to the unit for cooling. The jog button allows the welder to manually feed wire for trimming prior to initiating the arc. (Figure adapted from Reference 2.)

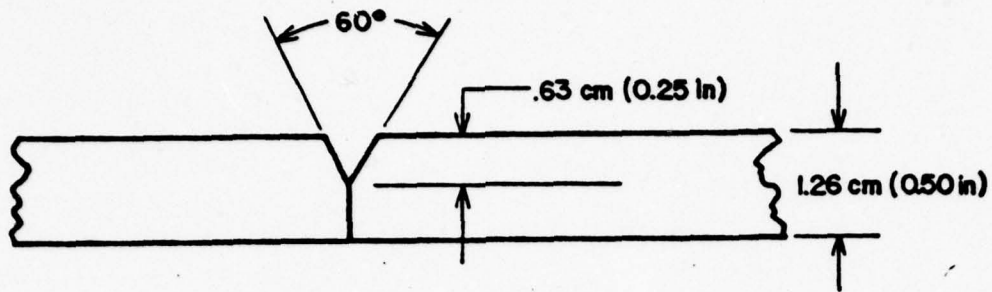
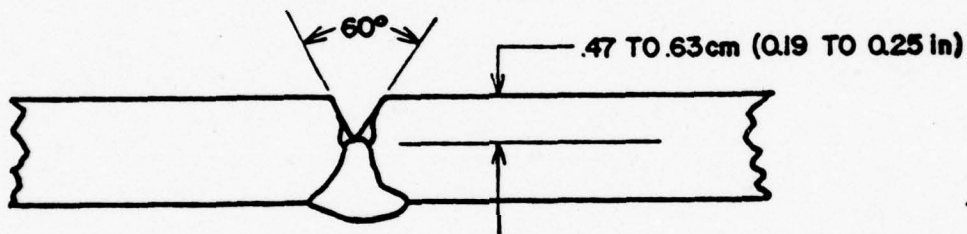
Figure 7 (a)

Figure 7. (a) This figure represents the joint preparation performed prior to laying the first "downhand" or "flat" weld bead. After the first pass the plate is allowed to cool to a specified interpass temperature of 66°C (150°F) or less. The reverse side is backmilled to a minimum depth of 4.8 mm ($3/16$ inch) and then welded in the "flat" position.

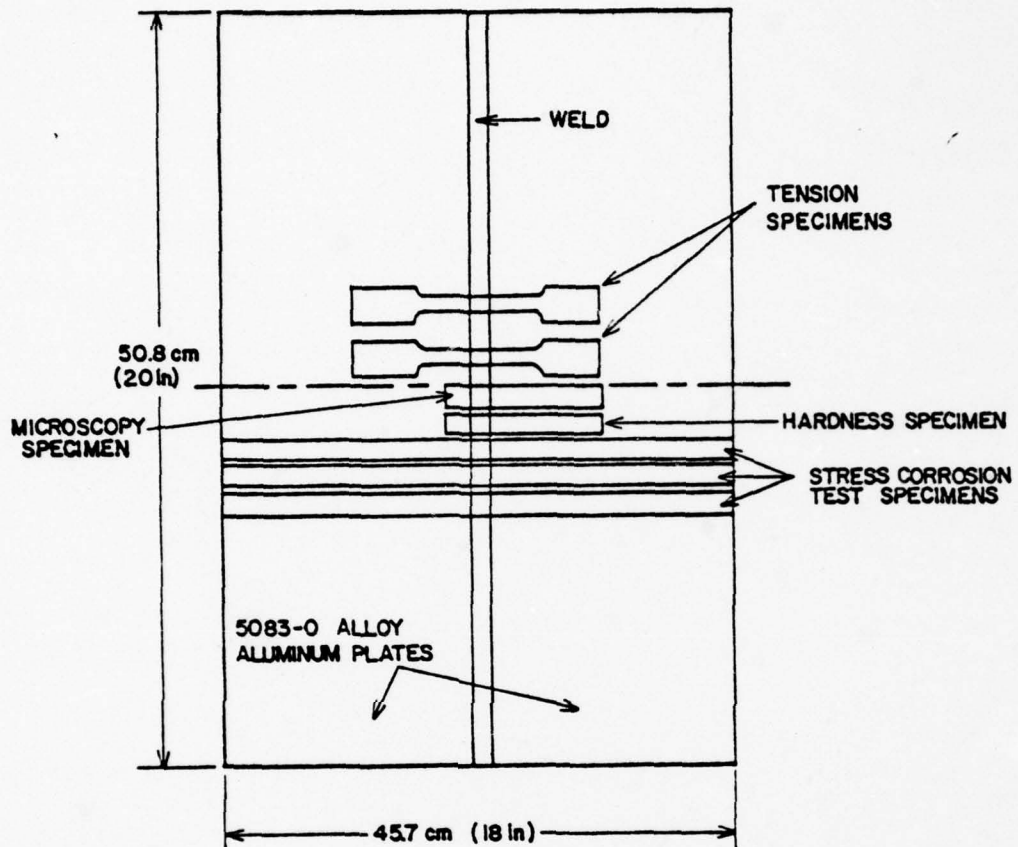
Figure 8. Schematic representing the areas of the welded test plates used for metallographic, mechanical, and stress corrosion testing. The specimens were taken as near the center of the test plates and as close together as possible to avoid significant differences in cooling rates between specimens.

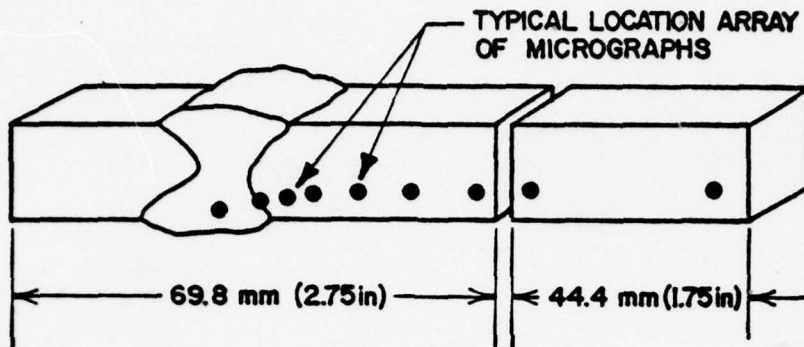
Figure 9. The metallography specimens showing general dimensions. The indicated location array is shown to give the reader a general idea of the areas represented by the micrographs. A single specimen was used for both the "as-polished" and etched micrographs.

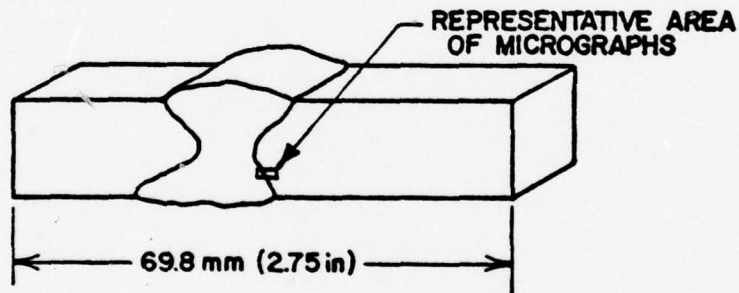
Figure 10. This figure is intended to show the area representing the panorama of micrographs taken of the specimen after etching with the H_3PO_4 solution. The specimen is the same piece as shown in the left side of Figure 9.

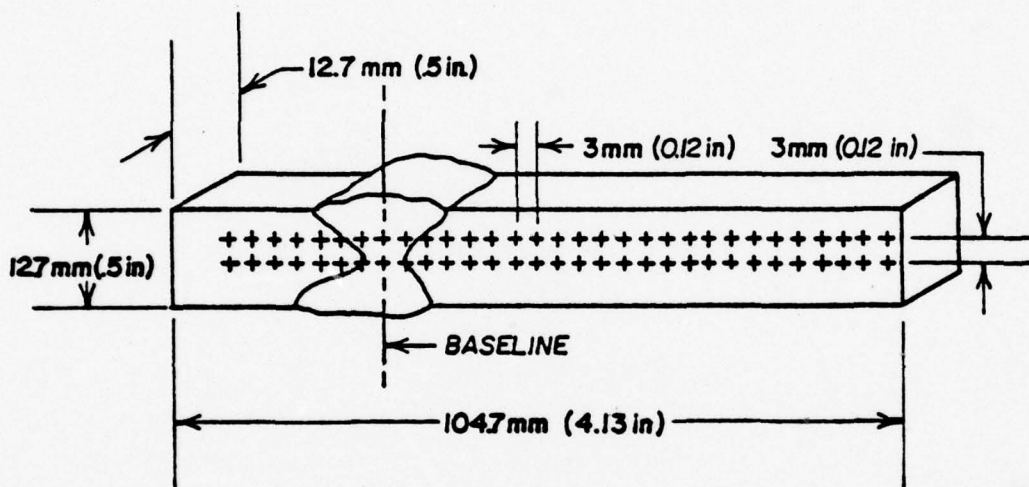
Figure 12. This figure represents the specimens used in determining the hardness profiles. The +'s indicate the locations where hardness data was compiled for each specimen. A series of hardness data was taken at 3 mm (0.118 inch) intervals along a line defining the midplane of the welded plate and at 3 mm from the midplane.

Hardness tests were performed on specimens taken from each of the nine test plates. Figure 12 shows the locations where hardness data was taken relative to the individual specimens. The specimens were prepared by machine surfacing to a surface finish of $\sqrt{65}$ followed by a final sanding on 600-grit wet/dry paper using kerosene lubricant.

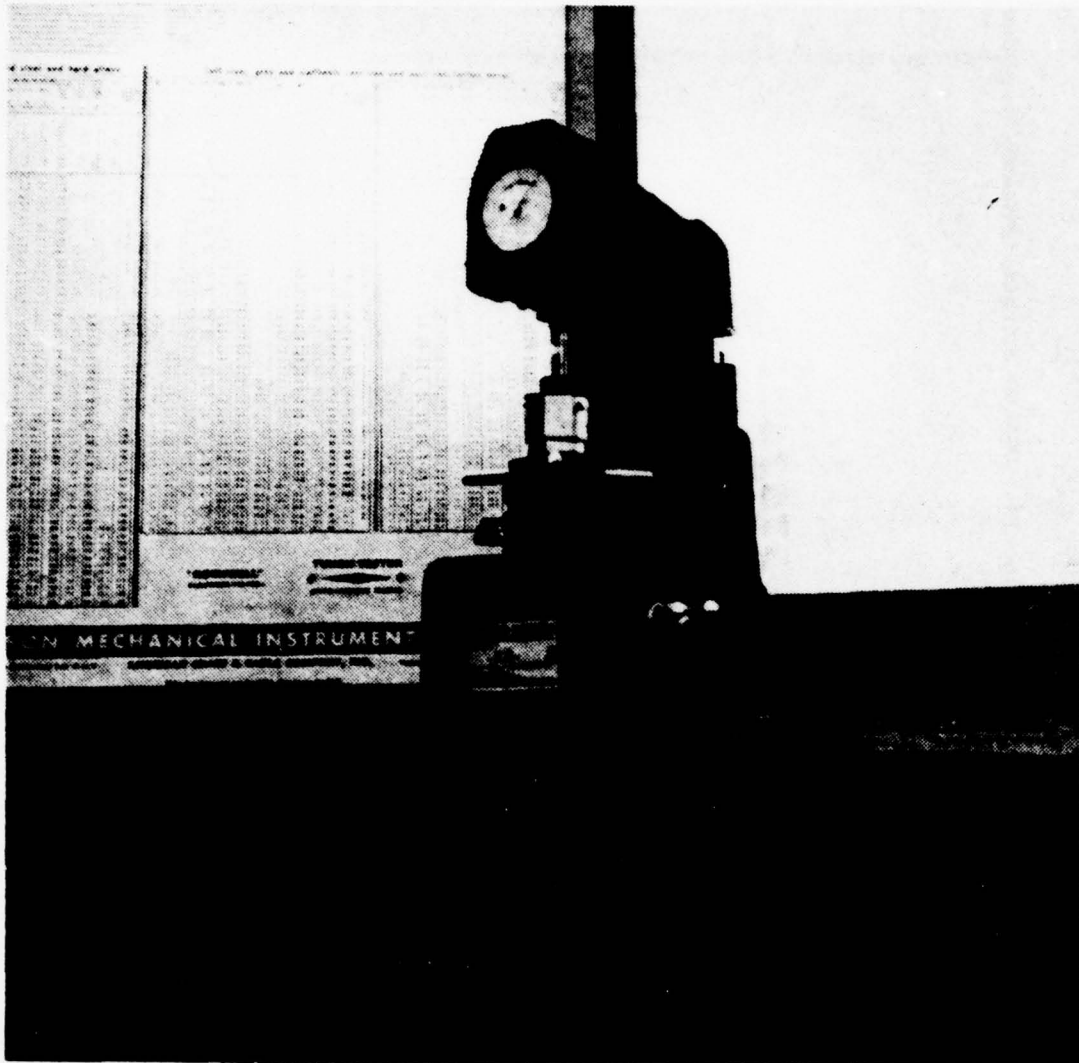
Figure 13. Photograph of the Wilson Model 1-JR Rockwell Hardness Tester utilized in obtaining data for construction of the hardness profiles contained in this thesis.

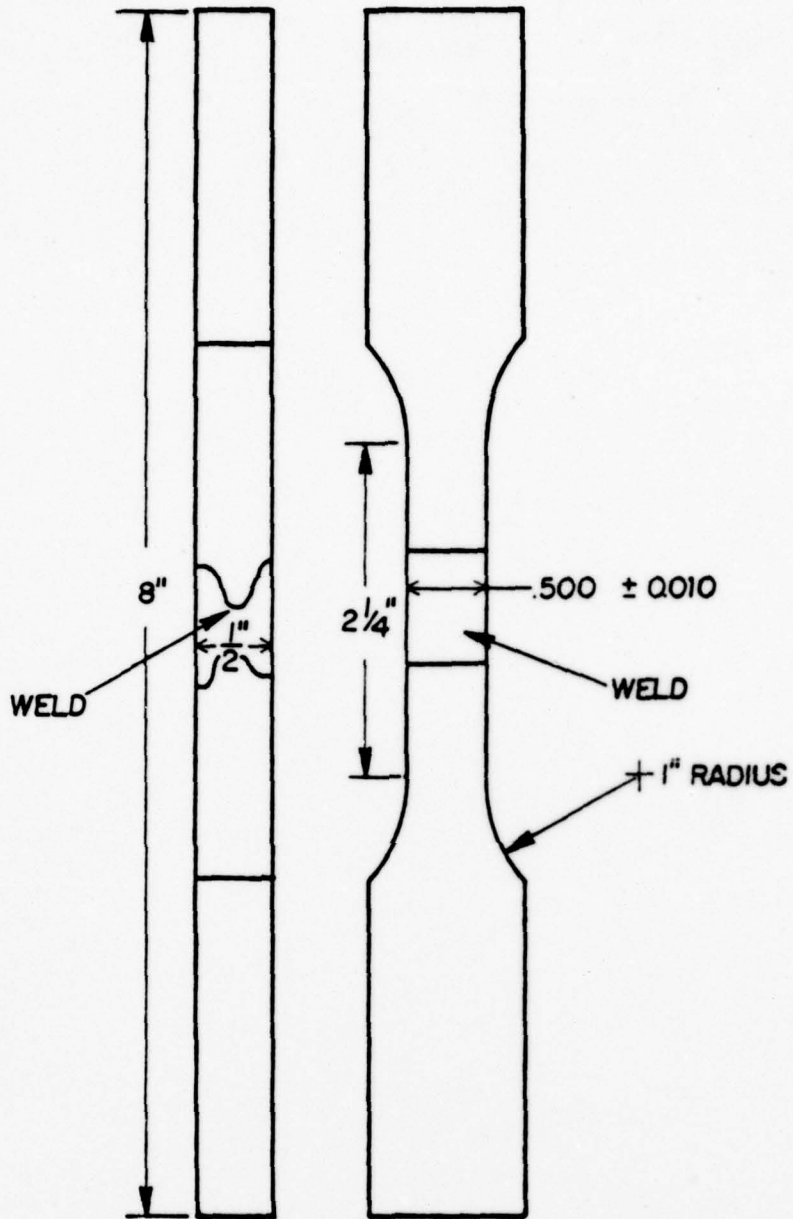
Figure 14. Schematic showing dimensions of the specimen used for tension testing for this thesis.

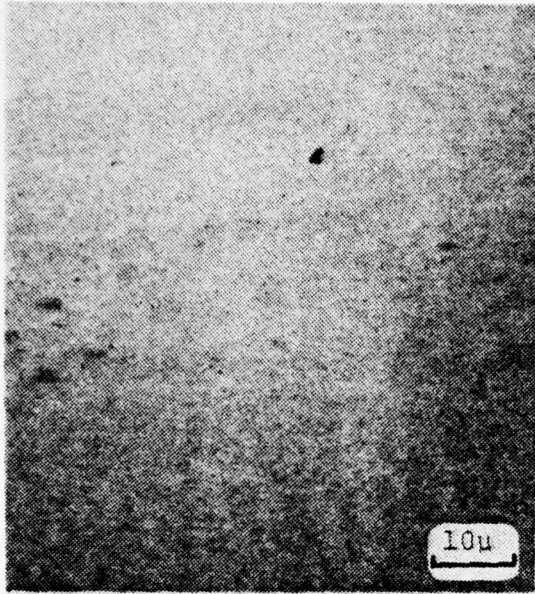
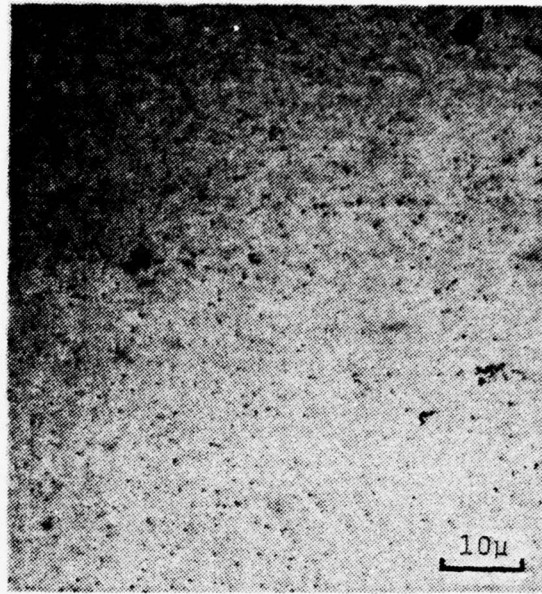
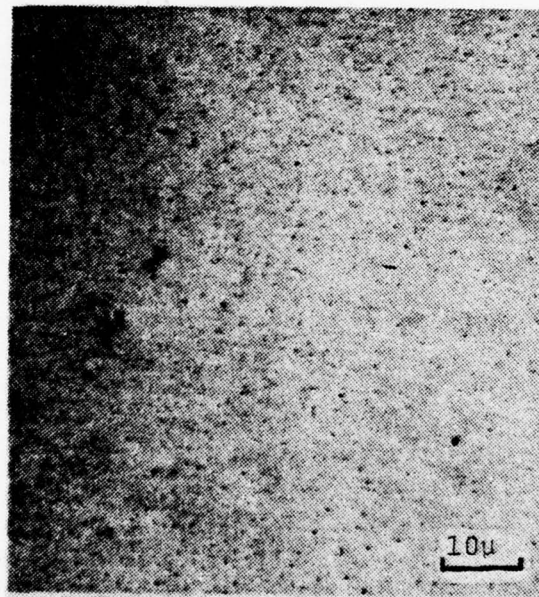
Figure 15. Photomicrographs in the "as-polished" condition and in the "as-cast" weld metal of specimens subjected to the original two-pass weld only, 8 and 16 repair simulations. (100X)

Figure 15 shows photomicrographs of the "as-cast" weld of the specimens consisting of the original two-pass weld and eight and sixteen repair simulations. It is evident from these micrographs that little difference may be found in the microstructure of the "as-cast" weld metal as a function of number of weld repairs. This result is to be expected. Since the repair simulations were effected by removing the previous weld metal and redepositing new weld metal, utilizing the same essential welding parameters, we have performed essentially the same procedure with each repair. Thus the deposited weld metal in the sixteenth repair simulation should duplicate that deposited in the original weld. The differences in the specimens as a function of number of repair simulations begins at the weld interface. Figures 16 through 20 are

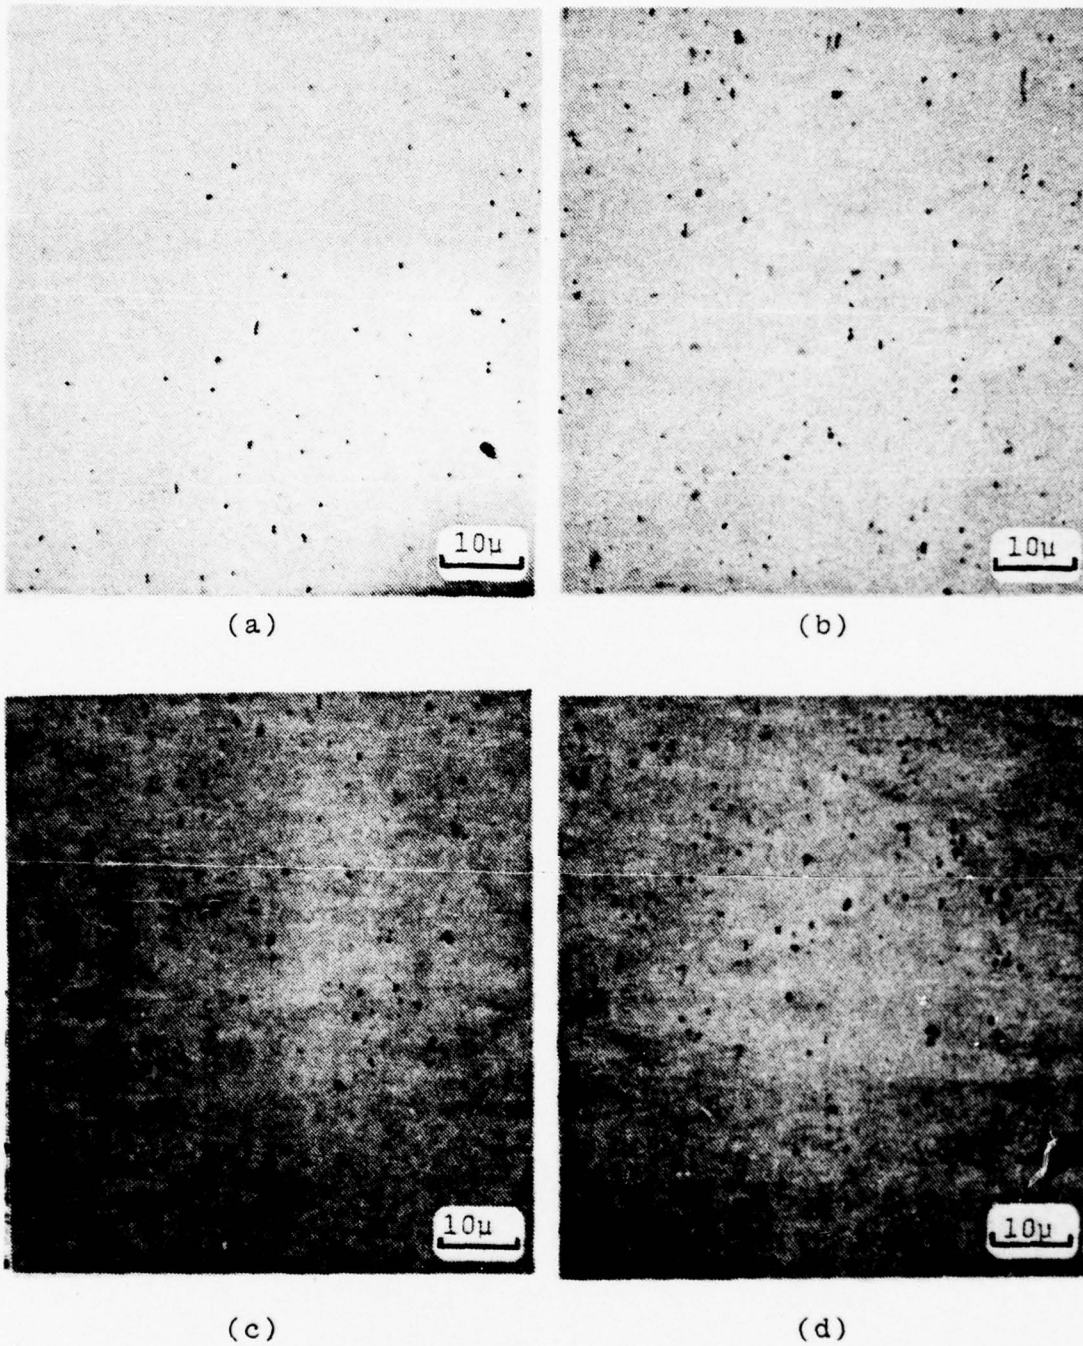
Figure 16. Photomicrographs taken of the "as-polished" specimen subjected to the original two-pass weld only. The locations represented are the interface (a), approximately 6 mm (b), 18 mm (c) and 27 mm (d) from the interface. (100X)

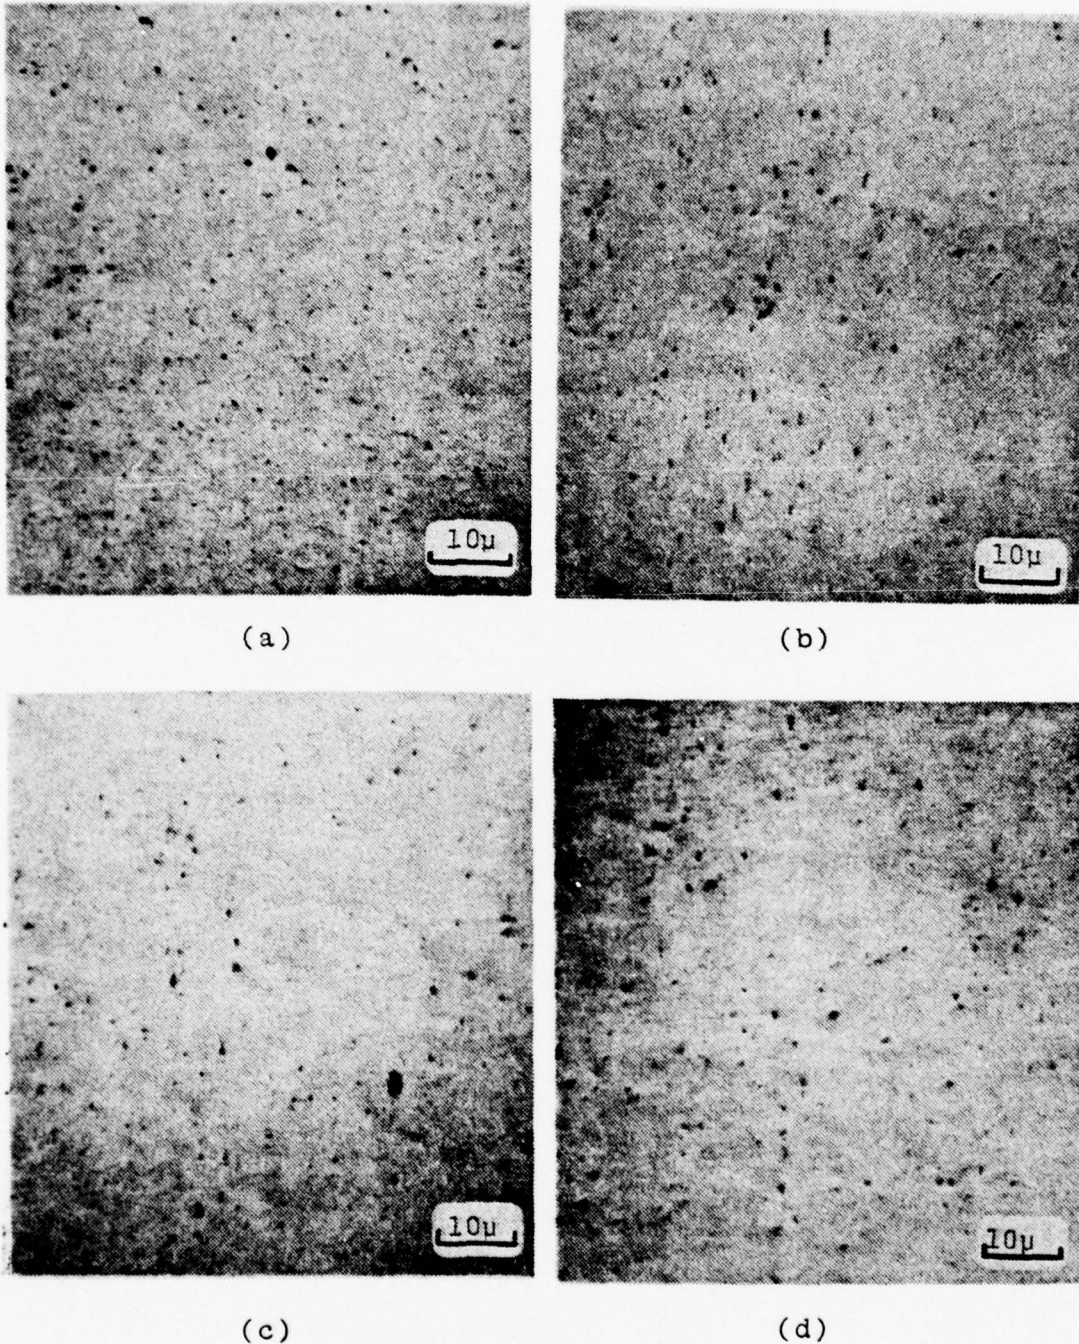
Figure 17. Photomicrographs taken of the "as-polished" specimen subjected to 4 repair simulations. The locations represented are the interface (a), approximately 6 mm (b), 18 mm (c) and 27 mm (d) from the interface. (100X)

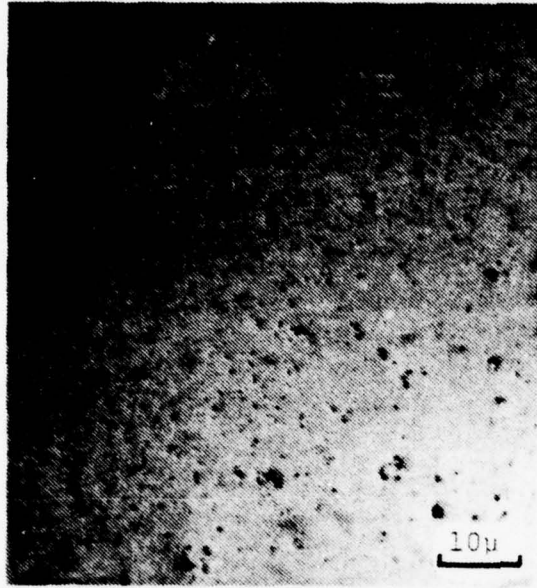
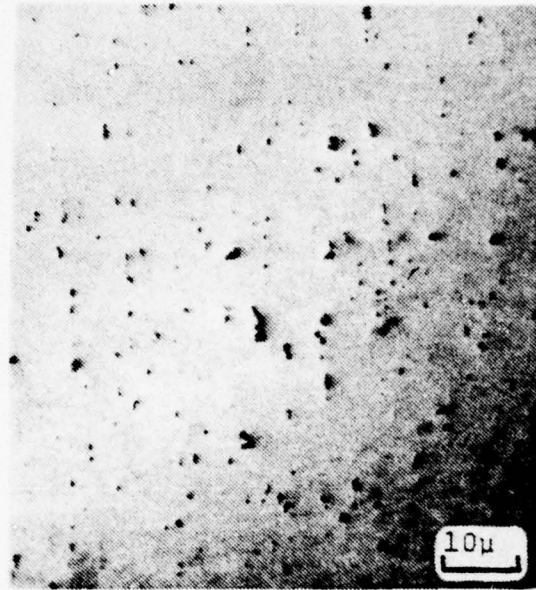
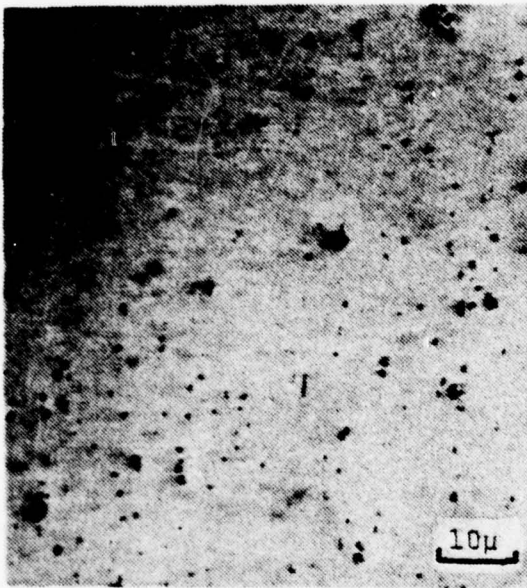
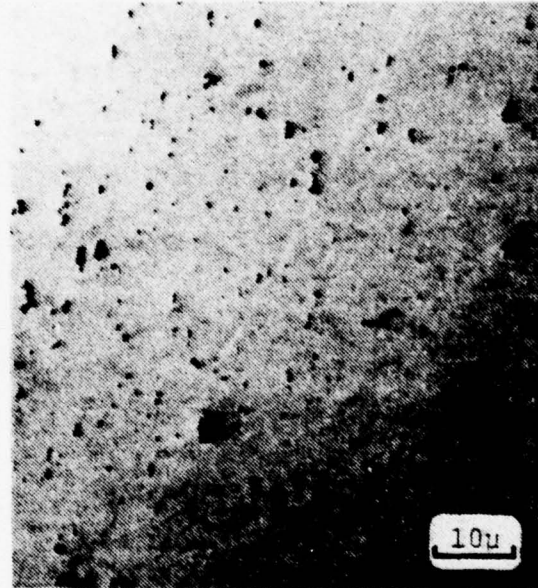
Figure 18. Photomicrographs taken of the "as-polished" specimen subjected to 8 repair simulations. The locations represented are the interface (a), approximately 6 mm (b), 18 mm (c) and 27 mm (d) from the interface. (100X)

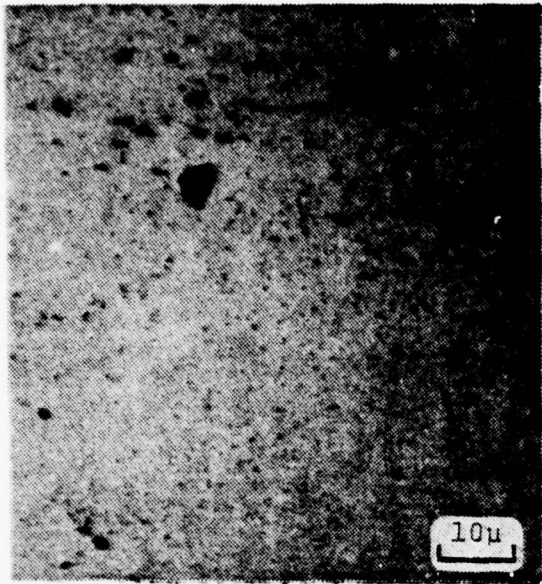
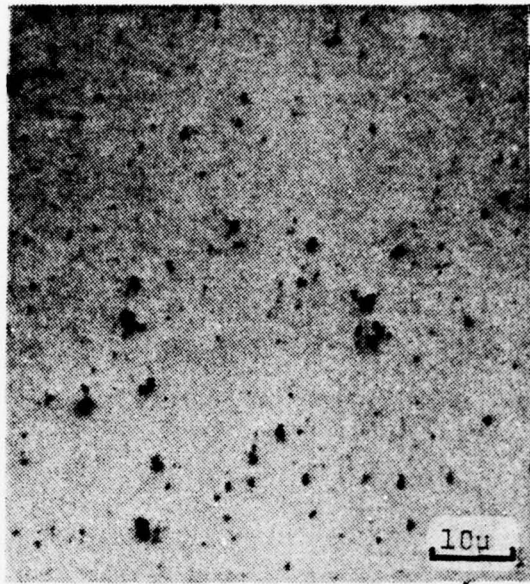
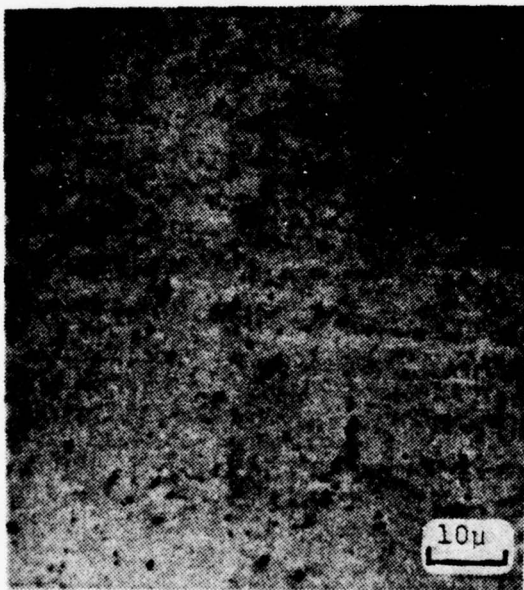
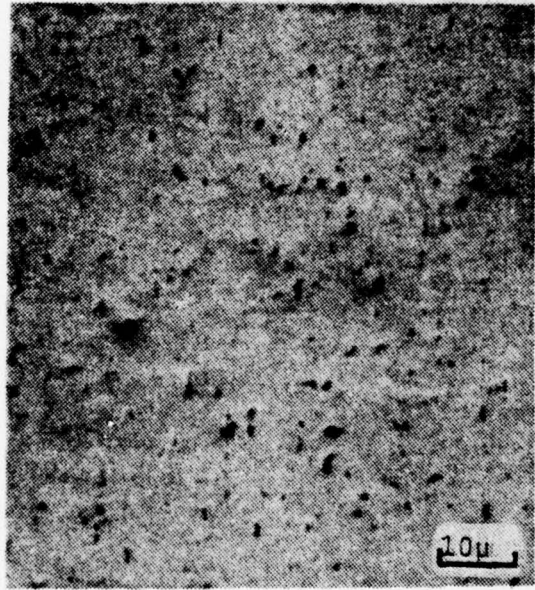
Figure 19. Photomicrographs taken of the "as-polished" specimen subjected to 12 repair simulations. The locations represented are the interface (a), approximately 6 mm (b), 18 mm (c) and 27 mm (d) from the interface. (100X)

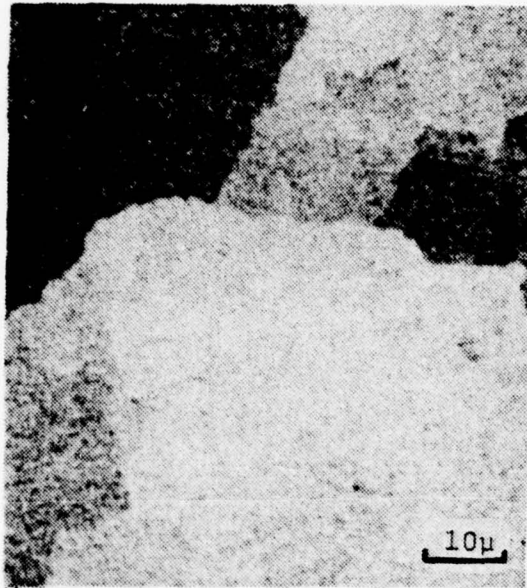
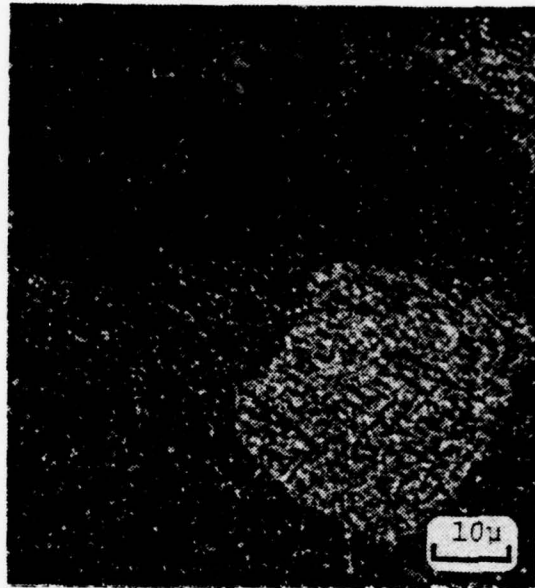
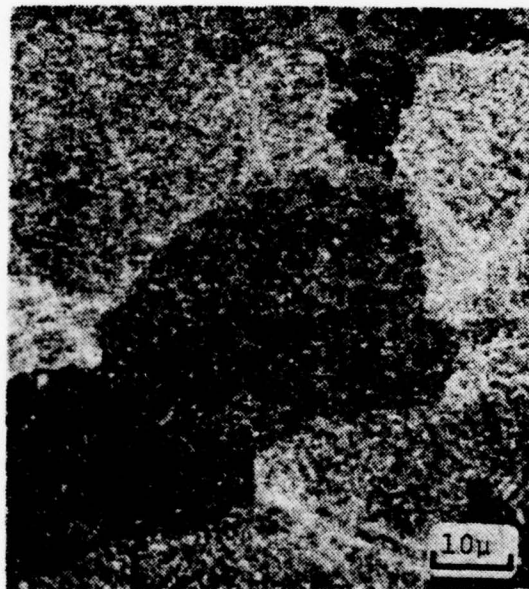
Figure 21. Photomicrographs in the etched condition of the specimens subjected to the original two-pass weld only (a), 8 (b) and 16 (c) repair simulations. The area represented in each of these micrographs is the "as-cast" weld metal. (100X, etchant: modified #12)

Figure 21 shows micrographs in the etched condition of the "as-cast" weld metal of specimens subjected to the original

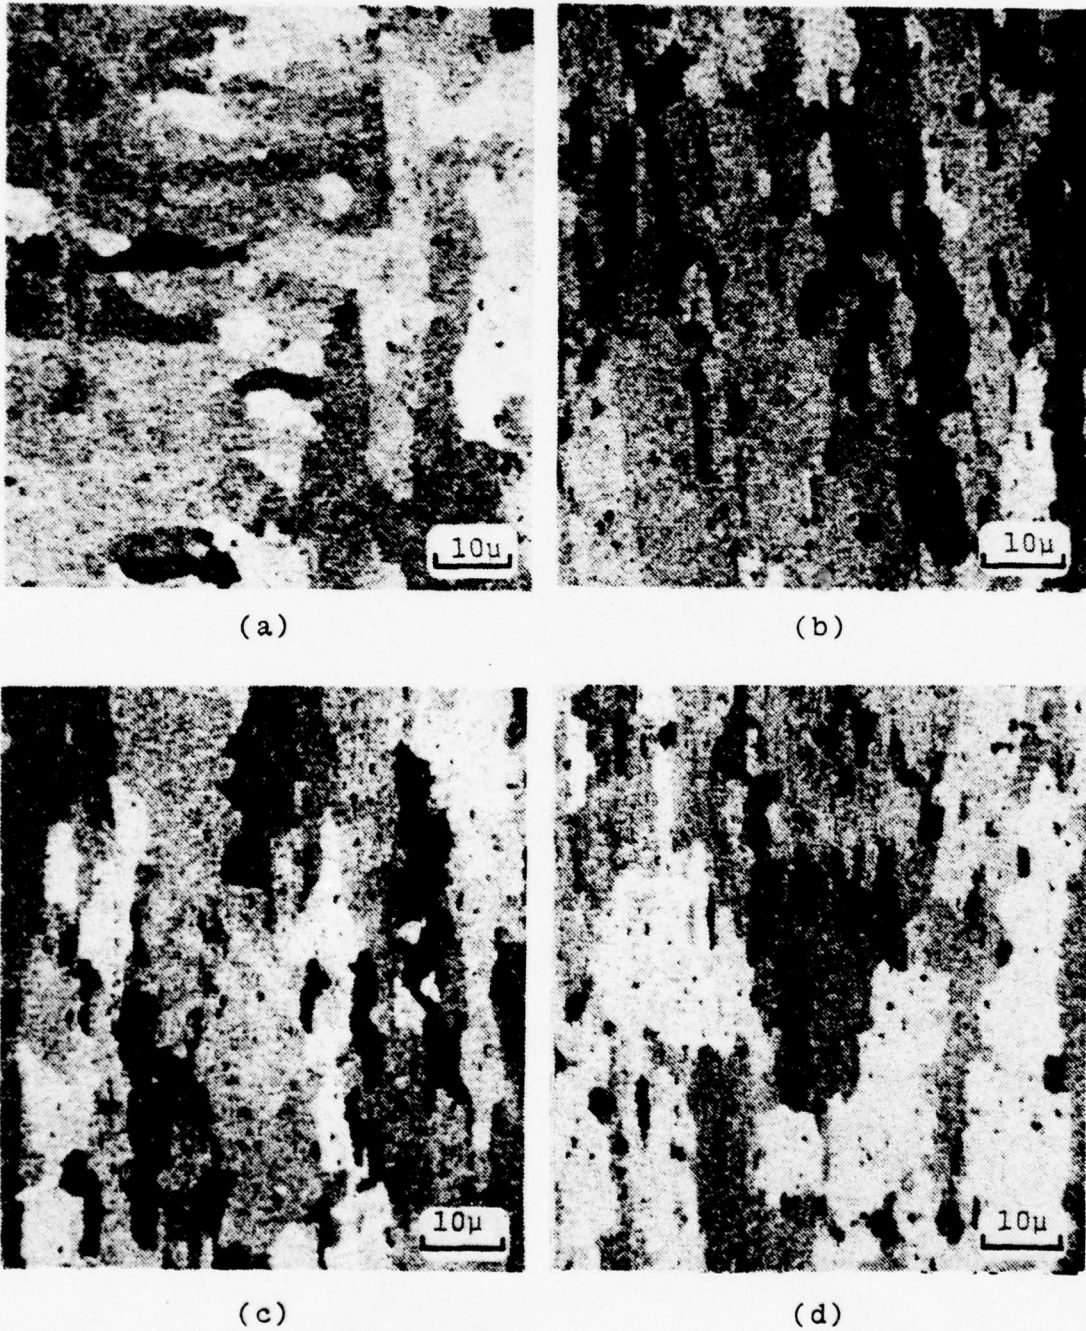
Figure 22. Photomicrographs taken of the etched specimen subjected to the original two-pass weld only. The locations represented are the interface (a), and approximately 6 mm (b), 18 mm (c) and 27 mm (d) from the interface. (100X, etchant: modified #12)

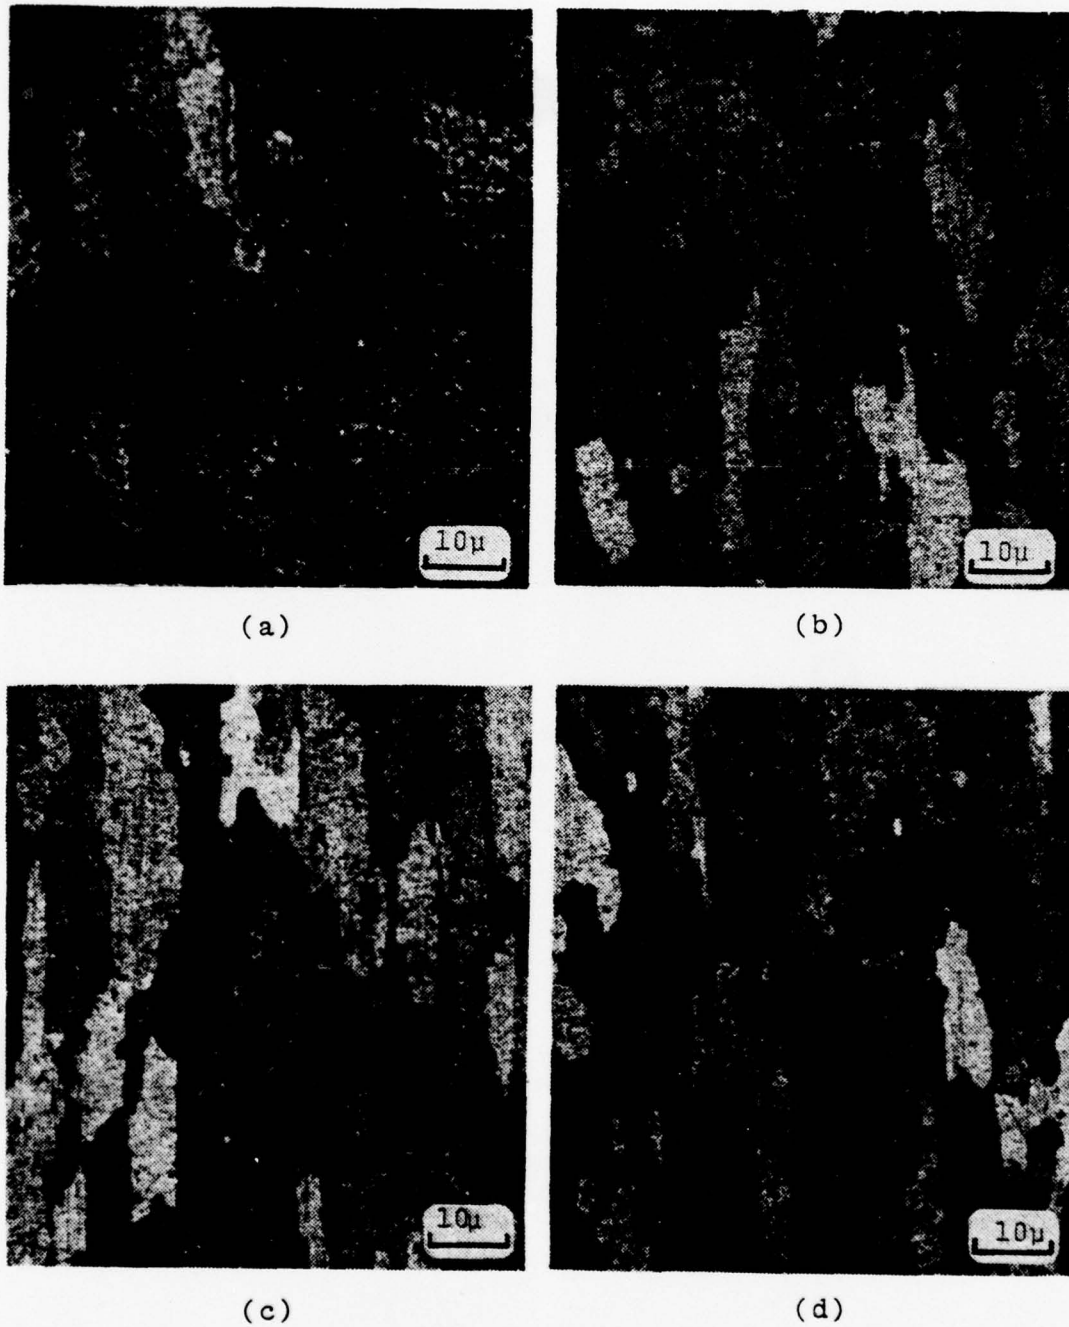
Figure 23. Photomicrographs taken of the etched specimen subjected to 4 repair simulations. The locations represented are the interface (a), and approximately 6 mm (b), 18 mm (c) and 27 mm (d) from the interface. (100X, etchant: modified #12)

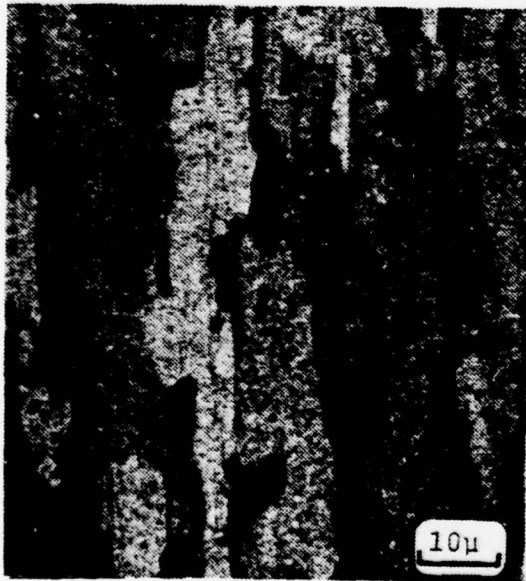
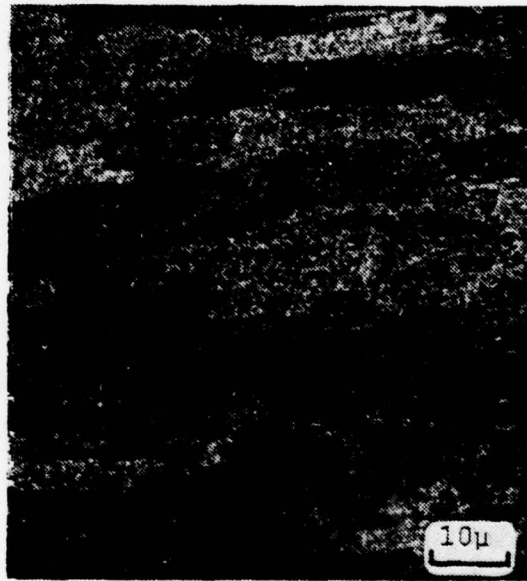
Figure 24. Photomicrographs taken of the etched specimen subjected to 8 repair simulations. The locations represented are the interface (a) and approximately 6 mm (b), 18 mm (c) and 27 mm (d) from the interface. (100X, etchant: modified #12)
