6 THE EFFECTS OF MULTIPLE WELD REPAIRS ON THE ALUMINUM-MAGNESIUM ALLOY 5083-0.

9 Master's thesis, by 10 George R. Speight, Jr.

Thesis Advisor: Terry R. McNelley

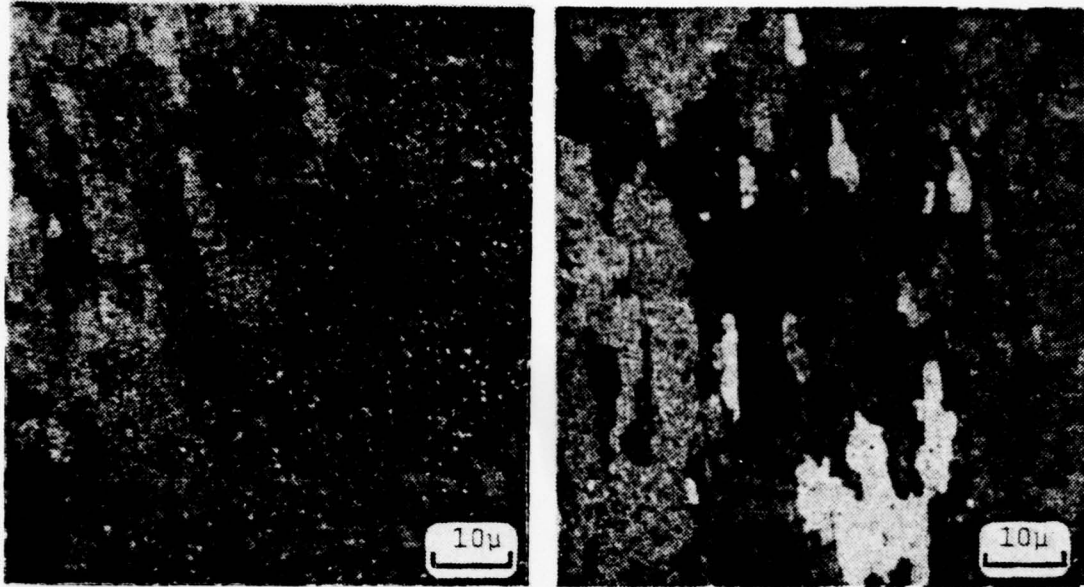
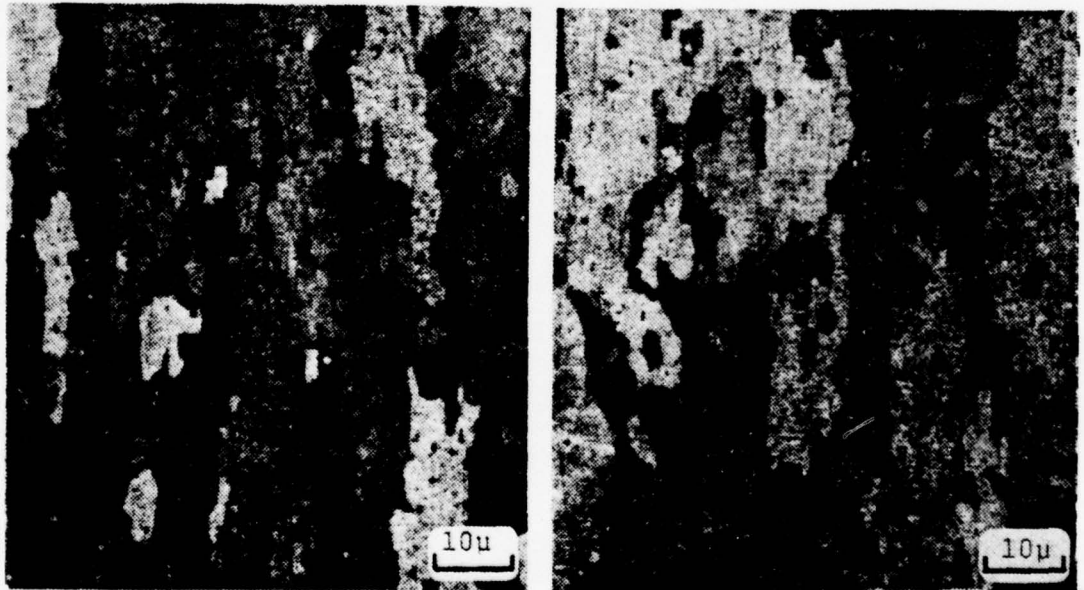
Figure 25. Photomicrographs taken of the etched specimen subjected to 12 repair simulations. The locations represented are the interface (a) and approximately 6 mm (b), 18 mm (c) and 27 mm (d) from the interface. (100X, etchant: modified #12)

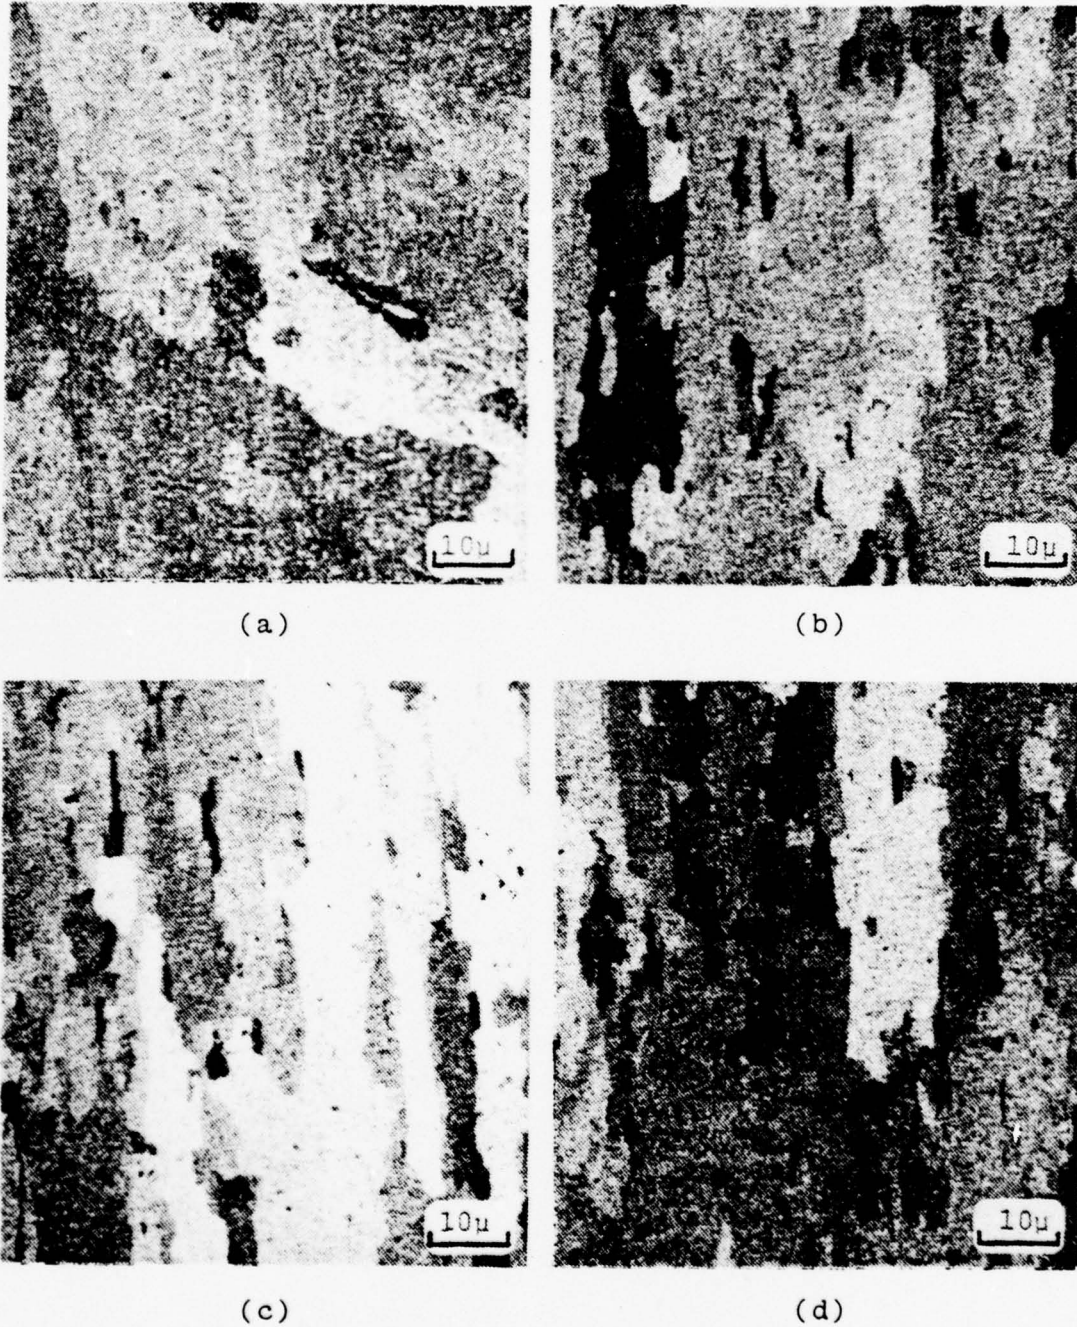
Figure 26. Photomicrographs taken of the etched specimen subjected to 16 repair simulations. The locations represented are the interface (a) and approximately 6 mm (b), 18 mm (c) and 27 mm (d) from the interface. (100X, etchant: modified #12)

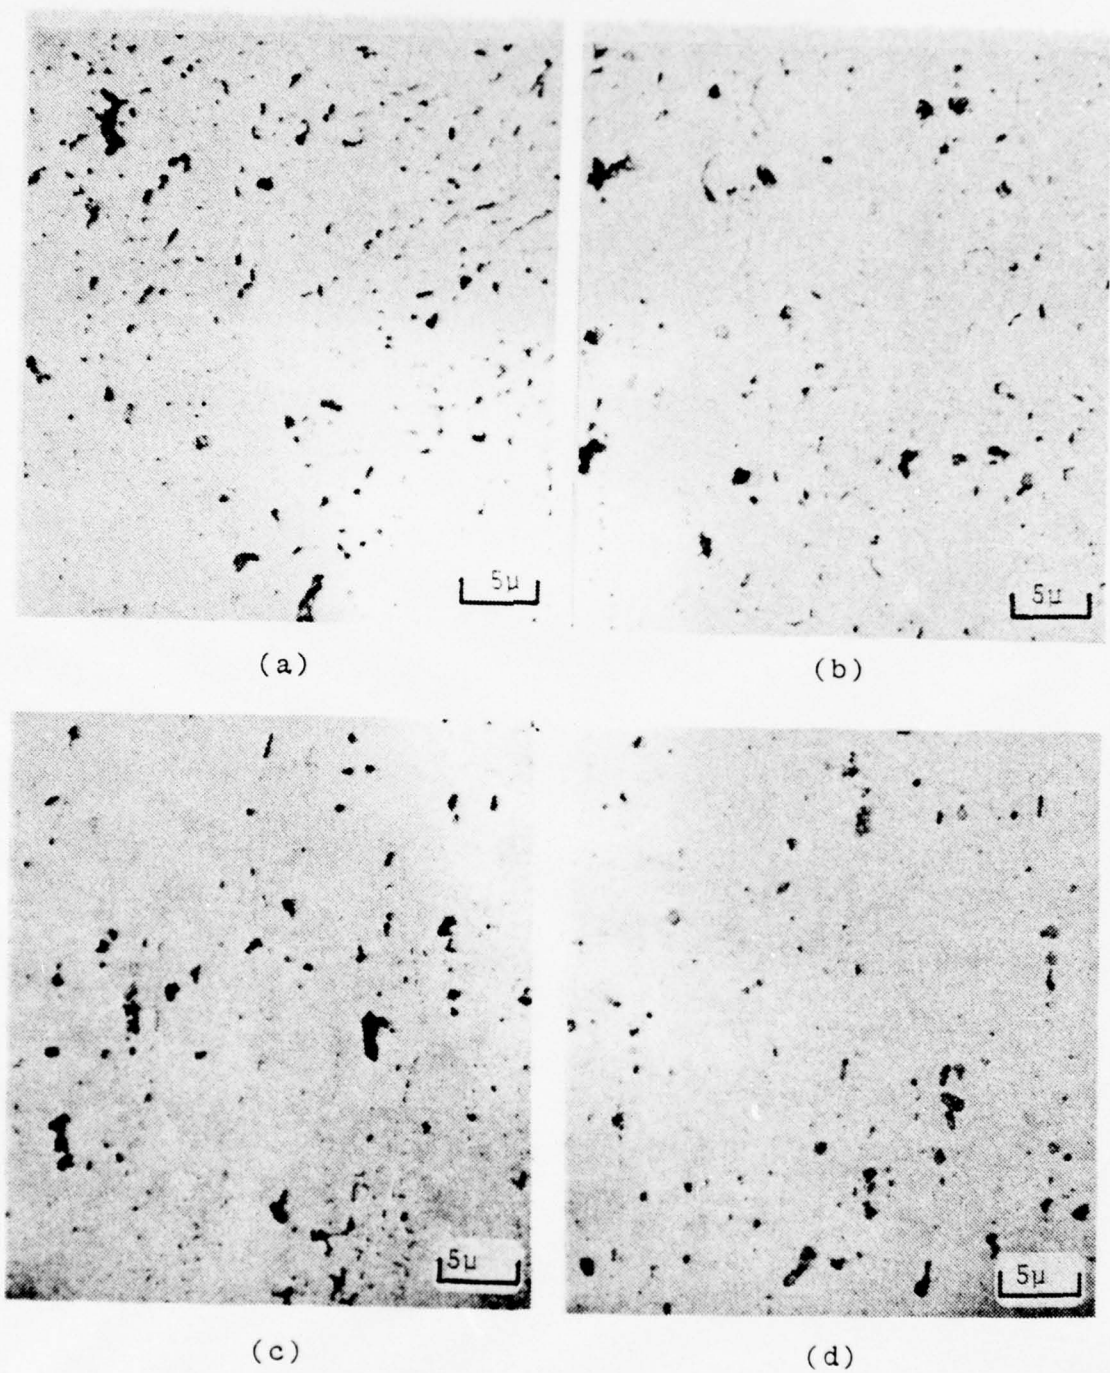
Figure 27. Photomicrographs of the specimen subjected to the original two-pass weld only. These micrographs were taken following etching with the H_3PO_4 solution. (200X, etchant: H_3PO_4)

Figures 27 through 29 show photomicrographs of specimens representing the original two-pass weld, and represent an area of approximately 2 mm (0.08 inches) in length, starting with a location in the "as-cast" weld metal approximately 0.5 mm (0.02 inches) from the weld interface. Figure 27 represents that area of the specimen exposed only to the original two-pass weld. Examination of this figure reveals a slight indication of grain boundary precipitation. This is observed as the thin, hair-like lines found in Figure 27 (b) and 27 (c). It should be noted that these precipitate lines are found only in the area beginning at the interface and are concentrated primarily between the interface and at a distance of approximately 0.75 mm (0.03 inches) from the interface. Examination of Figure 28 representing the specimen subjected to eight repair simulations shows an increase in grain boundary precipitation relative to the as-welded specimen. In addition to an increase in numbers of indications, the precipitate lines have become wider and longer. Further examination will reveal that in addition to the definite precipitation lines, very small precipitate particles have begun to agglomerate adjacent to these lines. These fine particles, dispersed about the grain boundaries, are seen to coalesce at the grain boundaries with subsequent repairs as seen in Figure 29. These observations indicate a tendency for the material to exhibit

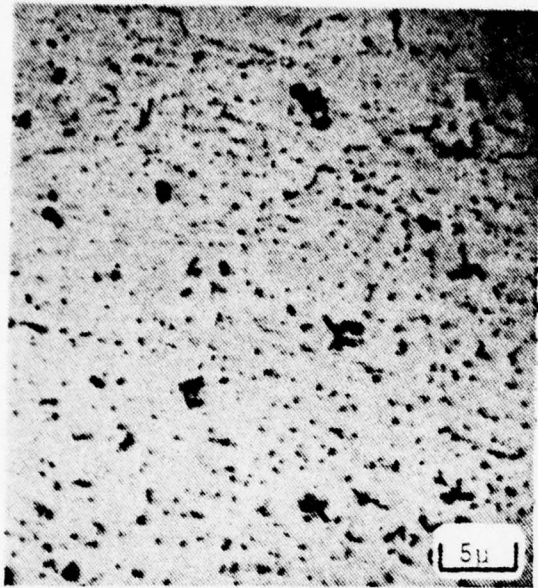
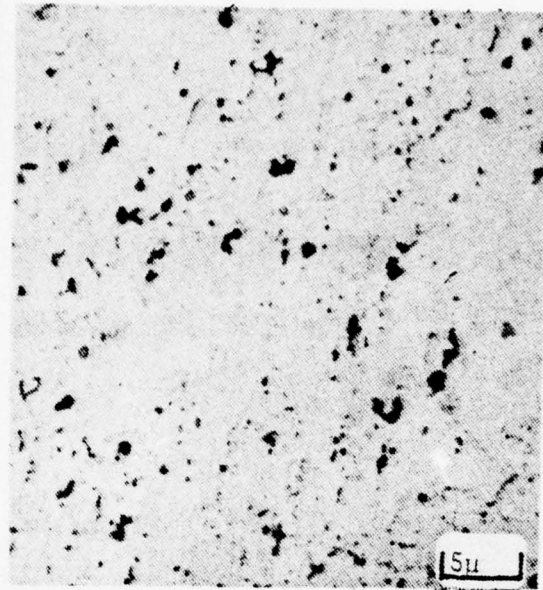
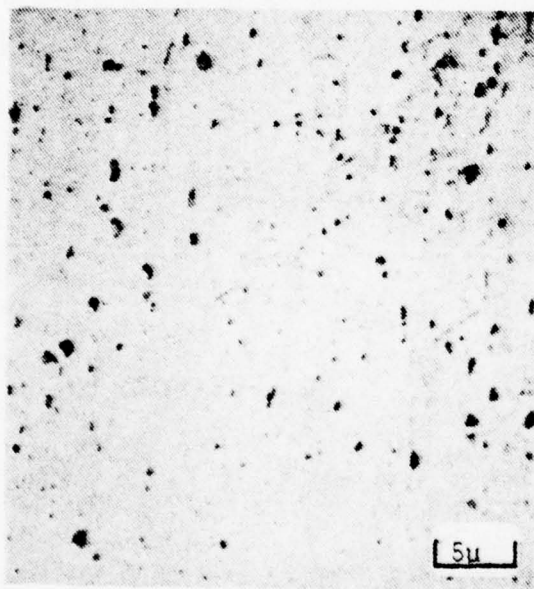
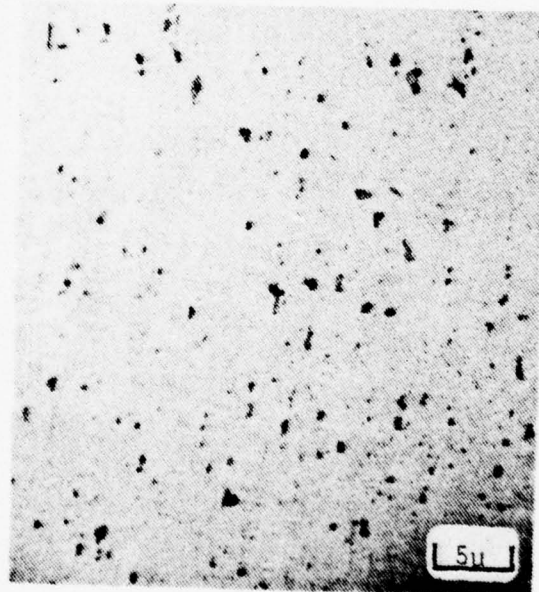
Figure 28. Photomicrographs of the specimen subjected to 8 repair simulations. These micrographs were taken following etching with the H_3PO_4 solution. (200X, etchant: H_3PO_4)

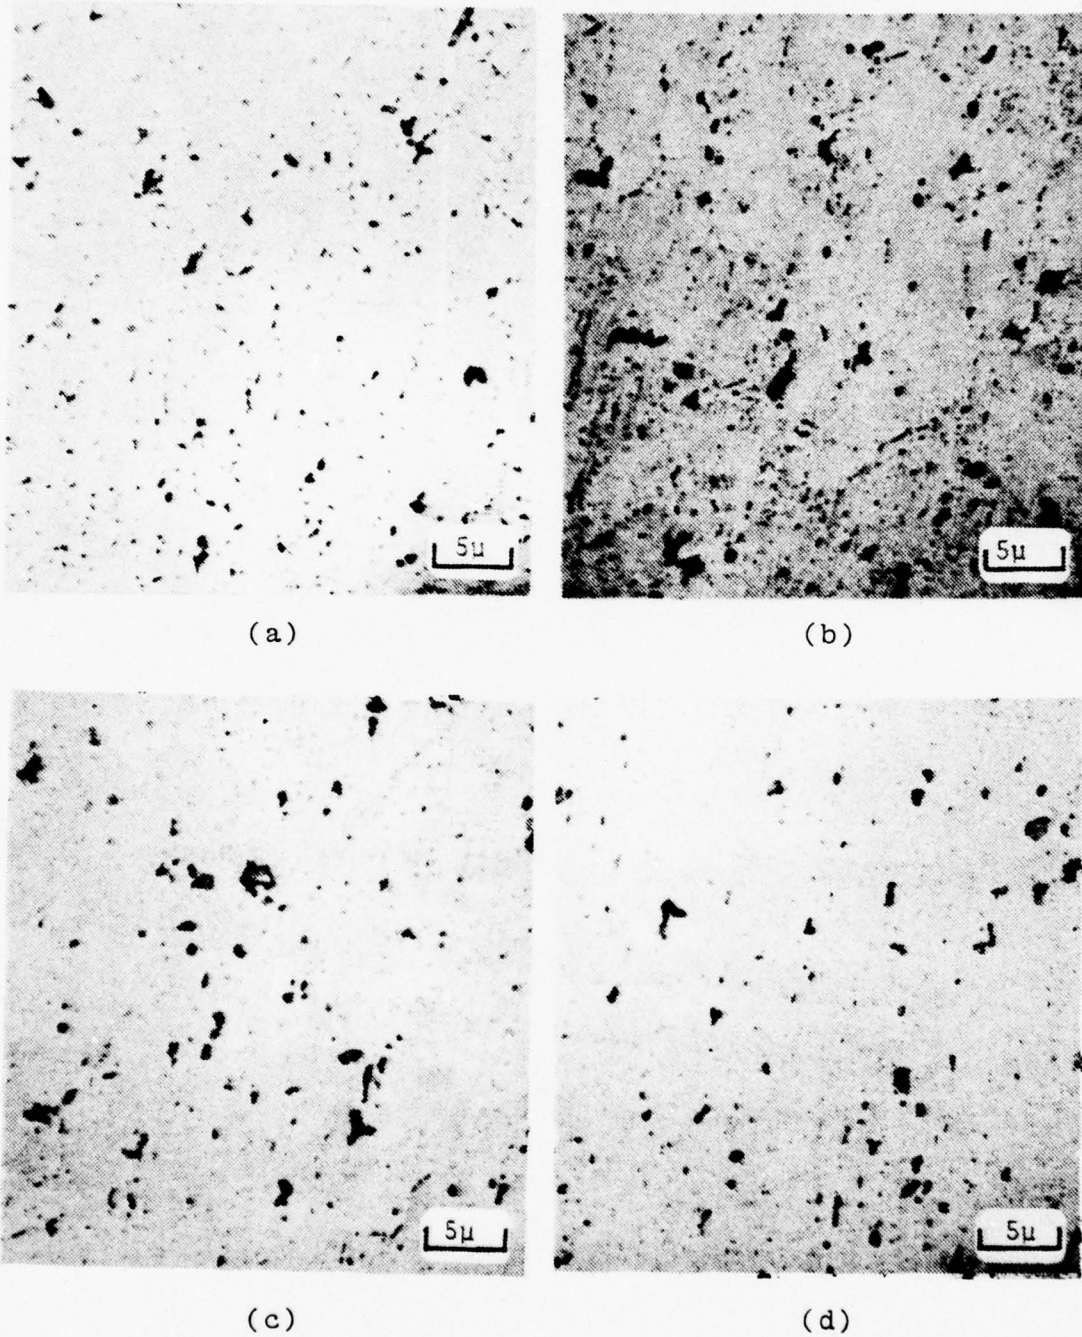
Figure 29. Photomicrographs of the specimen subjected to 16 repair simulations. These micrographs were taken following etching with the H_3PO_4 solution. (200X, etchant: H_3PO_4)

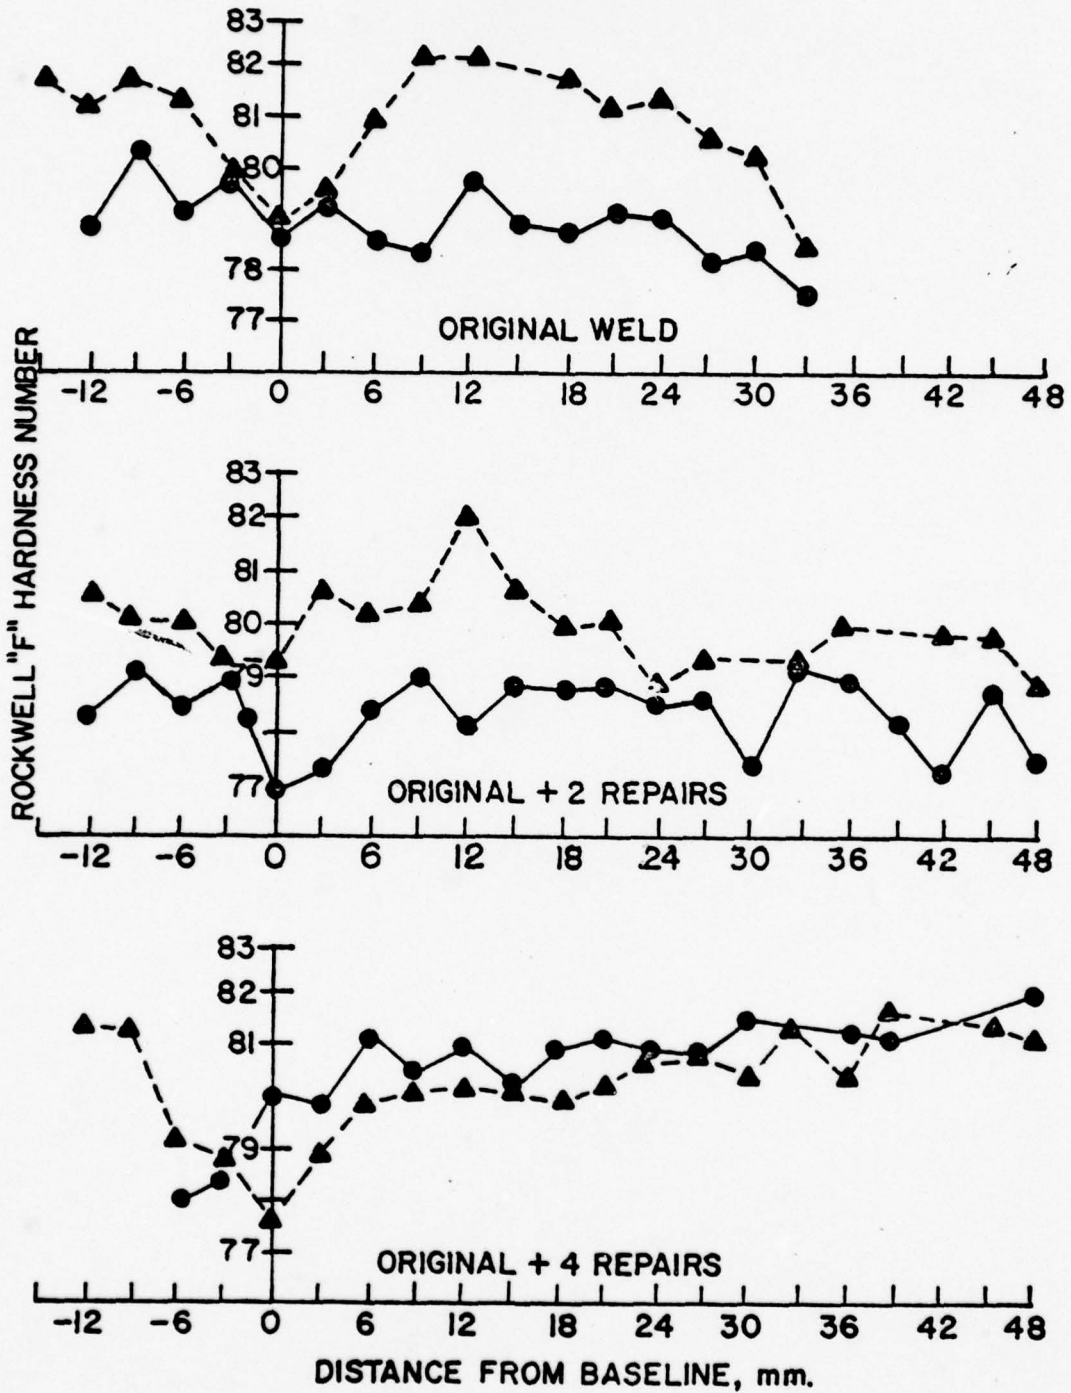
Figure 30. Hardness profiles for specimens subjected to the original two-pass weld, 2 and 4 repair simulations. The solid line indicates data taken along the specimen centerline and the dashed line represents data taken along the line 3 mm from the centerline.

Hardness testing was performed on specimens from each of the nine test plates. The data were recorded taken along the centerline and at a distance of 3 mm from the centerline of each specimen. The plane of the surface of the hardness specimen is defined by the short and long transverse directions. Thus the lines of the hardness traverses correspond to the midplane of the plate and a plane parallel to the midplane but 3 mm removed. Examination of Figures 30 through 32 reveals that with the exception of a few points, the data fell within a hardness range of from 77 to 83 on the Rockwell F scale. The specimen subjected to the original two-pass weld only exhibited hardness readings taken along the specimen between 78 and 80. These readings indicated no significant

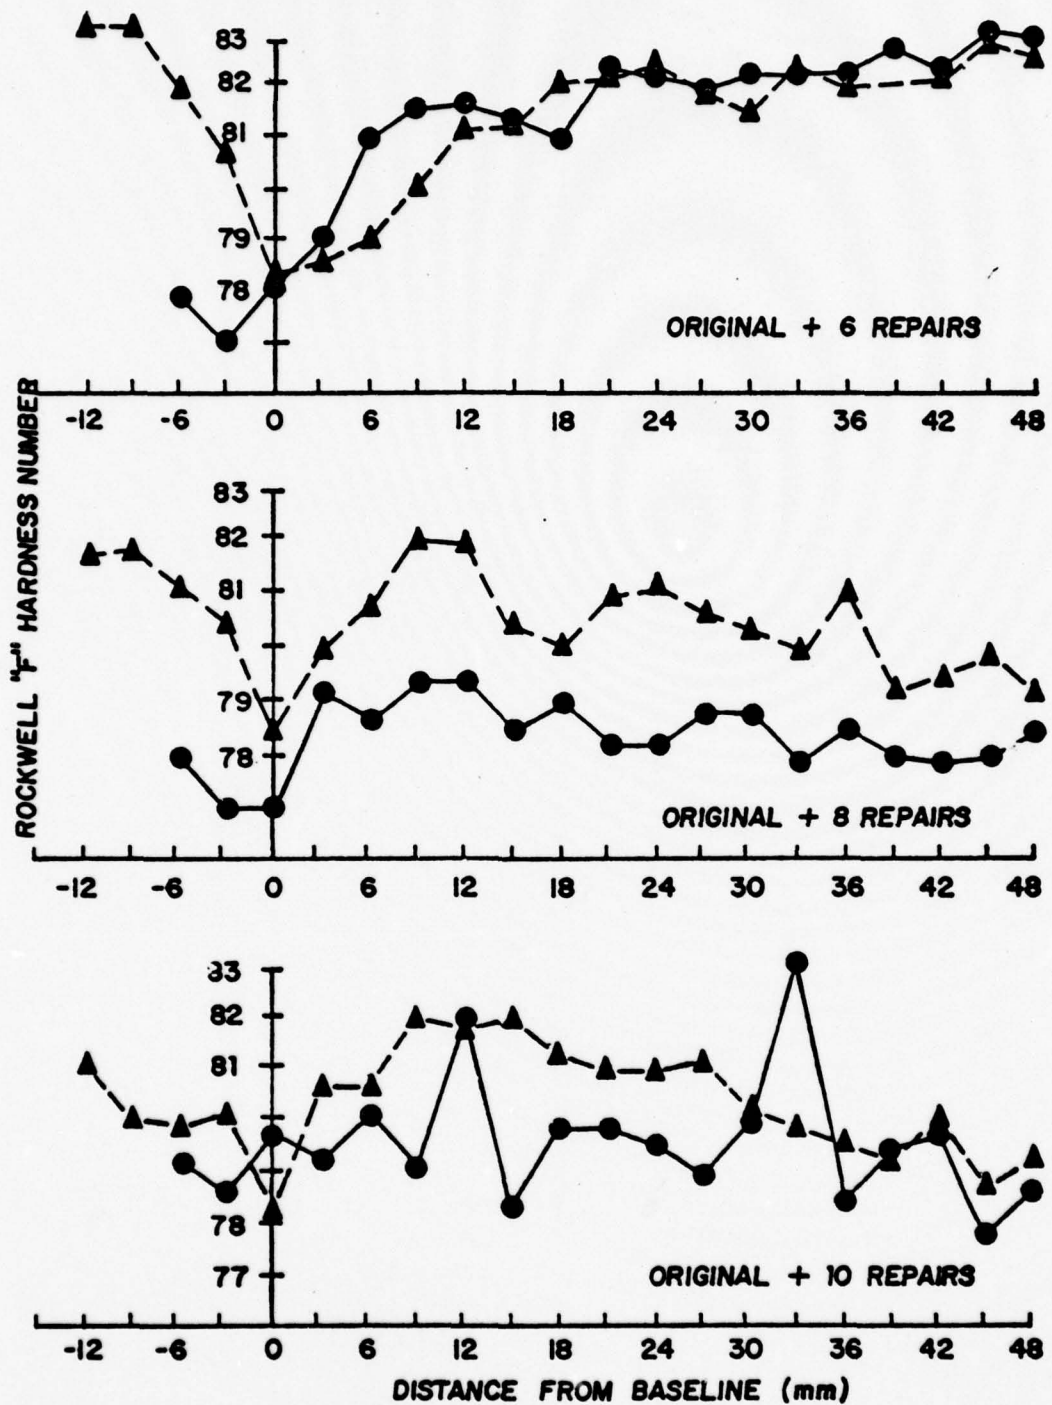
Figure 31. Hardness profiles for specimens subjected to 6, 8 and 10 repair simulations.

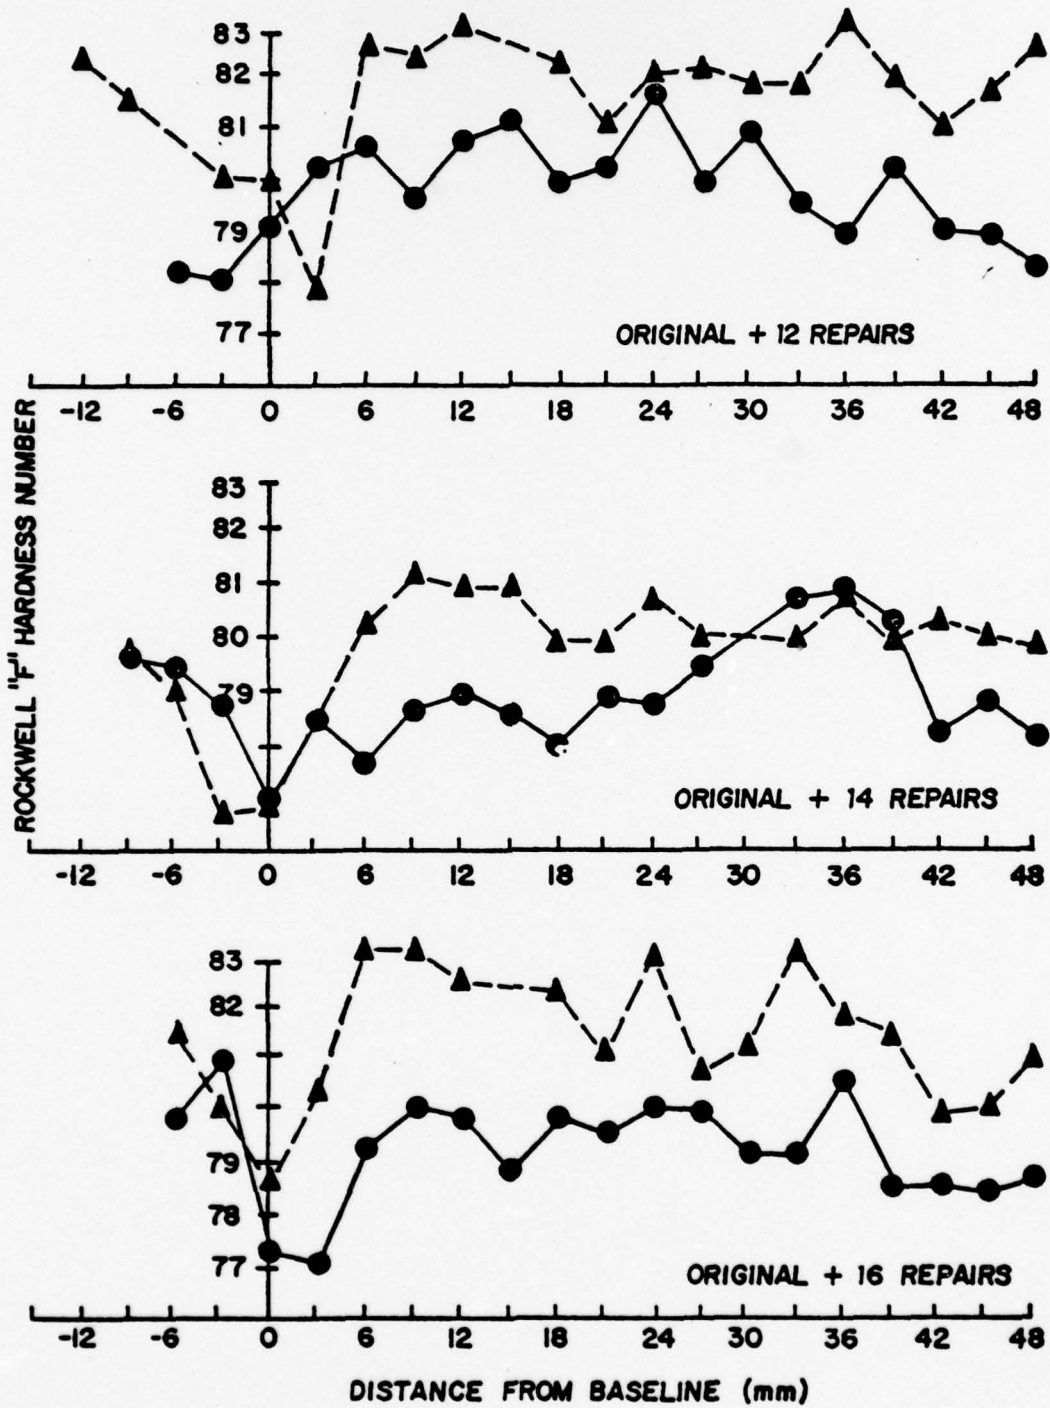
Figure 32. Hardness profiles of specimens subjected to 12, 14 and 16 repair simulations.

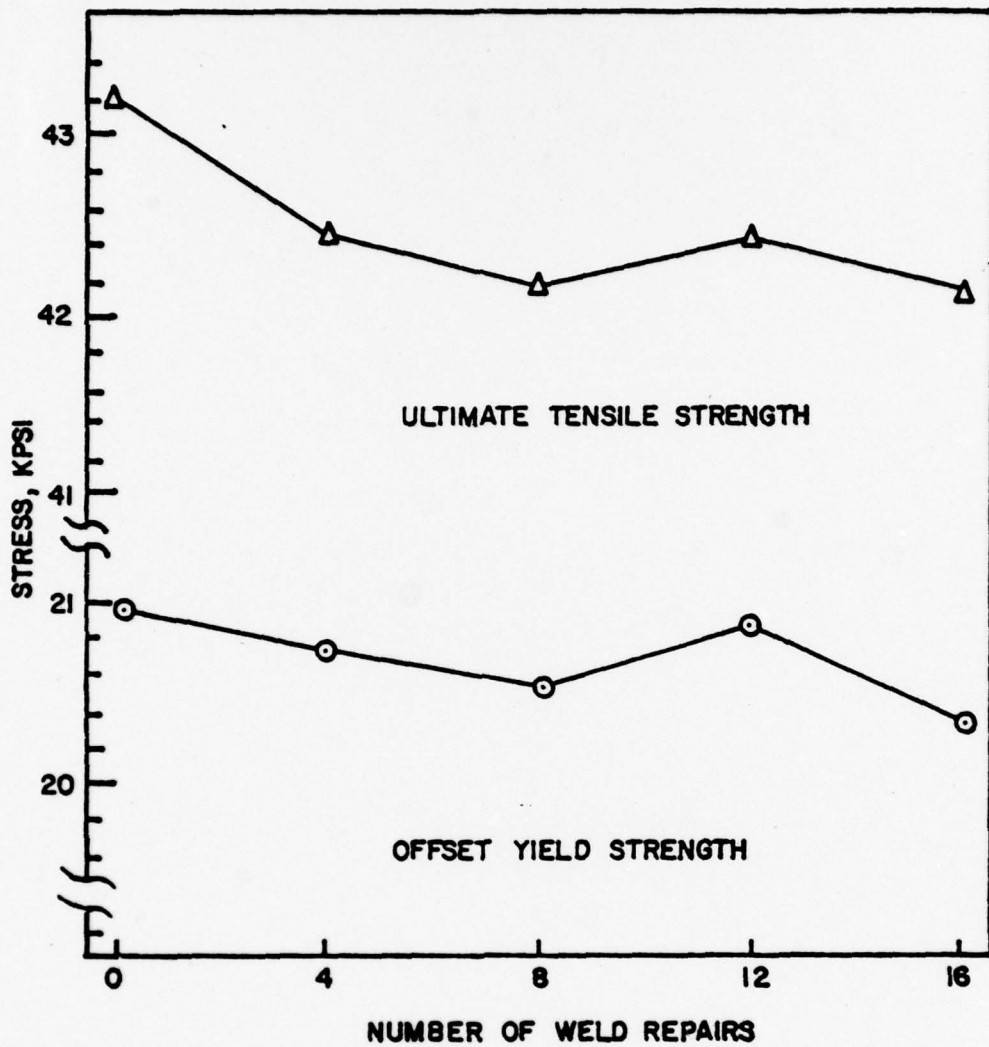
Figure 33. This figure is a plot of the average tensile strengths recorded for specimens subjected to the original two-pass weld only, 4, 8, 12 and 16 repair simulations as a function of number of weld repairs.
