Performance of the
St. Marys River ice booms, 1976-1977

10 Roscoe E. Perham

Prepared for
U.S. ARMY ENGINEER DISTRICT
DETROIT, MICHIGAN
By
COLD REGIONS RESEARCH AND ENGINEERING LABORATORY
U.S. ARMY CORPS OF ENGINEERS
HANOVER, NEW HAMPSHIRE

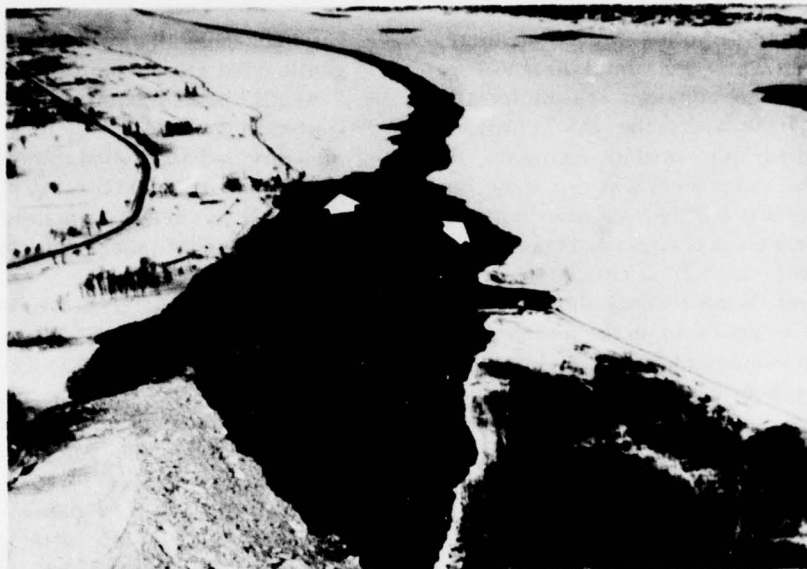
Figure 3. Head of Little Rapids Cut showing ice cover behind west boom (upper left arrow) cracked free from shore. Right arrow indicates east boom.

Late in the afternoon of 20 January the ice behind the west ice boom cracked away from shore in a manner almost identical to that shown in the upper left of Figure 3, a photo taken last year. That night, at about 2050 hours, while a large ore carrier was moving downstream in the ship track well above the bend, also shown, the shore anchor chain of the west boom broke with a loud noise and approximately 500 ft of ice cover passed through the boom location. The line of timbers remained connected to the upstream anchor but it moved out into mid-stream, partially blocking the opening. The ship stopped, backed up, and tied up near the Soo locks at 2310 hours. The Soo Area Office personnel and equipment repaired the ice boom, completing most of the work by the evening of 22 January. That night the last four ships — the Callaway, Blough, Clarke and Doan Transport — went downstream without incident.
