USAAEFA PROJECT NO. 74-77 - Vol 1

**ROTARY WING ICING SYMPOSIUM.**

**SUMMARY REPORT.  
VOLUME I,**

UNITED STATES ARMY AVIATION ENGINEERING FLIGHT ACTIVITY  
EDWARDS AIR FORCE BASE, CALIFORNIA 93523

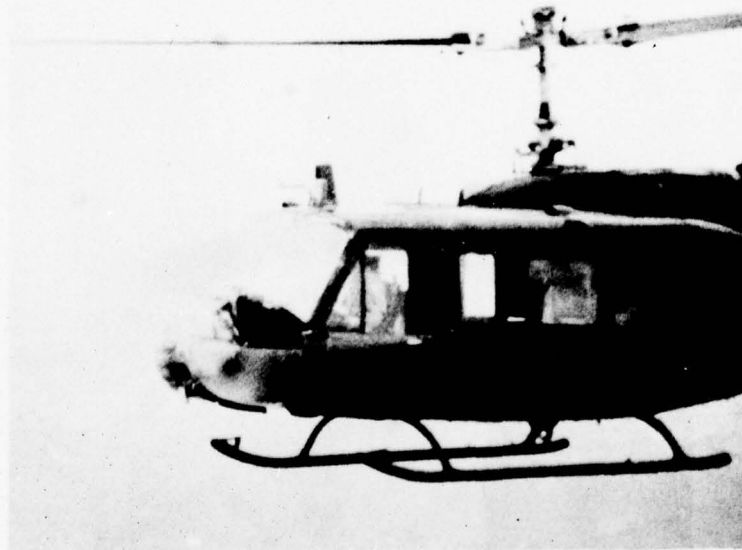
Slide 2. Heated Glass Windshield Capability.

The heated section of the glass windshield was completely effective in preventing ice buildup when it was activated prior to entry into the HISS spray cloud. Turning the system on after entry into the spray cloud required 45 seconds to deice approximately 1/8 inch of ice from the heated section. The optical characteristics of the windshield were satisfactory when evaluated under daylight, twilight, and night conditions in a non-icing environment.

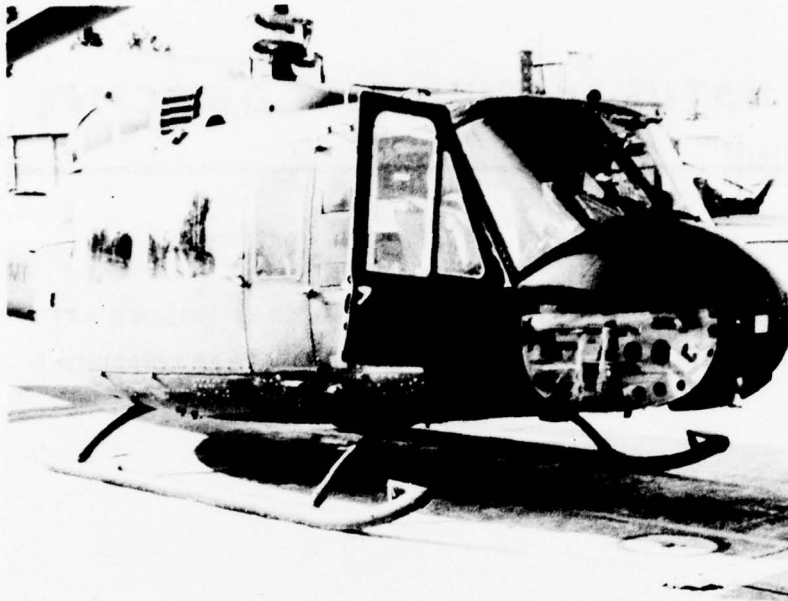
Slide 3. UH-1H Test Helicopter.

The test aircraft, a UH-1H utility helicopter, serial number 64-13679, was manufactured by Bell Helicopter Company. A detailed description of the standard UH-1H helicopter may be found in the operator's manual.<sup>4</sup> The standard auxiliary exhaust heater system and the standard engine air inlet filters for the Arctic environment were installed. The engine air particle separator had been removed from the aircraft in accordance with normal winter procedures and the engine air inlet filters (3) installed. Nonstandard equipment installed on the airframe to assist in the conduct of this evaluation included a windshield alcohol anti-ice system mounted on the pilot's windshield wiper, a visual ice accretion measuring device (visual probe) located externally on the cabin roof above the copilot's overhead plexiglass panel, and a Rosemount ice detection system mounted on the cabin roof aft of the

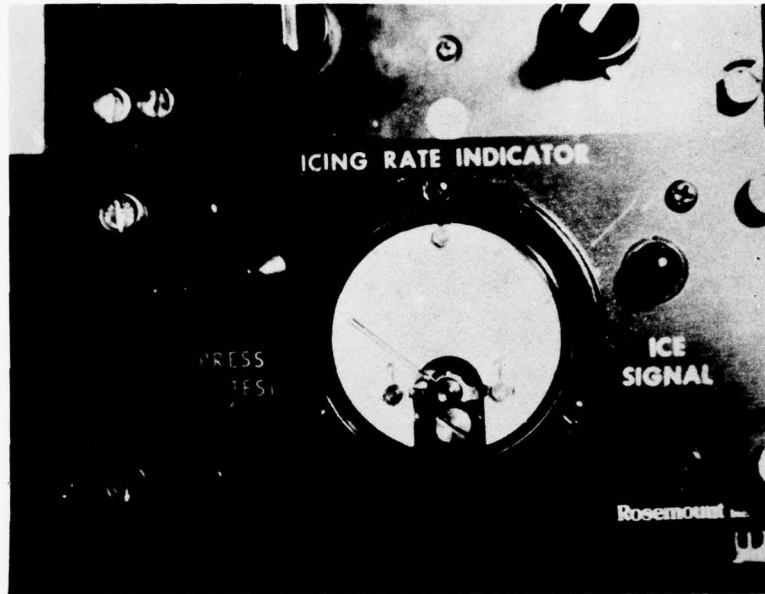
SLIDE 3. ROSEMOUNT ICING RATE METER.

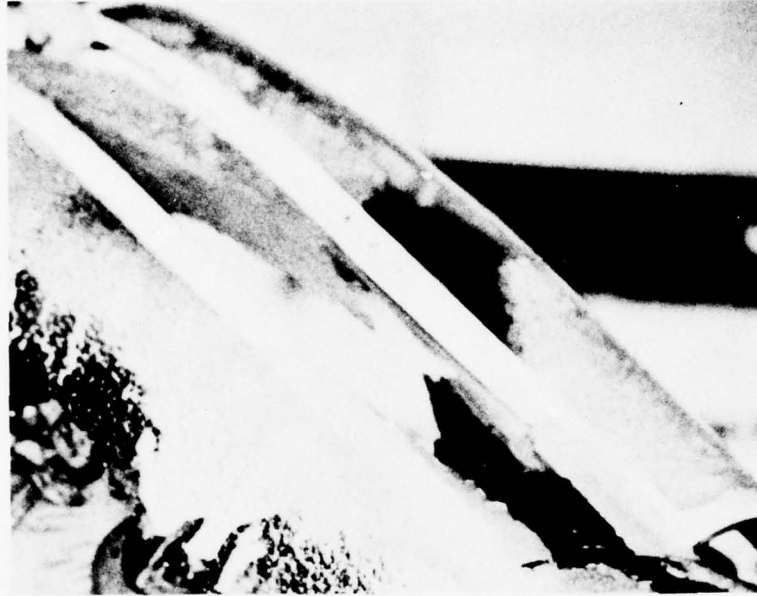
SLIDE 7. RUNBACK AND REFREEZING CAUSED RESTRICTED FIELD OF VIEW.
