**ADVANCED TURBINE ENGINE
GAS GENERATOR (ATEGG)**

**FRACTOGRAPHY OF
CAST NICKEL BASE SUPERALLOYS**

DAVID F. GRAY

Final Report 1 October 1976 - 30 June 1978

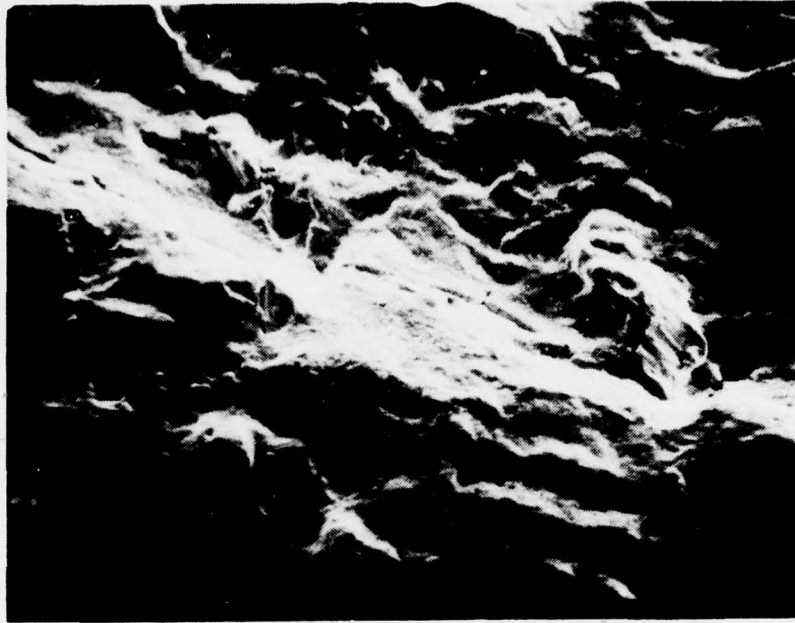
Figure 5. Specimen 8U-PP-7 - Low Cycle Fatigue, PP Loading
Test Temperature - 1832^oF Vacuum
Material - Rene' 80
Total Strain Range - 0.00247, 22115 Cycles
Top 400X, Bottom 1000X
Transgranular Fatigue Striations

The pp (see Figure 2 for notation) fracture surfaces were found to have definite striations and transgranular plane surfaces when tested in a total strain range of 0.5 percent or less, as shown in Figures 4, 5, 6, and 7. At greater than 0.5 percent total strain, the fracture surface tends to remain transgranular, but is less planar and seems to prefer the interdendritic zones, as seen in Figures 8, 9, and 10. Initiation at these higher strains may be associated with intergranular specimen surface separation (Figure 10), but slip plane formation is still evident in the interior metal at these higher strain rates, as can be seen in Figures 8 and 9.

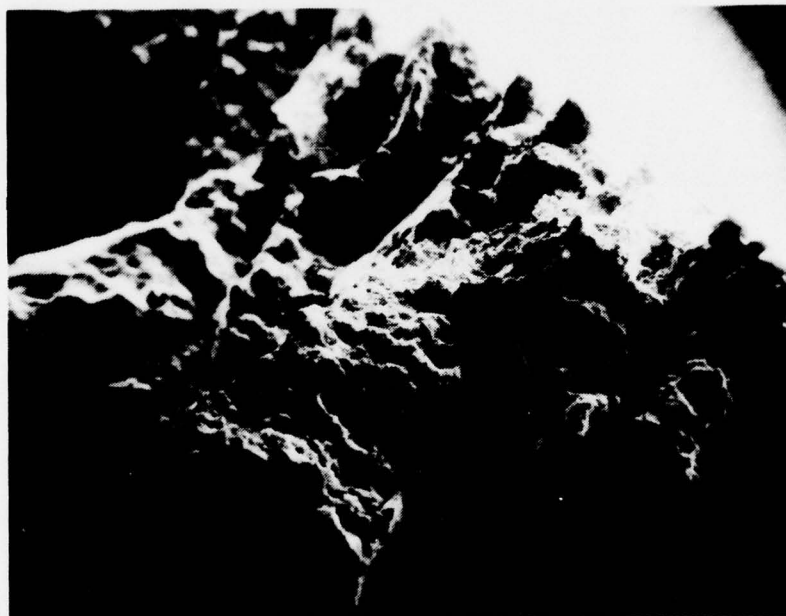
Figure 9. Specimen INN-3-PP - Low Cycle Fatigue, PP Loading
Test Temperature - 1700° Air
Material - IN-100
Total Strain Range - 0.0092, 96 Cycles
Top 400X, Bottom 50X
Dominant Transgranular (Interdendritic) Fatigue
Note Some Slip Planes (Arrow).

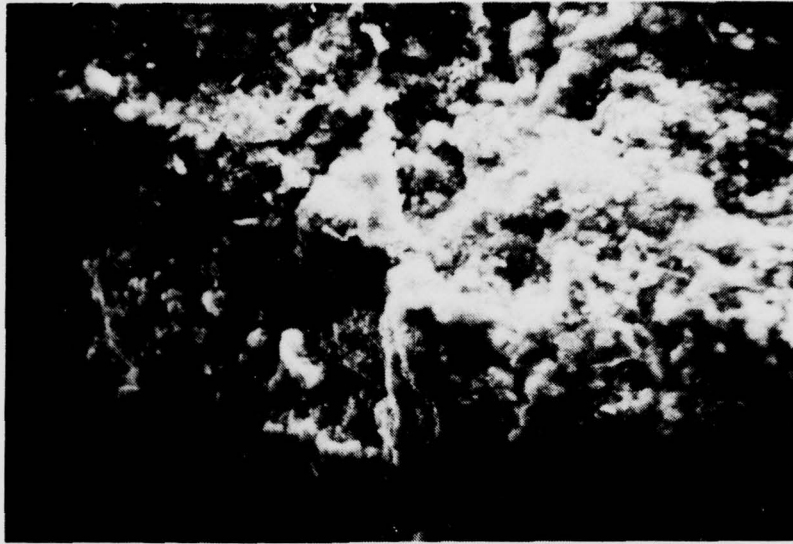
Figure 14. Specimen INN-13-PC - Low Cycle Fatigue, PC Loading
Test Temperature - 1700°F Air
Material - IN-100, Total Strain Range - 0.0058, 139 Cycles
Test Time - 87.3 Hrs., 1000X
A Compression Dominated Hold can Damage The Grain Boundary
Fatigue Indications, Particularly in an Air Environment.

When a creep hold is introduced into the cycle, such as during cc, pc, and cp loading, the low-profile dimpled, grain boundary rupture is generally more prevalent, as is evident in Figures 11, 12, and 13. These generated grain boundary voids tend to become less uniform in size with lower strains (greater number of cycles of failure), as can be seen by comparing Figures 12 and 13, and are probably the result of void coalescence with time, number of cycles, and grain orientation with respect to the loading direction. The presence of heavy surface oxides and surface contacts during reversed loading tends to obliterate some surface characteristics at times, as may be seen in Figure 14, 15, and 16. However, the general intergranular failure is still evident.

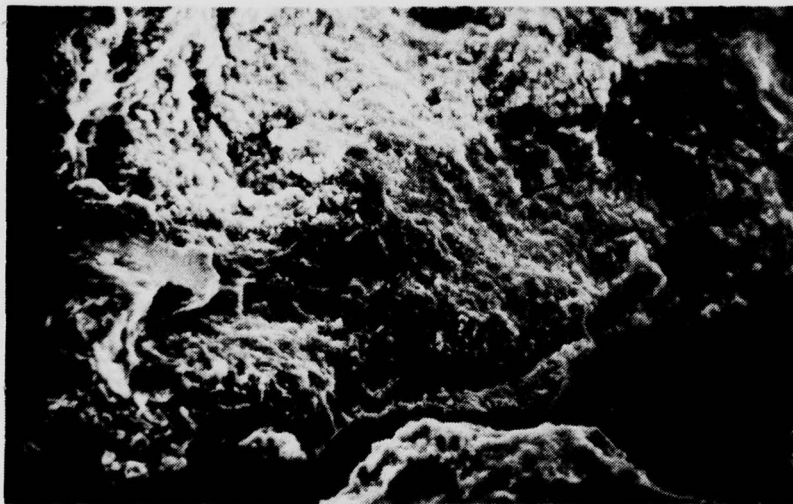
Figure 15. Specimen INN-9-CP - Low Cycle Fatigue, CP Loading
Test Temperature - 1700°F Air
Material - IN-100, Total Strain Range - 0.0041, 1100 Cycles
Test Time - 159.3 Hrs., 400 X
Reverse Loading Can Damage the Dimples Found in Grain Boundary
Fatigue, But is Less Damaging in a Tension Hold
Dominated Fatigue Load.

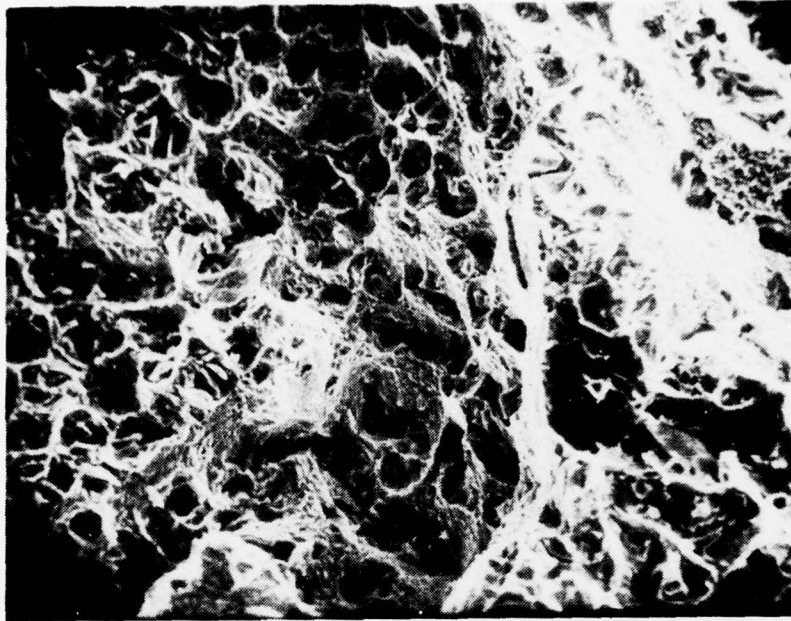
Figure 18. Specimen 123C-T-3 - Tensile, Test Temperature - 1600°F Vacuum
Material - Rene' 80, Top 400X, Bottom 1000X
Short Time Tensile Fracture Surfaces are Transgranular at 1600°F,
and Also Associated with Carbide Phases. However, Notice that
the Matrix Also Has Multiple Small Dimples (Arrow Typical).
Compare with Figure 17.

Tensile and short life creep-rupture surfaces are included for the reader to compare fracture surfaces, in Figures 17, 18, 19, and 20. It can be seen that tensile failures at 871°C (1600°F) and 1000°C (1832°F) are both dominated by transgranular rupture and tend to be associated with particulate phases, such as carbide. Short time creep-rupture tends to show evidence of grain boundary influence on the fracture surface, but at 871°C (1600°F) transgranular failure is still present as evidenced by the multiple slip planes in Figure 20.
