NRL Memorandum Report 3859

Ultrasonic Measurement of Motor Case Insulation Thickness

NAVAL RESEARCH LABORATORY Washington, D.C.

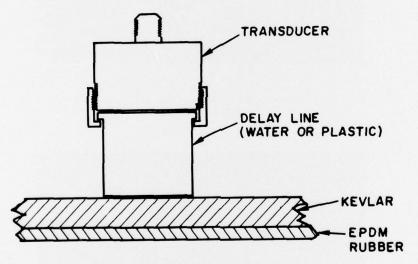
The motor case is built of Kevlar fiber reinforced epoxy and the insulator is EPDM rubber. The ultrasonic approach is to send a pulse of ultrasound through the motor case and observe echoes from the motor case-insulator interface and from the free surface of the insulator. Figure 1 shows the ultrasonic probe used and Figures 2a and 2b show oscilloscope traces of the echoes. Separation of these echoes in time depends on the velocity of ultrasound in the EPDM. The ability to resolve these echoes is a quality the instrumentation. The purpose of the stand-off, or delay line, in Figure 1 is to aid in this resolution by giving the very strong transmitted pulse (or "Main Bang") time to die out before echoes return. There is an echo

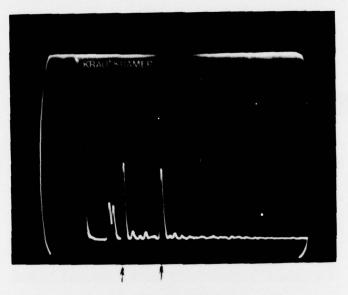
Fig. 2a – Echoes from case-liner interface and from inner surface. Unfired motor case

from the delay line-Kevlar interface but it is not nearly so strong as the Main Bang. A typical oscillogram is shown in Figure 2a. The echo at the left comes from the delay line-Kevlar interface. The echo at 2.6 is from the Kevlar-insulator interface and the one at 4.2 is from the free surface of the insulator.

Figures 2a and 2b are oscillograms taken from a Krautkramer USIP-11 ultrasonic instrument. The transducer was a Holosonics 9.5 mm, 3 MHz, untuned, with a piezo-ceramic element, designed for immersed operation. The USIP-11 was operated in the 2-8 MHz band. It was found that untuned transducers are necessary because the tuned units ring too long for

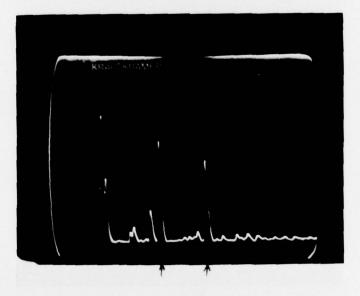
Fig. 2b – Echoes from case-liner interface and porous layer. Fired motor case.

This was taken on a piece of unfired motor case. In Figure 2b echoes from equivalent interfaces of a piece of fired motor case are shown. However, the third echo does not actually come from the free surface of the insulator. After firing, the free surface is not only charred, but is porous to a depth of approximately a millimeter. The third echo in this case comes from the interface between the remaining solid and the porous layer. Figure 3 shows these layers and part of the Kevlar-epoxy motor case. The fact that the ultrasound reflects from this porous layer interface is of course the best of information, for it is the amount of insulation remaining after firing that is of interest. It may be noticed that the two echoes of interest appear at different locations on the base line. This is due to the fact that the Kevlar is thicker in the second case. The baseline calibration is 2 μ seconds per division in both oscillograms.
