Special Report 78-16

EFFECTS OF LOW GROUND PRESSURE VEHICLE TRAFFIC ON TUNDRA AT LONELY, ALASKA

COLD REGIONS RESEARCH AND ENGINEERING LABORATORY
U.S. ARMY CORPS OF ENGINEERS
HANOVER, NEW HAMPSHIRE

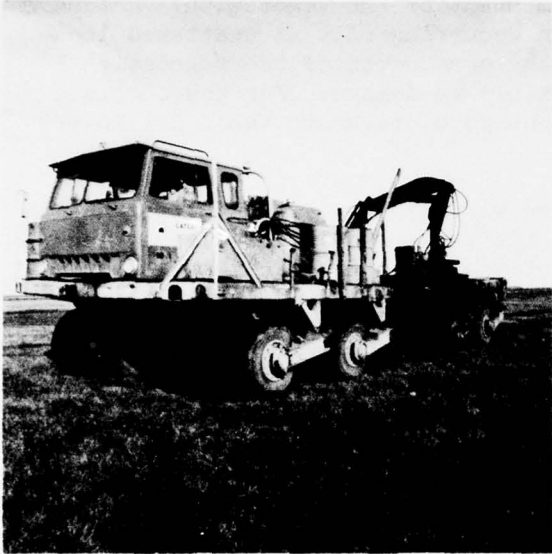
Figure 2. CATCO Rolligon

1. CATCO Rolligon (11,700 kg or 26,000 lb, empty), an 8-wheel, low pressure, smooth, wide tire vehicle, inflation pressure 0.35 kg/cm² (5 psi), minimal load (Fig. 2)
2. Houston Rolligon (6,800 kg or 15,000 lb, empty), a 6-wheel, low pressure, ribbed, wide tire vehicle, inflation pressure 0.2 to 0.3 kg/cm² (3 to 4 psi), no load (Fig. 3)
3. Nodwell, FN-10 (2,250 kg or 5000 lb empty), low pressure (0.1 kg/cm² or 1.4 psi), tracked vehicle, no load (Fig. 4)

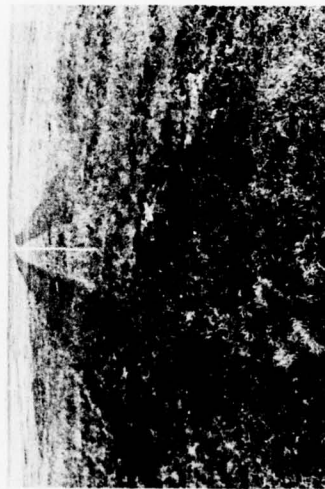
Figure 9. Lane 7, after 1 year

- 1) The trails which originally appeared lighter than the adjacent terrain surface are now darker (greener) than the undisturbed surface (typical examples: Fig. 8 vs Fig. 9, Fig. 22 vs. Fig 23).

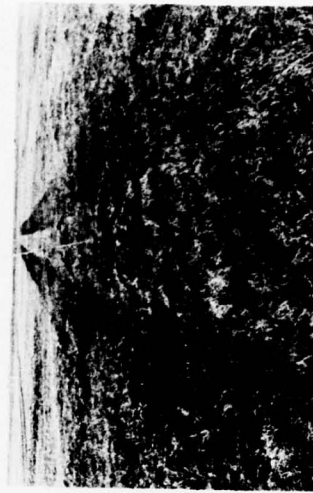
Figure 11. Lane 13, after 1 year

- 2) Although all trails are now darker than the adjacent, undisturbed surface, the ones viewed against the direction of travel are darker than those viewed in the direction of travel (typical examples, same vehicle and same number of passes: Fig. 11 vs. Fig. 17, Fig. 23 vs. Fig. 29, Fig. 35 vs. Fig. 41).

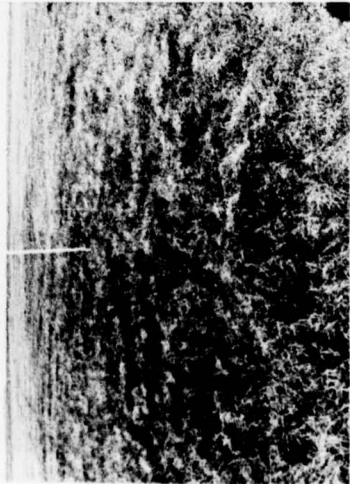
Figure 19. Lane 2, after 1 year

- 3) Virtually all trails are more visible now than after the tests during the previous year (compare top row of photos with those in the bottom row on each page). The only exception is Lane 2 (Fig. 18 vs. Fig. 19), which is no longer visible from the ground.

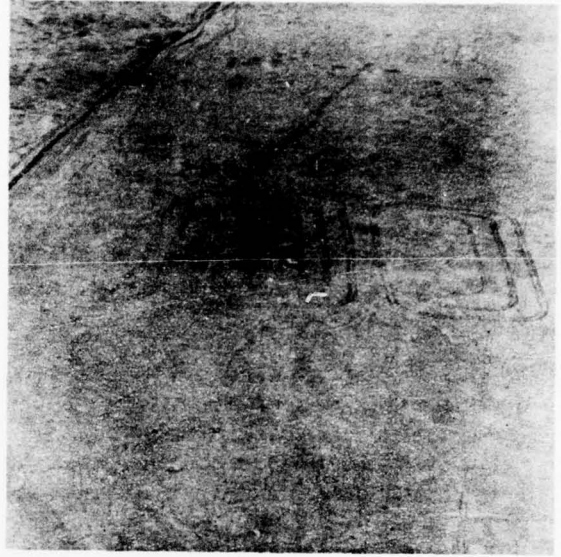
Figure 43. Aerial view of test site, after 1 year, viewed toward north

Aerial views of the test area are shown in Figures 42 through 45. It is interesting to compare the appearance of the traffic signatures in Figure 42 (immediately after the tests) and in Figure 43 (1 year later). Both sets of photos were taken late in the afternoon, looking towards north, so that the sun angles in both are similar.

After one year (Fig. 43), the visual appearance of the trails from the air corresponds to the observations on the ground, discussed previously. The difference in appearance due to traffic direction is obvious (compare Fig. 43 with Fig. 45, a view of the test area from the opposite direction). And, as in the ground observations, the CATCO trails are slightly more prominent than the Houston trails, the Nodwell trails being the least prominent, and the degree of visibility (traffic signature darkness) increasing with the number of traffic passes for all vehicles. The lower visibility of the Nodwell signature, when viewed from the air, is also due to the narrower track, in comparison with the wider Rolligon tire.

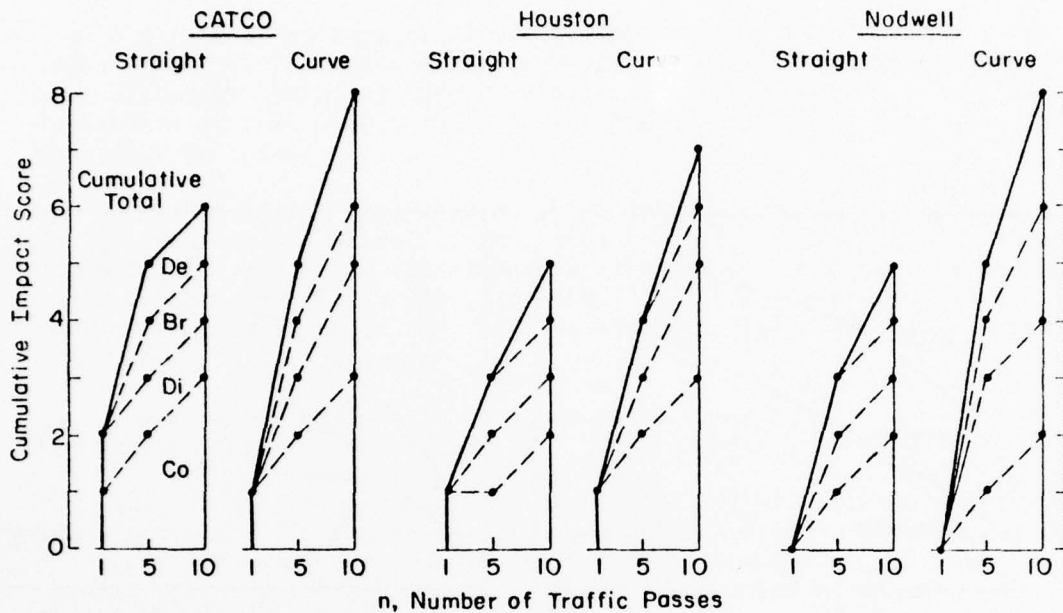
Figure 60. Comparison of impact scores for each vehicle (1 year after traffic)

To enable a more convenient comparison of the impact (after 1 year) caused by the three vehicles, the impact scores listed in Table 5 are shown in a graphical format in Figure 60.

Co = Compression of Vegetation to Tundra Surface
 Di = Displacement of Vegetation
 Br = Breakage of Plant Stems or Stalks
 De = Deposition of Moss or Mud to Sides of Track

It should be noted that the values shown in Table 5 or Figure 60 represent observed damage without regard for variations in vehicle weight, payload, tire characteristics, or number of tire passes. On this basis alone, the CATCO Rolligon created more damage than either of the other two vehicles, particularly along the straight portions of the tracks (Fig. 61a). This was due mostly to the deeper, more uniform compression of the vegetation in the smooth tire CATCO track. The ribbed tires of the Houston and the Nodwell tracks tended to abrade the vegetation in the curves of the 5 and 10-pass lanes, and although the total damage in the curves was similar for all three vehicles (Fig. 61b), the causes of the damage were different.

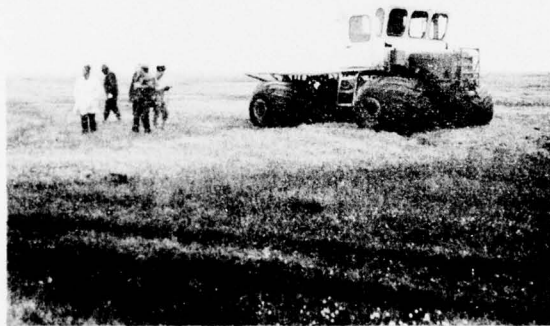
Figure B-1. Rolligon vehicle used for traffic tests. Ribbed (cleated) rubber tires; tire inflation pressure (and approximate ground contact pressure) between 0.2 and 0.3 kg/cm² (3 to 4 psi); no load, except for 2 men and fuel.

The test vehicle had ribbed (gleated) tires with an inflation pressure between 0.2 and 0.3 kg/cm² (approx. 3 to 4 psi) and carried no load. In one section of the 15-pass lane, initially intended for 25 passes, the Rolligon tires had penetrated through the active layer almost down to the permafrost after 10 passes; traffic was therefore stopped after 15 passes.

On 7 August 1974, three test lanes, 1, 5 and 15 traffic passes, were made with a 4-wheel Rolligon Vehicle (Fig. B-1) at a site approx. 4 miles southeast of Barrow, near the Ikpik Slough, where Air Cushion Vehicle (ACV or SEV) and Weasel traffic tests had been conducted during the summer of 1971 (Abele, 1976). The test area is on a level, drained lake bottom, with a relatively uniform and homogeneous saturated active layer and vegetation, the organic mat having a moisture content of approx. 1000% and thaw depth in the 20-30 cm range.
