Report No. FAA-RD-78-122

TESTS OF CRASH-RESISTANT FUEL SYSTEM FOR GENERAL AVIATION AIRCRAFT

DECEMBER 1978

FINAL REPORT

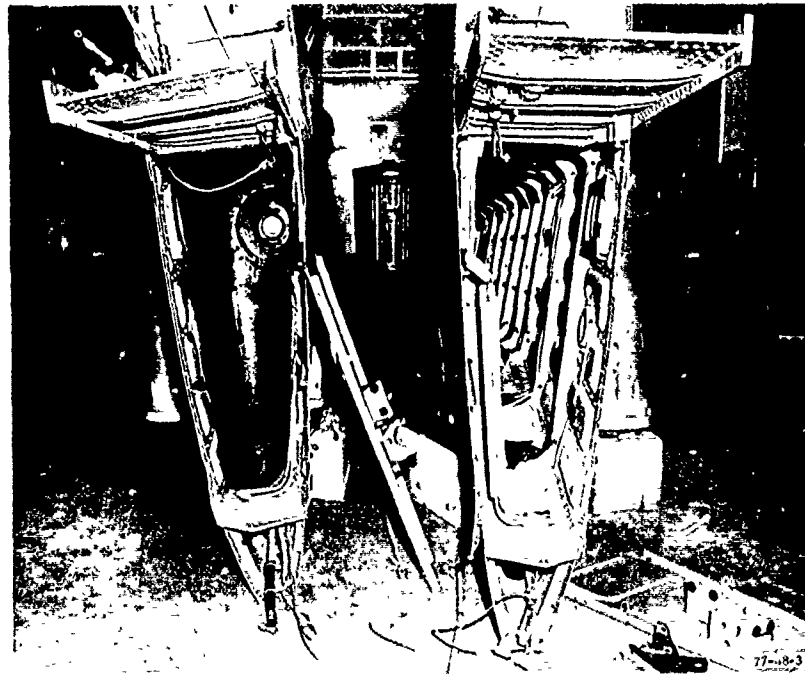
FIGURE 3. INSTALLATION OF TWO-PLY FUEL TANK

- ① EQUIV. TO MS33656-8
- ② EQUIV. TO MS33514-12 MOD.
- ③ EQUIV. TO MS33649-12

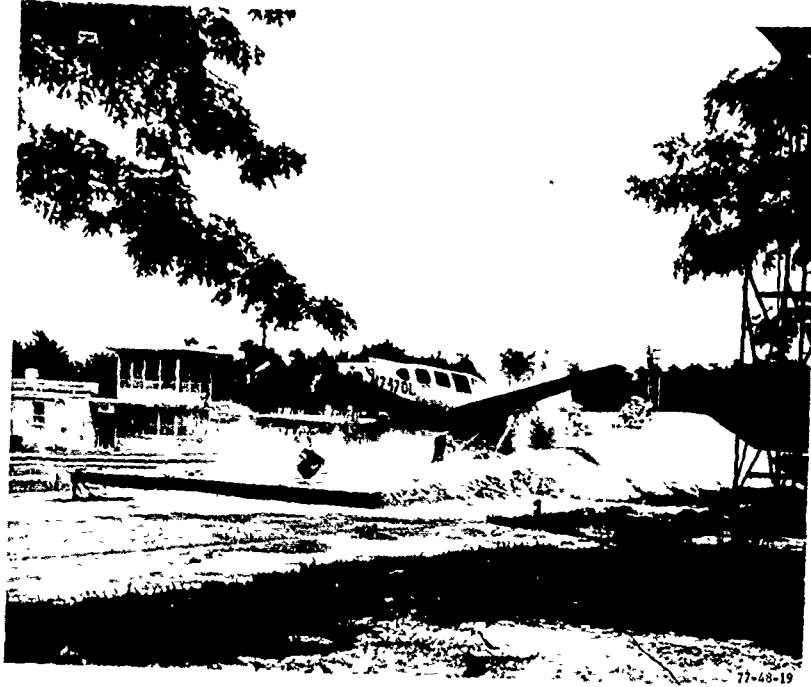
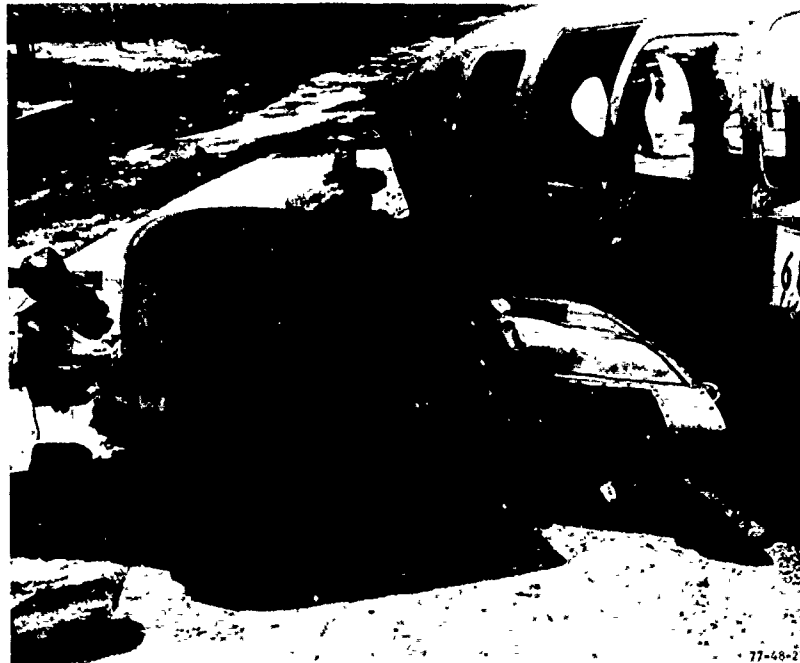
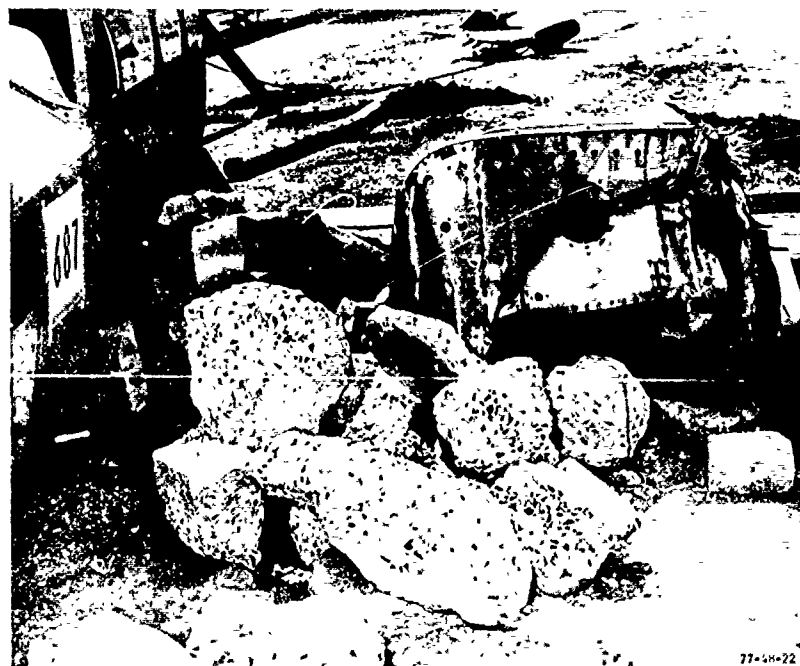
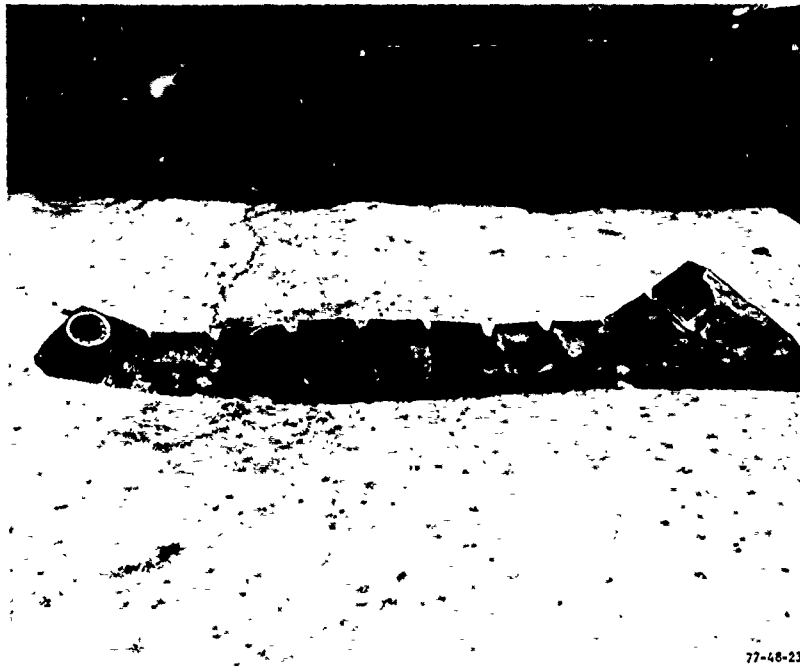
FIGURE 13. AIRCRAFT IMPACT, TEST 2, (NOTE WATER SPRAY FROM RIGHT WING)

FIGURE 14. DAMAGE TO RIGHT WING, ORIGINAL AIRCRAFT BLADDER CELL, TEST 2

FIGURE 15. DAMAGE TO RIGHT WING, ORIGINAL AIRCRAFT BLADDER CELL, TEST 2

FIGURE 16. DAMAGE TO LEFT WING, TWO-PLY FUEL TANK, TEST 2

FIGURE 17. REGULAR (NON-CRASH-RESISTANT) BLADDER CELL AFTER IMPACT

FIGURE 18. DAMAGE TO REGULAR AIRCRAFT CELL DUE TO POLE IMPACT (INBOARD)

FIGURE 19. DAMAGE TO REGULAR AIRCRAFT CELL DUE TO POLE IMPACT (OUTBOARD)

Test 2 compared the existing bladder cell (right wing) with a two-ply crashworthy cell. The two-ply tank survived the 93-ft/s impact with no damage, but the original bladder cell failed catastrophically, spraying out its contents almost instantaneously. The cell failed predominantly by tearing (figures 13 through 19). During impact, the aircraft rotated counterclockwise about its center of gravity as viewed from above, as the forces delivered to the left wing were higher due to the stiffening effect of the two-ply tank. It came to rest at about a 30° angle. Acceleration levels are shown in figure 20.

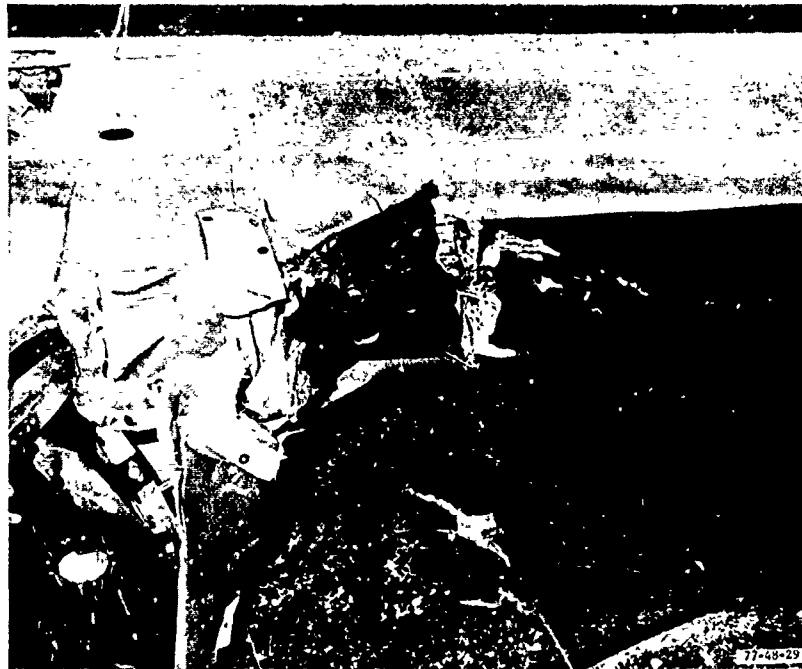
FIGURE 21. DAMAGE TO LEFT WING, TEST 3

FIGURE 22. DAMAGE TO RIGHT WING, TEST 3

FIGURE 23. EFFECT OF ROCK IMPACT, TEST 3

Test 3 was performed to evaluate the performance of a 12.75 oz single-ply tank installed in the right wing. A two-ply tank was run concurrently. Both of these tanks survived the 95-ft/s impact with no damage discernable to a visual inspection (figures 21 through 23). Acceleration levels are shown in figure 24.

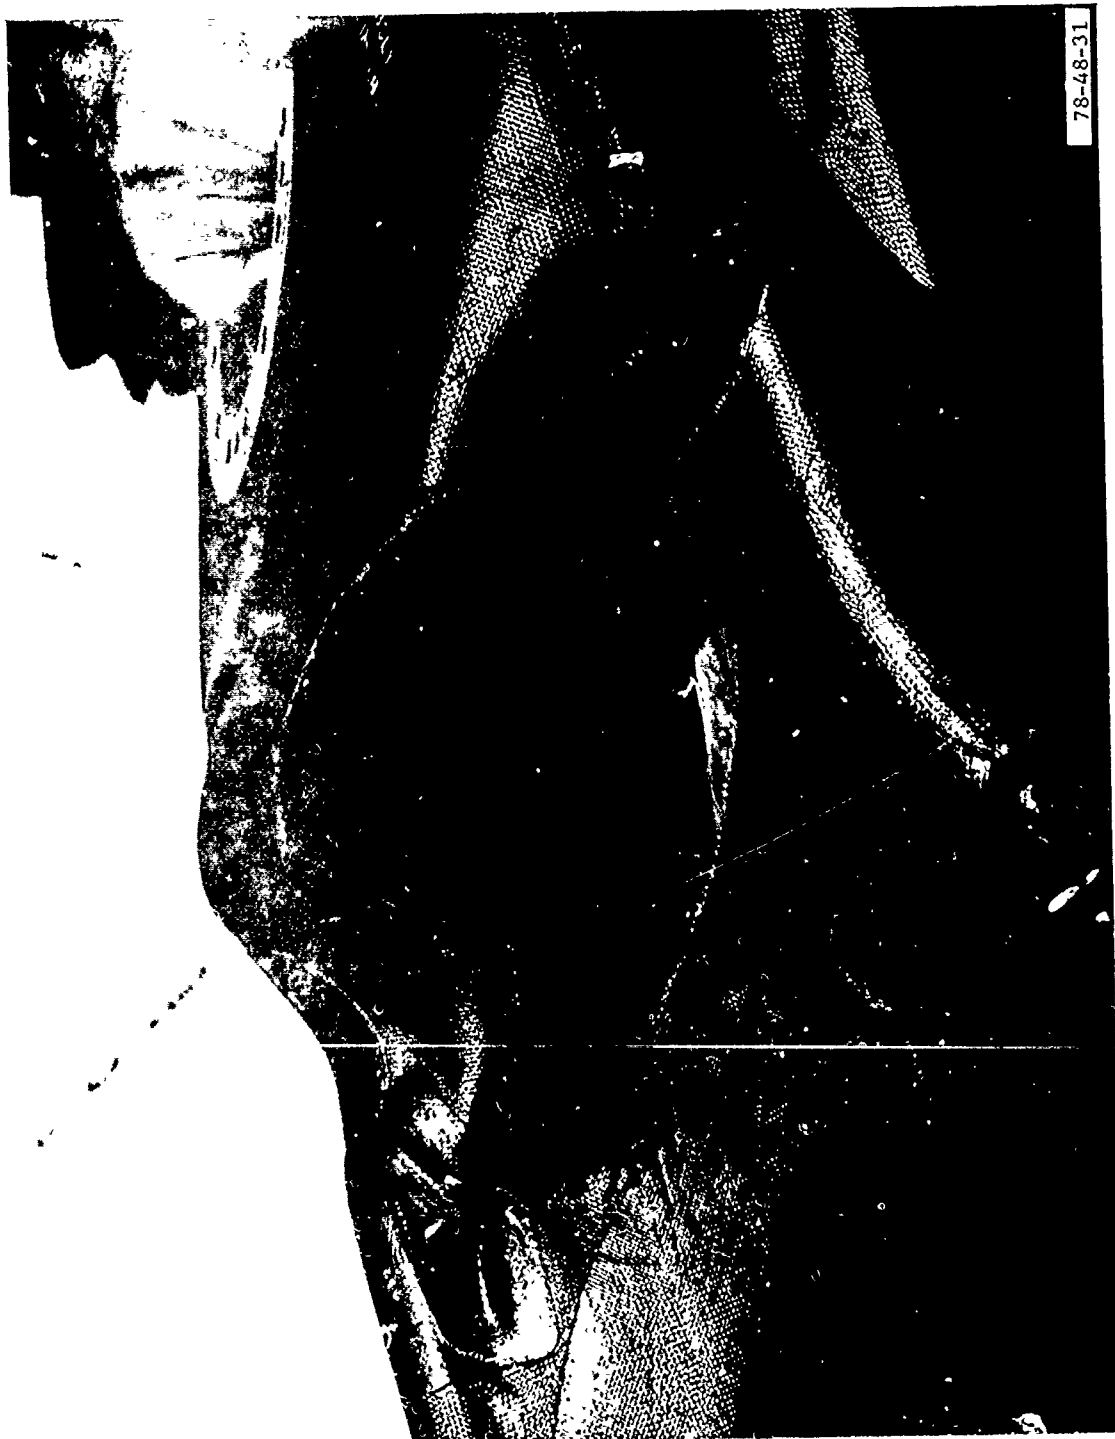
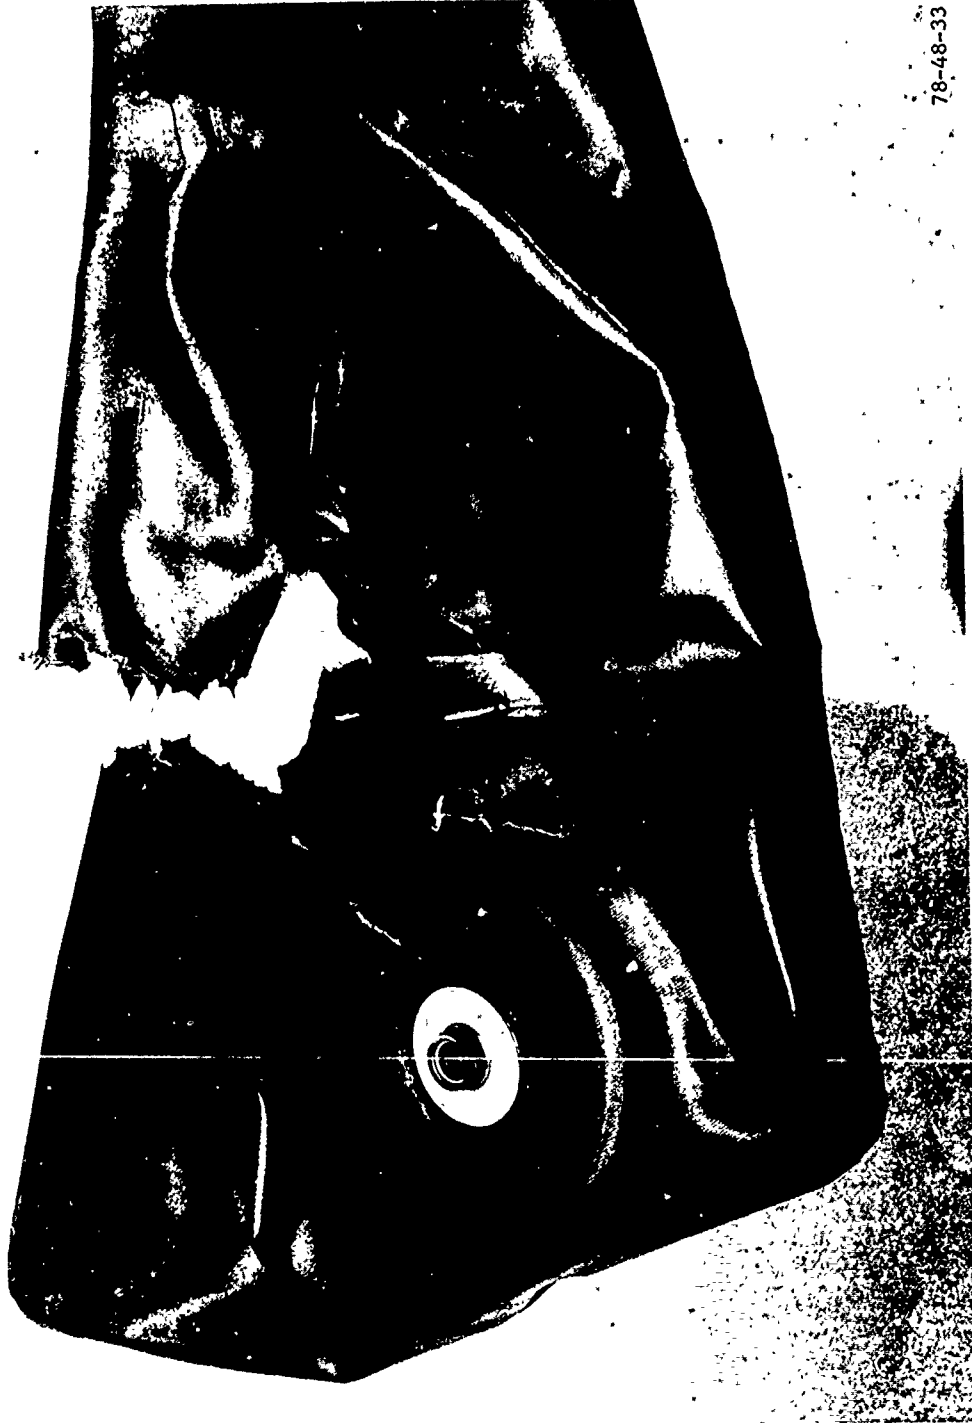
FIGURE 25. DAMAGE TO OUTBOARD AREA OF 5.5 OZ TANK

FIGURE 26. DAMAGE TO INBOARD AREA OF 5.5 OZ TANK

FIGURE 27. DAMAGE TO BOTTOM INBOARD AREA OF 5.5 OZ TANK

Test 4 was run with a single-ply 8.0 oz tank in the right wing and a single-ply 5.5 oz tank in the left wing. At the impact speed of 95 ft/s, both tanks failed. The 5.5 oz tank failed by tearing, which propagated extensively (figures 25 to 27). The 8.0 oz tank was only slightly damaged, the tears were limited to less than 2 inches and

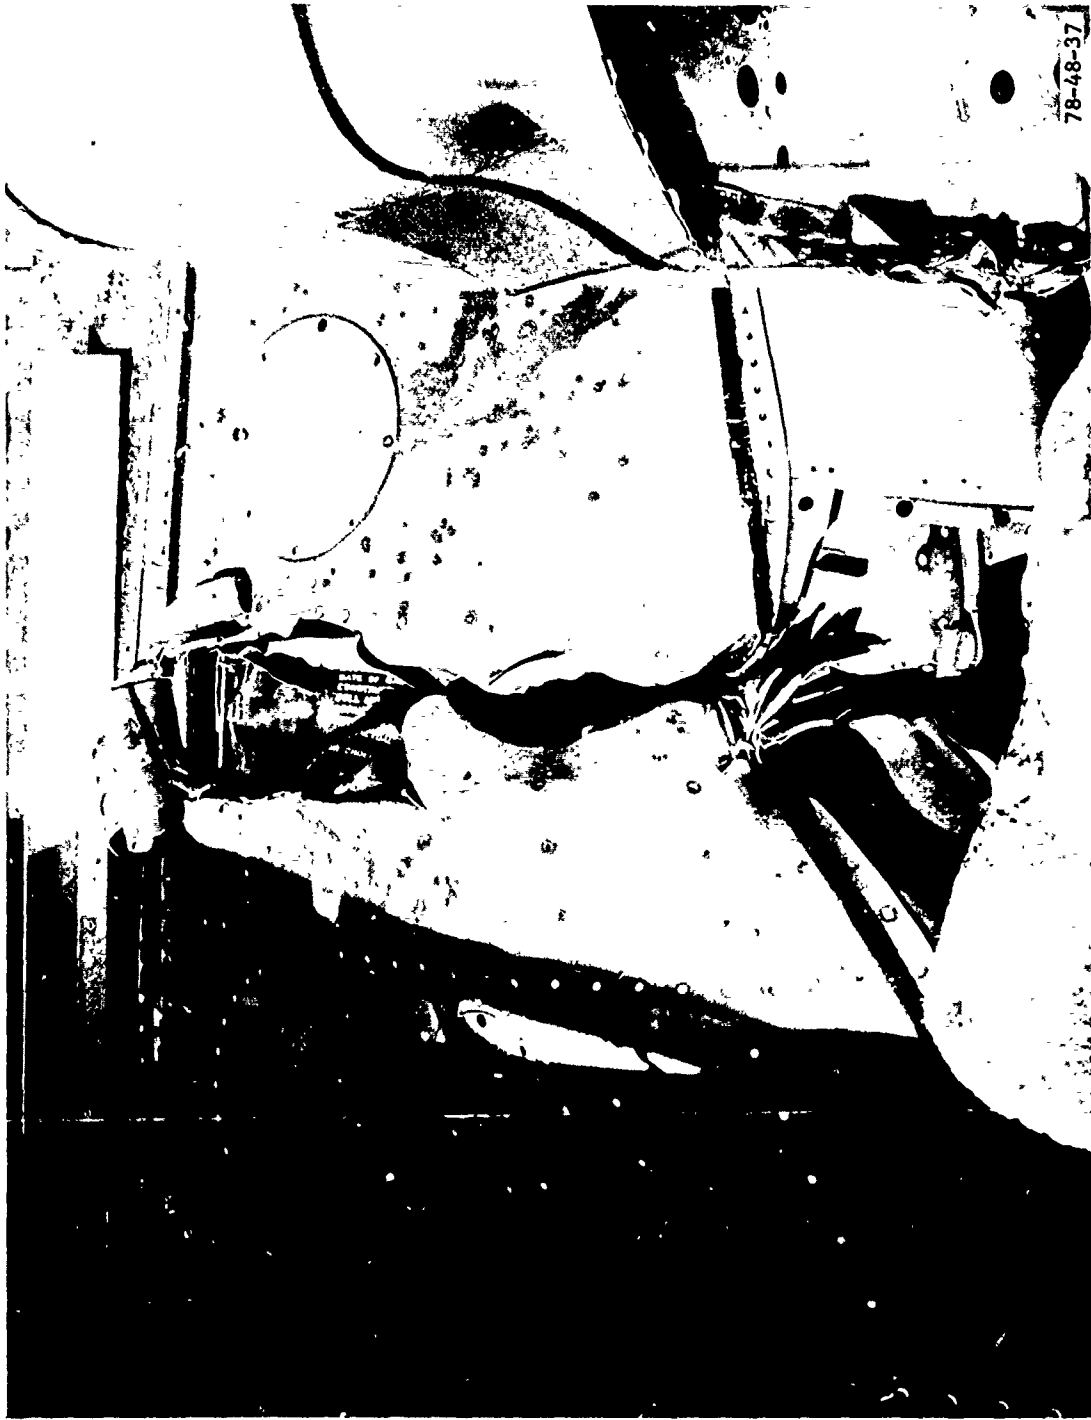
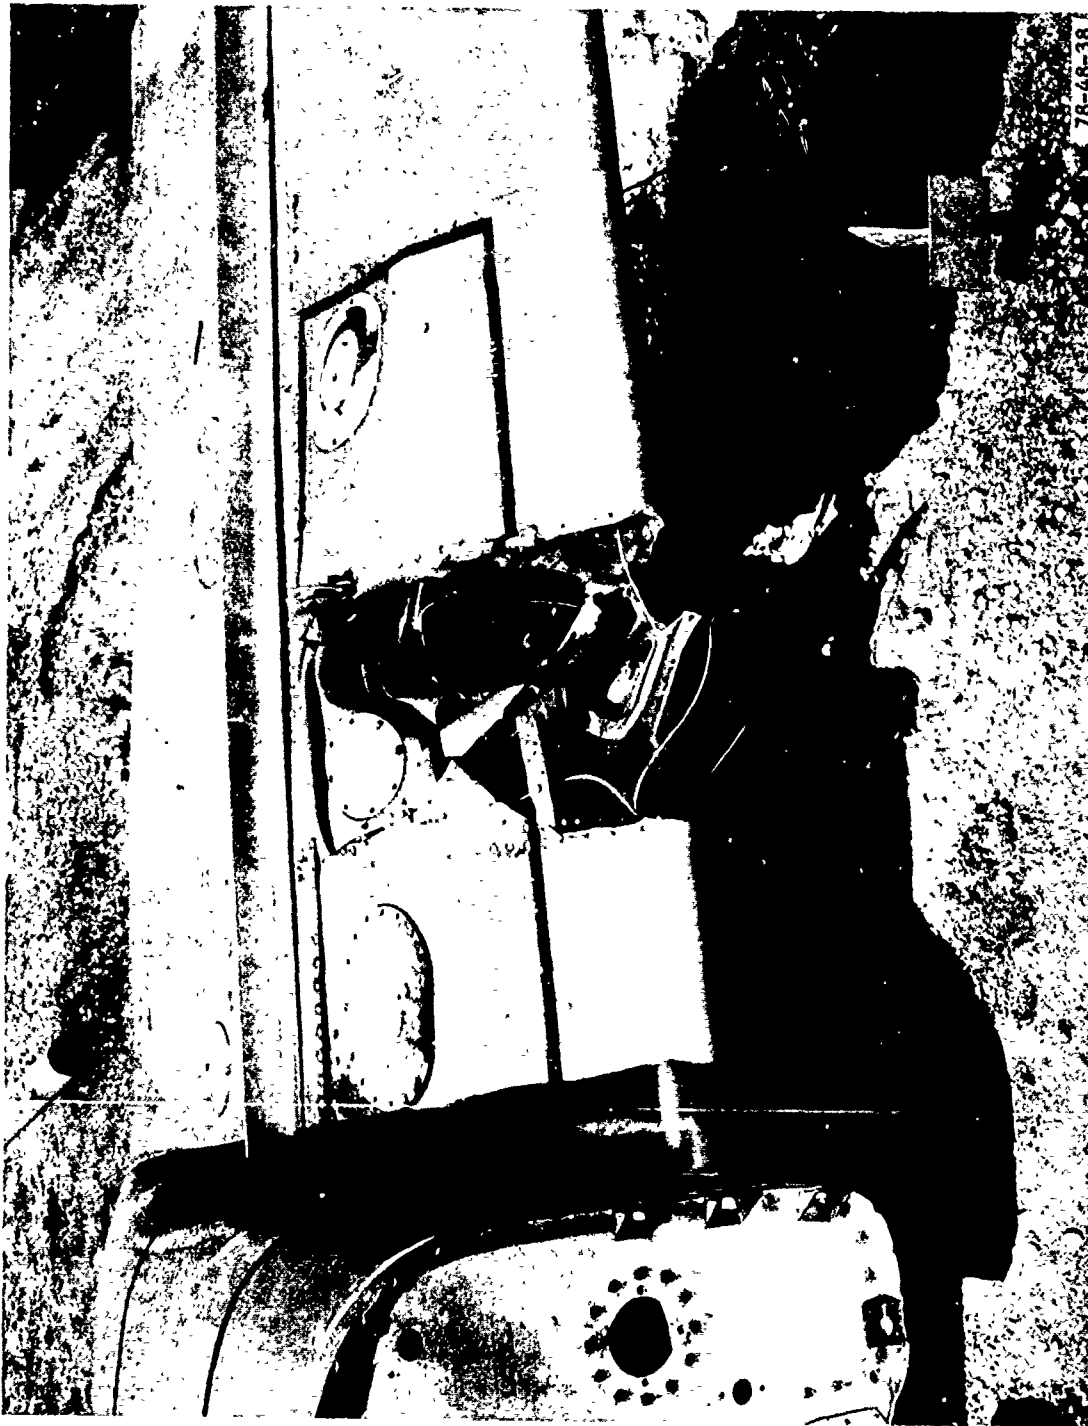
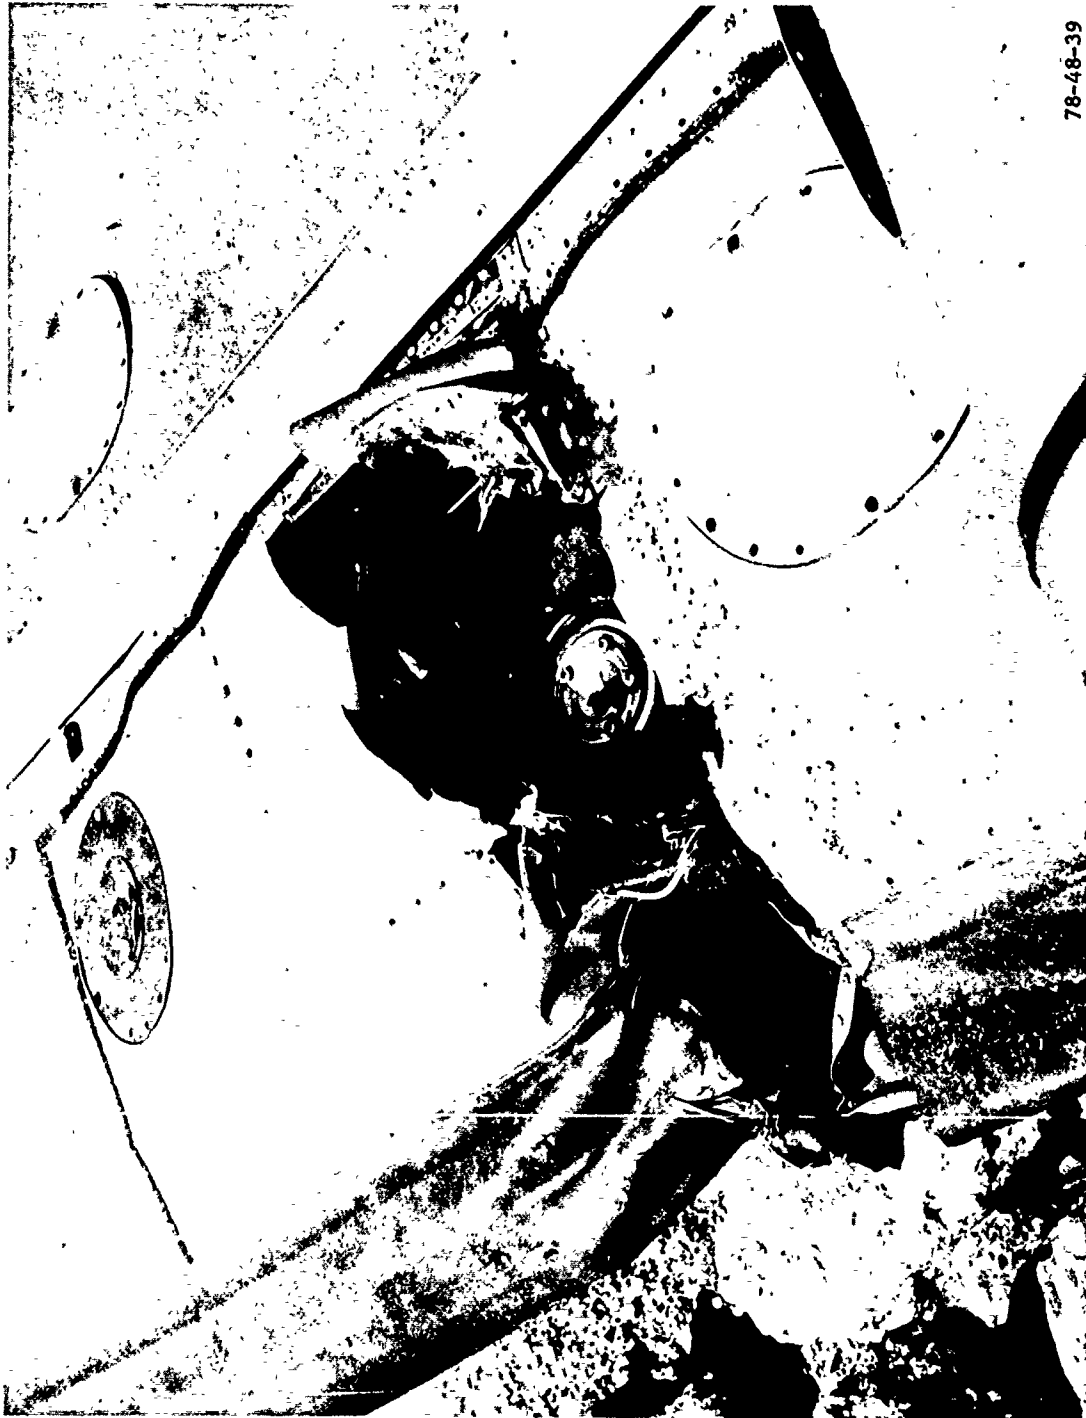
FIGURE 31. DAMAGE TO INBOARD LEFT WING

FIGURE 32. DAMAGE TO OUTBOARD LEFT WING

FIGURE 33. DAMAGE TO OUTBOARD RIGHT WING

FIGURE 34. DAMAGE TO INBOARD RIGHT WING

occurred in three areas (figures 28 to 30). Due to instrumentation problems, acceleration data were not obtained. Refer to figures 31 through 34 for structural damage.
