DREDGED MATERIAL RESEARCH PROGRAM

TECHNICAL REPORT D-77-23

HABITAT DEVELOPMENT FIELD INVESTIGATIONS WINDMILL POINT MARSH DEVELOPMENT SITE JAMES RIVER, VIRGINIA

SUMMARY REPORT

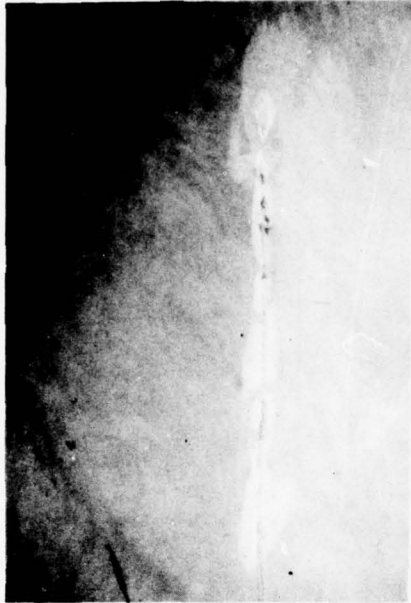
Figure 4. Construction of hydraulic fill dike section during the period 15 December 1974 to 15 January 1975

a. HYDRAULIC FILL CONSTRUCTION SCHEDULE

c. HYDRAULIC FILL CONSTRUCTION, 7 JAN 1975

b. HYDRAULIC FILL CONSTRUCTION, 15 DEC 1974

d. COMPLETED HYDRAULIC FILL, 17 JAN 1975

pipe continuously along the dike alignment with closure near the southeast corner. However, dredge production along the north dike alignment dropped significantly on 18 December as shown in Figure 4a. The dredge pipeline length had reached approximately 2,500 m and pump capacity was inadequate. A suitable booster pump could not be located; consequently, discharge was moved on 4 January 1975 to the northwest corner to reduce overall pipeline length by approximately 610 m.

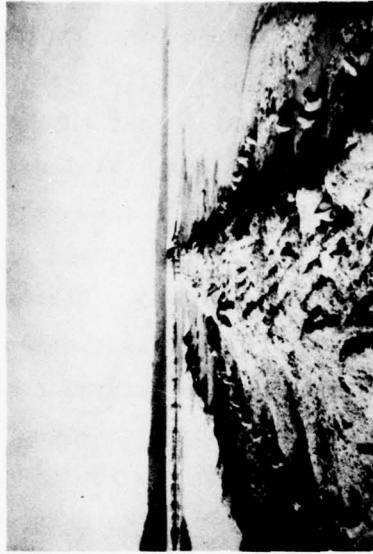
Figure 6. Construction of dragline fill dike section during the period 15 to 20 January 1975

a. DRAGLINE FILL CONSTRUCTION SCHEDULE

b. DRAGLINE FILL CONSTRUCTION

c. COMPLETED DRAGLINE FILL ALONG
NORTH DIKE ALIGNMENT

38. Construction of the dragline fill section (Figure 6) was done by Higginson-Buchanan, Inc. under subcontract to Merritt Dredging Company. Dragline fill placement was initiated on 15 January 1975 on the east dike alignment and progressed continuously along the hydraulic fill section to completion at the southeast corner on 20 January 1975. In Figure 6 are shown the construction schedule (Figure 6a), photographs of dragline fill placement operations (Figure 6b), and a completed dragline fill section (Figure 6c). Fill was placed to elevations from 1.8- to 2.4-m CELW. Dragline fill cross-sections surveyed on 17 January 1975 are shown on Figure 5 as superimposed on hydraulic fill cross-sections surveyed on 8 to 9 January 1975. Dike settlement problems were experienced during dragline fill construction. On several occasions, vibration during dragline movement caused recently placed fill to settle excessively. Settled sections were immediately repaired by placing additional fill. Repaired sections tended to remain stable during additional dragline movement. However, dike settlements continued at certain locations requiring treatment as discussed in the following section.

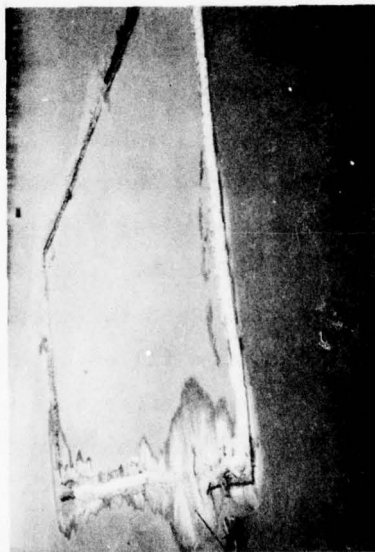
Figure 8. Dike breaches repaired during 22 through 26 January 1975

a. BREACH LOCATIONS

c. BREACH ON SOUTH DIKE ALIGNMENT, 24 JAN 1975

b. REPAIRED BREACH ON NORTH DIKE ALIGNMENT, 24 JAN 1975

d. REPAIR OF BREACH ON SOUTH DIKE ALIGNMENT, 26 JAN 1975

40. Excessive dike settlement resulted in breaches along the north and south dike alignments as shown in Figure 8a. The breached section along the north dike alignment was approximately 76.2-m long and was reported to have settled 0.9 m in one day. The rapid subsidence indicated that an embankment-foundation shear failure had occurred. Personnel directly involved in the project and engineers consulted from the Savannah District examined the failed section. Detailed field investigations and analyses of the failure were not conducted; however, site observations and review of dike construction procedures indicated that failure was likely caused by development and entrapment of foundation mud waves during hydraulic fill construction. Hydraulic fill placement normally causes mud waves to form as soft foundation soils are displaced. Mud wave material is generally weakened in its remolded or disturbed condition and may not provide adequate support when trapped beneath the hydraulic fill. Entrapment of mud waves is a common problem at hydraulic fill tie-in or closure locations. The breach in the north dike alignment corresponds closely to the 91.4-m gap near the northwest corner, which was closed on 15 January 1975 (Figures 4a and 4c). Earlier hydraulic fill placement at both ends of the gap could have generated mud waves that were later covered with hydraulic fill during final closure on 15 January 1975.

41. The breached dike sections on the north and south dike alignments (Figure 8a) were repaired by placement of additional hydraulic fill (sand) obtained from the borrow area near Bucklers Point (Figure 2). In dike repair, the dredge discharge pipe was supported on elevated cribbing along the centerline of the breached sections. Fill material was discharged from the end of the pipe and from bleeder holes in the

underside of the pipe. Hydraulic fill was placed to design elevation (5.7-m CELW) without additional working by dragline. The repaired breach on the north dike alignment is shown in Figure 8b. The breached section on the south dike alignment and subsequent hydraulic fill repair work are shown in Figures 8c and 8d, respectively. Dike repair was completed on 26 January 1975. Channel dredging and disposal into the habitat site was continued on 27 January 1975.

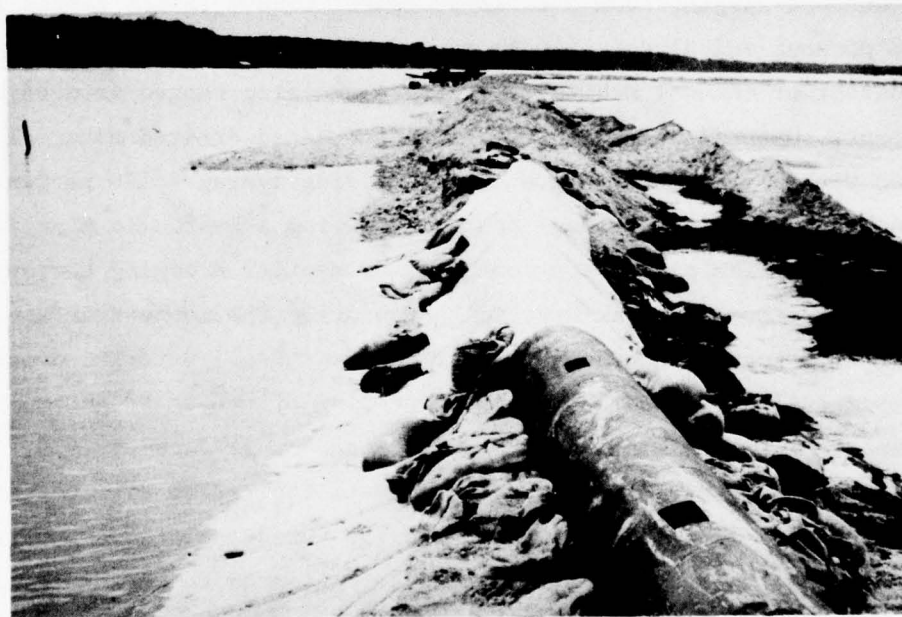
Figure 9. Dike breach repaired during the disposal operations, 27 Jan-4 Feb 1975

a. LOCATION OF BREACH

b. REPAIRED BREACH, 29 JAN 1975

43. Dike settlement was concentrated along the eastern half of the south dike alignment. An approximately 61-m long breach developed near the southeast corner as shown in Figure 9a. Dike repair was accomplished by placing dredge pipe sections, polyethylene sheeting, and sand bags across the settled zone as shown in Figure 9b. Seepage through the dike was observed along the repaired section and several other locations along the south dike alignment. Seepage was predominant during low tide periods when interior-exterior head differential was a maximum (approximately 0.6 to 0.8 m). Dike sand was very soft at seepage exit locations, however, seepage water was clear with no indication of subsurface erosion or piping within the dike. Localized minor settlement along the south dike alignment continued to develop throughout the disposal operations. Settled areas were filled with sand (or sand bags) as needed until disposal within the habitat site was completed on 4 February 1975. Dredging and disposal operations are discussed in the next section.

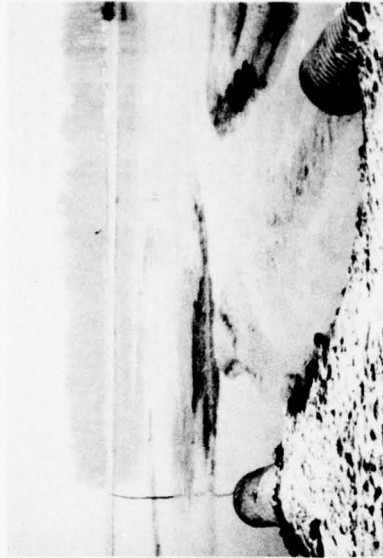
Figure 10. Dredged material discharge in habitat development disposal site during the period 27 January to 4 February 1975

a. LOCATION OF DREDGE DISCHARGE AND EFFLUENT OUTLET PIPES

b. DREDGED MATERIAL DISCHARGE

c. EFFLUENT OUTLET PIPES

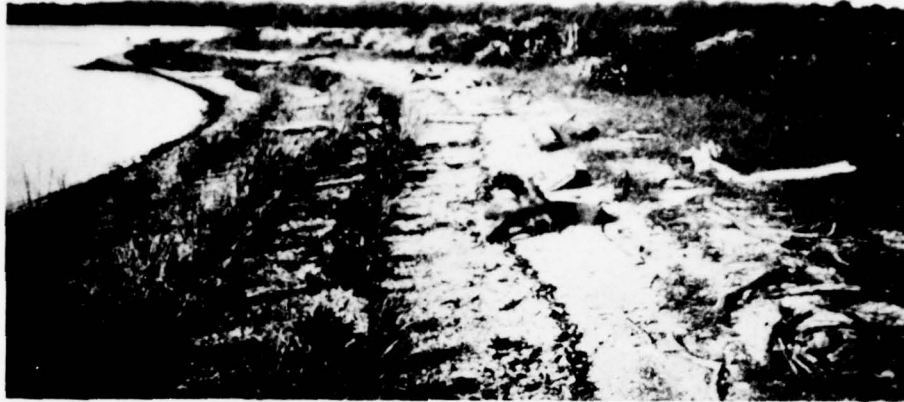
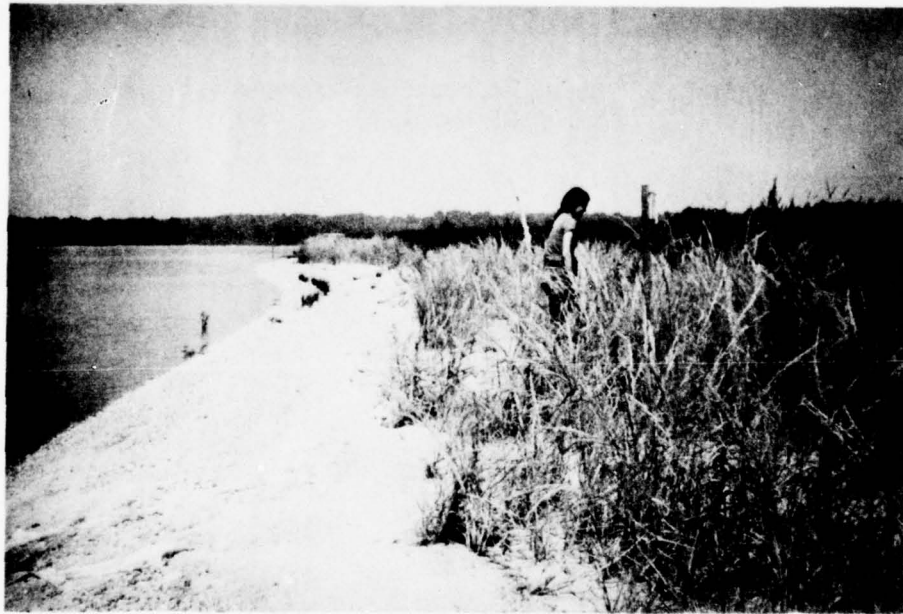
Figure 14. Plantings for exterior slope stabilization on the west dike

a. EXTERIOR SLOPE, OCT 1975

b. EXTERIOR SLOPES, SEP 1976

49. In July 1975, a small tractor was used to grade the remaining dragline fill section and portions of the hydraulic fill. Dredged material within the habitat site was not graded. After grading, marsh vegetation was propagated along the exterior (hydraulic fill) slopes to provide long-term erosion protection. Smooth cordgrass (Spartina alterniflora) plants were sprigged along the slopes in July 1975 and developed quite rapidly as shown in Figure 14a. However, these plants were ultimately destroyed by wave action and animal depredation. In September 1975 portions of the dike's exterior slopes did not support any vegetation as shown in Figure 14b.

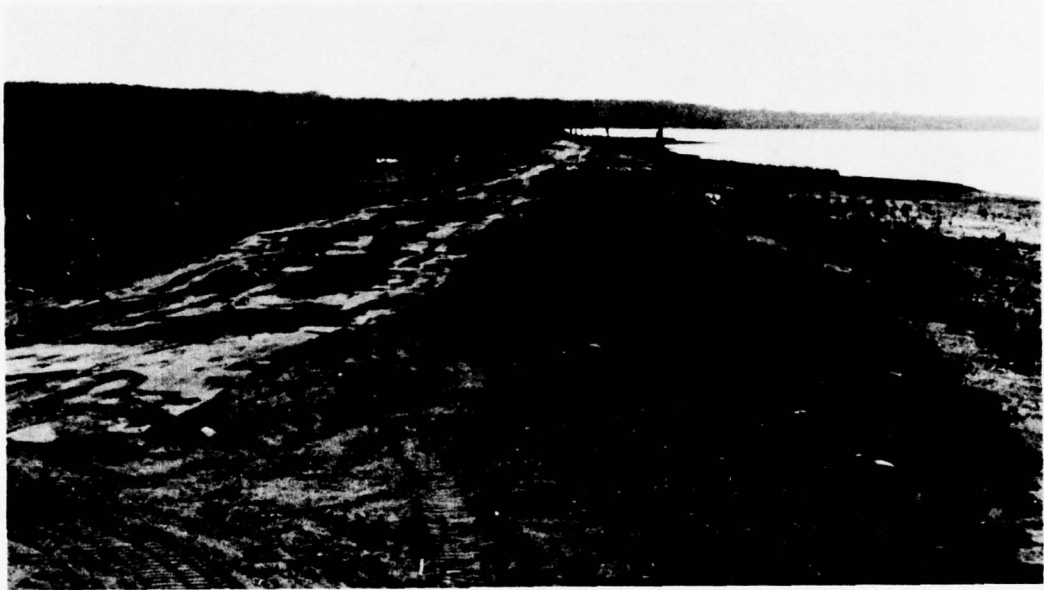
Figure 18. Northeast corner of the dike looking west along the north side on 31 July 1975 just following seeding (after Garbisch 1978).

59. Plantings on unconsolidated confined dredged materials. By mid-July 1975, most of the confined dredged material had naturally vegetated (Figure 17). The only portion of the confined dredged material substrate available for planting studies was a small supratidal area located in the northeast corner of the confined area. The area was fertilized and seeded with a mixture of tall fescue (Festuca elatior), orchard grass (Dactylis glomerata), ladina white clover (Trifolium repens), switch grass (Panicum virgatum) and coastal panic grass (Panicum amarulum) (Figure 18).

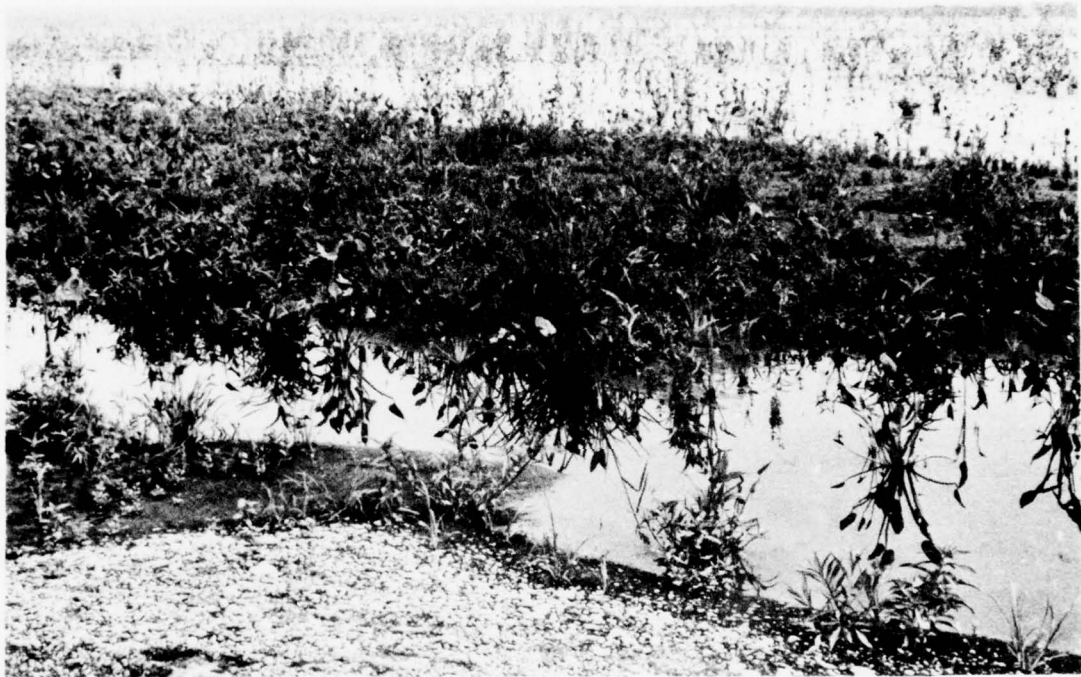
Figure 21. Looking northwest across the contained dredged materials at the site on 18 June 1975.

66. The natural invasion of the vegetation following the February 1975 disposal operations was unexpectedly rapid and extensive. By mid-April 1975, propagules were visible, and by mid-June the intertidal elevations of the dredged material substrate were largely covered with a diversity of endemic plant species (Figure 21). At that time plant growth was also apparent at the higher elevations. By mid-July, the confined dredged material was thickly vegetated (Figure 17) with exception of a few small and discrete upland areas on the sand dike and at various elevations within the confinement. More than 75 plant species were documented at the site, the greatest species diversity occurring in the high intertidal area. An incomplete listing of plant species collected in July 1975 is presented in Table 5. Based on the field observations and collections made by WES personnel in July 1975, initial plant development was described (Dredged Material Research Program 1975). Three vegetative communities were well established on

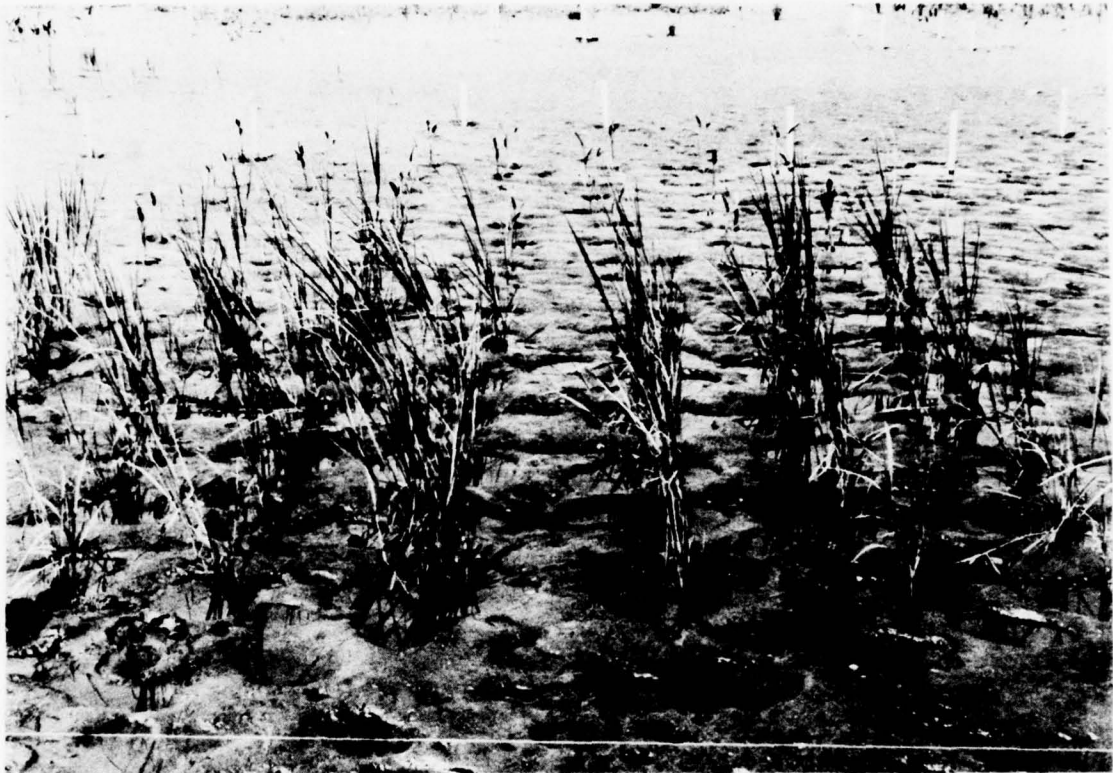
Figure 22. Animal excavations at the base of *S. cynosuroides* in sprigged plots as seen on 29 August 1975.

68. The successful trend changed abruptly, though, during August 1975 when many of the intertidal plantings were lost primarily to Canada goose grazing (Figure 22). Plants also were washed out by wave action that resulted from continual ship and barge traffic on the James River and by high current energies during periods of high water on the river. By 30 September 1976 only two out of 128 intertidal monotypic study plots remained with transplants growing on them. One of the remaining plots was sprigged with smooth cordgrass and the other with big cordgrass. These plantings continued to grow during the 1977 growing season but replacement of them by the invasion of willows (Salix nigra) appears quite possible by the next growing season.

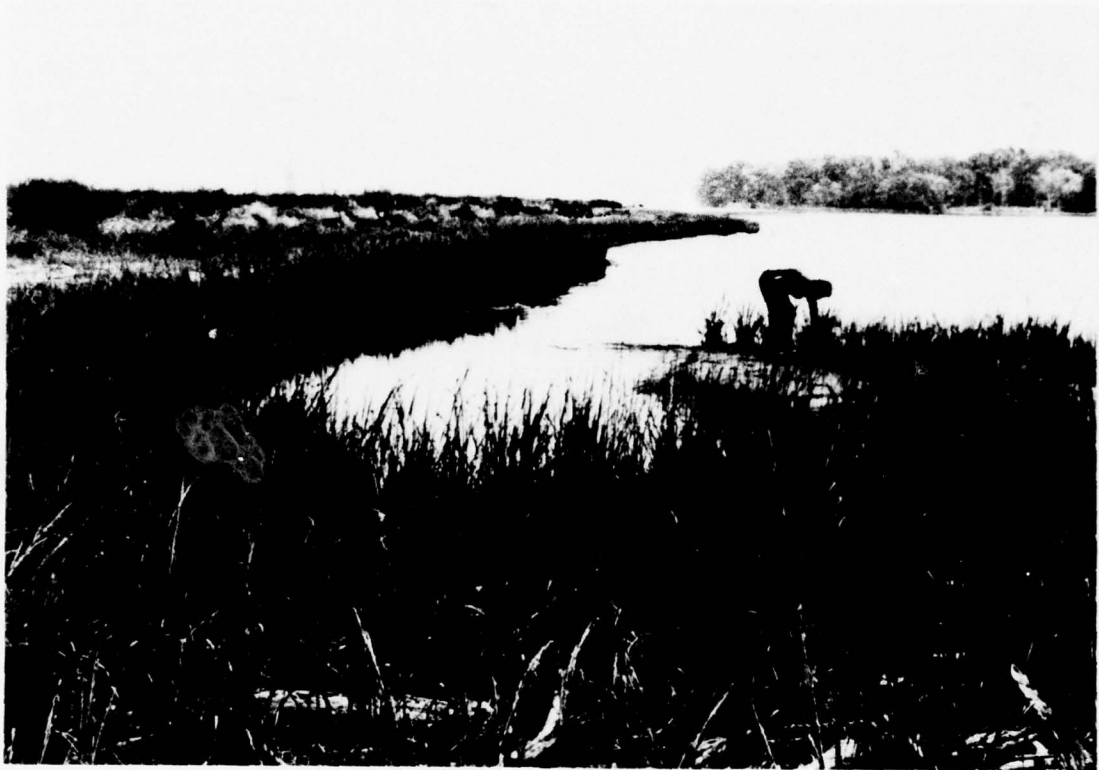
Figure 23. Looking east at the fringe marsh along the exterior southern side of the dike from the southwest corner on 16 October 1975.

69. Intertidal plantings of common three-square and smooth cordgrass on the exterior intertidal portions of the dike suffered the same general fate. Only sparse patches of these plantings remain on the low energy side of the experimental site although initial response was good as is evidenced by Figure 23. It is anticipated that these remaining plantings will develop significantly during the 1978 growing
