NRL Memorandum Report 3985

**Sonar Transducer Reliability  
Improvement Program FY 79**

**Second Quarter Progress**

## Sonar Transducer Reliability Improvement Program

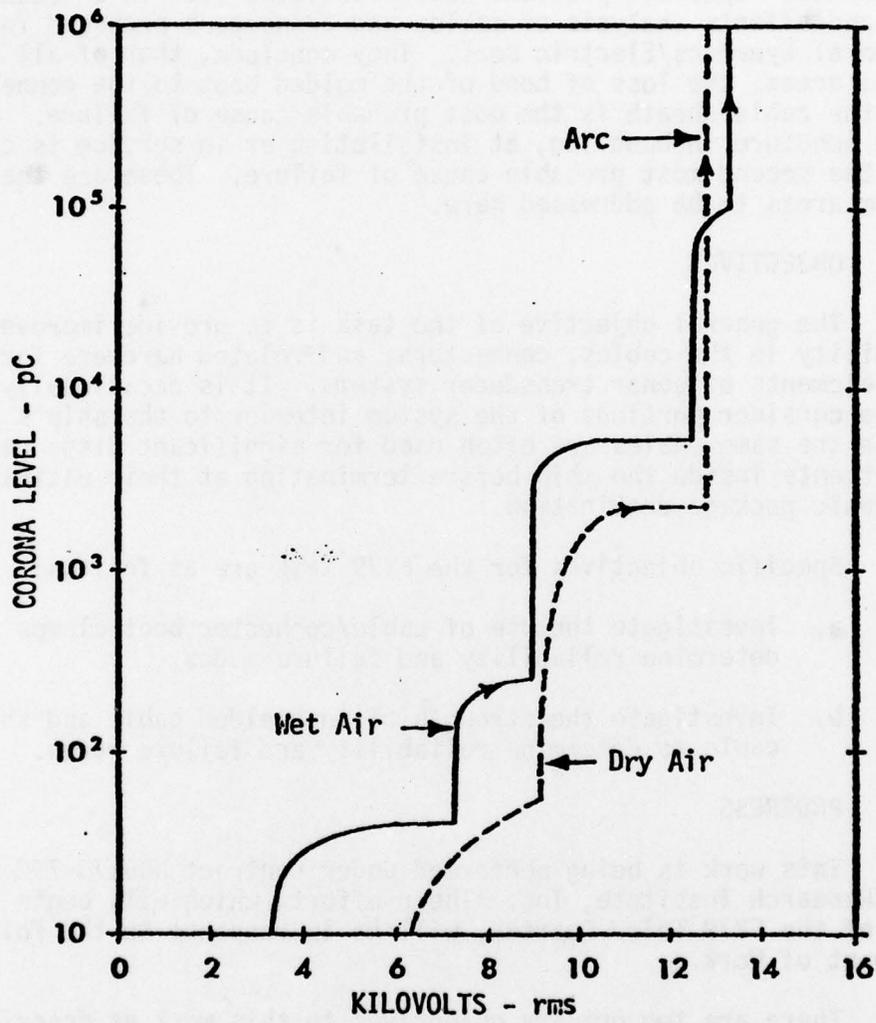
Figure 3.1  
PZT CERAMIC CORONA IN AIR

Between the CIV and flashover levels the corona discharge magnitude increased in step increments of an order of magnitude (10/1) or more at 2 or 3 drive voltage levels. Figure 3.1 illustrates a representative function of corona discharge level in picocoulombs (pC) with ac drive voltage. In any specific case, the corona levels were observed to be highly variable even when the drive voltage was maintained constant or the test was repeated on the same sample of PZT. Flashover was always on the ceramic surface between electrodes and a straight dark line was burned.

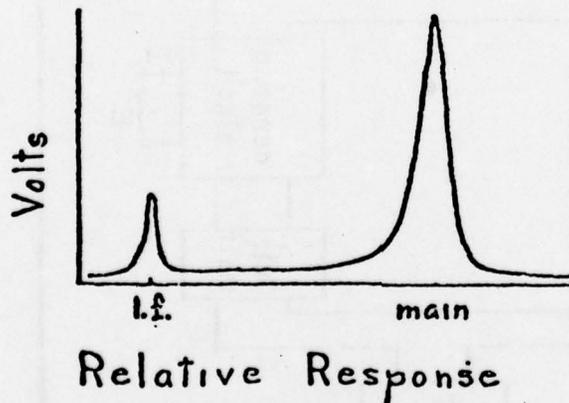
Figure 5.2  
MEASUREMENT RESULTS

## Resonance Frequencies (in kHz)

loading mass stress level	heavy		light	
	i.f.	main	i.f.	main
high	1.09	3.58	1.41	3.57
low	.58	3.54	.62	3.53

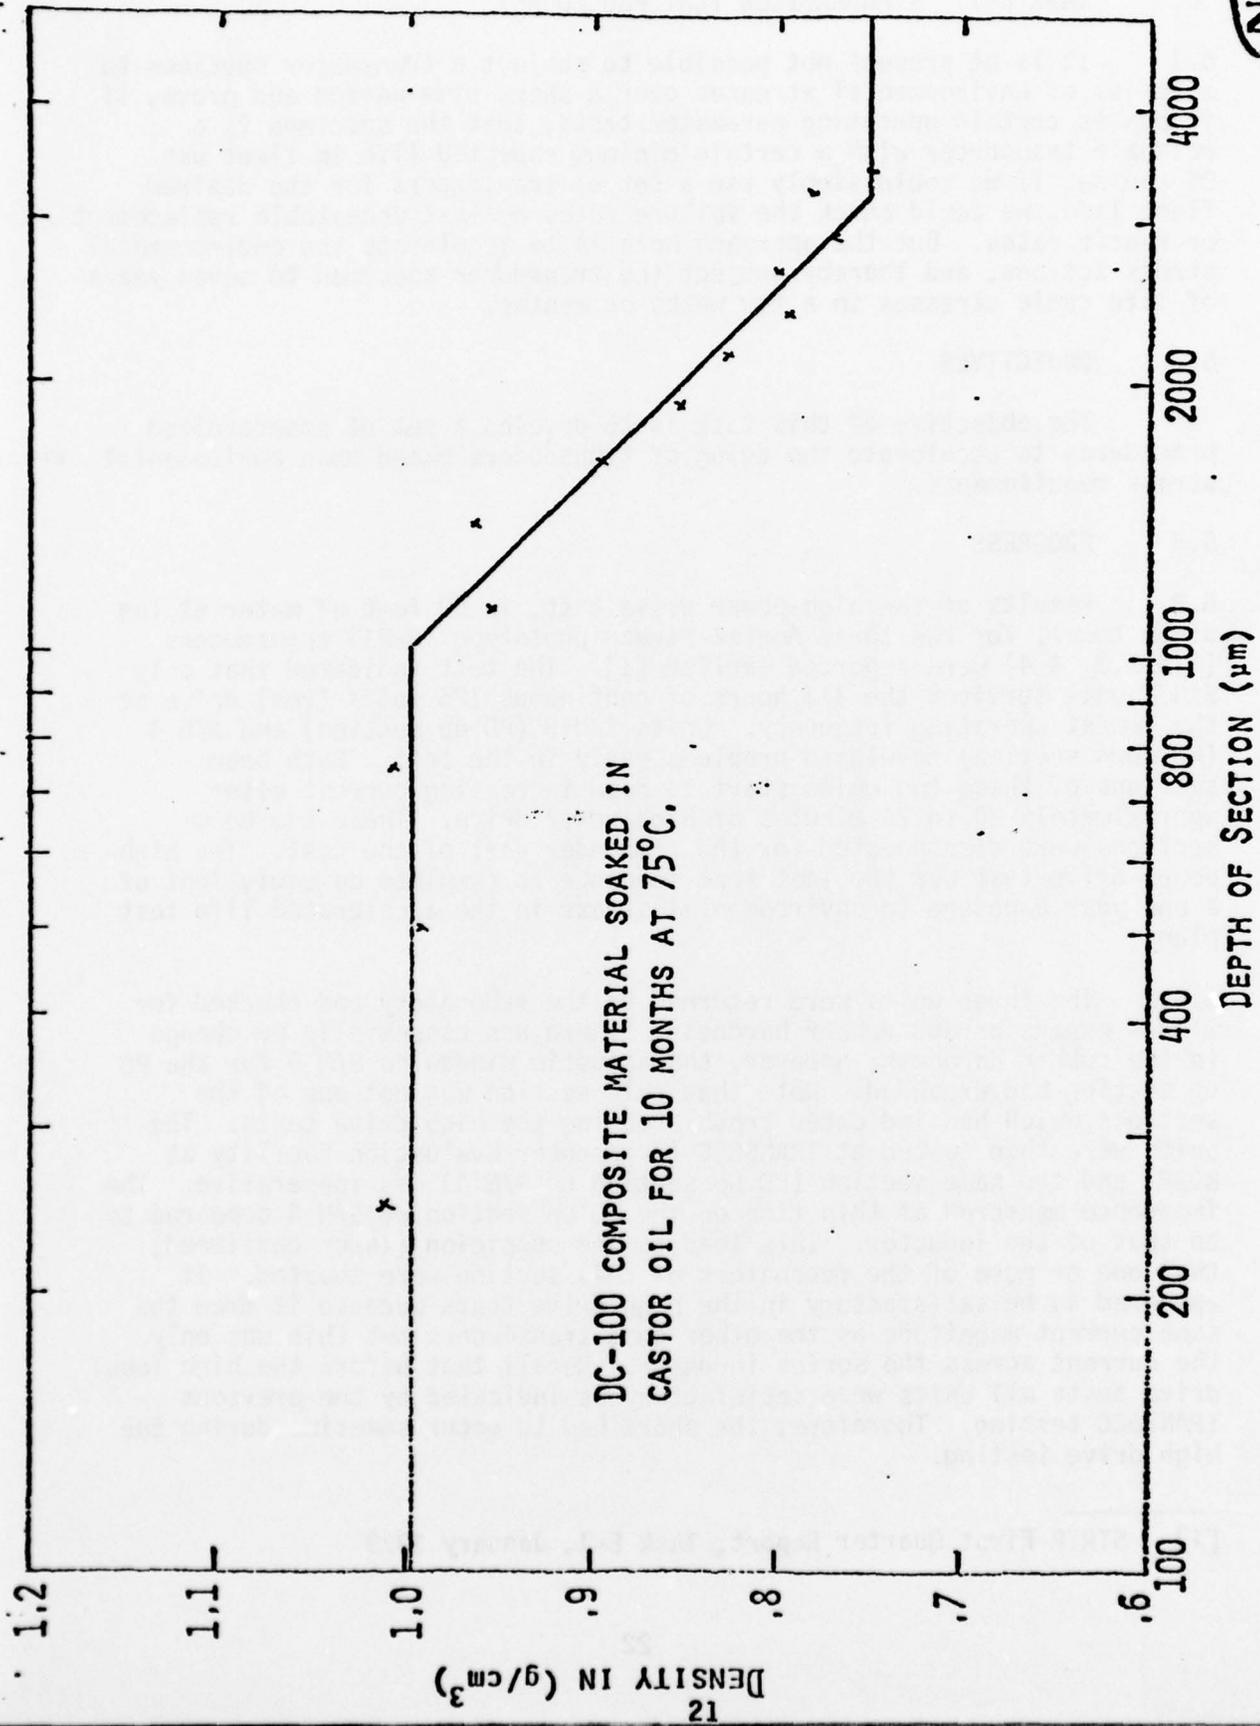
Figure 5.4  
OIL PENETRATION DEPTH

saturation at a given depth of oil penetration. Figure 5.4 is a graph obtained from the sectioning and weighing of DC-100 immersed in castor oil. The elapsed time for this particular sample was 10 months, at a temperature of 75°C. From Figure 5.4, it is evident that three distinct regions exist. An area of 100% saturation, an area of decreasing saturation, and an unsaturated area. All samples tested follow this general pattern with differences in slope at the transitional line and depth of penetration at a given time. When observed by the sectioning technique DC-100 appears to be more predictable than NC-710. NC-710 did not show as well-defined a fluid front as did DC-100. Instead "fingers" of saturated material were protruding past the fully saturated material leaving a very poorly defined fluid front. This could make an accurate mathematical model of the changes in acoustic properties with oil saturation of NC-710 impossible.

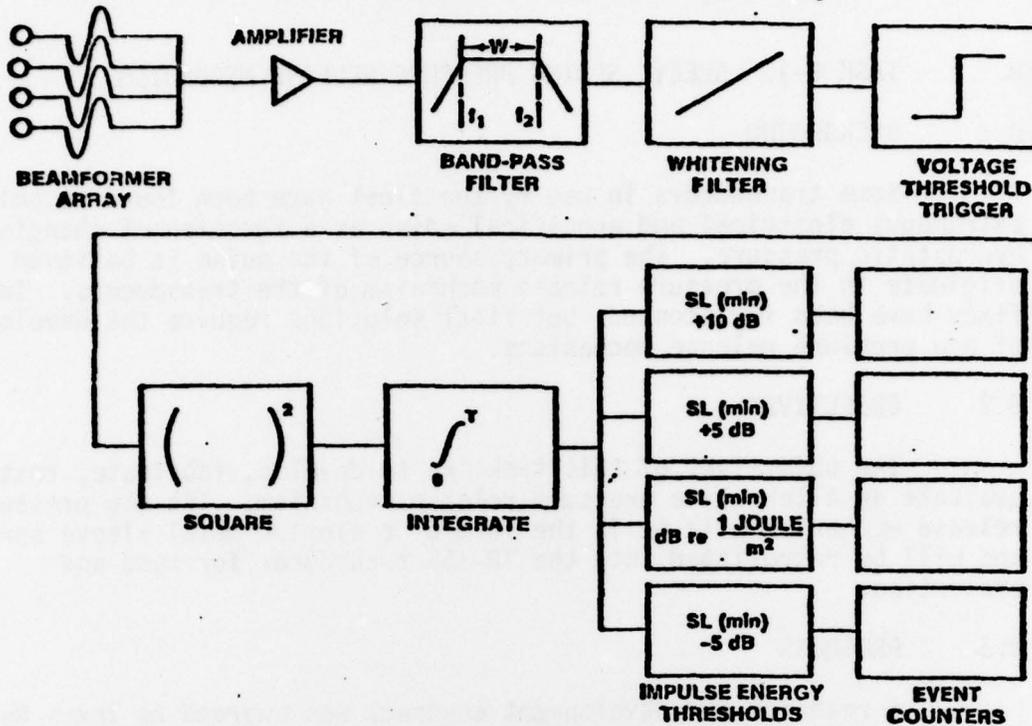
Figure 7.1

**OPTIMAL DETECTION SYSTEM (FOR USE IN TRANSDUCER  
RADIATED SELF-NOISE EVALUATION)**

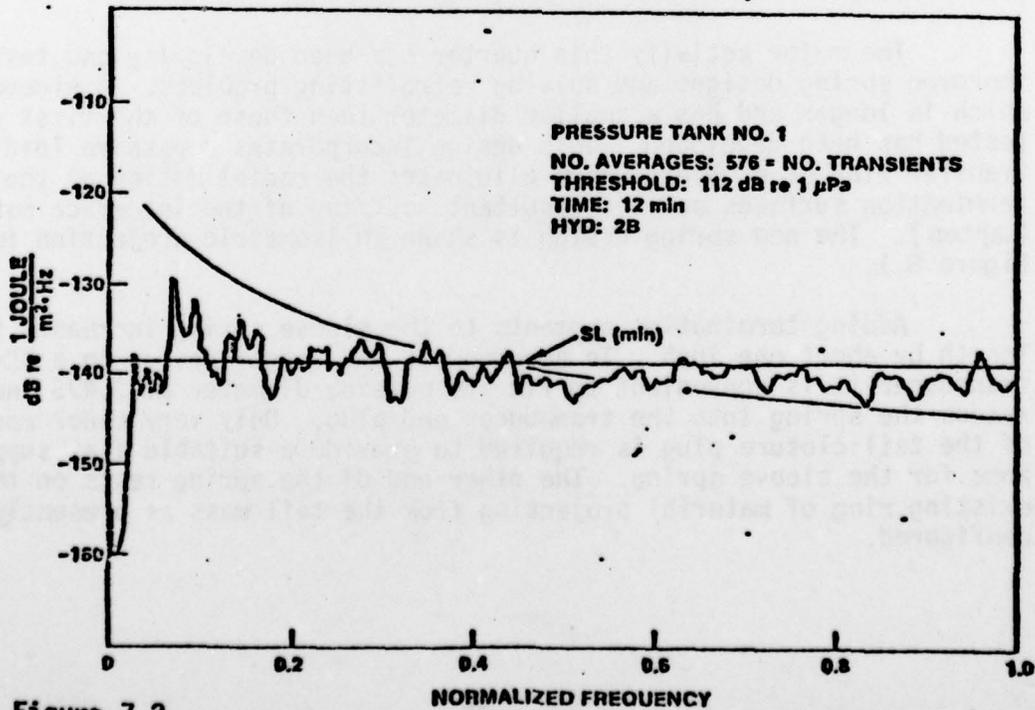
representative sample of the results of those tests. In this figure, 576 self-noise transients were detected during a twelve-minute period and the average ESD calculated. SL (min) is the minimum detectable source level as calculated in the STRIP Second Quarter Report, of April 1978. The line which resembles an exponential decay is SL (min) when whitening for a reference sea state curve is used instead of the sea state curve value at a single frequency. In Figure 7.2 it appears that the self-noise of the TR-215 is detectable when compared to SL (min). but this is not true. No attempt has been made to convert the ESD from a pressure tank, near field measurement at approximately 10 centimeters, to a far field, free measurement at one meter, because of the uncertainty of the validity of the results when this is done. However, if simple spherical spreading loss is applied to the ESD of Figure 7.2, then an additional 19 dB could be subtracted from the overall energy level. In addition, it is felt that the reflections from the surfaces of the pressure tank along with the effects of measuring the noise in the near field would tend to make the ESD measurement higher in level than a corresponding free-field measurement. Therefore, the radiated self-noise of the TR-215 does not appear to be detectable with this worst case assumption.

**SEPT 78  
TR-215 (NEW) RADIATED SELF-NOISE AVERAGE  
(ENERGY SPECTRAL DENSITY)**

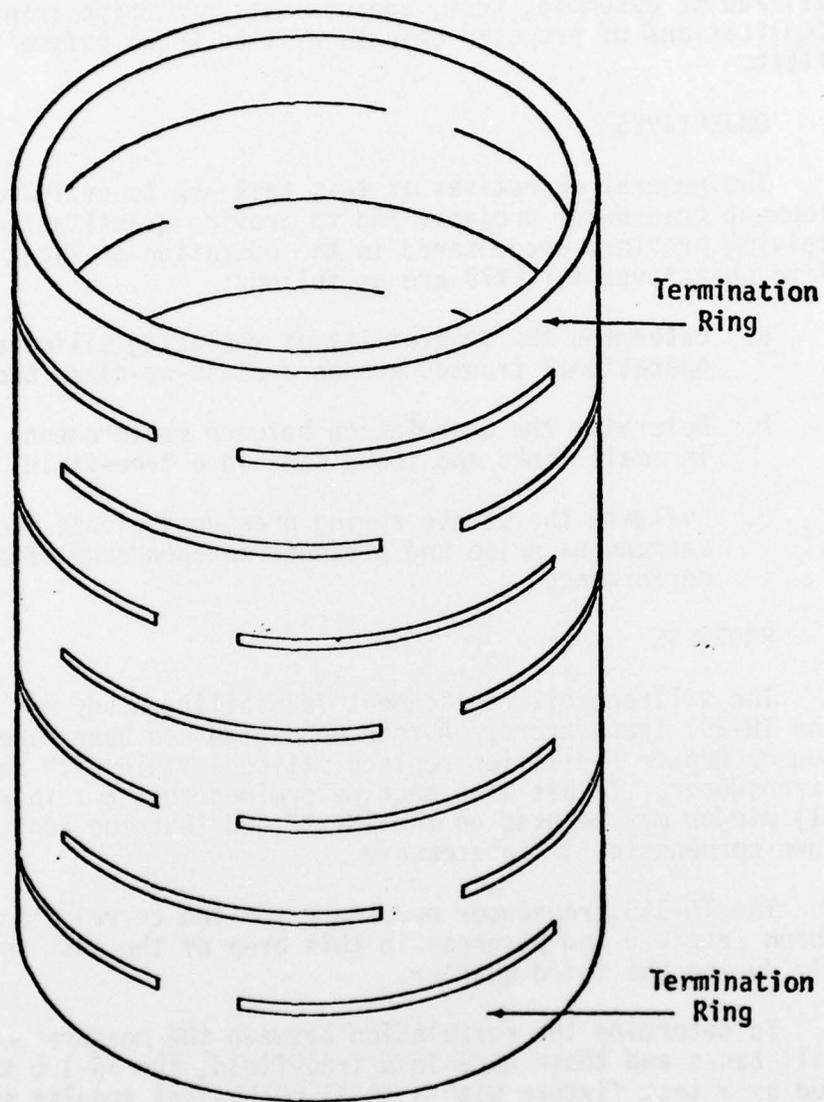
Figure 8.1  
SLEEVE SPRING--ISOMETRIC PROJECTION
