**AERONAUTICAL RESEARCH LABORATORIES**

Structures Technical Memorandum 303

A REVIEW OF AUSTRALIAN INVESTIGATIONS ON  
AERONAUTICAL FATIGUE DURING THE PERIOD  
APRIL 1977 TO MARCH 1979

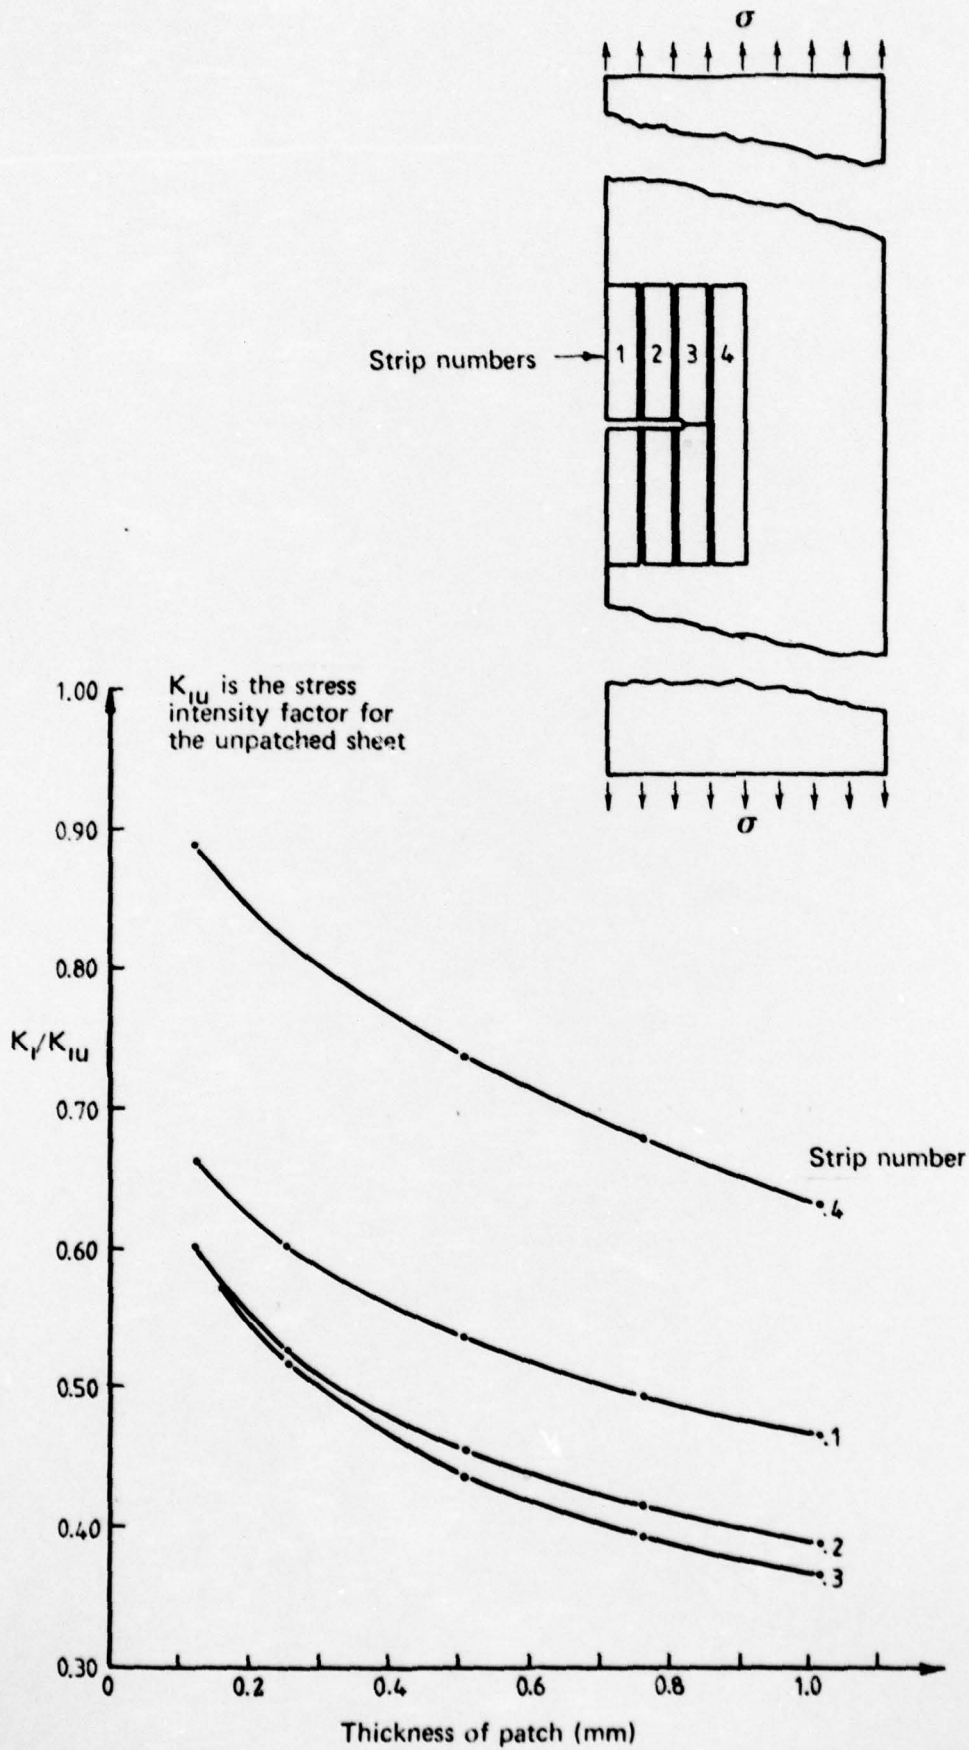
FIG. 9.16 EFFECT OF PATCH LOCATION ON THE STRESS INTENSITY FACTOR
