USAAEFA PROJECT NO. 76-11-1

**PRELIMINARY AIRWORTHINESS EVALUATION**

**OH-58C HELICOPTER**

FINAL REPORT

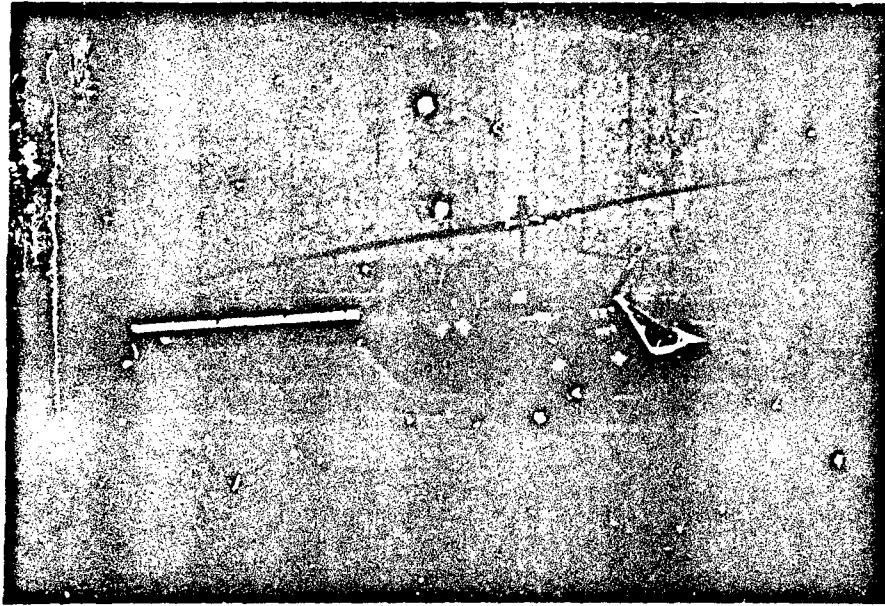
**Photo A. Test Helicopter Right-Side View.**

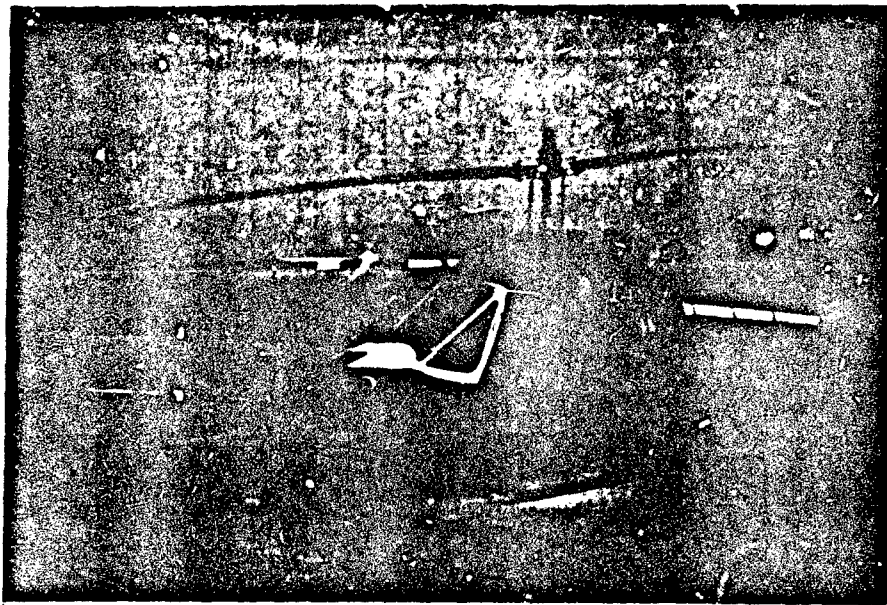
**Photo B. Test Helicopter Left Quarter View.**

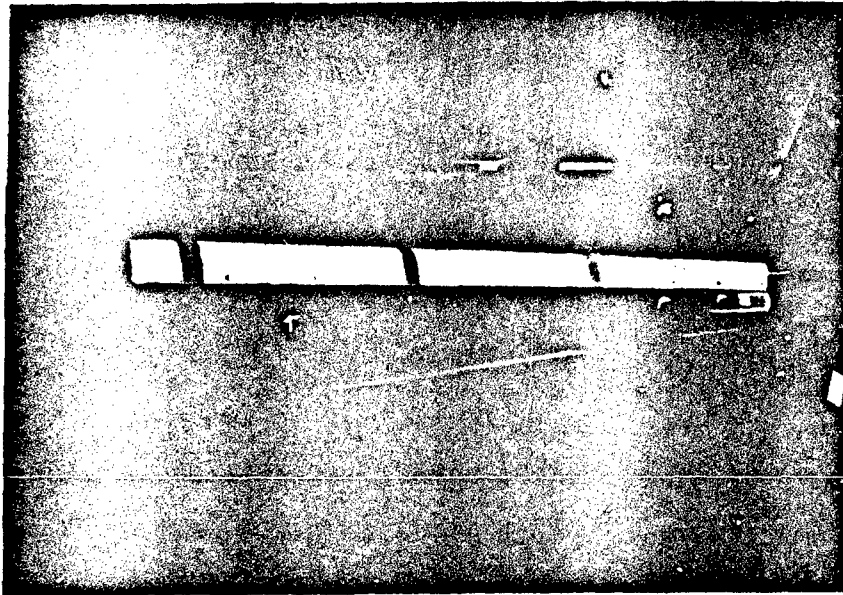
Photo 1. Tail Rotor Drive Shaft Cover.

8. A cover is installed over the tail rotor drive shaft to aid in keeping dust and dirt from the tail rotor drive shaft bearings. The cover, illustrated in photo 1, extends from the engine oil reservoir cowling to just forward of the tail rotor gearbox.

9. New tail rotor drive shaft bearings and improved rubber seals are installed on the OH-58C. The new bearing, which must be periodically lubricated, and the improved rubber seal increase the reliability of the tail rotor drive shaft.

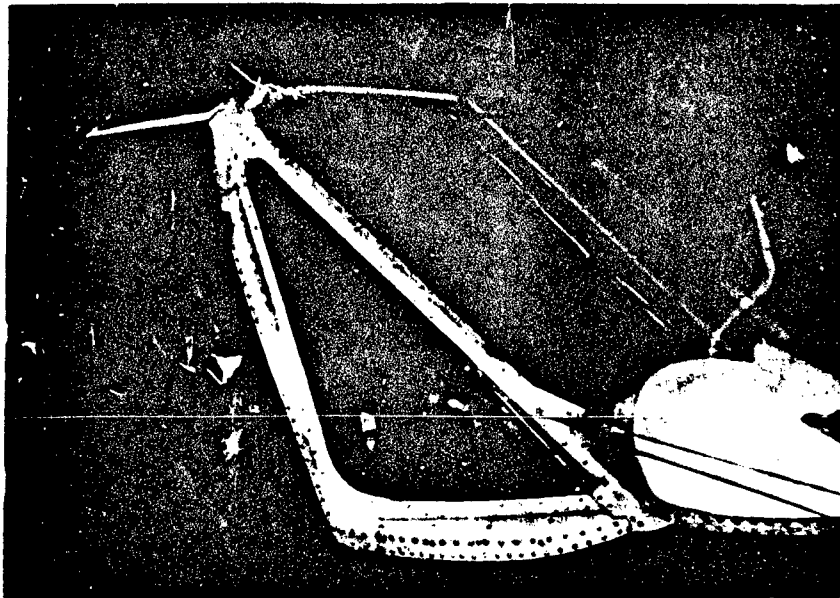
Photo 2. Flat Plate Canopy-Right Side.

10. A four-panel flat plate canopy is installed on the OH-58C in place of the bubble canopy on the OH-58A. Two rectangular forward panels and two triangular side panels are fabricated from stretched acrylic and riveted in place. Photos 2 and 3 illustrate the flat plate canopy installation. Additional descriptions are presented in reference 11, appendix A.

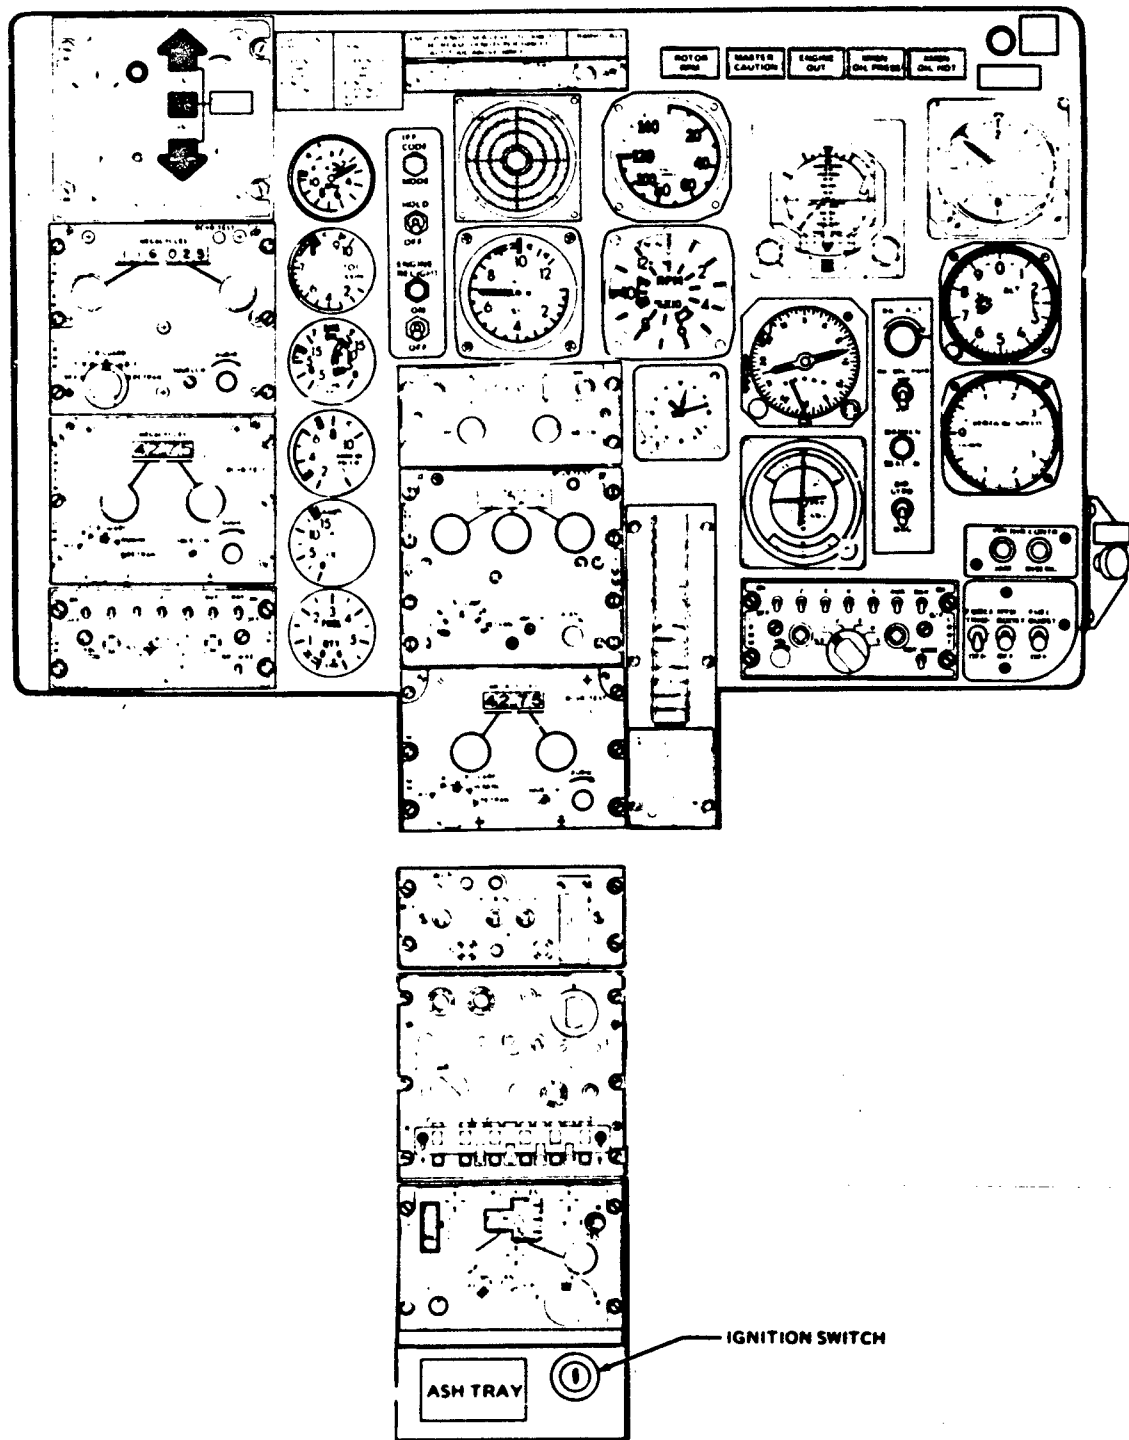
Figure 4. OH-58C Instrument Panel.

17. The OH-58C instrument panel is enlarged to incorporate additional instruments, indicators, and avionics controls. A diagram of the instrument panel is presented in figure 4. Four principal new items of avionics equipment have been added and are listed below. A more detailed description including operational procedures for these items is presented in the operator's manual.

18. All instruments, indicators, and control panels on the instrument panel are internally lighted with red light. In addition, the engine and flight instruments employ low-light level symbology.

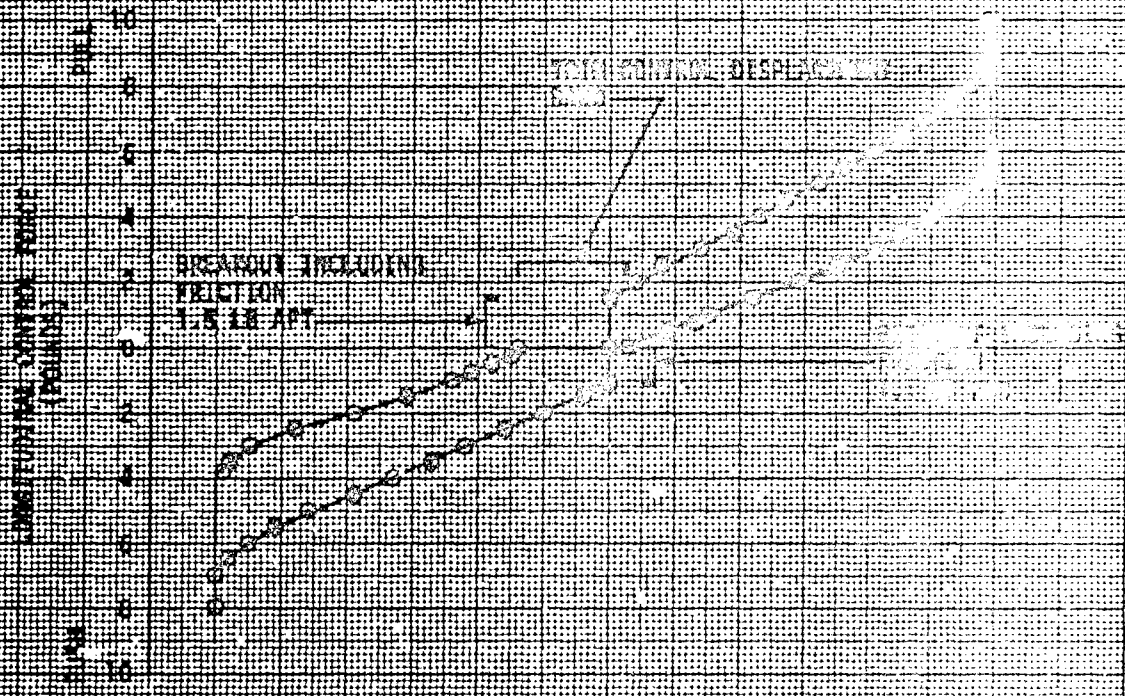
FIGURE 2  
 LATERAL CONTROL SYSTEM CHARACTERISTICS  
 (CONT. OF FIG. 1)

- NOTES: 1. SYSTEM STATIC  
 2. FORCE AND POSITIONS MEASURED AT CENTER OF CG  
 3. TRIMMED AND ELECTRICAL POWER PROVIDED BY  
 MAIN POWER UNIT  
 4. TEST FILTER ON  
 5. TOTAL LATERAL CONTROL TRAVEL = 3.5 INCHES  
 6. LONGITUDINAL CONTROL POSITION = 50 INCHES FROM  
 FULL FORWARD  
 7. FORCE TRIM ON LONGITUDINAL CONTROL POSITION 0%

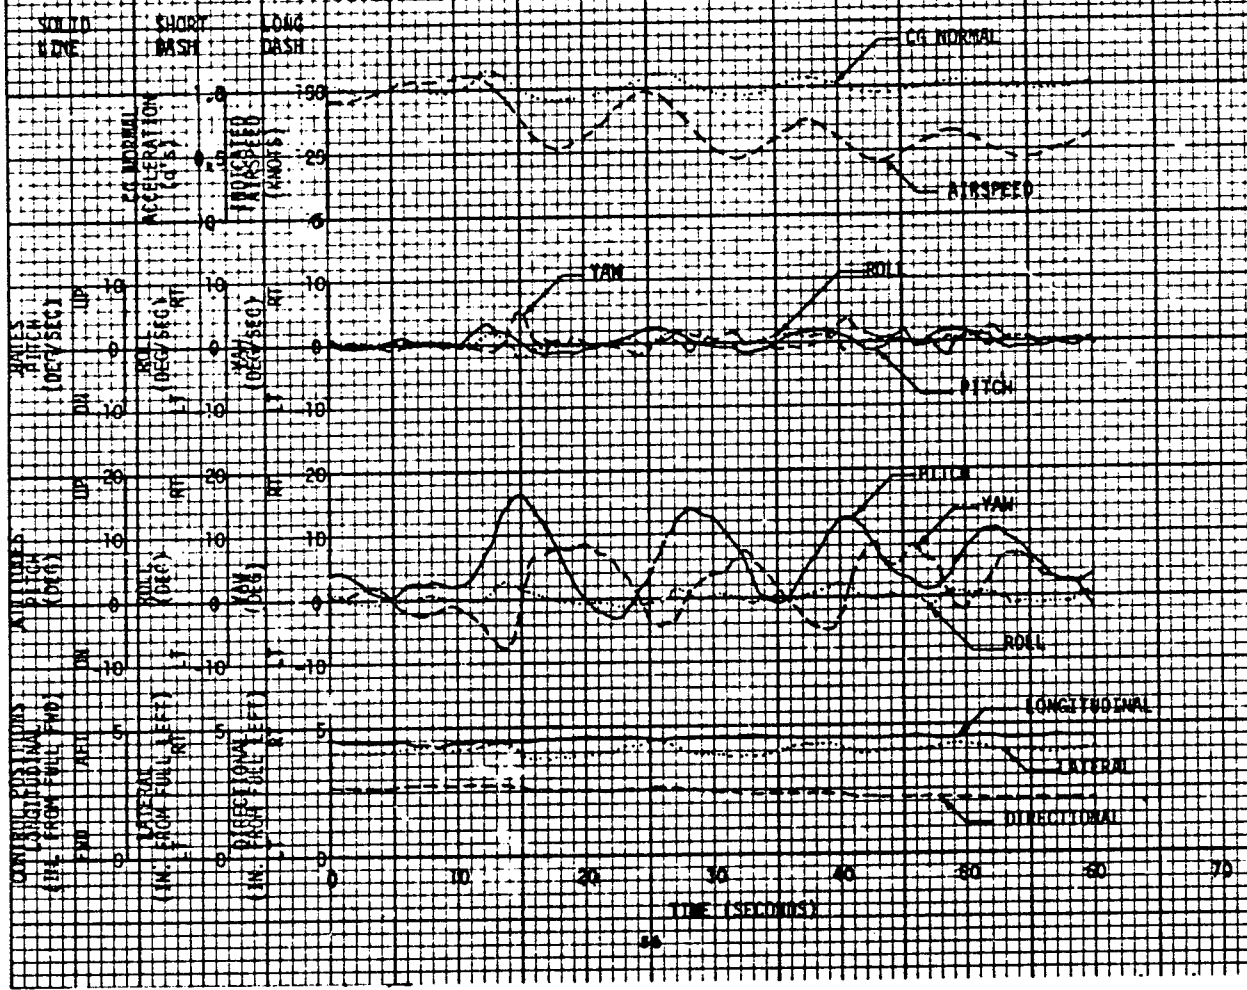
FIGURE 12  
 LONGITUDINAL LONG TERM RESPONSE  
 OH-580 USA S/N 63-16850

GROSS WEIGHT (LB)	CG LOCATION (IN)	DENSITY (PC)	ALTITUDE (FT)	DAY (°C)	TRIM INSTR SPEED (RPM)	TRIM FLIGHT CONDITION
3120	412.1(AFT)	0.2	7780	3.0	954	LEVEL

22. At a trim airspeed of 51 KCAS, the longitudinal long-term response was convergent but very lightly damped. Damping ratios ( $\zeta$ ) less than 0.05 were observed. The period of the oscillation was approximately 25 seconds. A typical time history of a longitudinal long-term response at 51 KCAS is presented in figure 12, appendix E. The oscillatory long-term response was readily excited in turbulent air and maneuvering flight at airspeeds between 40 to 60 knots indicated airspeed (KIAS) but was easily controlled (HQRS 3). The longitudinal long-term response at 51 KCAS was similar to the OH-58A and is satisfactory.

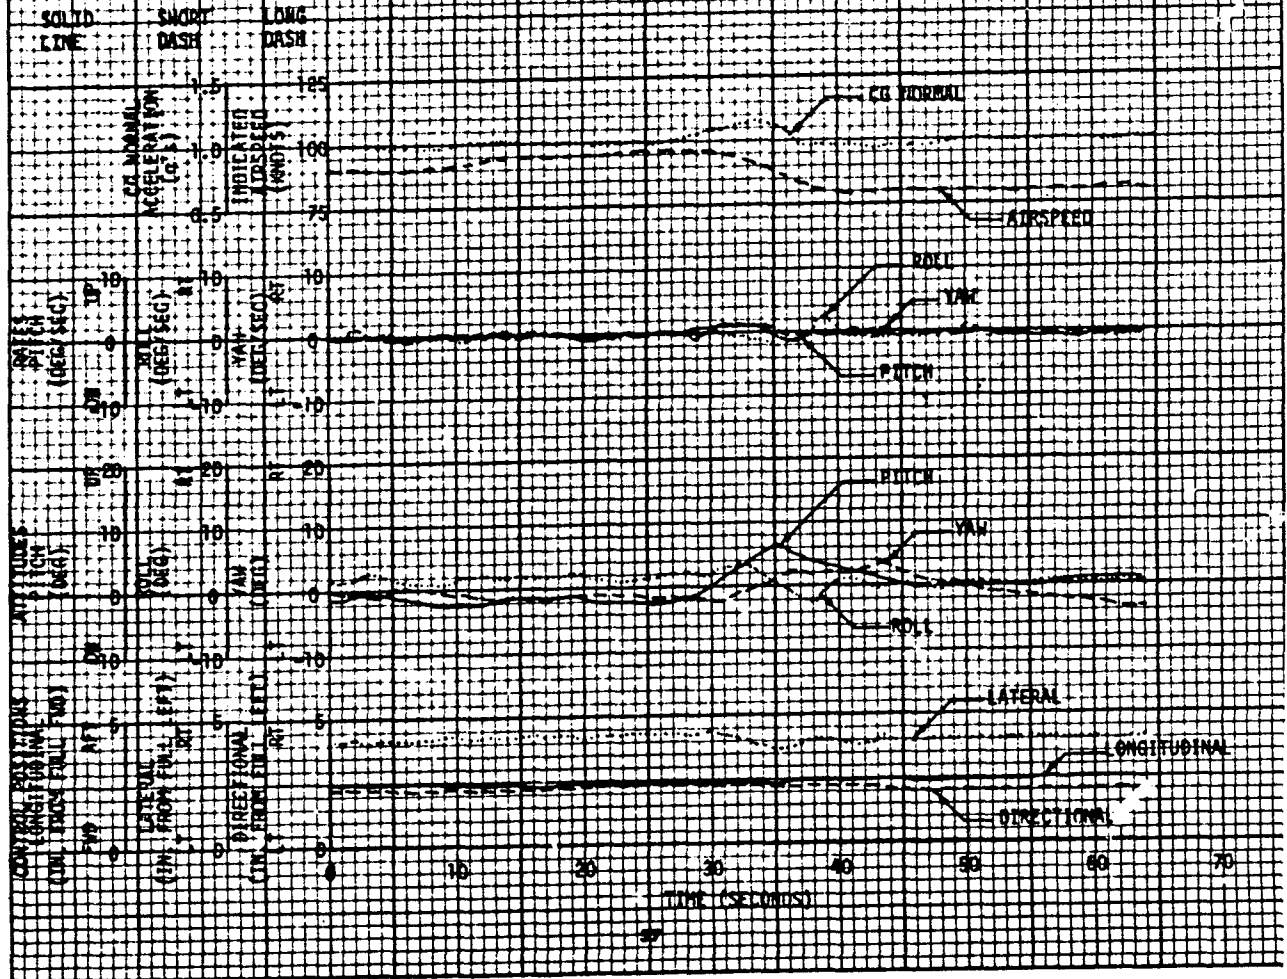
FIGURE 13

LONGITUDINAL LONG TERM RESPONSE  
DH-60C USA S/N 48-15860

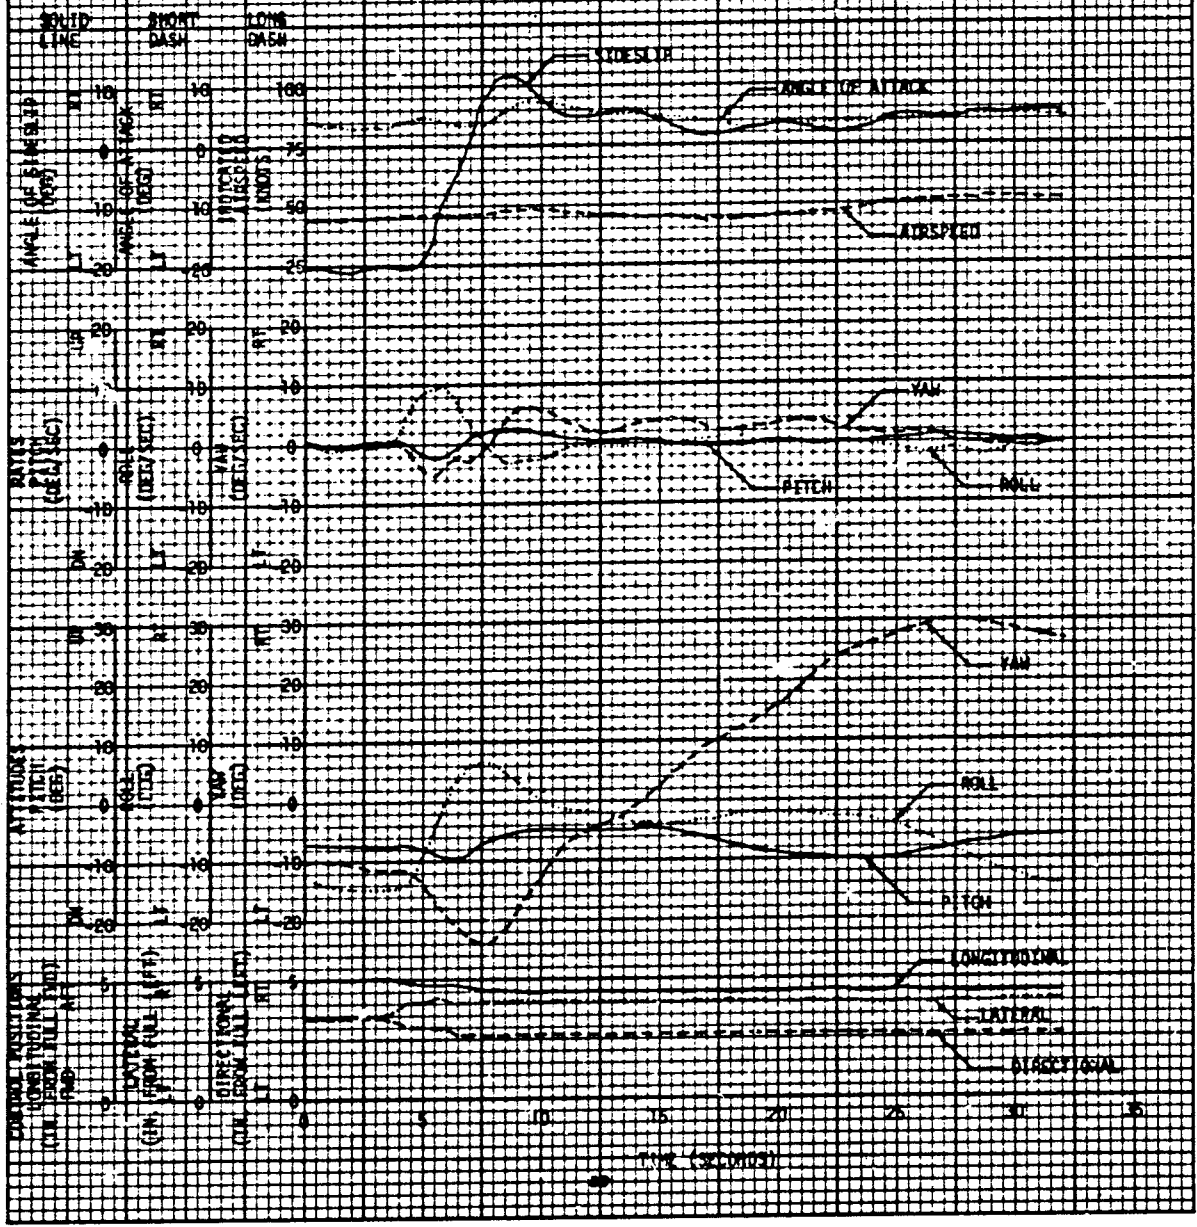
FIGURE 15  
RELEASE FROM STEADY SIDESLIP  
ON SBC USA 3/4 IN 58-16850

CROSS WEIGHT (LB)	CR LOCATION (FEET)	SENSITIVITY (IN)	DENSITY ALTITUDE (FT)	TRIM (IN)	TRIM SPEED (KTS)	TRIM ALTITUDE CONDITION
3180	112.10 (AFT)	0.2	7300	1.0	354	LEVEL

24. Lateral-directional dynamic characteristics of the OH-58C were evaluated following releases from steady sideslips at the conditions shown in table 1. Test techniques are described in appendix D. The roll and yaw response was deadbeat following releases from right and left sideslip at 51 KCAS (fig. 15, app E). However, following all releases at 51 KCAS, the aircraft entered a shallow turn (4 to 8-degree bank angle). Following releases from right and left sideslips at 94 KCAS, moderately damped Dutch-roll oscillations were observed, which subsided in approximately 2 cycles (fig. 16). Roll to yaw ratio was approximately 1, and the oscillation period was approximately 5 seconds. A shallow turn (4 to 6-degree bank angle) was entered following releases from right sideslips at 94 KCAS. The lateral-directional dynamic stability characteristics of the OH-58C are satisfactory.

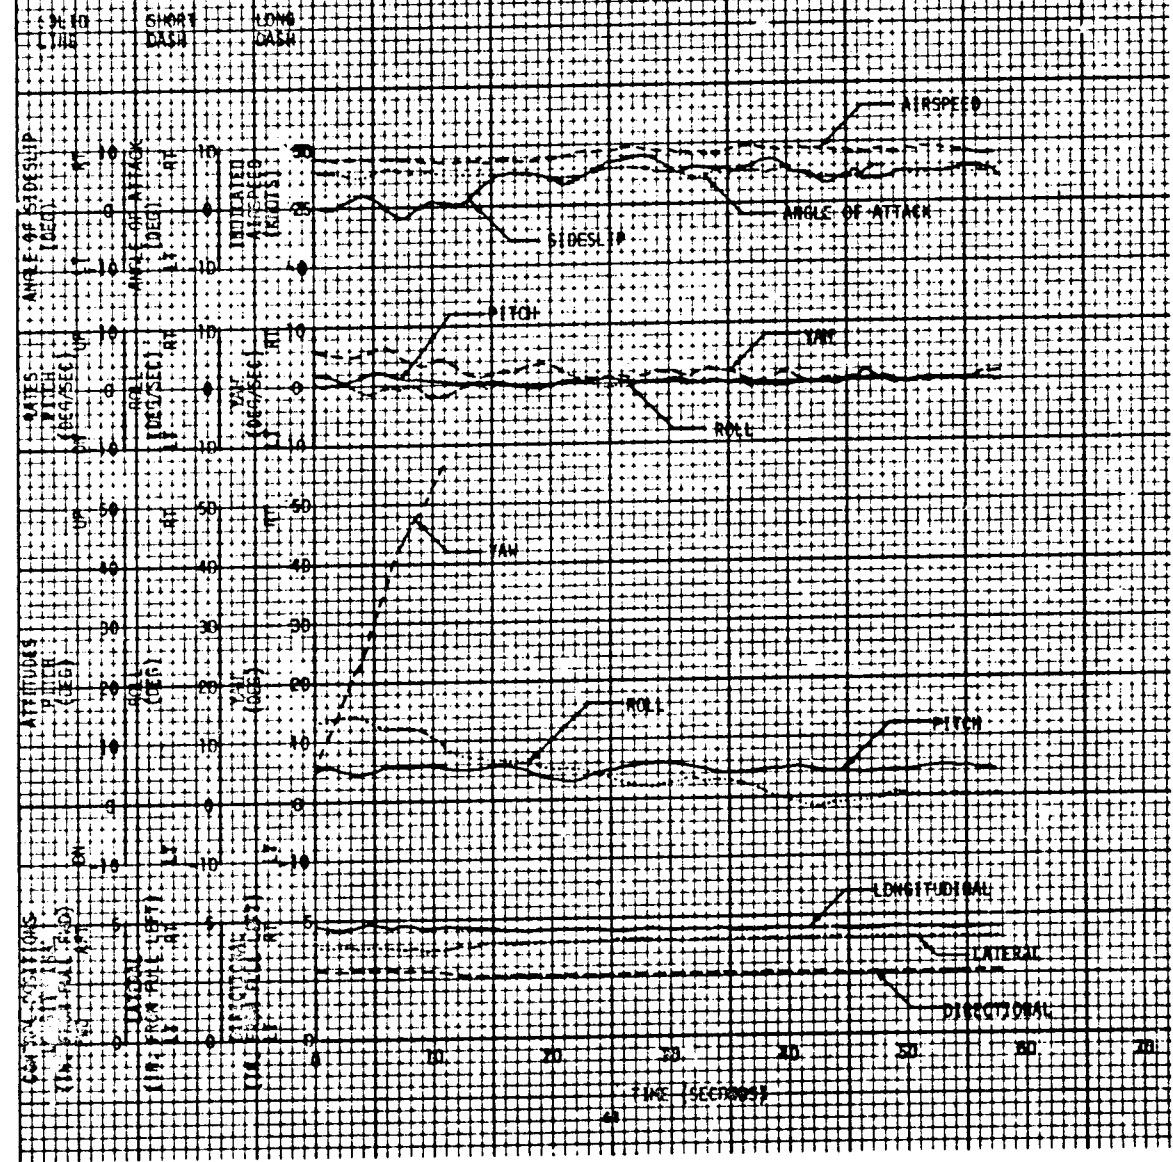
FIGURE 17  
 SPIRAL STABILITY  
 ON: C-130A (S/N 14850)

CRUIS HEIGHT (10)	QC LOCATION EGRS (100)	EAT (10)	DENSITY ALTITUDE (FT)	BARO CORRECTION (10)	WIND SPEED (KTS)	WIND DIRECTION CONDITION
8000	112.1 (LEFT)	0.2	7700	0.0	354	LEVEL

25. An evaluation of the spiral stability characteristics of the OH-58C was conducted in level flight at the conditions shown in table 1. Test techniques are described in appendix D. At 51 KCAS the spiral response was convergent, with a time to half amplitude of 13.5 seconds (fig. 17, app E). At 94 KCAS, the spiral response was also convergent with a time to half amplitude of 4.5 seconds (fig. 18). The spiral stability characteristics of the OH-58C are satisfactory.

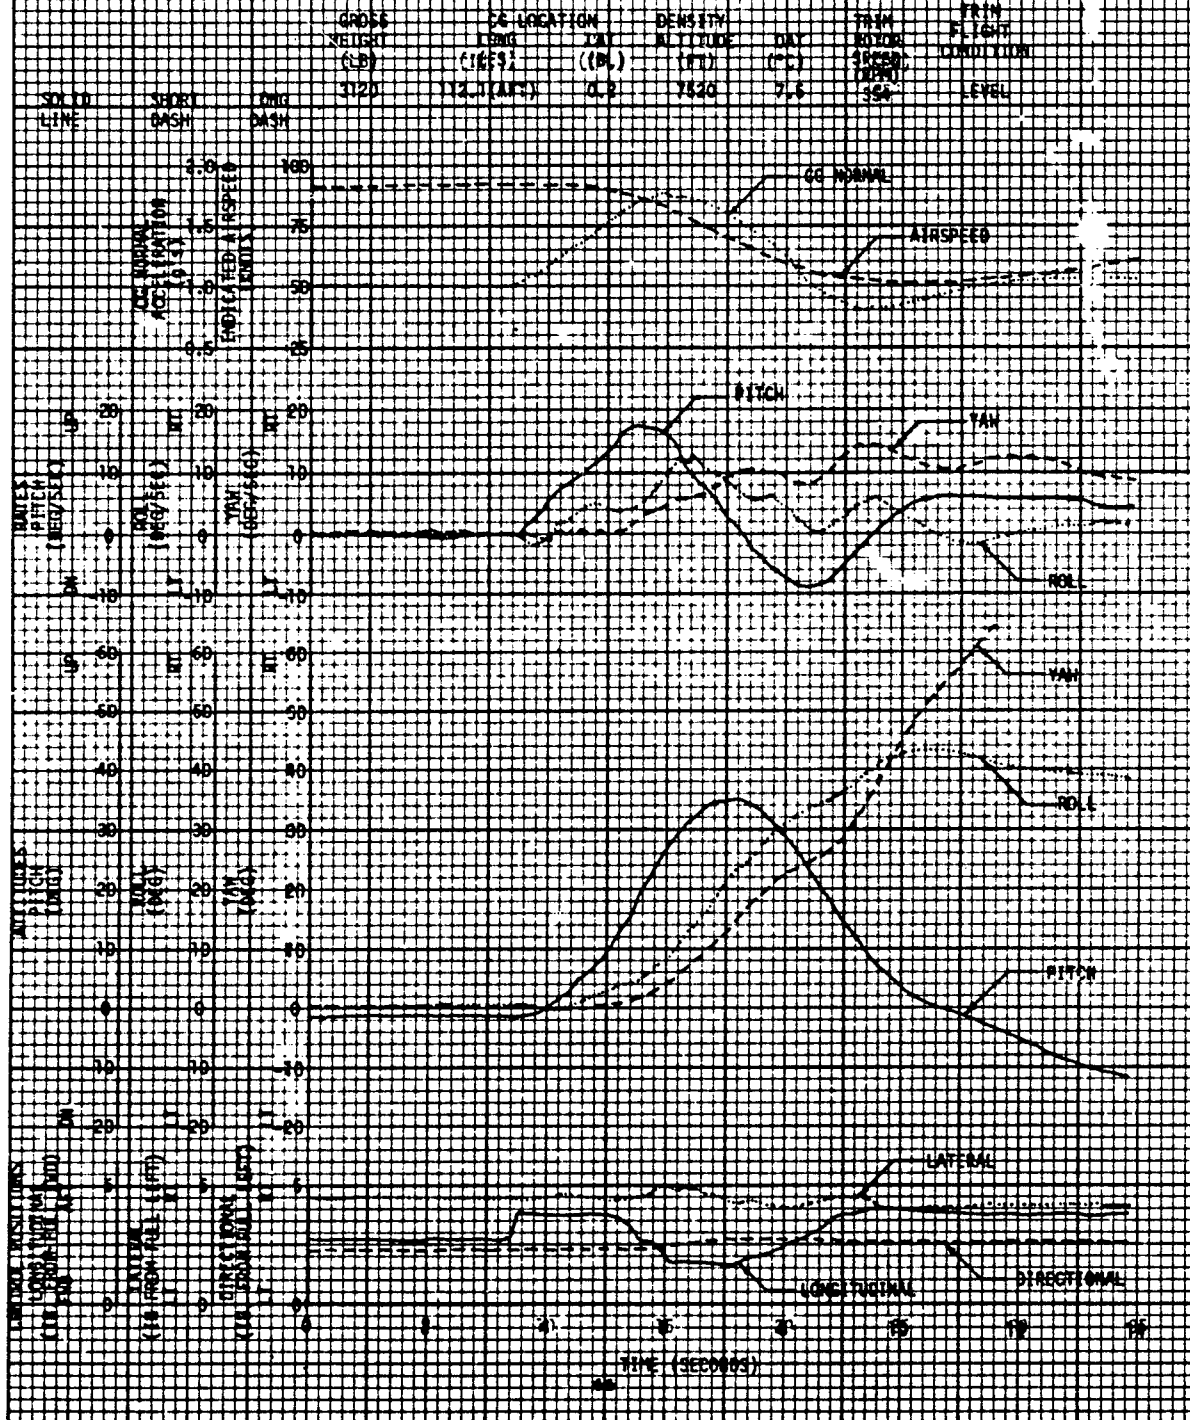
FIGURE 22

ART LONGITUDINAL STEP  
DR-200 USA SV# 40-16830

The pitch-up tendency at aft cg and cruise airspeed is a shortcoming. The pitch rate and cg normal acceleration response following an aft longitudinal control step input at 94 KCAS and aft cg failed to meet the requirements of paragraph 3.2.11.1 of MIL-H-8501A, in that time histories of these responses did not remain concave down or achieve a maximum value.

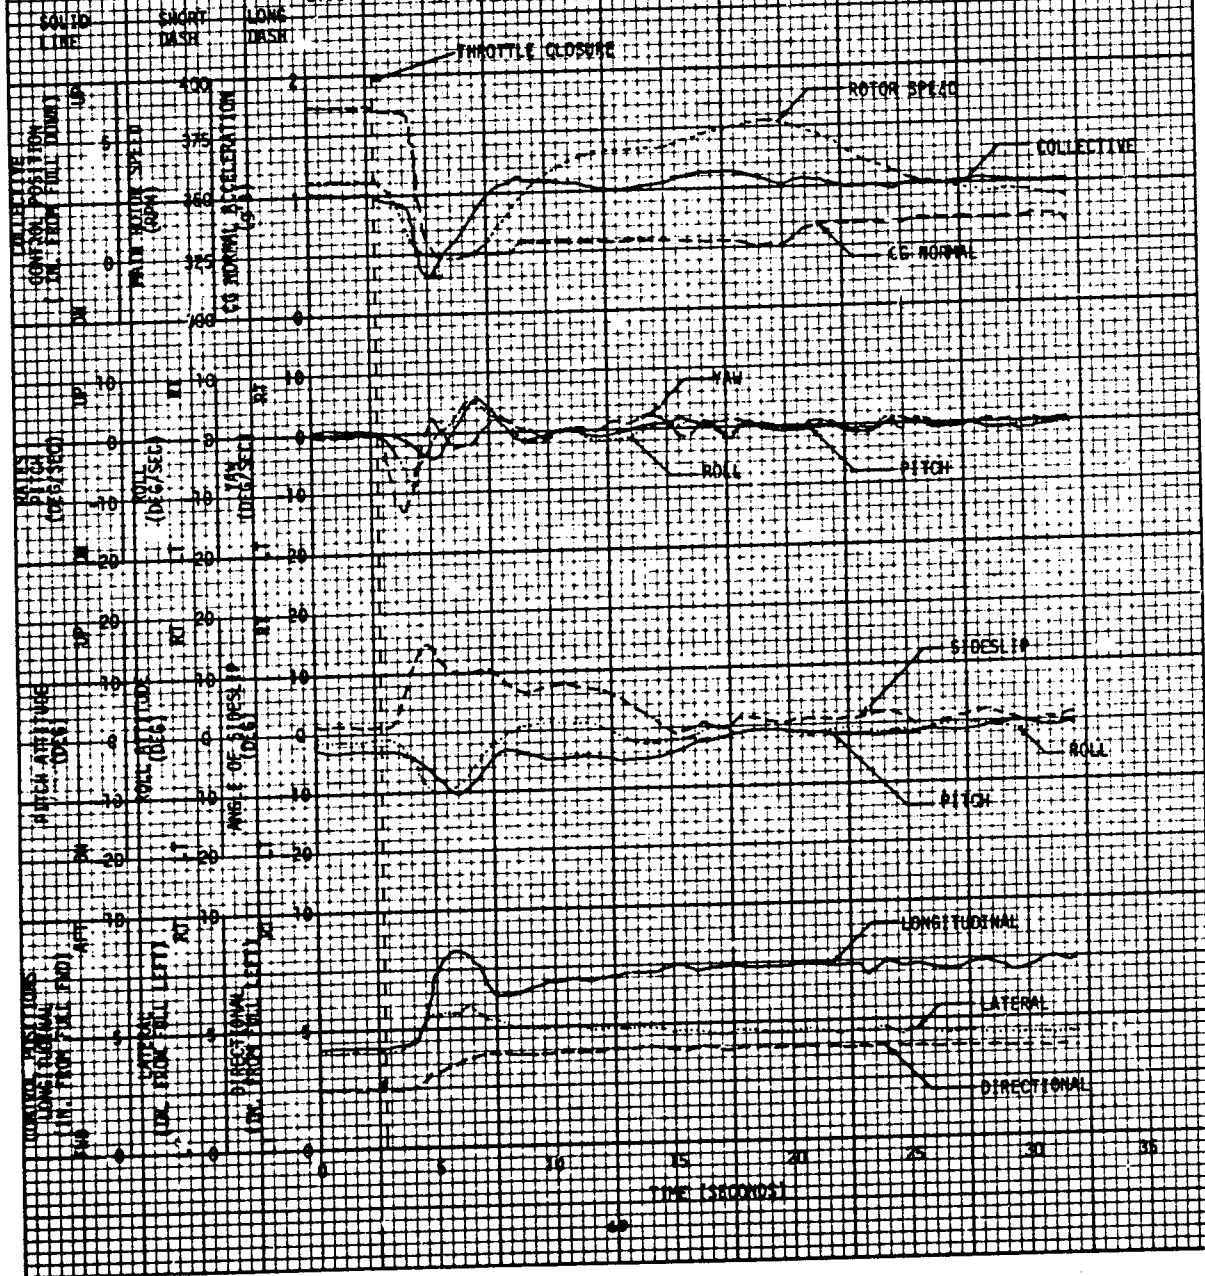
FIGURE 28

SIMULATED SUDDEN ENGINE FAILURE  
ON 560 USA 3/N 88-16880

GROSS WEIGHT (LB)	CG LOCATION (IN)	DENSITY ALTITUDE (FT)	QAT (FO)	TRIM AIRSPEED (KIAS)	INITIAL FLIGHT CONDITION
3770	107.4 (F40)	6.2	5340	77.0	LEVEL

32. The response of the OH-58C following a simulated engine failure was evaluated at the conditions shown in table 1. Test techniques are described in appendix D. Time histories of aircraft response to simulated engine failure in level flight at 96 KCAS with maximum continuous power and in climbing flight at 53 KCAS with takeoff power are presented in figures 25 and 26, appendix E, respectively. The response of the aircraft following a simulated engine failure was generally characterized by rapid rotor speed decay, rapid left yaw, slight nose-down pitching (which increased with airspeed), and slight left roll.

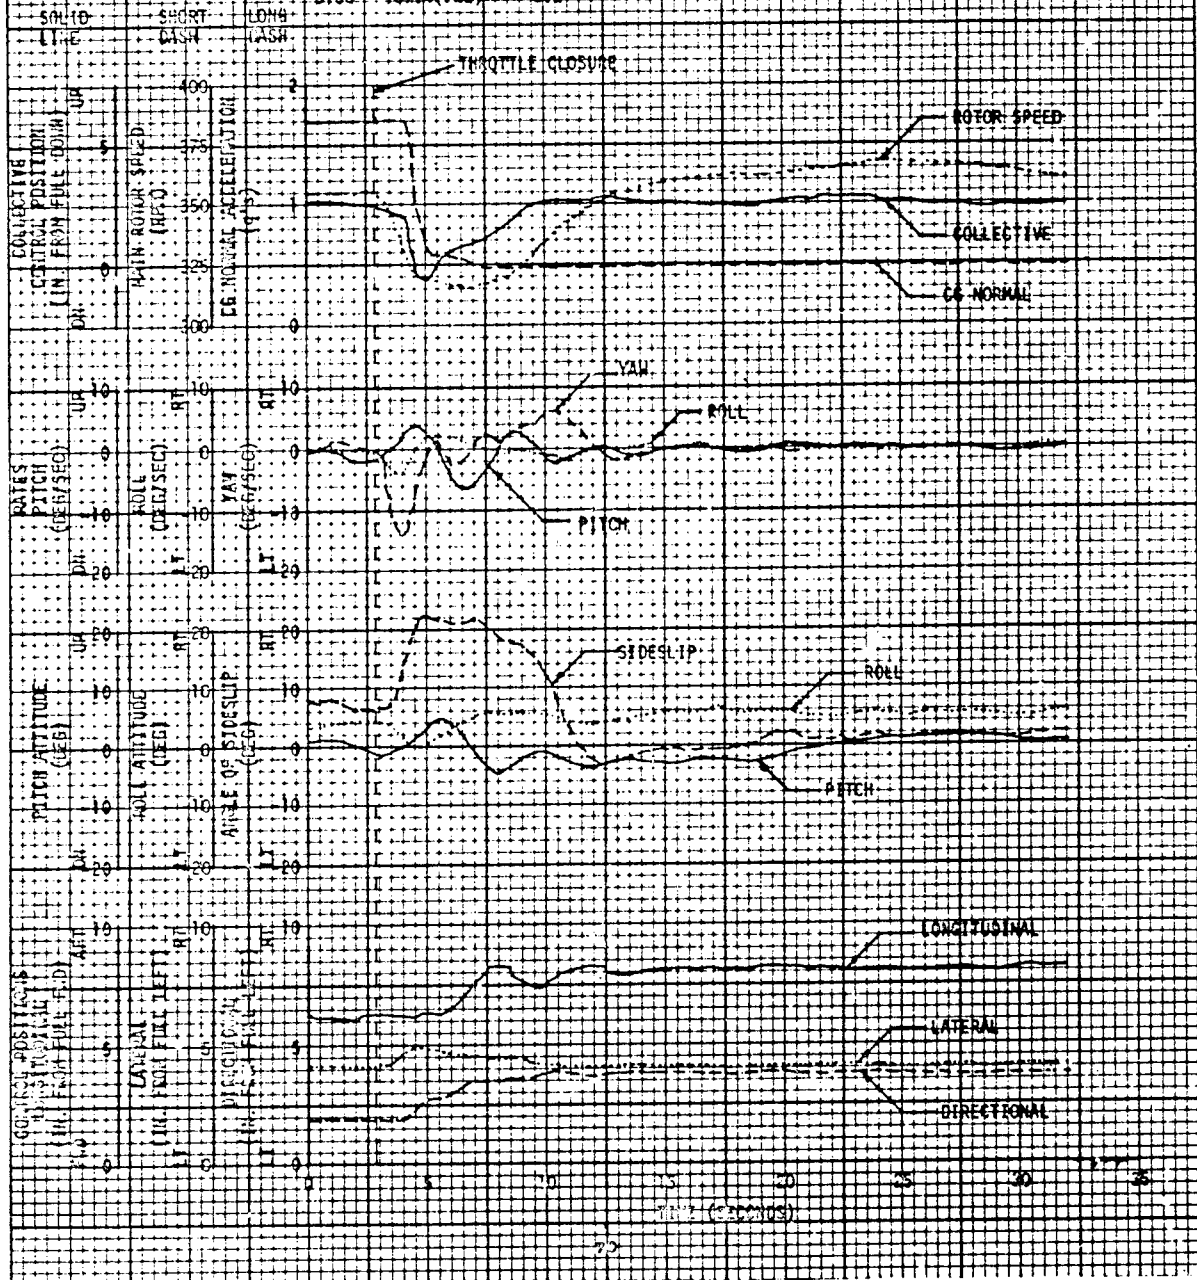
FIGURE 24

SIMULATED SUDDEN ENGINE FAILURE  
 CH-530 USA S/N 68-16350

GROSS WEIGHT (LB)	CG LOCATION (F4)	DENSITY (BL)	TRIM AIRSPEED (KIAS)	TRIM FLIGHT CONDITION		
3100	107.3 (FWD)	0.2	5040	15.5	53	CLIMB
