AMMRC TR 79-12  
BRITTLE MATERIALS DESIGN,  
HIGH TEMPERATURE GAS TURBINE

Arthur F. McLean, Ford Motor Company, Dearborn, Michigan 48121  
John R. Secord, Ford Motor Company, Dearborn, Michigan 48121

Interim Report Number 14, September 30, 1977 to March 31, 1978

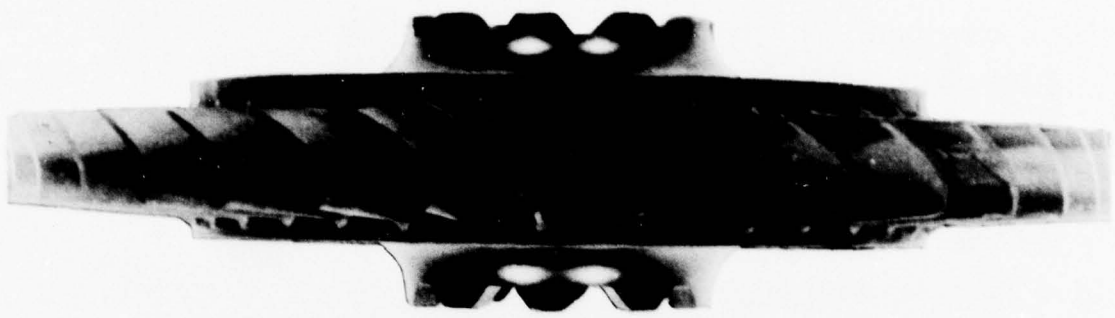
Figure 3.3 — Turbine Rotor with Curvic Couplings.

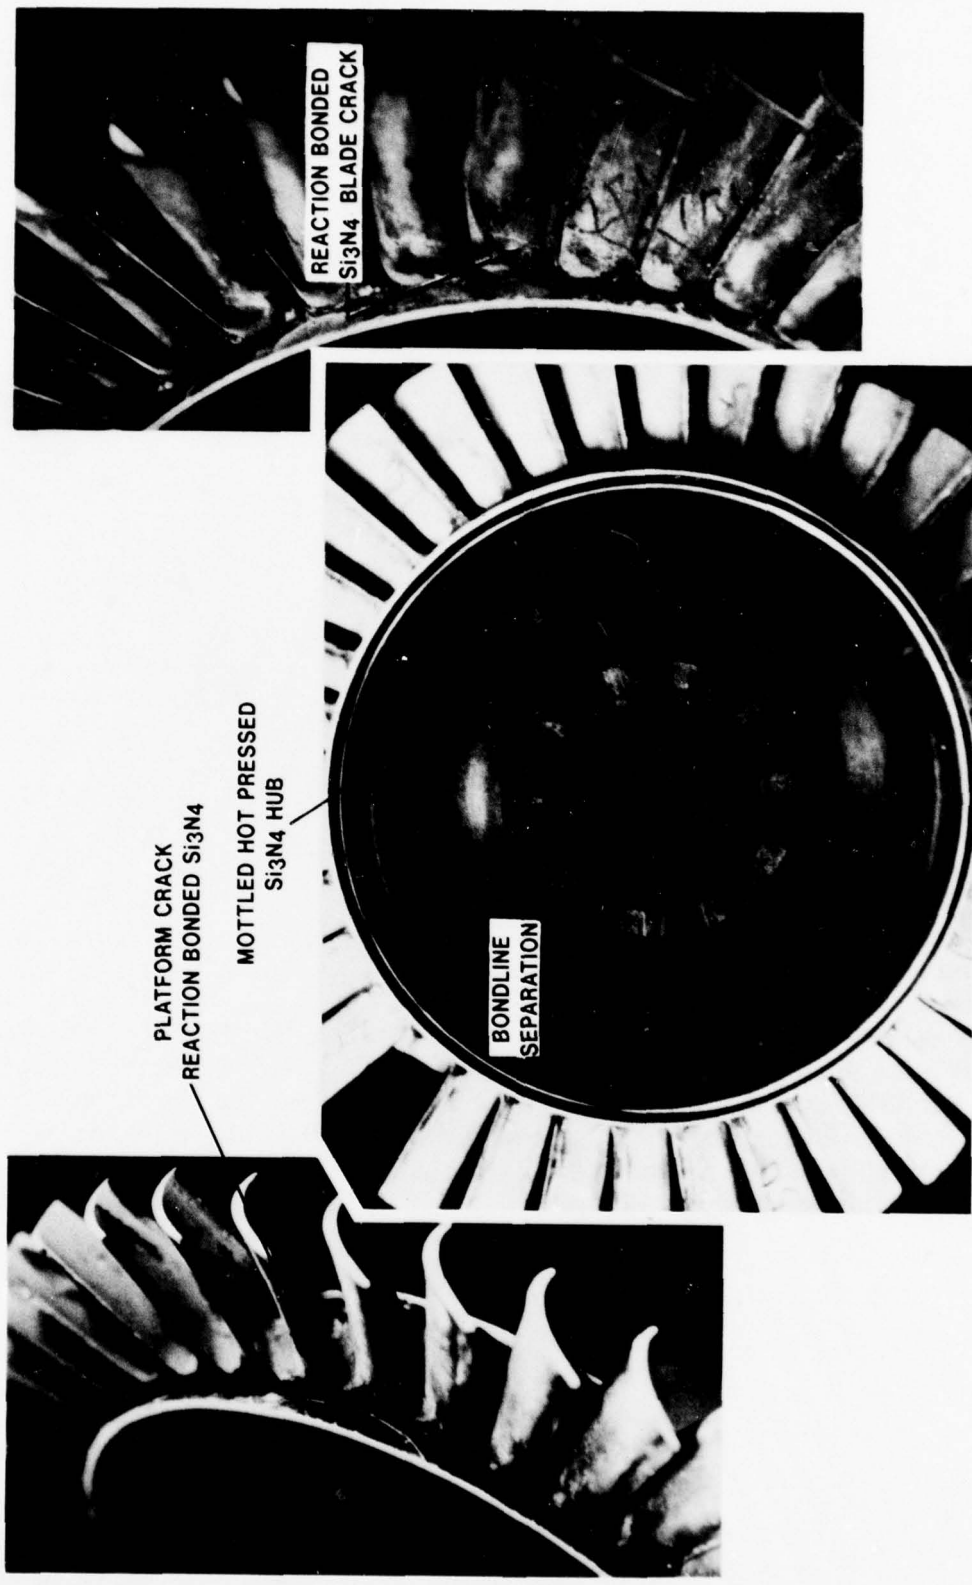
The fluorescent dye penetrant inspection reveals bonding defects, cracks induced during machining, high porosity regions, and mottling effects (13) in the hot pressed silicon nitride disk. Several of these defects are shown in Figure 3.4. The fluorescent dye penetrant technique is also useful in detecting blade root cracks which are difficult to observe under visual examination. Table 3.2 summarizes the results of this examination for the rotors currently through final machining.

Figure 3.4 — Examples of Turbine Rotor Defects Revealed by Zyglo. T.M.  
ROTOR 1355

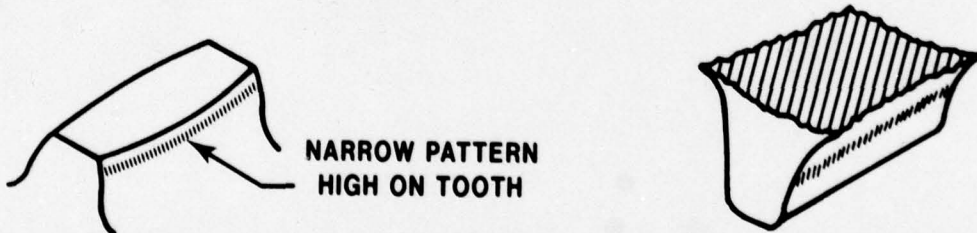
**Figure 3.5 — Curvic Tooth Contact Patterns.**

Inspection of the curvic coupling starts with an examination of the tooth contact pattern between mating parts. The contact pattern is established using a non-drying blueing compound which is applied to one set of curvic teeth and transferred to the mating part when gently tapped. This contact pattern is then compared to an acceptance standard. The standard calls for the 0.05 inch contact pattern depth to be centralized and the contact width be at least 90% of the tooth face. Also, the standard requires a bearing pattern on both sides of all teeth. Examples of contact patterns are shown in Figure 3.5. Next, the rotor is checked for squareness and concentricity when mounted on a set of master curvic coupling gages. Concentricity of the rotor and gages is held to within 0.0005 inches while squareness is held to within 0.0015 inches. Finally the spacing between the curvic coupling teeth pitch lines is checked. This dimension controls the axial location of the rotor and is held to within  $\pm 0.001$  inches.

**TYPICAL SATISFACTORY CONTACT PATTERN**

**UNSATISFACTORY CONTACT PATTERN — BRIDGED BEARING**

**UNSATISFACTORY CONTACT PATTERN — EXTREME END CONTACT**

**UNSATISFACTORY CONTACT PATTERN — PRESSURE ANGLE MISMATCH**

**UNSATISFACTORY CONTACT PATTERN — EXCESSIVE CHAMFER**
