MISCELLANEOUS PAPER SL-79-16

# EXAMINATION OF GROUT AND ROCK FROM DUVAL MINE, NEW MEXICO

Alan D. Buck, Jerry P. Burkes

July 1979

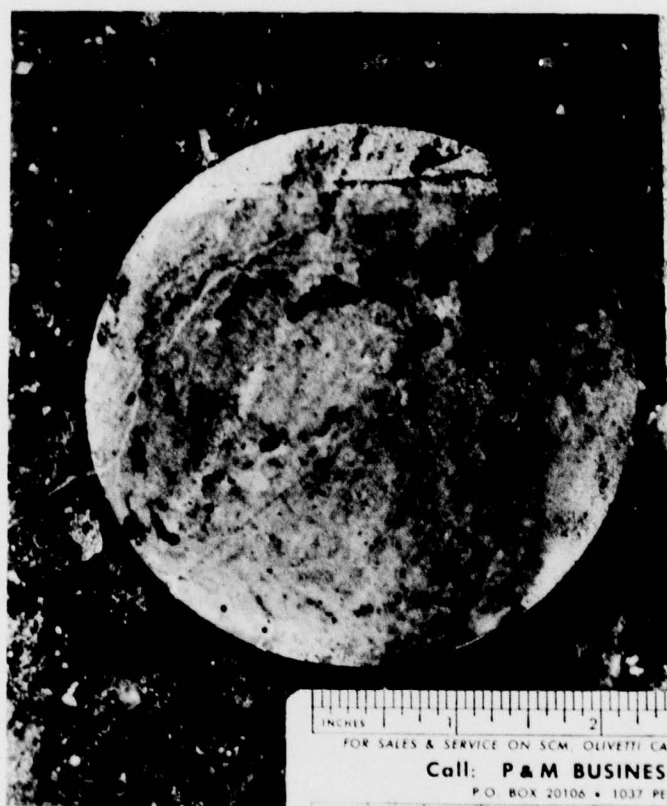
Figure 1. Central portion of sawed surface from lower part of Section 1, X0.8. The circular area is the grout plug surrounded by rock salt. Note the uniformly tight contact of grout and rock salt.

6. The upper surface of the slice from the bottom of Section 1 is shown in Figure 1. Samples of grout, rock, and their contact were obtained by taking small cores about 1/2 in. in diameter from this surface with a small diamond core drill. A small amount of lubricating water was used during the drilling.

a. The contact between the grout and the rock was tight everywhere that it could be seen. This tight contact is well shown in Figure 1. The interface in the F samples had to be separated using pliers which also indicates the tightness of the contact.

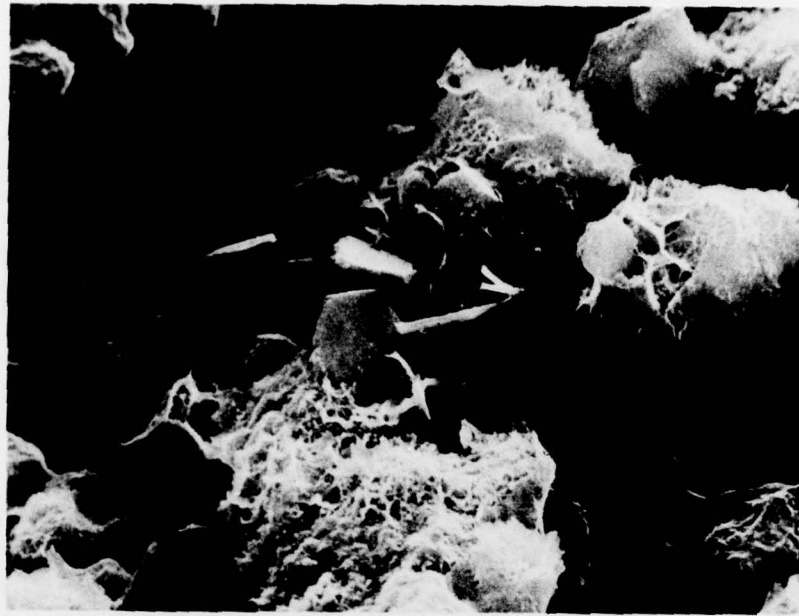
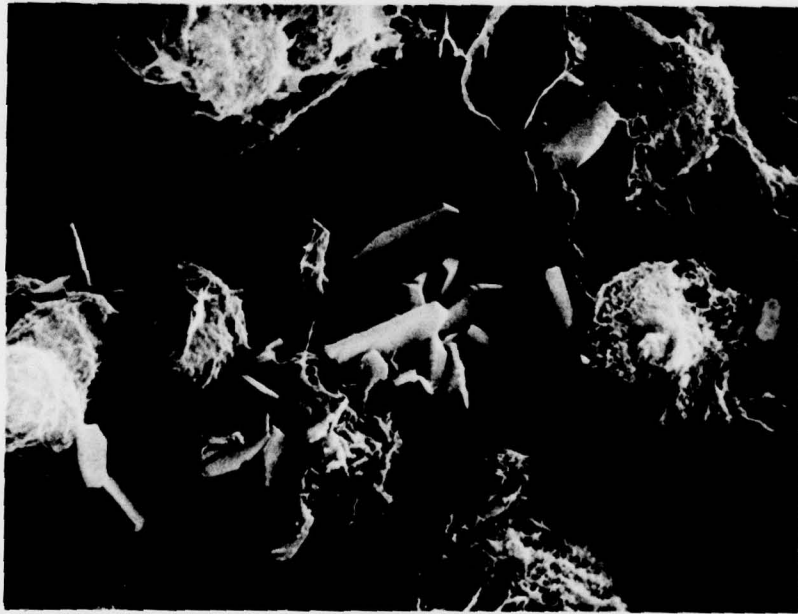
Figure 4. Grout samples E, X2300. Upper sample was freeze dried following vacuum drying while bottom one was not. There is no detectable effect of this difference. These are enlargements of the areas shown in Figure 3.

14. Eight scanning electron micrographs of the grout are shown in Figures 2-5. The pair in Figure 2 show the grout side of the grout to rock contact (sample F) at two magnifications. While it is not shown, the rock side was similar but showed more salt, as would be expected, than the grout side. Figures 3 and 4 show grout sample E at two magnifications. They also show that the effect of freeze drying after lengthy vacuum drying was not significant. These four photomicrographs show the typical microstructure of this grout. This open microstructure, when compared with the microstructure of other cement pastes of known low water-cement ratio, is proof that the Duval sample had a high water content. This comparison was illustrated by SEM photomicrographs in the ERDA 10 report.<sup>1</sup> The low unconfined compressive strength of about 300 psi for the Duval Mine grout verifies what is indicated by the open structure in Figures 3 and 4.
