# NAVAL POSTGRADUATE SCHOOL

## THESIS

FRACTURE TOUGHNESS CHARACTERIZATION  
OF SELECTED ULTRA HIGH CARBON STEELS

June 1979

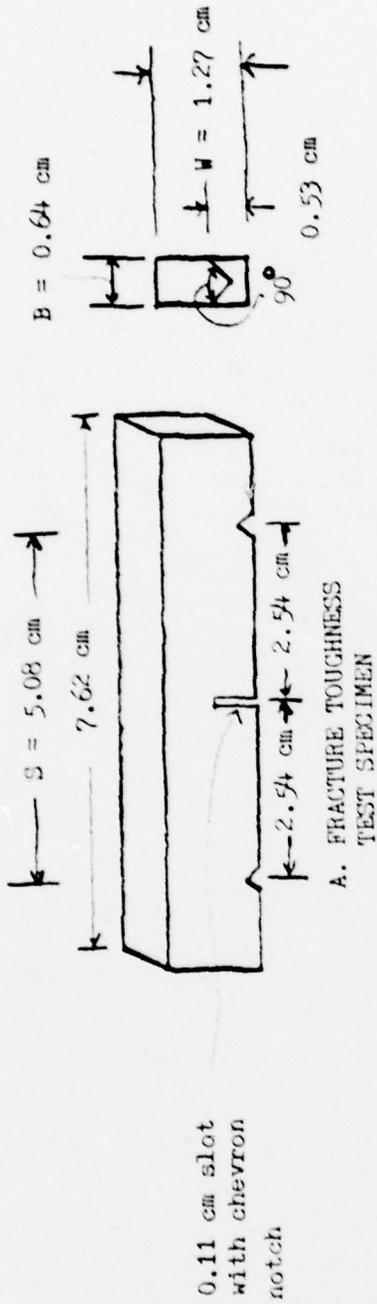
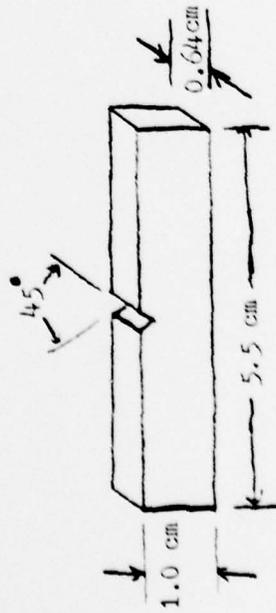
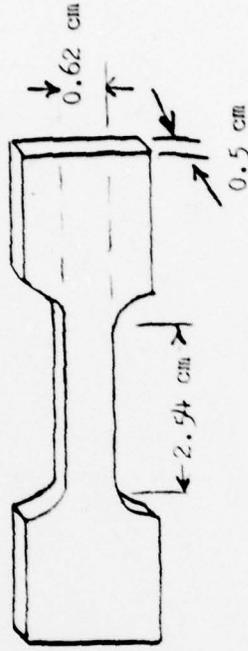
TEST SPECIMEN SPECIFICATION

Fig. 1. Test specimen specifications. These drawings depict the dimensions of the UHC steel specimens used in fracture toughness (A), impact (B) and tensile (C) tests.

Fracture toughness, tensile and Charpy specimens were cut to specifications shown in Fig. 1 from the various alloys upon their receipt at NPS. Several of the fracture toughness specimens from the 53150 and 10150 alloys were subsequently annealed at 650°C and air cooled to room temperature at NPS. Testing after such annealing was conducted to determine the influence of this heat treatment on fracture toughness.

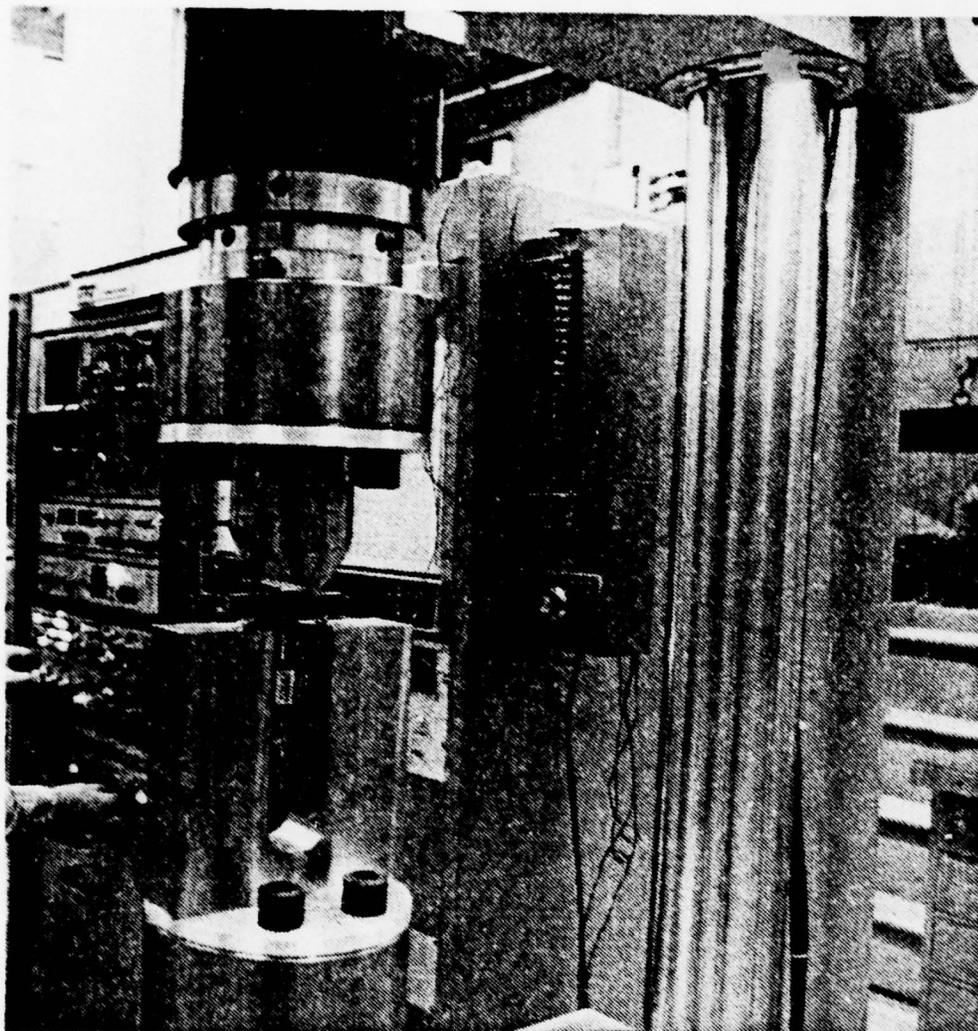
Fig. 2: Series 810 Materials Testing System and associated loading apparatus. Fracture toughness specimen is mounted with clip gage monitoring crack opening displacement.

An MTS Model 632.20B extensometer was used as the displacement gage for accurately measuring the relative displacement of the two gage positions spanning the slot. A pair of accurately machined knife edges were bonded to the specimen with 3M strain gage epoxy and the displacement gage was clipped to these edges to monitor crack opening displacement. Since gage lengths were maintained below one half of the specimen width, displacements were essentially independent of gage length. The displacement gage was calibrated by MTS Corporation in March, 1979, and a range card was also provided by MTS to provide compatibility between the gage and the model 440.21 Transducer Signal Conditioner. The gage provides a linear voltage output over a 0.254 cm range of displacement.

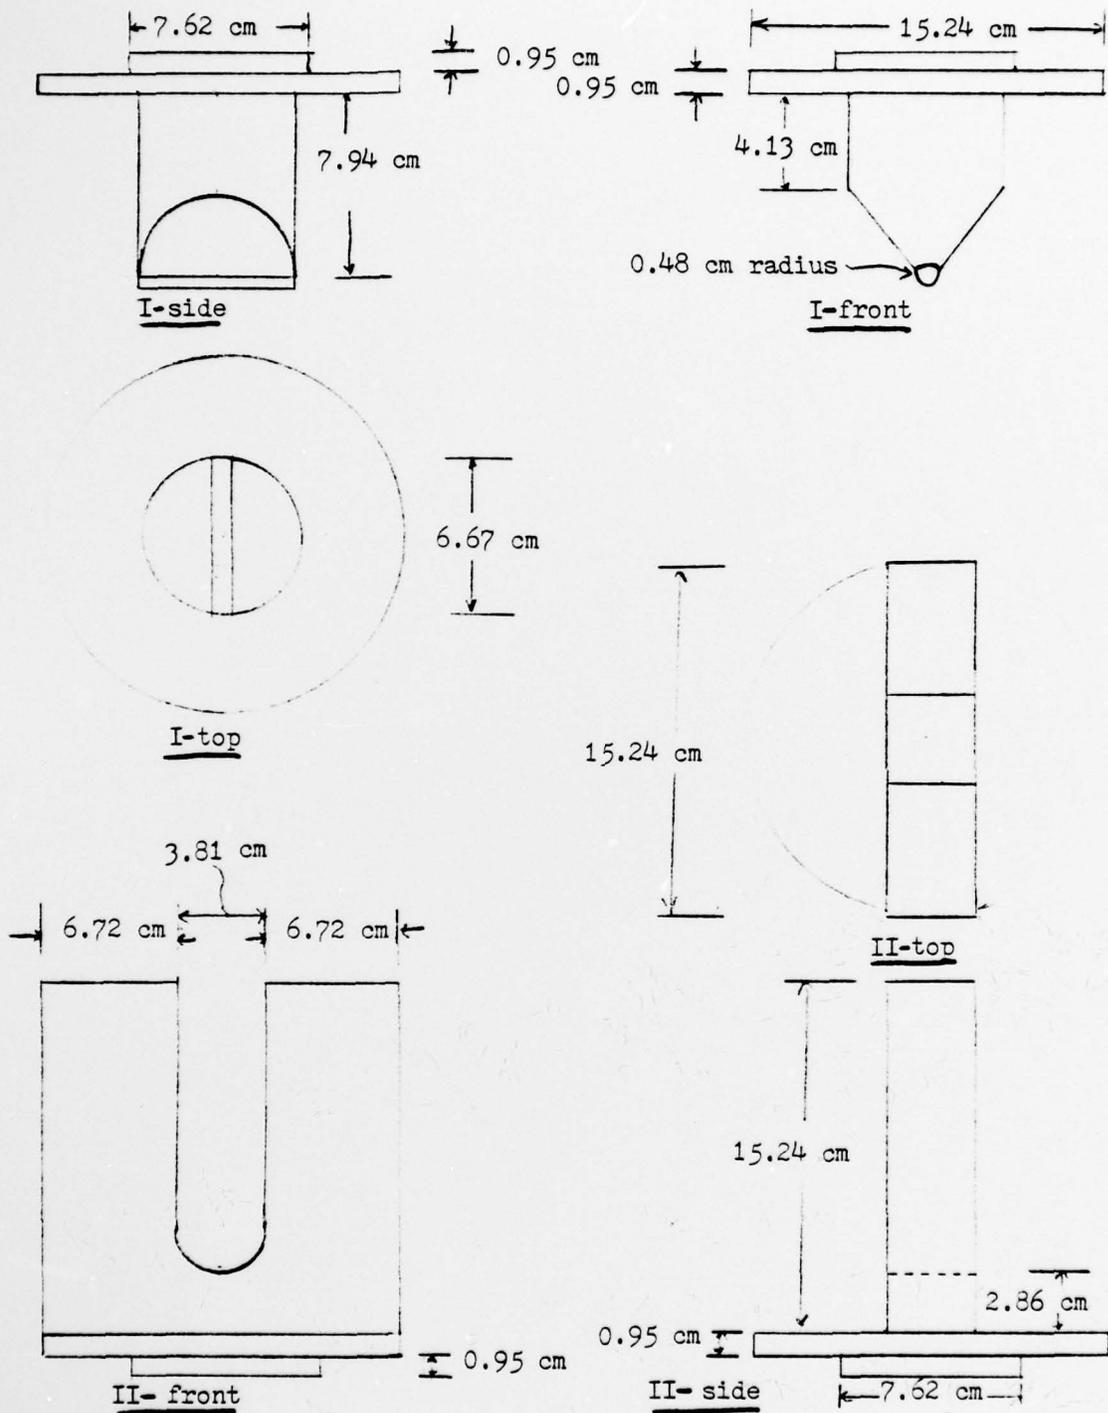
Fig. 3: Top (I) and bottom (II) mounting assemblies for three point bend fracture toughness specimen. Assembly manufactured from a medium strength steel.

to the upper fixture, which provided a point loading effect on a line directly above the specimen slot. Careful attention was given to machining of the loading fixture to insure that good alignment could be achieved during tests.

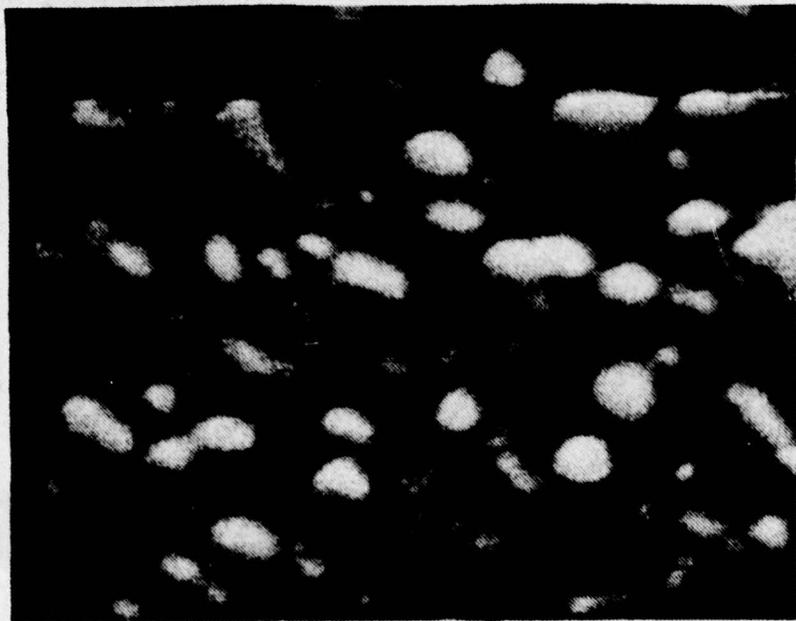
Fig. 9. Micrographs of a 10150 UHC steel etched in a 2% nital solution for 20 seconds. Many spheroidal carbides in the one micron diameter region are evident. 11000X

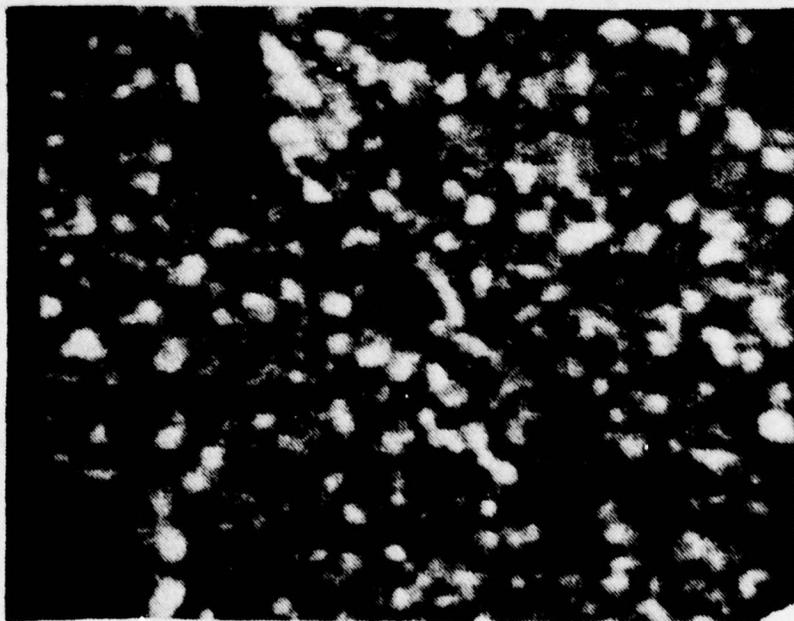
Fig. 10. Micrographs of a 52100 UHC steel etched with a saturated picral solution for 25 seconds. Spheroidal carbides are very fine with none visible over one half micron diameter. 11000X

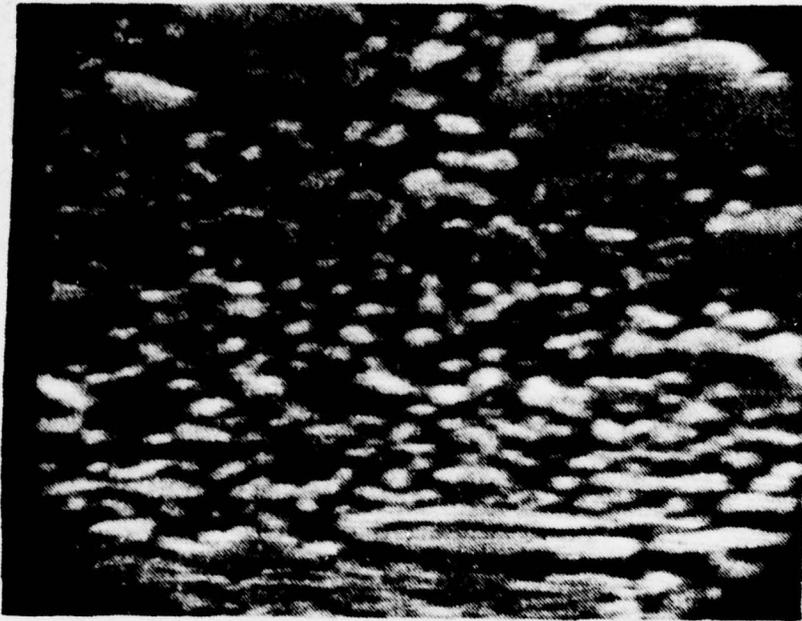
Fig. 11. Micrograph of 52150 UHC steel etched in a saturated picral solution for 25 seconds. Most spheroidal carbides are less than one half micron diameter with some large carbides over four microns across. 13000X

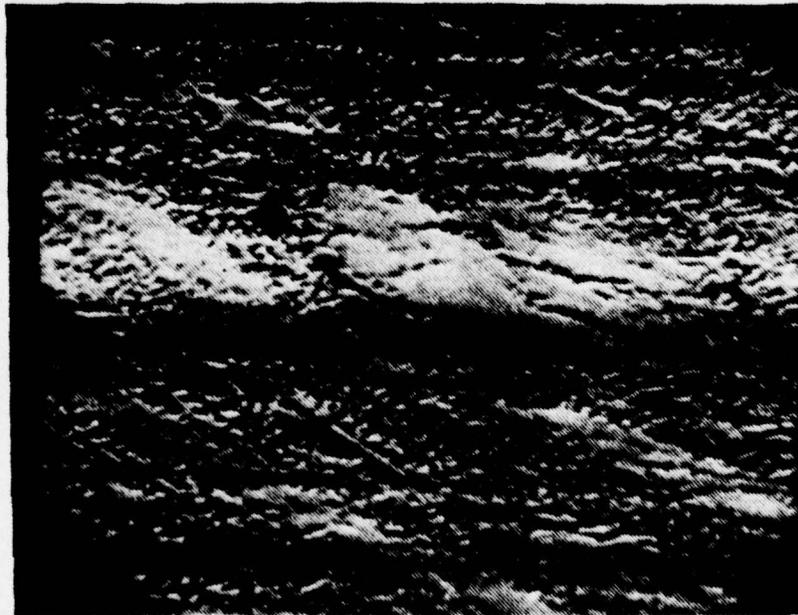
Fig. 12. Micrograph of 52150 UHC steel etched in a saturated picral solution for 25 seconds. This region has very coarse carbides aligned in the rolling direction. 2550X

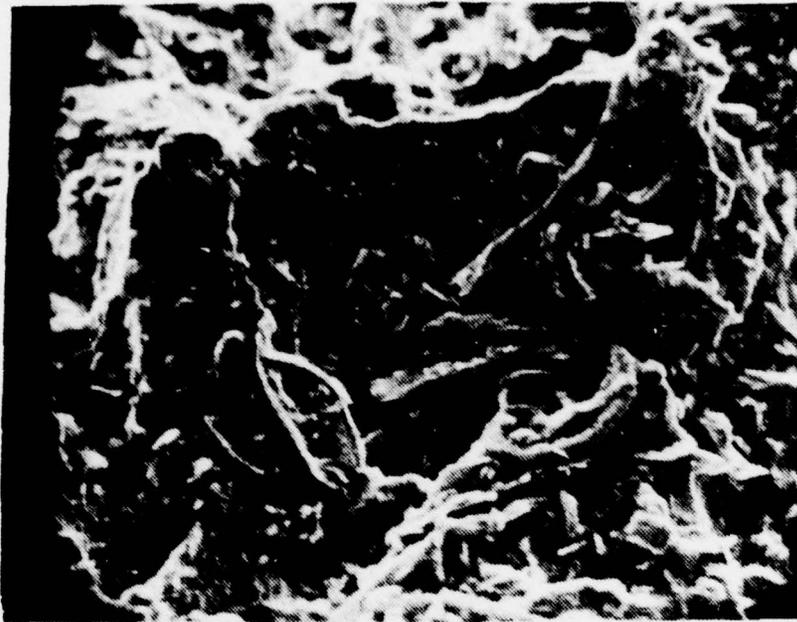
Fig. 13. Micrograph of fracture surface of 52150 UHC steel fractured at room temperature in a Charpy Impact Test. Surface condition indicates a cleavage fracture mode. 1500X

An examination in the SEM was made of the microstructure at the fracture surface of a 52150 UHC steel specimen broken in a Charpy Impact Test. Impact testing was accomplished over a range of temperatures. Figure 13 shows the microstructure of the fracture surface of a sample fractured at room temperature. The surface shows no evidence of ductile fracture and appears to have failed by cleavage. Figure 14 shows the same material fractured at 100°C and again the fracture mechanism appears to be some form of cleavage. Figure 15 shows the same result in

This material had a yield strength of 951.4 MPa, an ultimate tensile strength of 1063.9 MPa and an elongation to fracture of 10.3%. The hardness in the as-rolled condition was  $R_c$  33.0. The material had very low energy absorption, 2.4 joules, on the Charpy V-Notch Impact Test and broke in a brittle mode (Fig. 13).

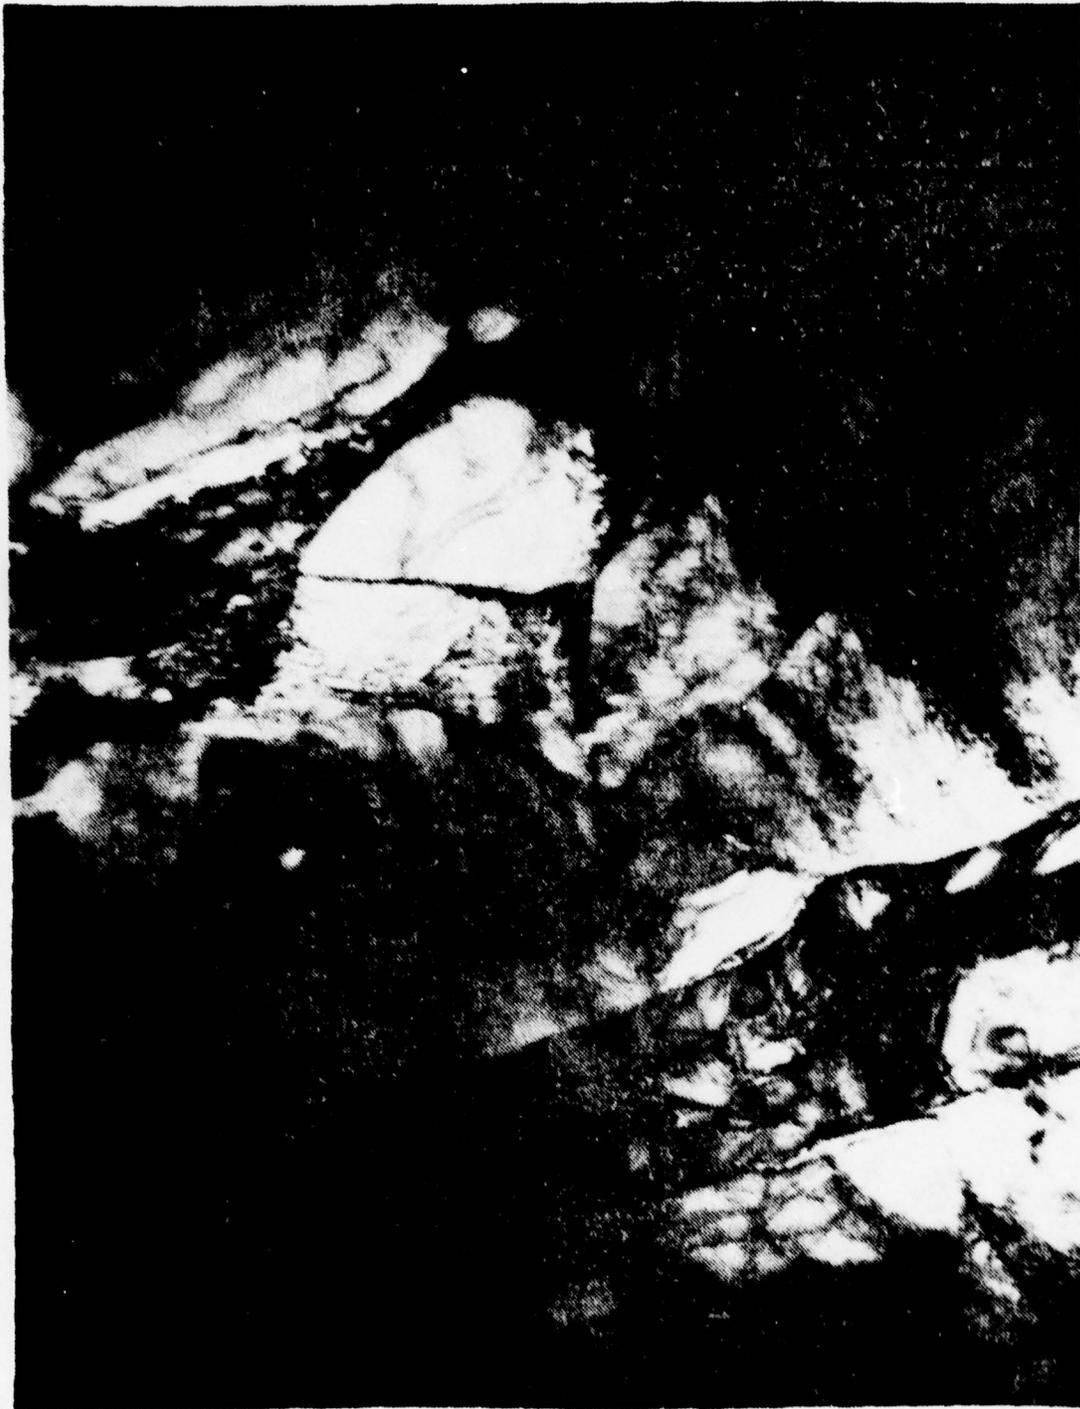
Fig. 18. Micrograph of 10150 UHC steel taken with TEM at 20000X. Subgrain boundaries are clearly visible. Black lines represent a high density of dislocations in the microstructure.

lines in this picture is indicative of the large amount of working the material has undergone. This dislocation density may help explain the poor toughness exhibited by this material considering its low relative strength, as it is already highly work hardened. Figure 19 is a micrograph of a selected-area diffraction pattern for the 10150 UHC steel. While this pattern is not indexed with the area in Fig. 18, it is taken from that region and the aperture of five microns indicates that grain size is in excess of this value, since there is no superposition on the diffraction pattern. This indicates that the ferrite grains are larger than was anticipated after being worked by the Sherby Process and that the boundaries visible in Fig. 18 represent a subgrain structure. The carbides did not act as effectively as hoped as pinning agents to produce a fine ferrite grain size.

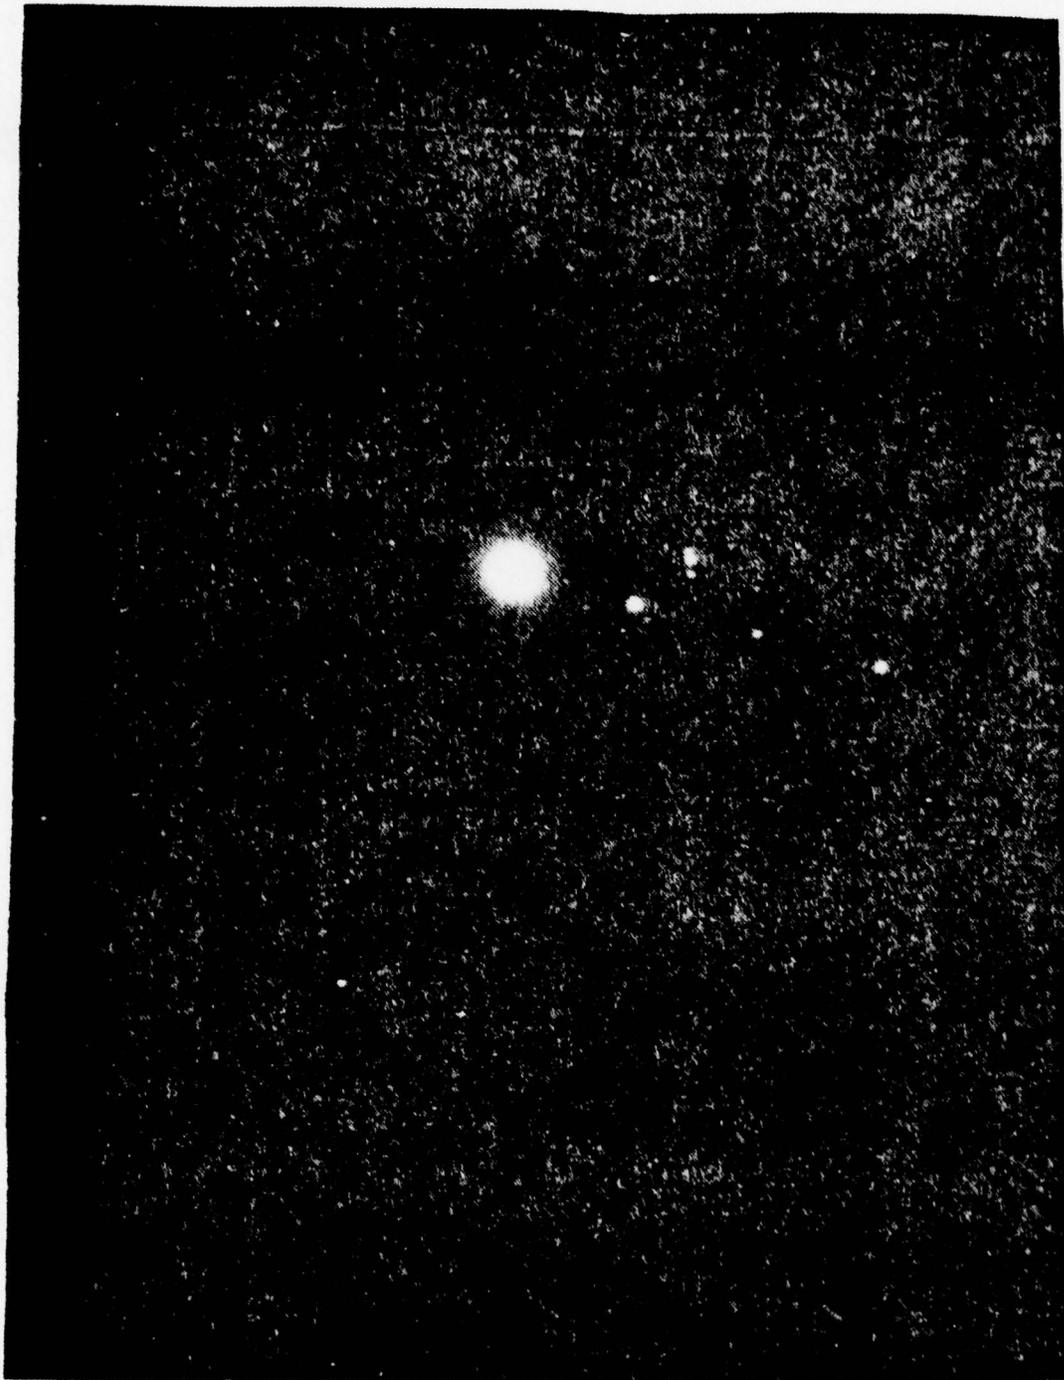
Fig. 19. Micrograph of 1015 UHC steel taken with TEM. This one second exposure clearly shows the defraction pattern of the crystal structure.

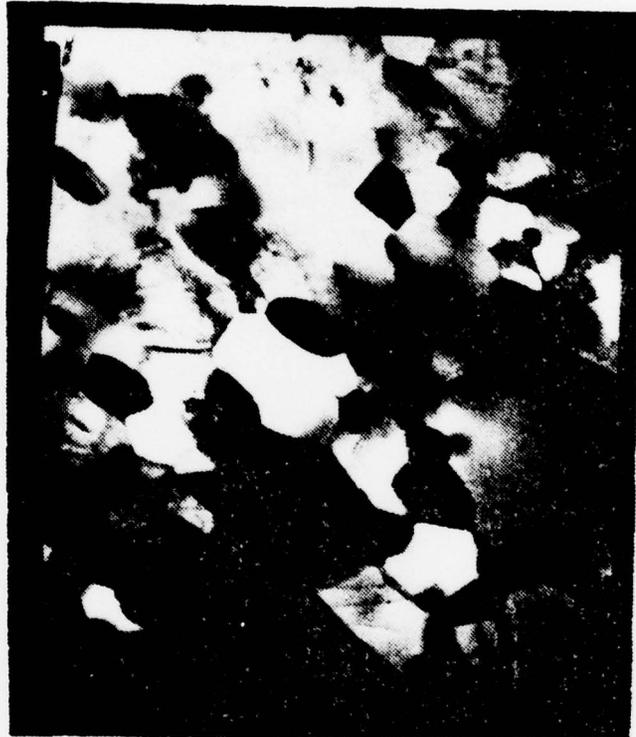
Fig. 20. Micrograph of 10150 UHC steel annealed at 650°C taken with TEM. Dislocation density is reduced from that noted in Fig. 18. 20000X

Figure 20 is a TEM micrograph of the 10150 UHC steel after a one-hour anneal at 650°C, followed by an air cool to room temperature. The dislocation density is reduced in this structure over that observed in the as-rolled condition. Webs of dislocations are still visible, however, at some of the subgrain boundaries of the structure.

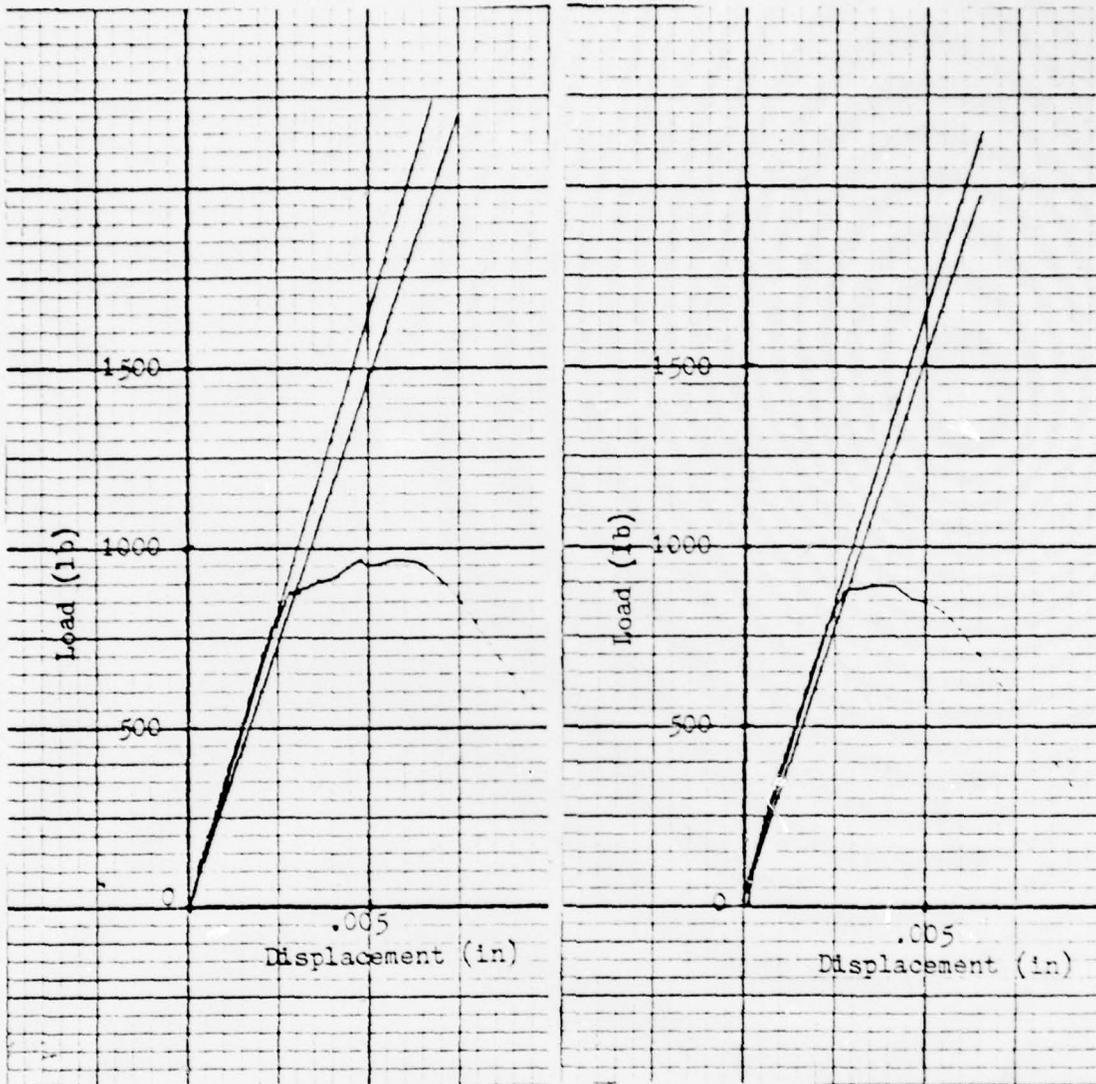
Fig. 21. Graphs of 53150 UHC steel tests one and two, respectively. Both graphs are Type I records and both records are for valid  $K_{IC}$  tests.

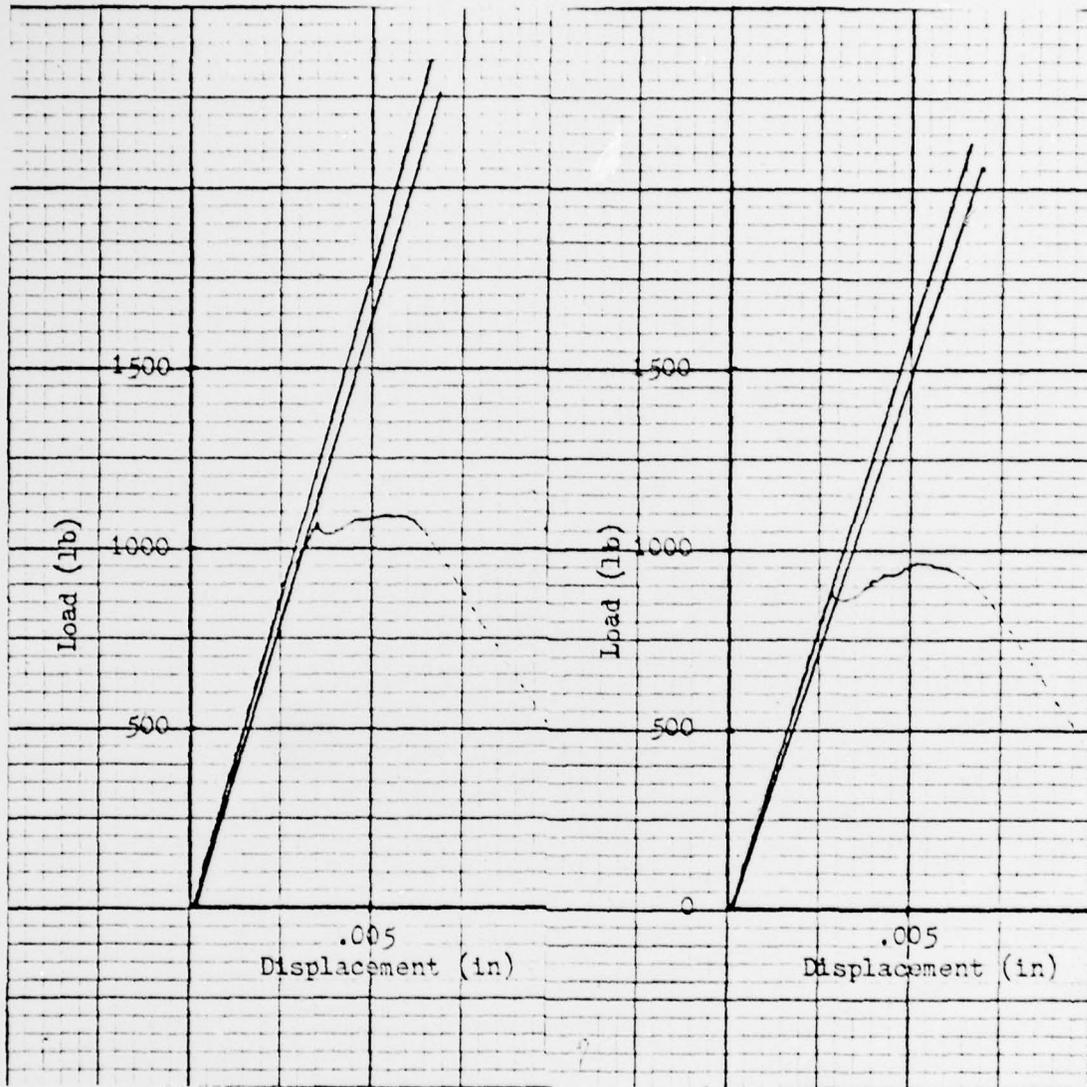
Fig. 22. Graphs of 53150 UHC steel tests three and four, respectively. Graph three is a Type I record and graph four is a Type II record. Both records are for valid  $K_{IC}$  tests.

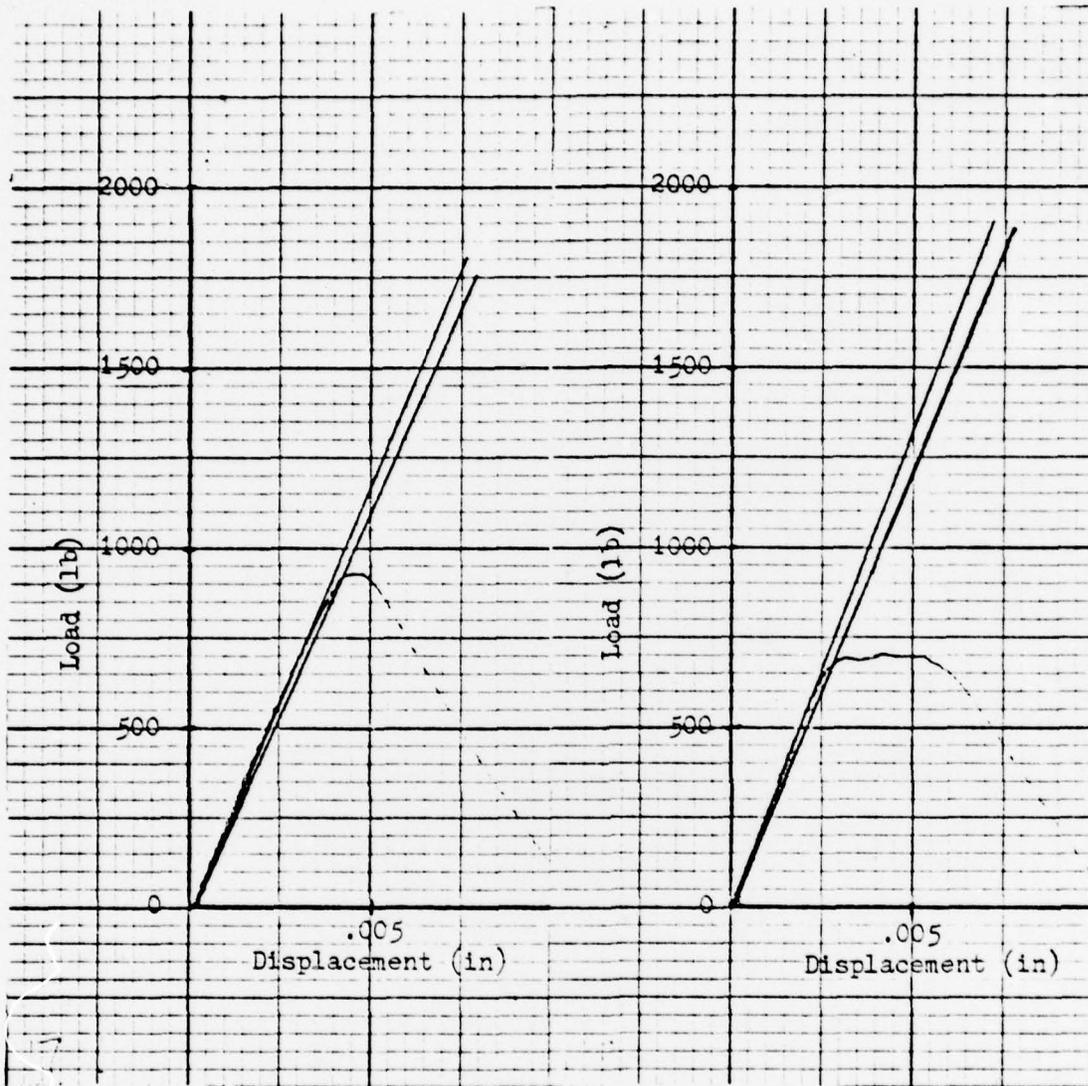
Fig. 23. Graphs of 43150 UHC steel tests one and two, respectively. Both are Type I records. Graph one is a valid  $K_{IC}$  test record while graph two was invalid due to an excessive maximum fatigue stress intensity.

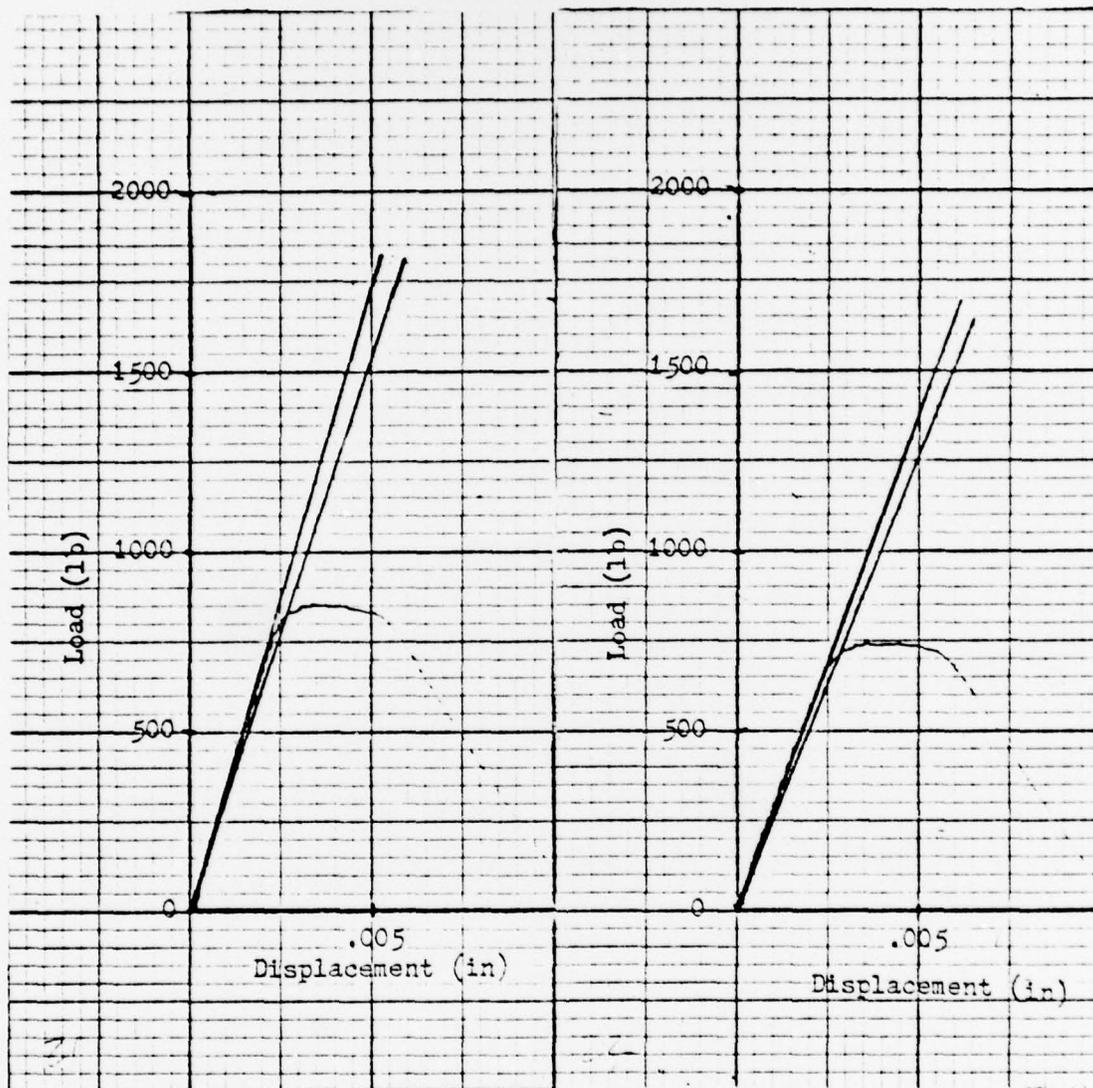
Fig. 24. Graphs of 43150 UHC steel tests three and four, respectively. Both are Type I records and both records are from valid  $K_{IC}$  tests.

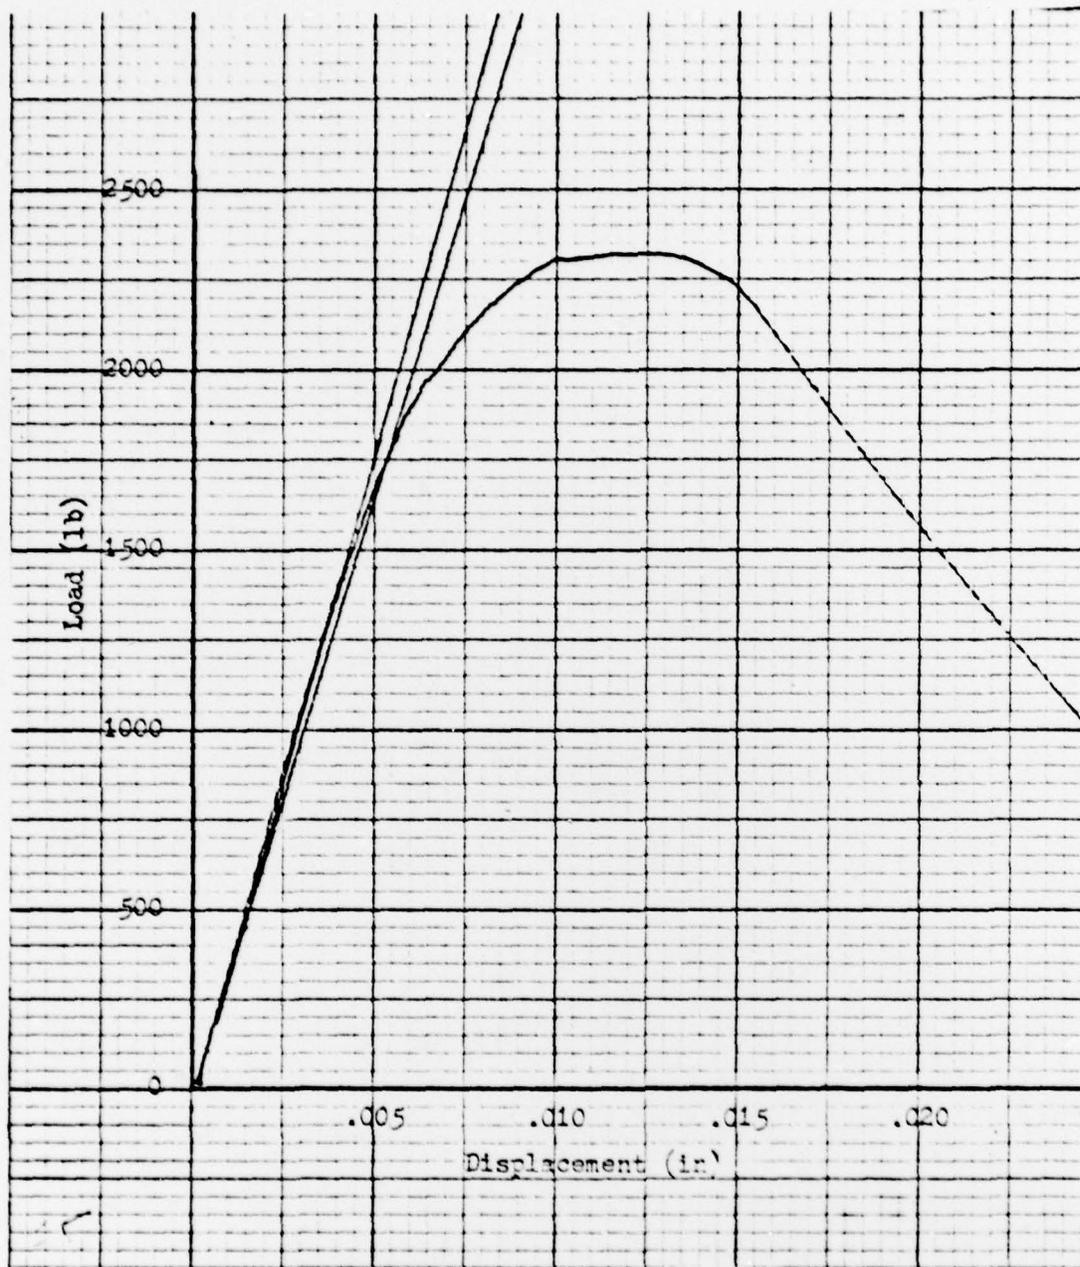
Fig. 25. Graph of 52100 UHC steel test one. This is a Type I record. The results were invalid for  $K_{IC}$ .

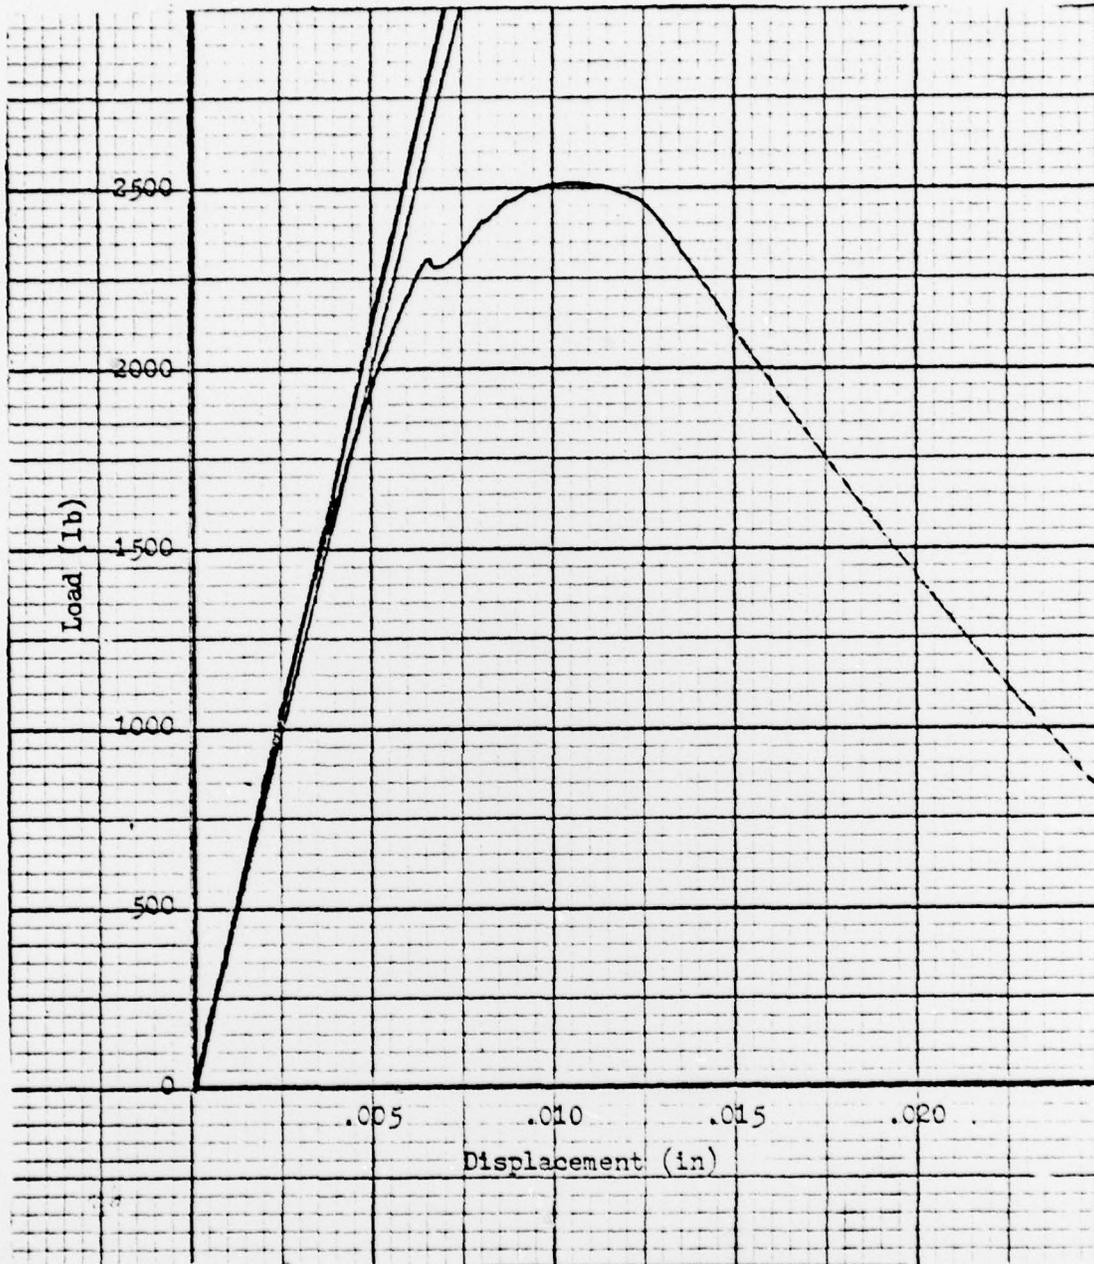
Fig. 26. Graph of 52100 UHC steel test two. This is a Type I record. The results were invalid for  $K_{IC}$ . Note the distinctive pop-in crack step at 2300 lbs.

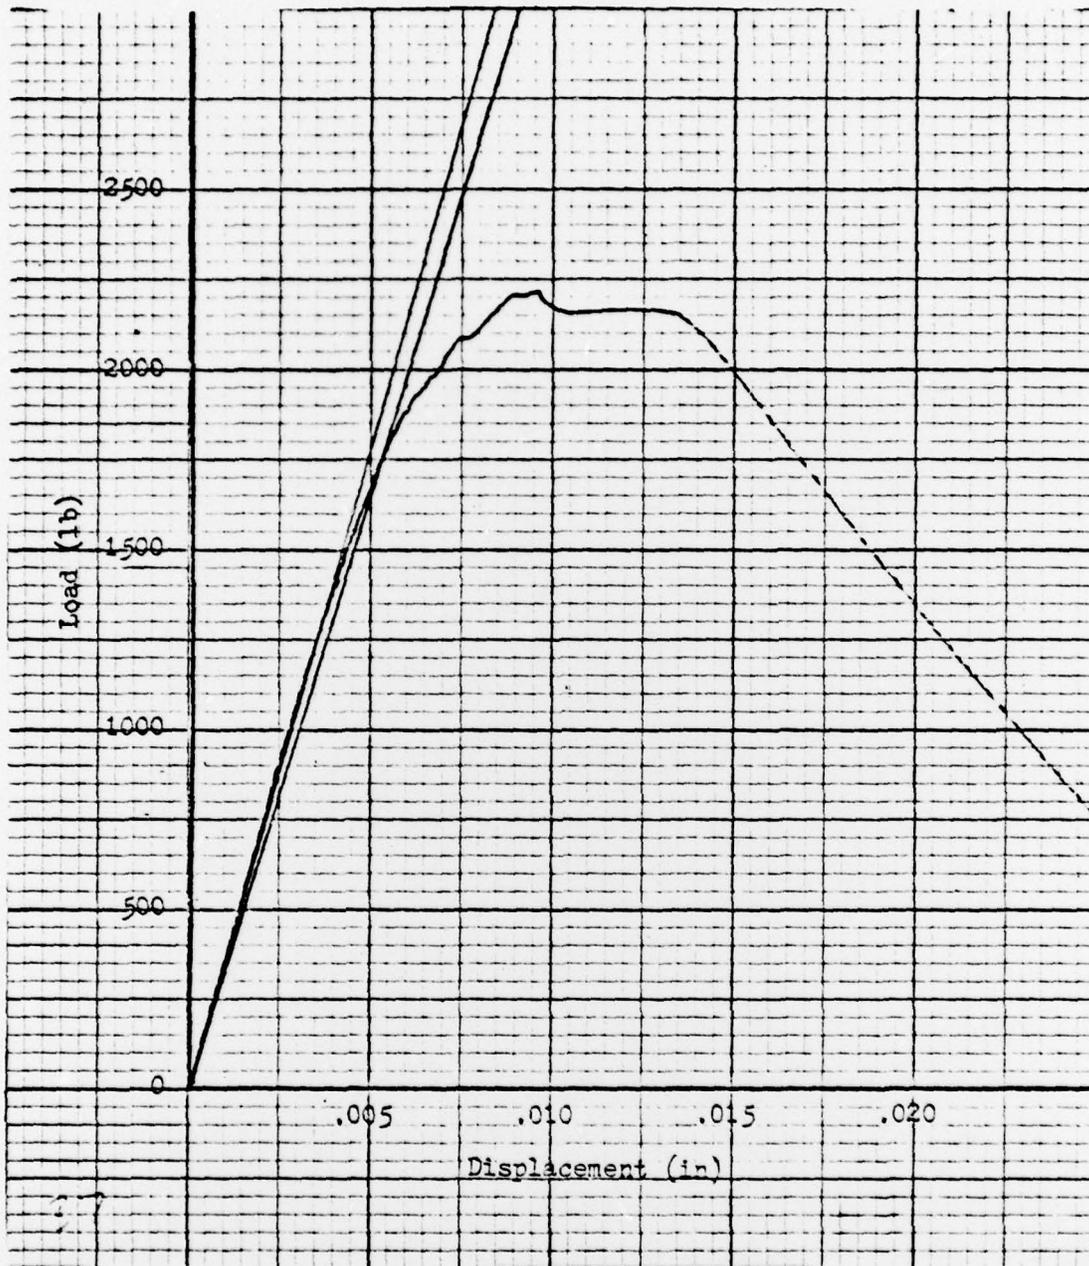
Fig. 27. Graph of 52100 UHC steel test three. This is a Type I record. The results were invalid for  $K_{IC}$ . Crack propagation consisted of a series of small steps.

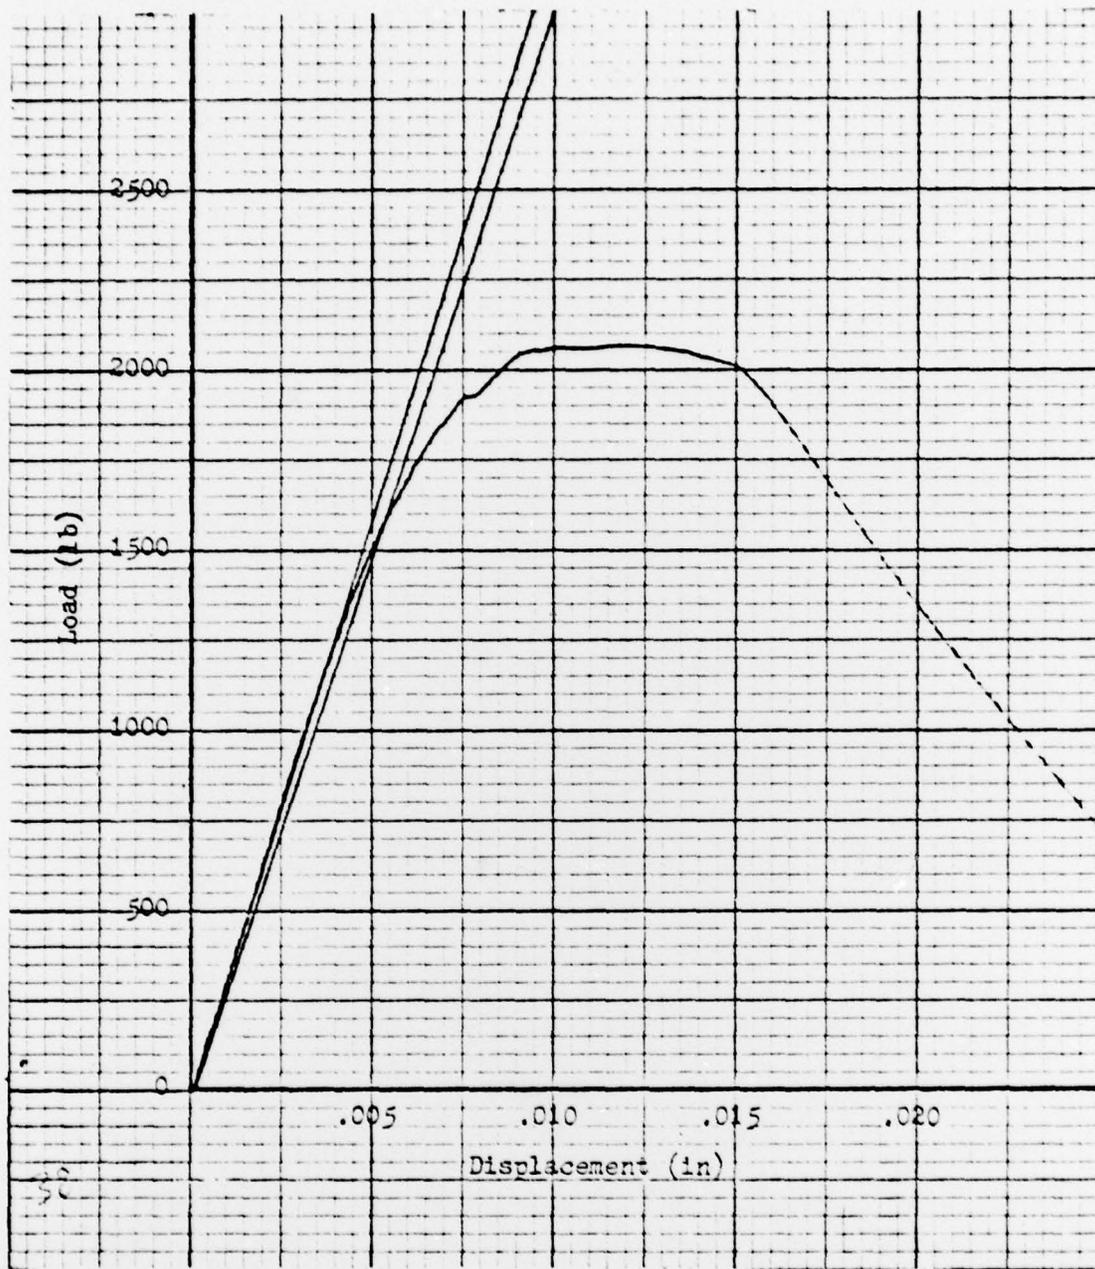
Fig. 28. Graph of 52100 UHC steel test four. This is a Type I record. The results were invalid for  $K_{IC}$ .
