RADC-TR-79-165
Final Technical Report
July 1979

RELIABILITY TEST AND EVALUATION OF MIL-M-38510 LINEAR MICROCIRCUITS

McDonnell Douglas Astronautics Company

ROME AIR DEVELOPMENT CENTER
Air Force Systems Command
Griffiss Air Force Base, New York 13441

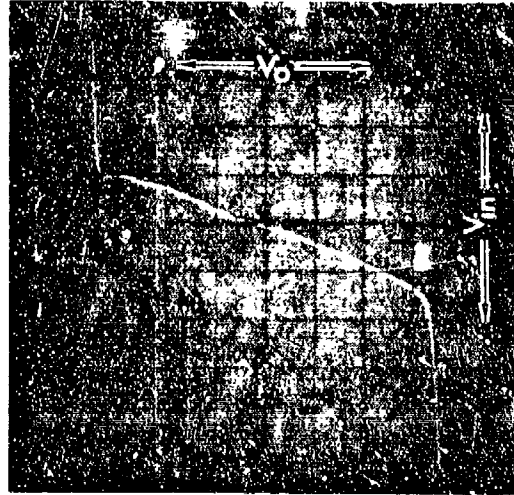
FIGURE 5 . IDEAL OPERATIONAL AMPLIFIER OPEN LOOP GAIN CURVE

The transfer function of the LM108A and LM118 operational amplifiers would ideally be the open-loop gain and would appear as in Figure 5. However, internal thermal effects cause the slope and linearity to change, as can be noted in Figures 6 and 7. In addition to Manufacturer B's LM108A and LM118 devices, the LM111 devices exhibited one or both of these thermal effects. Differences in phase and linearity are caused by thermal gradients which exist between the input and output circuits. These temperature gradients are produced by the

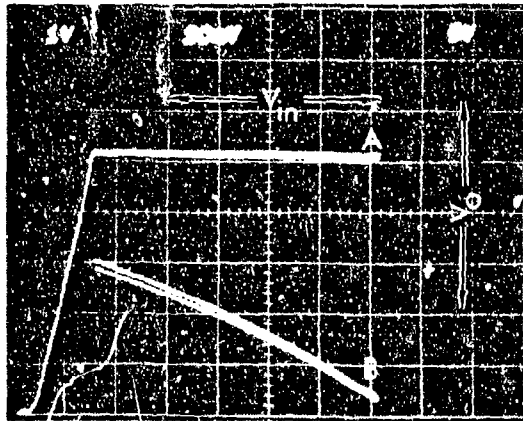
FIGURE 8. TYPICAL VOLTAGE REGULATOR TRANSFER CHARACTERISTIC CURVE

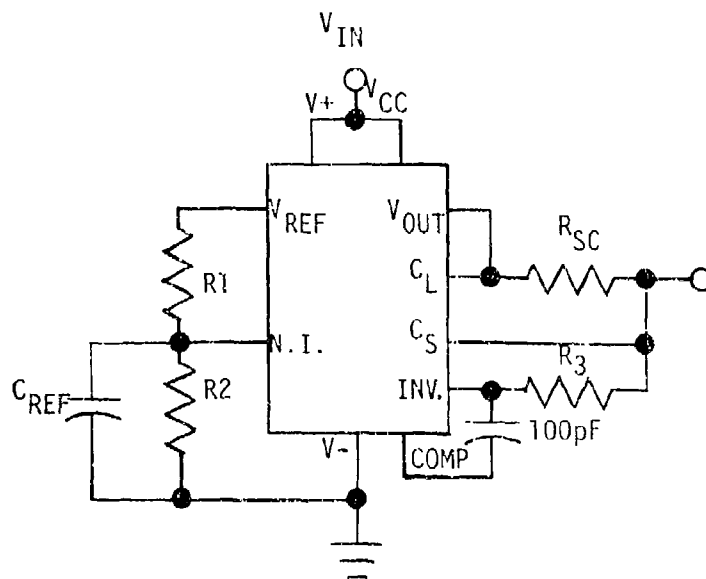
FIGURE 10. 723 APPLICATIONS CIRCUIT

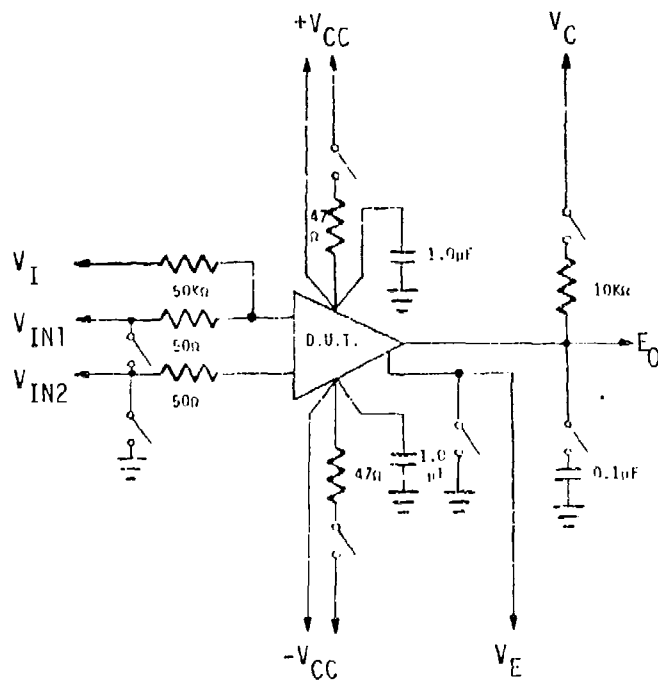
FIGURE 12. LM111 STATIC TEST CIRCUIT FOR I_O , I_G , V_{OL} , I_{CC} AND I_I MEASUREMENTS

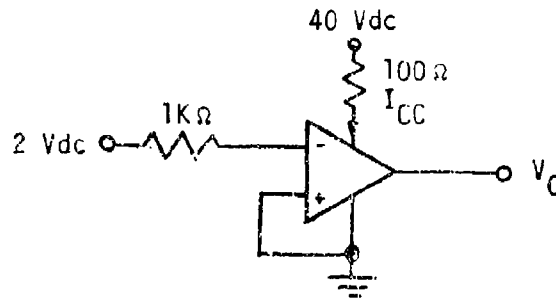
RECOMMENDED AMPLIFIER LIFE TEST CIRCUIT

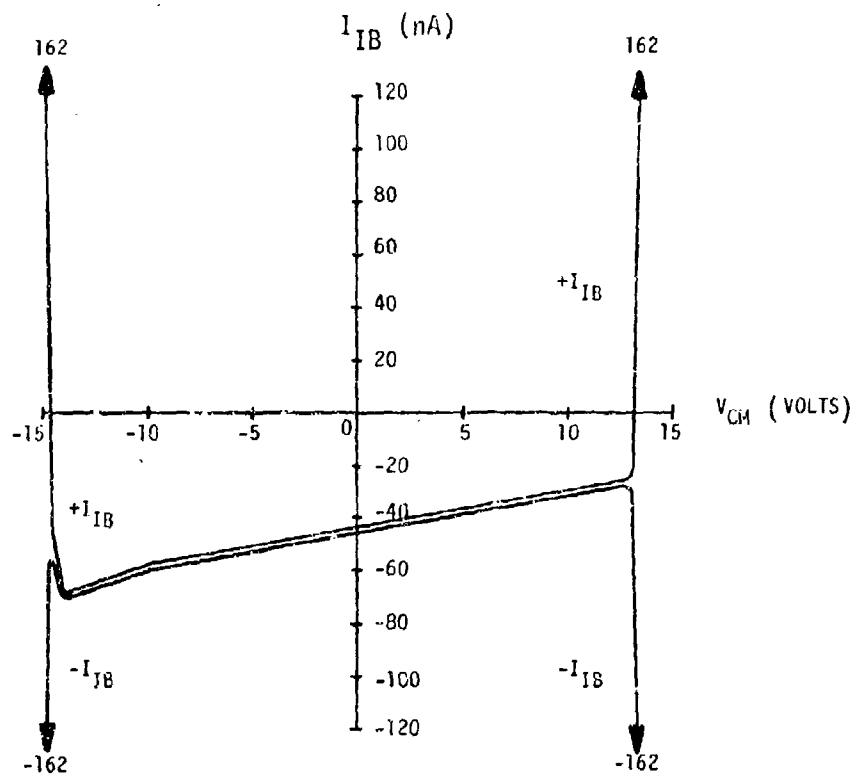
FIGURE 14 . PLOT OF M38510/10304 (LM111) I_{IB} VS. COMMON MODE VOLTAGE (V_{CM})

The MIL-M-38510/10304 (LM111) device was found to exhibit erratic behavior in the extreme common mode voltage regions. Analysis of device operation in these regions showed that electrical tests performed at common mode voltages of -14.5 Vdc and +13 Vdc resulted in device operation at or close to the saturation limits of the input transistors. Figure 14 shows a typical plot of I_{IB} current versus common mode voltage. At common mode voltages of -14.5 and +13 Vdc the device is at or near the point where it is driven into saturation. Thus, the output of the nulling amplifier is also driven into saturation, resulting in a large out-of-tolerance value of I_{IB} . It is suggested that the tests on these devices be modified to common mode voltages of -13.5 Vdc and +12 Vdc.

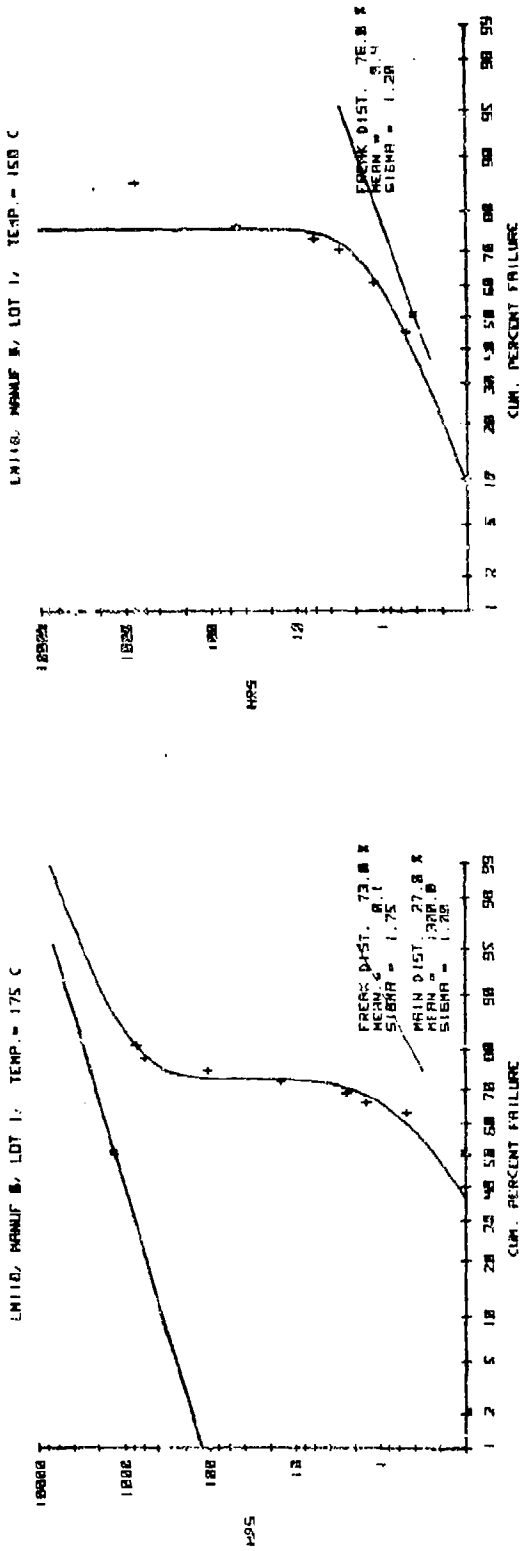
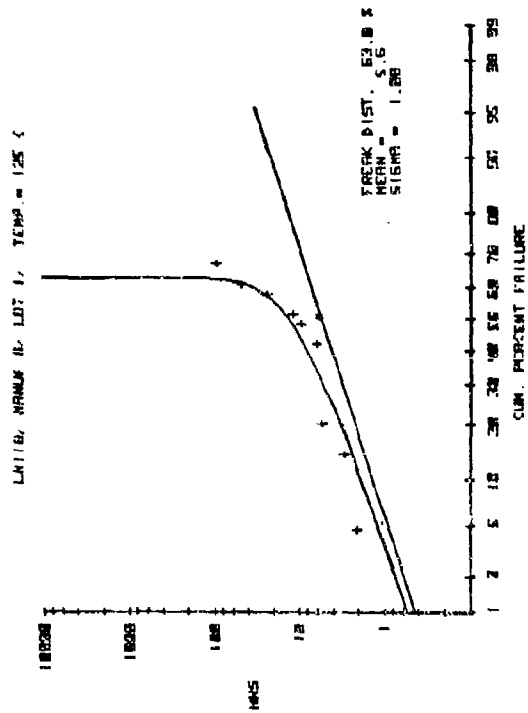
FIGURE 21. MANUFACTURER B LM118 FAILURE DISTRIBUTIONS - RESISTOR TUB INVERSION

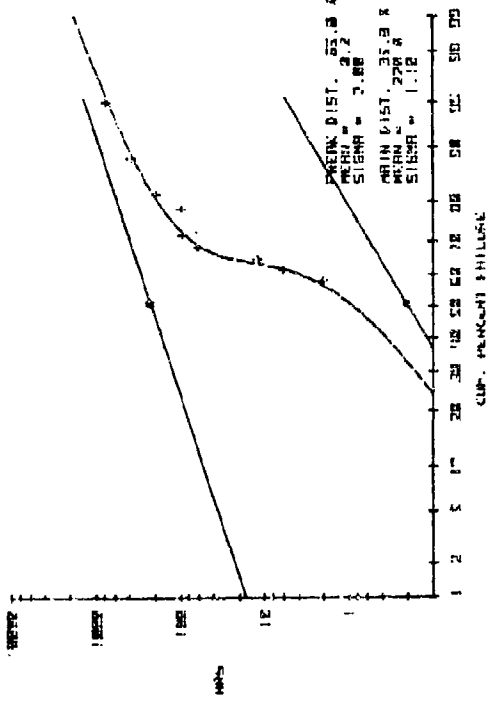
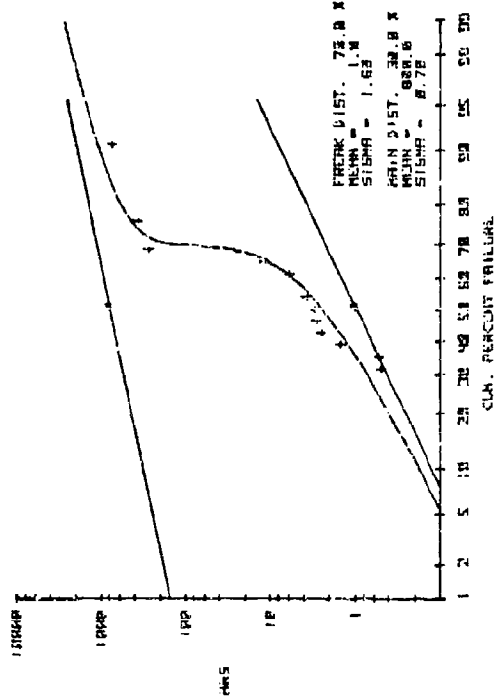
FIGURE 22. MANUFACTURER B 1M108A FAILURE DISTRIBUTIONS - RESISTOR TUB INVERSION

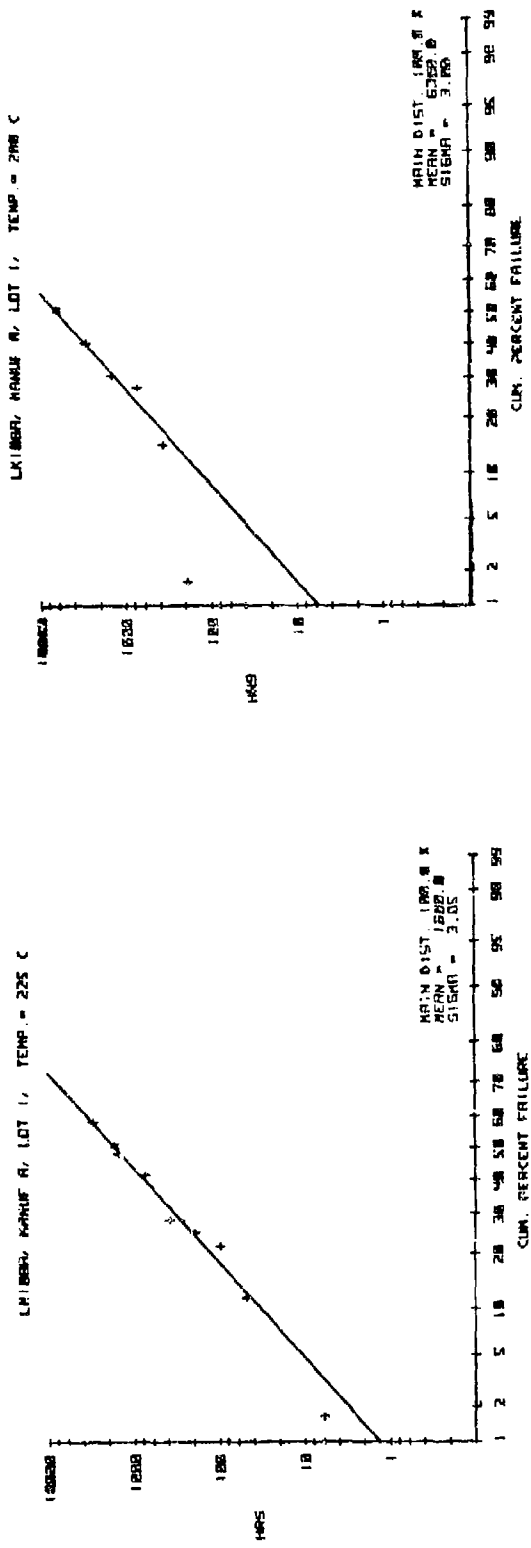
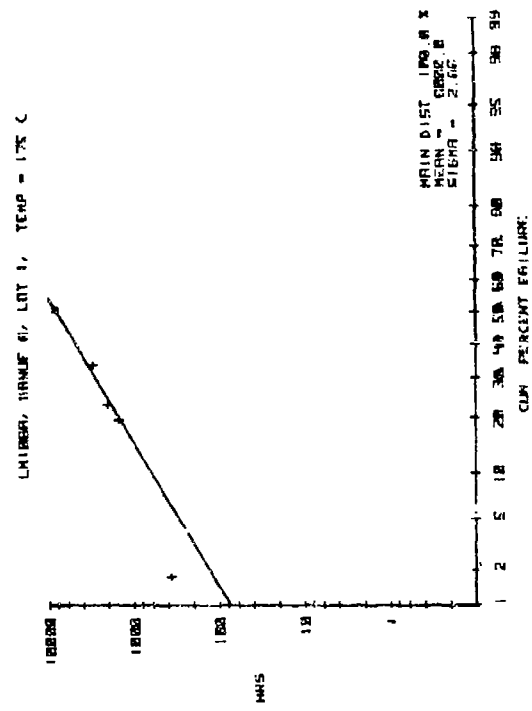
FIGURE 23. MANUFACTURER A LMI08A FAILURE DISTRIBUTIONS- LOCALIZED THERMAL RUNAWAY

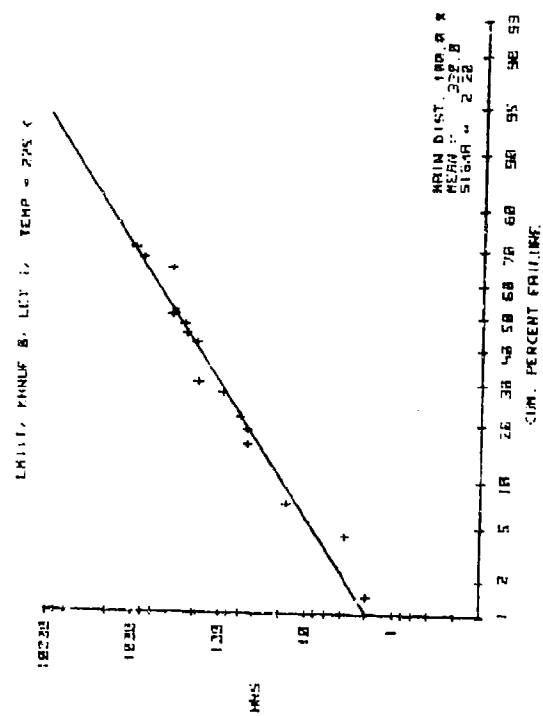
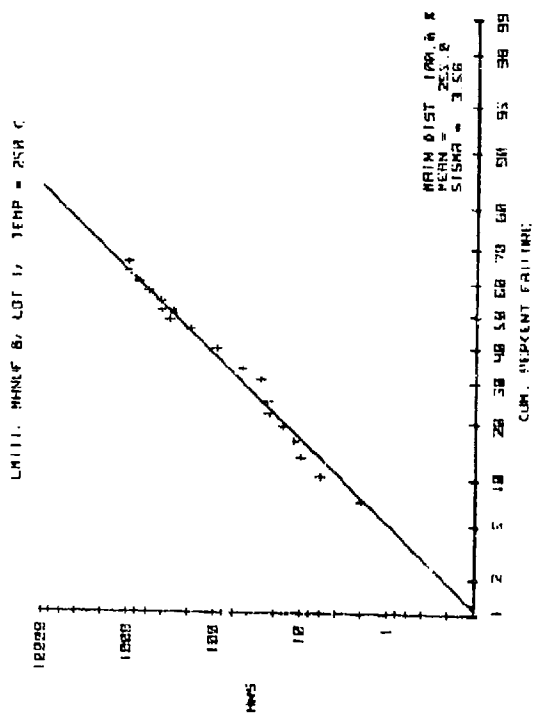
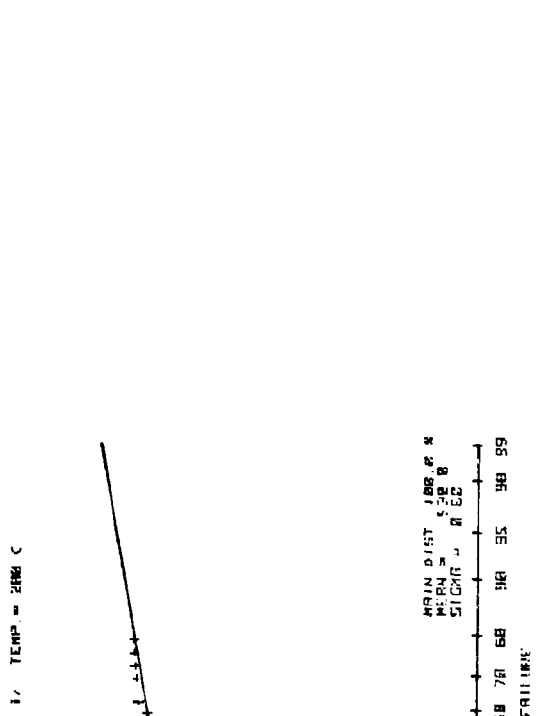
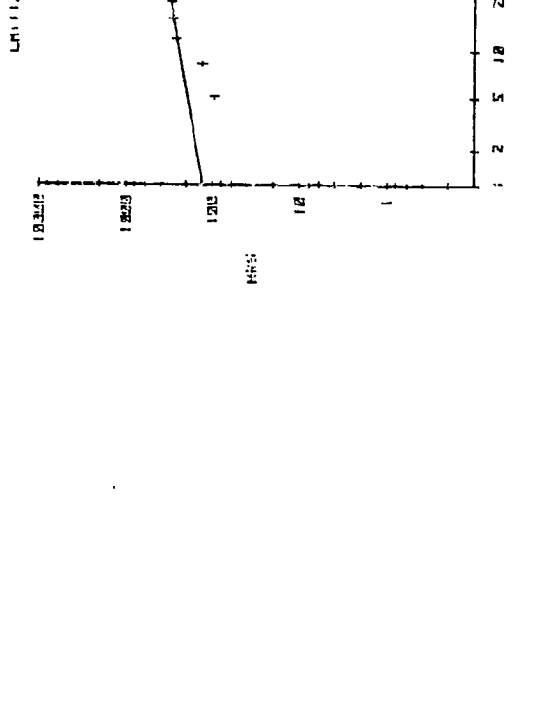
FIGURE 24. MANUFACTURER B LM111 FAILURE DISTRIBUTIONS - SURFACE INSTABILITY & BULK RELATED

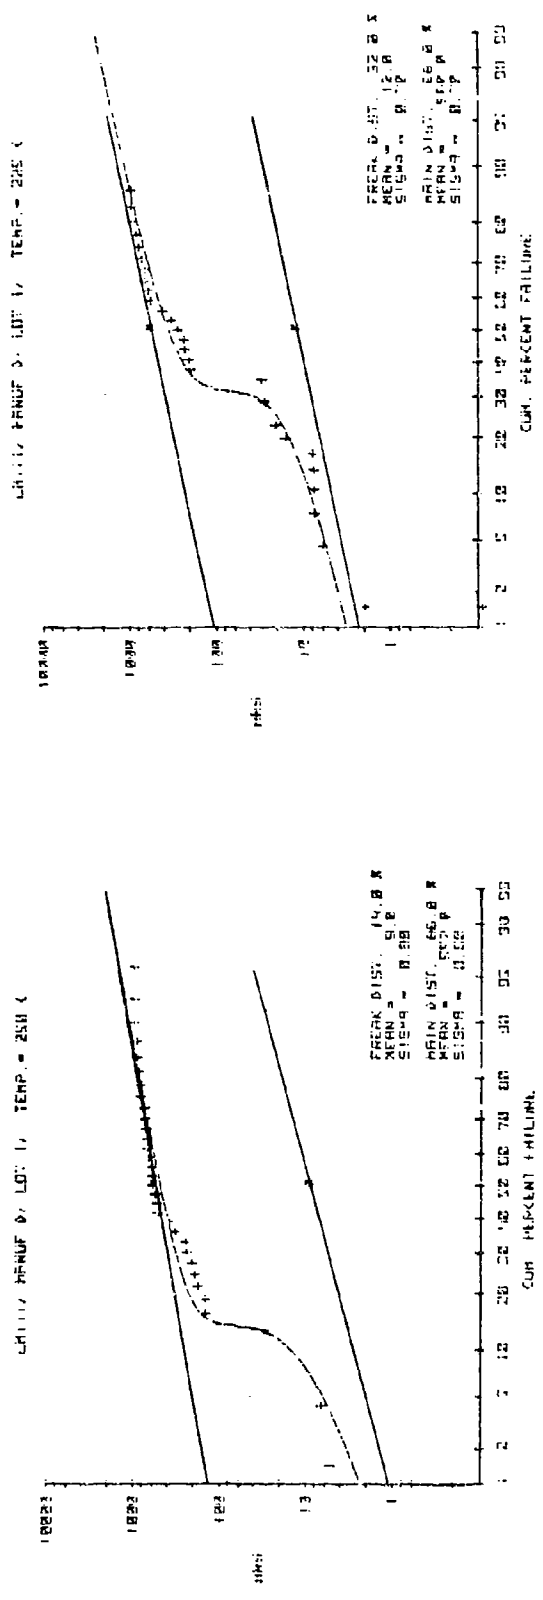
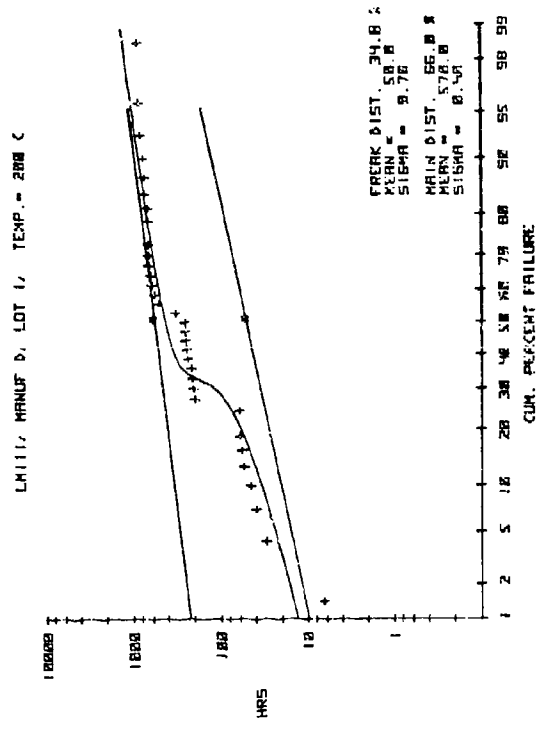
FIGURE 25. MANUFACTURER D LMI11 FAILURE DISTRIBUTIONS - TRANSISTOR BASE INVERSION

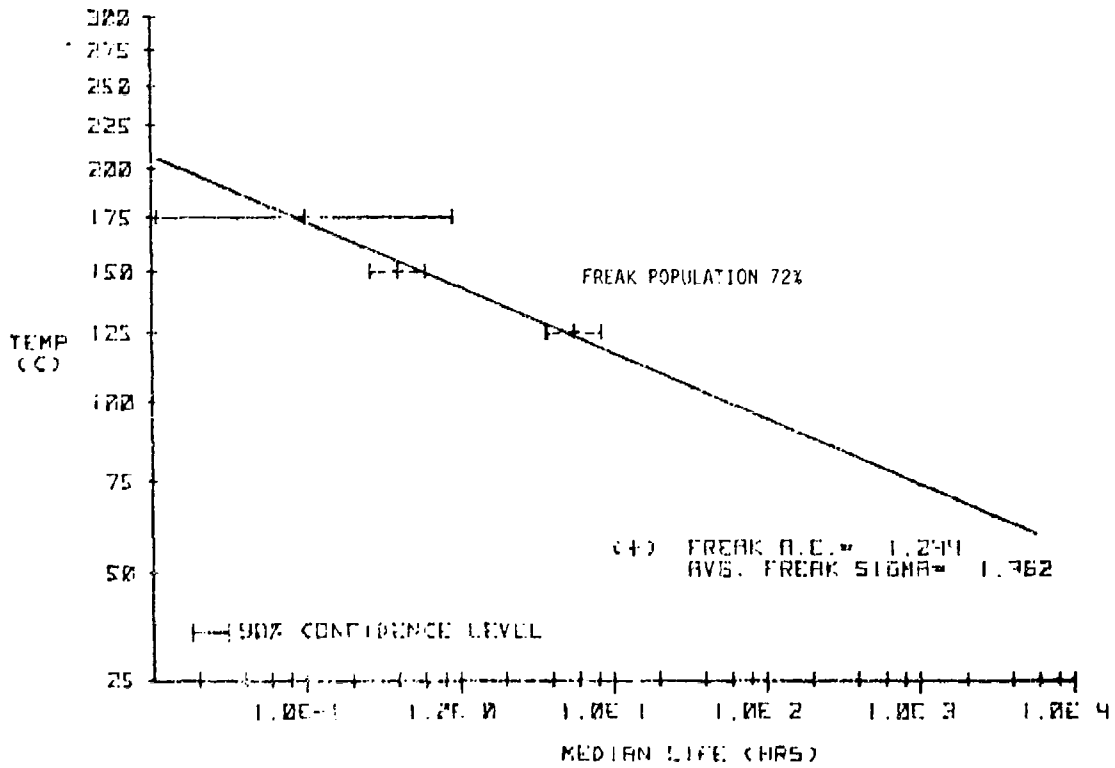
FIGURE 26. MANUFACTURER B LM118 ARRHENIUS PLOT - RESISTOR TUB INVERSION

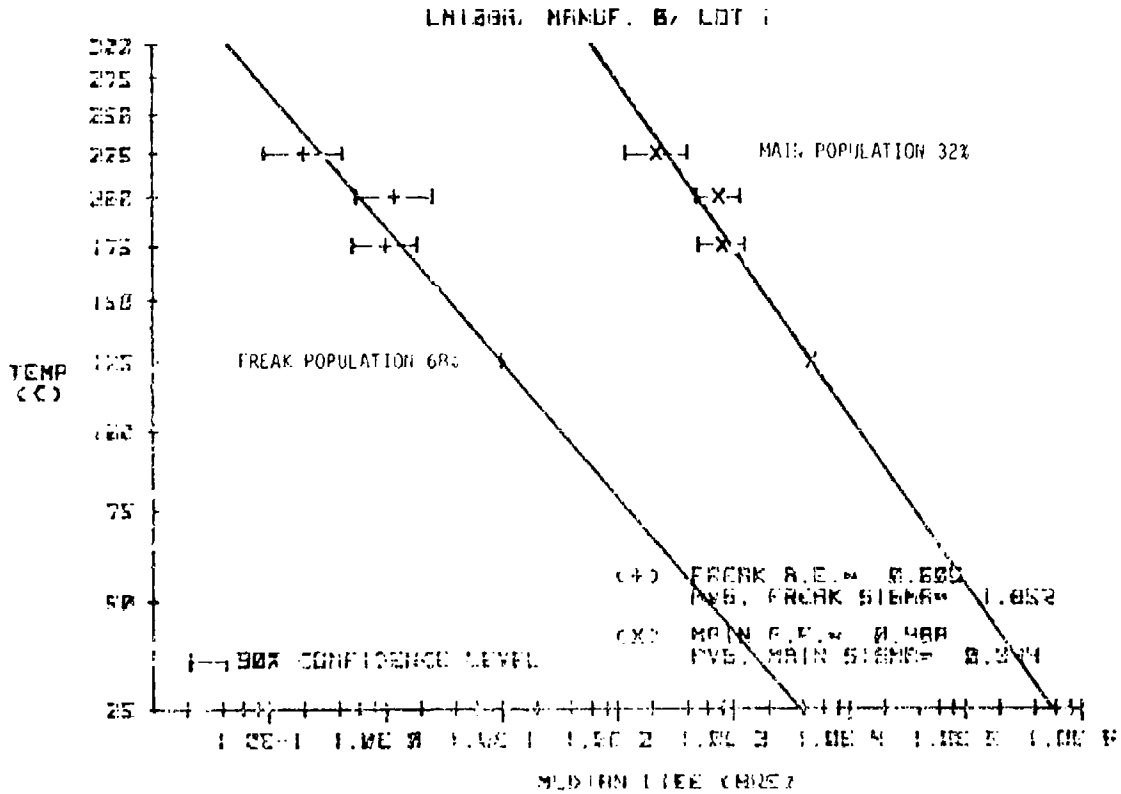
FIGURE 28. MANUFACTURER B LMT09A ARRHENIUS PLOTS - RESISTOR TUB INVERSION

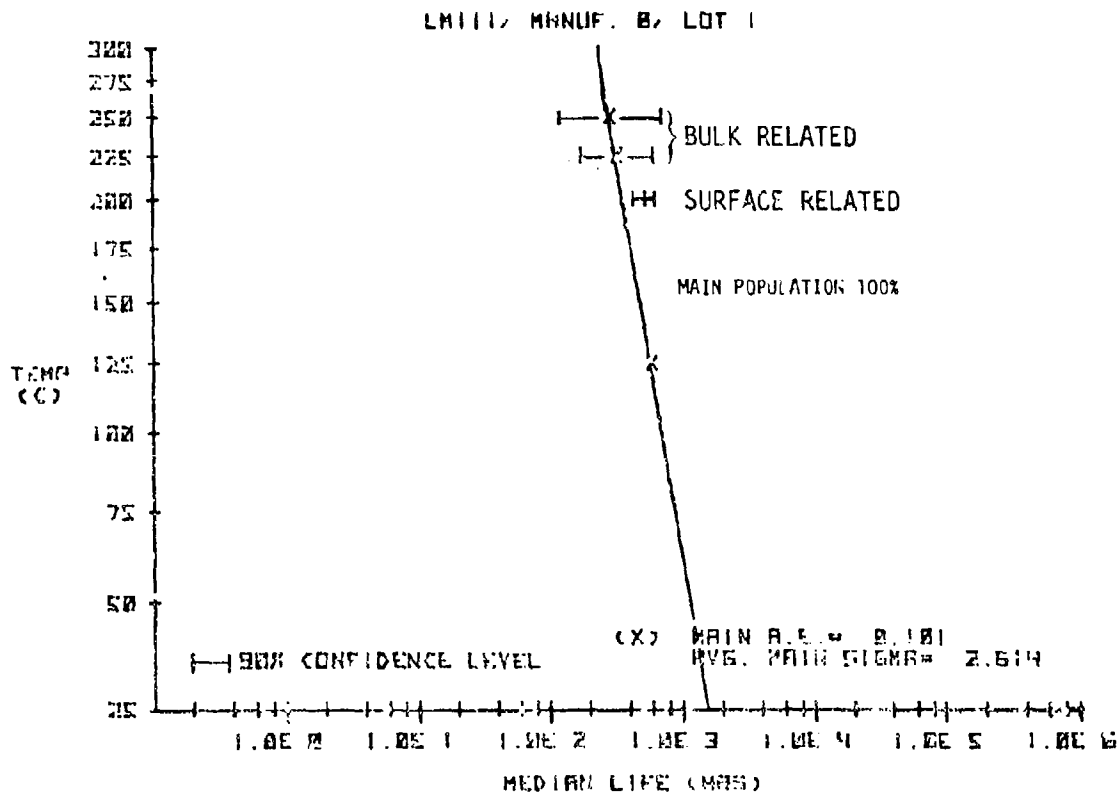
FIGURE 29. MANUFACTURER B LIMIT ARRHENIUS PLOTS - SURFACE
INSTABILITY AND BULK RELATED

8.4.5 Manufacturer D's LM111 Devices - The freak population accounted for an average of 28% of Manufacturer D's LM111 devices and exhibited an activation energy of 0.74 eV as shown in Figure 30. The main population exhibited a very low activation energy of 0.01 eV. This indicates a non-temperature dependent failure mechanism. Approximately 50% of the failures due to this mechanism occurred between the 500 and 1000 hour measurement points at each test temperature. Also, the calculated median lifetimes of the main population at each test temperature were all approximately 600 hours. An examination of the parameter drift data was made in an effort to determine the reason for this low activation energy. The value of the failing parameter (V_{I0}) was plotted versus test time as shown in Figure 31. It was noted that the parameter value would sometimes increase if the device were left on bias at 25°C for a period longer than 24 hours prior to being electrically tested. However, the overall drift of the devices does appear to be independent of temperature. The failure analysis of the devices determined that the mechanism was bake recoverable and that the failures were due to a gain mismatch in the input transistors, most probably caused by ionic contamination. This mechanism is generally time-temperature dependent, but there were no other anomalies that would account for the temperature independent nature of the failures.

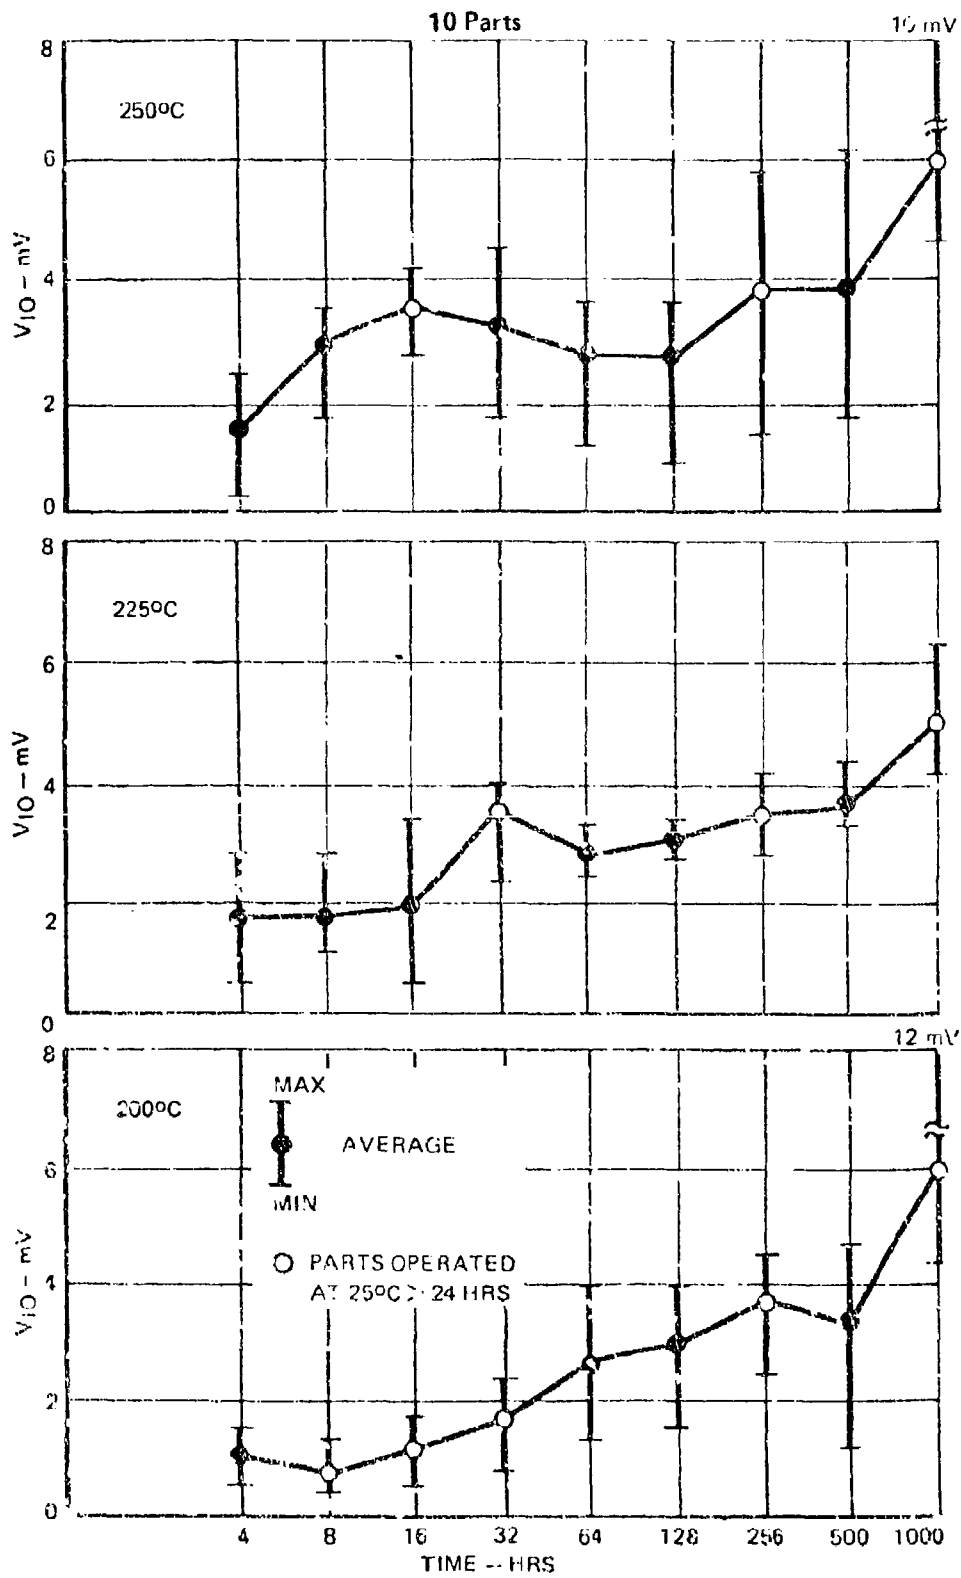
FIGURE 31. MANUFACTURER D LM111 OFFSET VOLTAGE PARAMETER DRIFT

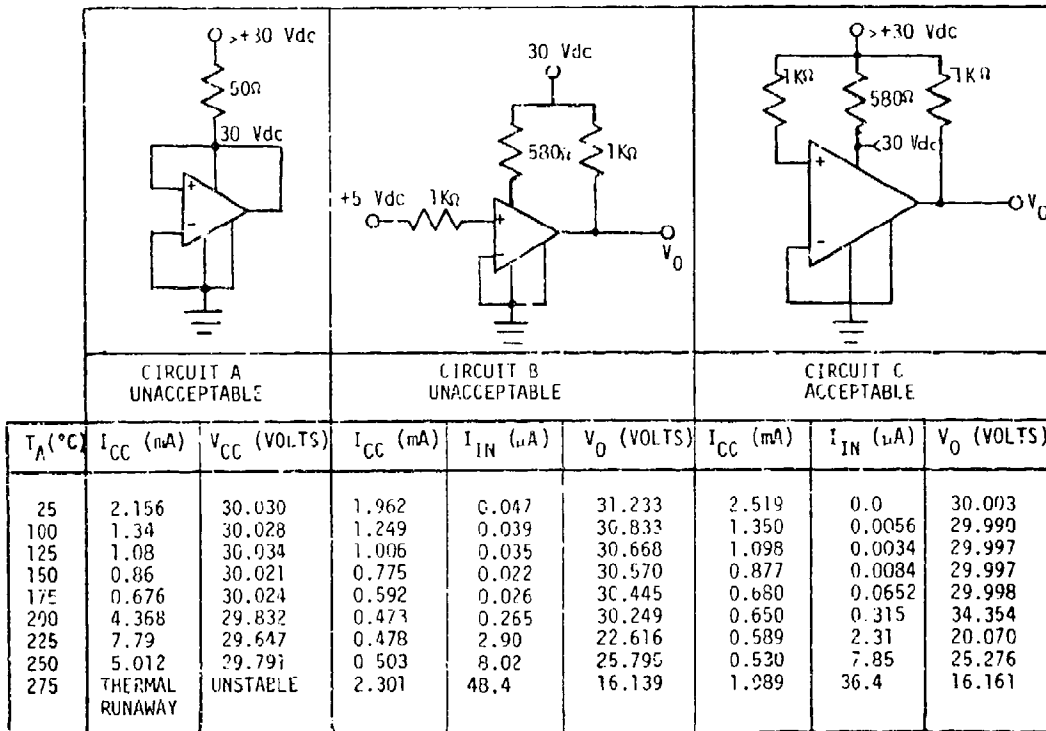
FIGURE D10. MIL-M-38510/10304 (LM111) CANDIDATE BIAS CIRCUITS

Operation of LM111 devices in the MIL-M-38510/103A accelerated life test circuit shown as Circuit A of Figure D10 indicated the circuit was not acceptable for use as an accelerated life test circuit. In this circuit the output was tied directly to V_{CC} , which forced the output to a high state and caused the device to draw excessive current at temperatures above 200°C. The circuit was modified, as shown in Circuit B of Figure D10, to current limit the input and output pins. Although this circuit operated acceptably, the circuit was modified at the request of RADC to apply the maximum voltage stress at the inputs. This circuit was evaluated, Circuit C of Figure D10, and operated satisfactorily up to 250°C. The results of the bias circuit evaluation on this circuit are shown in Figures D11 and D12. However, to maintain the output current to a reasonable level if the device should fail with the output in a low state, the resistor tied to the output was changed from 1K to 5K ohms for life testing. The input current was not sufficient to warrant a current limiting resistor; therefore, it was removed from the positive input (pin two) and this input was connected to V_{CC} at pin eight. The final life test circuit is shown in Figure D13. The life test temperatures were selected to be 250°C, 225°C, and 200°C.

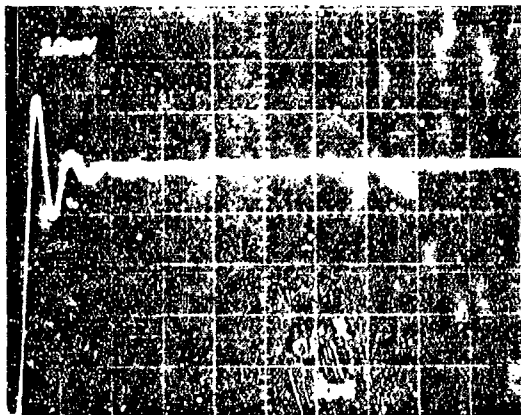
FIGURE E1. TYPICAL CURVE OF NORMAL MANUFACTURER A LM108A TRANSIENT RESPONSE AT 125°C

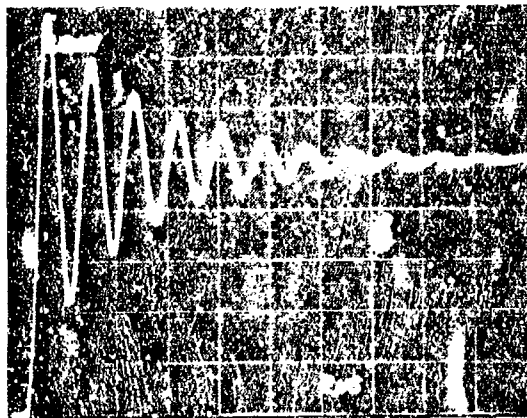
FIGURE E2. CURVE OF MANUFACTURER B LM108A FAILING TRANSIENT RESPONSE TEST AT 125°C

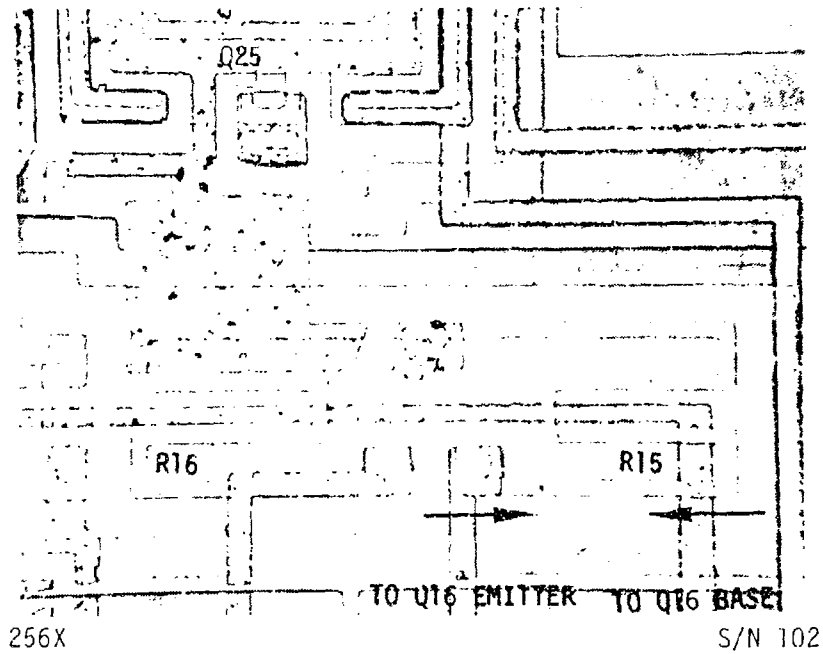
The anomalous leakage was traced to channel leakage from resistors R15 and R16 to the substrate (V-). Figure F4-3 shows R15 and R16 of S/N 102 after severing the stripes for isolation. Figure F4-4 shows the leakage from the common contact to R15 and R16 (+) to the substrate (-). This leakage, amplified by Q25, was primarily responsible for the anomalous current observed between V+ and V-. The pn junction between the resistor diffusion and the n-epi resistor isolation tub and the junction between the tub and the substrate exhibited no leakage and nominal reverse breakdown voltages of 90V and 98V, respectively. This indicated that the leakage from R15/16 to V- was caused by a channel in the tub which extended from the resistors to the substrate due to inversion of the n-type tub. Inversion of n-type material is caused by the accumulation of a net negative charge in or on the passivation layers. To further pin-point the location of the channel, a high potential field effect probe technique [1] was used. A manipulator probe, biased either positively or negatively with respect to the n-tub, was scanned over the region of the tub between the resistor and the substrate isolation diffusion of representative failures (before and after removing the glassivation) while monitoring V_{I0} of the part. It was found that positive potentials of up to 150 volts over any point on the tub did not reverse the inversion and improve V_{I0} . This indicated that the width of the anomalous channel was probably much greater than the diameter of the probe and simply could not be totally pinched off with the probe. Negative potential, as low as -75V, would affect V_{I0} . The area of greatest sensitivity was found to be along the outside of resistor R15, between the stripe to the emitter of Q16 and the stripe to the base of Q15 (see Figure F4-3). V_{I0} would latch negative at a probe potential of -125 volts above the tub along this area. This is because the negative field enhanced the inversion thereby increasing the conductance of the channel. Negative potential applied above the tub anywhere along the outside of R15 would worsen V_{I0} to some degree which indicated that the channel was distributed along the entire length of R15. A channel also existed along the

FIGURE F4-3. R15 AND R16 AFTER REMOVAL OF THE GLASSIVATION AND STRIPE SEVERING

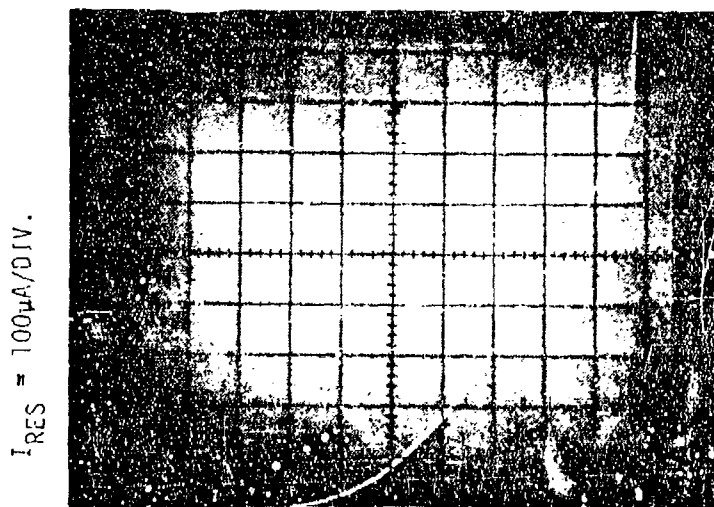
FIGURE F4-4. I-V CHARACTERISTIC FROM R15-R16 TO THE SUBSTRATE OF S/N 102

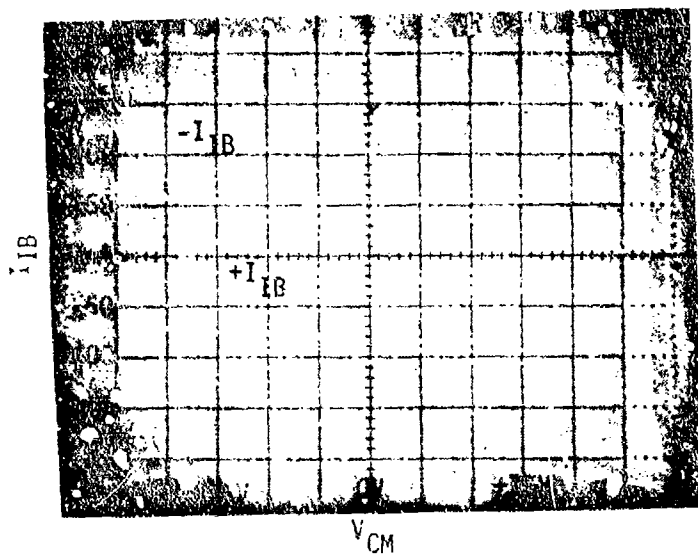
FIGURE F4-10. $+I_{IB}$ AND $-I_{IB}$ VS. V_{CM} OF A PART (S/N 174) THAT HAD FAILED 110 DUE TO LOW $+I_{IB}$ AFTER 1,000 HRS AT 150°C

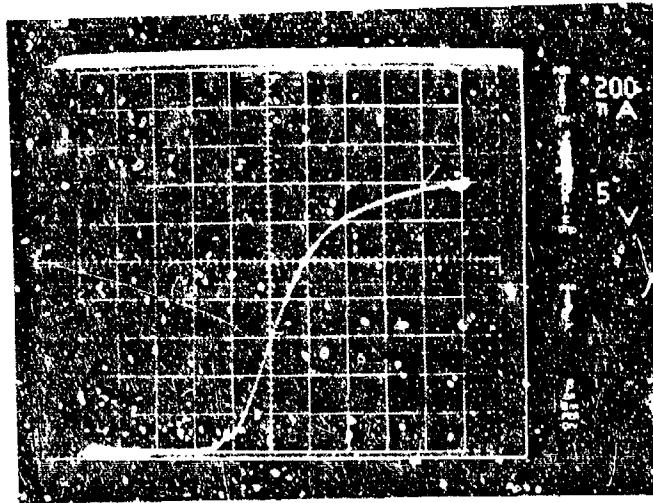
FIGURE F4-12. I-V CHARACTERISTIC FROM V_+ TO PIN 3 WITH V_- AND PIN 2 GROUNDED OF A PART (S/N 175) THAT HAD FAILED I_{10} DUE TO NEGATIVE $+I_{IB}$ AFTER 1,000 HRS AT 150 C

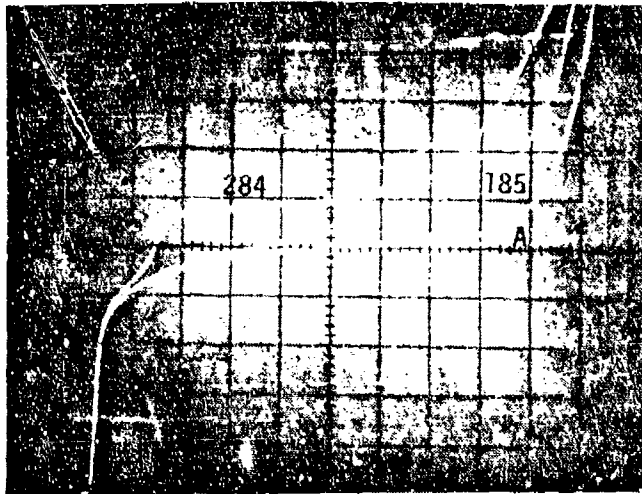
FIGURE E5-1. I-V CHARACTERISTICS FROM V_+ TO V_- OF A NORMAL PART (S/N A) AND OF TWO PARTS THAT HAD FAILED V_{10} (S/Ns 185 AND 284)

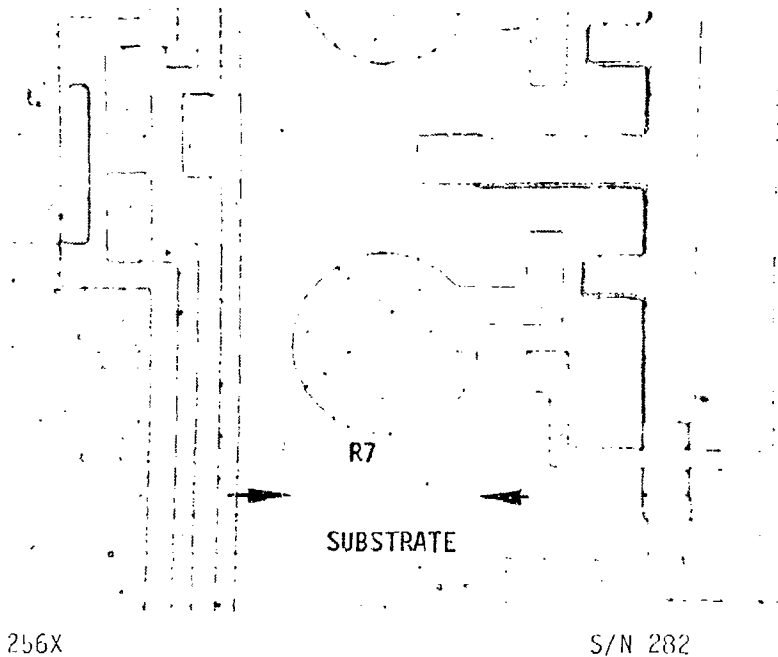
FIGURE E5-2. RESISTOR R7 SHOWING THE REGION OF ANOMALOUS CURRENT (ARROWS) AS DETERMINED VIA THE VOLTAGE PROBE.

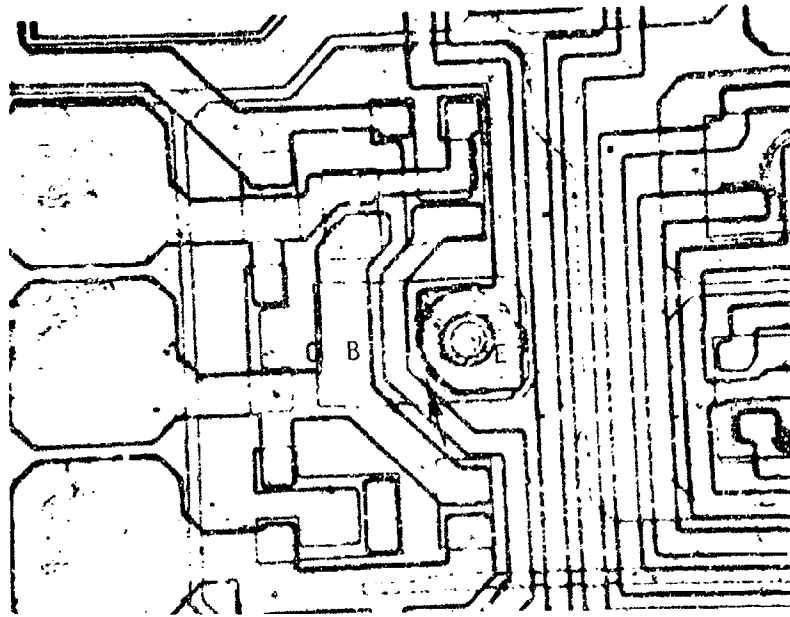
Q6 is a lateral PNP transistor. The failed Q6 transistors almost always contained an aluminum-silicon melt-channel or an aluminum spear extending from the emitter contact, indicative of excessive emitter current. The emitter of Q6 is connected directly to V+, but its collector-base is connected to circuitry of sufficient impedance to limit the collector current. However, a lateral parasitic PNP transistor exists between the emitter of Q6 and the substrate. As shown in Figure F5-10, the base current, I_B , of Q6 can cause a slight parasitic PNP collector current, I_{CP} , to flow from the Q6 emitter to V-. At elevated temperature, this current can possibly increase to damaging levels since there is no series limiting resistance for the parasitic current path. The path of damage emanating from the Q6 emitter always pointed in the direction of the c-b contact (the direction of base current flow), as illustrated in Figure F5-11, indicating that the damage probably was the result of excessive parasitic PNP collector current. Transistor Q6 is adjacent to three "zappable" transistors, Q29, Q30, and Q31, that are used to trim the offset voltage. However, in many of the failed parts, none of the three transistors had been zapped; therefore, the proximity of Q6 to these transistors was not considered significant.

FIGURE F5-10. CROSS-SECTIONAL SKETCH OF Q6

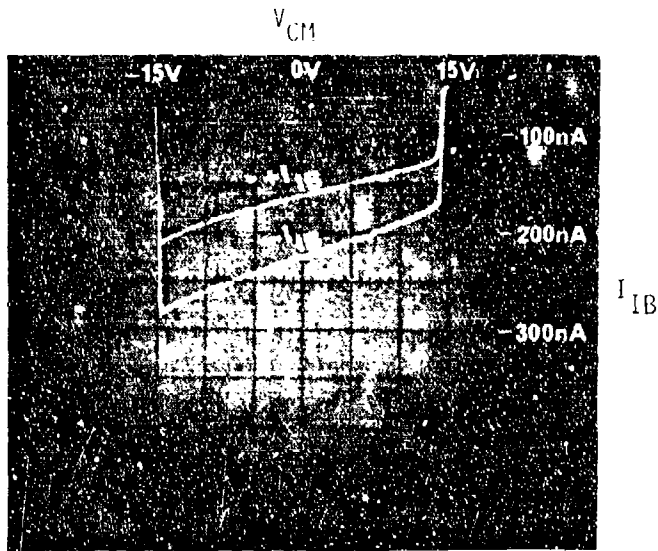
S/N 265 (500 HRS @ 225°C)

FIGURE F8-1 - $+I_{IB}$ AND $-I_{IB}$ (RAISED) VS. COMMON MODE VOLTAGE OF A PART WITH EXCESSIVE $I_{IO(R)}$

Analysis of parts with positive excessive I_{IO(R)} established that the failures were caused by a gain mismatch in the PNP input transistors. The input bias currents are the base currents of the PNP input transistors Q1 and Q2. +I_{IB} is the quotient of h_{FE} of Q1, the noninverting input transistor, and I_C of Q1 (+I_{IB} = I_{C1}/h_{FE}). Likewise, -I_{IB} is the quotient of h_{FE} of Q2, the inverting input transistor, and I_C of Q2 (-I_{IB} = I_{C2}/h_{FE}). Die level probing of representative failures established that the collector currents of Q1 and Q2 were equal, but that h_{FE} of Q2 was lower than h_{FE} of Q1, as shown in Table F8-2, which is why -I_{IB(R)} was greater than +I_{IB(R)}. To determine what change took place during life test, the test data was examined. +I_{IB(R)} and -I_{IB(R)} were not measured during the tests (they are not specified parameters), but +I_{IB}[12] and -I_{IB}[12] were measured. +I_{IB}[12] and -I_{IB}[12] are the input bias currents at $\pm V = \pm 15V$ and V_{CM} = 0 volts with BAL and BAL/STB open (dc wise). As shown in Table F8-3, the values of +I_{IB}[12] and -I_{IB}[12] of the representative failure before and after accelerated life indicate that the gain of both transistors decreased during life, but that h_{FE} OF Q2 decreased more than did h_{FE} of Q1.

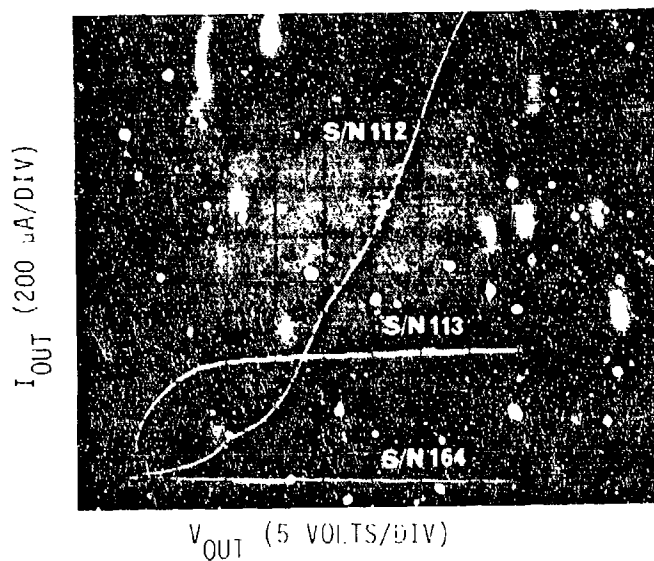
FIGURE F8-2 - I-V CHARACTERISTIC FROM OUTPUT (+ ON PIN 7) TO SUBSTRATE (- ON PIN 4) OF THE THREE PARTS WHICH HAD FAILED

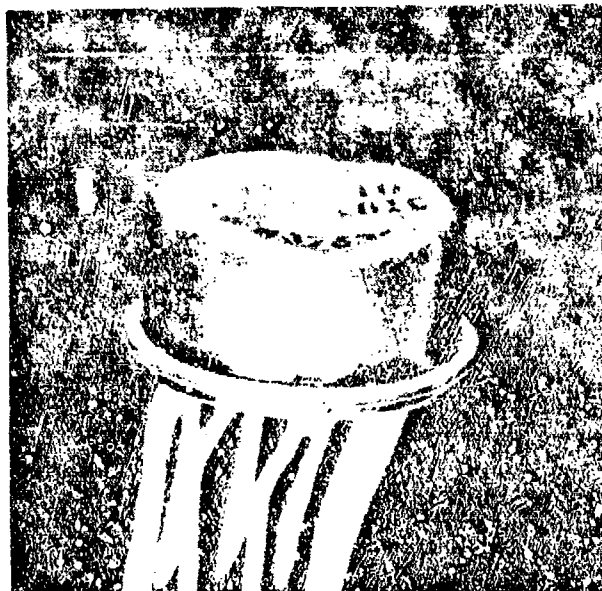
Upon receipt at MDAC-St. Louis, all devices were subjected to external visual examinations, hermeticity test, and electrical test. During these tests, five of Manufacturer D's MIL-M-38510/10201 JAN qualified devices were found to be defective. Two devices were rejected during the visual inspection test. Shown in Figure G1 is a device which has been physically damaged and in Figure G2 a device is shown with a cavity in the package base. During the fine leak hermeticity tests one device failed with a leak rate of 2.0×10^{-6} atm cc/sec. Initial data taken at 25°C, +125°C and -55°C is shown in Figure G3 for the two devices (S/N 301 and S/N 302) which did not meet the electrical specifications. No further data was taken on any of the five failed devices.

FIGURE G1. DAMAGED M38510/10201
