**PARTICLE IMPACT DAMAGE
IN SILICON NITRIDE**

Annual Report — Part III

May 1979

By: K. C. Dao, D. A. Shockey, L. Seaman,
D. R. Curran, and D. J. Rowcliffe

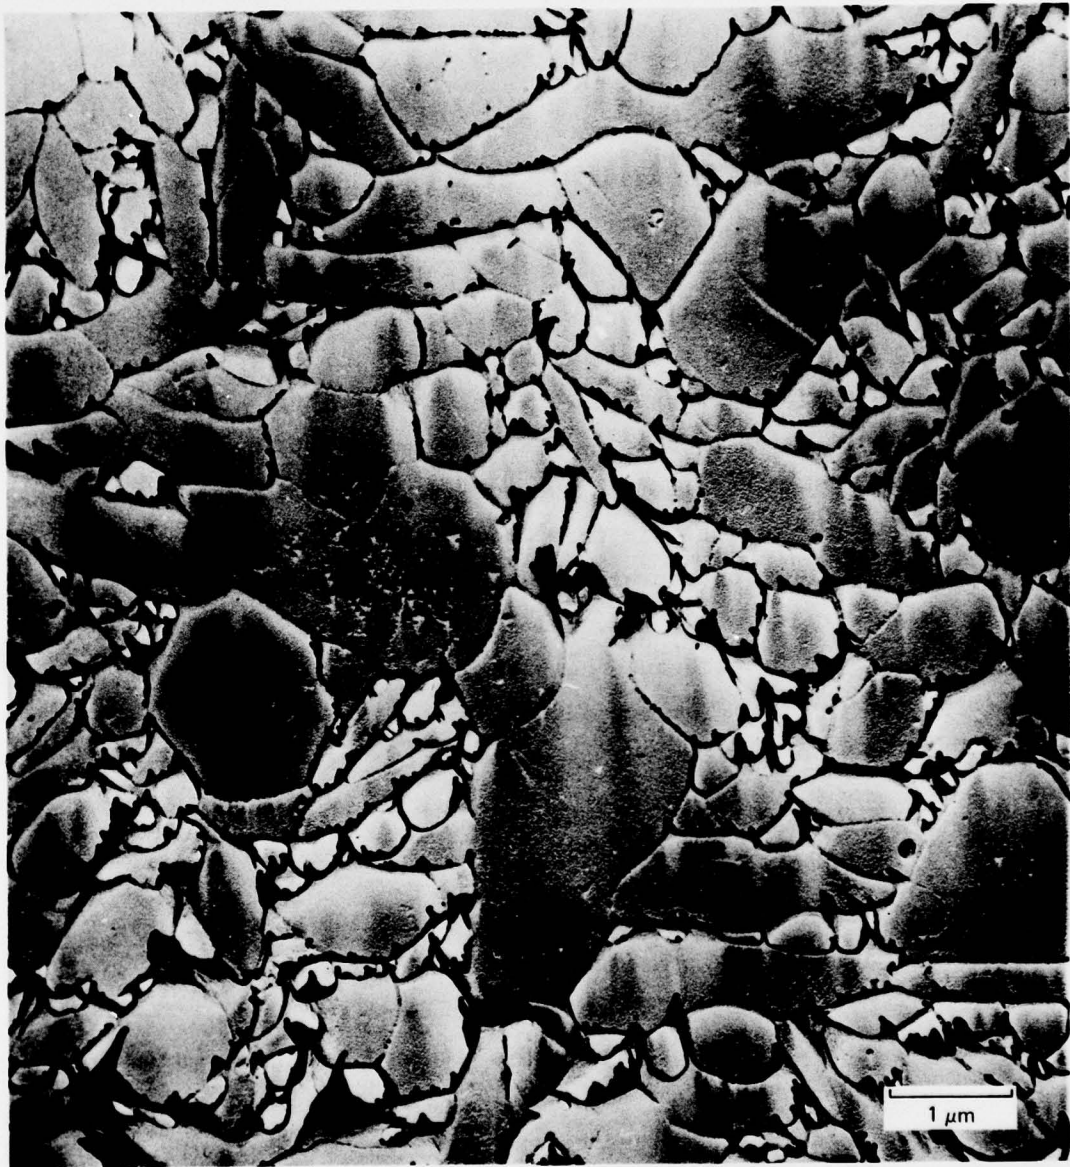
MP-4928-71

FIGURE 1 MICROSTRUCTURE OF HOT PRESSED SILICON NITRIDE

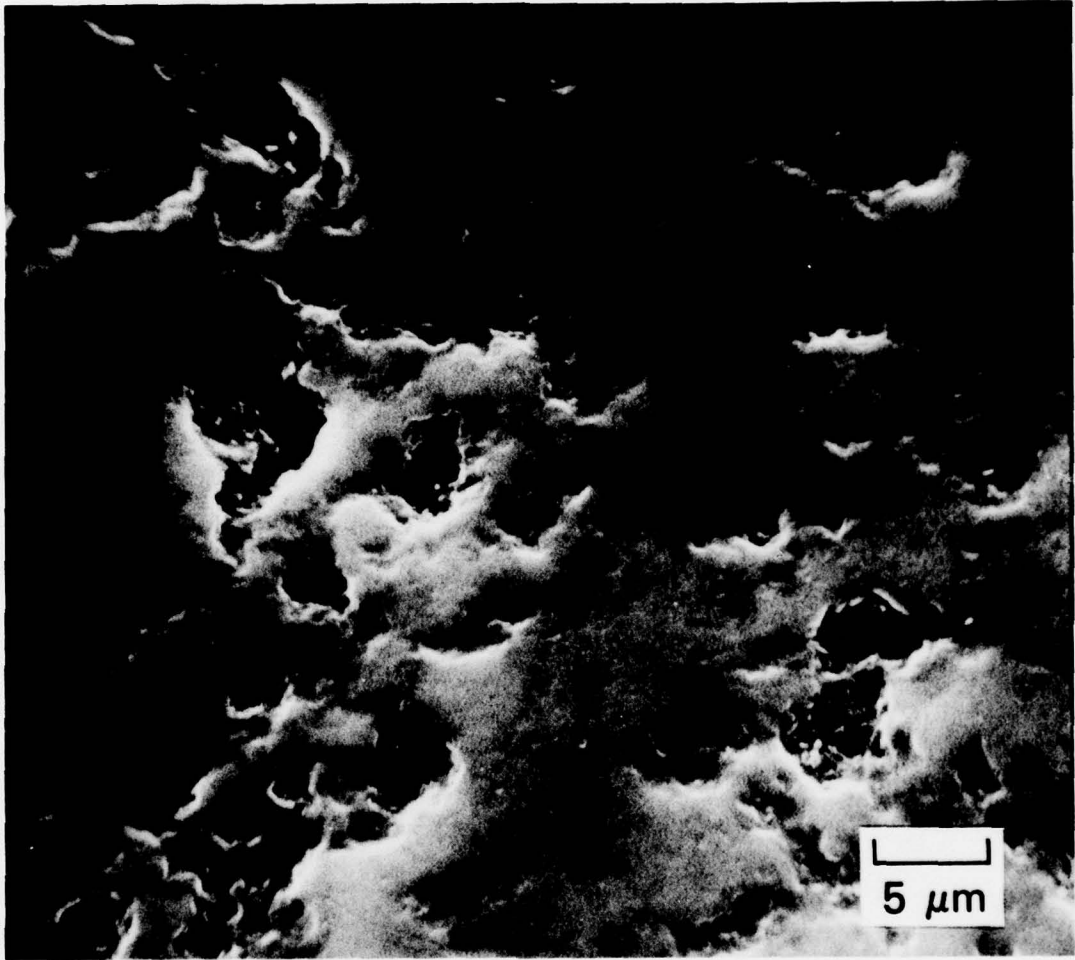
MP-4928-72

Reaction bonded silicon nitride (RB Si_3N_4), NC350, was obtained from the Norton Company in the form of a disc approximately 22.5 cm in diameter by 6 cm thick. Test specimens were polished to a 1- μm particle finish. A scanning electron micrograph of the microstructure at the specimen surface is shown in Figure 2. Density and pore size distribution were measured using a mercury porosimeter; the results are shown in Figure 3. The density was 2.65 g/cm^3 , which is 84.5% of the theoretical value. The pore size ranged from 0.01 to 0.1 μm , with the mean close to 0.05 μm . X-ray diffraction studies identified α - and β - Si_3N_4 with no other second phases. A comparison of peak intensities showed the material to consist of approximately 60% α - Si_3N_4 and 40% β - Si_3N_4 .

FIGURE 2 MICROSTRUCTURE OF REACTION BONDED SILICON NITRIDE

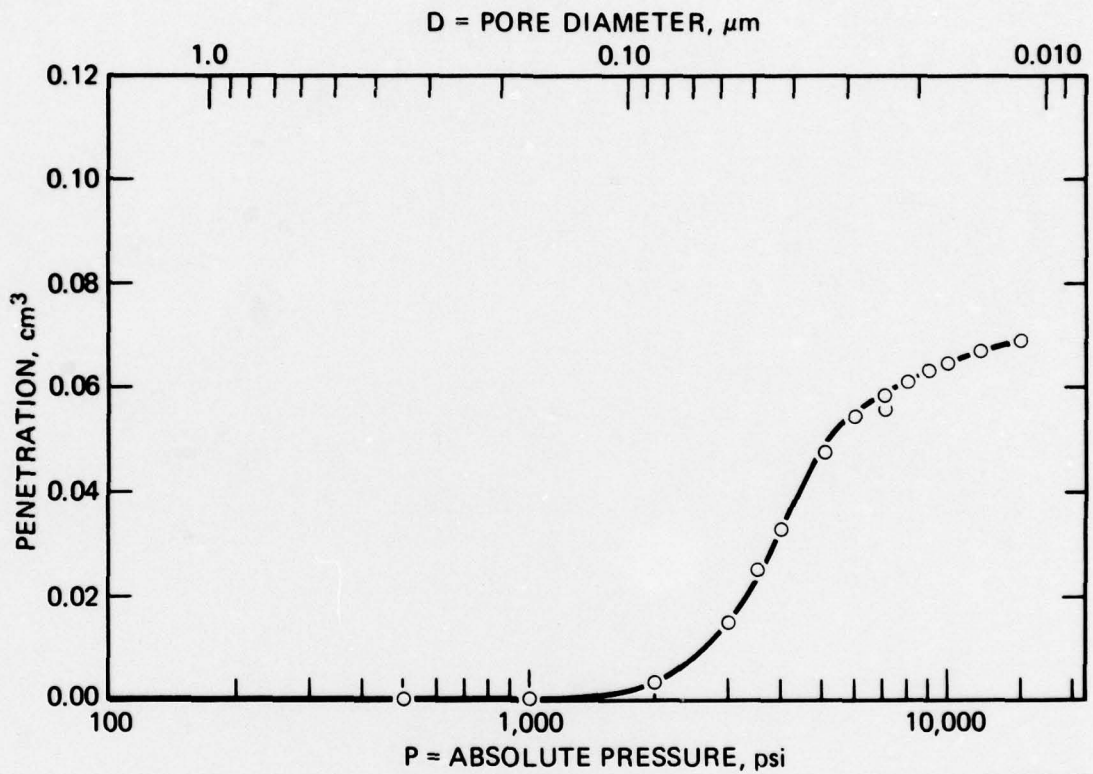
MA-4928-73

FIGURE 3 PORE SIZE DISTRIBUTION IN REACTION BONDED SILICON NITRIDE (PENETRATION IS A DIRECT MEASURE OF VOLUME FRACTION OF PORES AND MAXIMUM PENETRATION, ABOUT 0.07 cm^3 CORRESPONDS TO VOLUME FRACTION OF ALL PORES, 0.155)

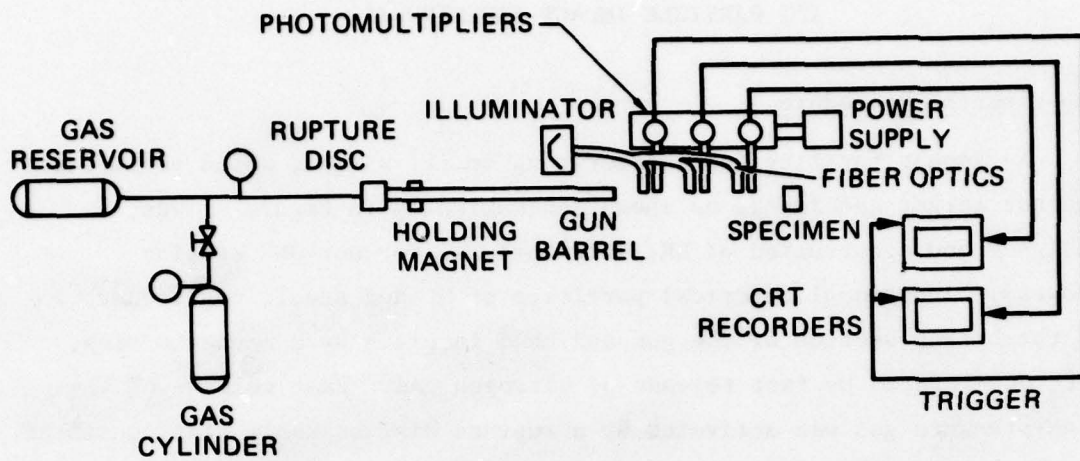
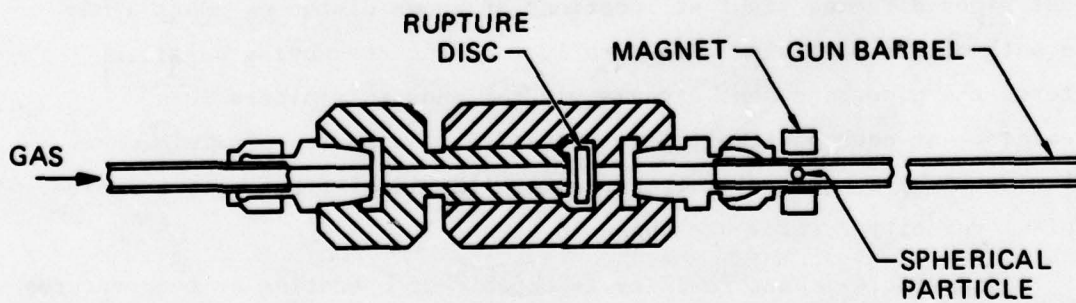
MA-4928-88

An impact facility for accelerating small, single, solid particles against target specimens, as shown schematically in Figure 4, was designed and constructed at SRI International for our ONR erosion program. Individual spherical particles of WC and steel, positioned in the breech section of the gun and held in place by a magnetic ring, were accelerated by fast release of nitrogen gas. Fast release of the high-pressure gas was activated by a rupture disc assembly that consisted essentially of a thin disc located in a two-part chamber, Figure 4(b). The gas pressure was allowed to build up on one side of the chamber. At a desired pressure, the disc ruptured, dumping the gas to the side where the particle was initially at rest. The expansion of the gas was rapid and the particle was propelled to high velocities. The disc material and thickness were varied to provide a wide range of velocity.

(a) SCHEMATIC OF THE FACILITY

(b) DETAIL OF RUPTURE DISC ASSEMBLY FOR FAST RELEASE OF GAS

The impact and rebound velocities were measured by a system of three photomultipliers, each consisting of a photosensitive element located in a housing that was connected to a light pipe. The three light pipes directed light at locations of known distances apart along the path of the particle. Light reflected from the moving particle entered the pipes and sent signals via the photomultipliers to a recorder. At each photomultiplier location, the moving particle was illuminated by a common light source via individual fiber optics cables. Typical velocity records are shown in Figure 5.

The particle-impact facility is capable of operating at temperatures from ambient to 1500°C and at velocities from 13 to 700 m/s. Maximum impact velocity depends on particle size. Velocities higher than 700 m/s can be obtained by higher gas pressures and improved gas-release devices. Particles of the following diameters can be accelerated in the facility:

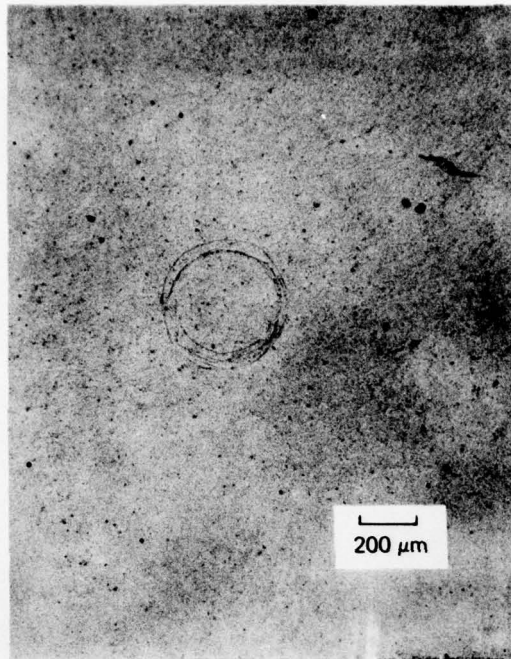
MP-4928-31

FIGURE 6 TYPICAL IMPACT DAMAGE IN HP Si_3N_4 BY 2.4-mm-DIAMETER STEEL SPHERES (Impact Configuration A)

(a) 19.5 m/s

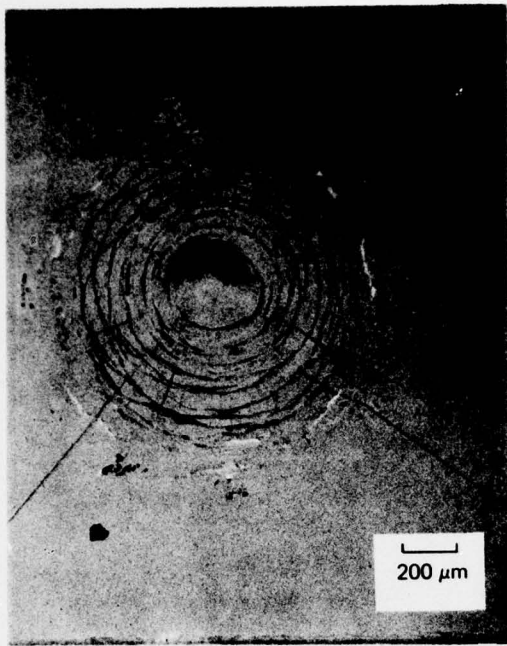
MP-4928-33

FIGURE 7 TYPICAL IMPACT DAMAGE IN HP Si_3N_4 BY 2.4-mm-DIAMETER WC SPHERES (Impact Configuration B)

(e) 121 m/s

The cracking sequence in the HP Si_3N_4 substrate was similar to that observed for the unoxidized material under similar impact conditions (compare Figures 7 and 18). The crack size distributions are compared quantitatively in Section VII.

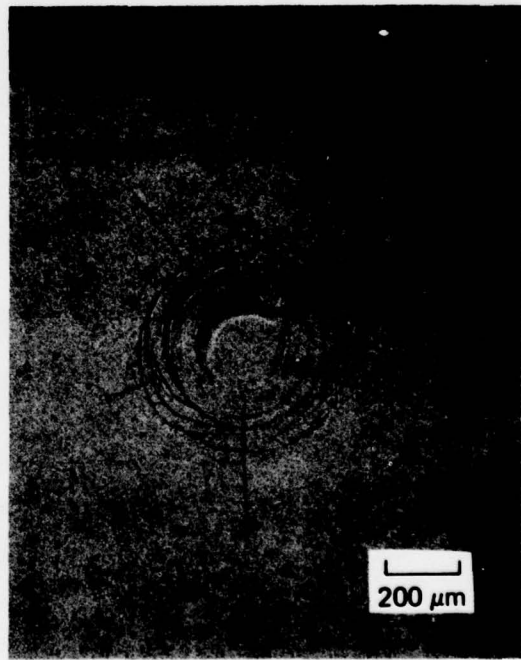
MP-4928-35

(a) 37.6 m/s

(b) 67.7 m/s

(d) 92.4 m/s

FIGURE 8 TYPICAL IMPACT DAMAGE IN HP Si_3N_4 BY 1.6-mm-DIAMETER WC SPHERES (Impact Configuration C)

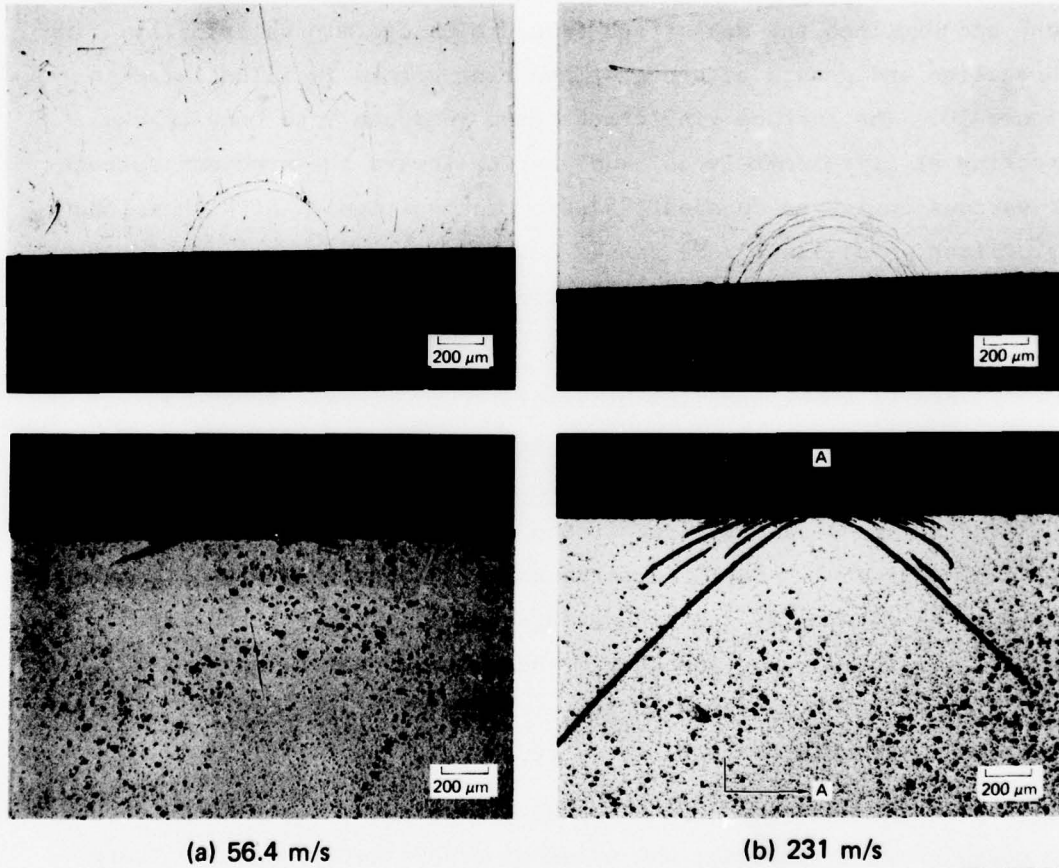
MP 4928-38

(a) 56.4 m/s

(b) 231 m/s

FIGURE 10 SECTIONAL VIEWS SHOWING SUBSURFACE GROWTH OF RING CRACKS INTO CONE CRACKS IN HP Si_3N_4 (Particles: 2.4-mm-Diameter Steel Spheres)

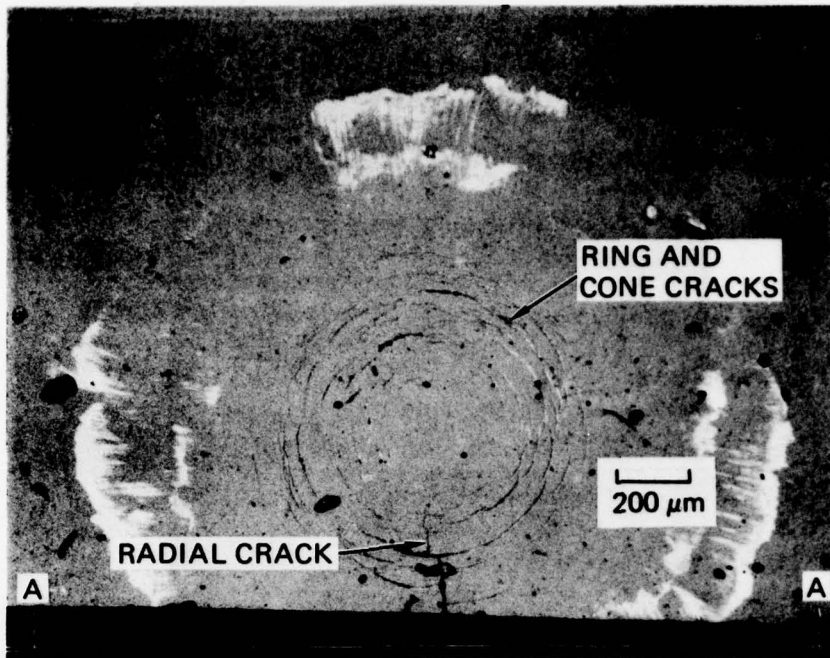
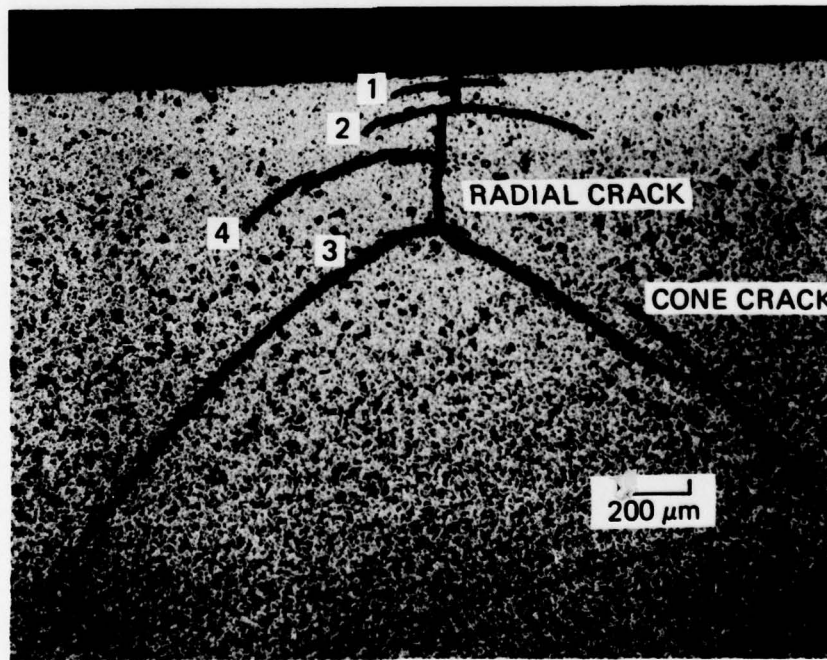
MP-4928-39

FIGURE 11 SECTIONAL VIEW OF SEVERAL CONE CRACKS AND ONE RADIAL CRACK 0.50 mm FROM CONTACT CENTER

Note the interaction between cone and radial cracks. Particle: steel, 2.4 mm; Target: HP Si_3N_4

Figure 11 shows profiles of several cone cracks, essentially depicting a section view across the cone cracks of the area marked AA in Figures 10 and 11. Figure 11 also illustrates the surface profile of a radial crack and its interaction with the cone cracks. Cone cracks 1, 2, 3, (Figure 11) appeared first and grew independently of each other followed by the radial crack that intersected the first two cone cracks, reached the third cone, and then branched out. Newer cone cracks seemed to nucleate and grow in the presence of radial cracks, and their growth was often interrupted (cone crack 4 in Figure 11).

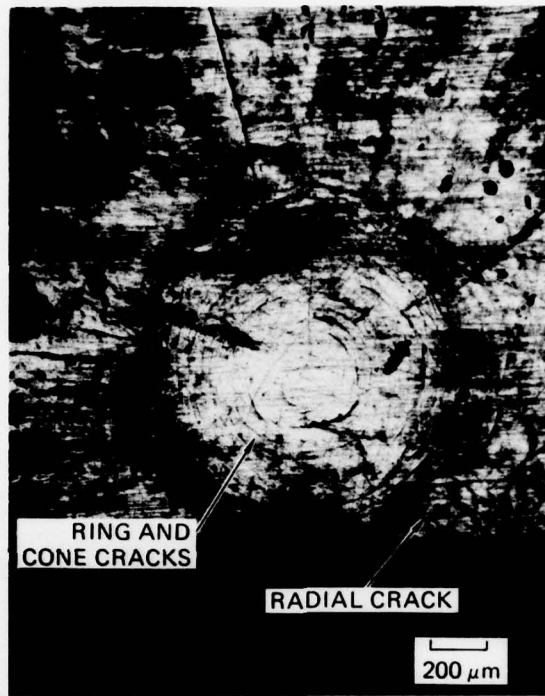
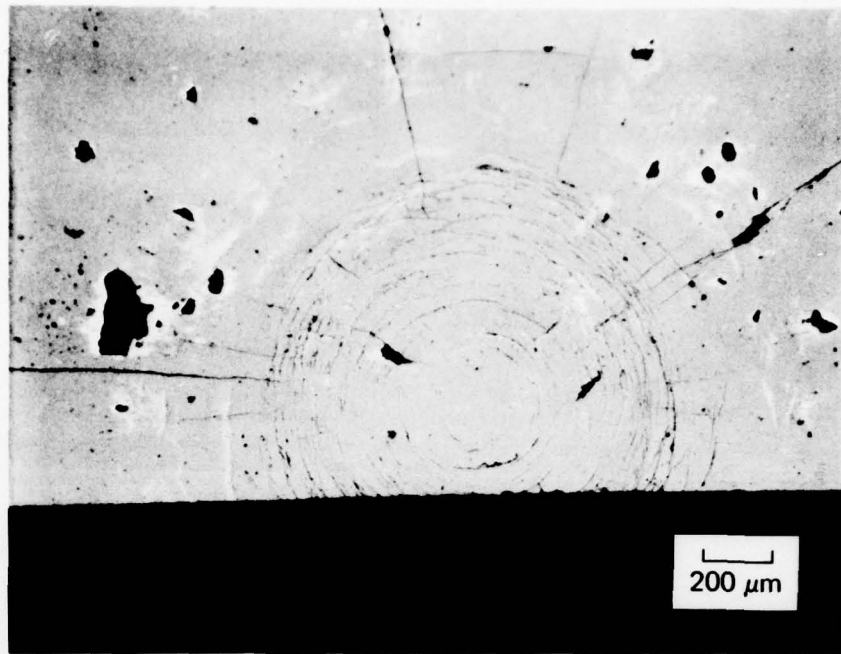
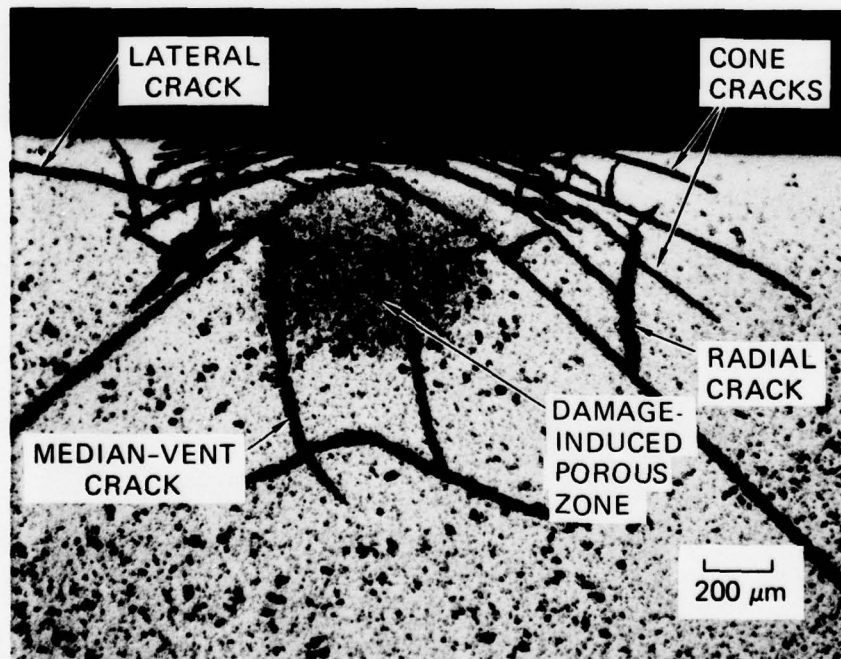
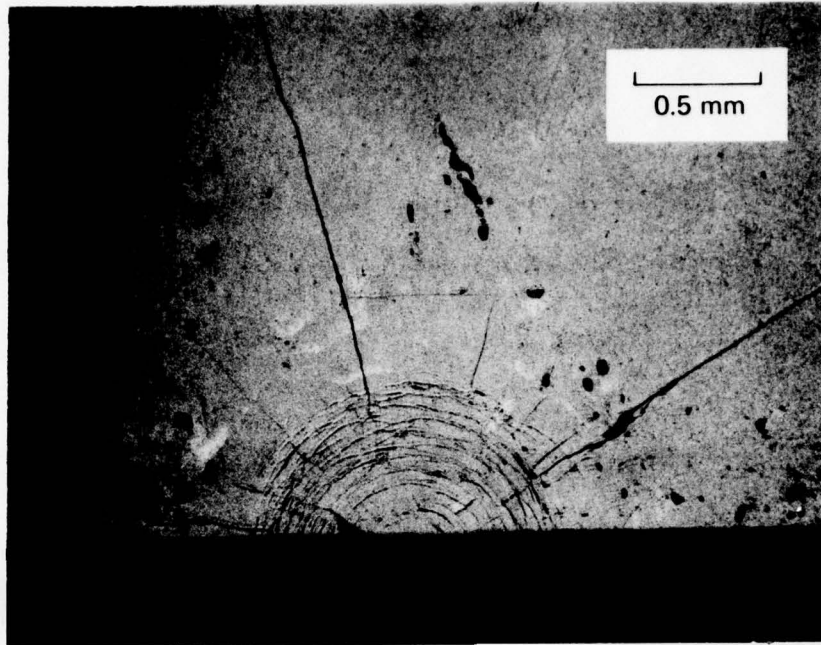
MP-4928-40

(a) 0.60 mm FROM CONTACT CENTER

FIGURE 12 SECTIONAL VIEW OF SEVERAL TYPES OF CRACKS IN HP Si_3N_4 IMPACTED AT 231 m/s BY A 2.4-mm-DIAMETER WC SPHERE

(b) 0.25 mm FROM CONTACT CENTER

(c) AT CONTACT CENTER

Under increasingly severe impacts, Figure 12, cone cracks seemed to cease growing; instead, new types of cracks were created. There were profiles of what appeared to be lateral cracks that nucleated near the contact center, ran approximately parallel to, and eventually veered sharply toward the specimen free surface. There were also vertical cracks that initiated from inside the innermost cone and converged to the damage center as successive sections were examined. We speculate that these are penny-shaped cracks similar to the median-vent cracks observed by Evans and Wilshaw in their quasi-static indentation experiments.⁵ A zone of damage-induced porous material, approximately spherical

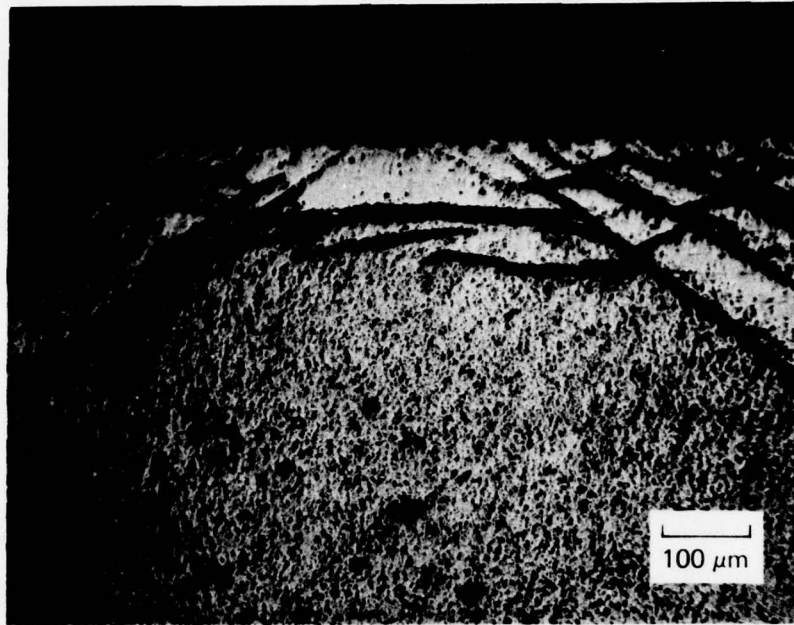
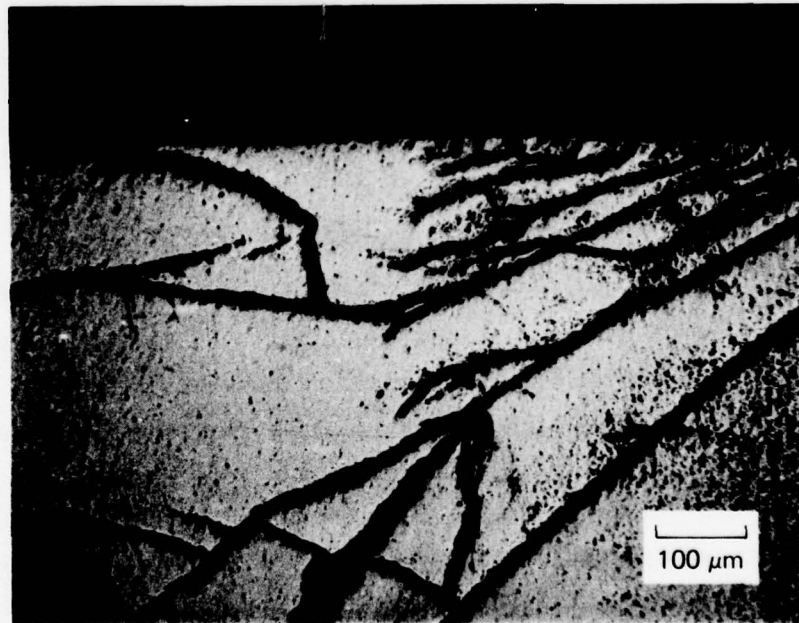
MP-4928-74

(d) MAGNIFIED VIEWS OF DAMAGE-INDUCED POROUS ZONE BENEATH CONTACT CENTER

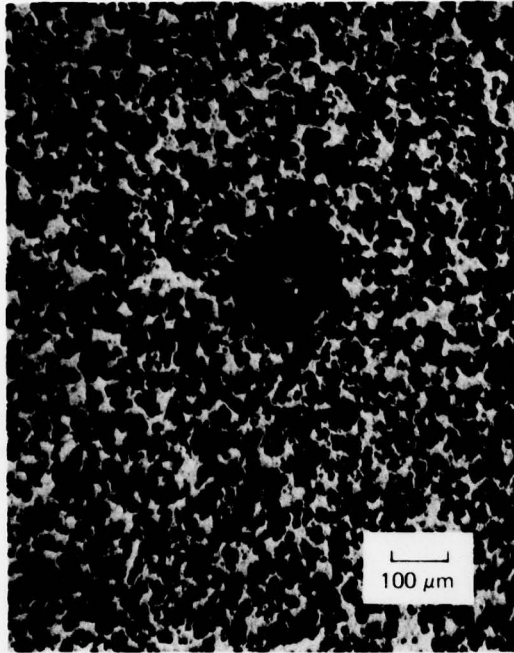
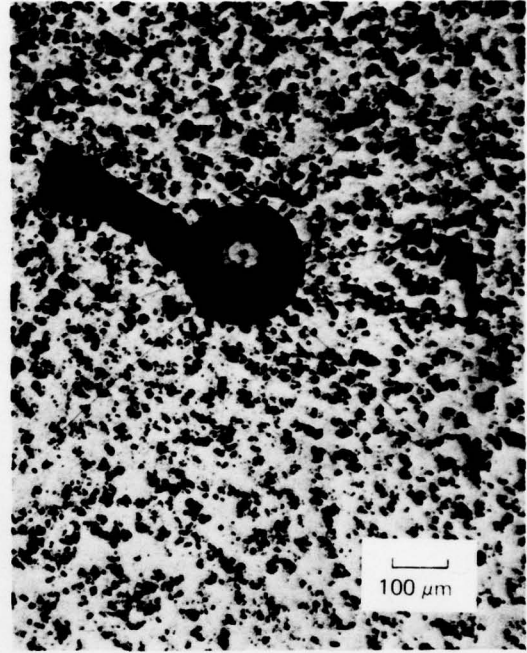
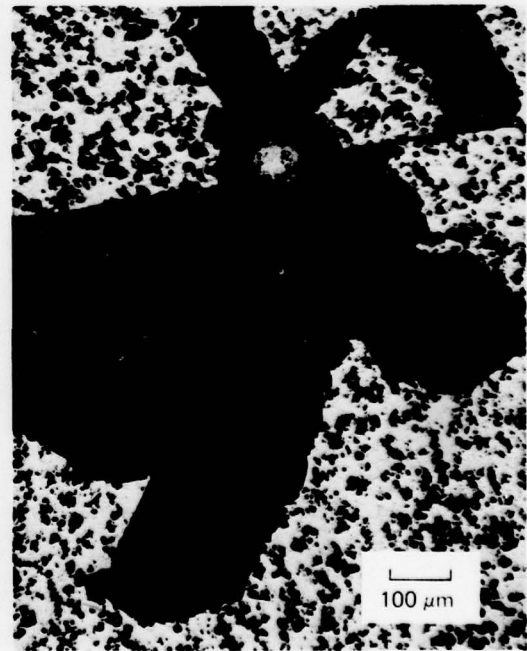
MP-4928-45

(a) 310 m/s

(c) 506 m/s

(b) 356 m/s

(d) 700 m/s

FIGURE 14 TYPICAL IMPACT DAMAGE IN RB Si_3N_4 BY 0.4-mm-DIAMETER WC SPHERES (Impact Configuration E)

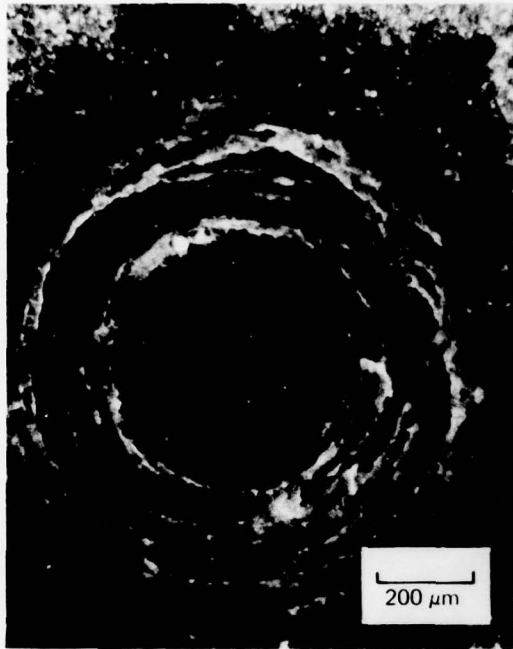
(a) SURFACE

(c) ~ 15 μm BELOW SURFACE

FIGURE 17 IMPACT DAMAGE VIEWED AT SUCCESSIVE DEPTHS (Oxidized HP Si_3N_4 Impacted at 150 m/s with a 2.4-mm-Diameter WC Sphere)

To determine internal damage in the oxide layer and in the host material, we removed successive layers of the oxide scale from the surface of the specimens. For test 14 at 150 m/s, the damage observed at different depths is illustrated in Figure 17. In the crater area where the impact spalled the specimen free of oxide material, the damage revealed was that sustained in the host material as shown by all four pictures in Figure 17, where a pattern of ring cracks was observed. Outside the crater zone, as successive layers of the oxide scale were removed by polishing (Figure 17a to c), no cracking was observed in the oxide. This was not surprising because the oxide scale was highly porous.

When the oxide layer was completely removed by polishing, Figure 17d, we observed damage in the substrate that consisted of ring cracks as well as radial cracks. Figure 18 illustrates substrate damage in different tests as a function of impact velocity. Surface damage to the oxide scale and to the HP Si_3N_4 substrate can be compared by comparing Figures 16 and 18.

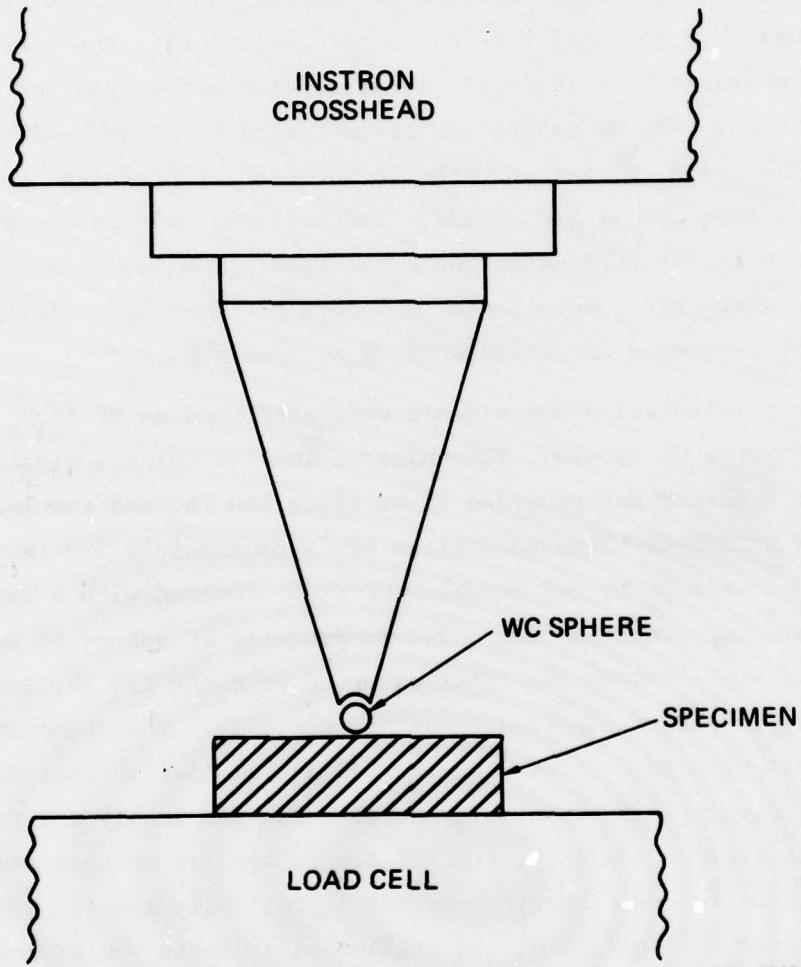
MA-4928-52

FIGURE 19 TEST FIXTURE FOR QUASI-STATIC INDENTATION EXPERIMENTS

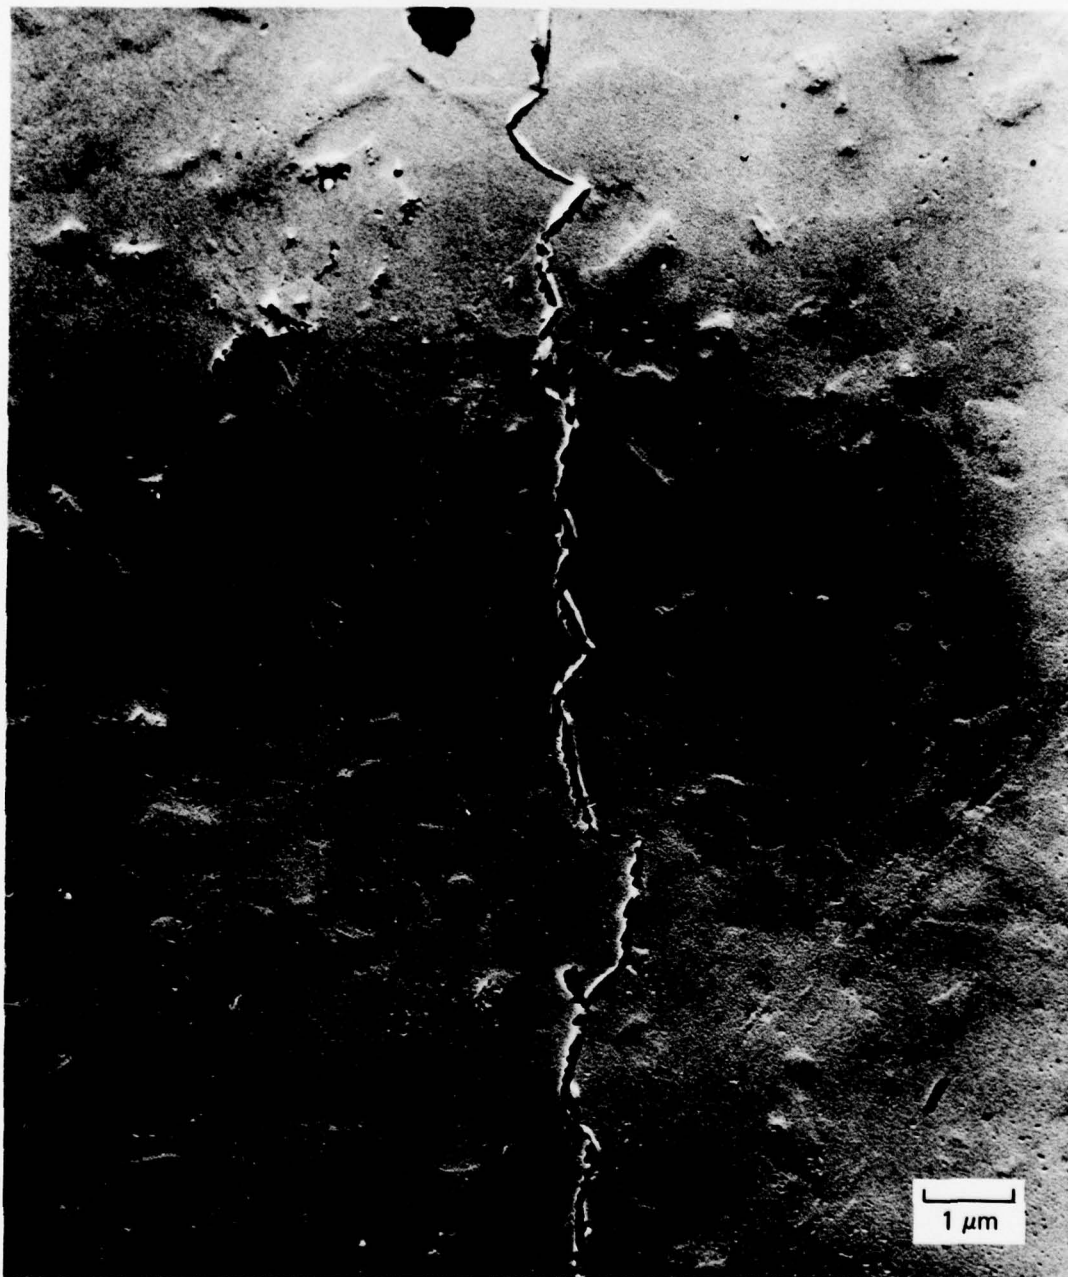
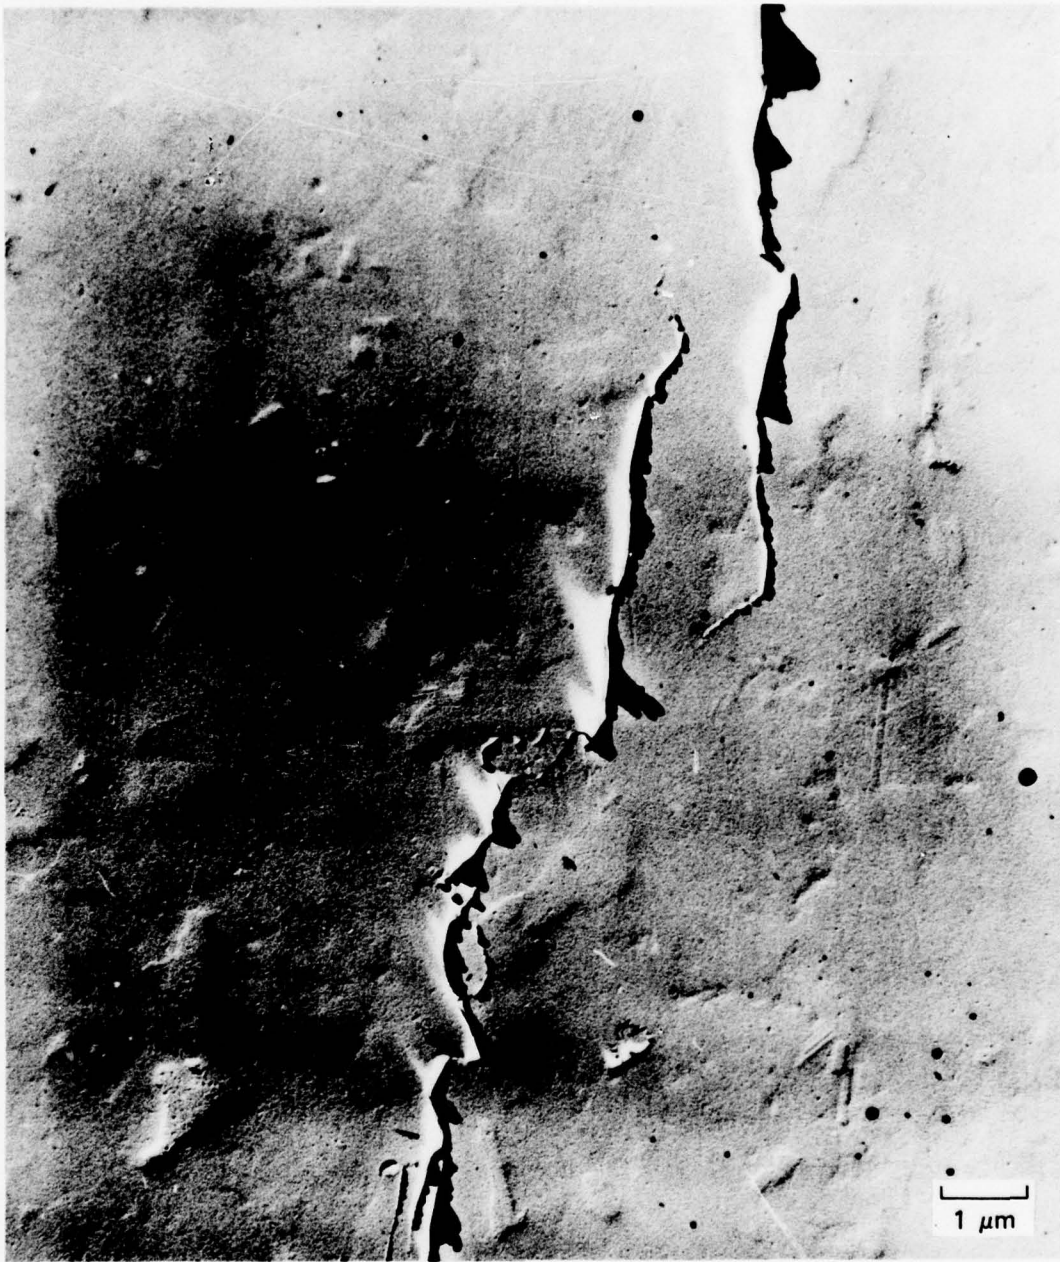
MP-4928-75

FIGURE 25 TYPICAL RING CRACKS IN HP Si_3N_4 PRODUCED BY QUASI-STATIC INDENTATION

In hot pressed Si_3N_4 the direction of the ring cracks is locally perturbed by the microstructure as illustrated in Figure 25(a). The effect of the microstructure is significant since in some instances the cracks appear to be forced into a radial orientation that may cause them to stop or to form concentric segments of ring cracks as shown in Figure 25(b). The general appearance of cracks indicates intergranular failure. This can be seen more clearly in Figure 26, which also shows that intergranular microfracture occurs in the immediate vicinity of the main propagating crack. These observations are important because they suggest that resistance to impact cracking might be improved by modifying the size and shape of the grains in hot pressed Si_3N_4 .

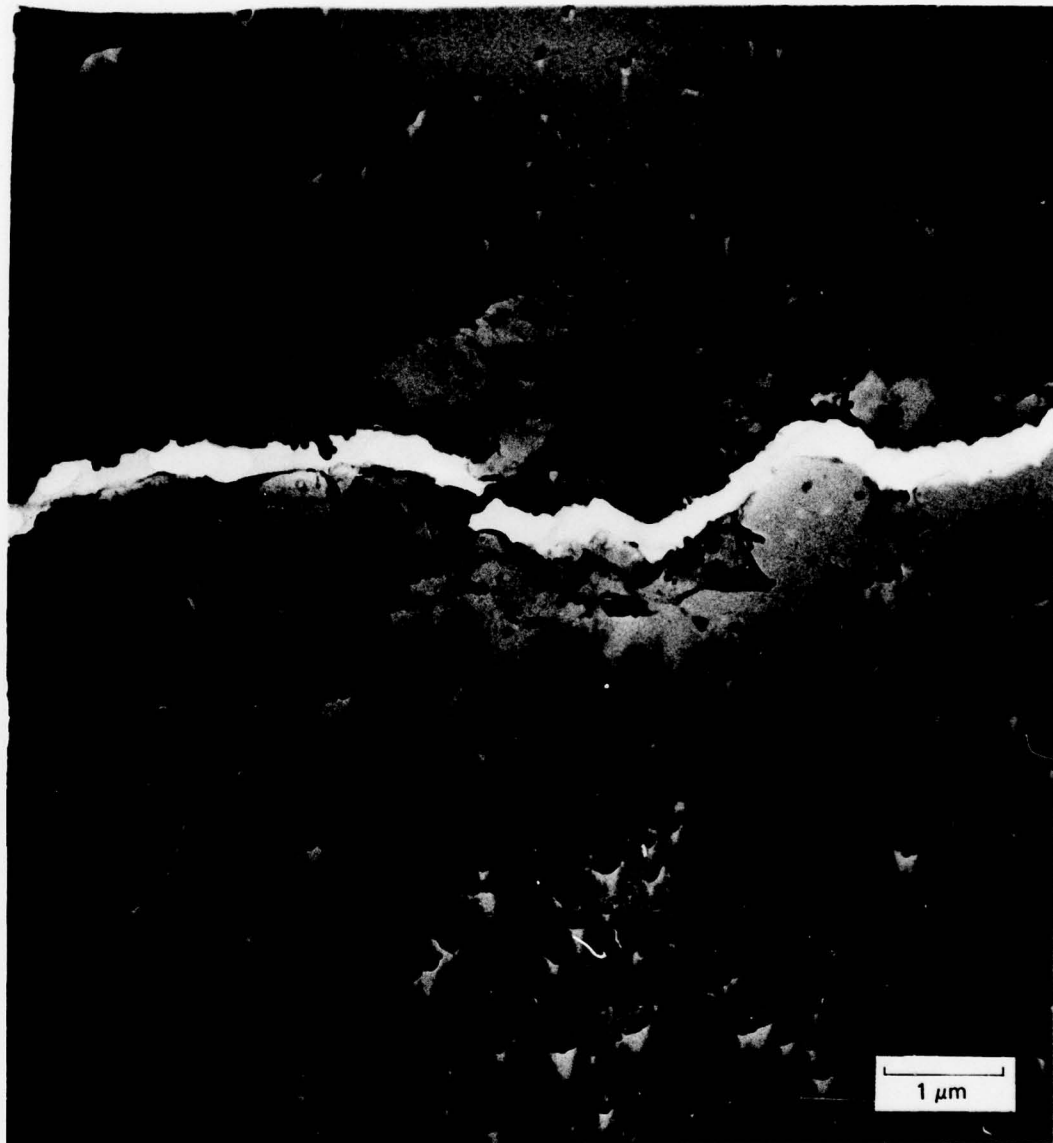
MP-4928-77

FIGURE 26 INTERGRANULAR PROPAGATION OF A RING CRACK IN HP Si₃N₄

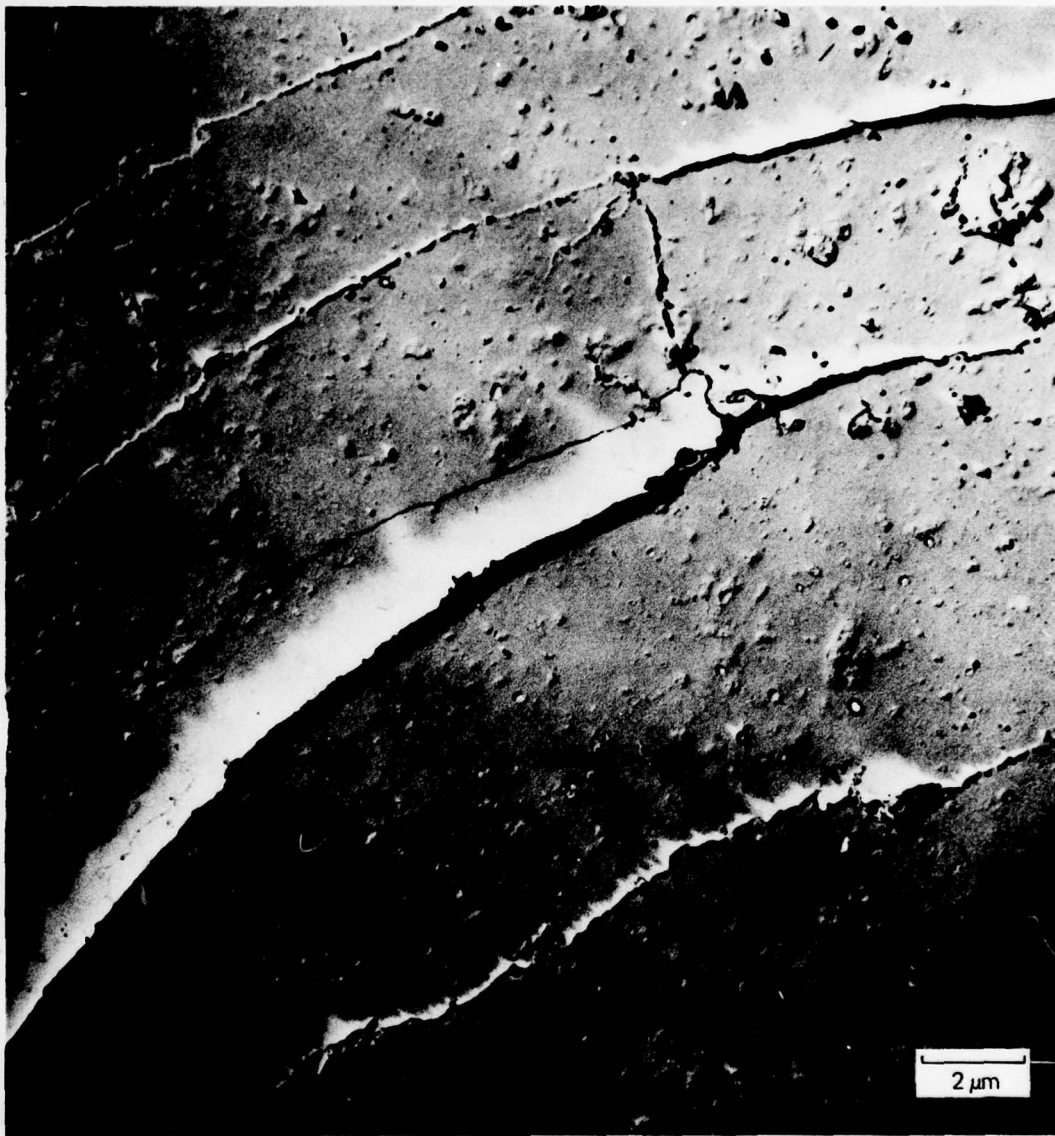
MP-4928-78

FIGURE 27 TYPICAL RING CRACKING BY QUASI-STATIC INDENTATION IN RB Si_3N_4 : A Population of Concentric Ring Cracks and Interconnecting Radial Segments

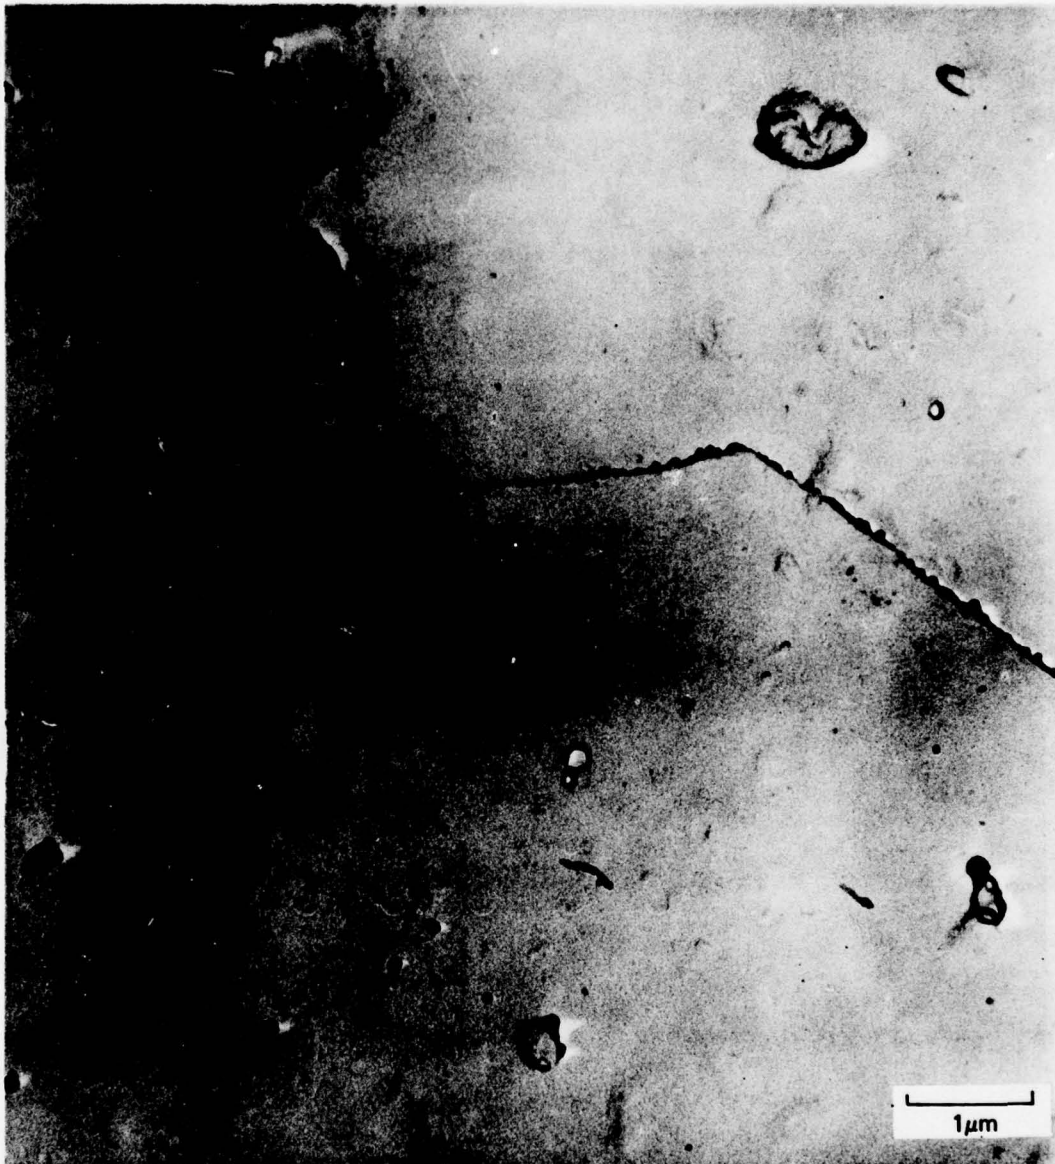
FIGURE 28 CRACK TIP OF A RADIAL SEGMENT (Shown in Figure 27) THAT VEERS TOWARD CONTACT CENTER

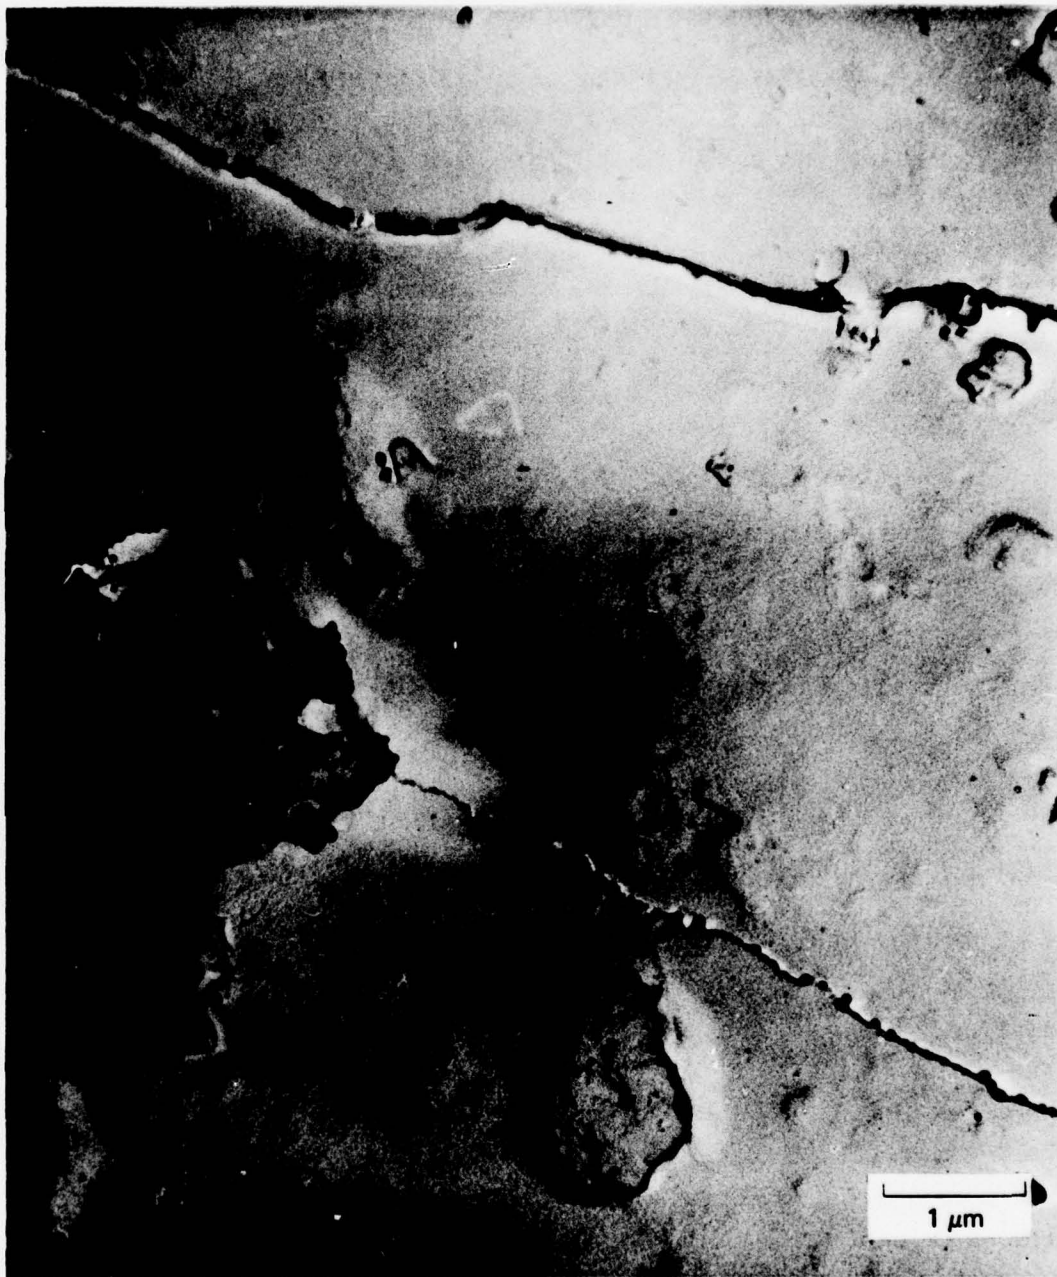
MP-4928-80

FIGURE 29 A RING CRACK IN RB Si_3N_4 PRODUCED BY QUASI-STATIC INDENTATION THAT TERMINATES AT A LARGE PORE
