**PARTICLE IMPACT DAMAGE
IN SILICON NITRIDE**

Annual Report — Part III

May 1979

By: K. C. Dao, D. A. Shockey, L. Seaman,
D. R. Curran, and D. J. Rowcliffe

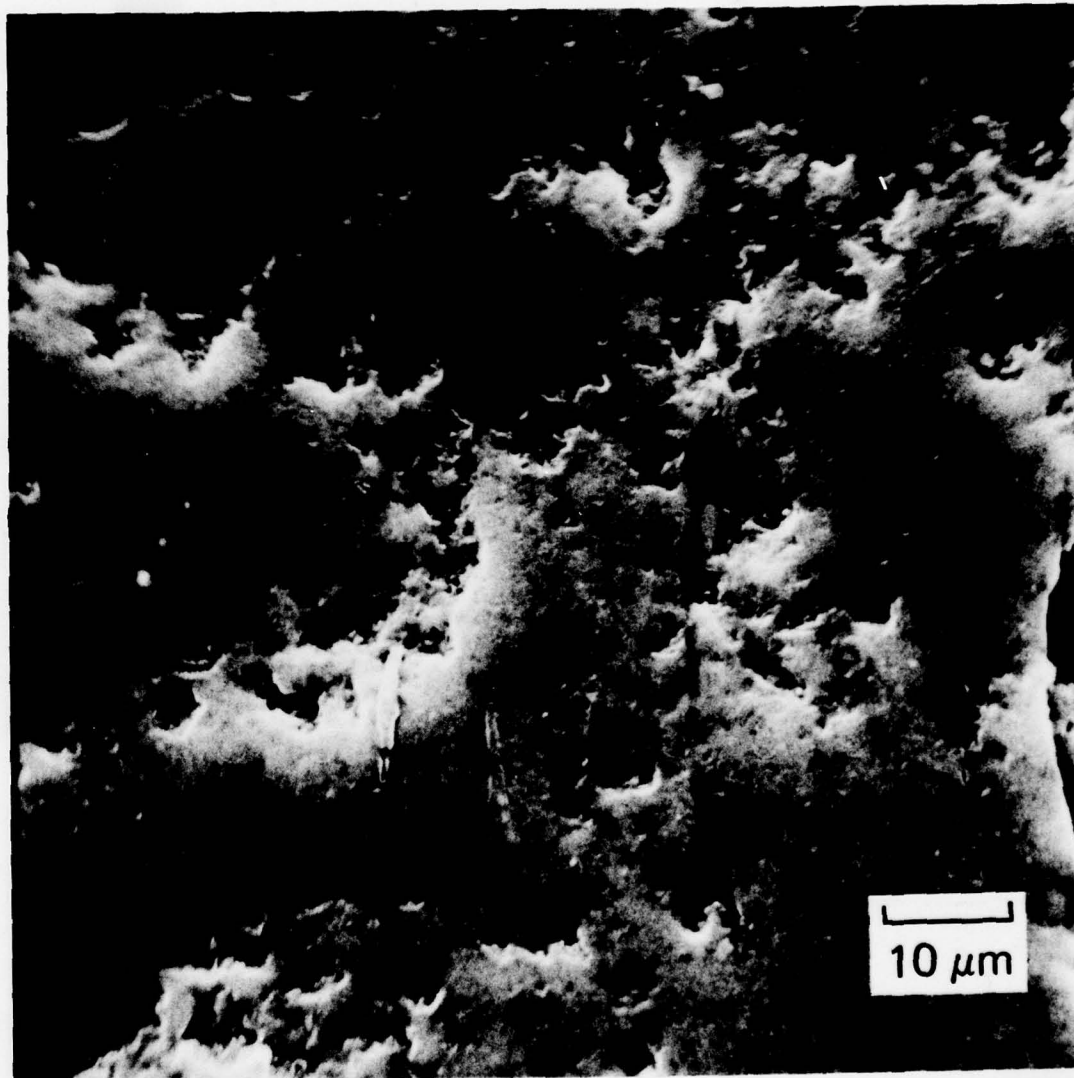
MP-4928-81

FIGURE 30 TYPICAL RING CRACKING BY PARTICLE IMPACT IN RB Si_3N_4

Samples of ring cracks produced in particle impacts on RB Si_3N_4 are shown in Figures 30 and 31. The general appearance of the ring cracks produced quasi-statically and dynamically is very similar (compare Figures 27 and 30). The effect of the microstructure also appears to be similar. Ring cracks produced in particle impacts are seen to be similarly diverted by large pores and often terminated in them (Figure 31). The grains and the majority of pores in RB Si_3N_4 are smaller than $1 \mu\text{m}$, however, and do not appear to exert a marked influence on crack propagation and macrofracture.

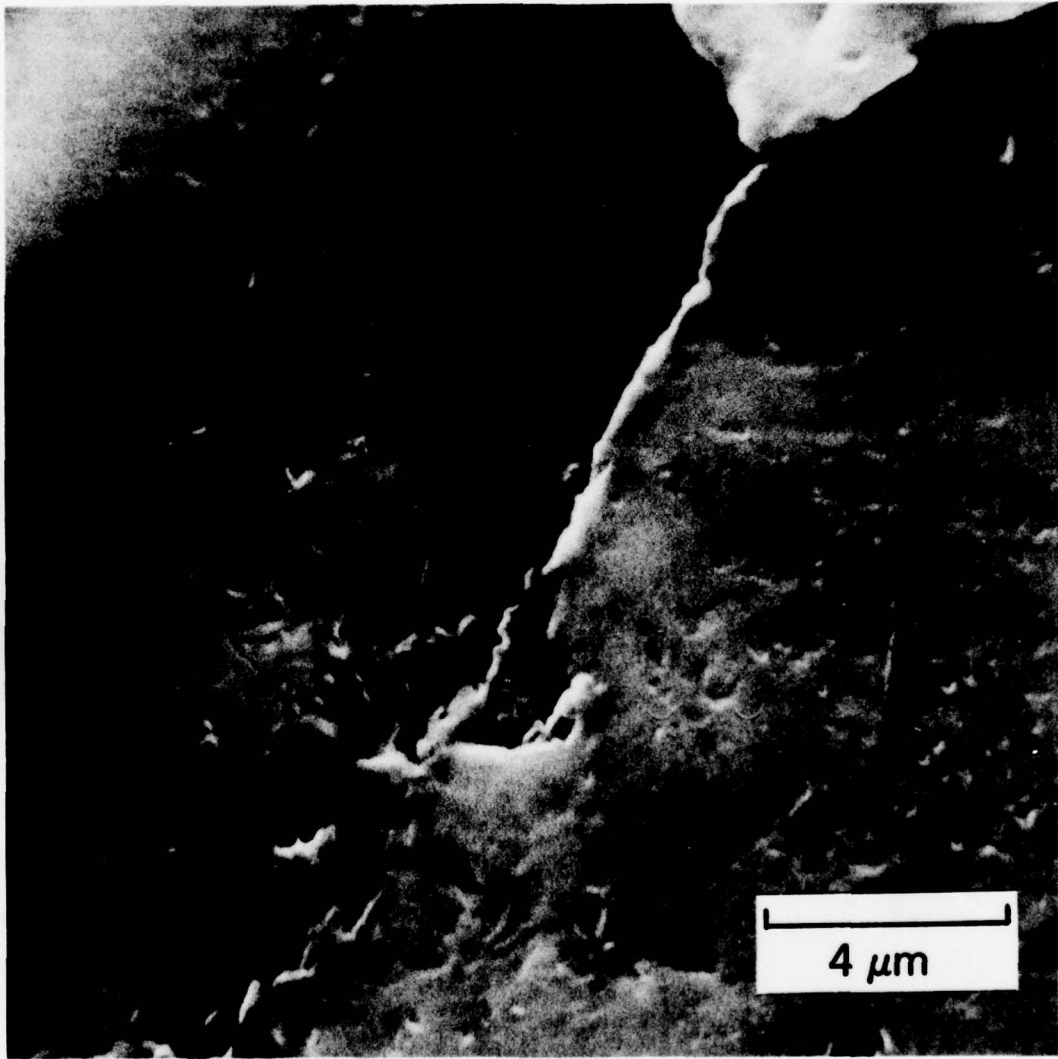
MP-4928-82

FIGURE 31 A RING CRACK IN RB Si_3N_4 PRODUCED BY PARTICLE IMPACT THAT TERMINATES AT A LARGE PORE

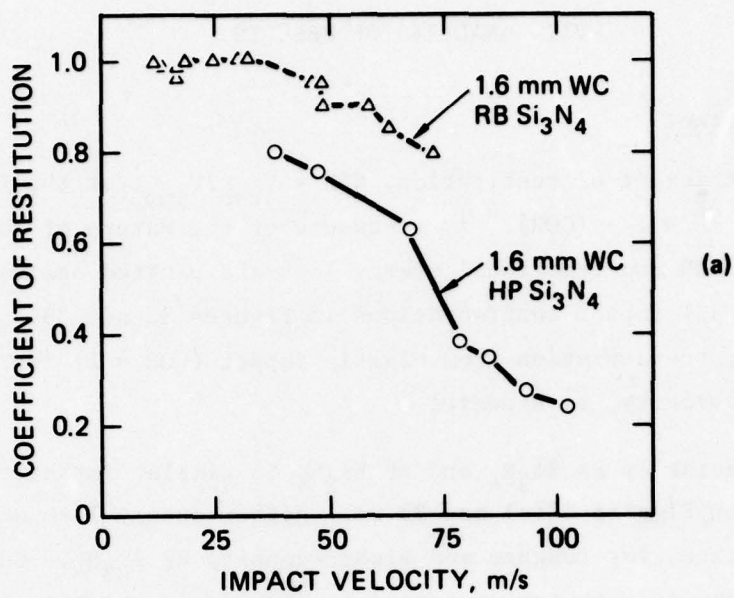
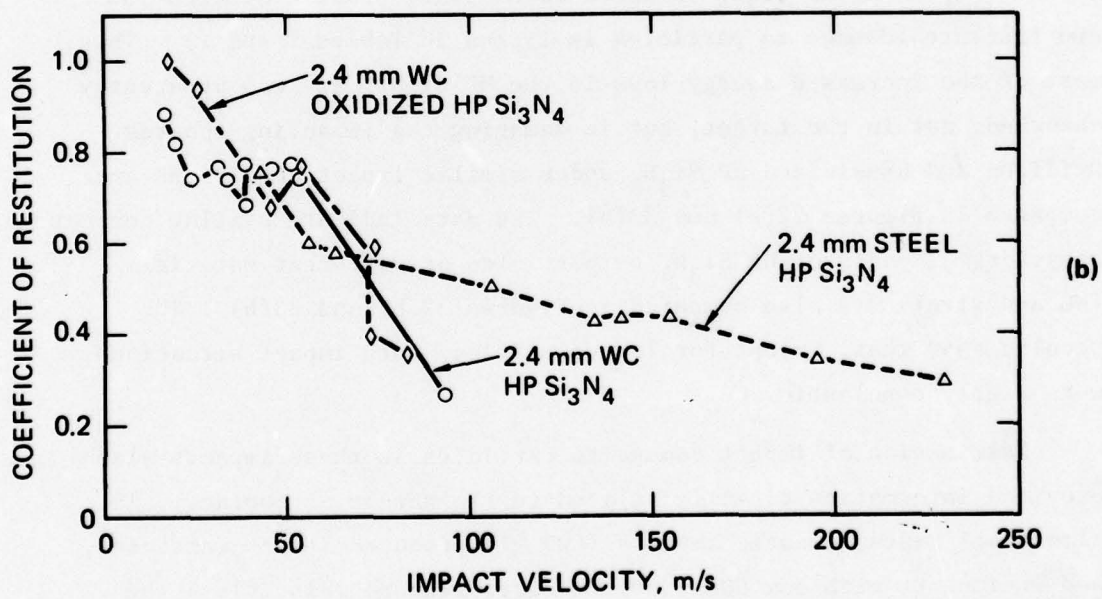
MA-4928-58

FIGURE 32 COEFFICIENT OF RESTITUTION

Examination of impact damage to particles in these impacts also provided information directly related to the nature of contact. In almost all cases, elastic impacts ($COR \approx 1$) produced intact particles, and in impacts with low COR (i.e., reduced rebound velocities) the particles were heavily deformed or fragmented. Observed particle damage for different tests is listed with other impact parameters in Tables 1 through 3.

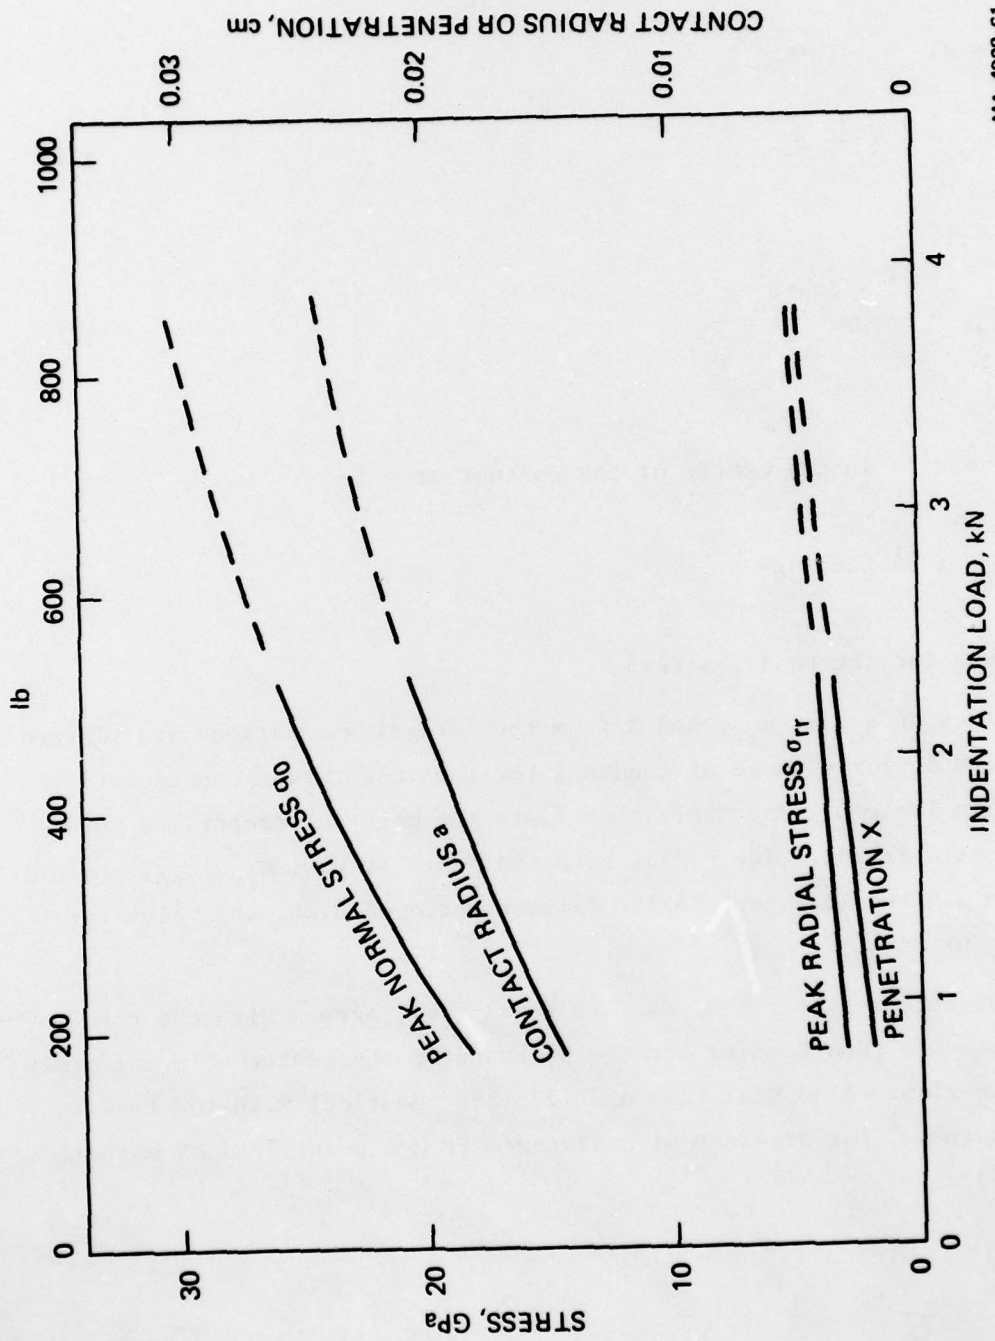
MA-4928-61

FIGURE 35 QUASI-STATIC CONTACT PARAMETERS (Indenter: 2.4-mm-Diameter WC Sphere Specimen: HP Si₃N₄)

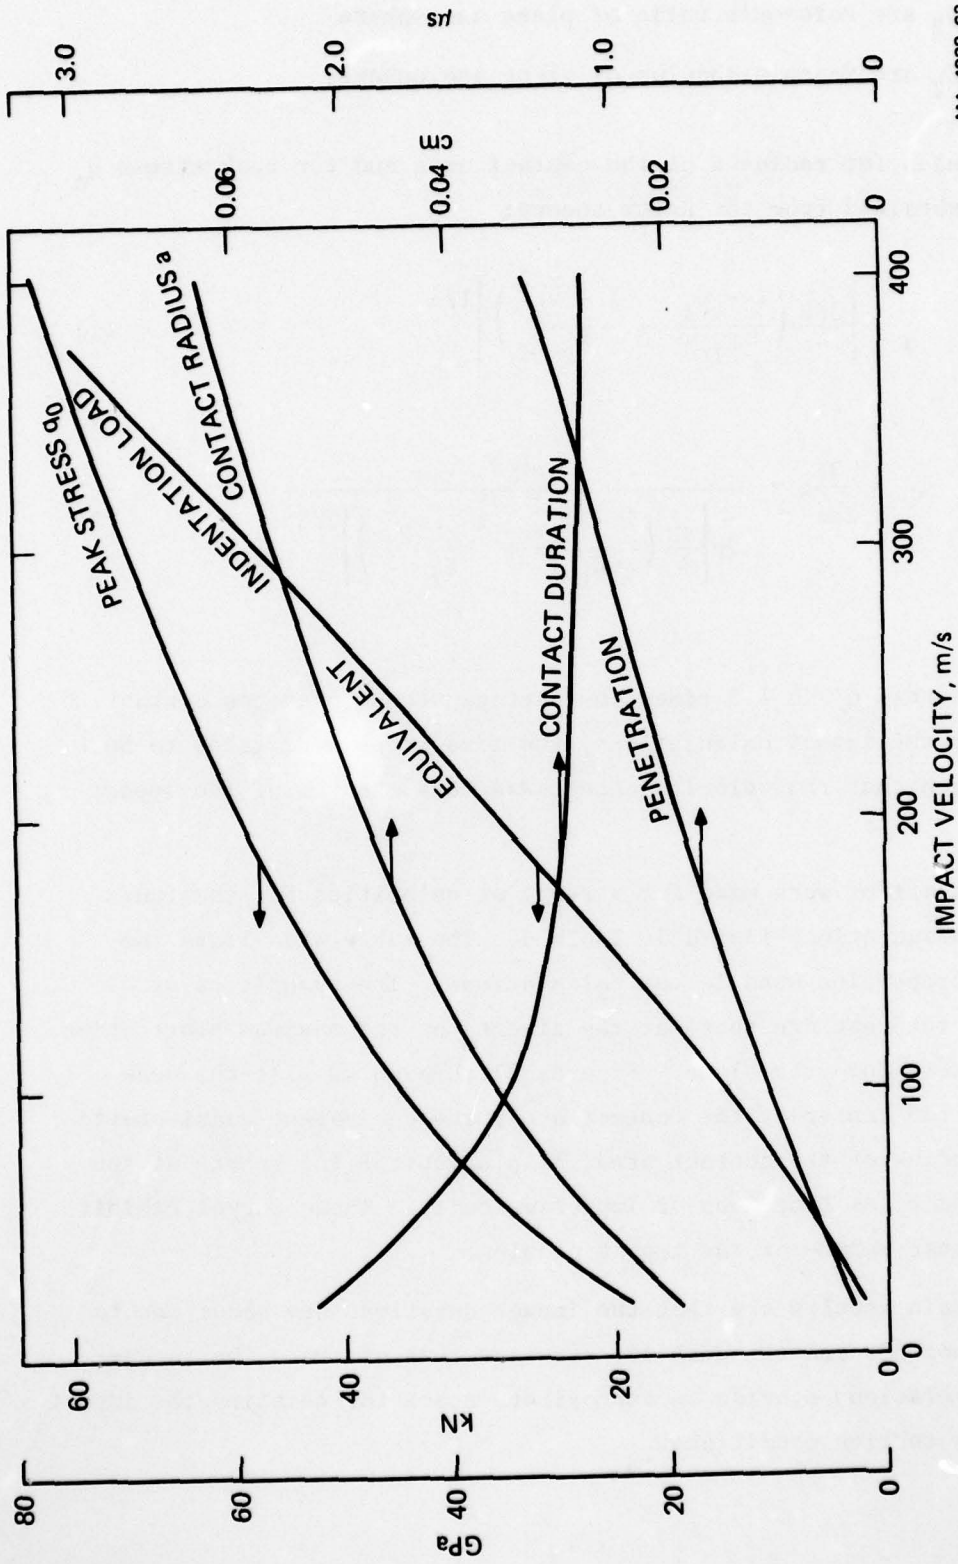
MA-4928-63

FIGURE 37 DYNAMIC CONTACT PARAMETERS (Particle: 2.4-mm-Diameter WC Sphere
Target: HP Si_3N_4)

The main results are that the impact durations are about one to two microseconds and the peak stresses are tens of GPa. The force-velocity relations provide an approximate means for relating the impact and static testing conditions.

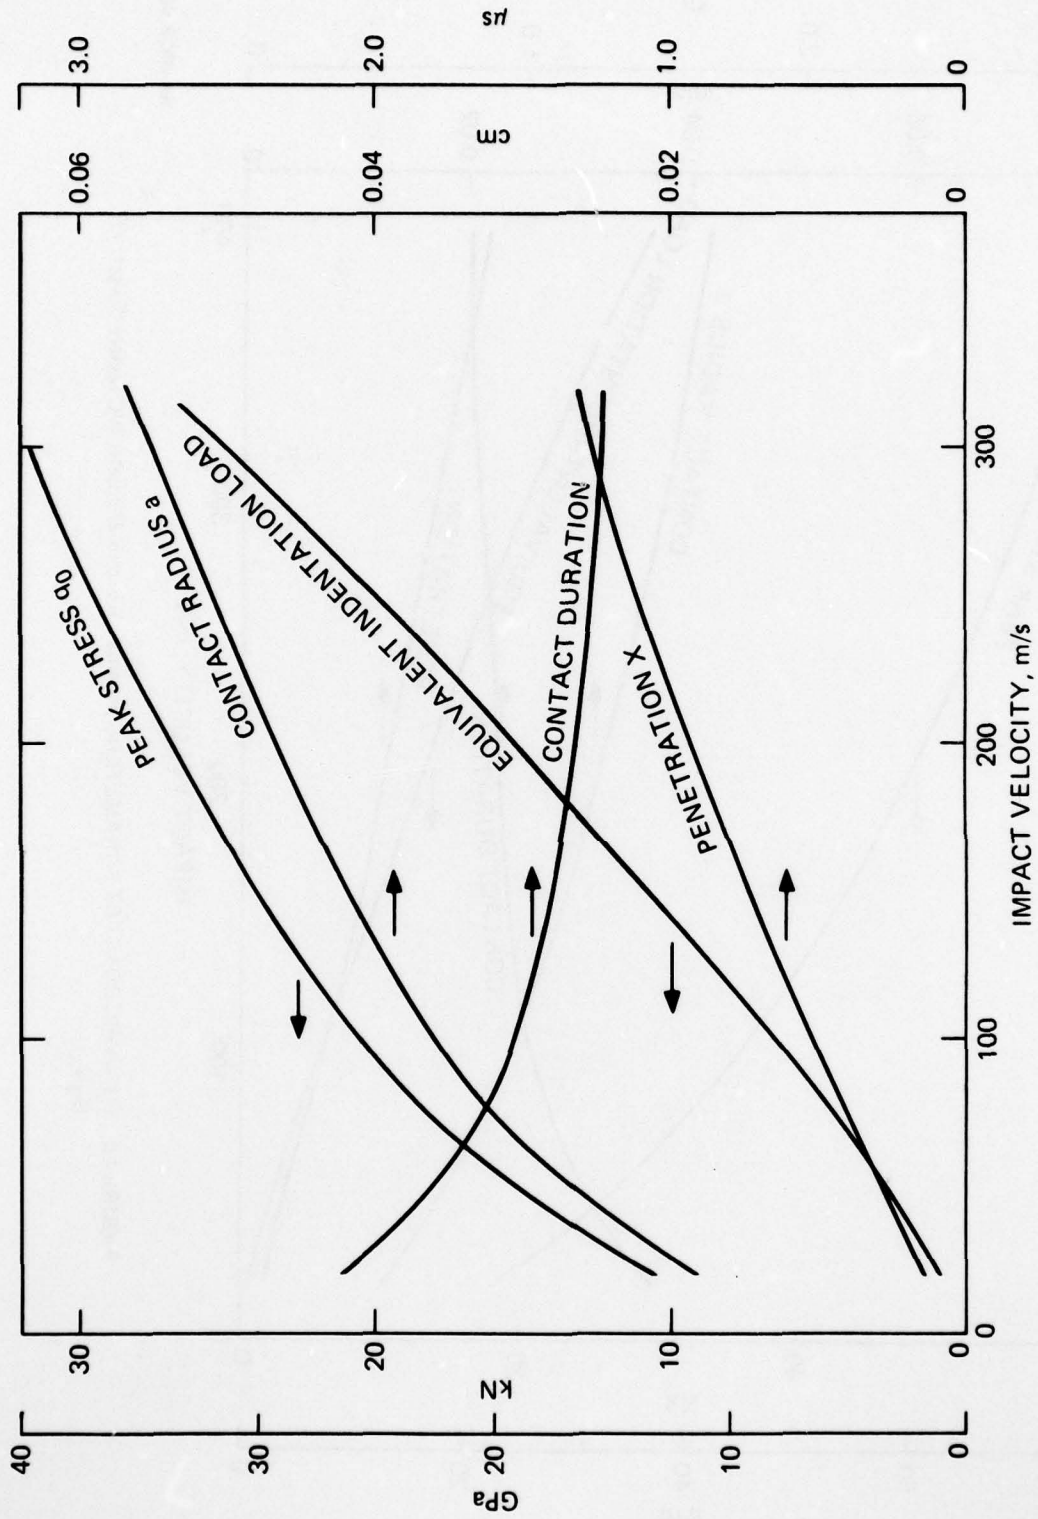
MA-4928-64

FIGURE 38 DYNAMIC CONTACT PARAMETERS (Particle: 2.4-mm-Diameter Steel Sphere Target: HP Si₃N₄)

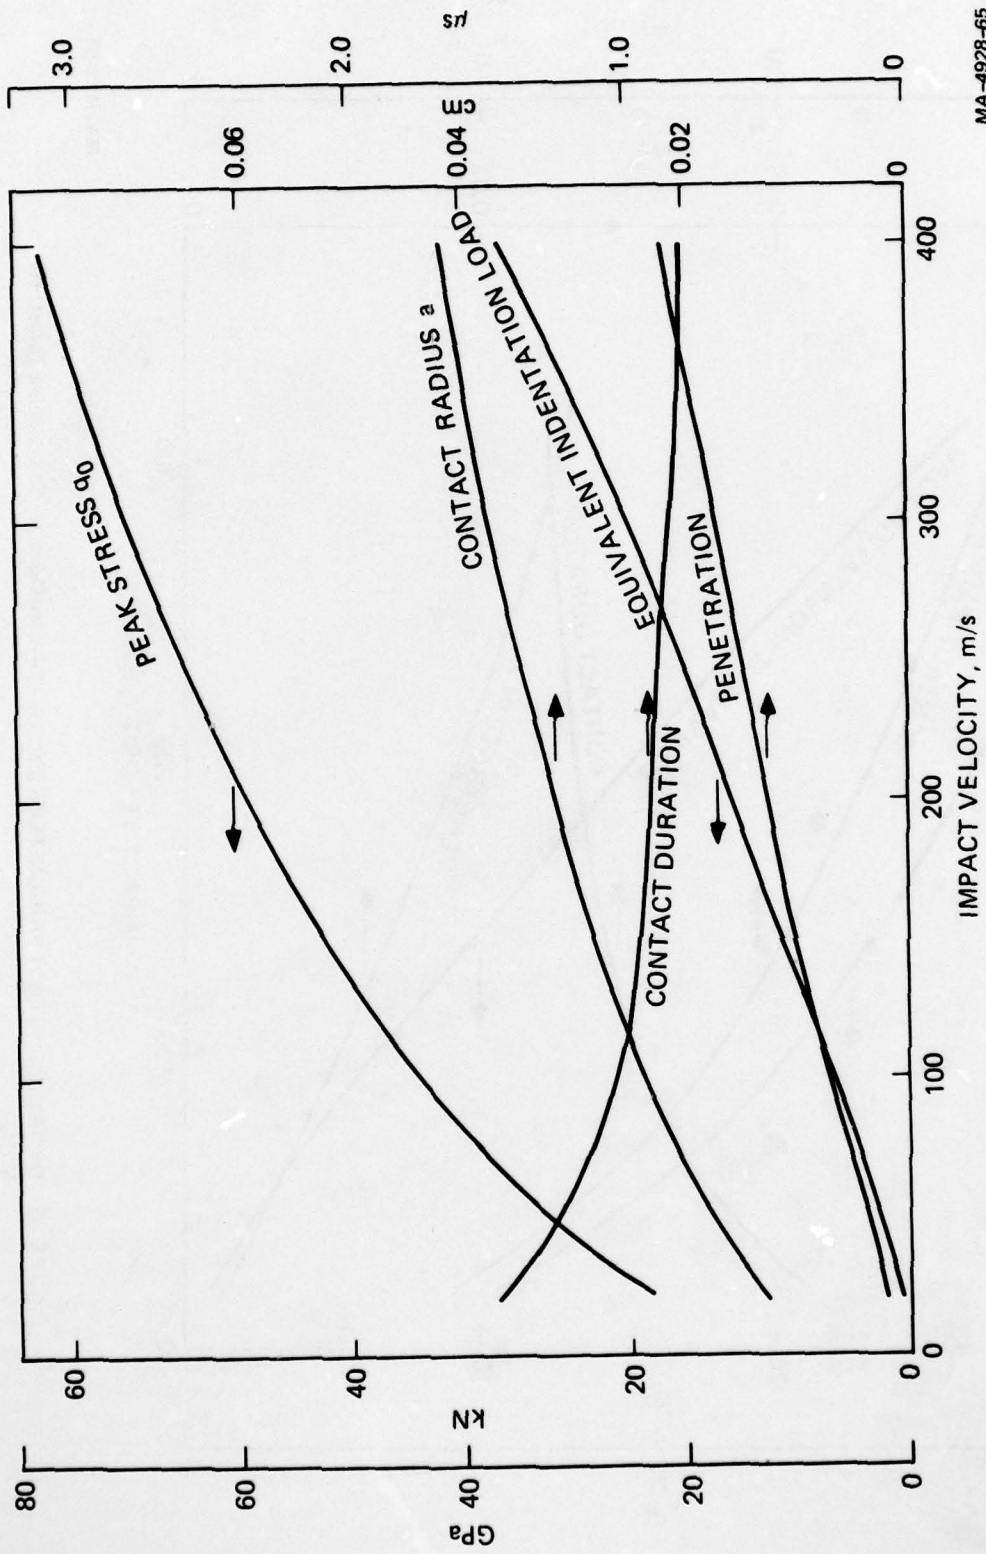
MA-4928-65

FIGURE 39 DYNAMIC CONTACT PARAMETERS (Particle: 1.6-mm-Diameter WC Sphere Target: HP Si₃N₄)

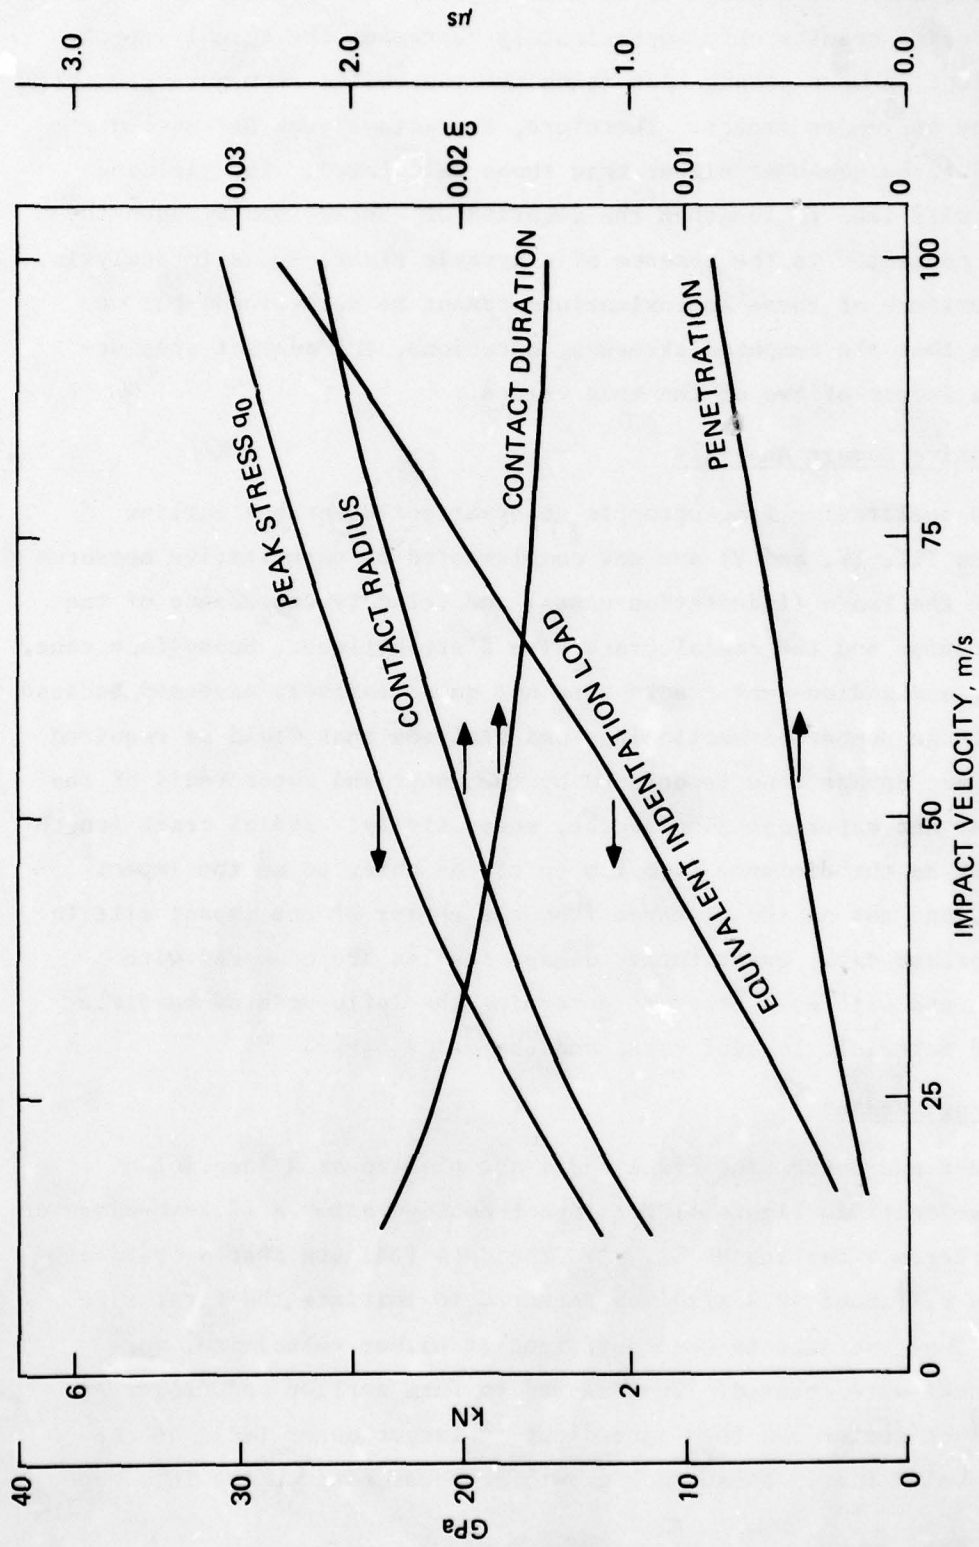
MA-4928-66

FIGURE 40 DYNAMIC CONTACT PARAMETERS (Particle: 1.6-mm-Diameter WC Sphere. Target: $\text{RB Si}_3\text{N}_4$)

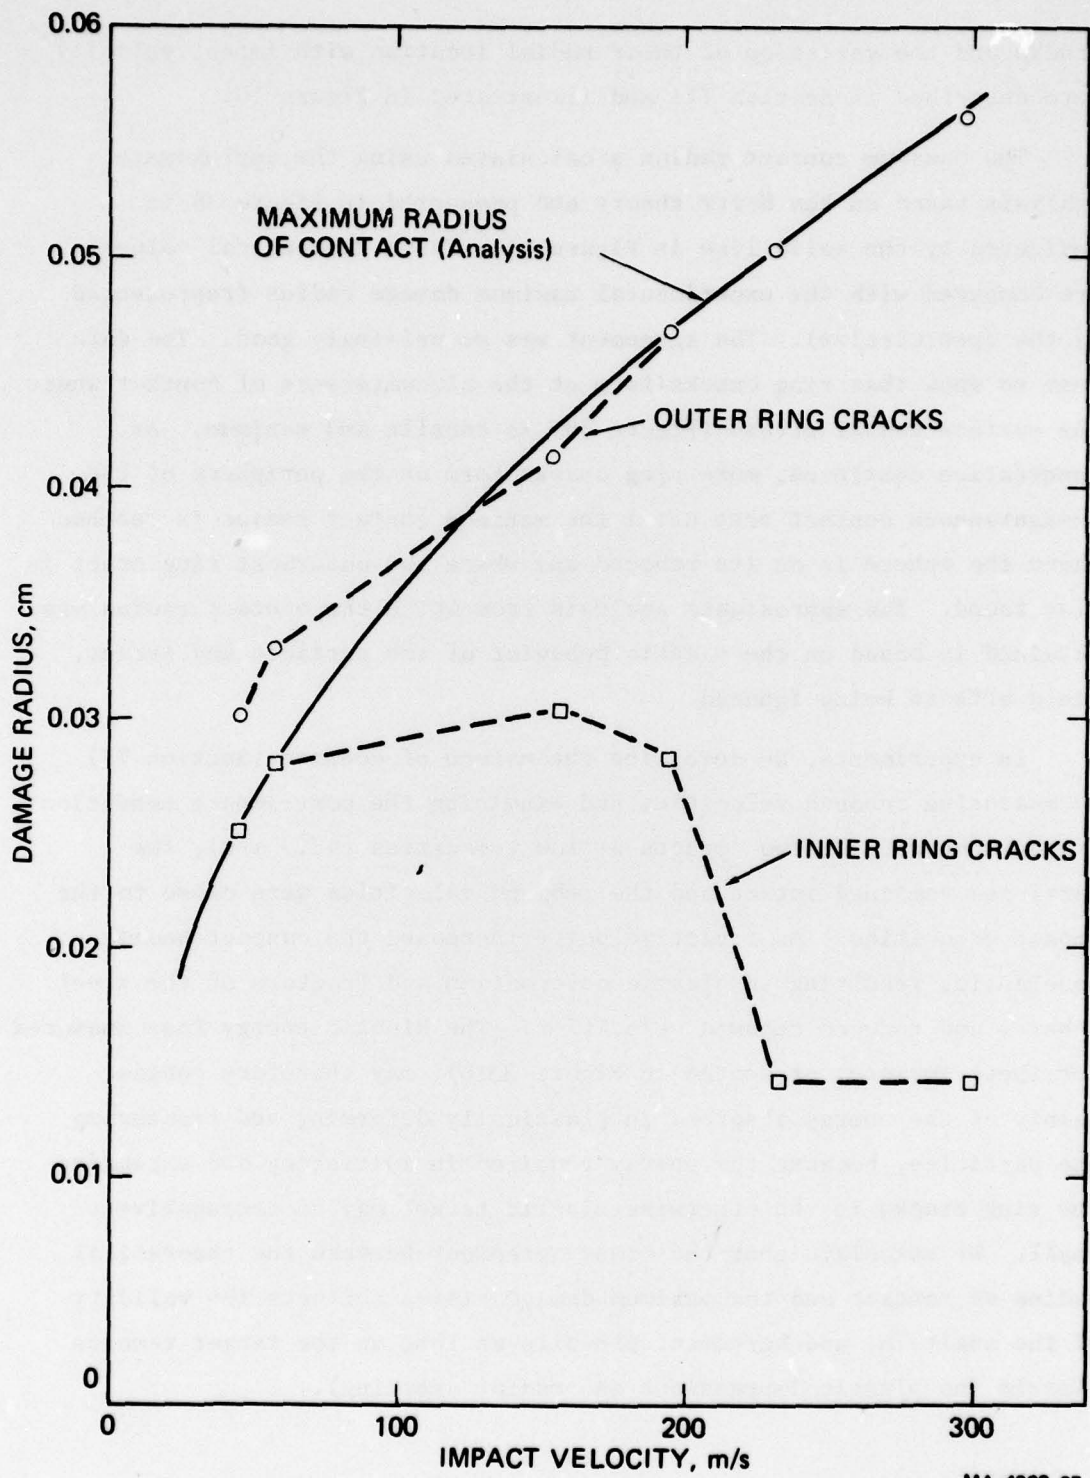
MA-4928-67

Inner and outer ring crack radii are plotted as a function of impact velocity in Figure 41 for impact configuration A (2.4-mm-diameter steel spheres impacting HP Si_3N_4). The data indicate that a critical velocity V_1 (about 42.3 m/s) was required to initiate the first ring crack. Then, as impacts were performed at higher velocities, more ring cracks were created. They seemed to form earlier and closer to the contact center and then spread out to larger outer radii at the highest velocities. Subsurface growth of these ring cracks into cone

FIGURE 41 DAMAGE RADIUS RESULTS FOR IMPACT CONFIGURATION A (2.4-mm-Diameter Steel Sphere/HP Si₃N₄)

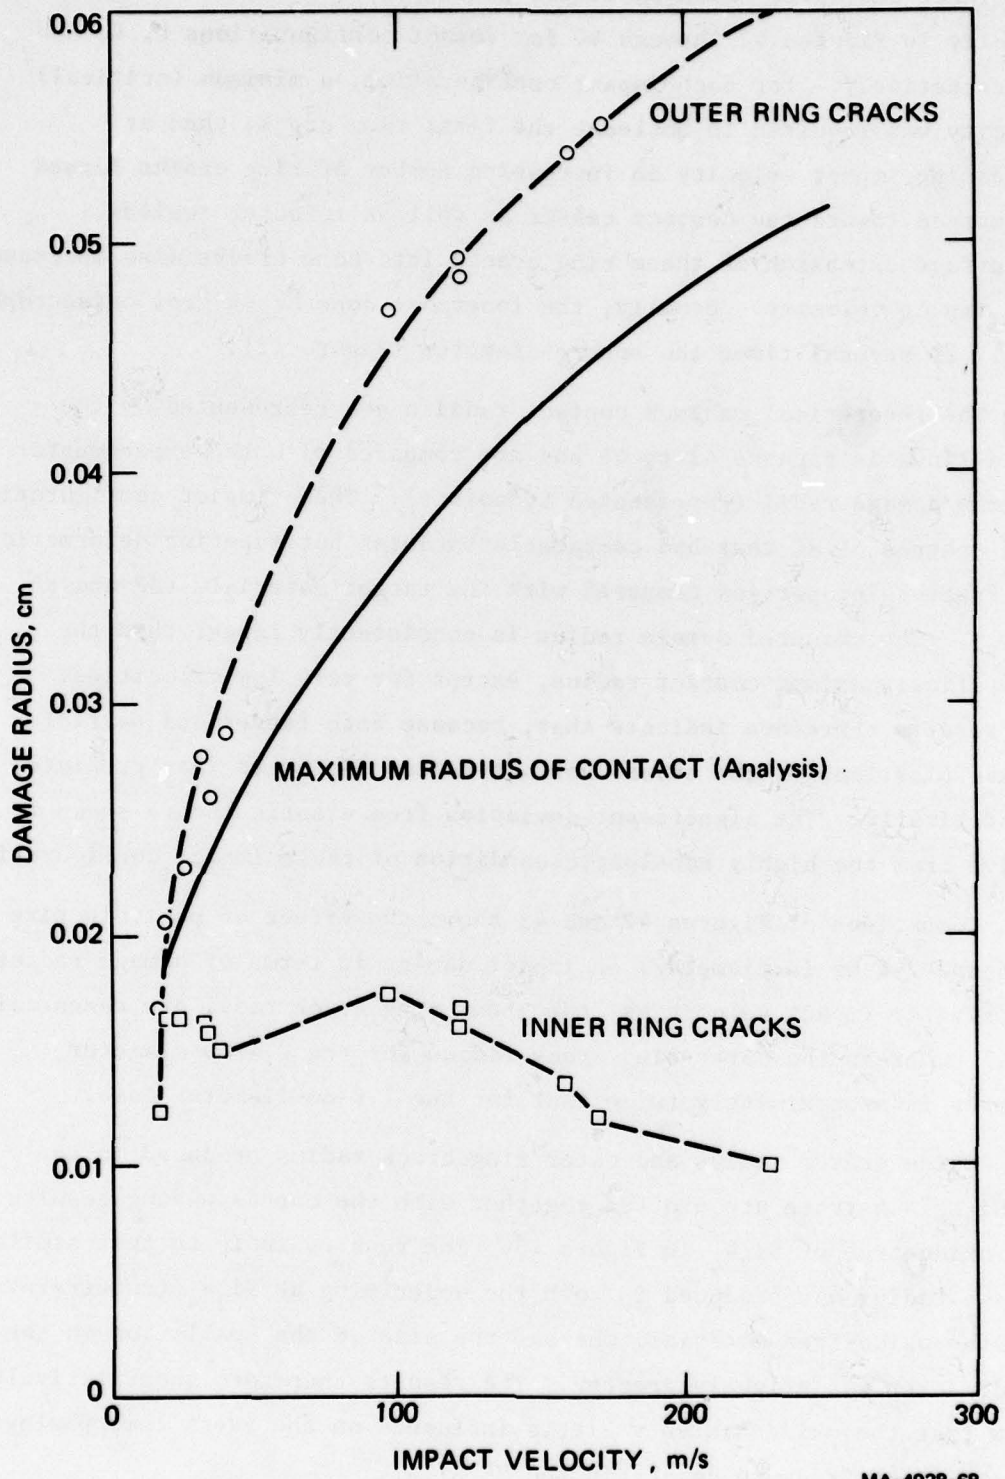
MA-4928-68

FIGURE 42 DAMAGE RADIUS RESULTS FOR IMPACT CONFIGURATION B (2.4-mm-Diameter WC Sphere/HP Si₃N₄)

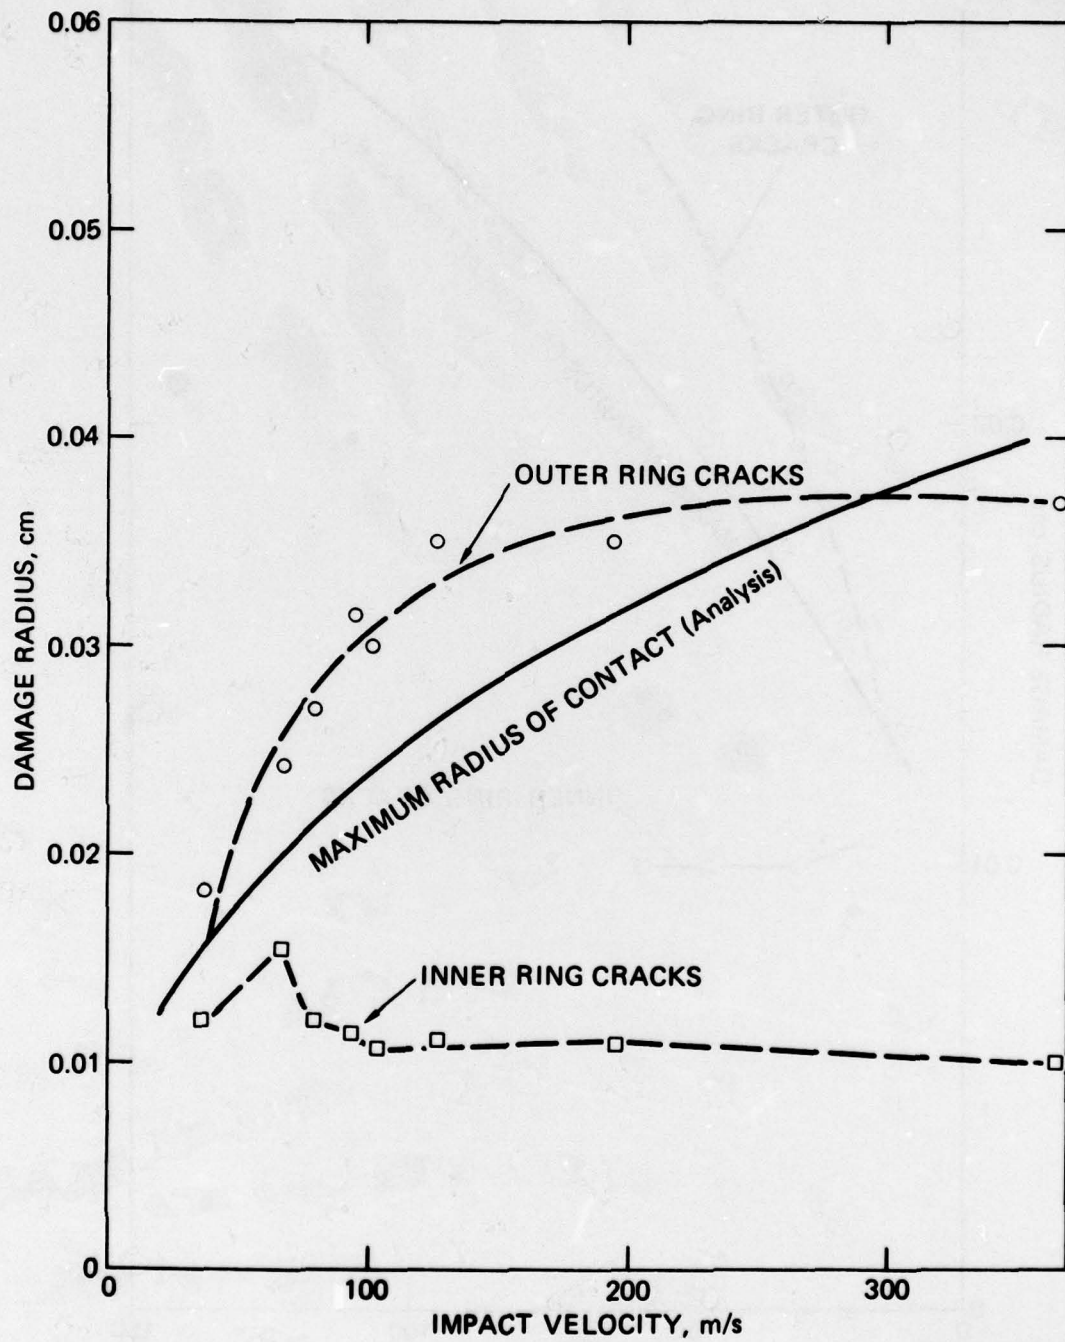
MA-4928-69

FIGURE 43 DAMAGE RADIUS RESULTS FOR IMPACT CONFIGURATION C (1.6-mm-Diameter WC Sphere/HP Si₃N₄)

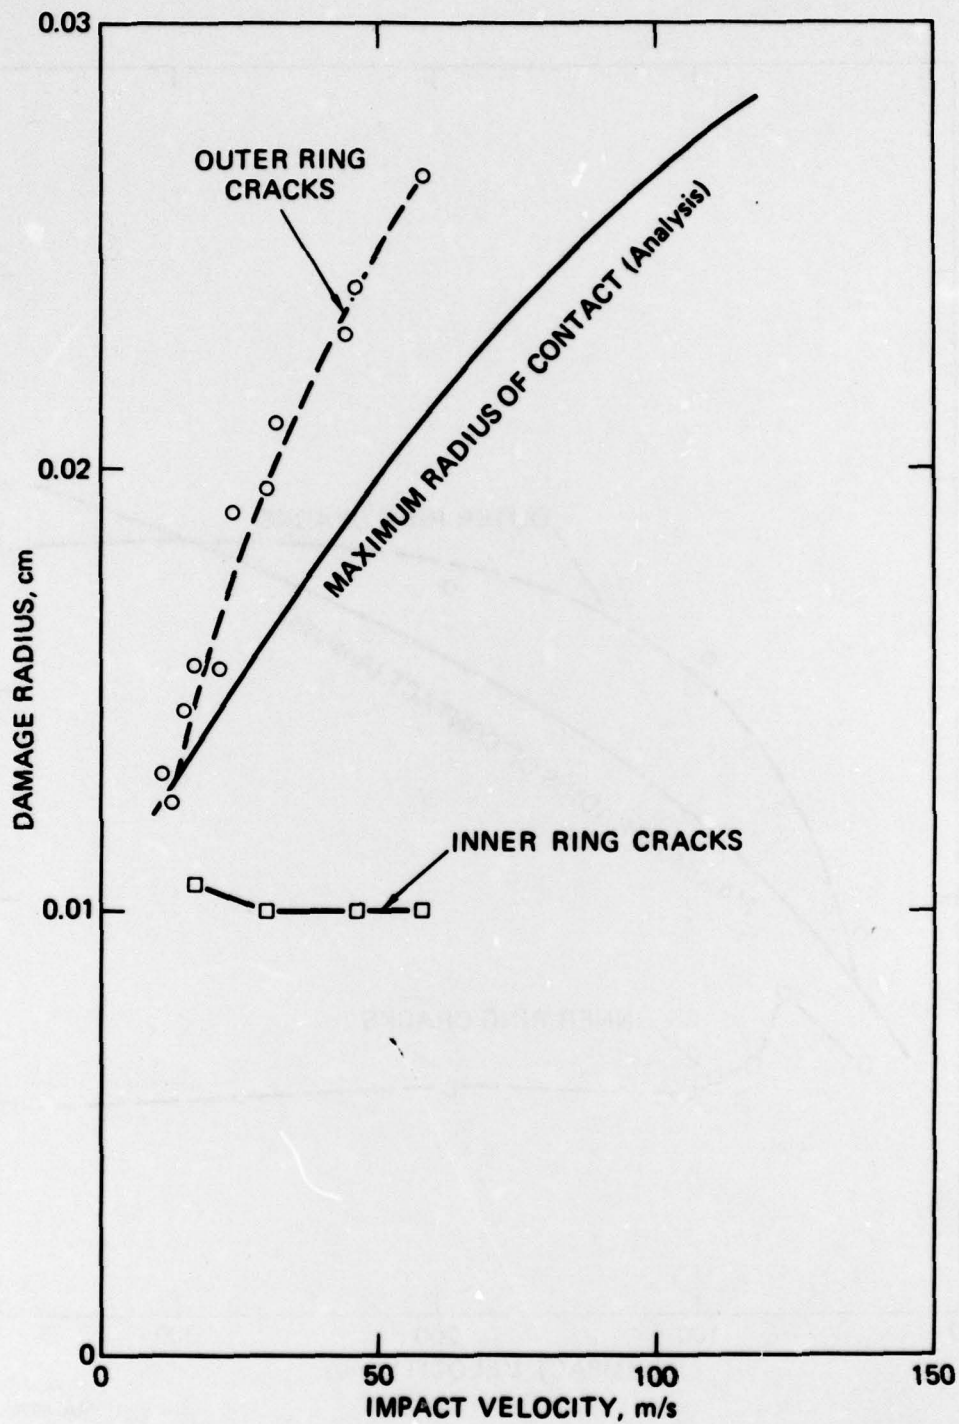
MA-4928-70

FIGURE 44 DAMAGE RADIUS RESULTS FOR IMPACT CONFIGURATION D (1.6-mm-Diameter WC Sphere/RB Si₃N₄)

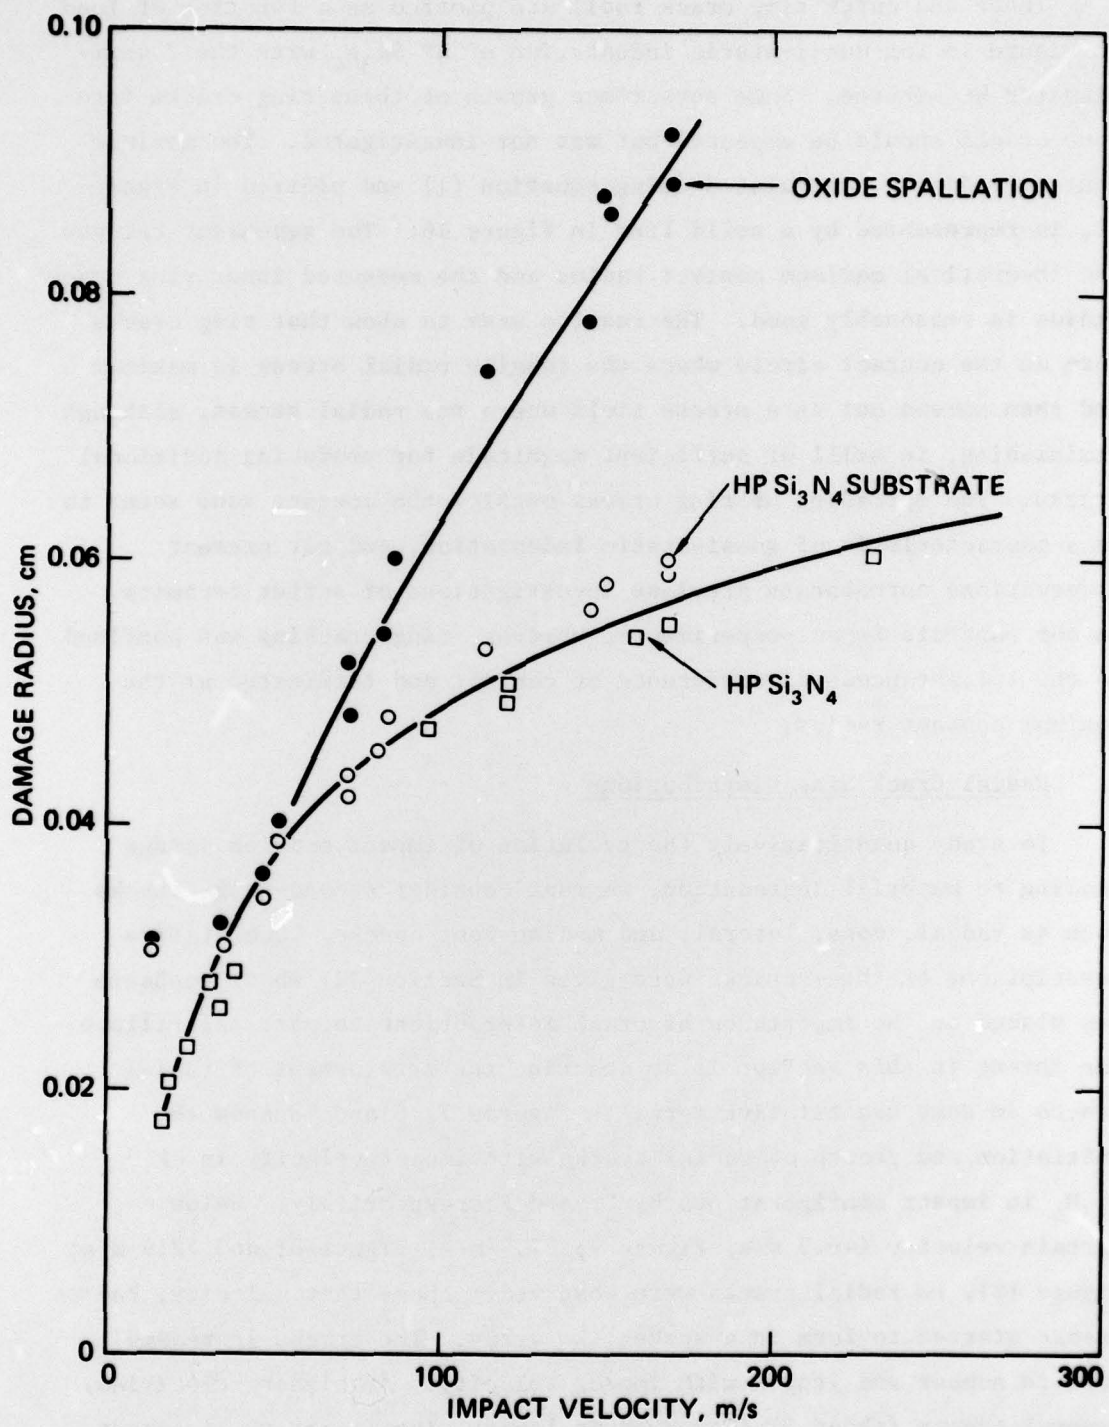
MA-4928-83

Oxide crater radius and outer ring crack radius produced in the HP Si_3N_4 substrate are plotted together with the corresponding results for oxide-free HP Si_3N_4 in Figure 45. The results indicate that similar damage radius was produced in both the underlying HP Si_3N_4 (substrate) and the oxide-free material, whereas the size of the spallation in the oxide layer was slightly greater. The results therefore quantitatively show that the oxide has very little influence on the overall morphology or extent of fracture damage in the HP Si_3N_4 .

FIGURE 45 DAMAGE RADIUS RESULTS FOR OXIDIZED AND UNOXIDIZED HP Si₃N₄ (2.4-mm-Diameter WC Spheres)

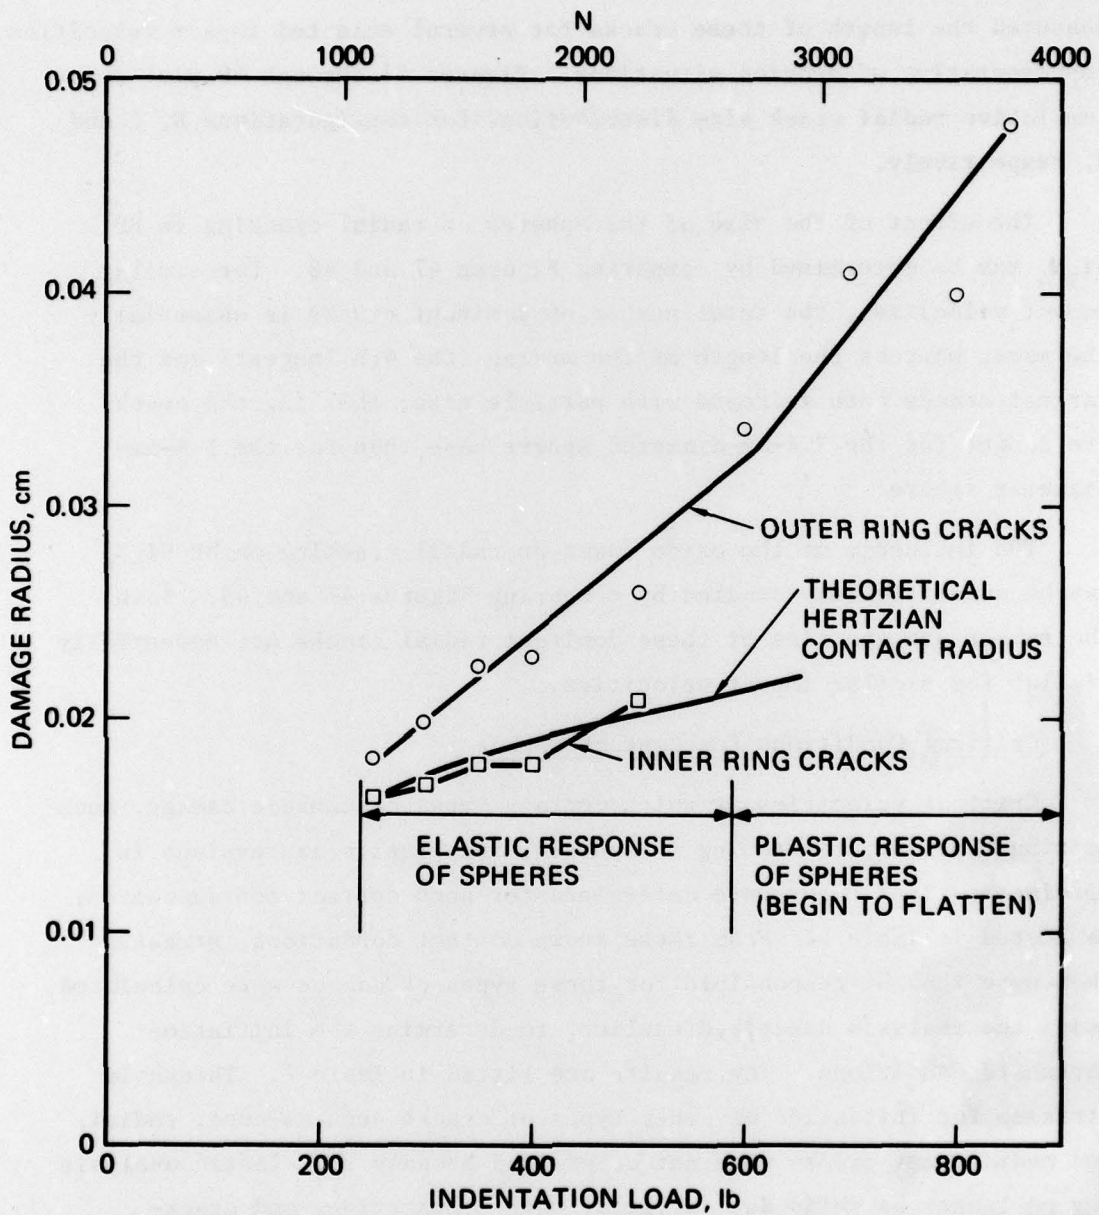
MA-4928-84

FIGURE 46 DAMAGE RADIUS RESULTS FOR QUASI-STATIC INDENTATION (2.4-mm-Diameter WC Spheres/HP Si_3N_4)

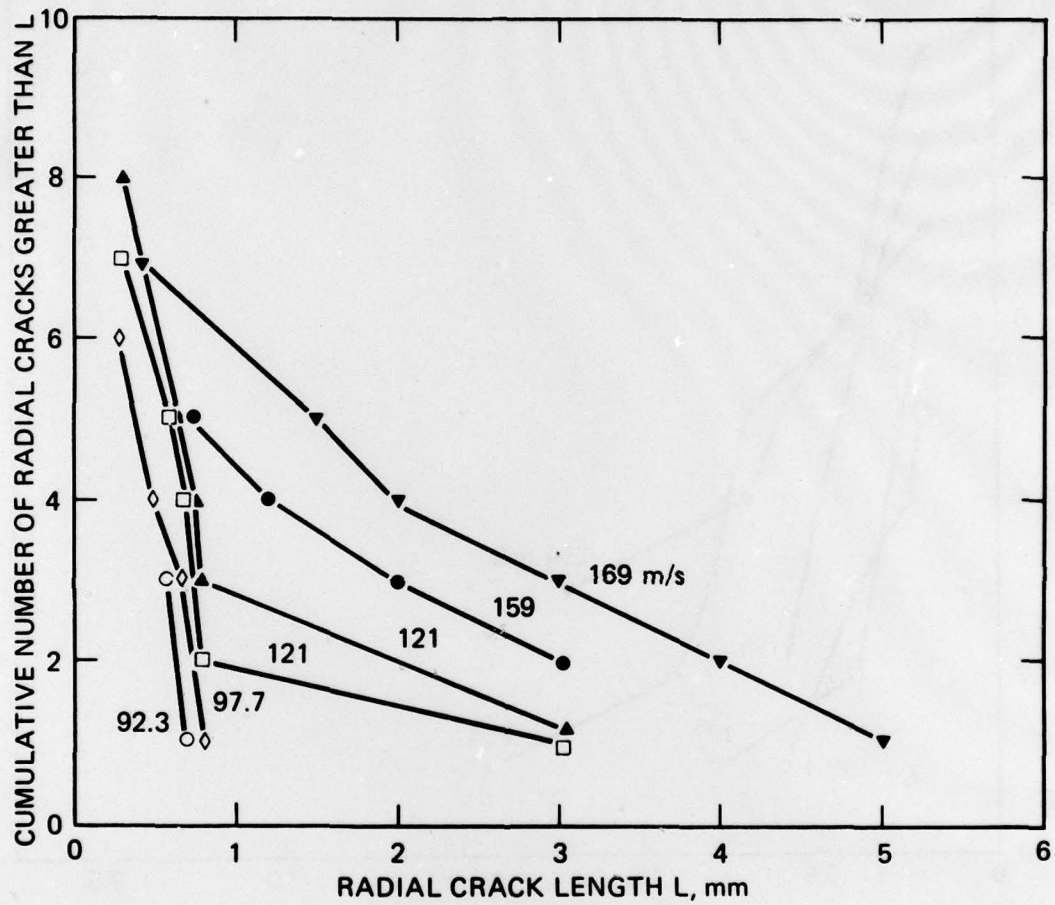
MA-4928-85

FIGURE 47 RADIAL CRACK SIZE DISTRIBUTIONS
(Impact Configuration B: 2.4 mm WC/HP Si₃N₄)

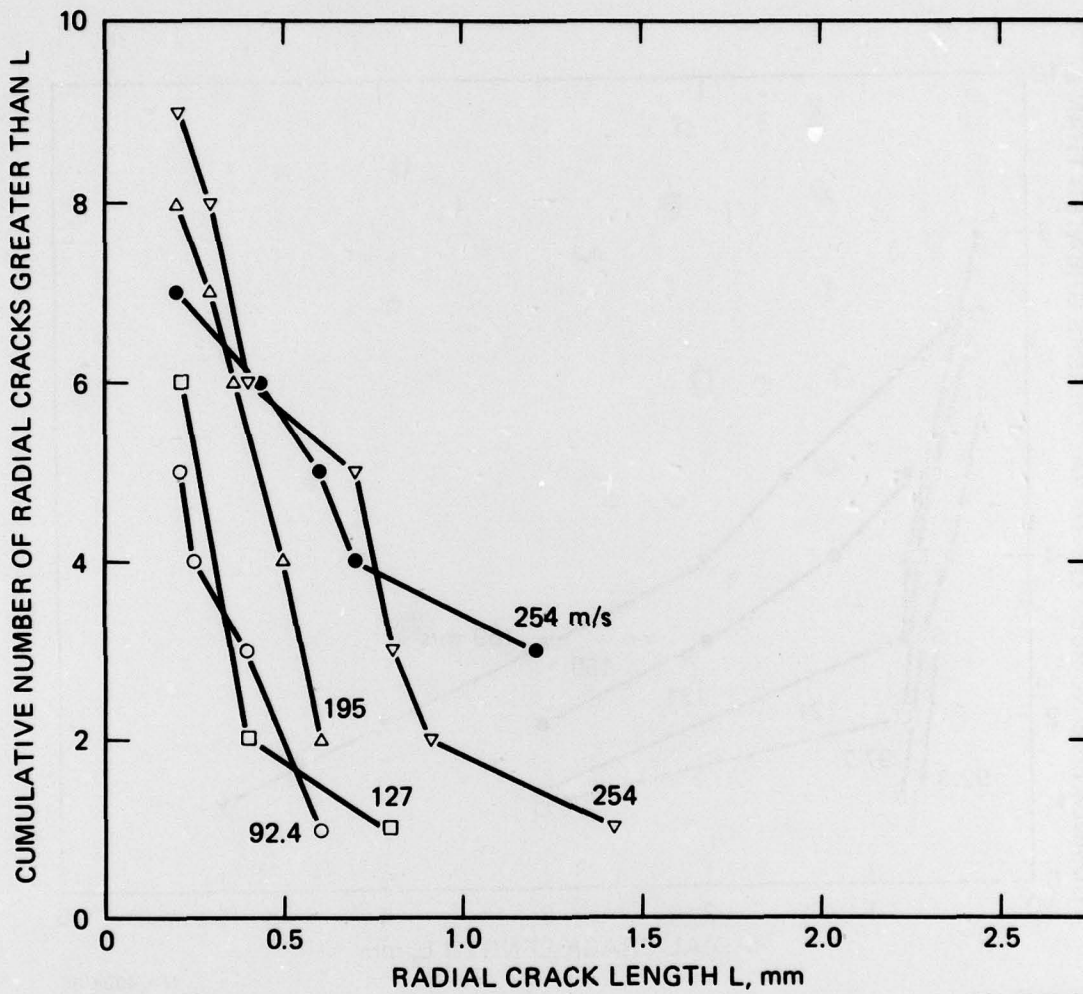
MA-4928-86

FIGURE 48 RADIAL CRACK SIZE DISTRIBUTIONS (Impact Configuration C: 1.6 mm WC/ HP Si₃N₄)
