**PARTICLE IMPACT DAMAGE
IN SILICON NITRIDE**

Annual Report — Part III

May 1979

By: K. C. Dao, D. A. Shockey, L. Seaman,
D. R. Curran, and D. J. Rowcliffe

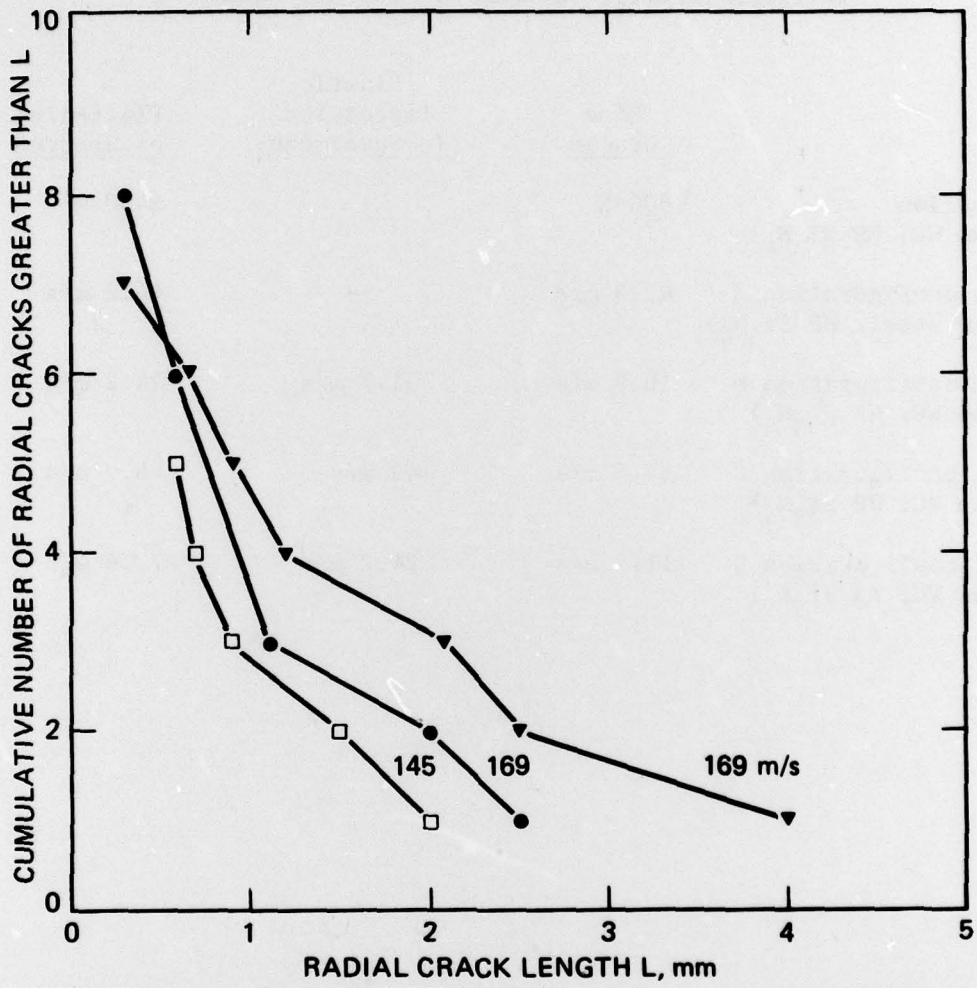
MA-4928-87

FIGURE 49 RADIAL CRACK SIZE DISTRIBUTIONS (Impact Configuration F: 2.4 mm WC/ Oxidized HP Si_3N_4)
